# ADDENDUM NO. 1

Bridge Rehabilitation, F-04-010, River Street (ST 31) over North Nashua River

# Bridge Rehabilitation, F-04-010, River Street (ST 31) over North Nashua River

CITY/TOWN B.I.N. BR. DEPT. NO. 8.-STRUCTURE NO. INSPECTION DATE FITCHBURG 1KR F-04-010 F04010-1KR-DOT-NBI AUG 15, 2022

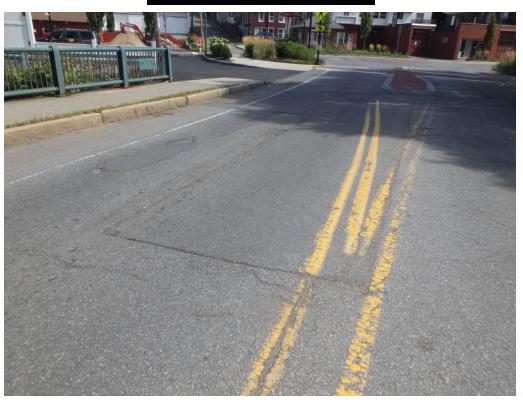
The North half of the Southbound lane has an "L" shaped 50 foot long x up to full width of the roadway bituminous patch. The patch is starting to deteriorate with shallow potholes and cracking at the edges and is slightly depressed. There are 2 temporary patches adjacent to this patch up to 10 feet long x 2 foot wide. **See photo #1.**

Photo 1: Repair in the Southbound lane at the North end.

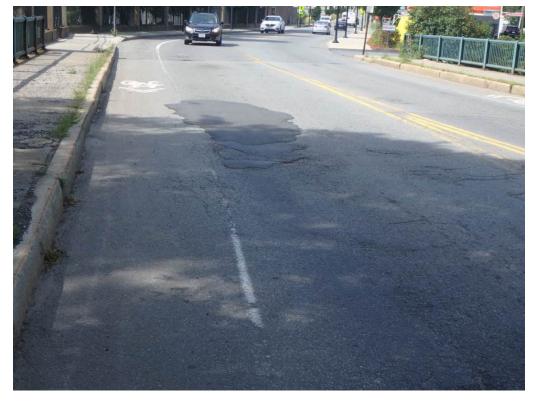
The Northbound lane has a temporary bituminous patch 23 feet long x 5 foot wide at midspan. **See photo #2.** The remainder of the wearing surface has isolated areas of hairline to moderate transverse, longitudinal and map cracking. There is a 3 foot diameter depressed area of map cracking at midspan centerline of the wearing surface. **See photo #3.**

Photo 2: Large patch in the Northbound lane near midspan.

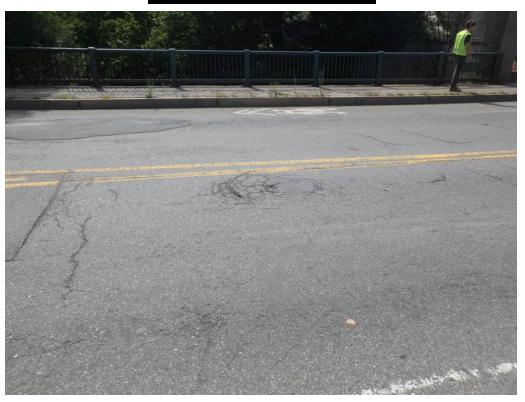
Photo 3: Cracking to the wearing surface at midspan of the structure.

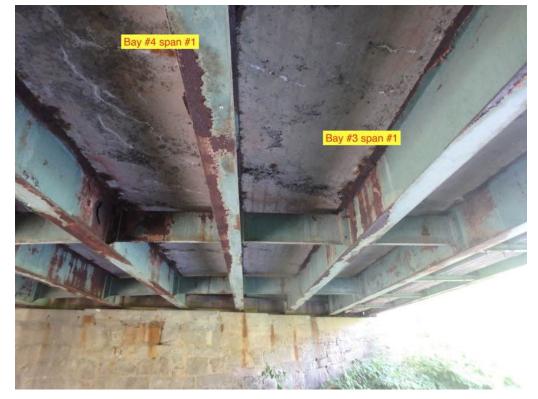
The deck has many areas of moderate honeycombing, scaling, full width hairline transverse cracking and isolated minor to moderate hairline map cracking with moderate efflorescence, heaviest in bays #3, #5 and #6 of span #2. See photos #4 - #7.

Beams #2 through #6 in both spans have many areas of paint peeling with moderate to heavy surface rusting and minor rust flaking below the areas of leaking at the cracking, scaling and honeycombing of the deck. **See photos #4 - #7.**

All the steel superstructure elements have moderate to heavy peeling of paint and minor to heavy surface rusting throughout. **See photos #4 - #7.**

Photo 4: Bays #3 and #4 of span #1.

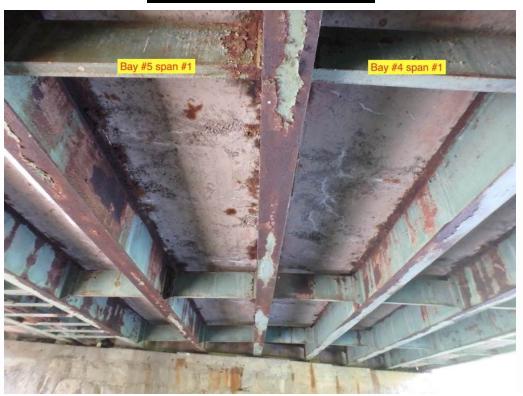
Photo 5: Bays #4 and #5 of span #1.

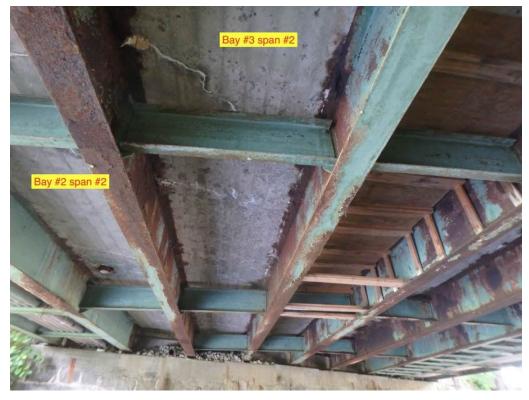
There is minor spalling and rust and efflorescence staining around the scupper drain pipe in bay #2 of span #2. **See photo #6.**

There is a scupper drain at the Northwest end of the wearing surface (bay #2). See photo #6.

Photo 6: Bays #2 and #3 of span #2. Note scupper drain in bay #2.

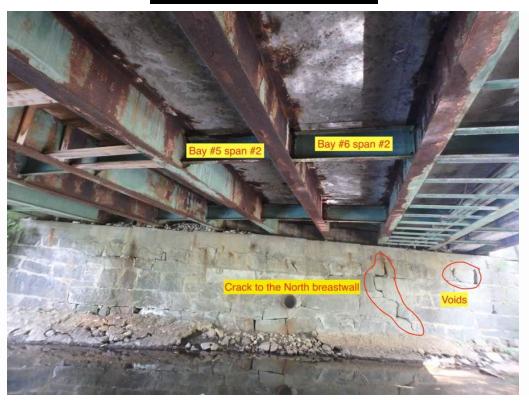
The breastwalls consist of mortared granite blocks with concrete caps. The North breastwall has a previous settlement and displacement crack along the pointing below beam #7 that does not extend into the concrete cap. There are 2 cracked stones in the area of the crack. This condition has not changed since the previous inspection. **See photo #7.**

The North breastwall cap has a 1 foot diameter shallow spall with exposed rusted rebar below beam #9, and a 1 foot diameter area of delamination and incipient spalling below beam #7. There are many areas of missing pointing throughout both breastwalls and voids with up to 4 feet of penetration, to the North breastwall at the East end. **See photo #7.**

Photo 7: Bays #5 and #6 of span #2. Note crack and voids to the North breastwall.

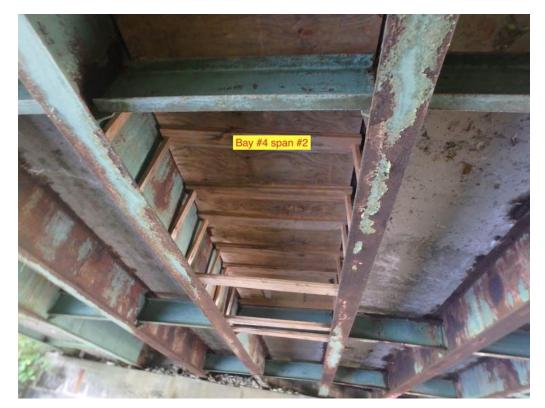
There is a full width x full depth repair to bay #4 of span #2 that extends from the north abutment to 6' north of the pier (wooden forms are still in place). **See photo #8.** This full depth concrete repair extends 6' out x full width of the bay in bays #4, #5 and #6.

Photo 8: Bays #4 of span #2.

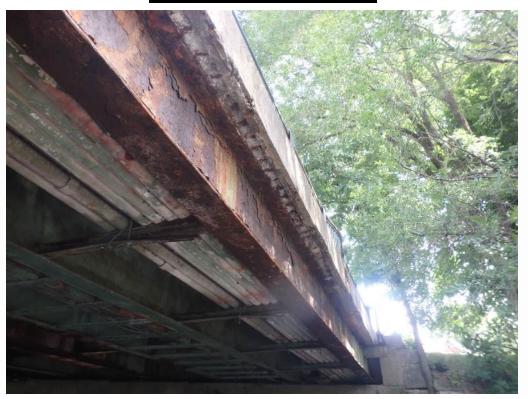
Both sidewalk/deck fascias have full length intermittent moderate spalling with exposed rusted rebar along the bottom corner. **See photos #9 and #10.**

Both sidewalk fascias have full length severe scaling and spalling, up to 3 inches deep, with exposed rusted rebar throughout, mostly along the bottom corner. **See photos #9 and #10.**

Photo 9: Typical spalls to the deck overhang at the East fascia, span #2.

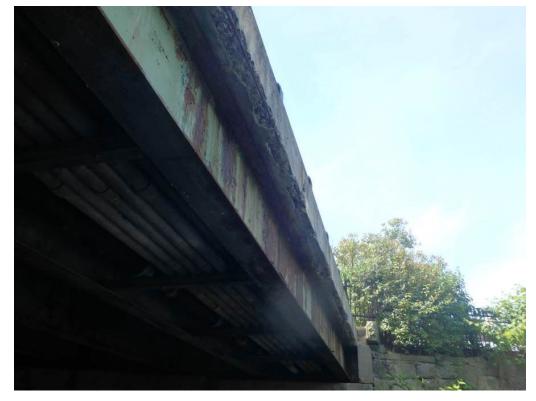
Photo 10: Typical spalls to the deck overhang at the West fascia, span #1.

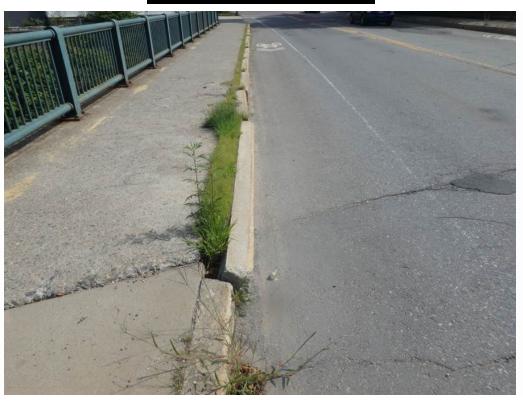
Photo 11: Loose curb stones at the South end of the West side.

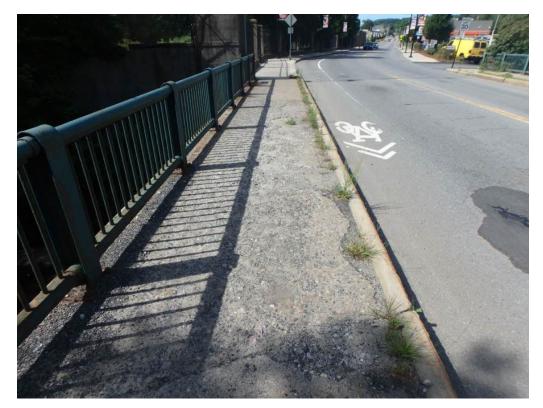
There is heavy scaling, up to 35 feet x full width, and spalling up to 6 inches long x 3 foot wide x 3 inch deep with exposed rebar, throughout the East sidewalk. It is hollow sounding from the pier to the South abutment. **See photo #12.**

Photo 12: Heavy scaling to the East sidewalk, span #1.

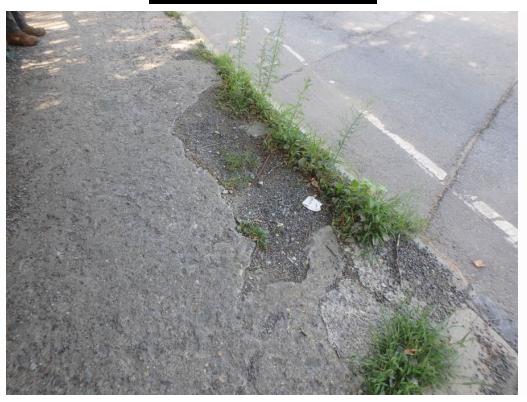
Photo 13: Spall to the North end of the East sidewalk.

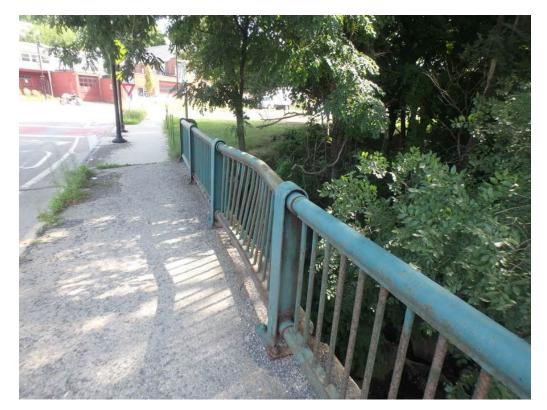
One 7 foot long section of the East rail at the North end has moderate collision damage between the posts. **See photo #14.**

Photo 14: Bent rail at the North end of the East bridge rail.

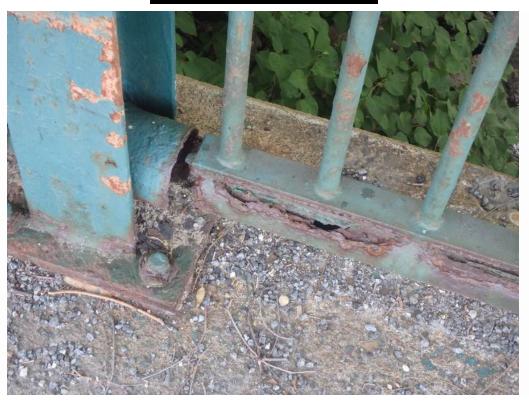
Photo 15: 100% section loss to the bottom rail of the East bridge rail at the North end.

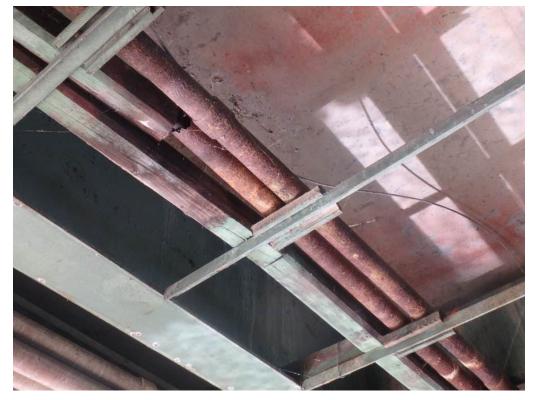
There is moderate rusting throughout to the utility conduits in bay #7, some up to 100% section loss . **See photo #16.**

Photo 16: Typical corrosion of the utility conduits in bay #7.

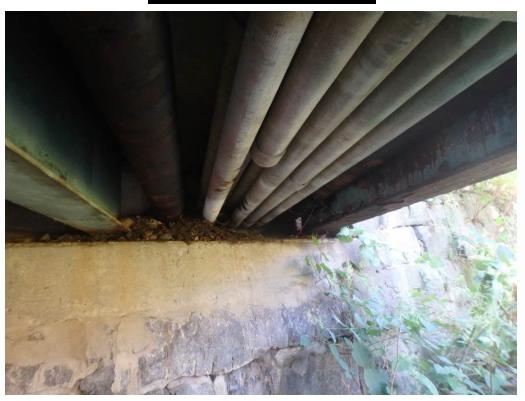
Several conduits in bays #1 of span #1 are broken and missing. See photo #17.

Photo 17: Missing section of the utility conduit in bay #1 near South abutment.

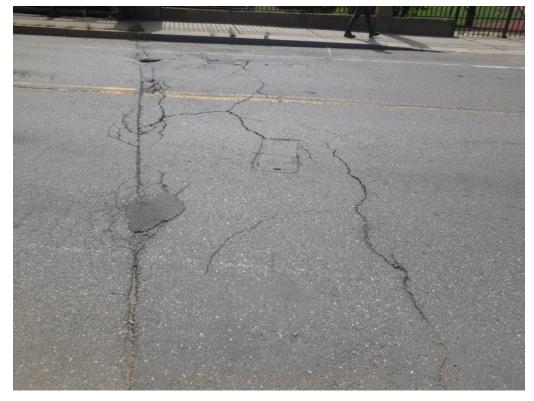
The South approach to deck transition has a full lane width cracking. There is a 1.5 foot diameter pothole in the Northbound lane and a 1 foot diameter patched pothole in the Southbound lane. **See photo #18.** The South approach pavement has moderate transverse and longitudinal cracking throughout.

Photo 18: South approach to deck transition. Note pothole in the Northbound lane.

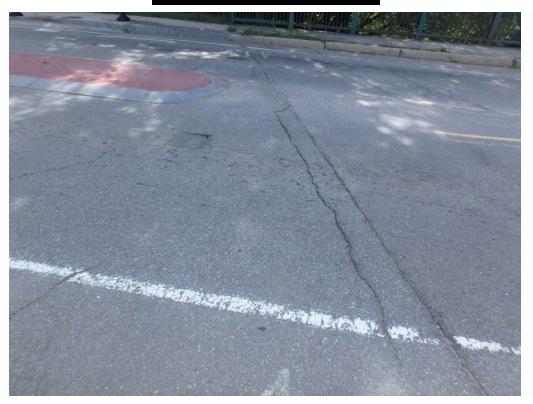
The North approach to deck transition has a full lane width crack in the Southbound lane extending 6 feet into the Northbound lane. There are three 1 foot diameter patched potholes in the Northbound lane and 1 in the Southbound lane. **See photo #19.**

Photo 19: North approach to deck transition.

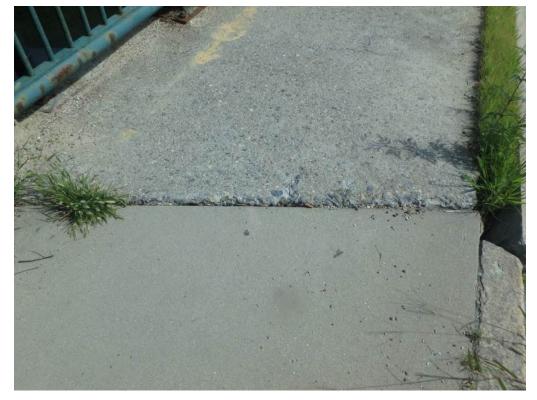
Photo 20: Southwest approach sidewalk settlement.

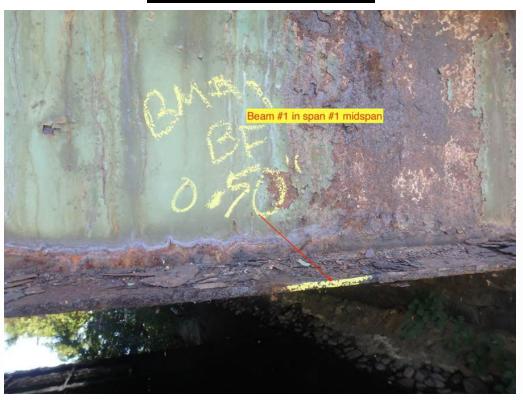
Beam #1 in both spans shows many areas of paint peeling with moderate surface rusting and minor rust flaking to the top and bottom flange on the West face. There is 0.5 inches remaining in span #1 bottom flange and 0.6 inches remaining in span #2 at approximately midspan. **See photo #21.**

Photo 21: Beam #1 in span #1 midspan.

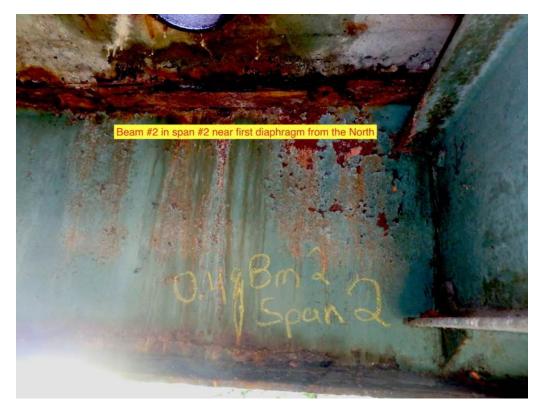
Photo 22: Beam #2 in span #2 near North end.

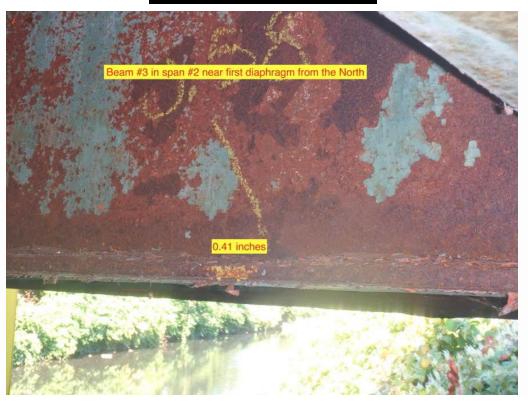
Photo 23: Beam #3 in span #2 near North end.

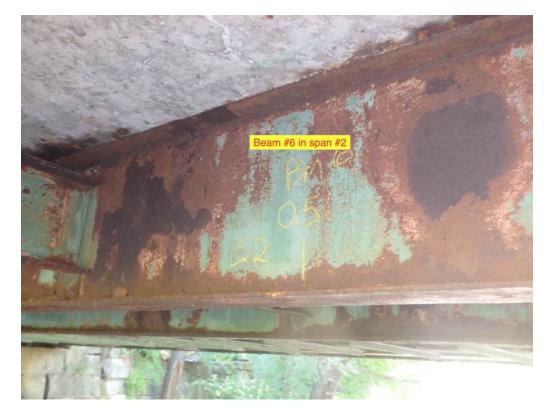
Beam #6 in both spans has the worst deterioration where the paint peeling and rusting encompasses larger areas of the beam. In span #1 at 10 feet from the South end there is 0.52 inches remaining and in span #2 there is 0.51 inches remaining 10 feet north of the pier. **See photo #24.**

Photo 24: Beam #6 in span #2 near midspan.

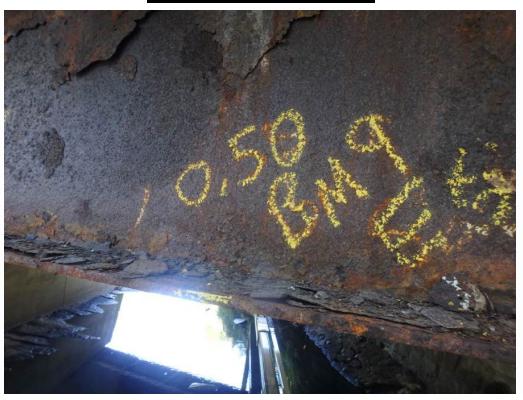
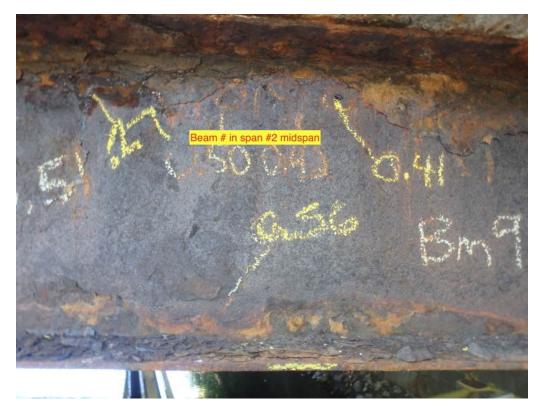
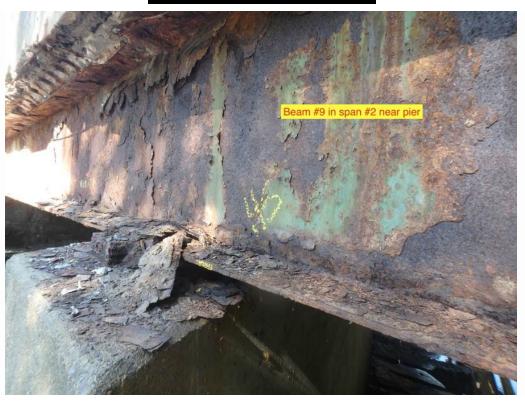
Beam #9 in both spans has many areas of paint peeling on both sides of the beam with moderate to heavy rust flaking to the entire length of the top and bottom flanges and several areas of the web on the outside (East side) of the beam. At the pier and near midspan in spans #1 and #2 there is moderate rust flaking to the web and bottom flange with as little as 0.45 inches remaining to the bottom flange. Near midspan of span #2 the web has areas of 0.27" remaining near the top. **See photos #25 - #27.**

Photo 25: Beam #9 in span #2 near midspan.

Photo 26: Beam #9 in span #2 near midspan.

Photo 27: Beam #9 in span #2 near pier.

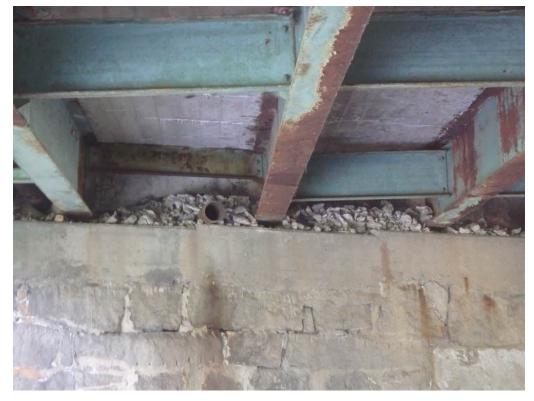
Photo 28: Debris on top of the North bridge seat in bays #2 - #4.

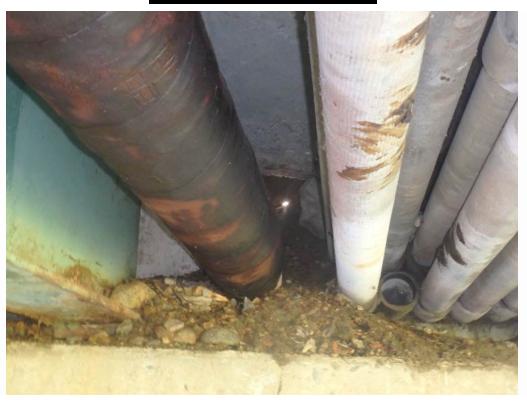
The utility cutout in bay #1 of the South backwall shows heavy deterioration with moderate loss of fill which is now on the bridge seat. The loss of fill area is 2 foot wide x 2 foot high x 2 foot deep. The area is below the misaligned curb with daylight coming through. **See photo #29.**

Photo 29: Fill from utility cutout at the South end of bay #1 in span #1. Note daylight.

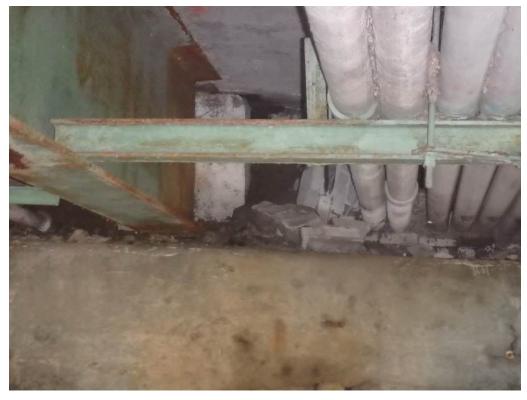
Photo 30: Collapsed brick around utility at the North end of bay #8 in span #2.

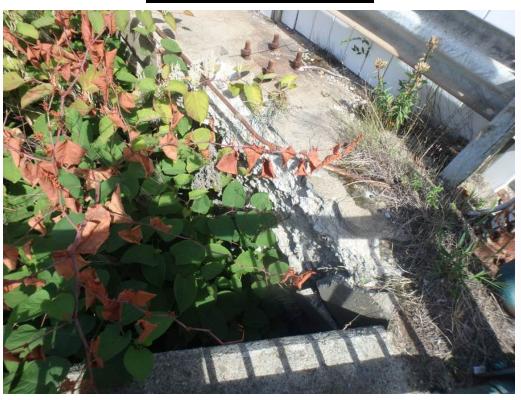
The Northwest channel wall concrete cap has severe scaling/spalling. See photo #31.

Photo 31: Heavy scaling to the top of the Northwest channel wall.

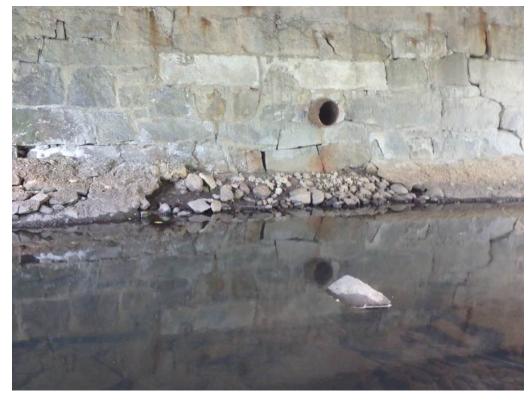
A 15 foot long x 4 foot wide section of concrete is missing from the concrete and stone scour protection in front of the North abutment, below bays #4 and #5 and the South abutment along the bottom of the stone scour protection. **See photo #32.**

Photo 32: Missing scour protection at the North breastwall.

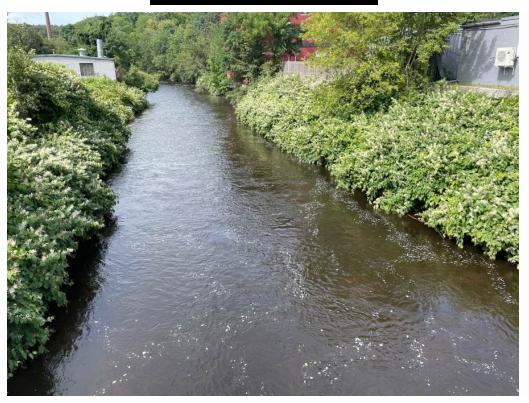
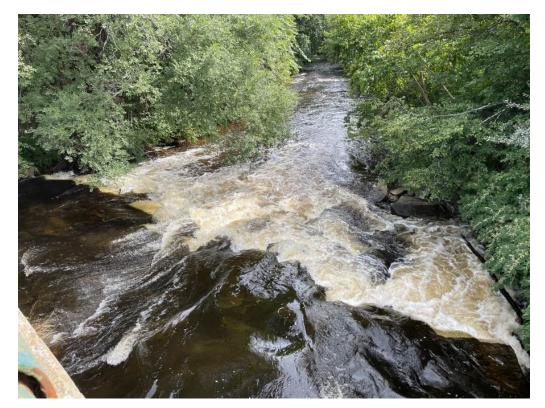
Water height and velocity are of normal conditions. See photos 1 - 3.

Photo 1: Upstream view

Photo 2: Downstream

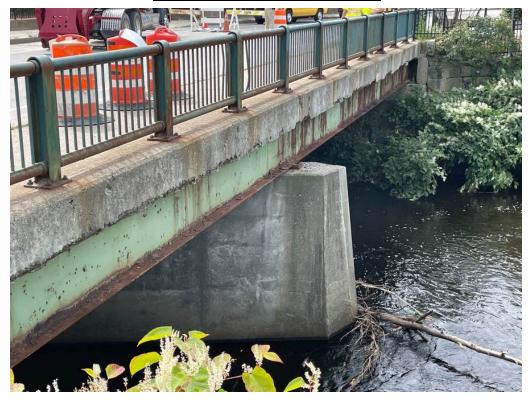
Photo 3: Debris at upstream channel nose
