PROJECT:
42 Inch PCCP Raw Water
Conveyance Pipeline and EDV
Facility
1515 Granville Road
Westfield, MA 01085
Project No. 24-01

ADDENDUM NO. 1 03/14/2024

**IFB# 24-01 WEST PARISH FILTERS WATER TREATMENT PLANT 42 INCH
RAW WATER CONVEYANCE REHABILITATION AND ENERGY
DISSIPATION VALVE CHAMBER
WESTFIELD, MASSACHUSETTS 01201**

Internal Inspection Findings – Summary

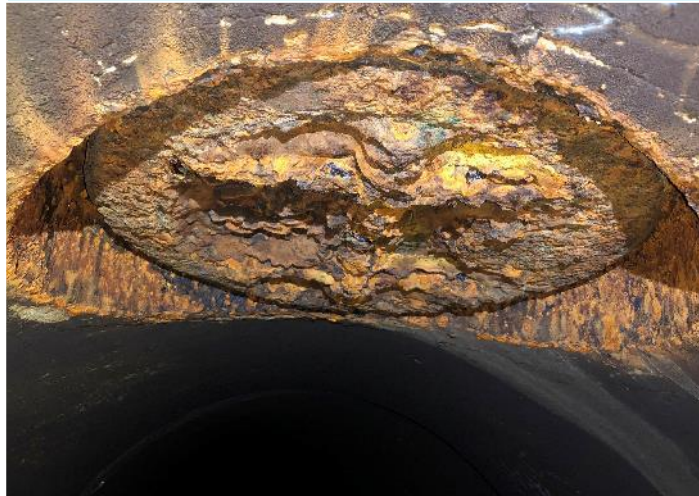
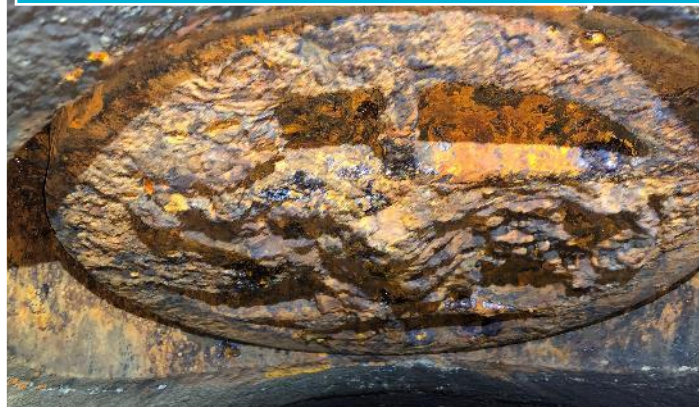
Manway 6: Boiler-Type, Corroded. No major cracks but faint mortar crack around opening. Couple of circumferential hairline cracks near manhole opening, autogenous healing visible.

Manway 6: Ditto

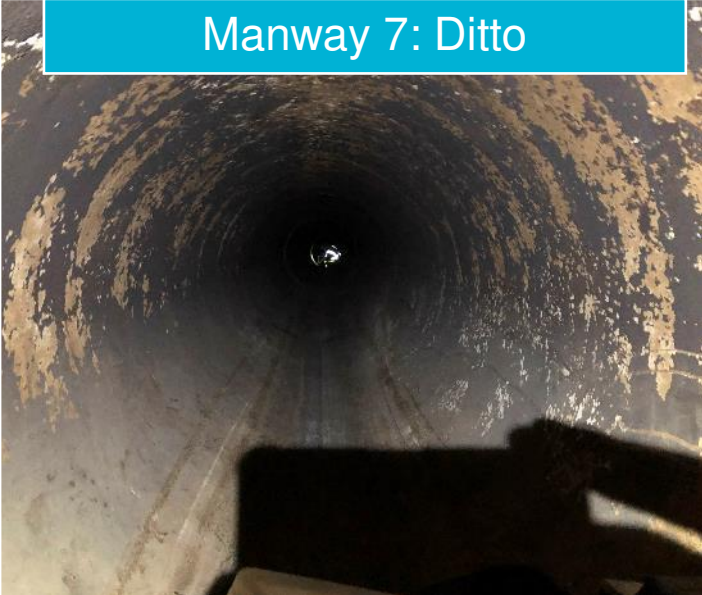
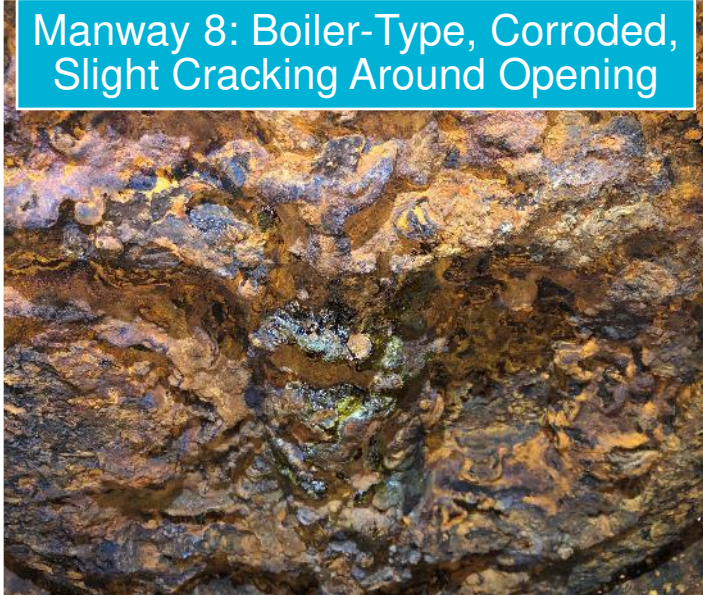
Manway 8: Boiler-Type, Corroded, Slight Cracking Around Opening

Manway 8: Ditto

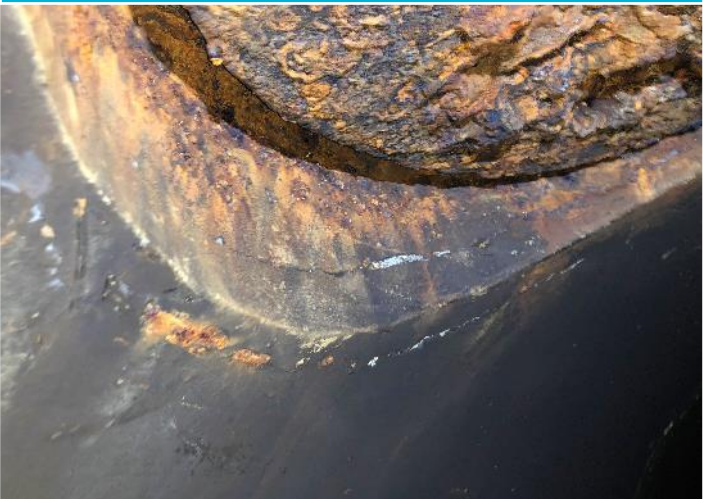
Manway 10: Boiler-Type, Corroded, Both Joints Good

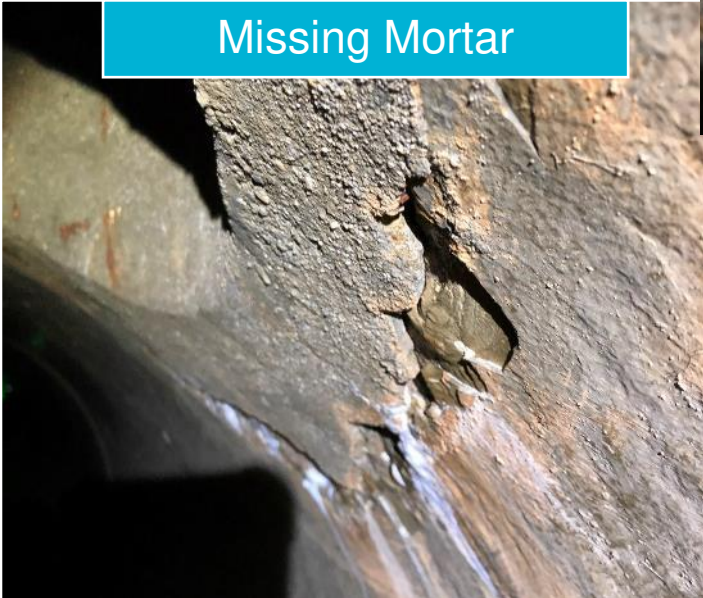
Missing Mortar

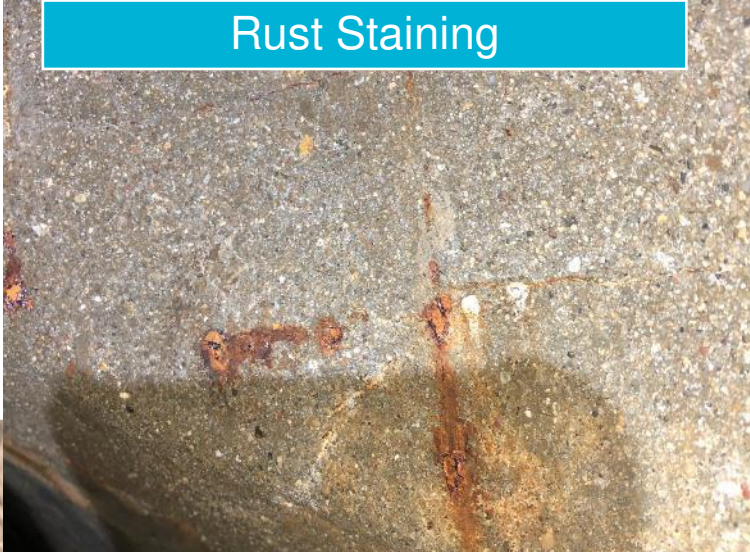
Rust Staining

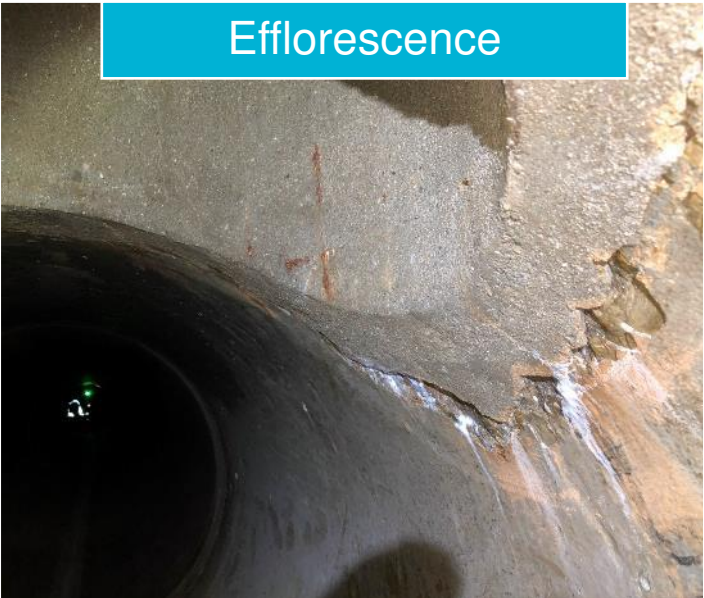
Efflorescence

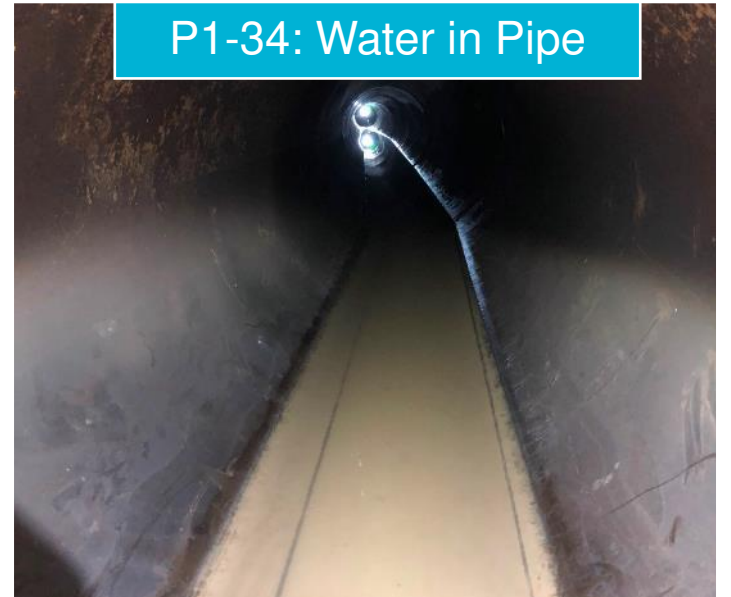
P1-34: Water in Pipe

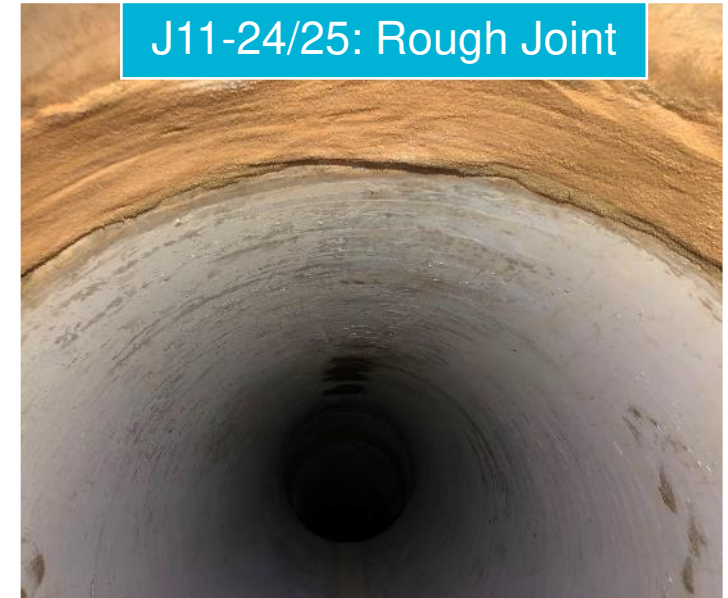
J11-24/25: Rough Joint

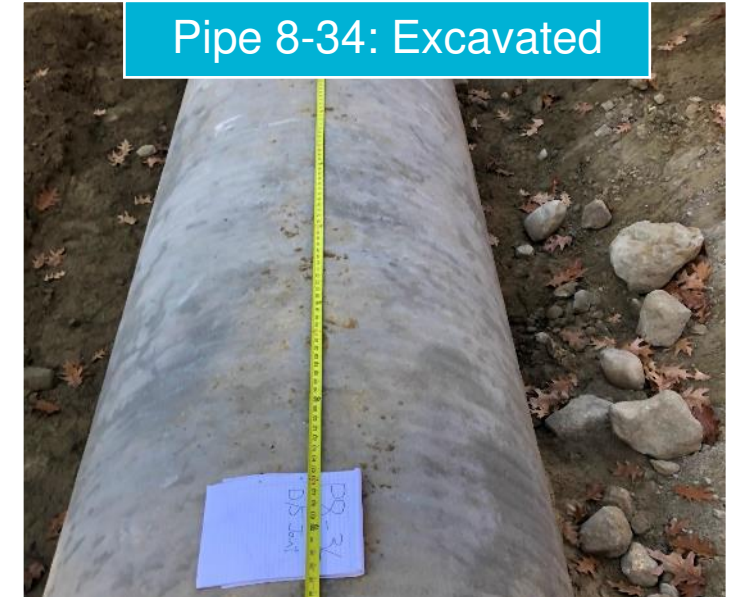
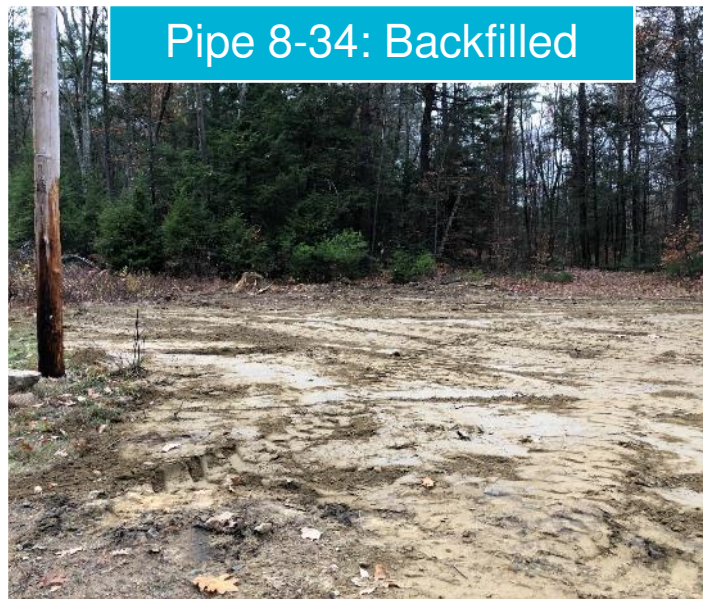
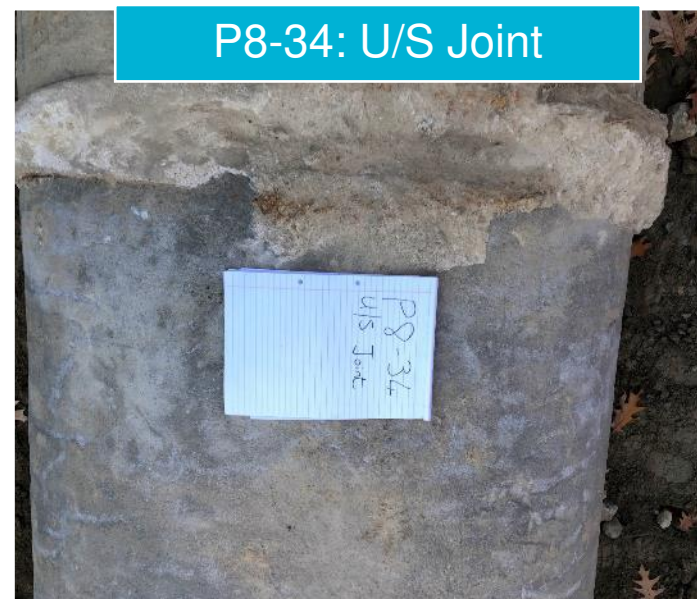
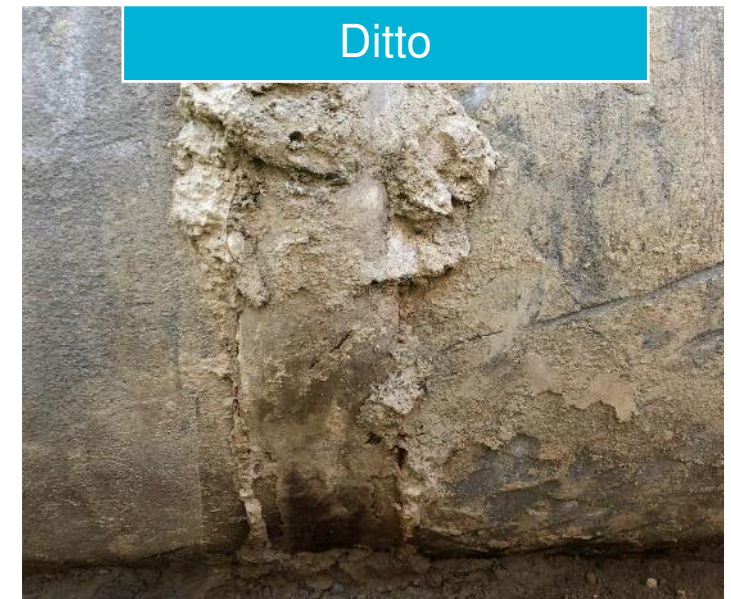
External Inspection: Day 6 – 9 November 2020 : Pipe 8-34

- Pipe 8-34 ECP 175 [5 wire breaks near joint] CH74+91.
- No visual signs of cracking, wire breaks, or damage.
- Performed hammer-sounding along full exposed length (crown, shoulder & springlines) & adjacent pipes.
 - No hollow sounds.
- Backfill material is imported clean fine sand (sample collected).
- Joint diaphragms appear acceptable and holding.
