NOTICE TO PROSPECTIVE BIDDERS
RI CONTRACT NO. 2024-CB-018 – ADDENDUM NO. 1

Add New Appendix to this Addendum No. 1. “Bridge Inspection Report” has been added.

SPECIAL INSPECTION SCOPE: The scope of the special inspection shall include the advanced deterioration of the beam ends including the web area beyond the end diaphragms, end diaphragms, fixed bearings and moveable bearings. The special inspection shall also include the AASHTO Fatigue Category E' welds at the transverse ends of the cover plates and the bottom flanges of the beams. If any cracks are observed at these weld details, the RIDOT Bridge Ratings Section shall be notified.

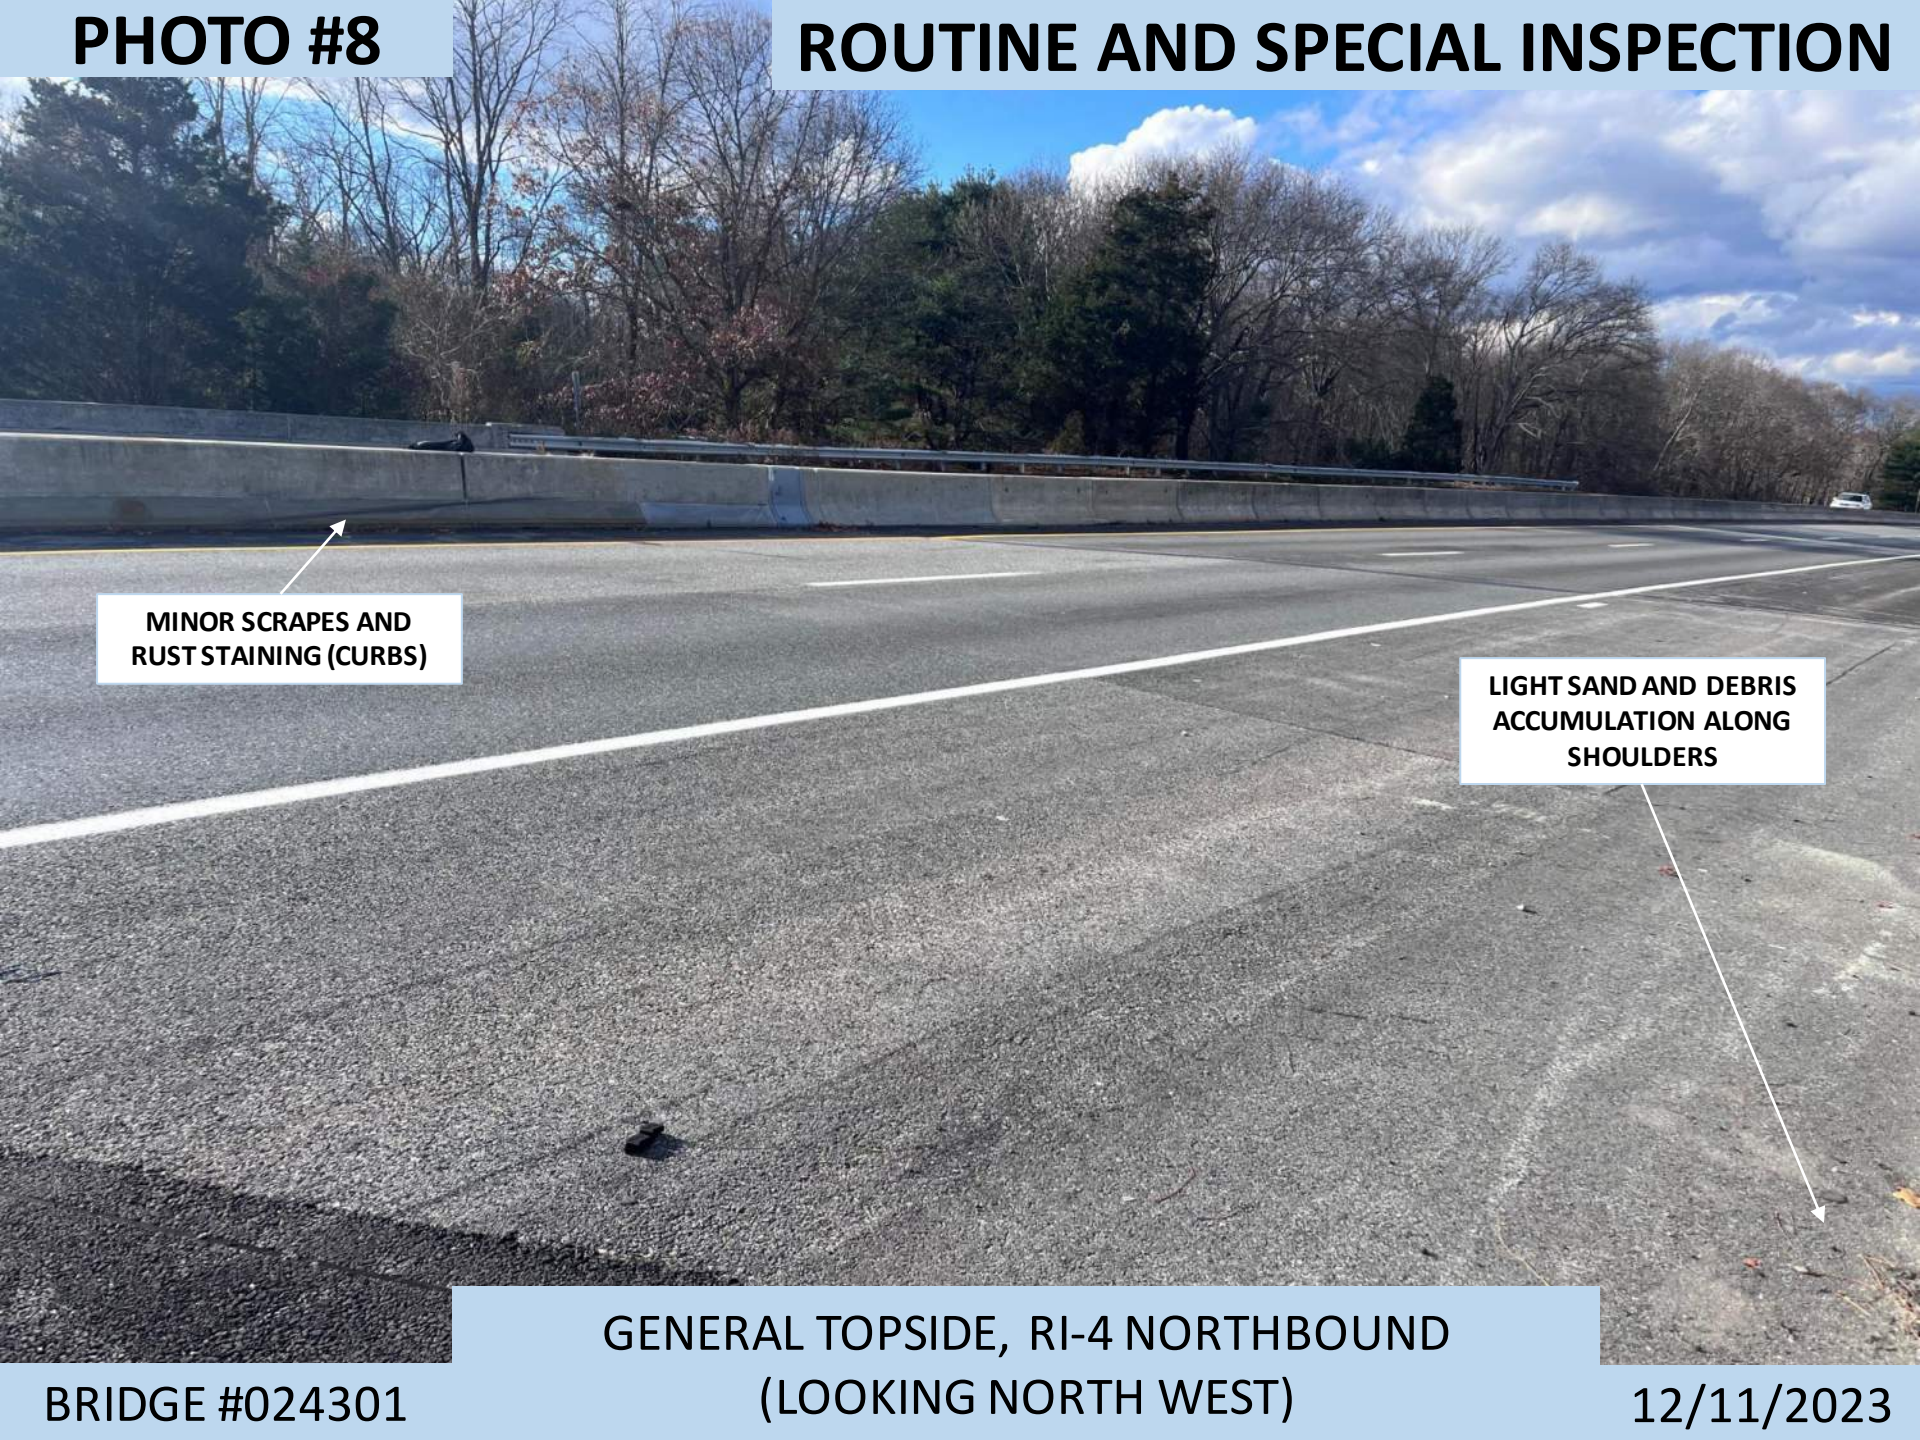
**MINOR SCRAPES AND
RUST STAINING (CURBS)**

**LIGHT SAND AND DEBRIS
ACCUMULATION ALONG
SHOULDERS**

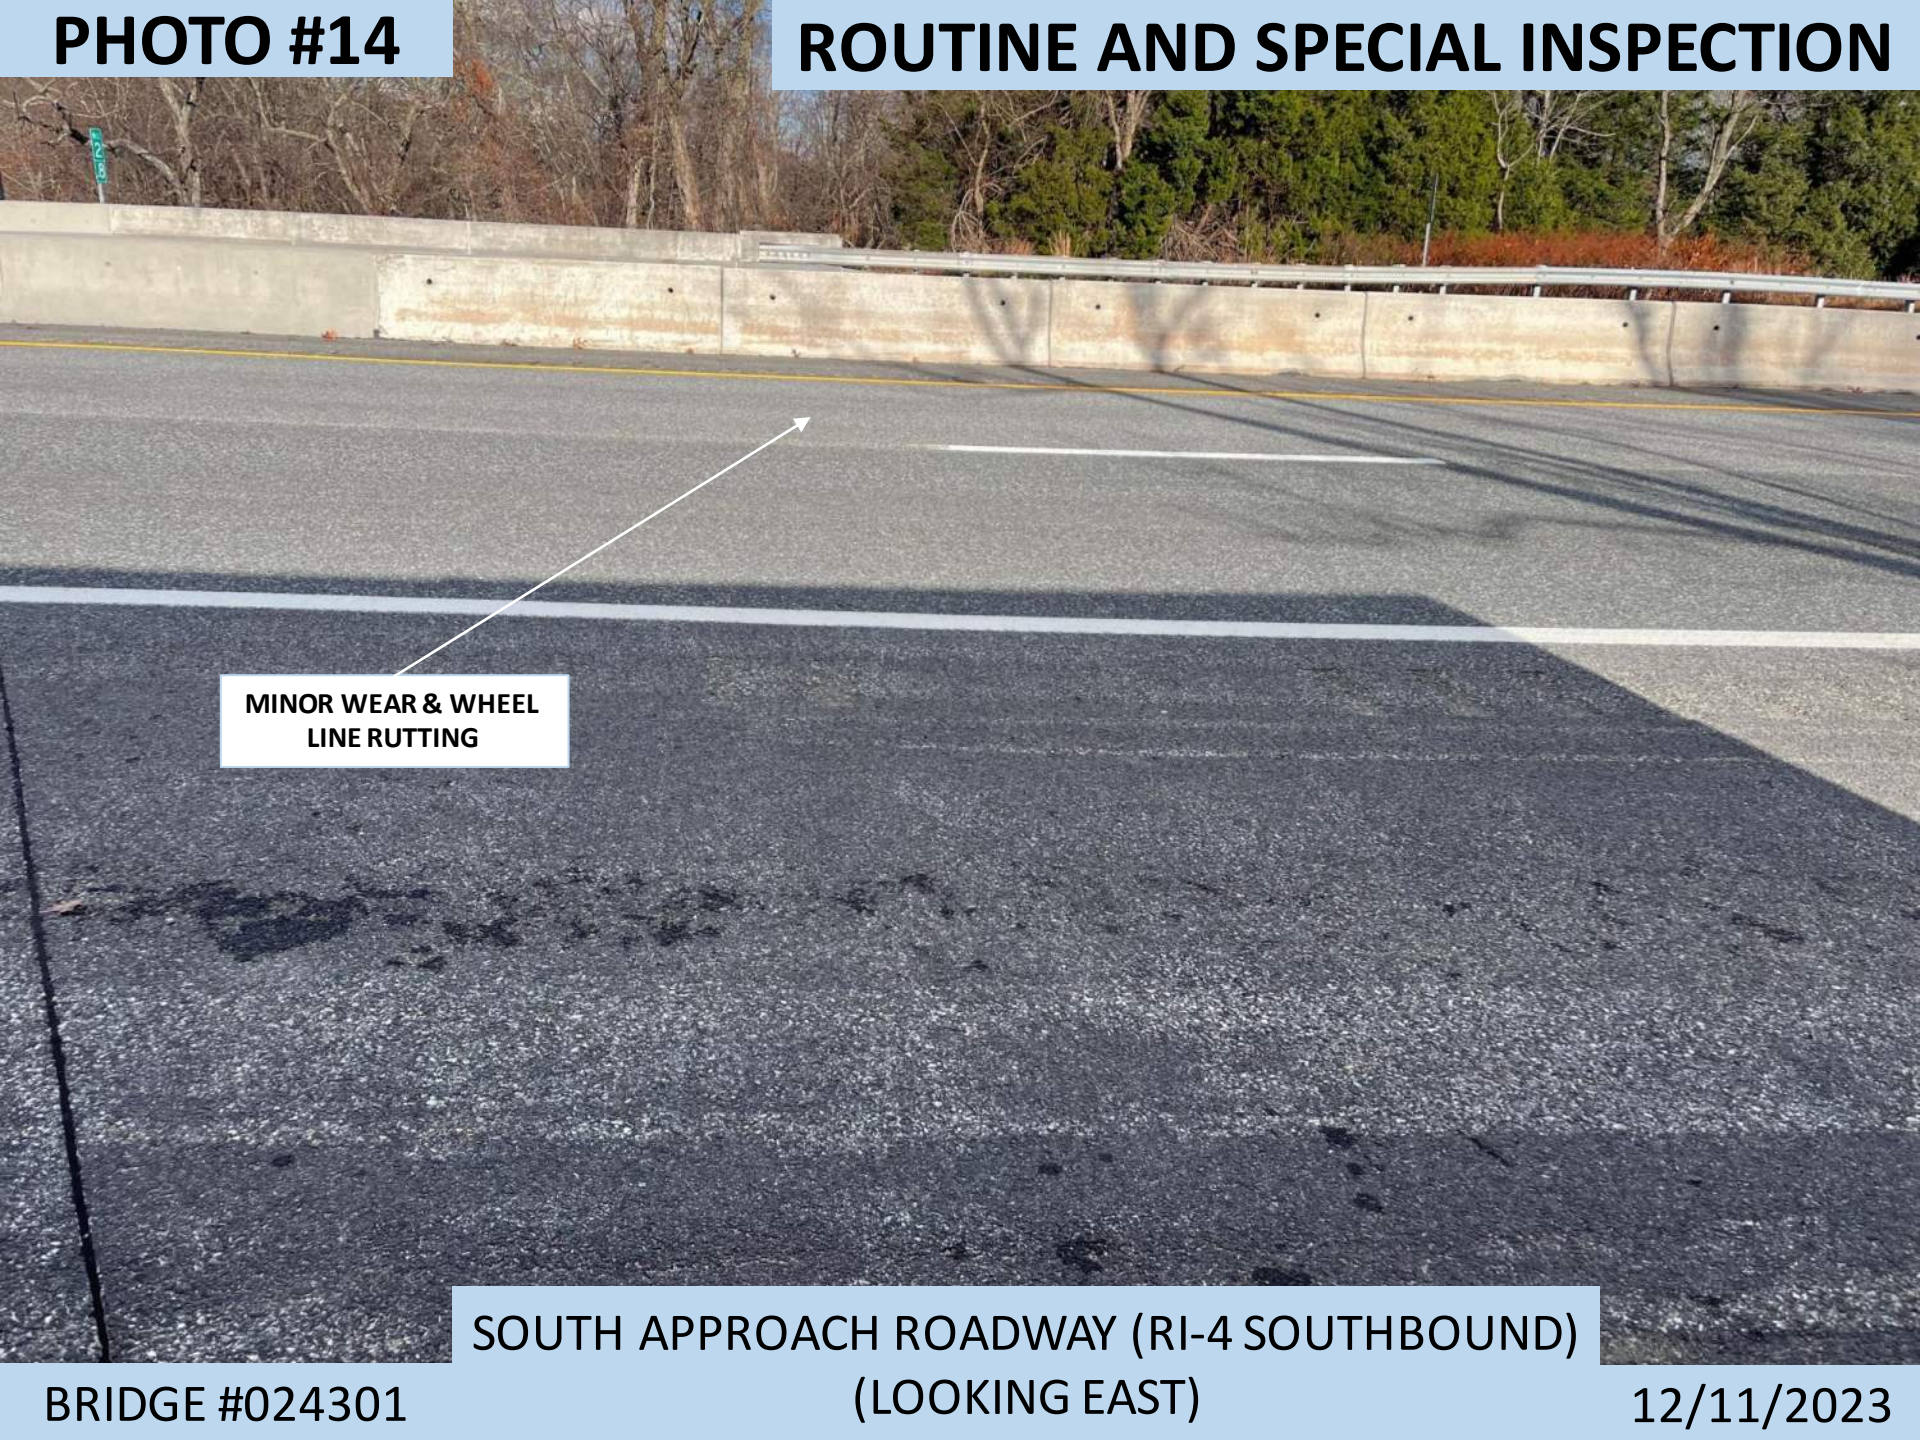
PHOTO #14

**MINOR WEAR & WHEEL
LINE RUTTING**

**SOUTH APPROACH ROADWAY (RI-4 SOUTHBOUND)
(LOOKING EAST)**

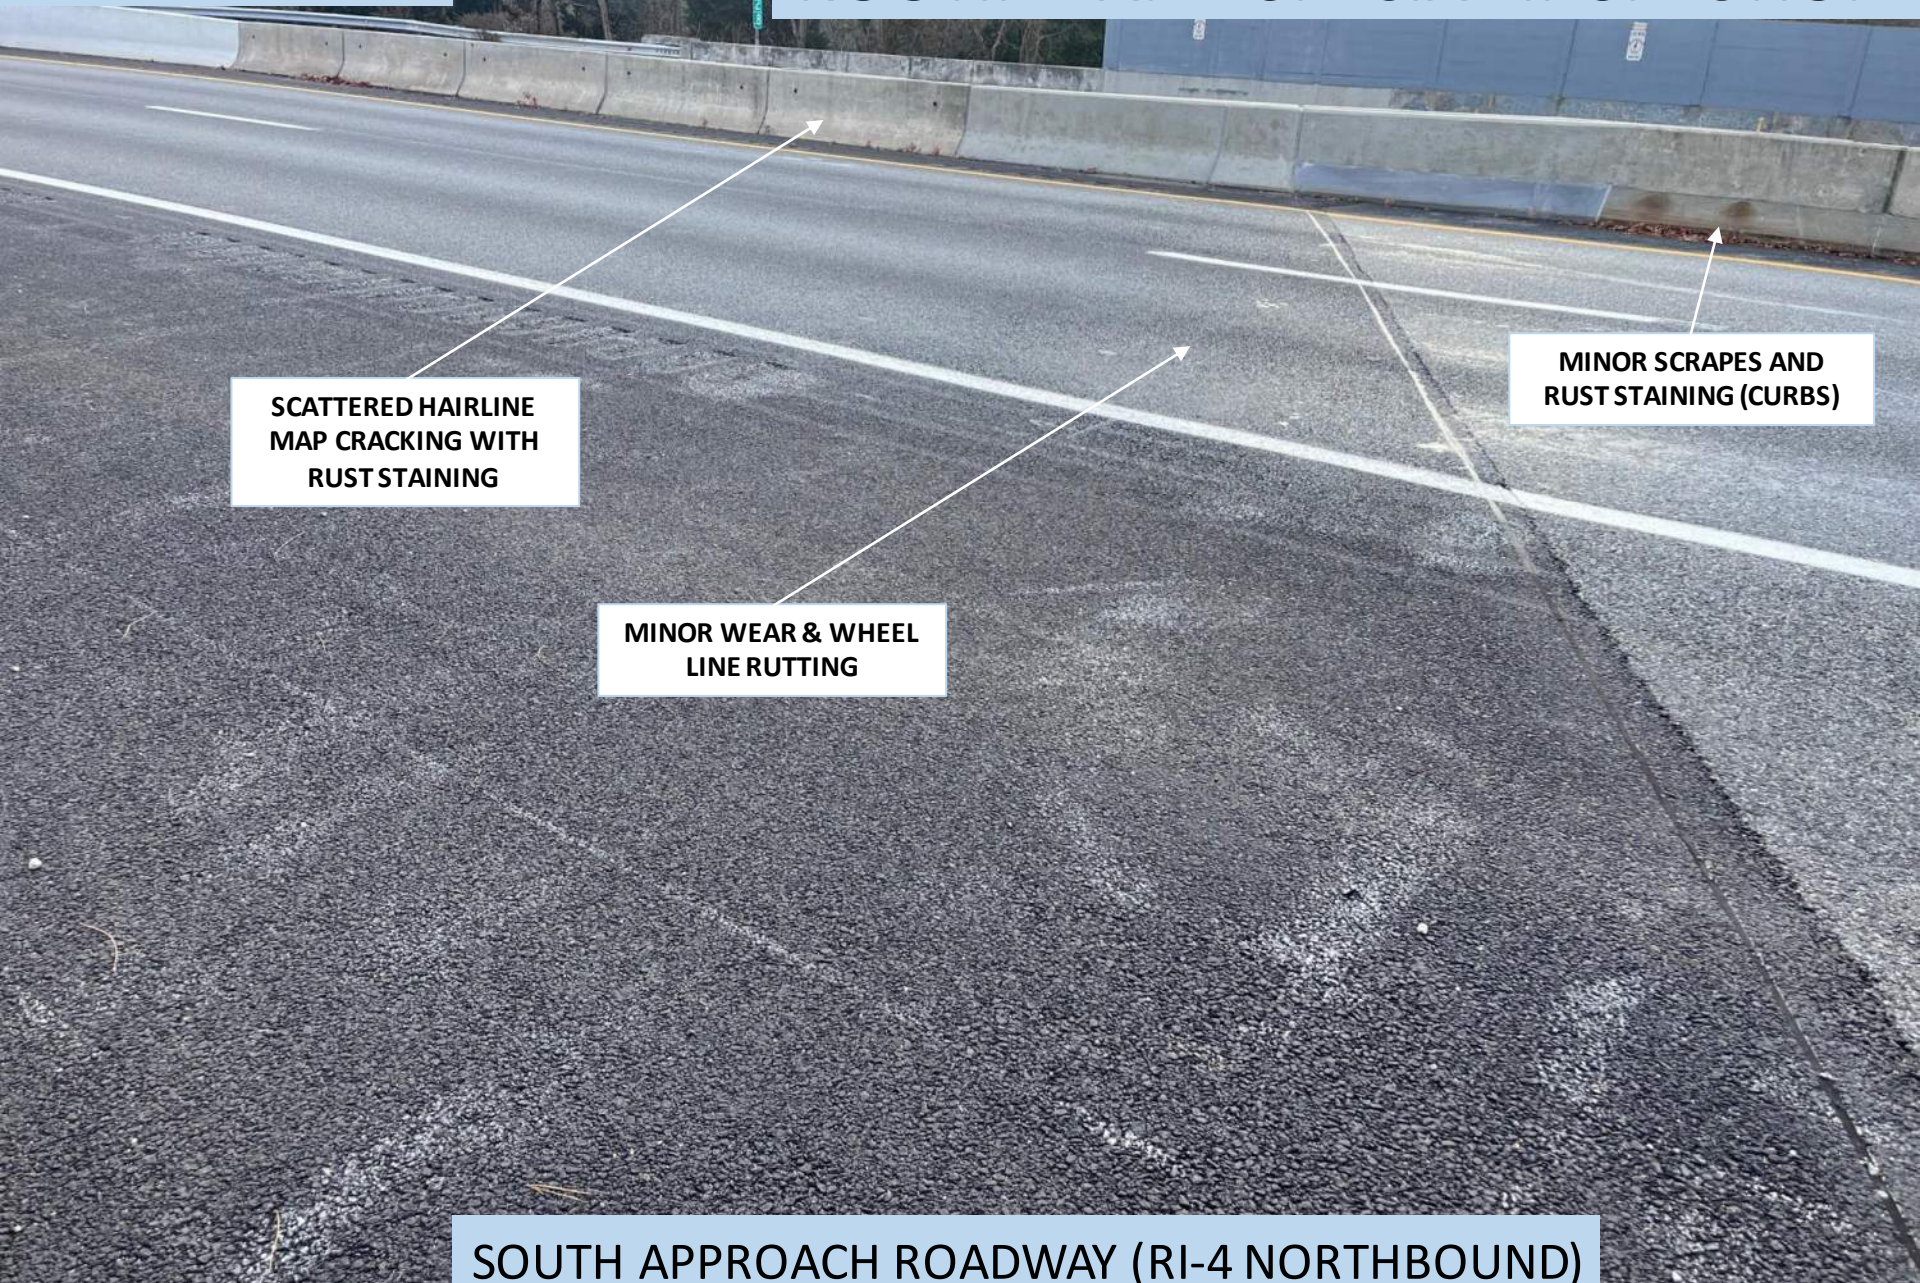
**SCATTERED HAIRLINE
MAP CRACKING WITH
RUST STAINING**

**MINOR WEAR & WHEEL
LINE RUTTING**

SOUTH APPROACH ROADWAY (RI-4 NORTHBOUND)

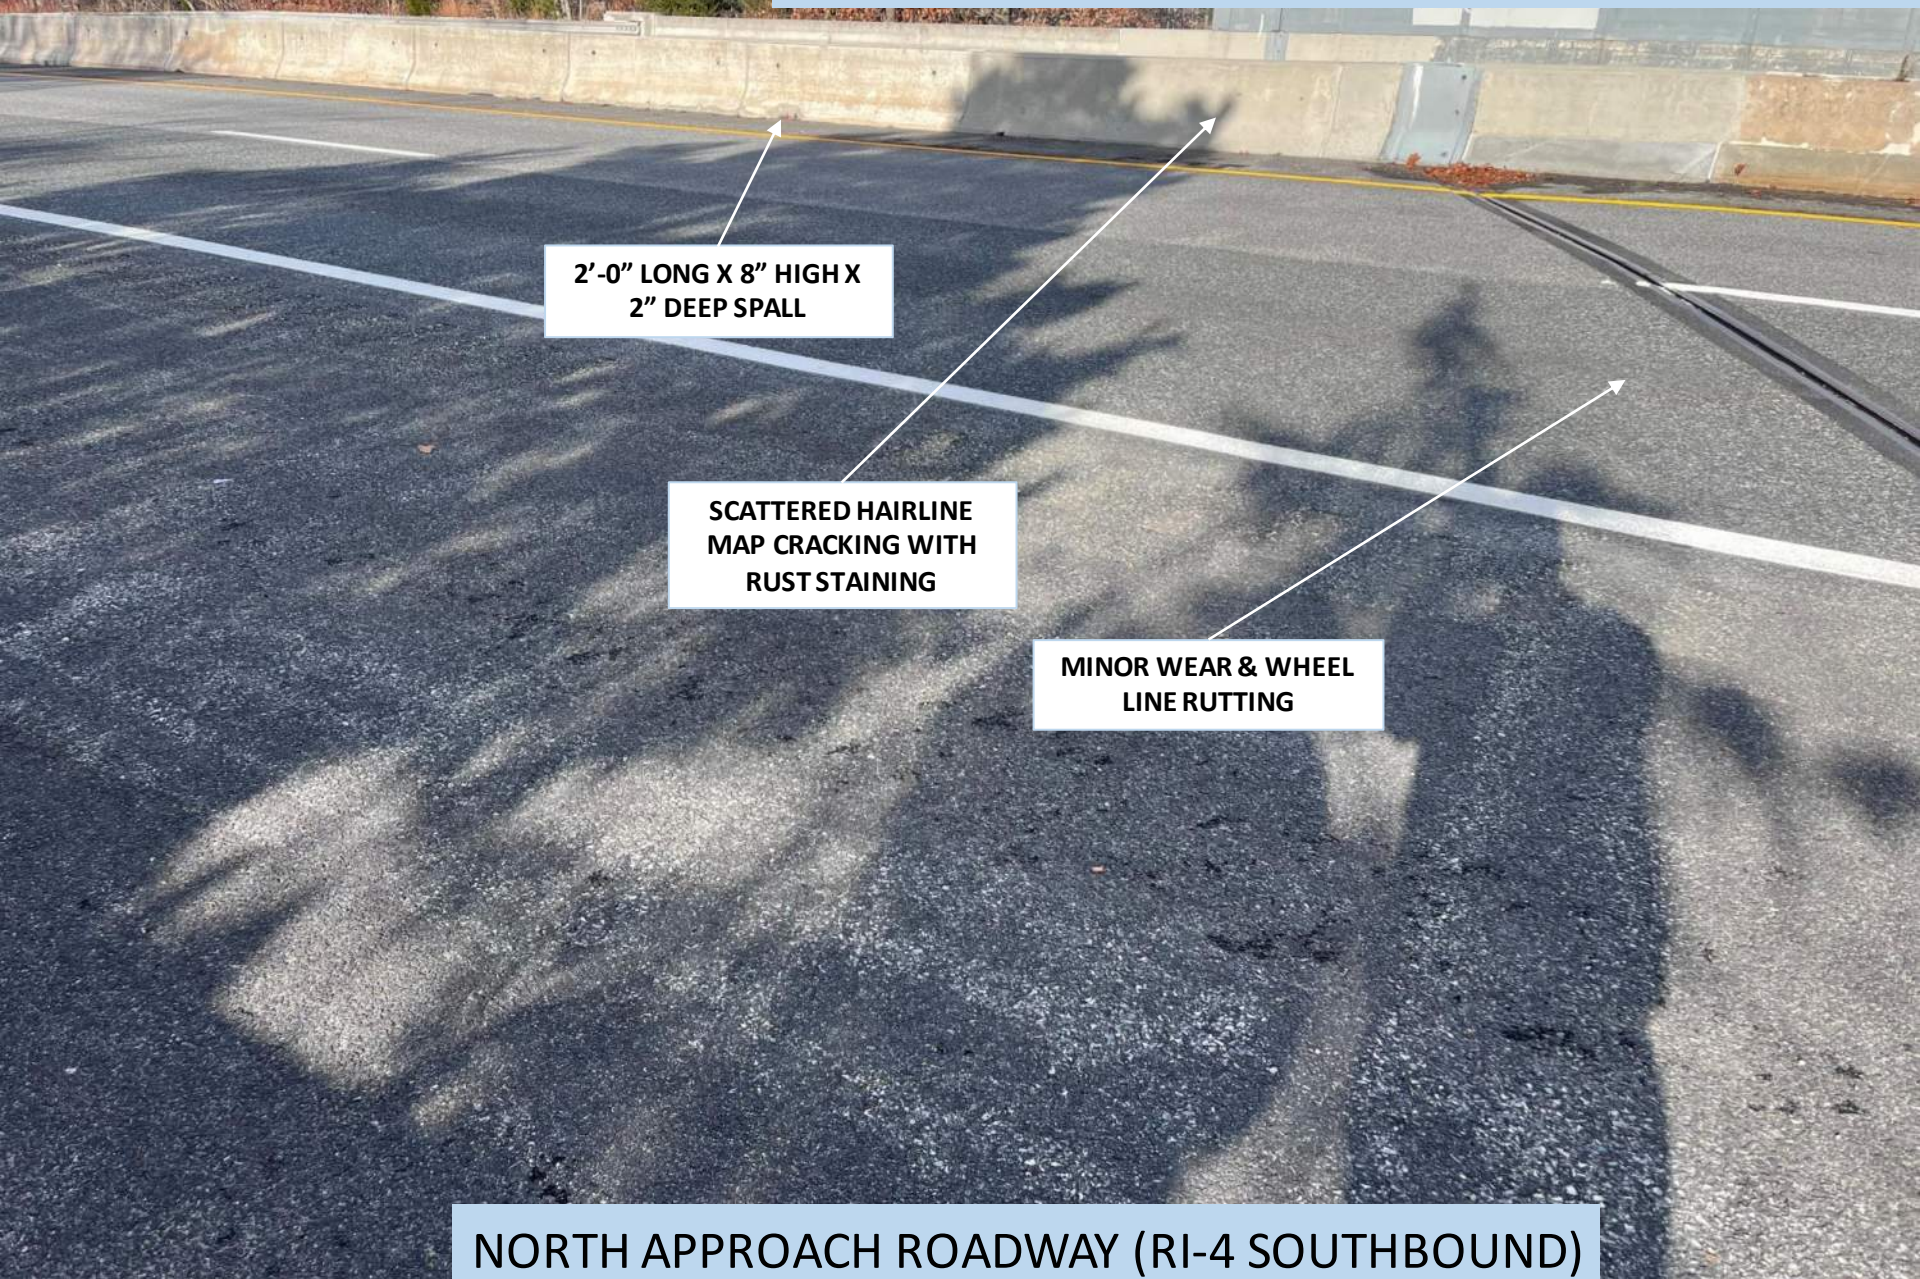
**2'-0" LONG X 8" HIGH X
2" DEEP SPALL**

**SCATTERED HAIRLINE
MAP CRACKING WITH
RUST STAINING**

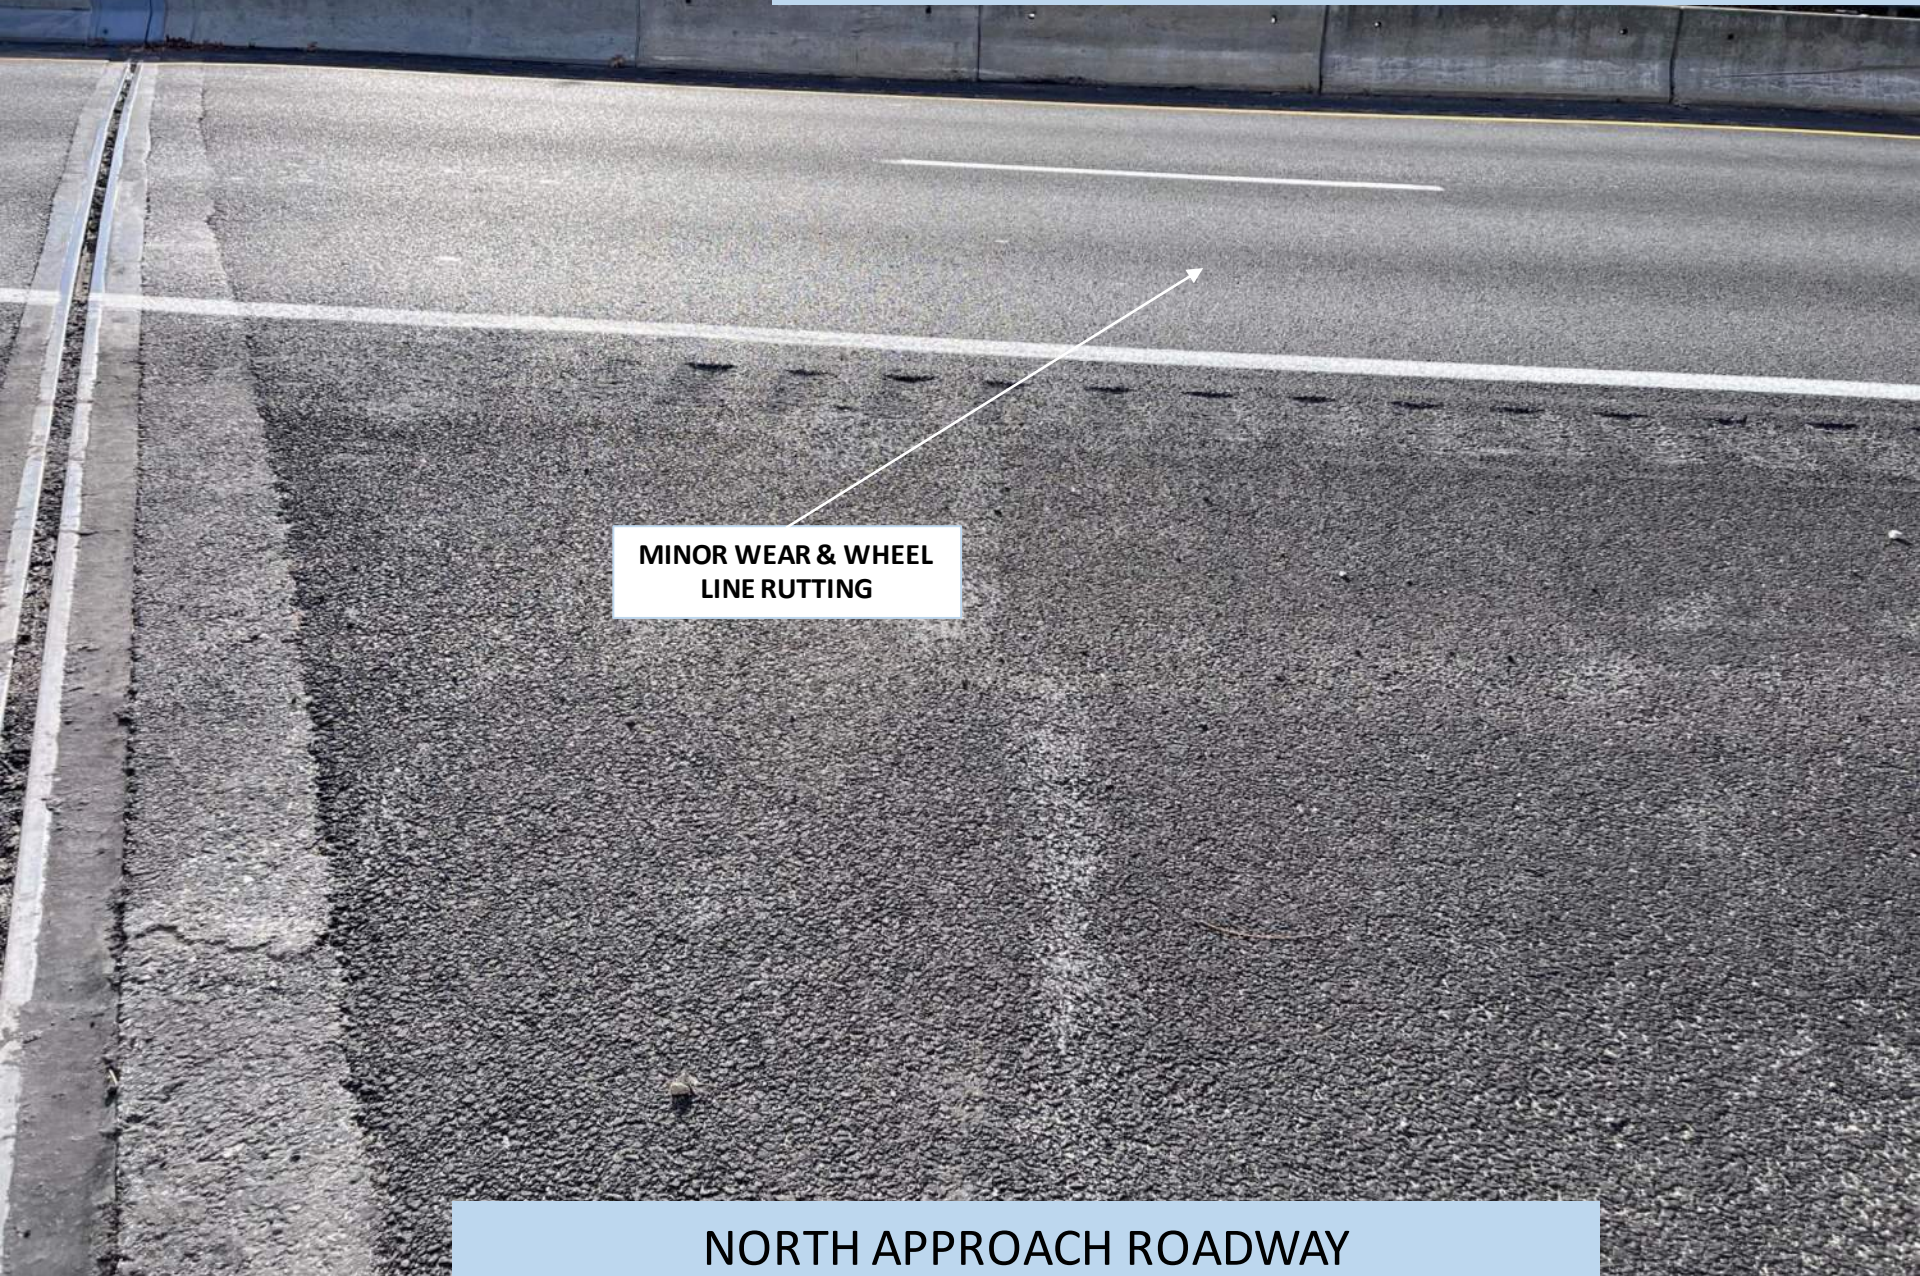
PHOTO #17

**MINOR WEAR & WHEEL
LINE RUTTING**

**NORTH APPROACH ROADWAY
(RI-4 NORTHBOUND) (LOOKING WEST)**

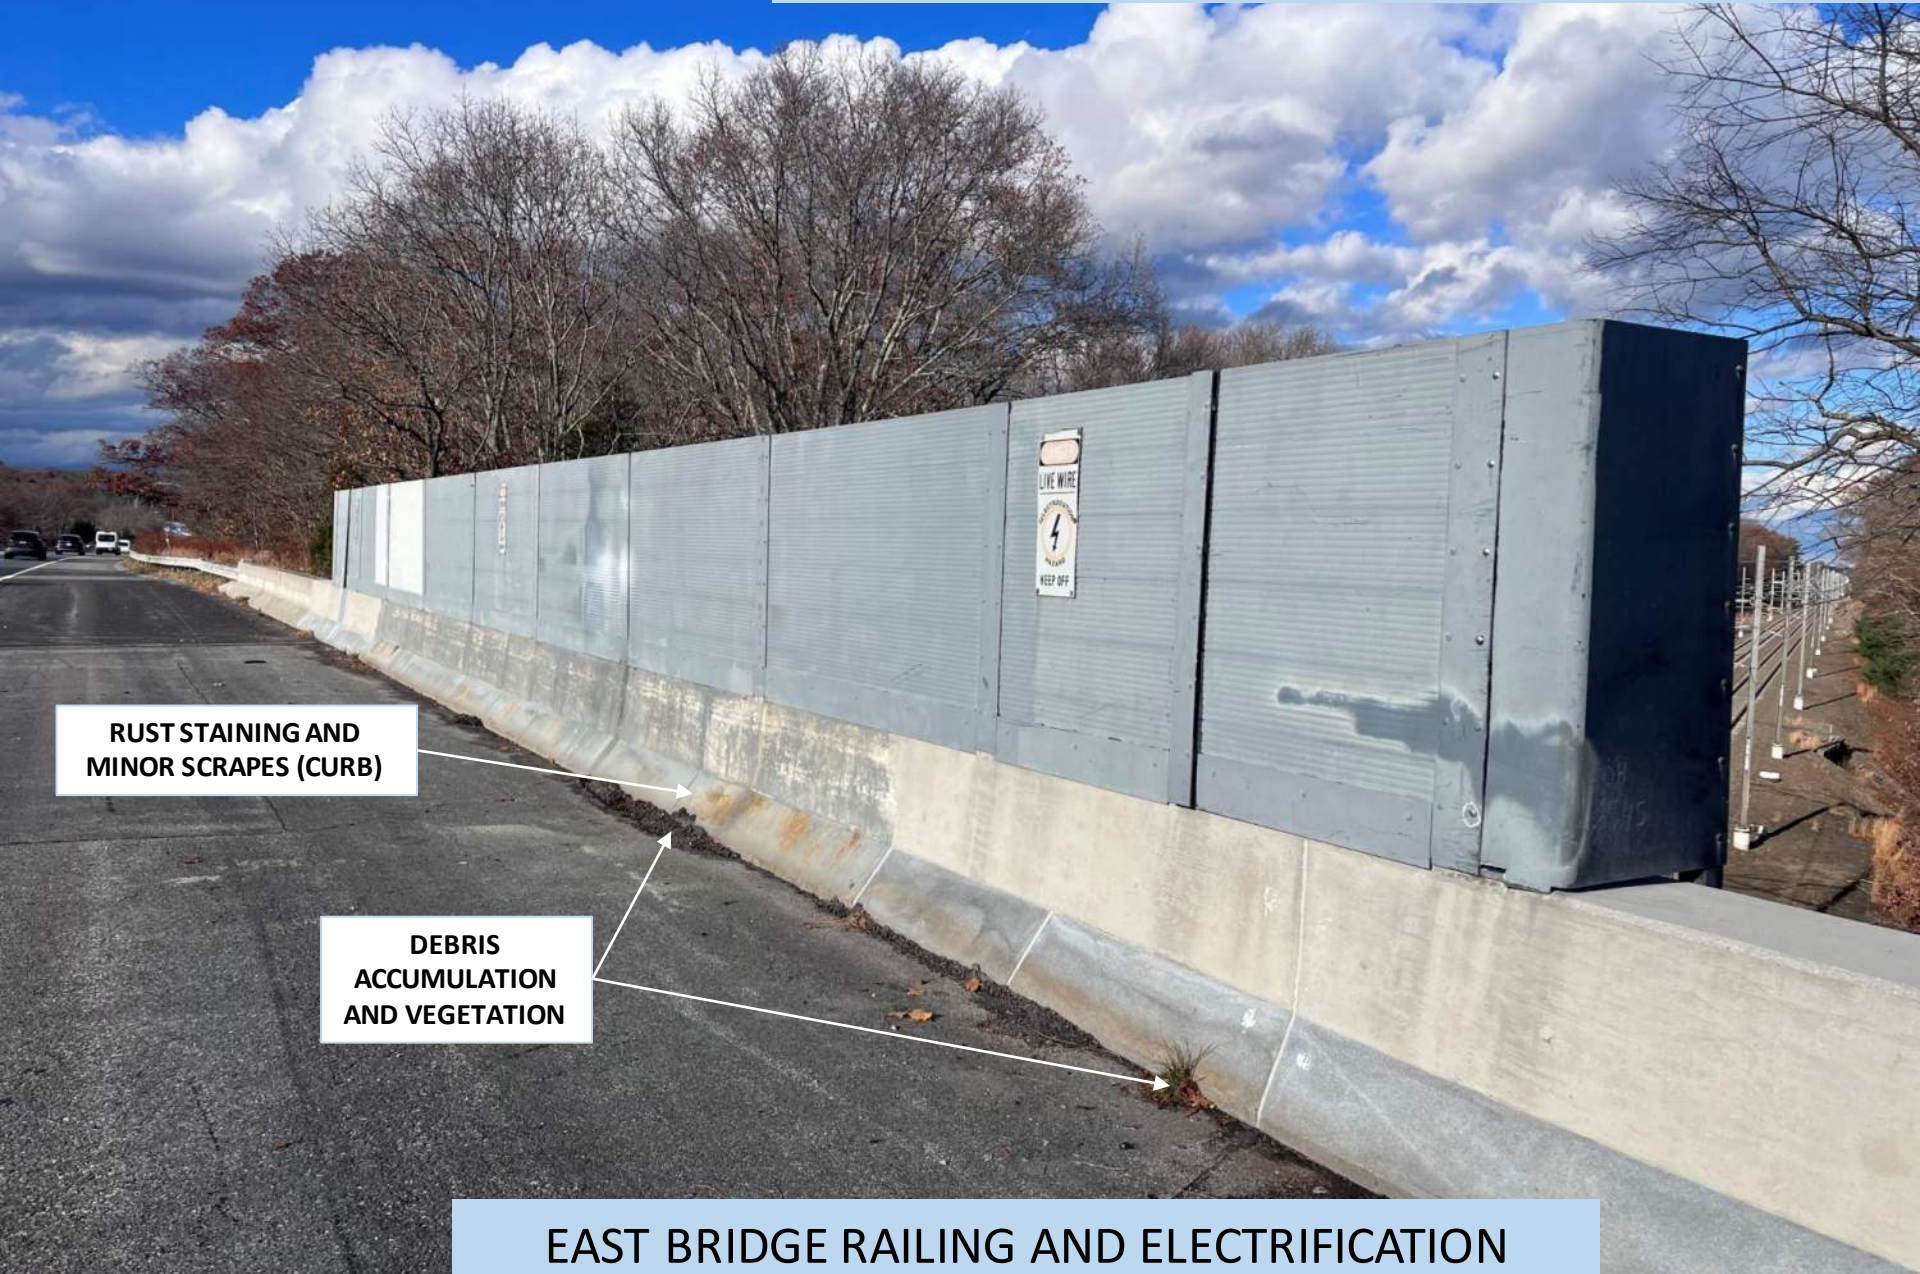
**RUST STAINING AND
MINOR SCRAPES (CURB)**

**DEBRIS
ACCUMULATION
AND VEGETATION**

**EAST BRIDGE RAILING AND ELECTRIFICATION
BARRIER (WEST FACE, LOOKING NORTH EAST)**

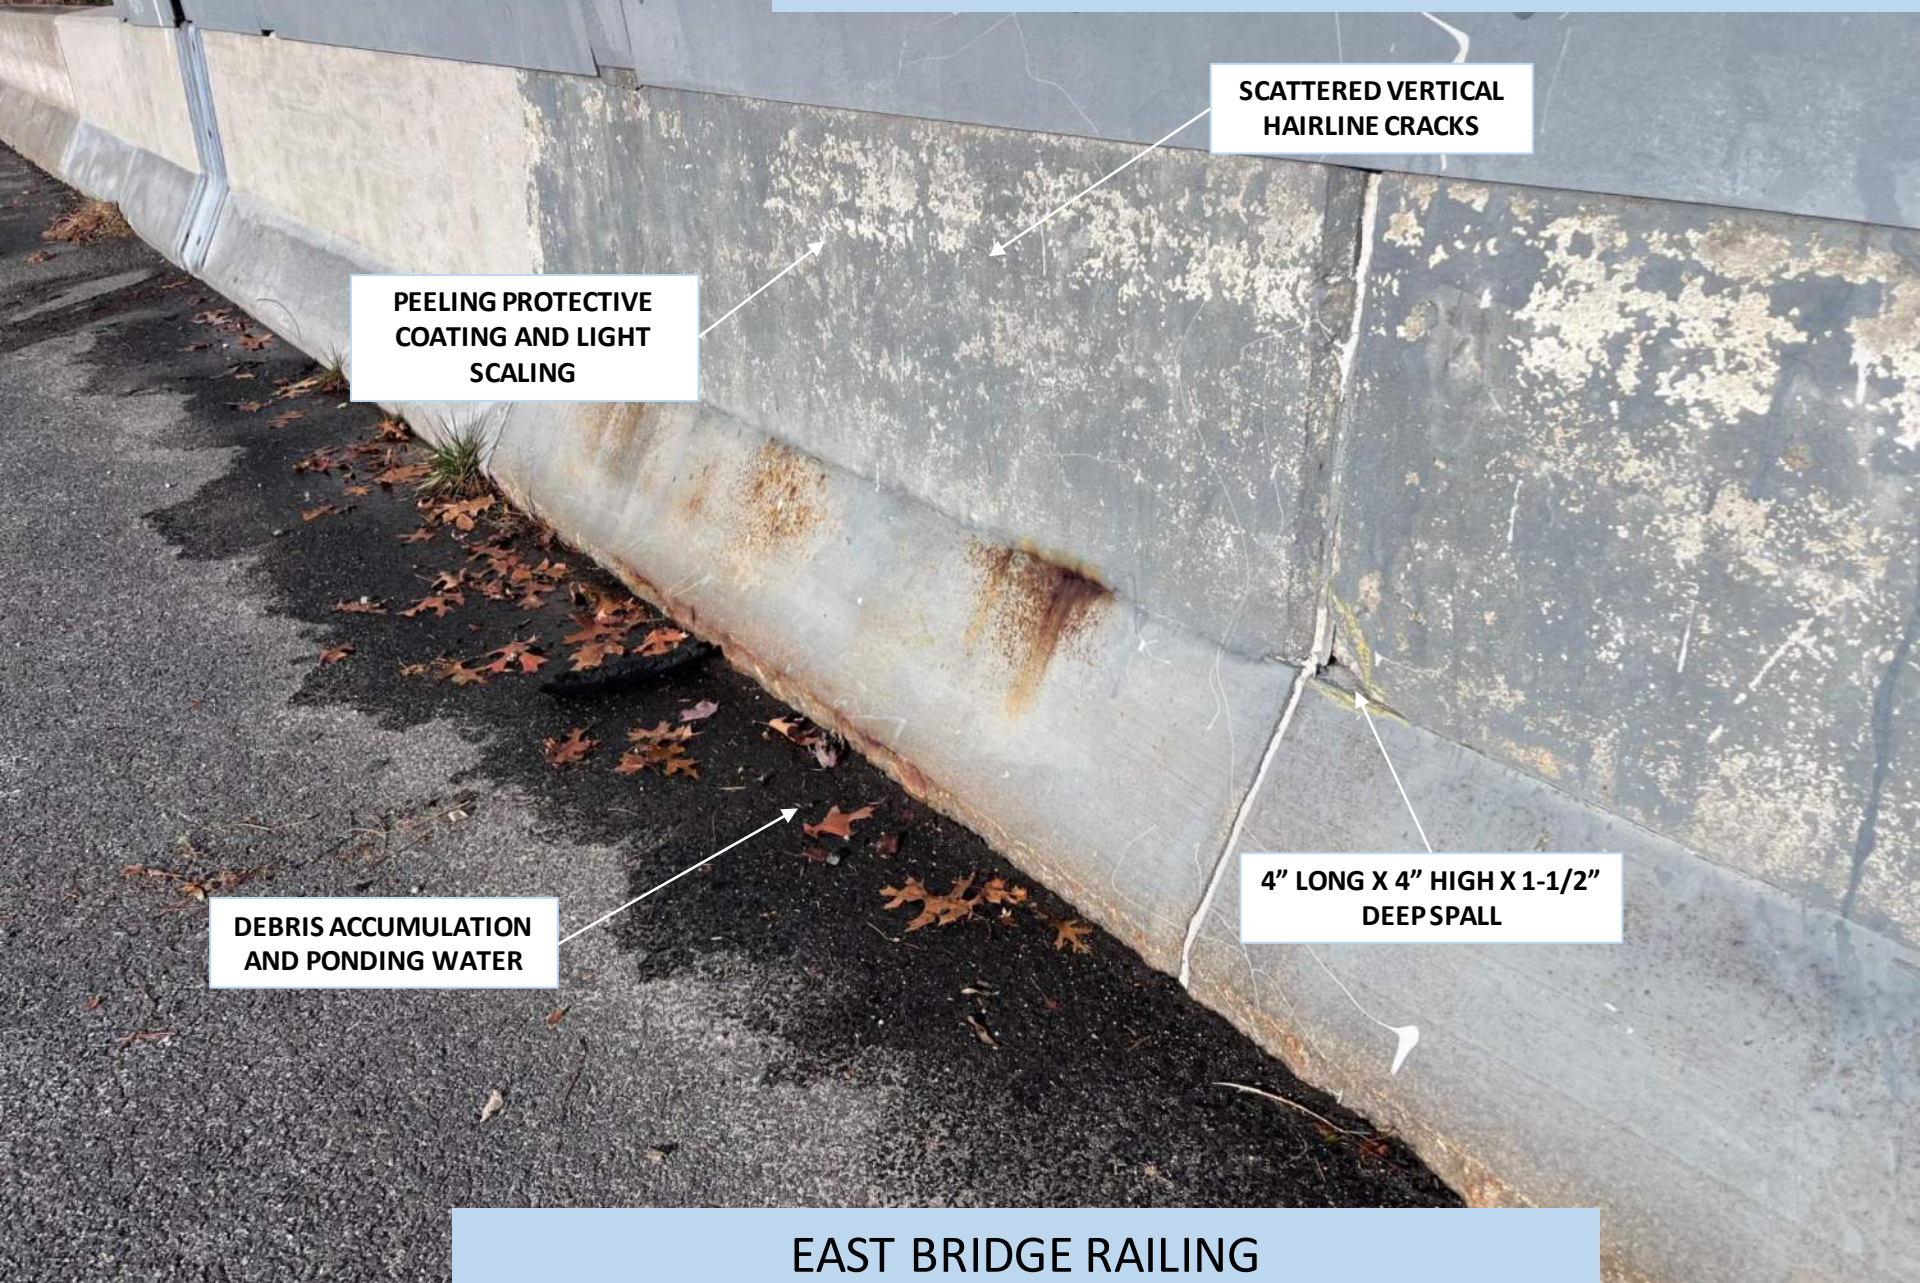
SCATTERED VERTICAL
HAIRLINE CRACKS

PEELING PROTECTIVE
COATING AND LIGHT
SCALING

DEBRIS ACCUMULATION
AND PONDING WATER

4" LONG X 4" HIGH X 1-1/2"
DEEPSPALL

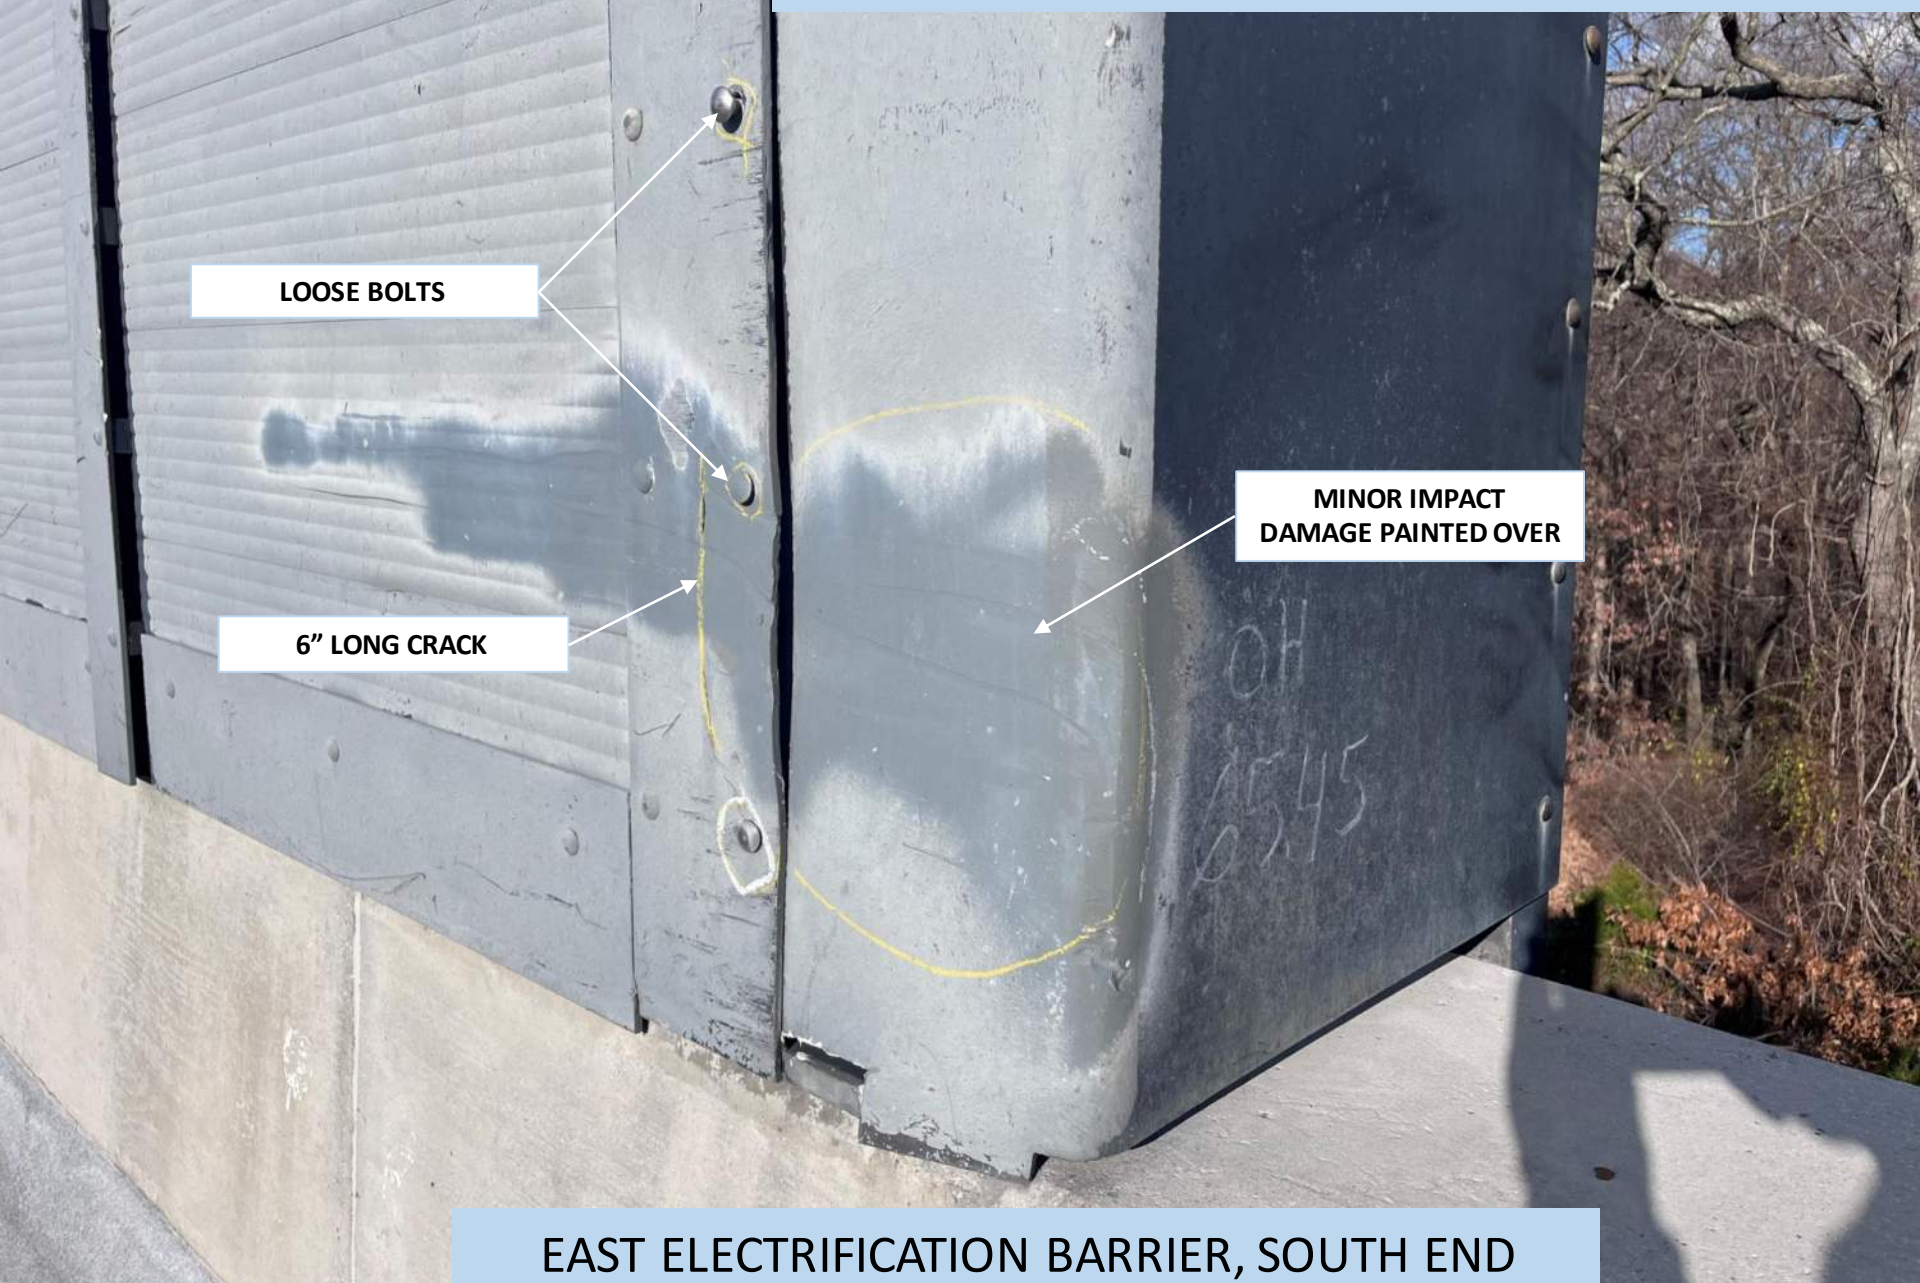
LOOSE BOLTS

6" LONG CRACK
