NOTICE TO PROSPECTIVE BIDDERS
RI CONTRACT NO. 2024-CB-018 – ADDENDUM NO. 1

Add New Appendix to this Addendum No. 1. “Bridge Inspection Report” has been added.

SPECIAL INSPECTION SCOPE: The scope of the special inspection shall include the advanced deterioration of the beam ends including the web area beyond the end diaphragms, end diaphragms, fixed bearings and moveable bearings. The special inspection shall also include the AASHTO Fatigue Category E' welds at the transverse ends of the cover plates and the bottom flanges of the beams. If any cracks are observed at these weld details, the RIDOT Bridge Ratings Section shall be notified.

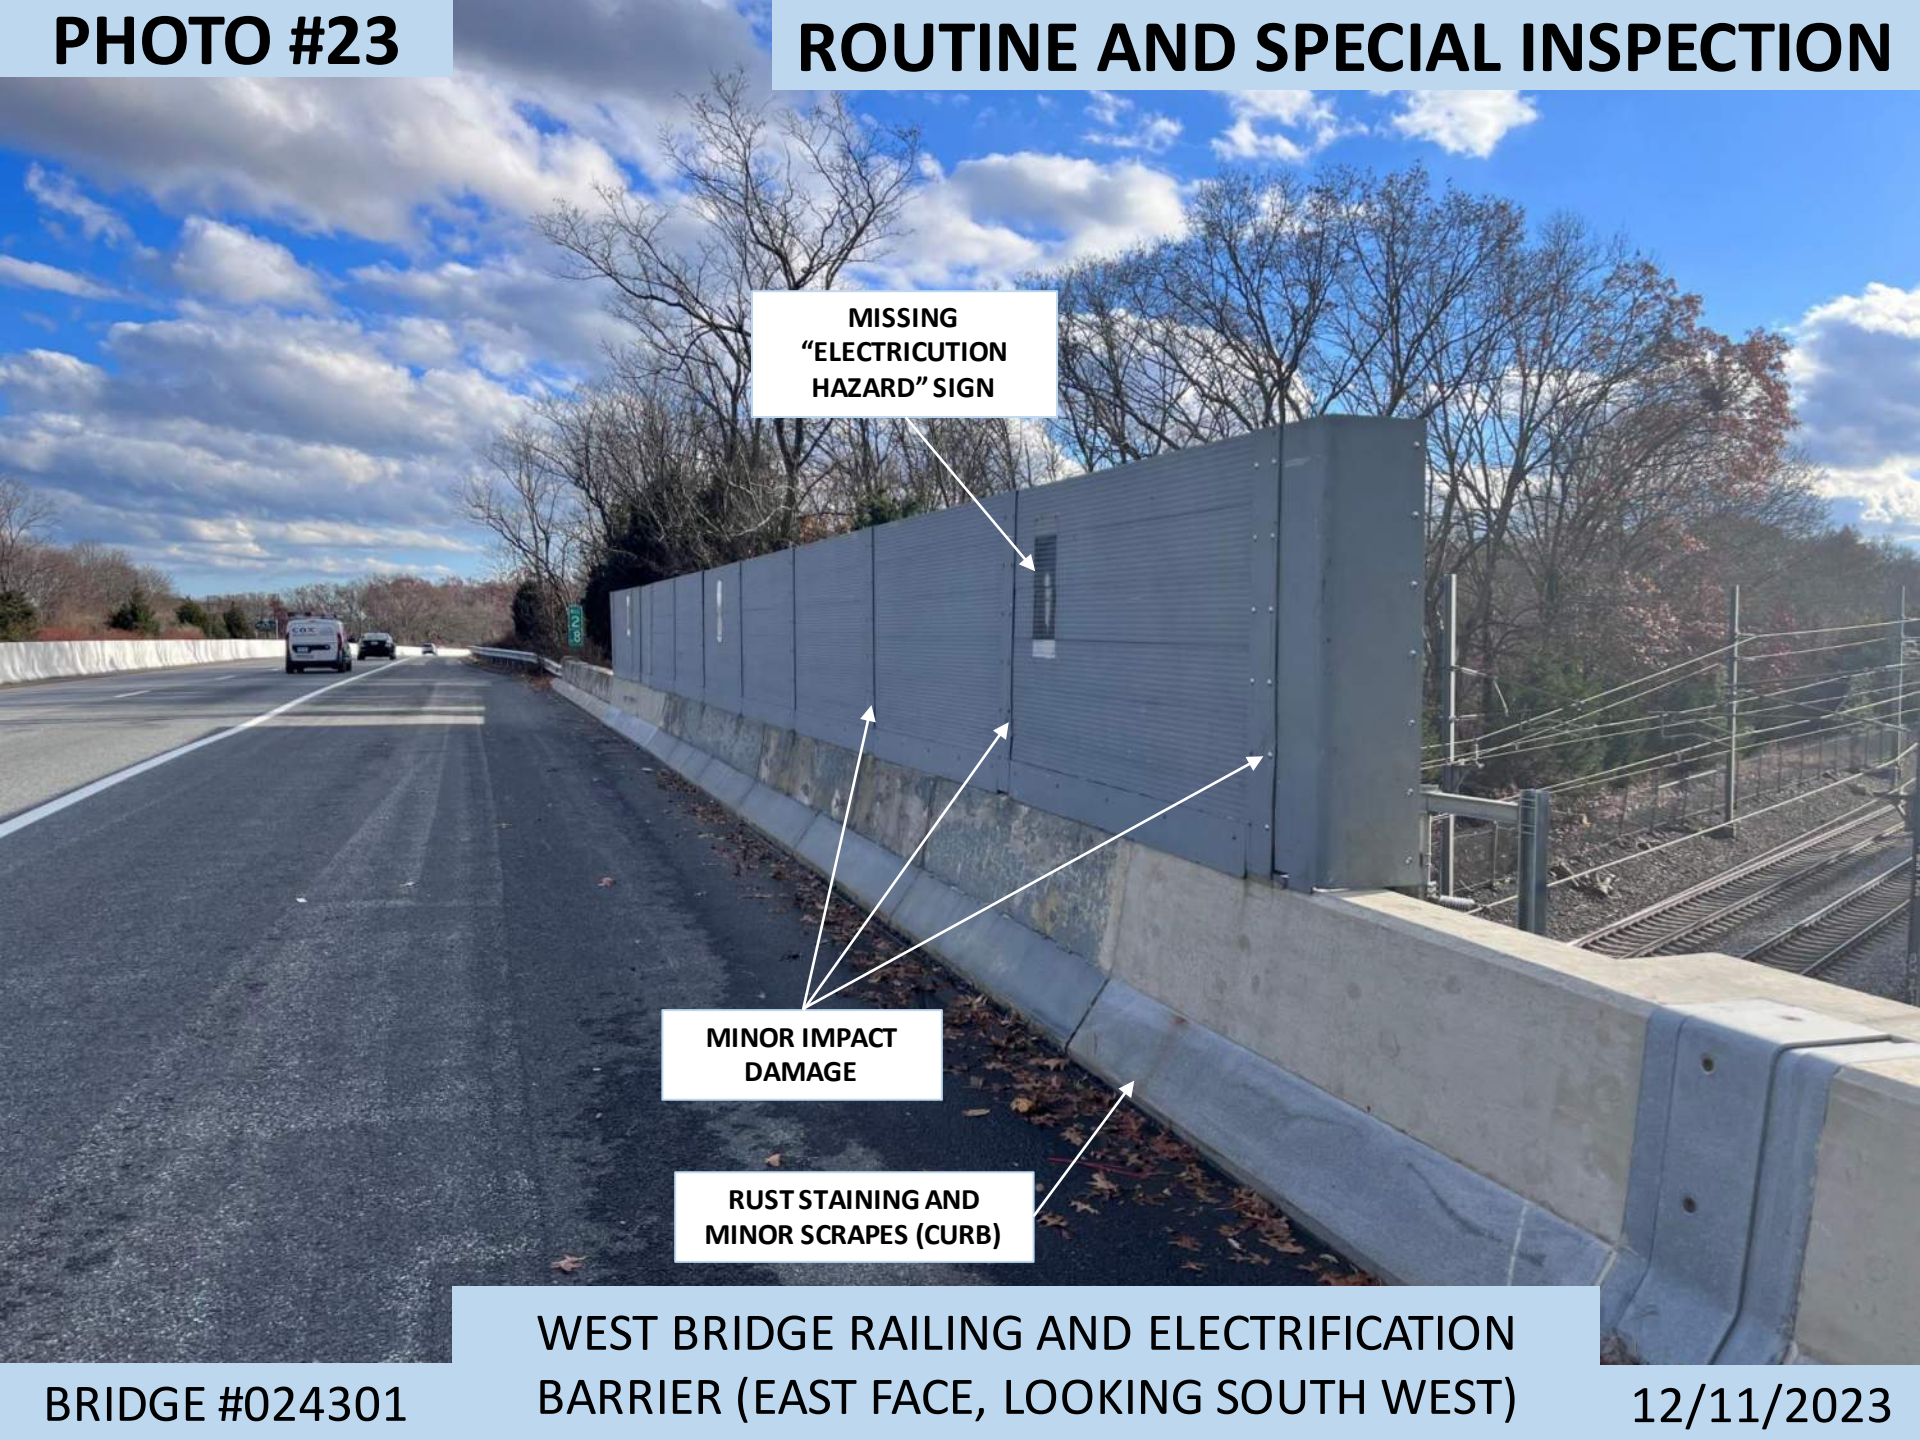
**MISSING
"ELECTRICATION
HAZARD" SIGN**

**MINOR IMPACT
DAMAGE**

**RUST STAINING AND
MINOR SCRAPES (CURB)**

**WEST BRIDGE RAILING AND ELECTRIFICATION
BARRIER (EAST FACE, LOOKING SOUTH WEST)**

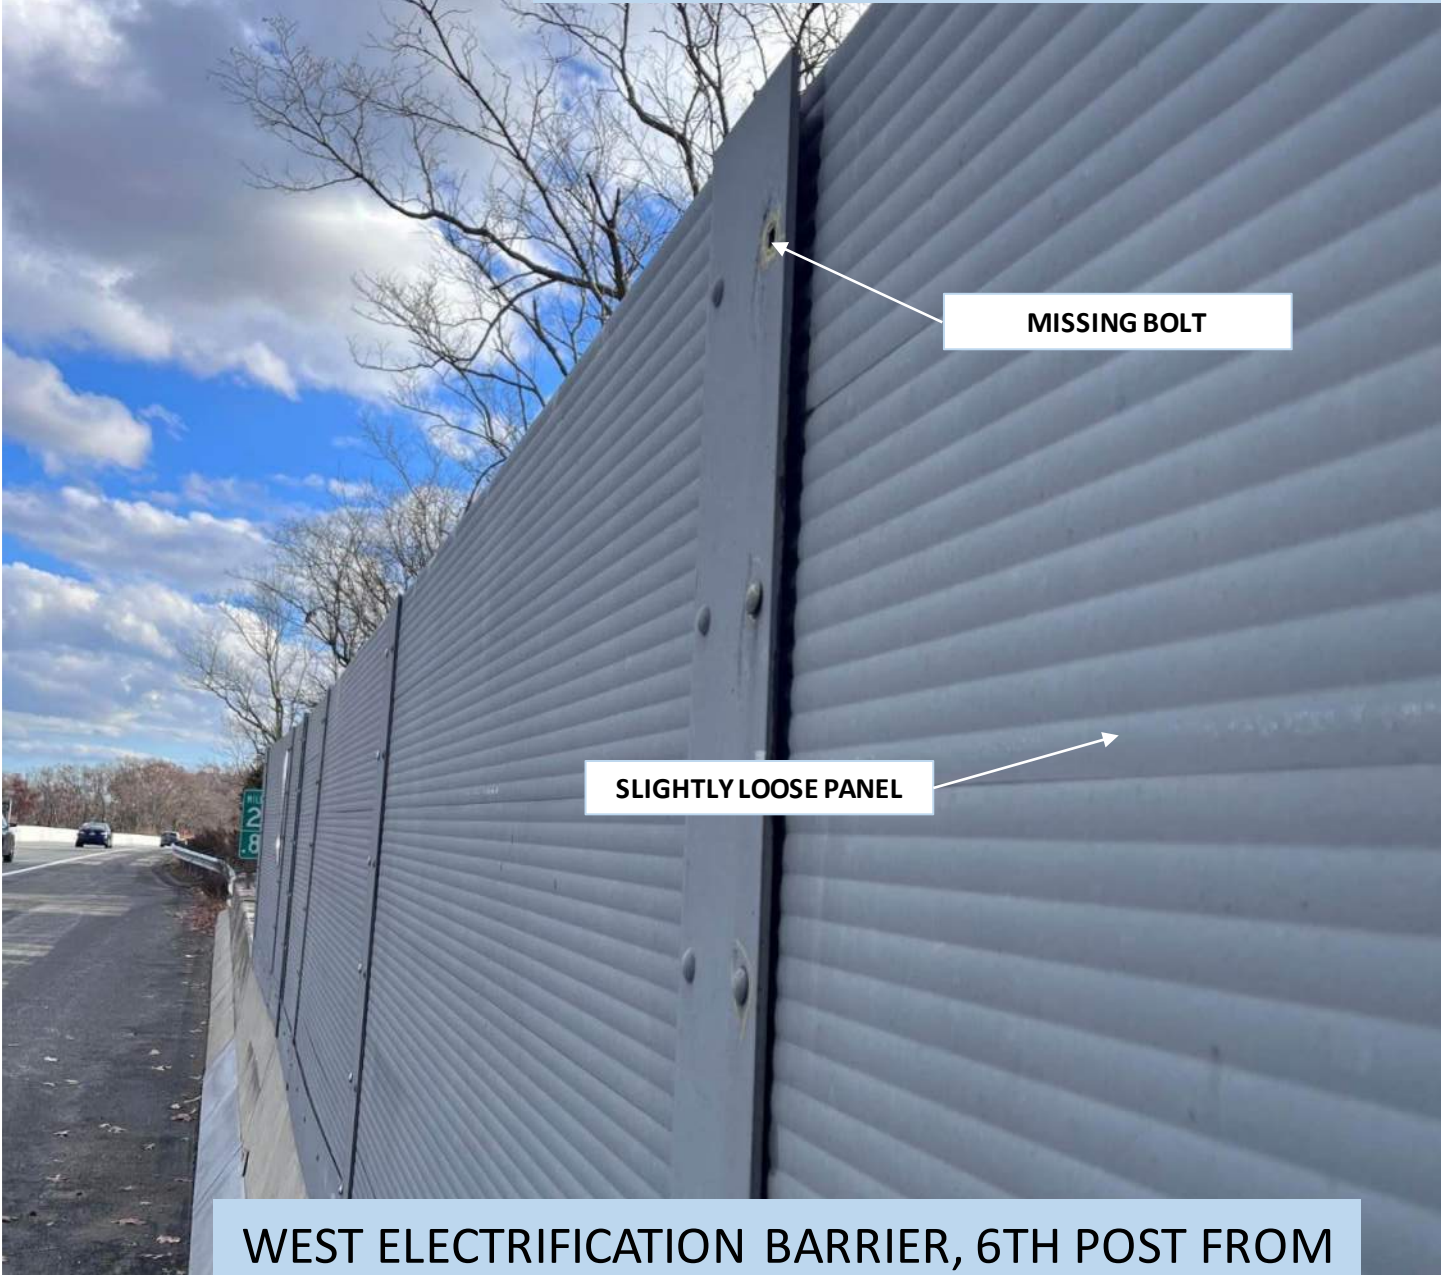
MISSING BOLT

SLIGHTLY LOOSE PANEL

WEST ELECTRIFICATION BARRIER, 6TH POST FROM SOUTH (EAST FACE, LOOKING SOUTH WEST)

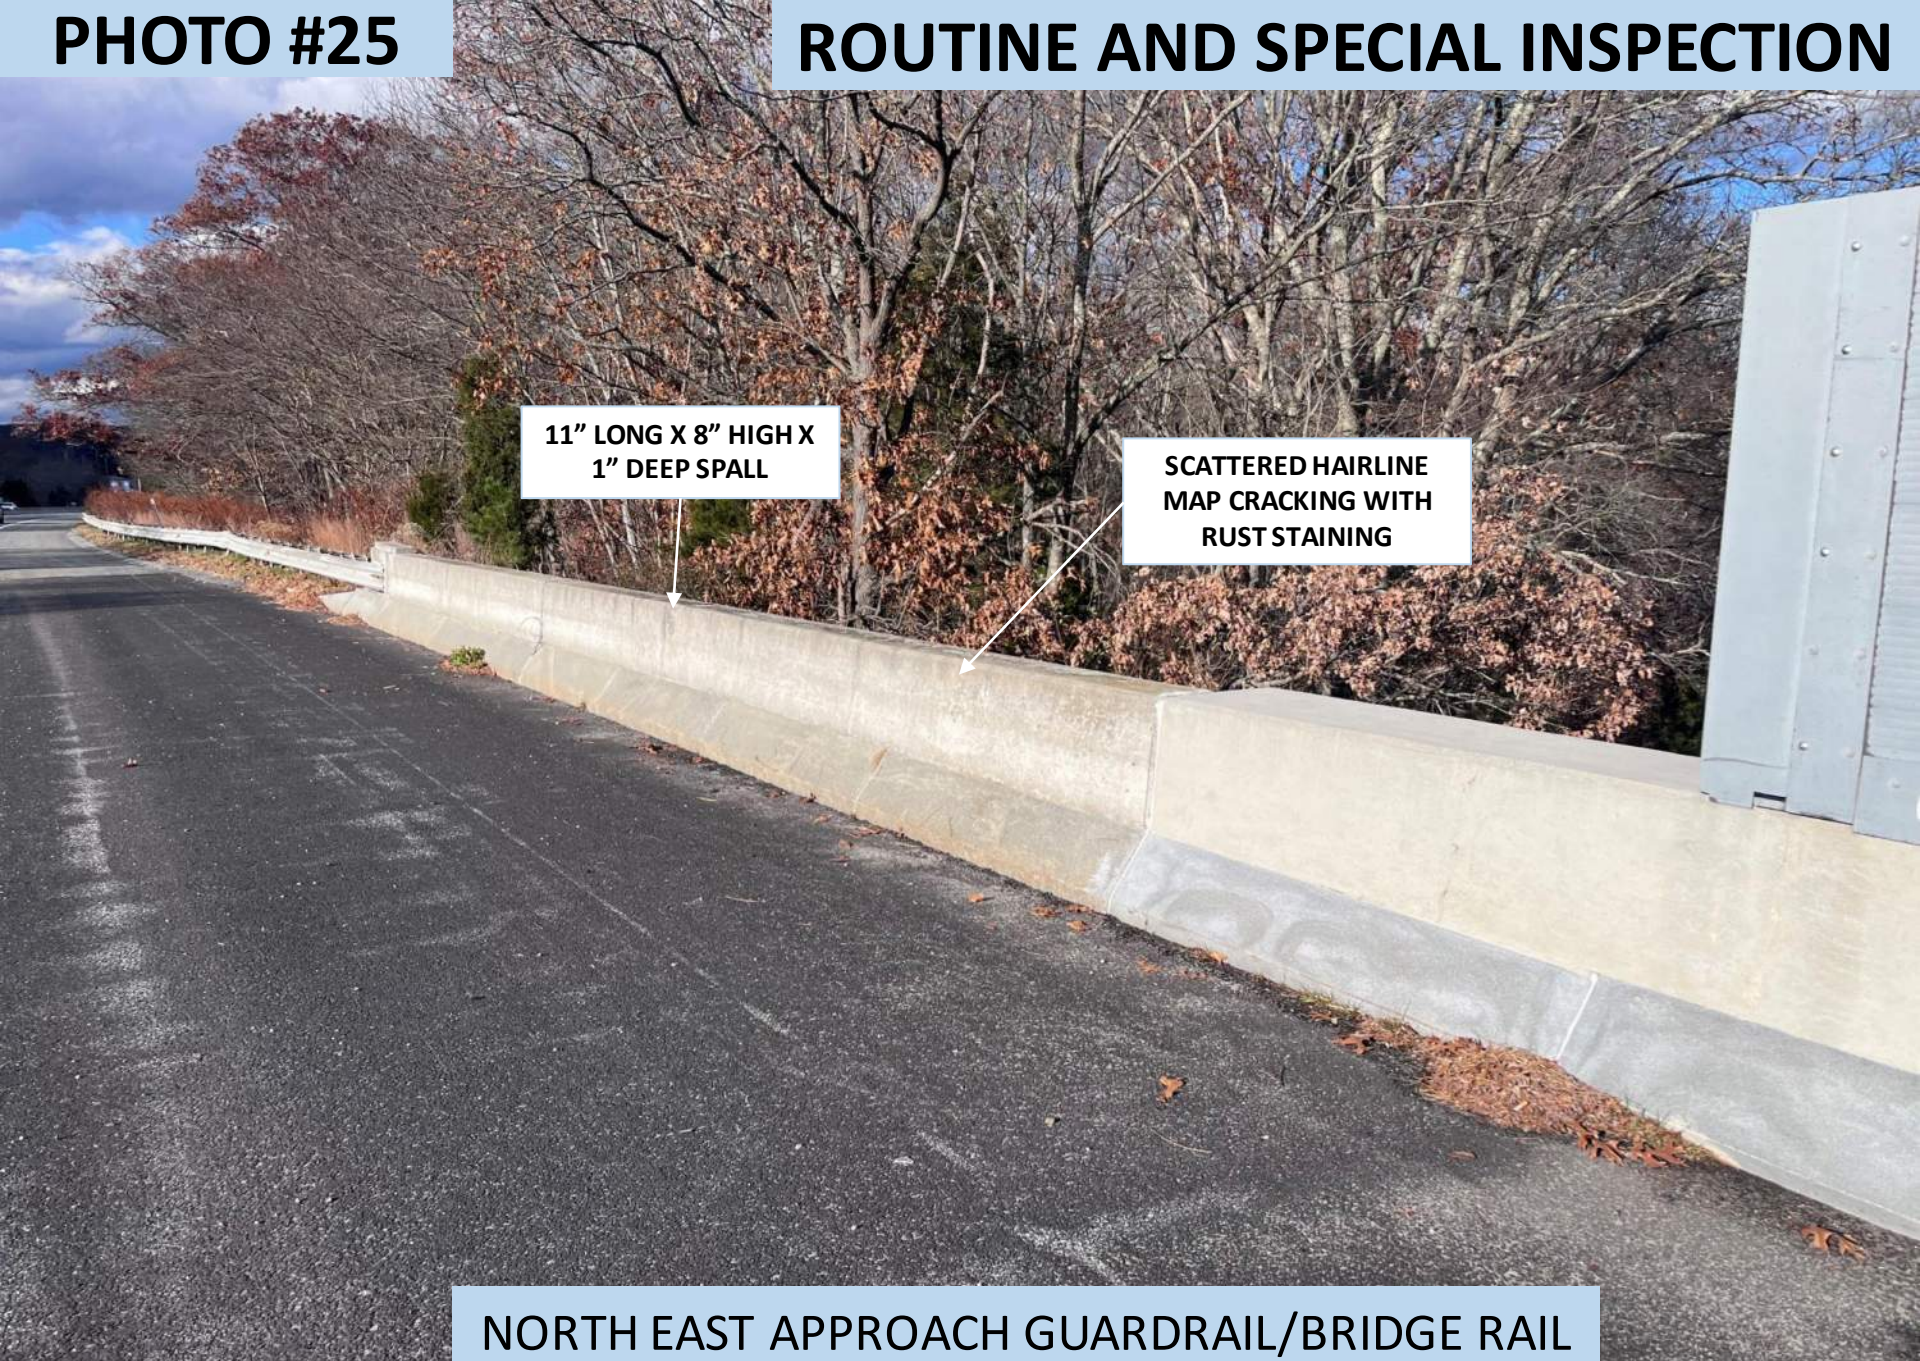
**11" LONG X 8" HIGH X
1" DEEP SPALL**

**SCATTERED HAIRLINE
MAP CRACKING WITH
RUST STAINING**

NORTH EAST APPROACH GUARDRAIL/BRIDGE RAIL

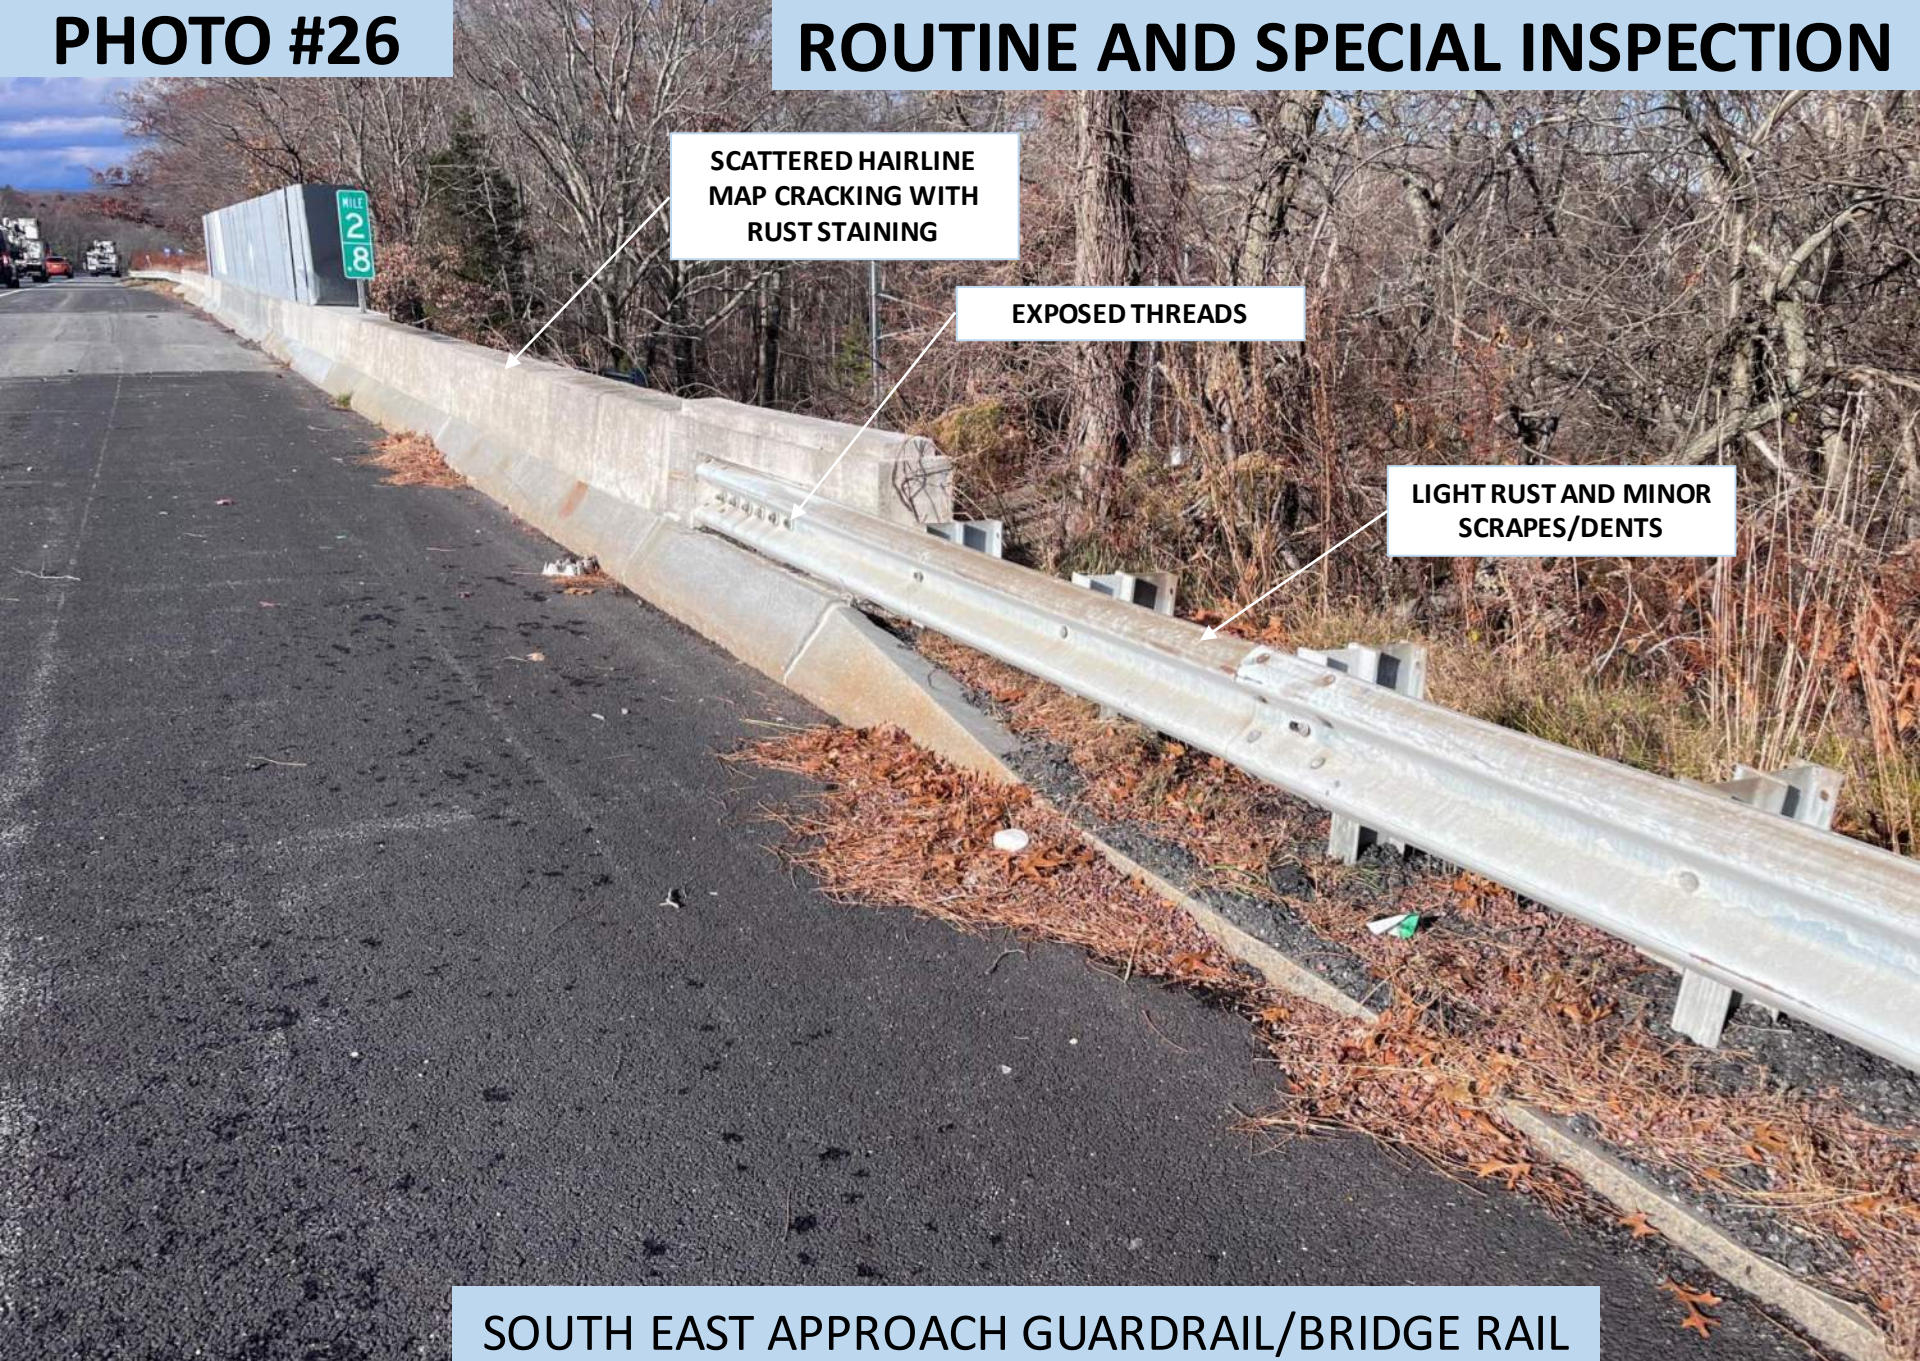
SCATTERED HAIRLINE
MAP CRACKING WITH
RUST STAINING

EXPOSED THREADS

SOUTH EAST APPROACH GUARDRAIL/BRIDGE RAIL

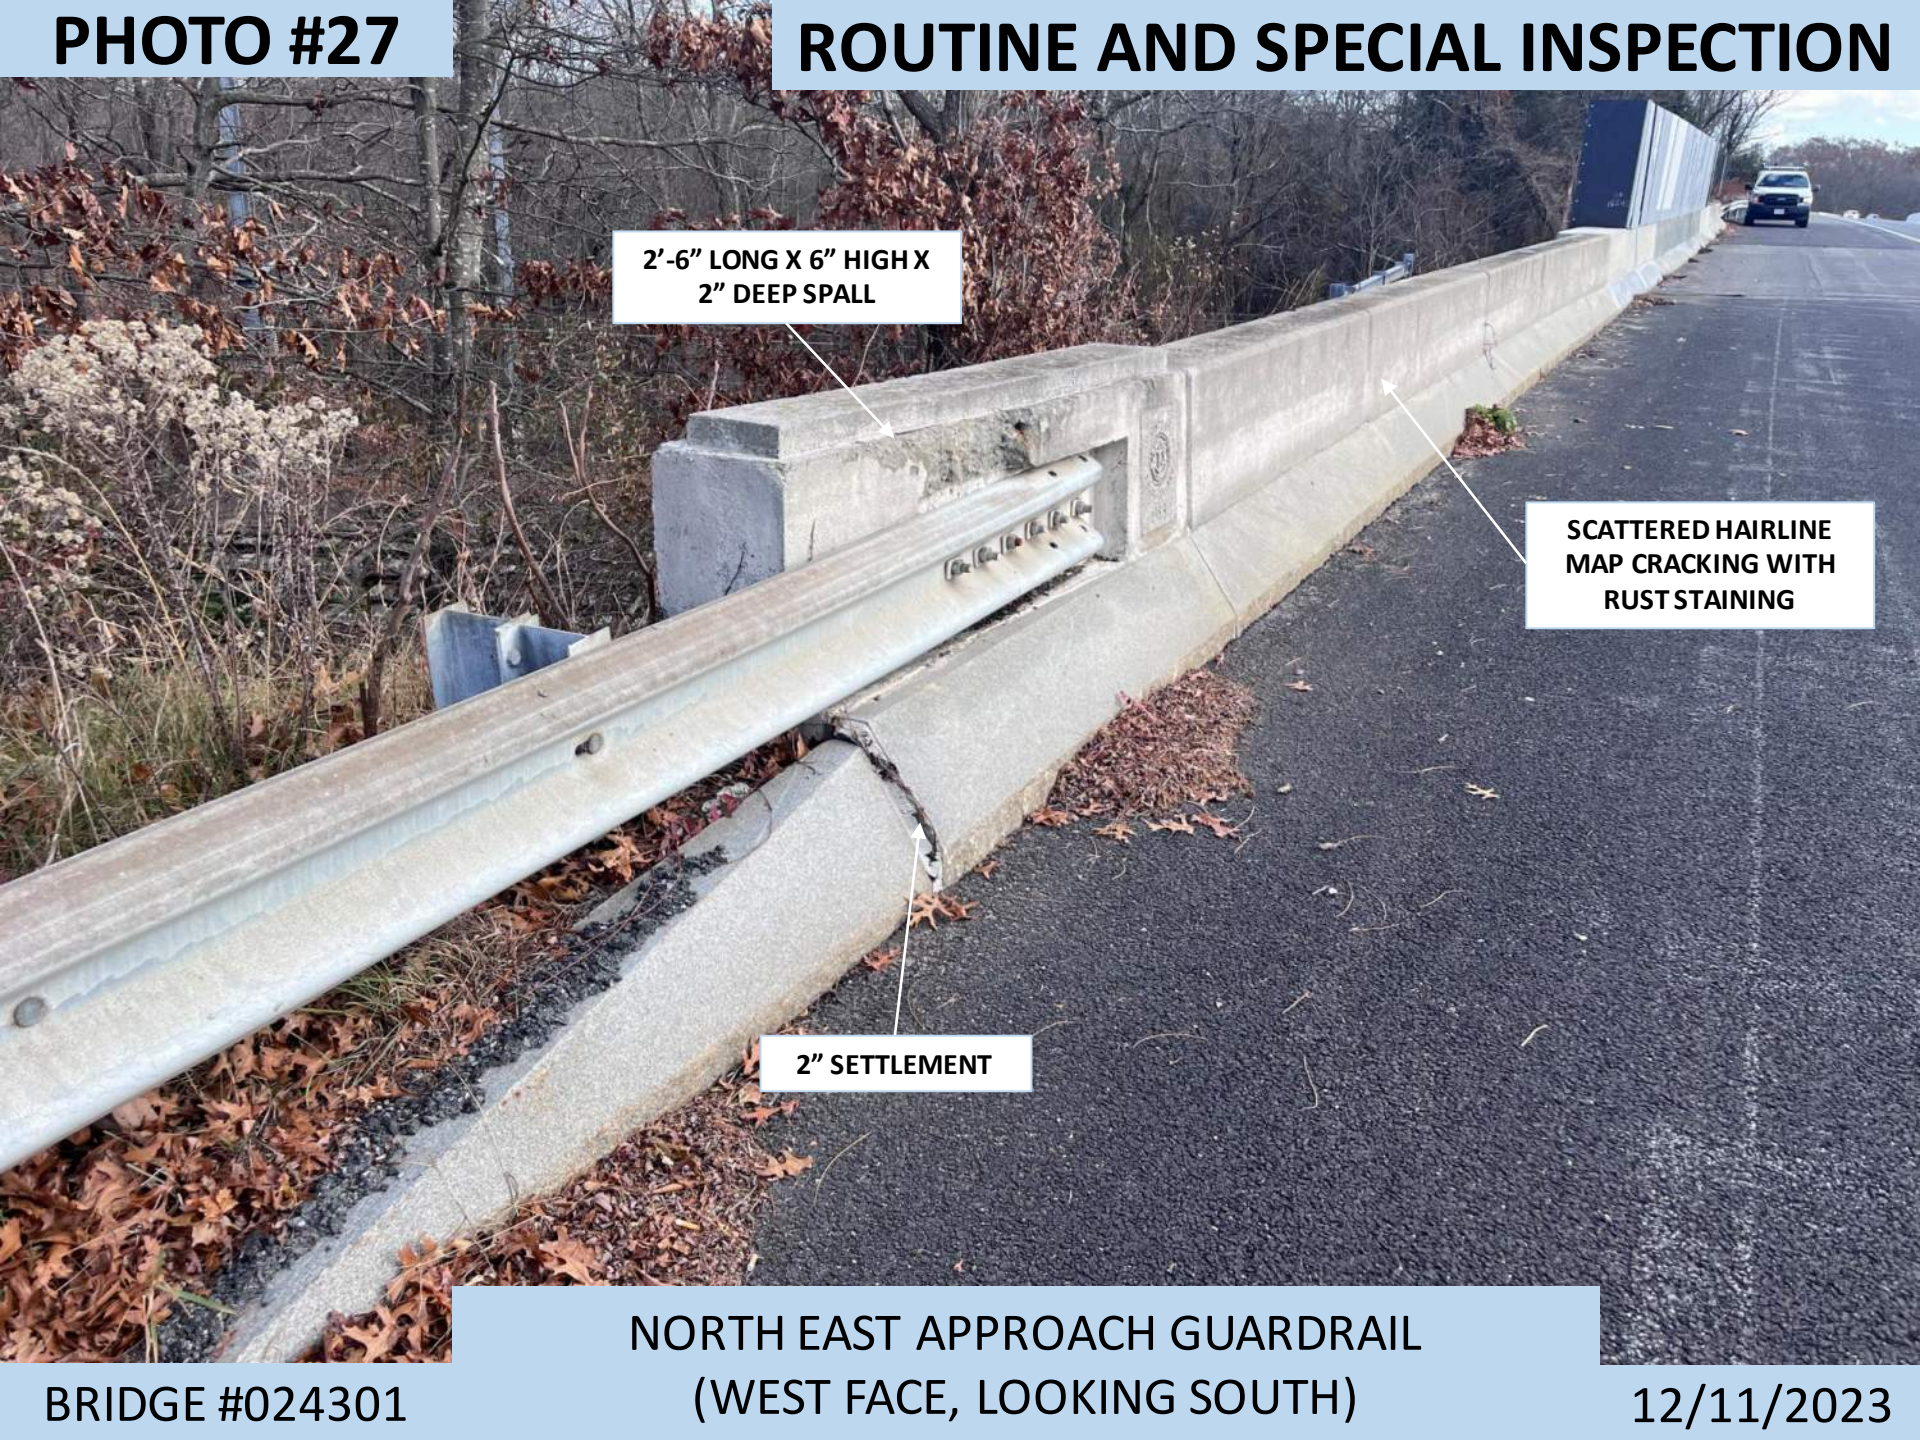
**2'-6" LONG X 6" HIGH X
2" DEEP SPALL**

**SCATTERED HAIRLINE
MAP CRACKING WITH
RUST STAINING**

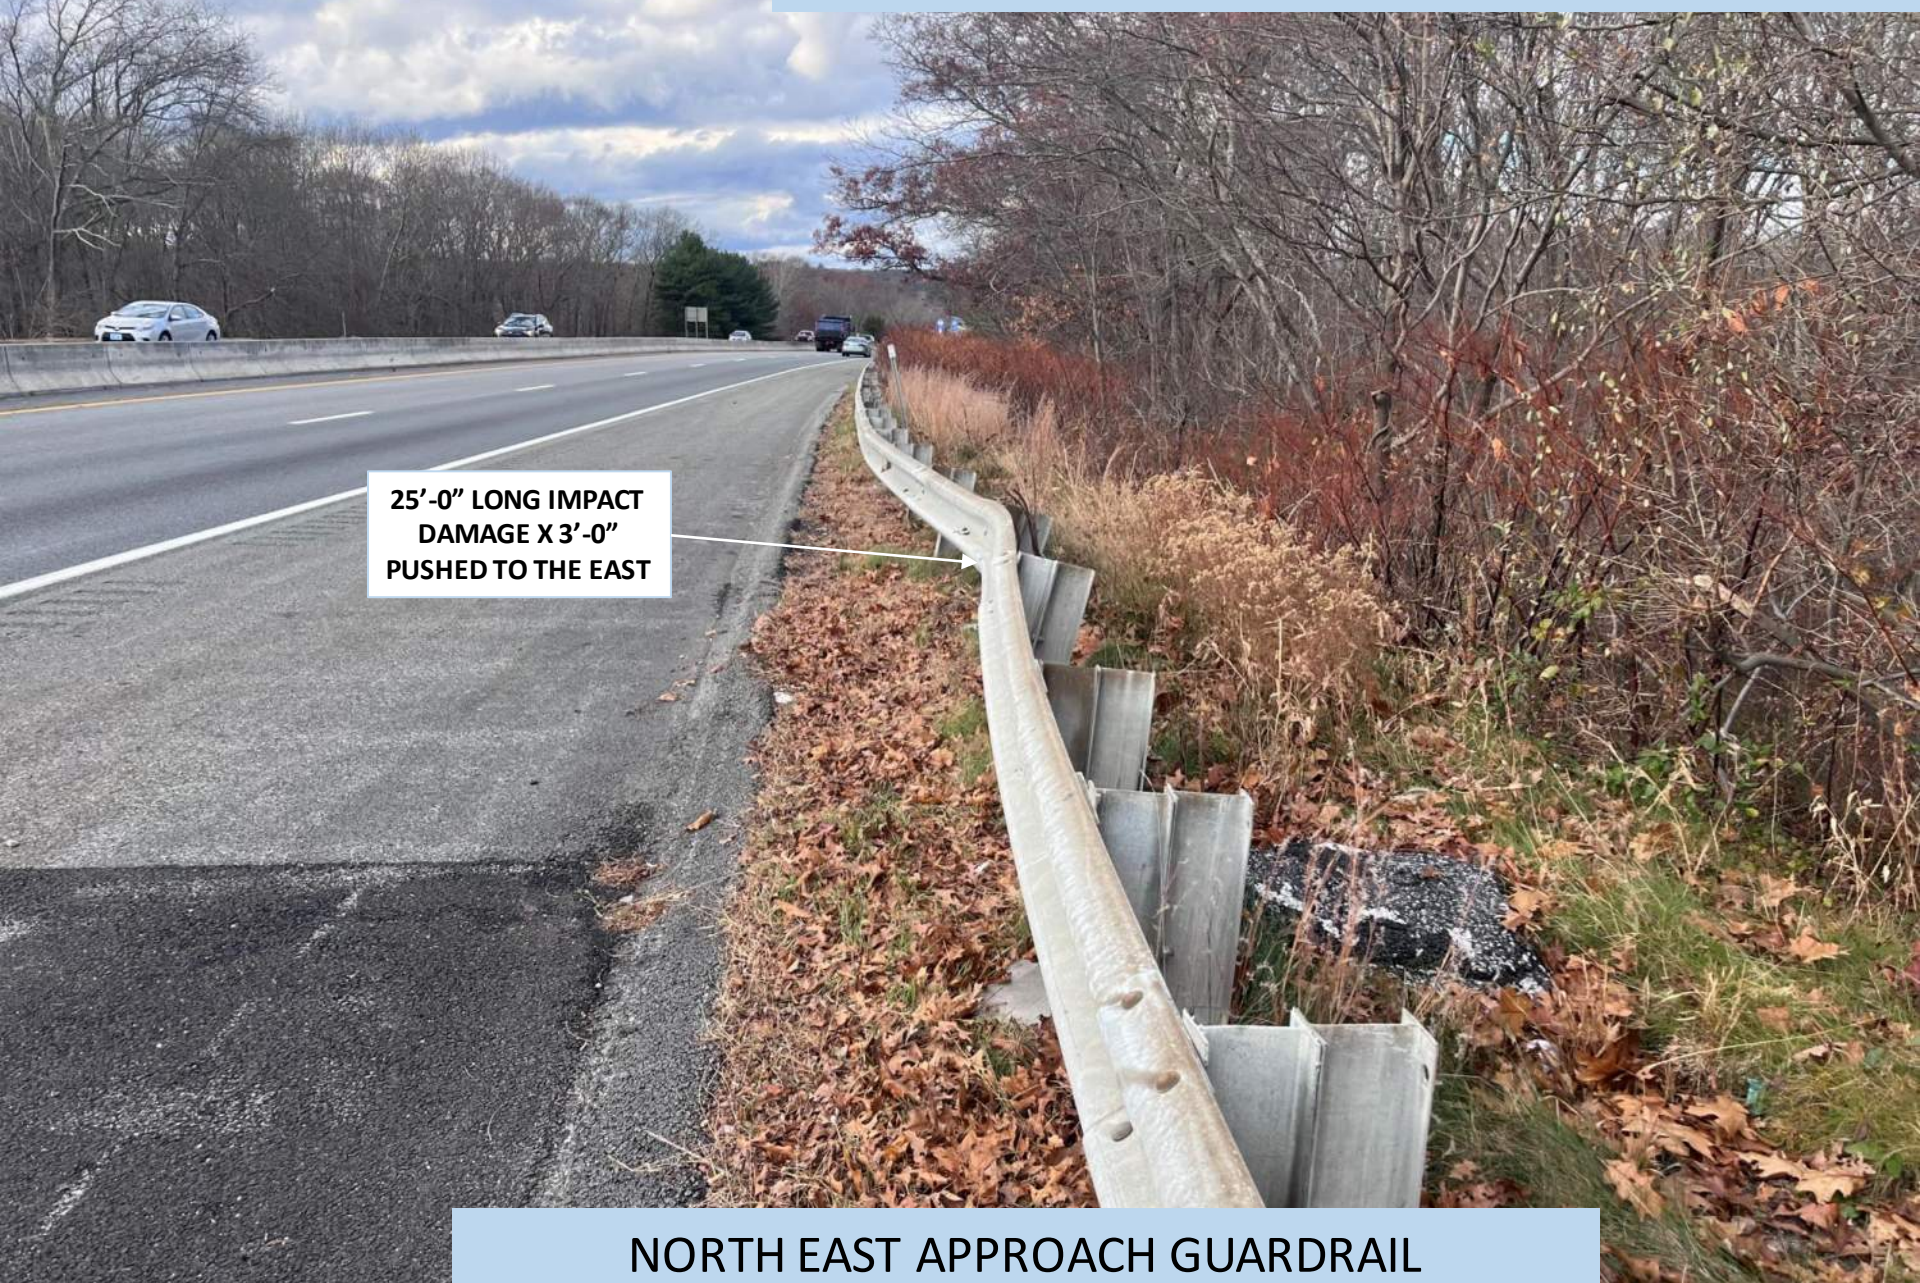
**25'-0" LONG IMPACT
DAMAGE X 3'-0"
PUSHED TO THE EAST**

**NORTH EAST APPROACH GUARDRAIL
(LOOKING NORTH)**

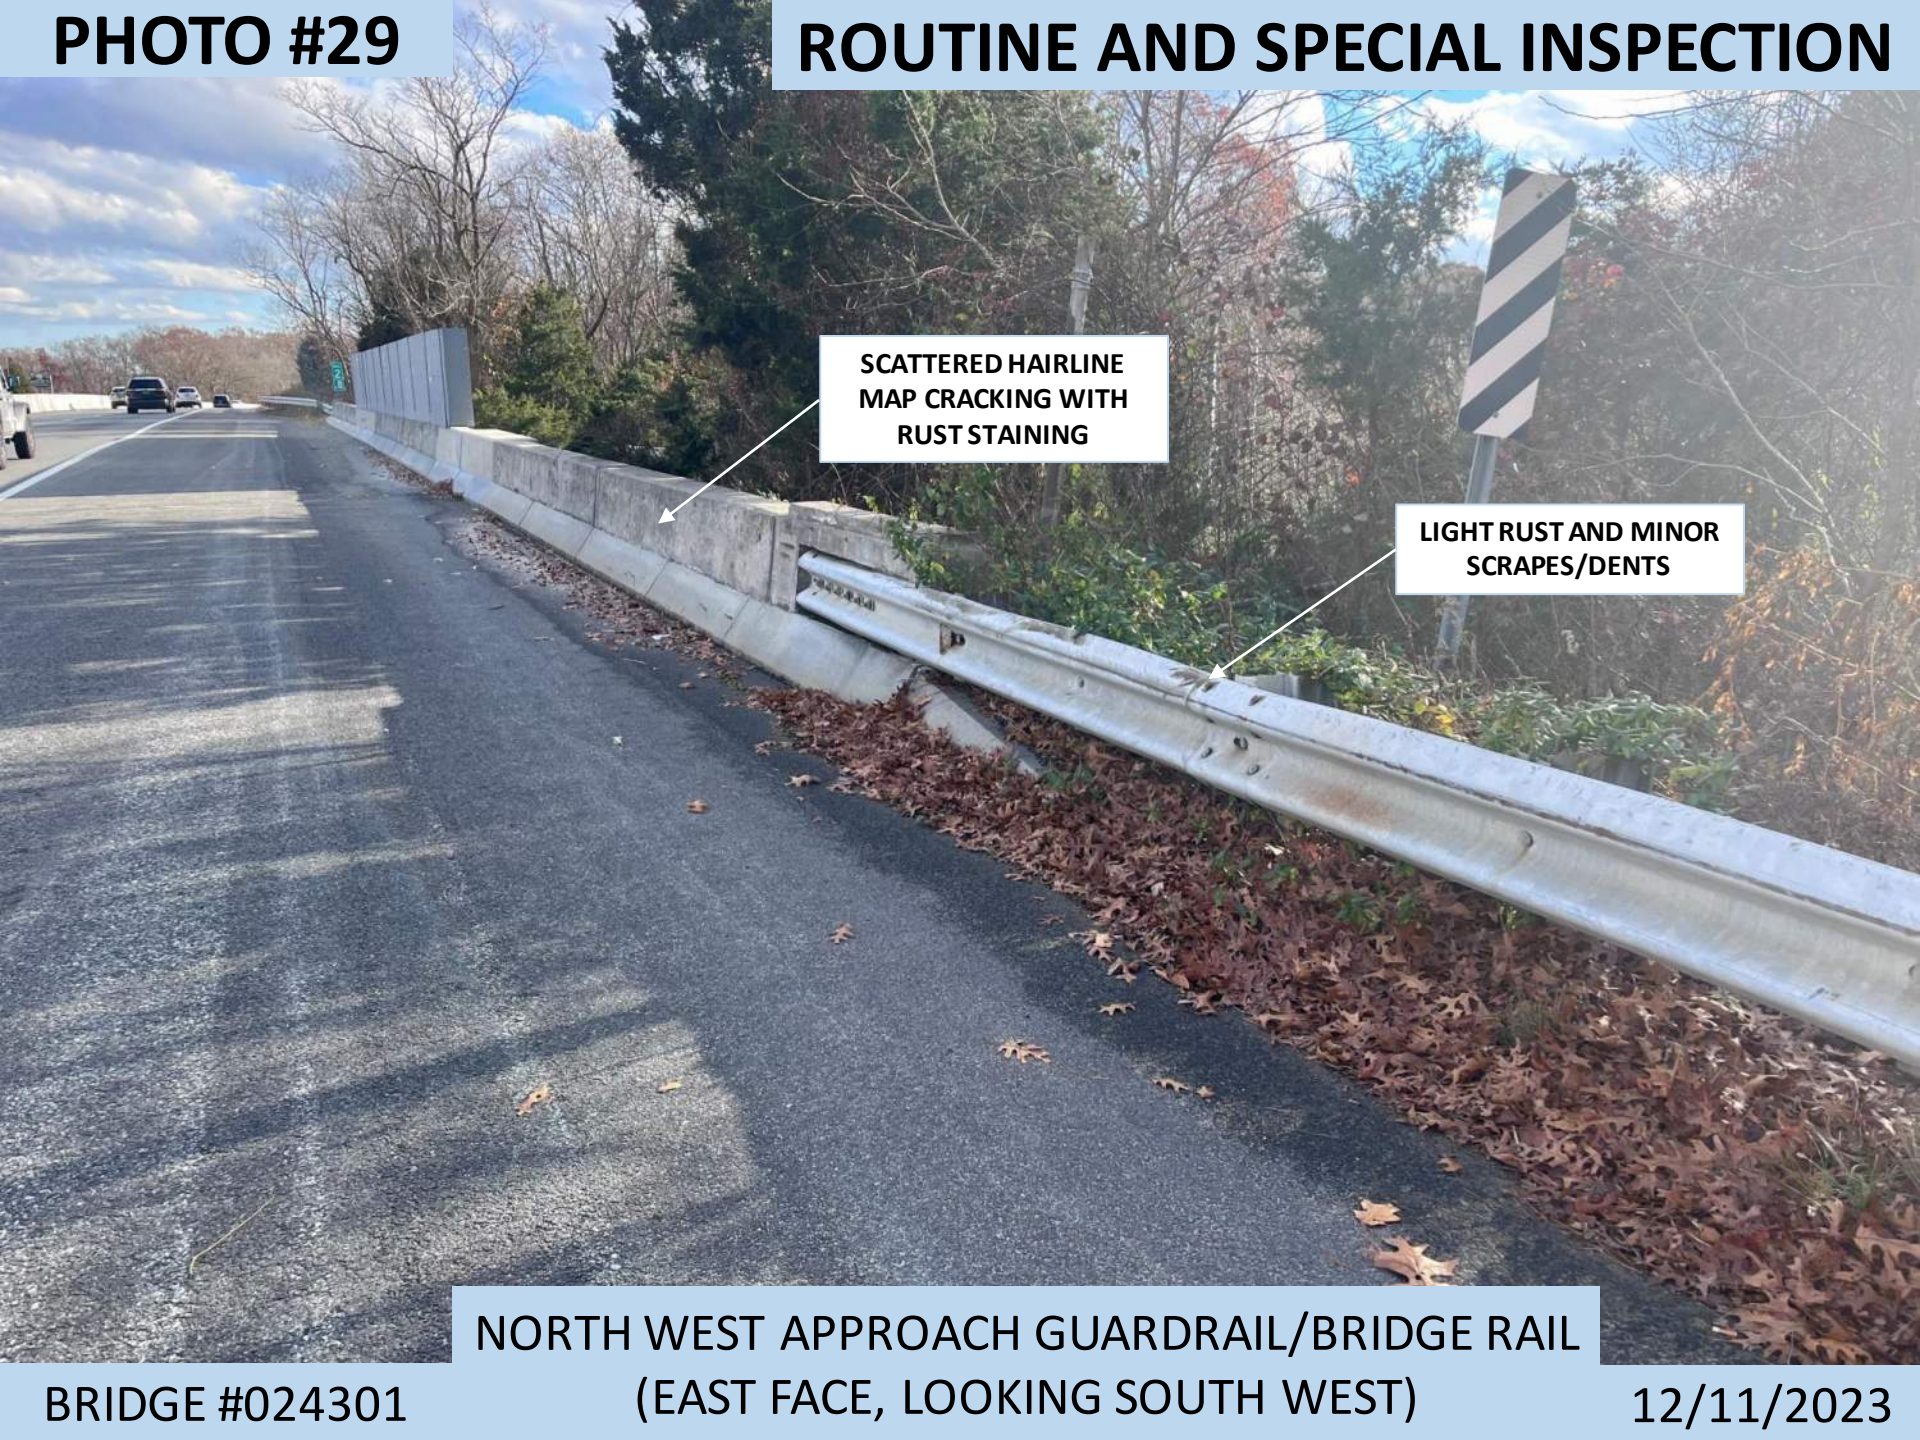
SCATTERED HAIRLINE
MAP CRACKING WITH
RUST STAINING

LIGHT RUST AND MINOR
SCRAPES/DENTS

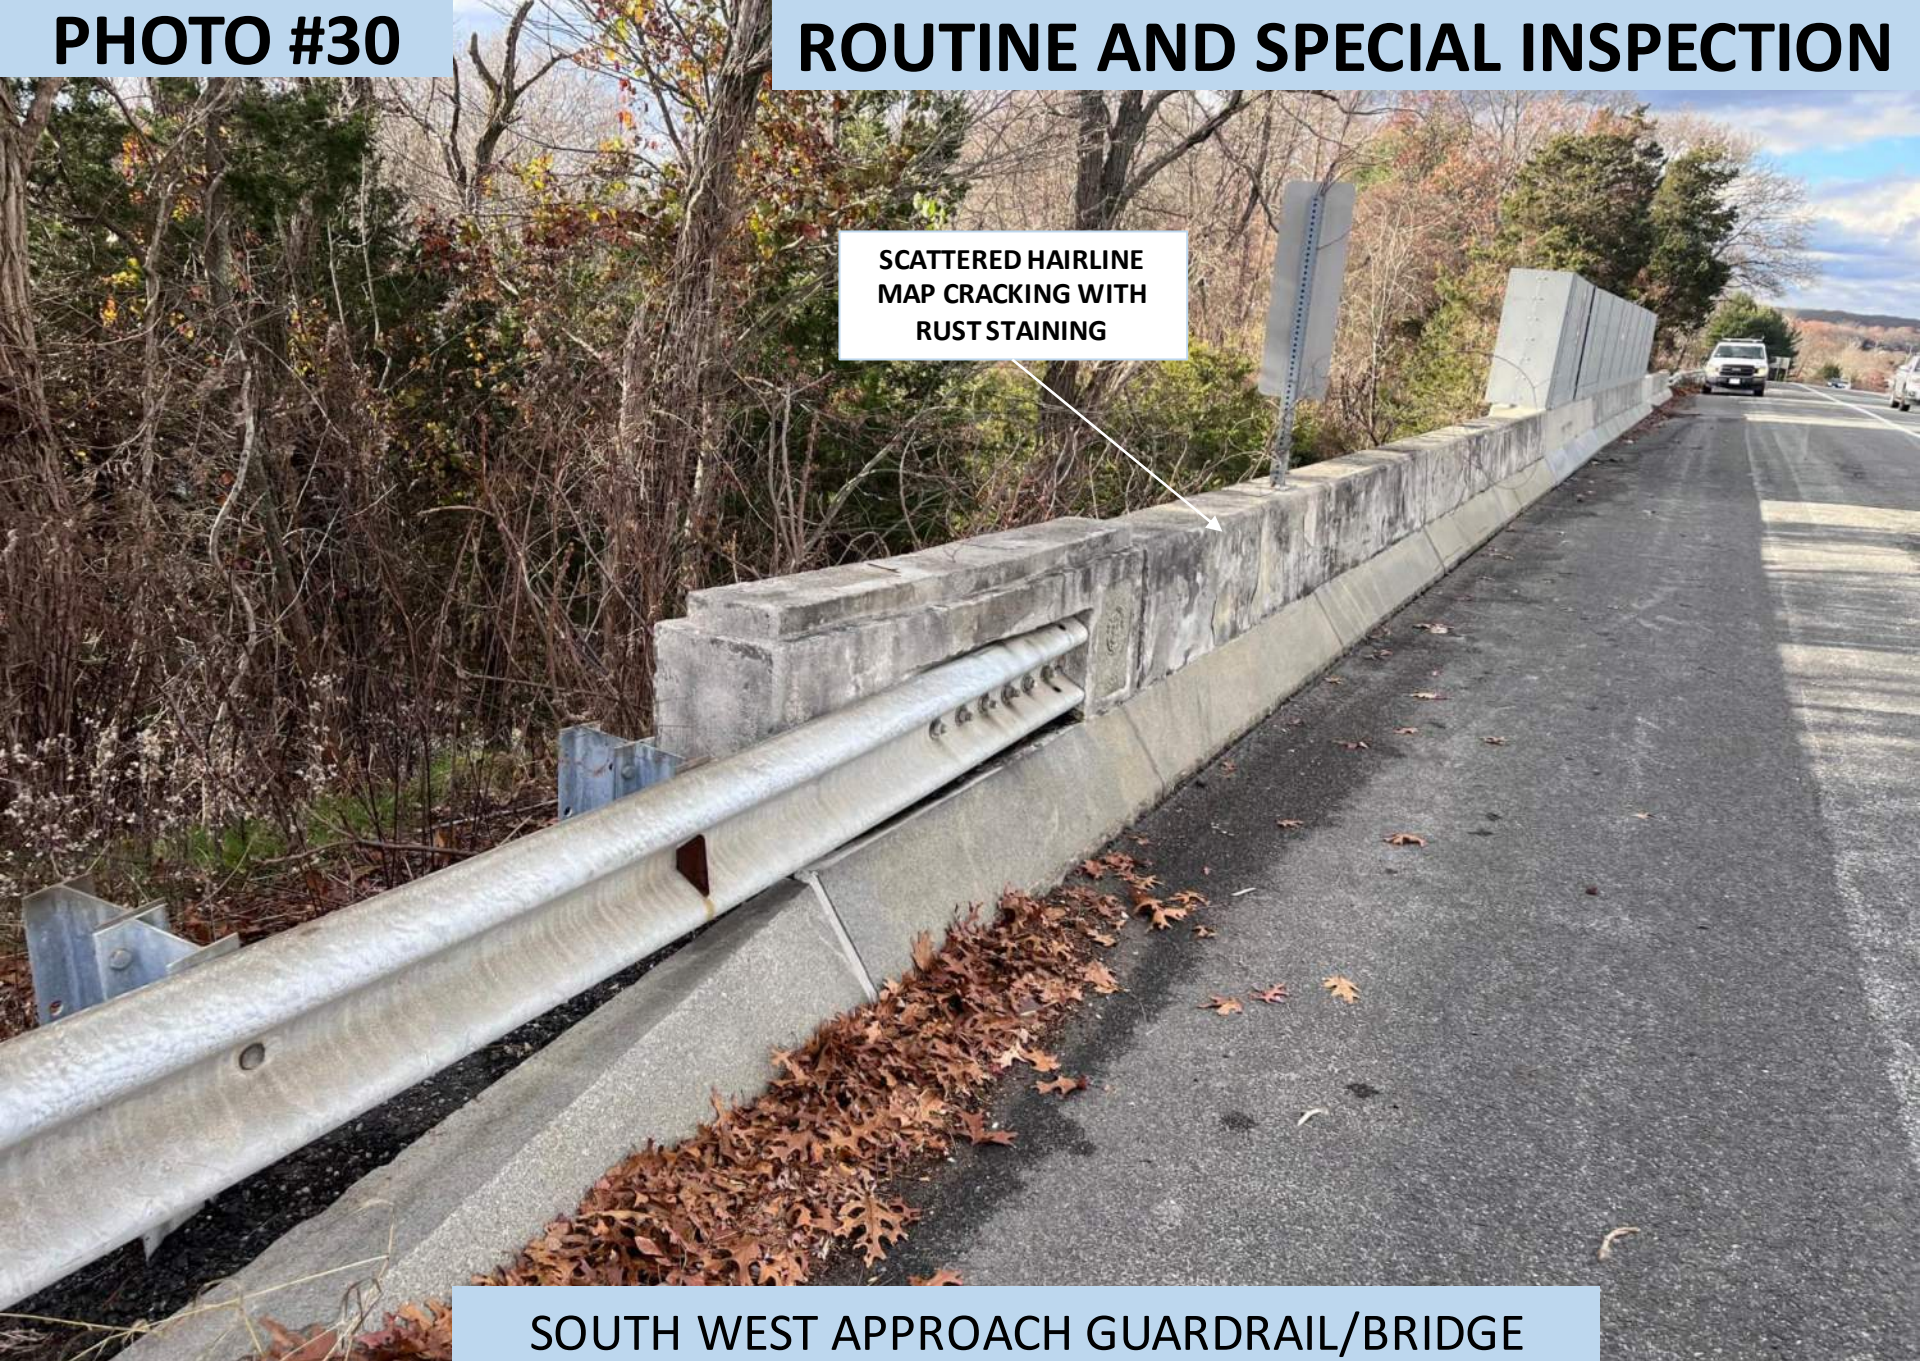
SCATTERED HAIRLINE
MAP CRACKING WITH
RUST STAINING

**SOUTH WEST APPROACH GUARDRAIL/BRIDGE
RAILING (EAST FACE, LOOKING NORTH WEST)**
