NOTICE TO PROSPECTIVE BIDDERS
RI CONTRACT NO. 2024-CB-018 – ADDENDUM NO. 1

Add New Appendix to this Addendum No. 1. “Bridge Inspection Report” has been added.

SPECIAL INSPECTION SCOPE: The scope of the special inspection shall include the advanced deterioration of the beam ends including the web area beyond the end diaphragms, end diaphragms, fixed bearings and moveable bearings. The special inspection shall also include the AASHTO Fatigue Category E' welds at the transverse ends of the cover plates and the bottom flanges of the beams. If any cracks are observed at these weld details, the RIDOT Bridge Ratings Section shall be notified.

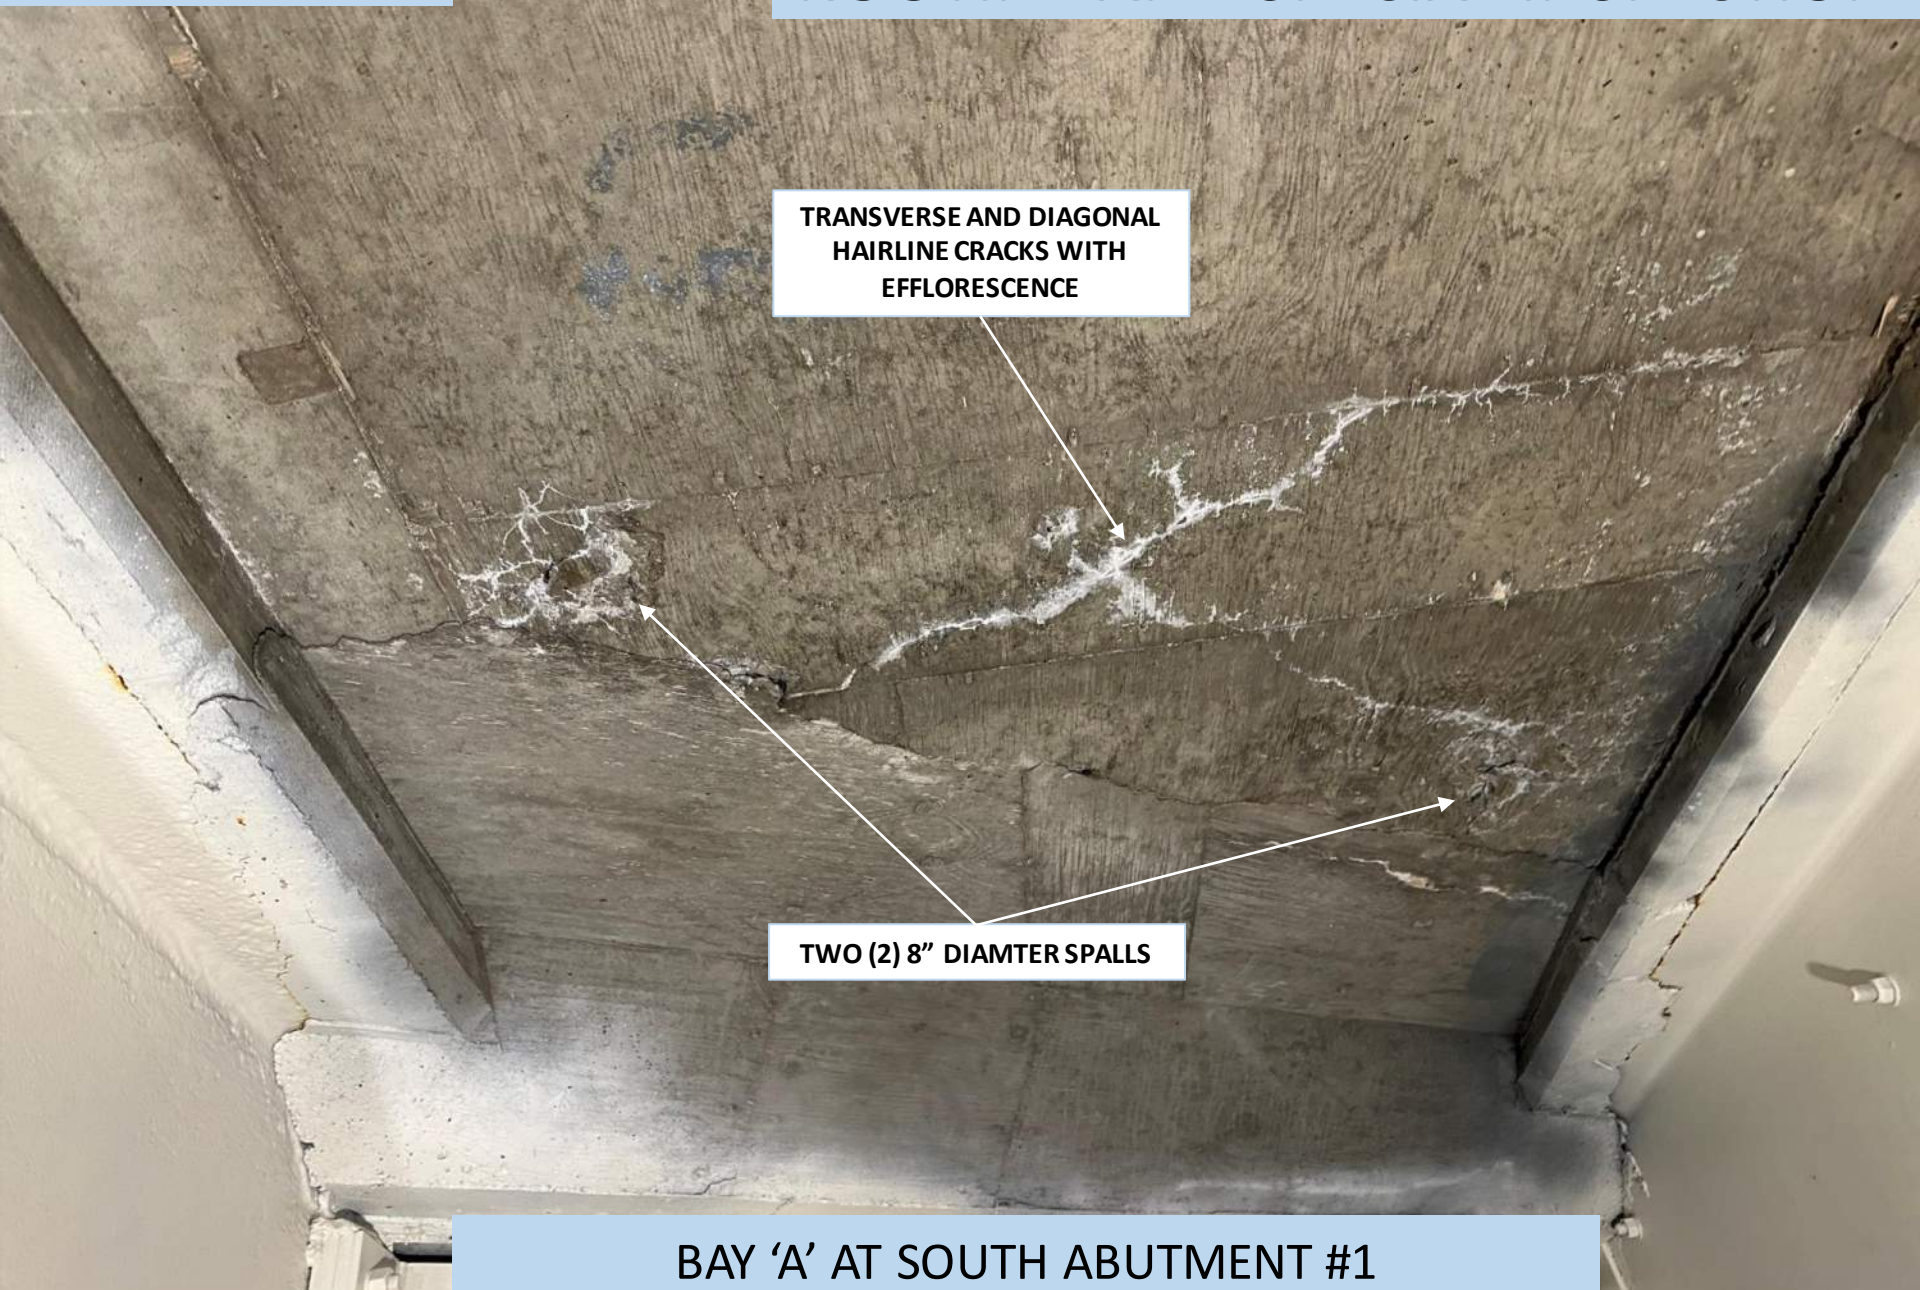
Bay 'A' near South Abutment #1 has two (2) up to 8" diameter spalls (see photo 31).

- Throughout Bay 'A' there are transverse and diagonal hairline cracks with efflorescence (see photo 31).
- Bay 'C' near North Abutment #2 has transverse and diagonal hairline cracks with efflorescence.
- Bay 'Q' between South Abutment #1 and the 1st interior diaphragm has transverse and diagonal hairline cracks with efflorescence (see photo 32).

**TRANSVERSE AND DIAGONAL
HAIRLINE CRACKS WITH
EFFLORESCENCE**

TWO (2) 8" DIAMTER SPALLS

**BAY 'A' AT SOUTH ABUTMENT #1
(LOOKING SOUTH)**

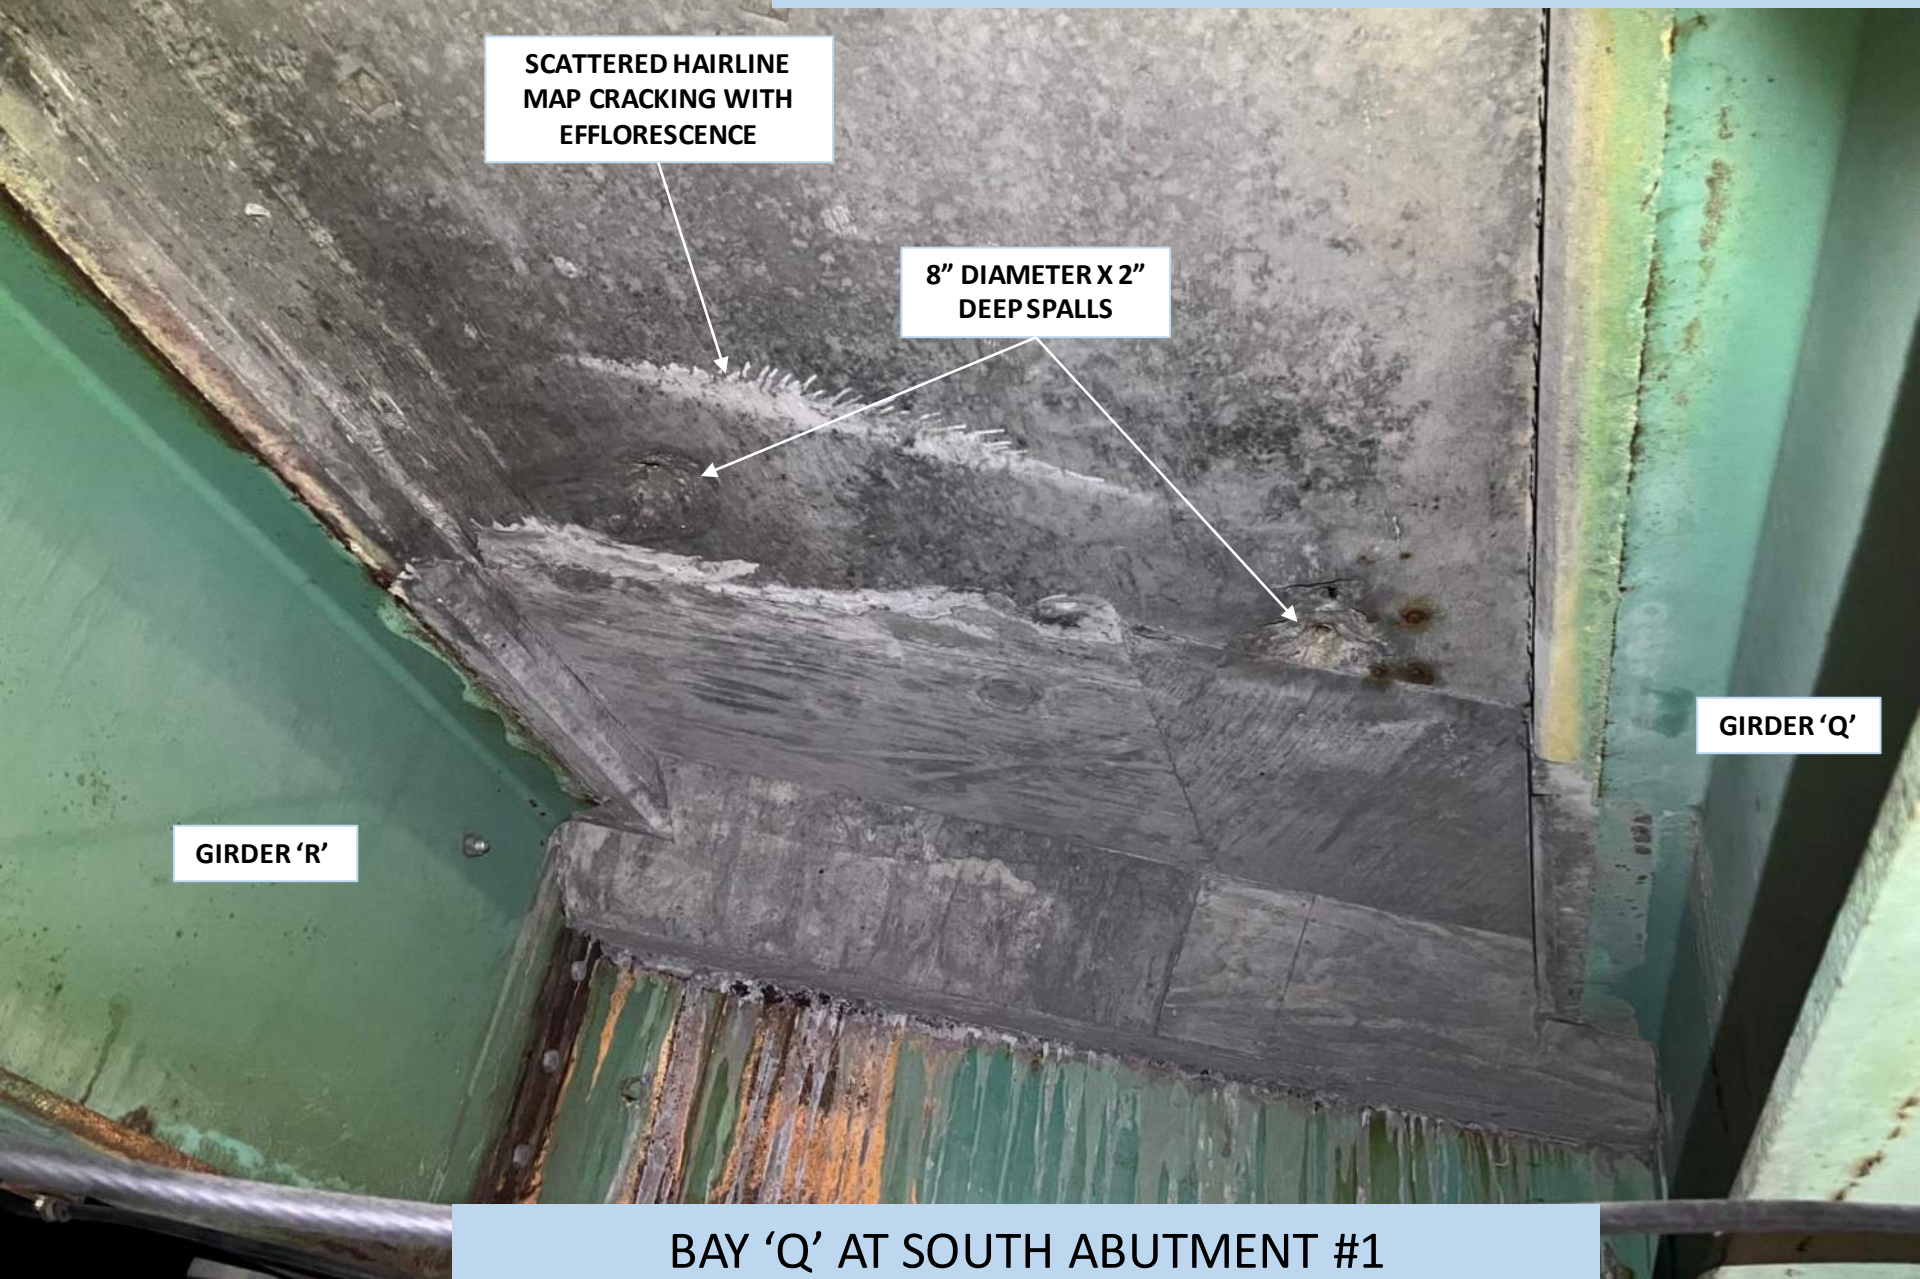
Bay 'Q' near South Abutment #1 has two (2) up to 8" diameter x 2" deep spalls (see photo 32).

SCATTERED HAIRLINE
MAP CRACKING WITH
EFFLORESCENCE

8" DIAMETER X 2"
DEEPSALLS

**BAY 'Q' AT SOUTH ABUTMENT #1
(LOOKING SOUTH)**

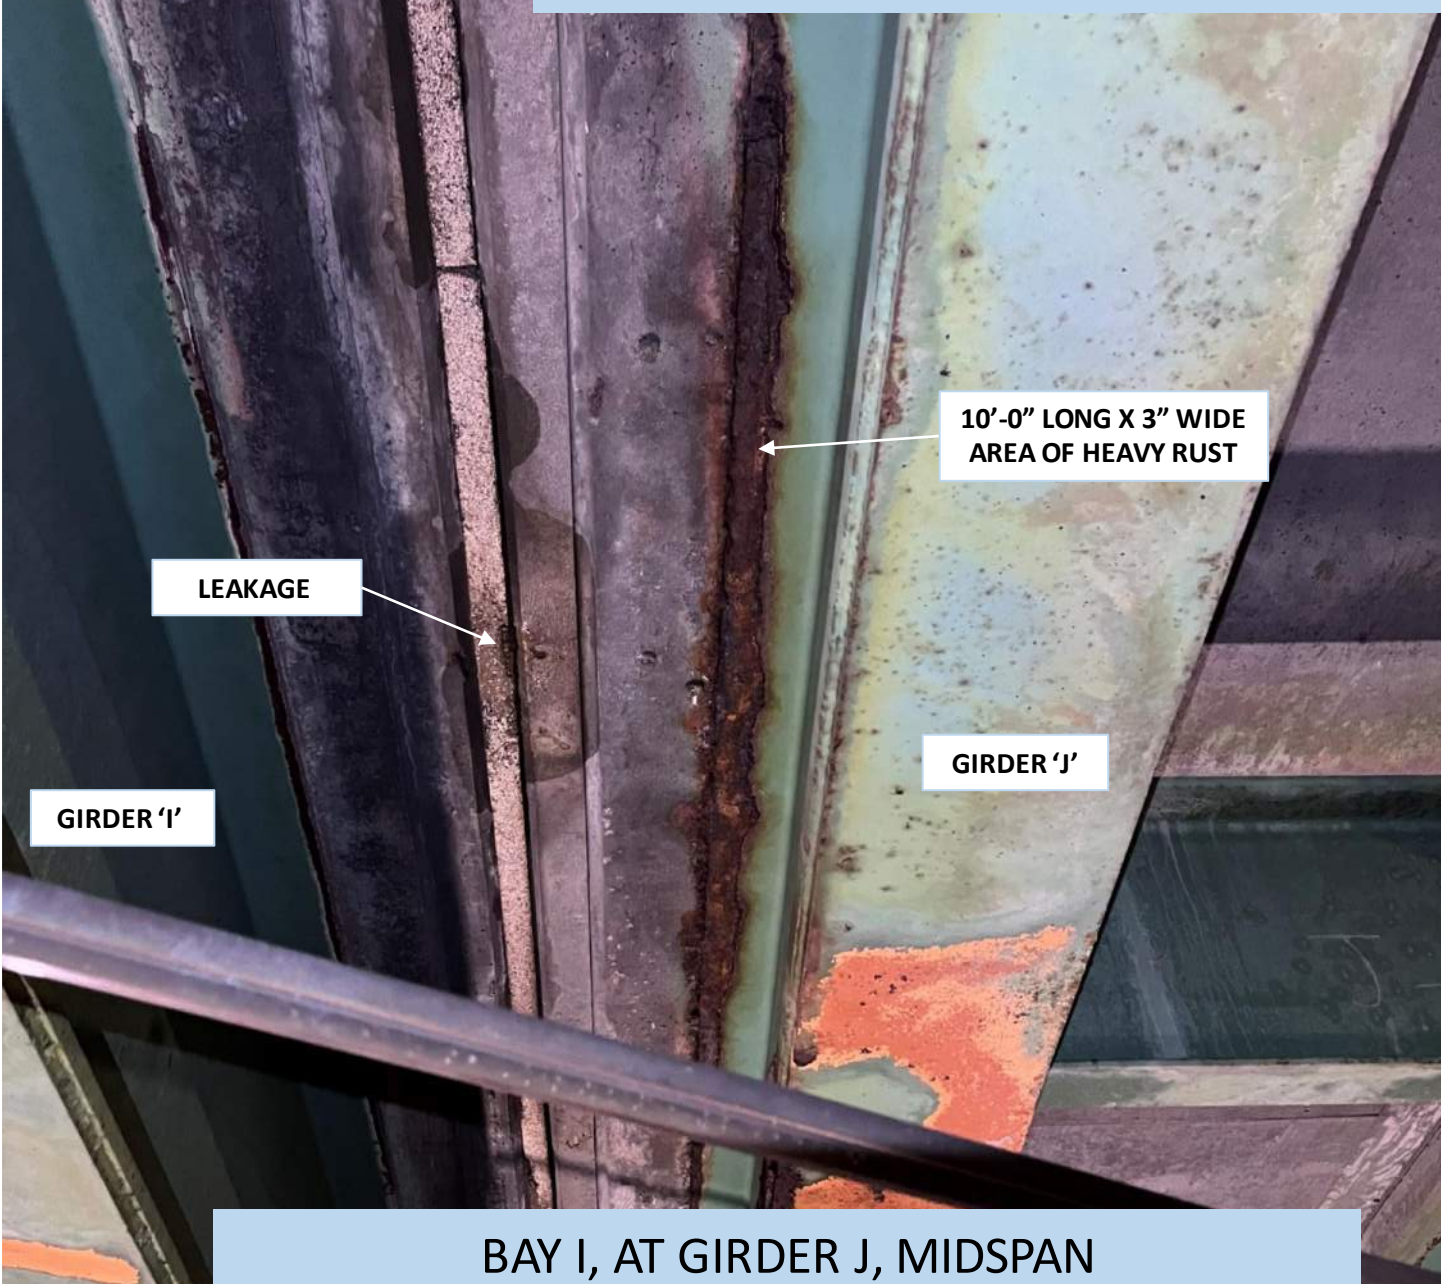
There is a reinforced concrete deck overlaid with a bituminous concrete wearing surface (see photos 5 - 9). Bay 'I' has active leakage adjacent to the median joint (see photo 33).

LEAKAGE

**10'-0" LONG X 3" WIDE
AREA OF HEAVY RUST**

**BAY I, AT GIRDER J, MIDSPAN
(LOOKING NORTH)**

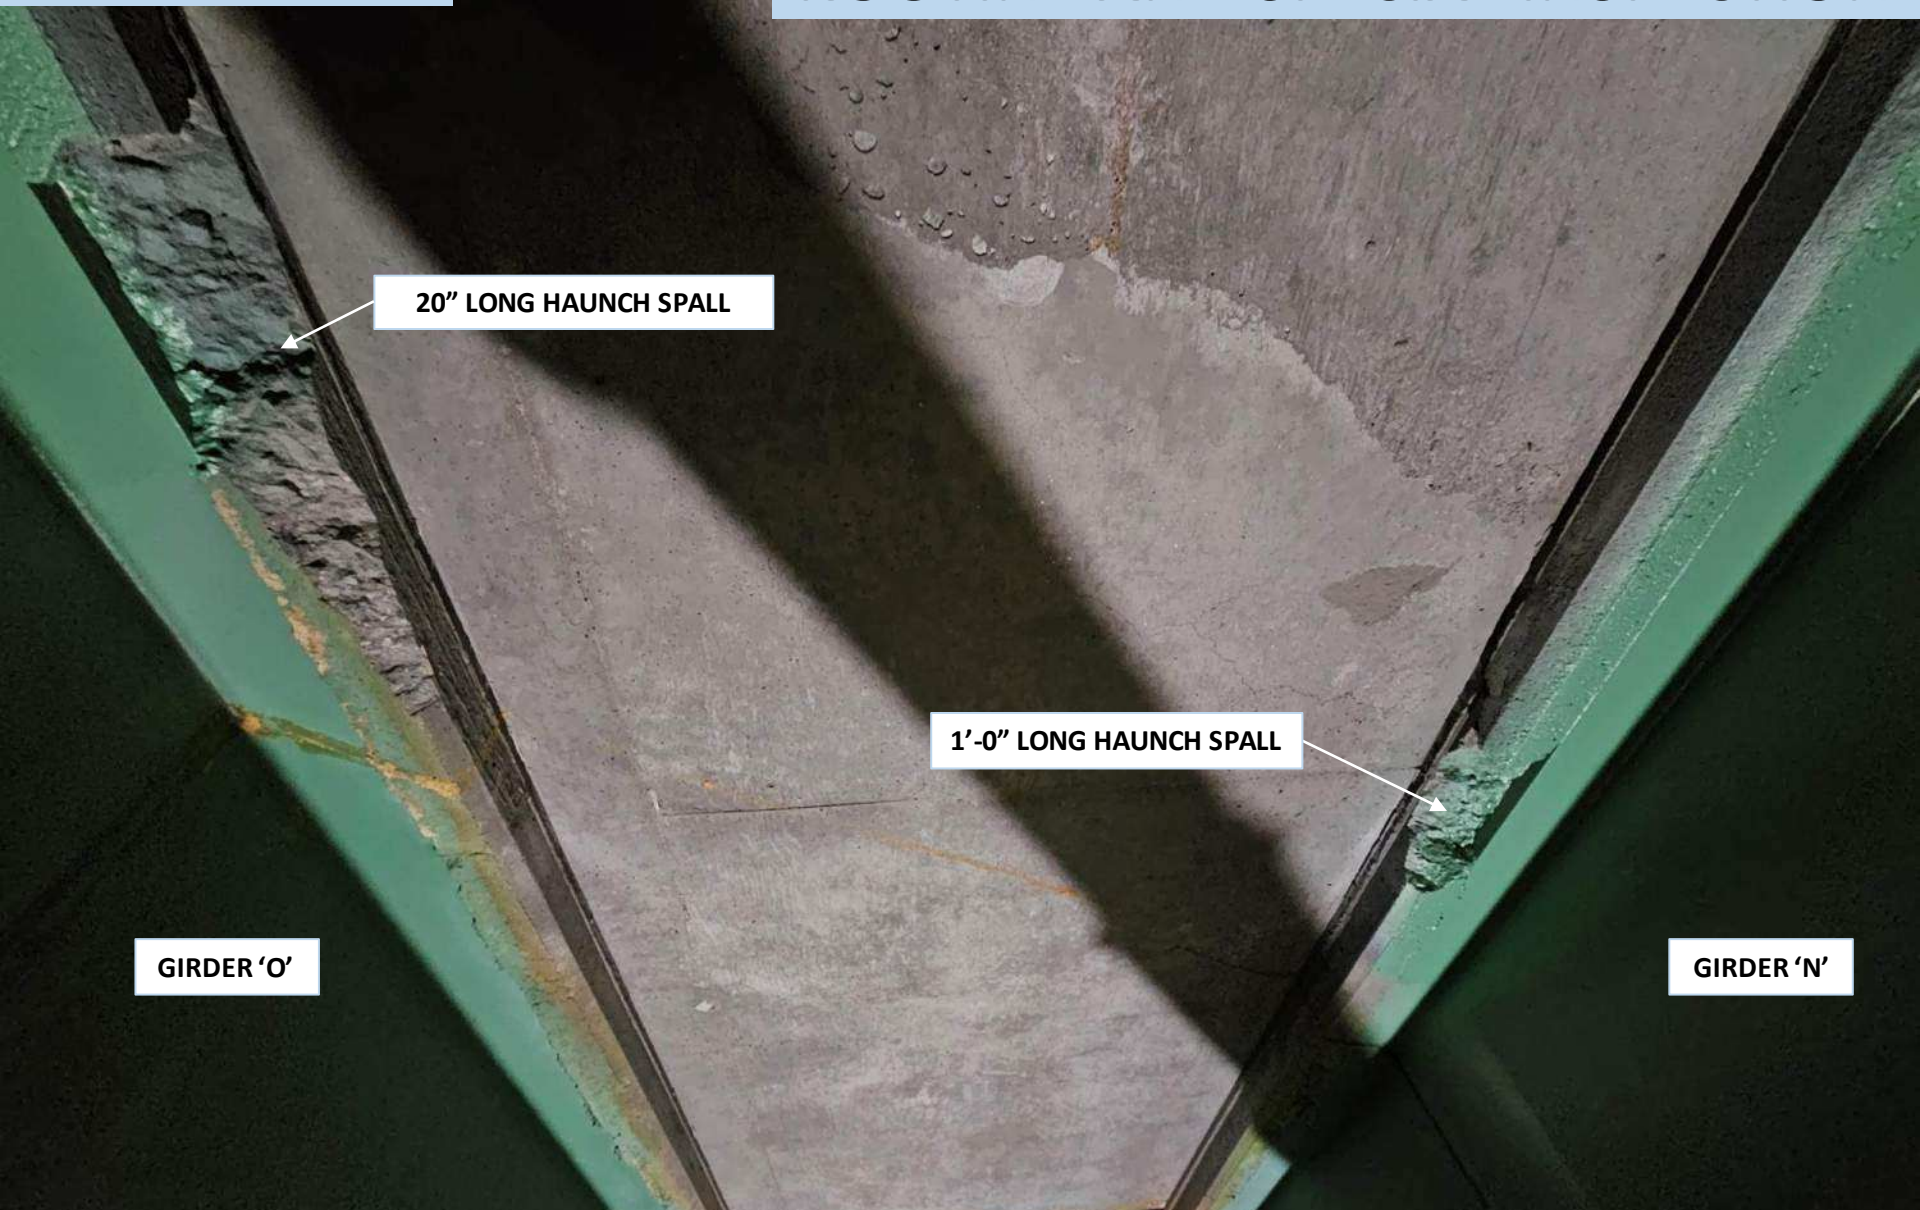
Bay 'N' near North Abutment #2 has two (2) up to 20" long haunch spalls (see photo 34).

20" LONG HAUNCH SPALL

1'-0" LONG HAUNCH SPALL

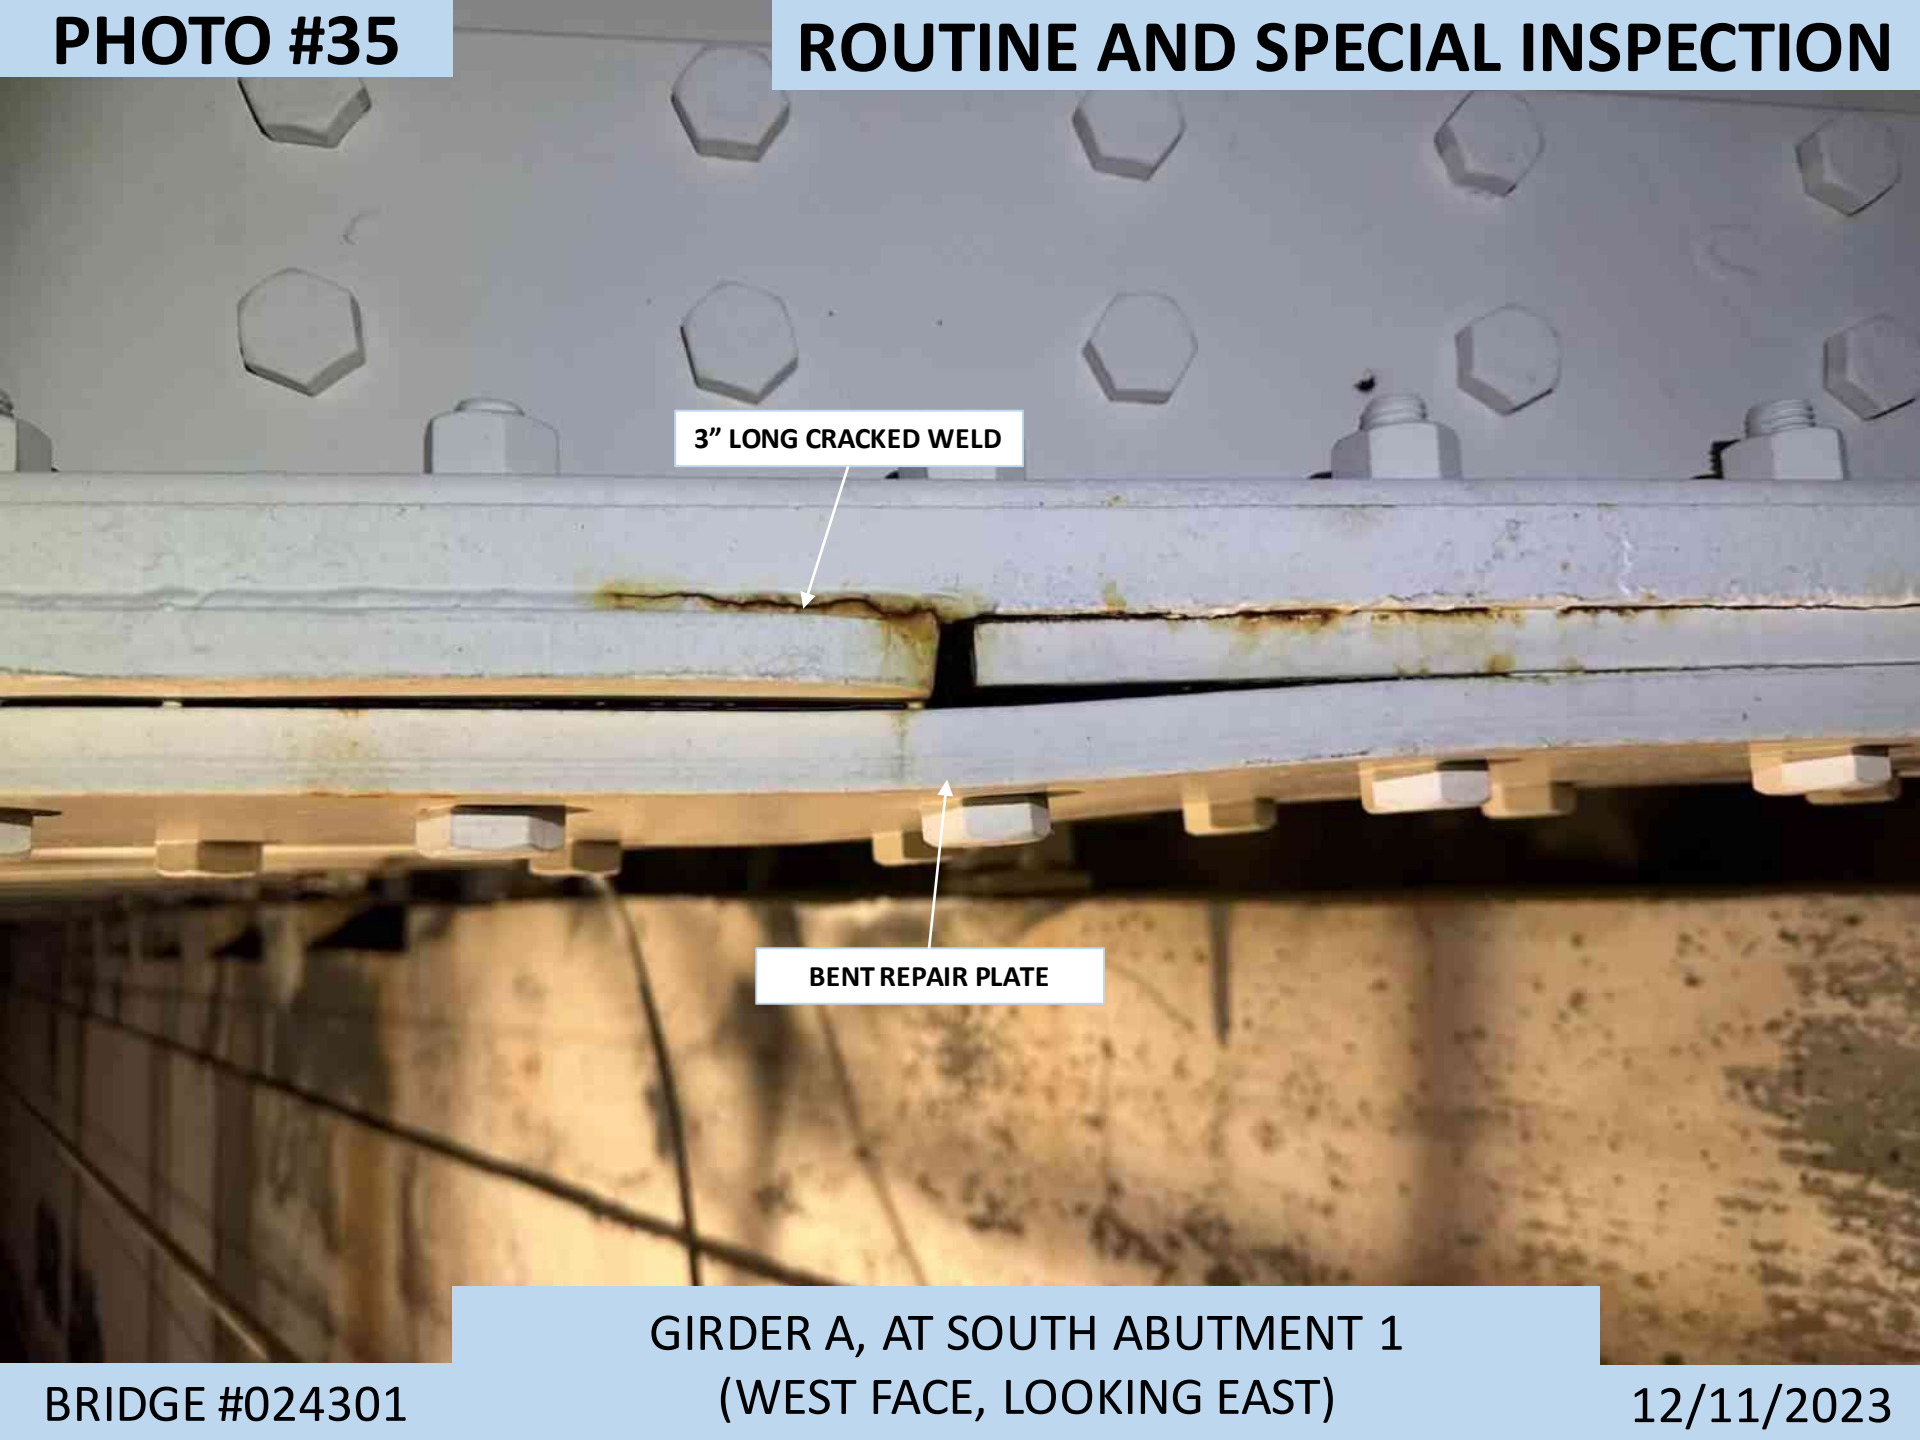
PHOTO #35

3" LONG CRACKED WELD

BENT REPAIR PLATE

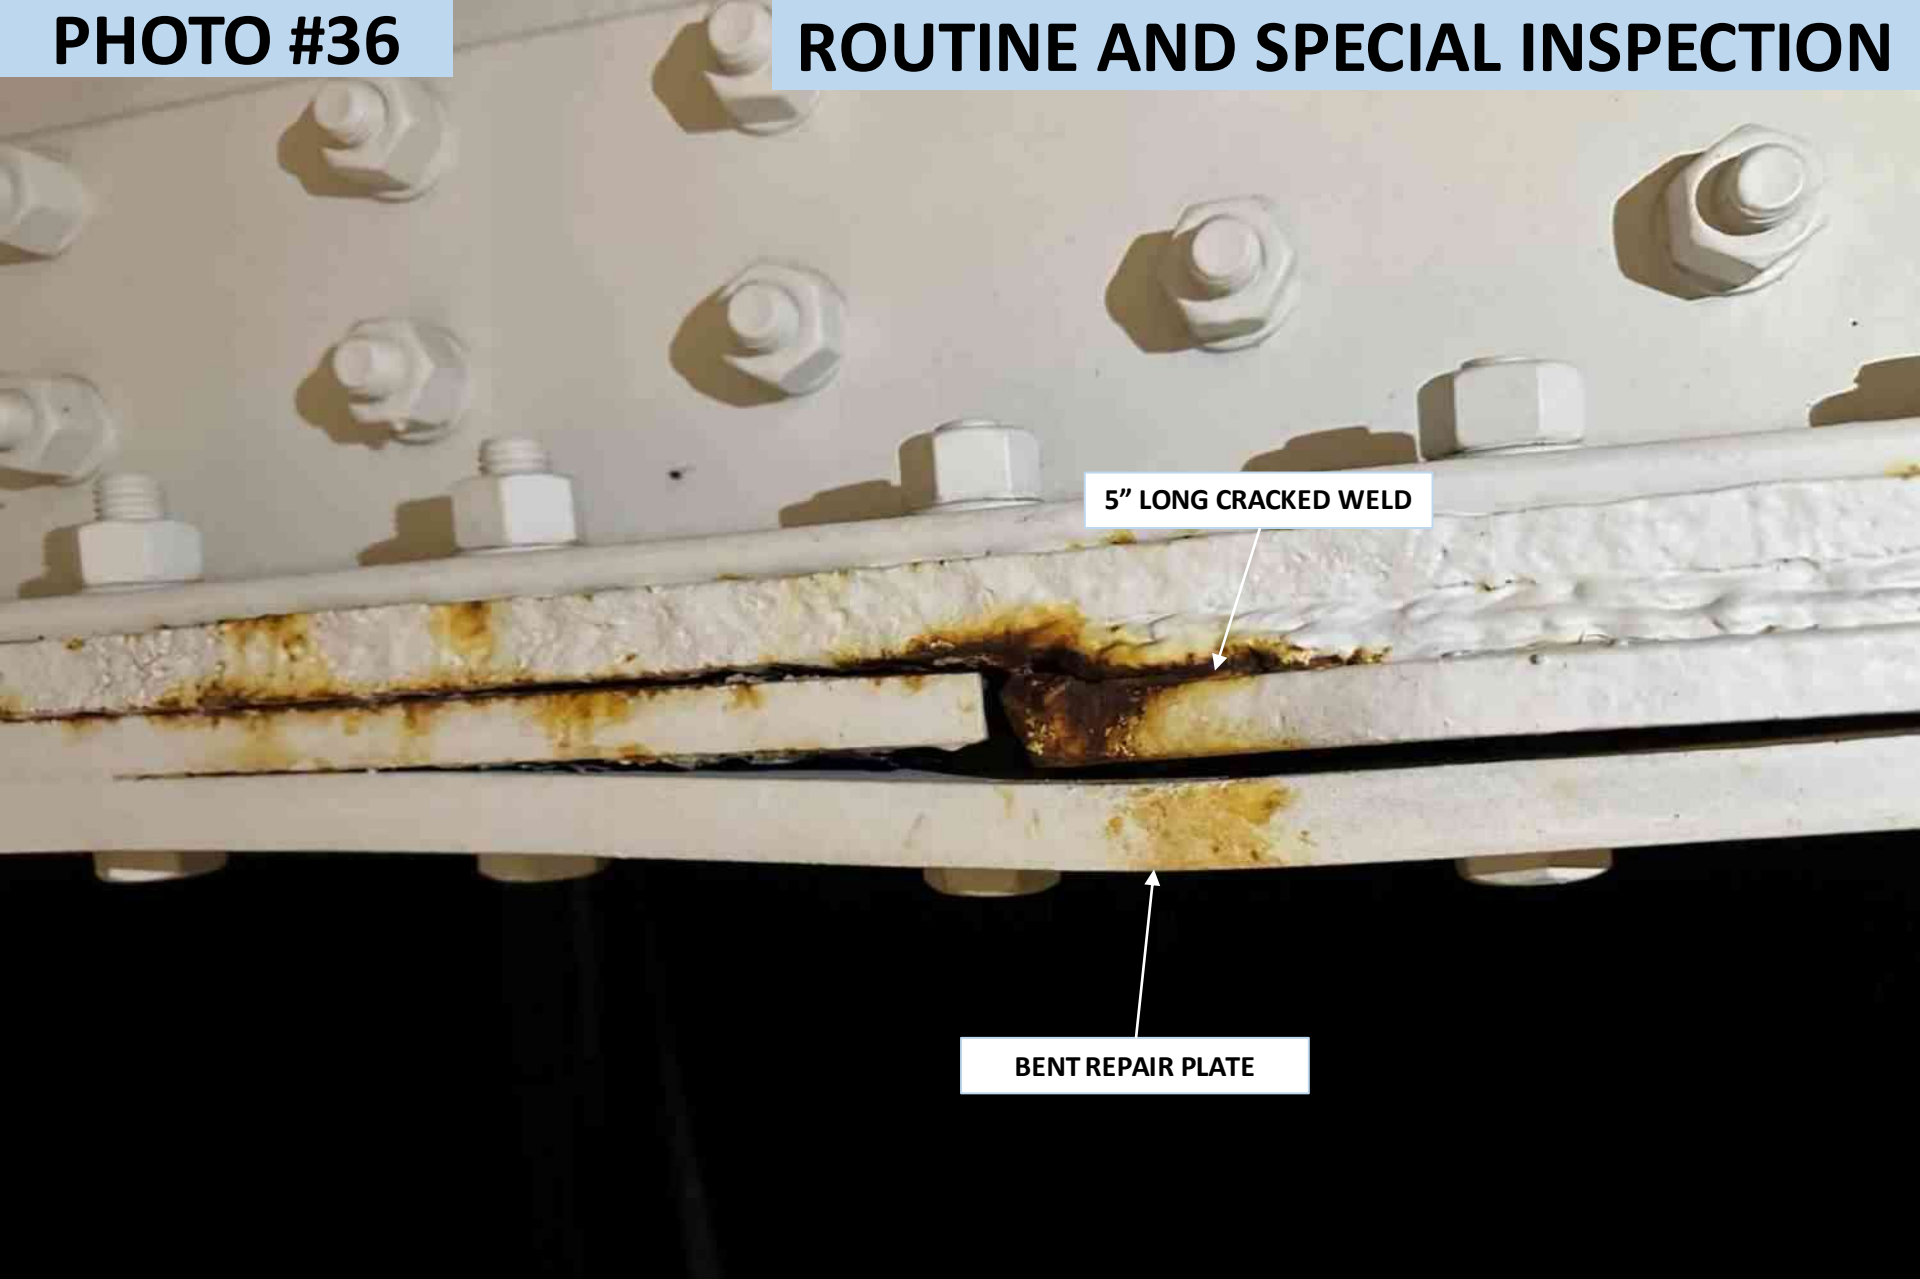
PHOTO #36

**GIRDER A AT SOUTH ABUTMENT 1
(EAST FACE, LOOKING WEST)**

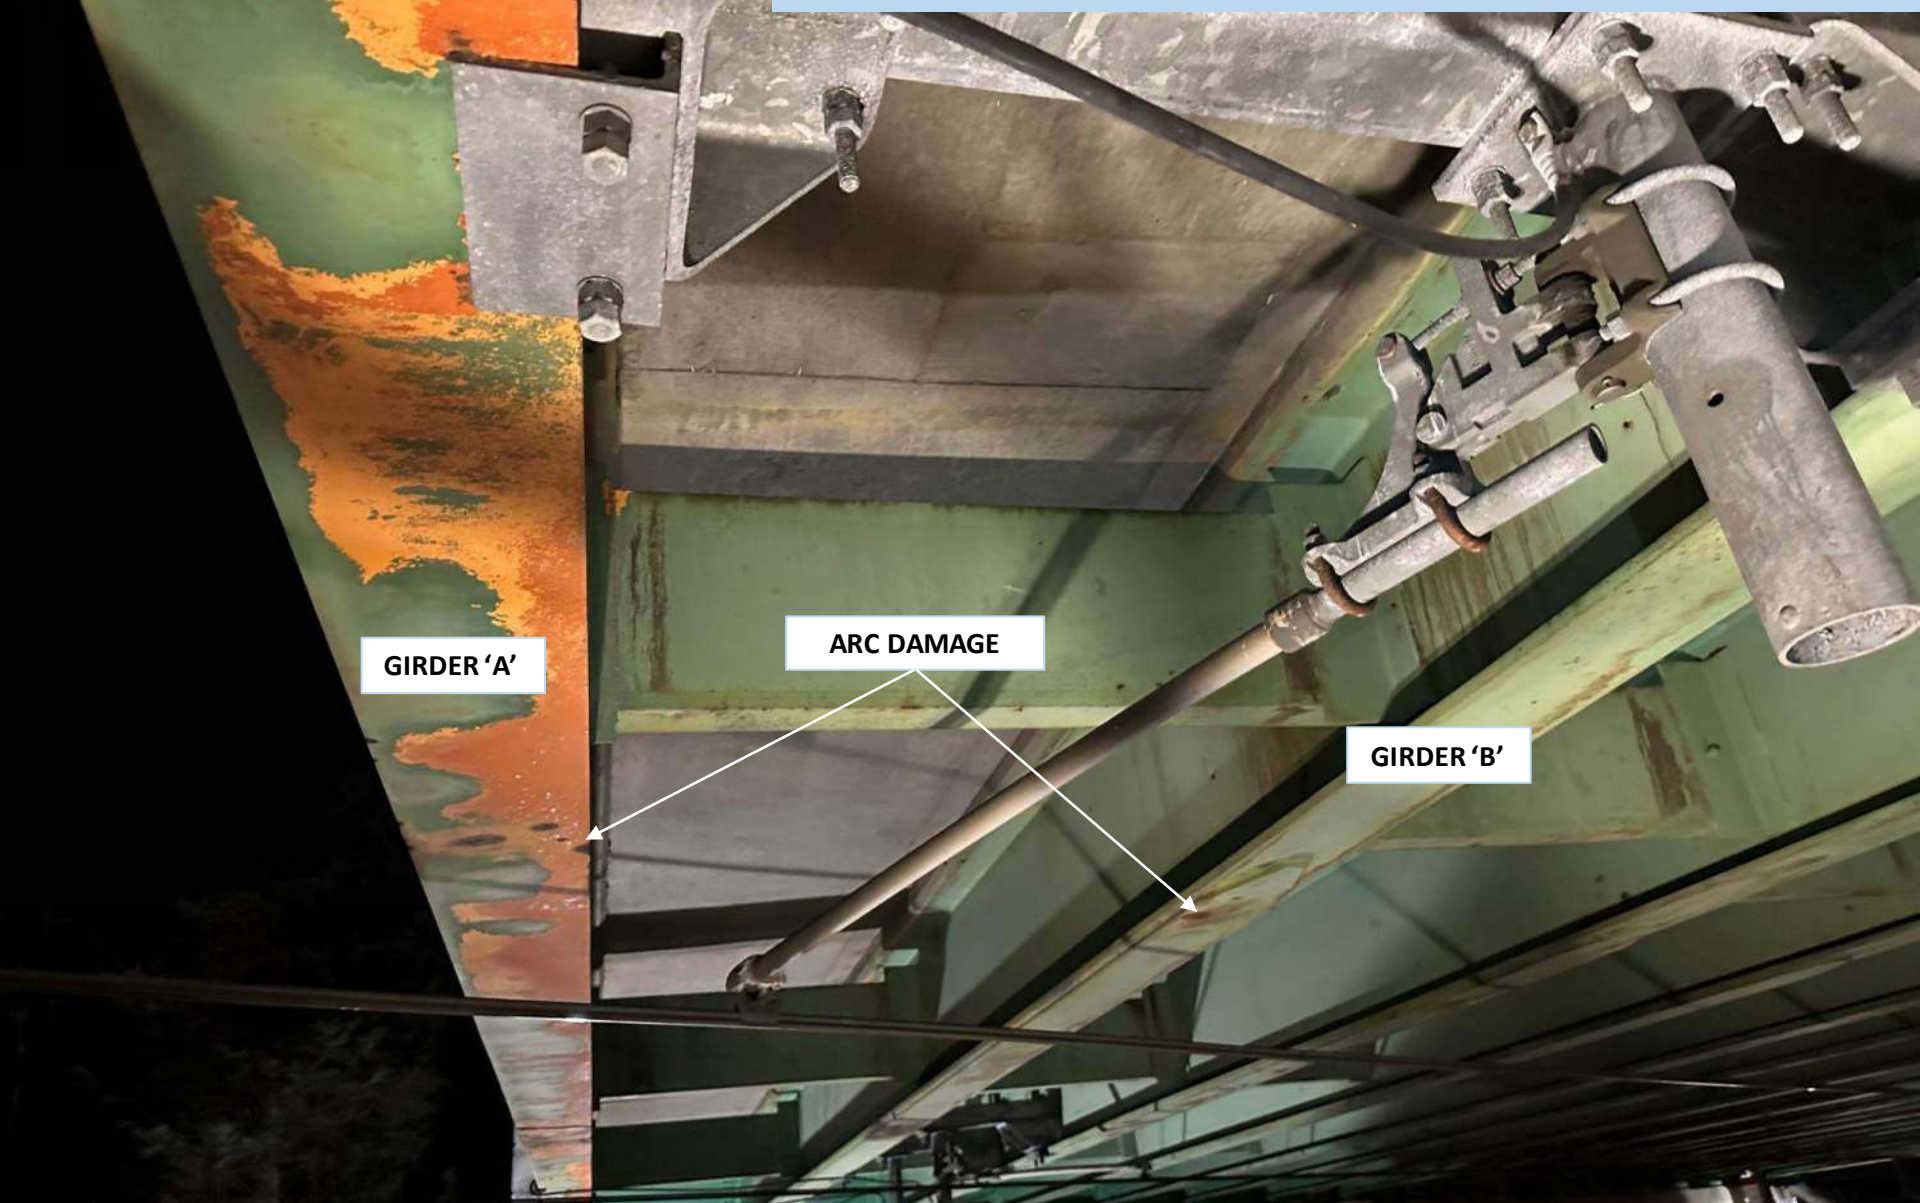
PHOTO #37

There are eighteen (18) steel girders labeled 'A' through 'R' from West to East (see photos 5 - 7). The cover plates of Girders "A" and "R" near South Abutment 1 have been retrofitted with bolted steel repair plates. A few girders have manufacturing defects and arc damage on the underside of the bottom flange (see photo 37).

ARC DAMAGE

**GIRDERS A AND B, UNDERSIDE NEAR
SOUTH ABUTMENT 1 (LOOKING NORTH)**

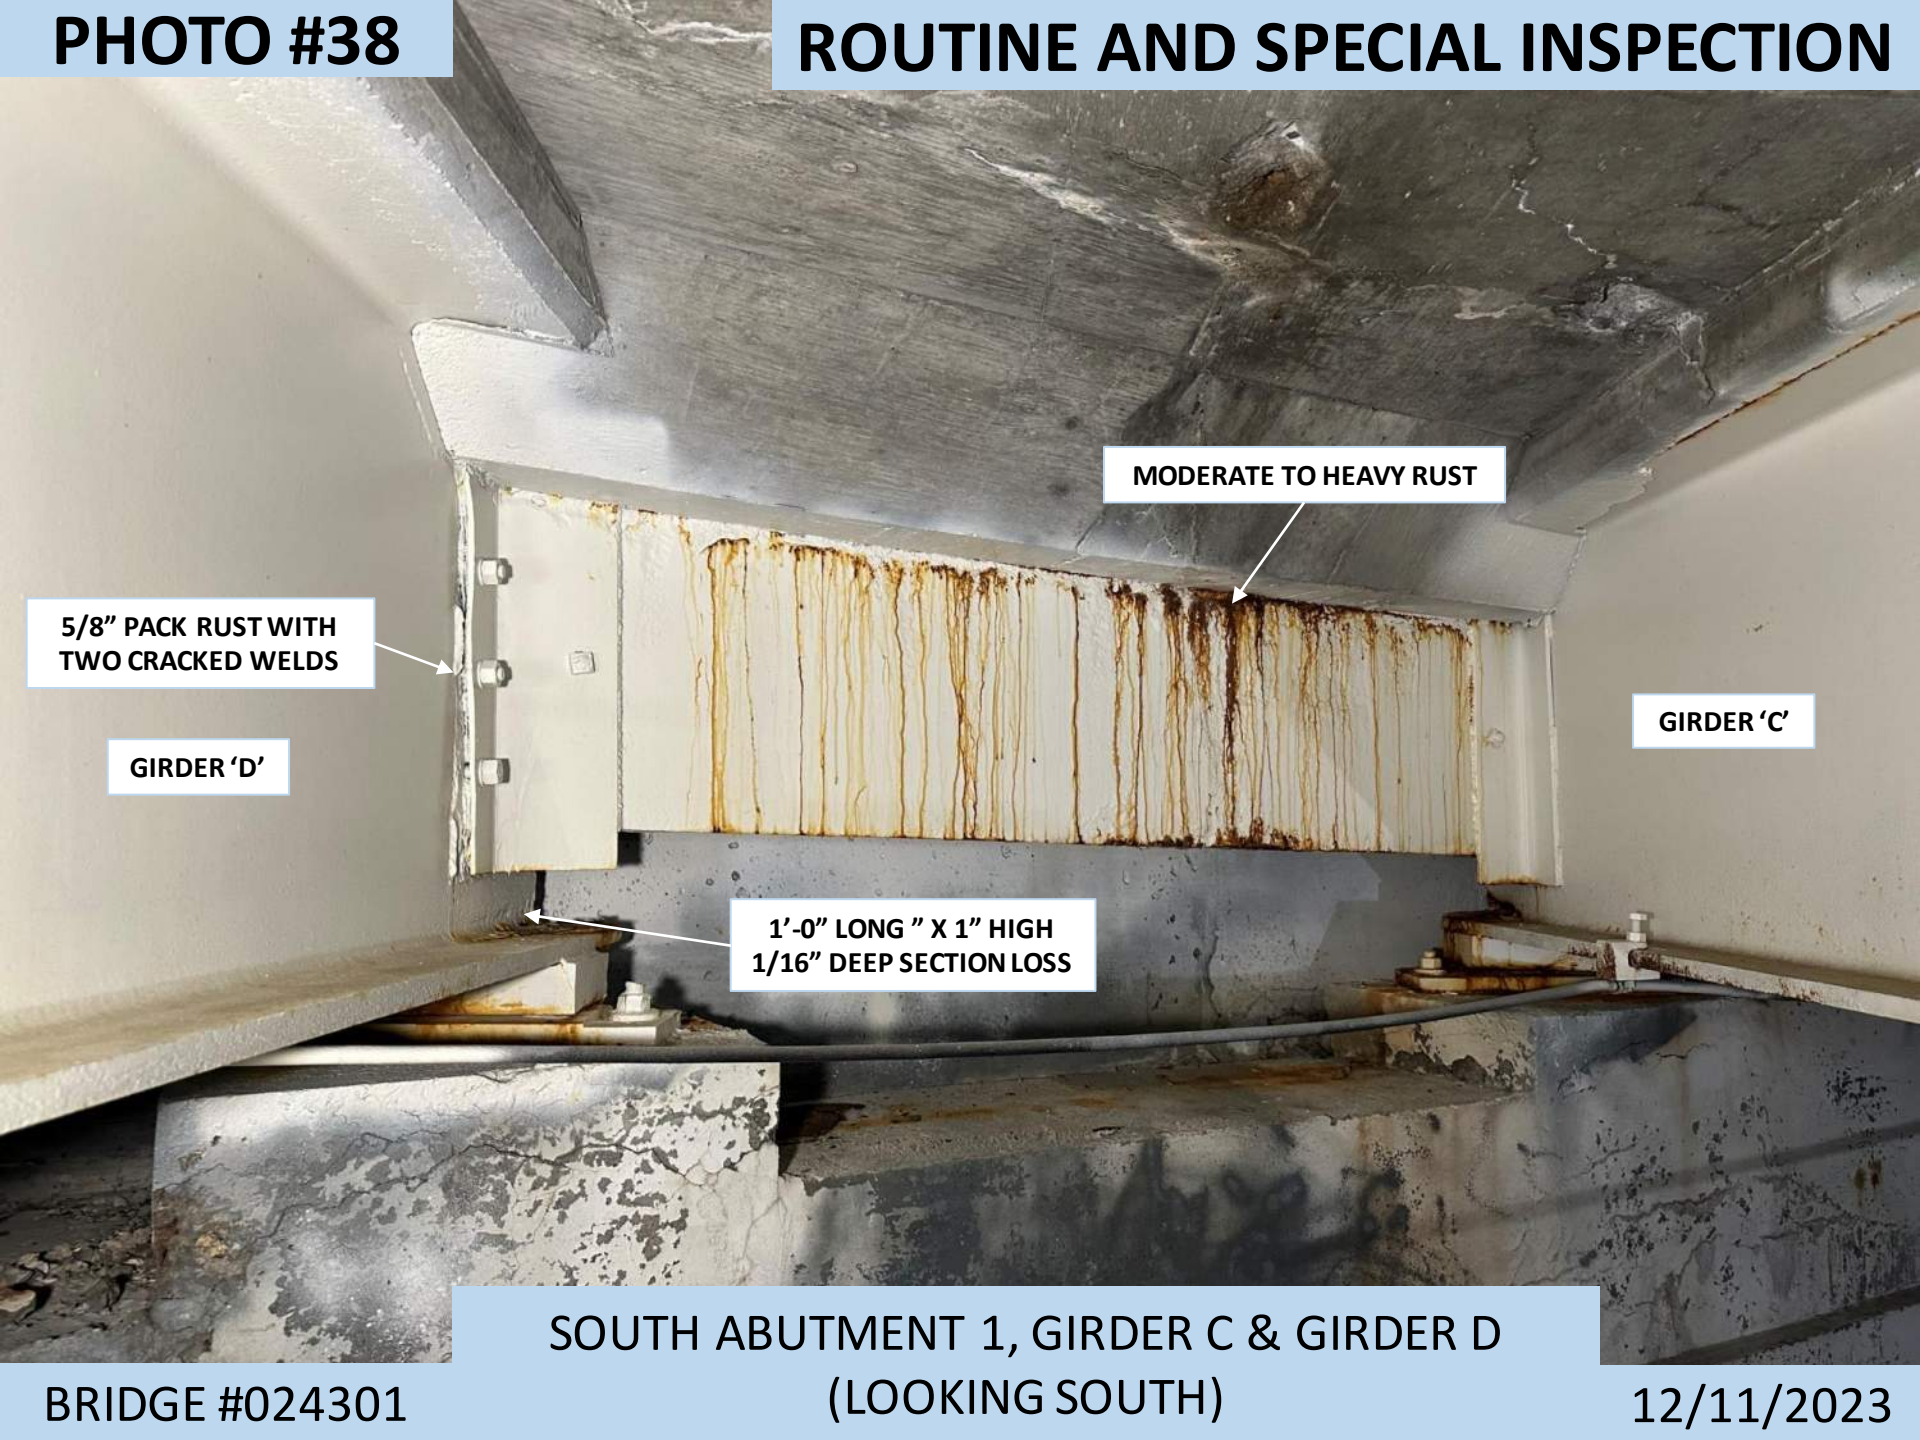
5/8" PACK RUST WITH TWO CRACKED WELDS

MODERATE TO HEAVY RUST

SOUTH ABUTMENT 1, GIRDER C & GIRDER D

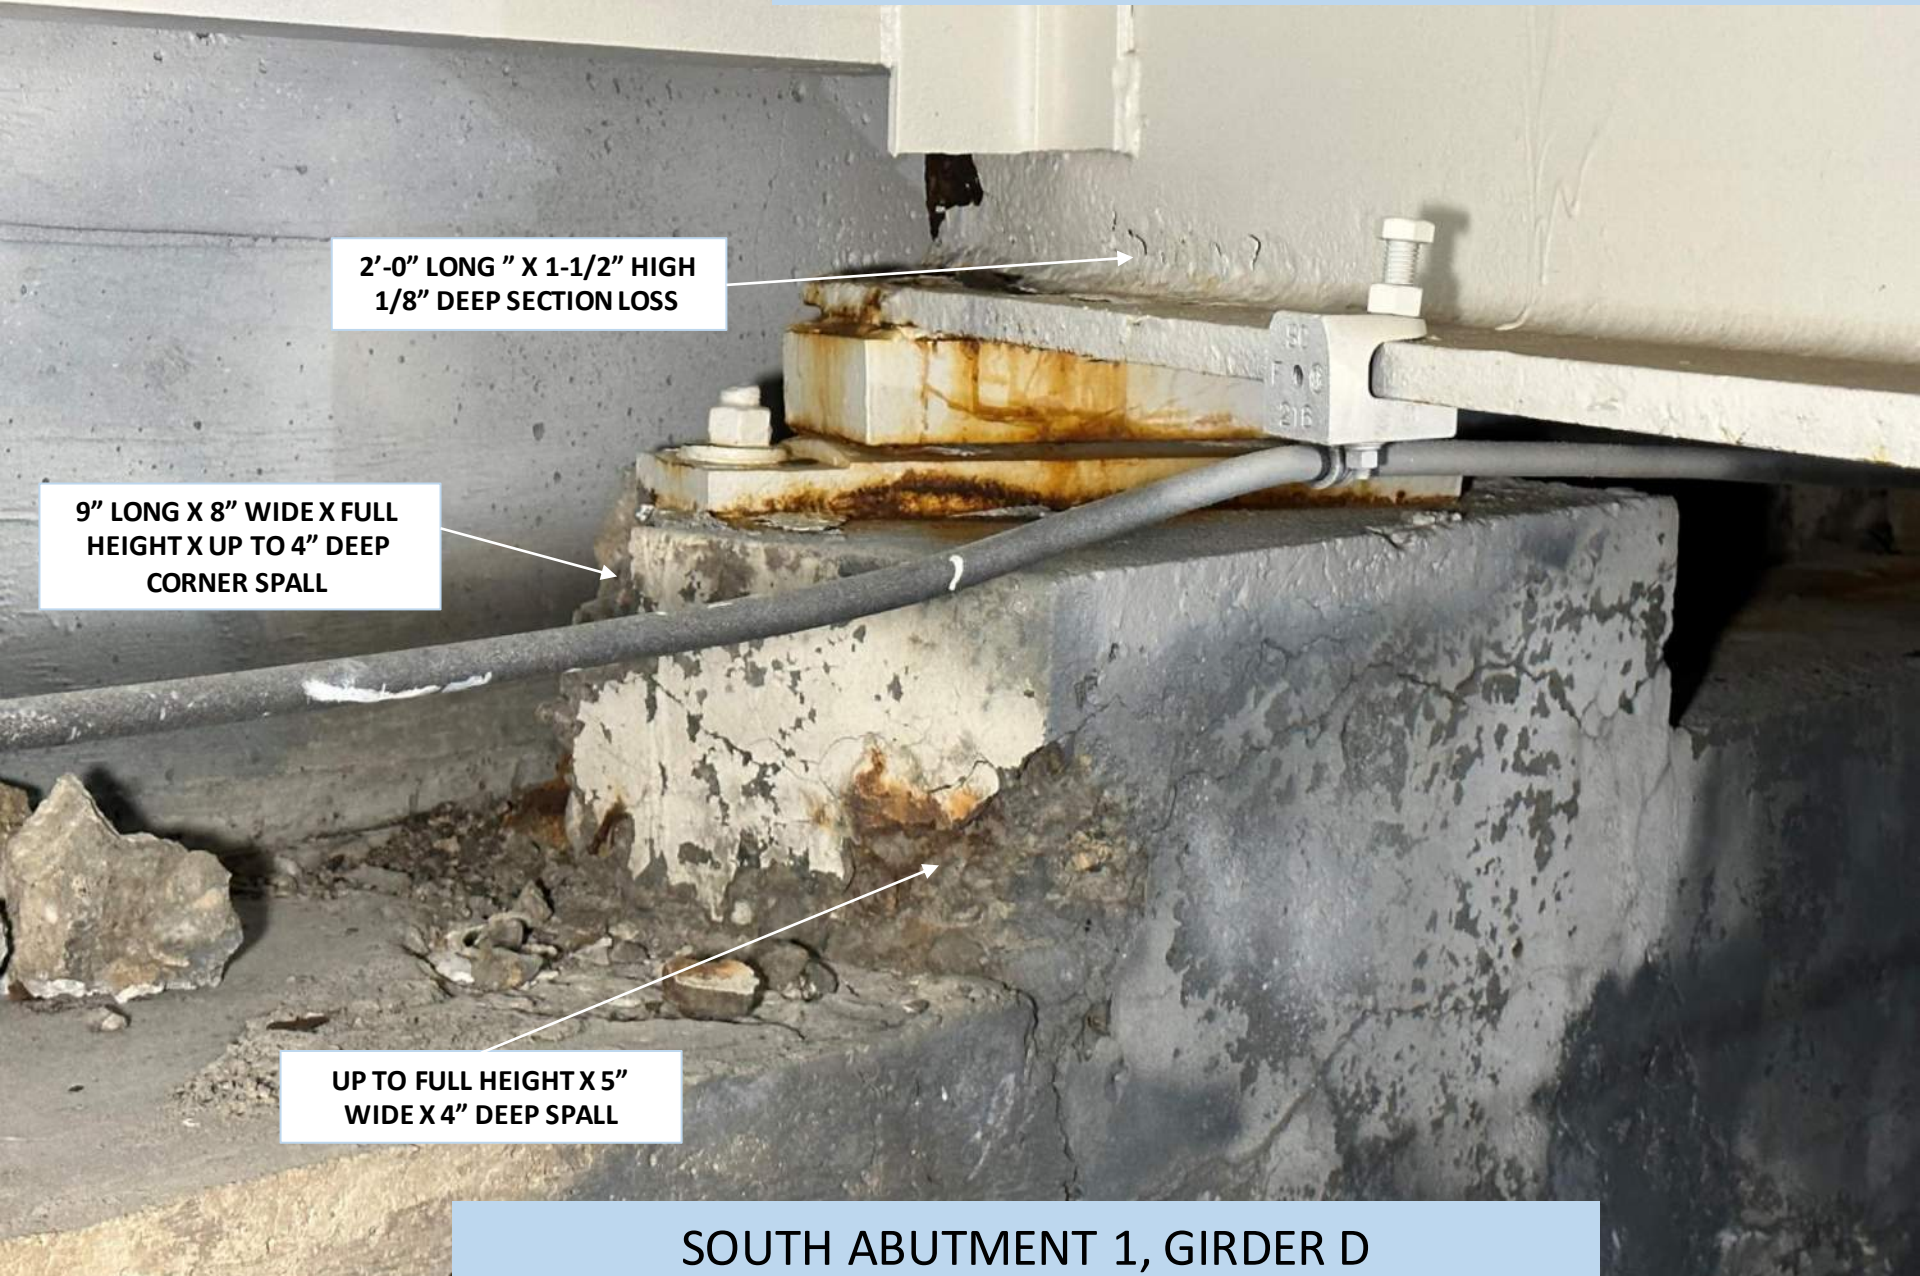
2'-0" LONG " X 1-1/2" HIGH
1/8" DEEP SECTION LOSS

9" LONG X 8" WIDE X FULL
HEIGHT X UP TO 4" DEEP
CORNER SPALL

UP TO FULL HEIGHT X 5"
WIDE X 4" DEEP SPALL
