NOTICE TO PROSPECTIVE BIDDERS
RI CONTRACT NO. 2024-CB-018 – ADDENDUM NO. 1

Add New Appendix to this Addendum No. 1. “Bridge Inspection Report” has been added.

SPECIAL INSPECTION SCOPE: The scope of the special inspection shall include the advanced deterioration of the beam ends including the web area beyond the end diaphragms, end diaphragms, fixed bearings and moveable bearings. The special inspection shall also include the AASHTO Fatigue Category E' welds at the transverse ends of the cover plates and the bottom flanges of the beams. If any cracks are observed at these weld details, the RIDOT Bridge Ratings Section shall be notified.

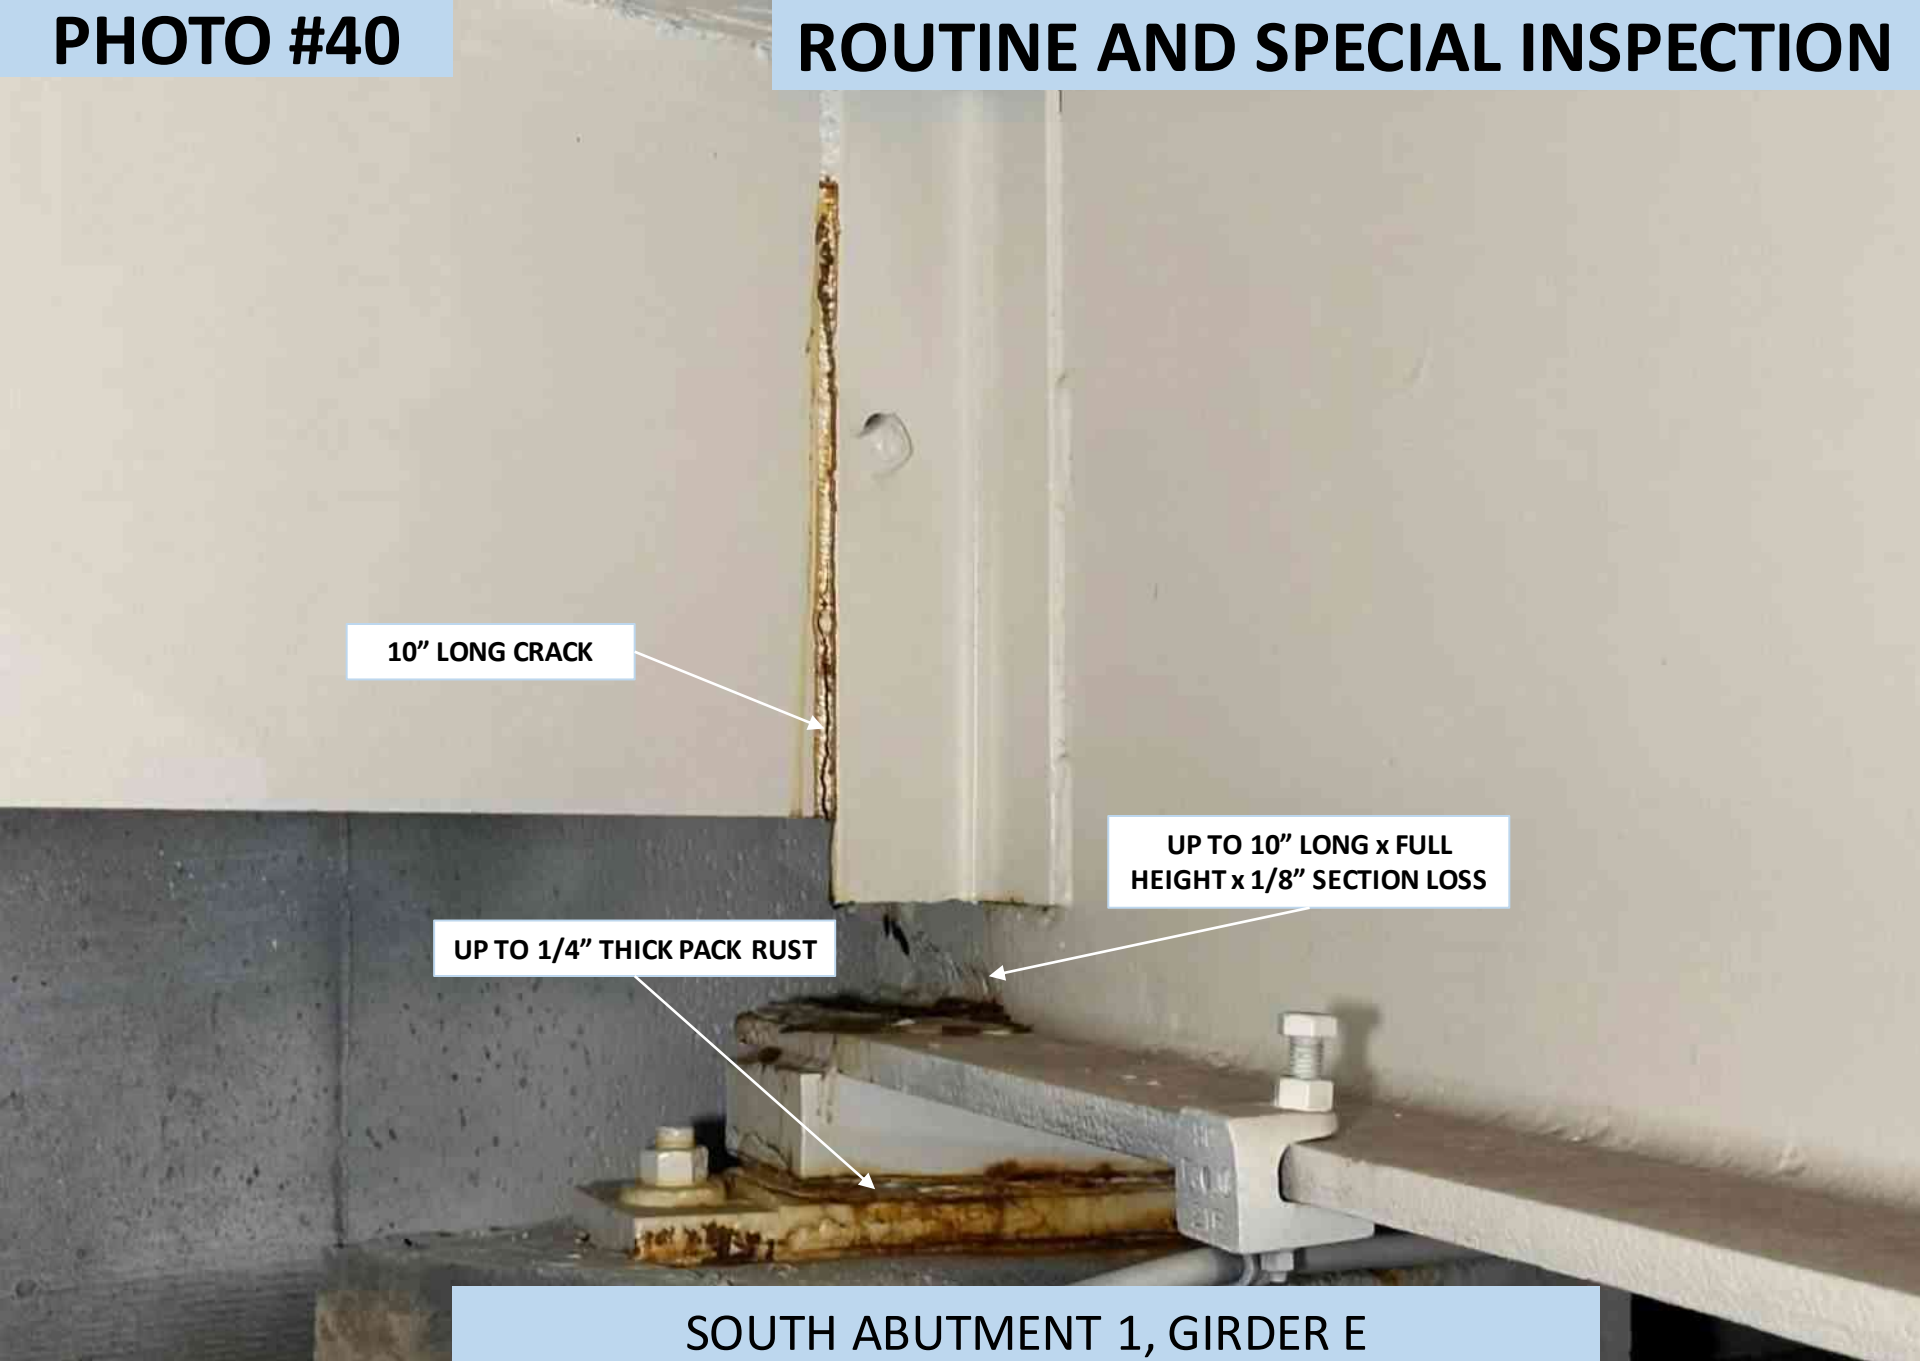
10" LONG CRACK

**UP TO 10" LONG x FULL
HEIGHT x 1/8" SECTION LOSS**

UP TO 1/4" THICK PACK RUST

**SOUTH ABUTMENT 1, GIRDER E
(EAST FACE, LOOKING SOUTH WEST)**

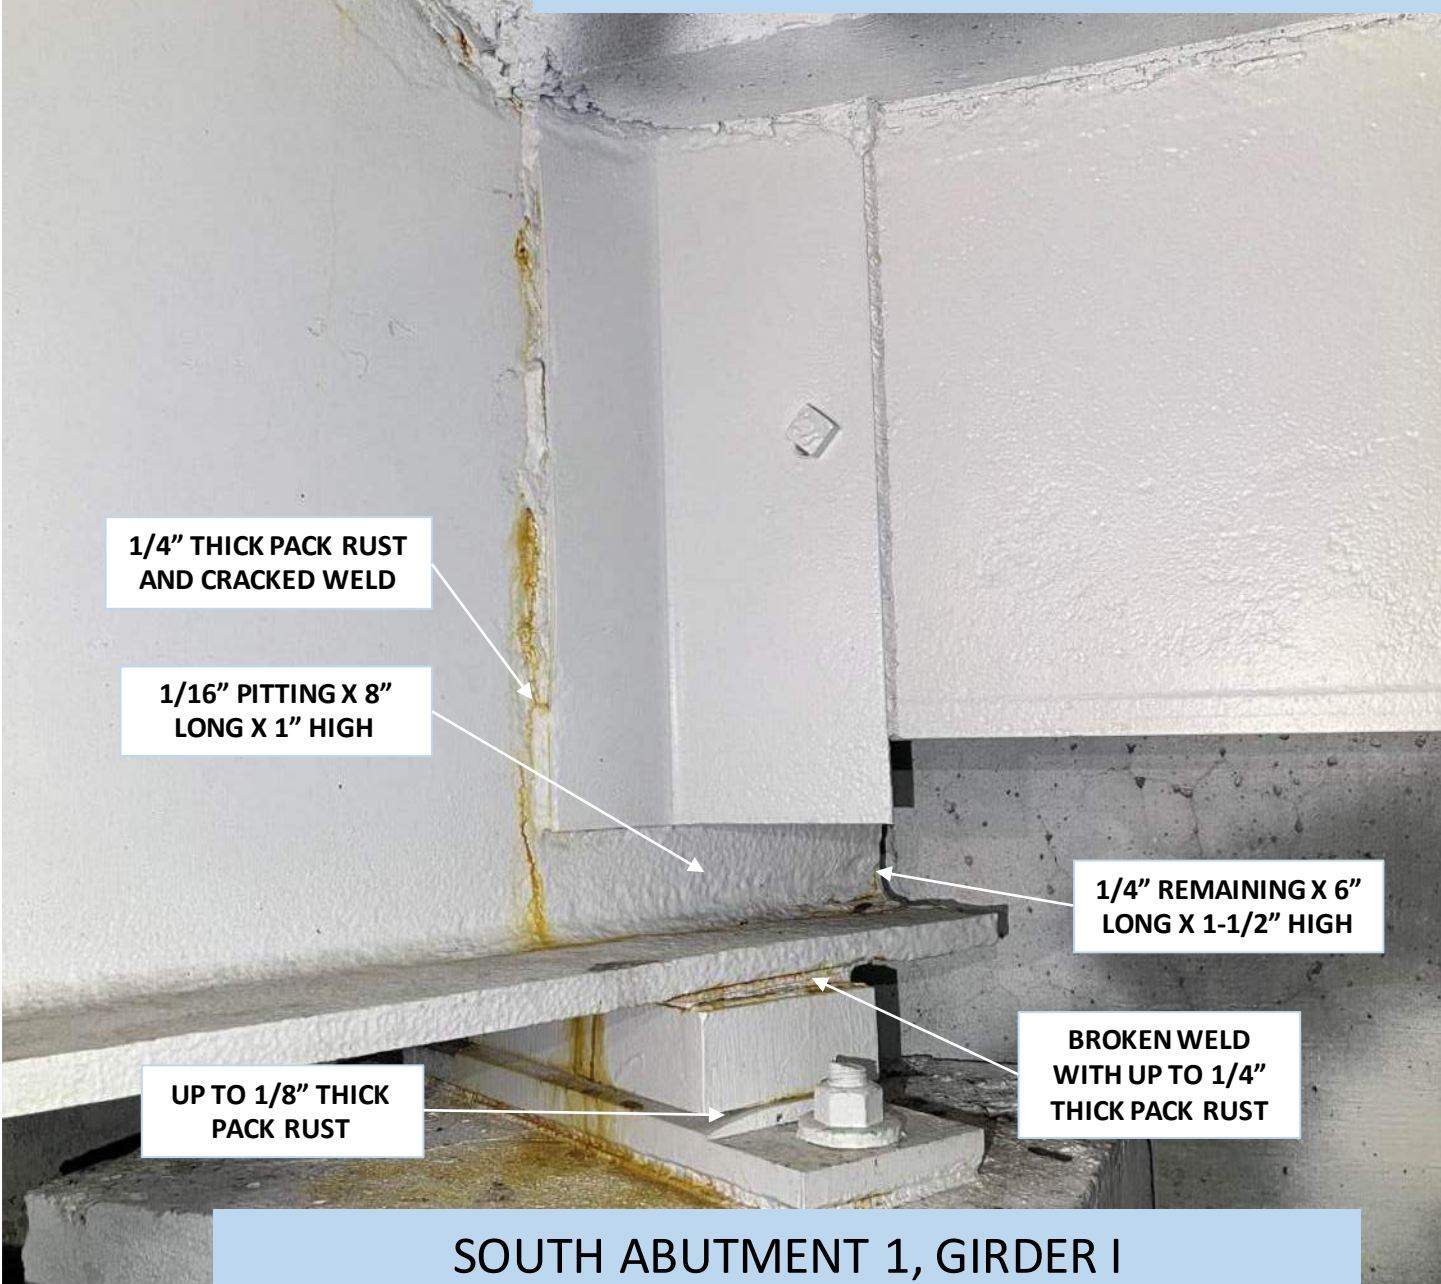
**1/4" THICK PACK RUST
AND CRACKED WELD**

**1/16" PITTING X 8"
LONG X 1" HIGH**

**UP TO 1/8" THICK
PACK RUST**

**SOUTH ABUTMENT 1, GIRDER I
(WEST FACE, LOOKING EAST)**

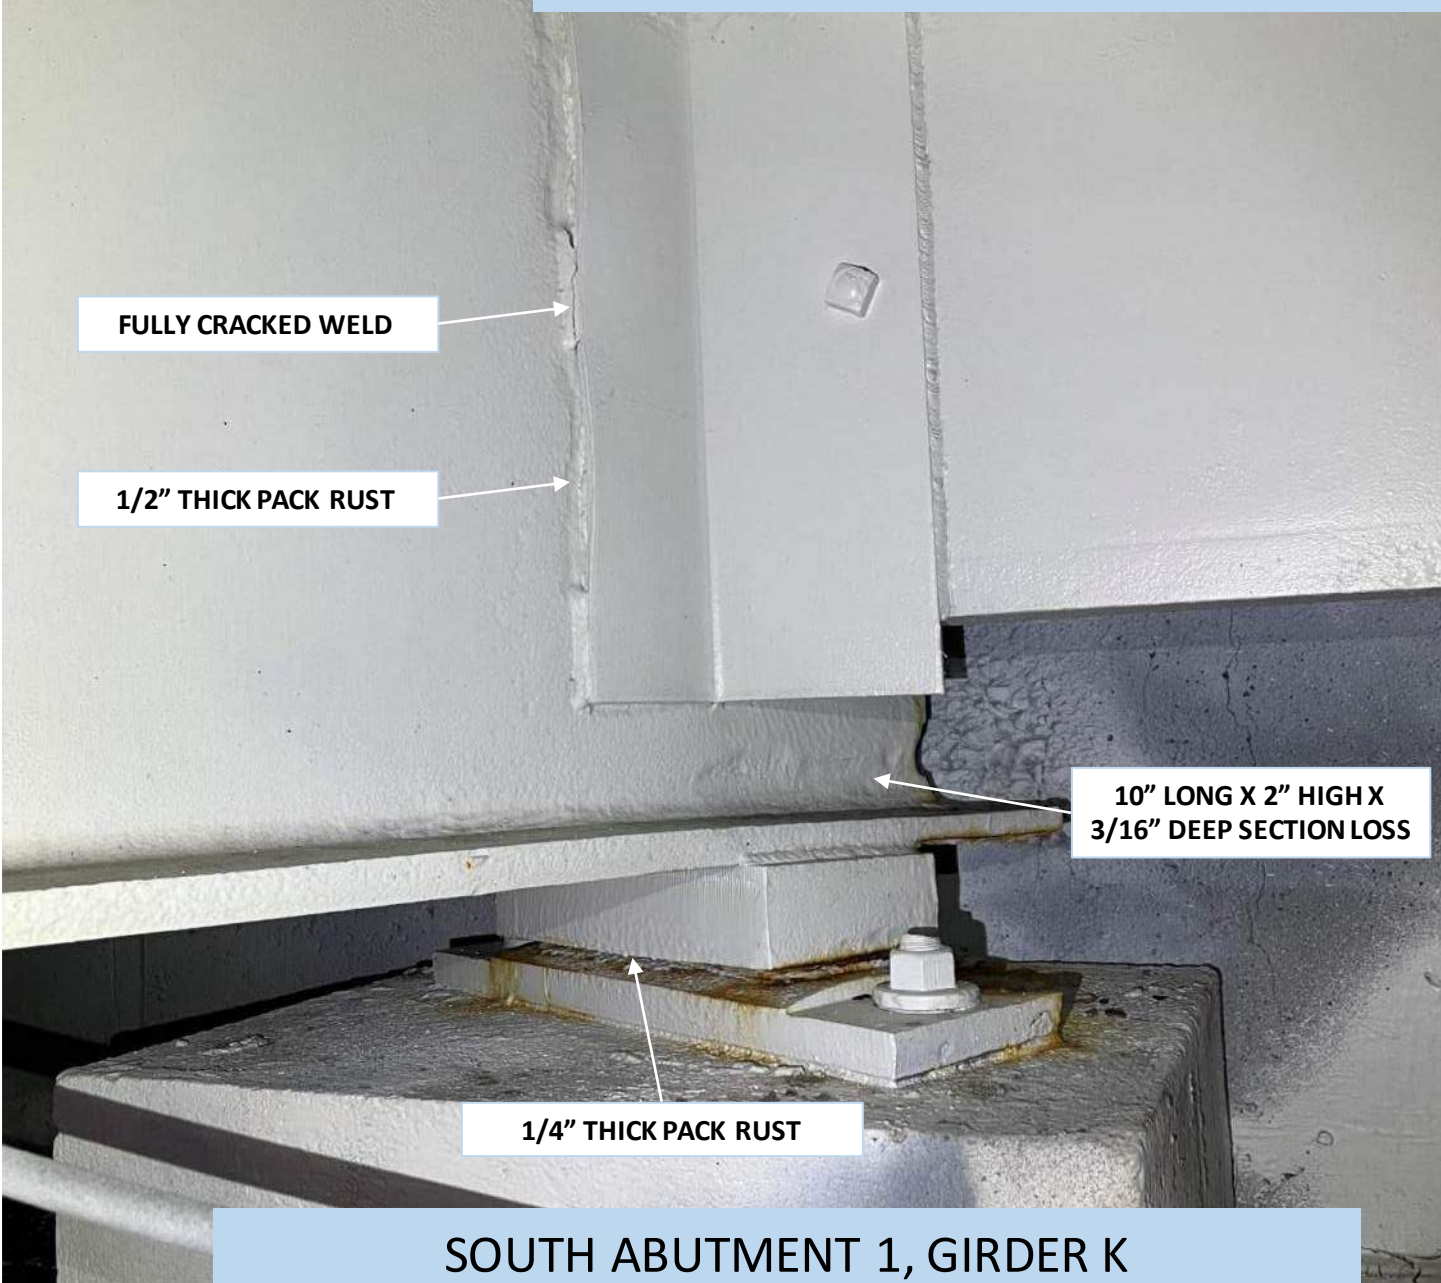
FULLY CRACKED WELD

1/2" THICK PACK RUST

1/4" THICK PACK RUST

**SOUTH ABUTMENT 1, GIRDER K
(WEST FACE, LOOKING EAST)**

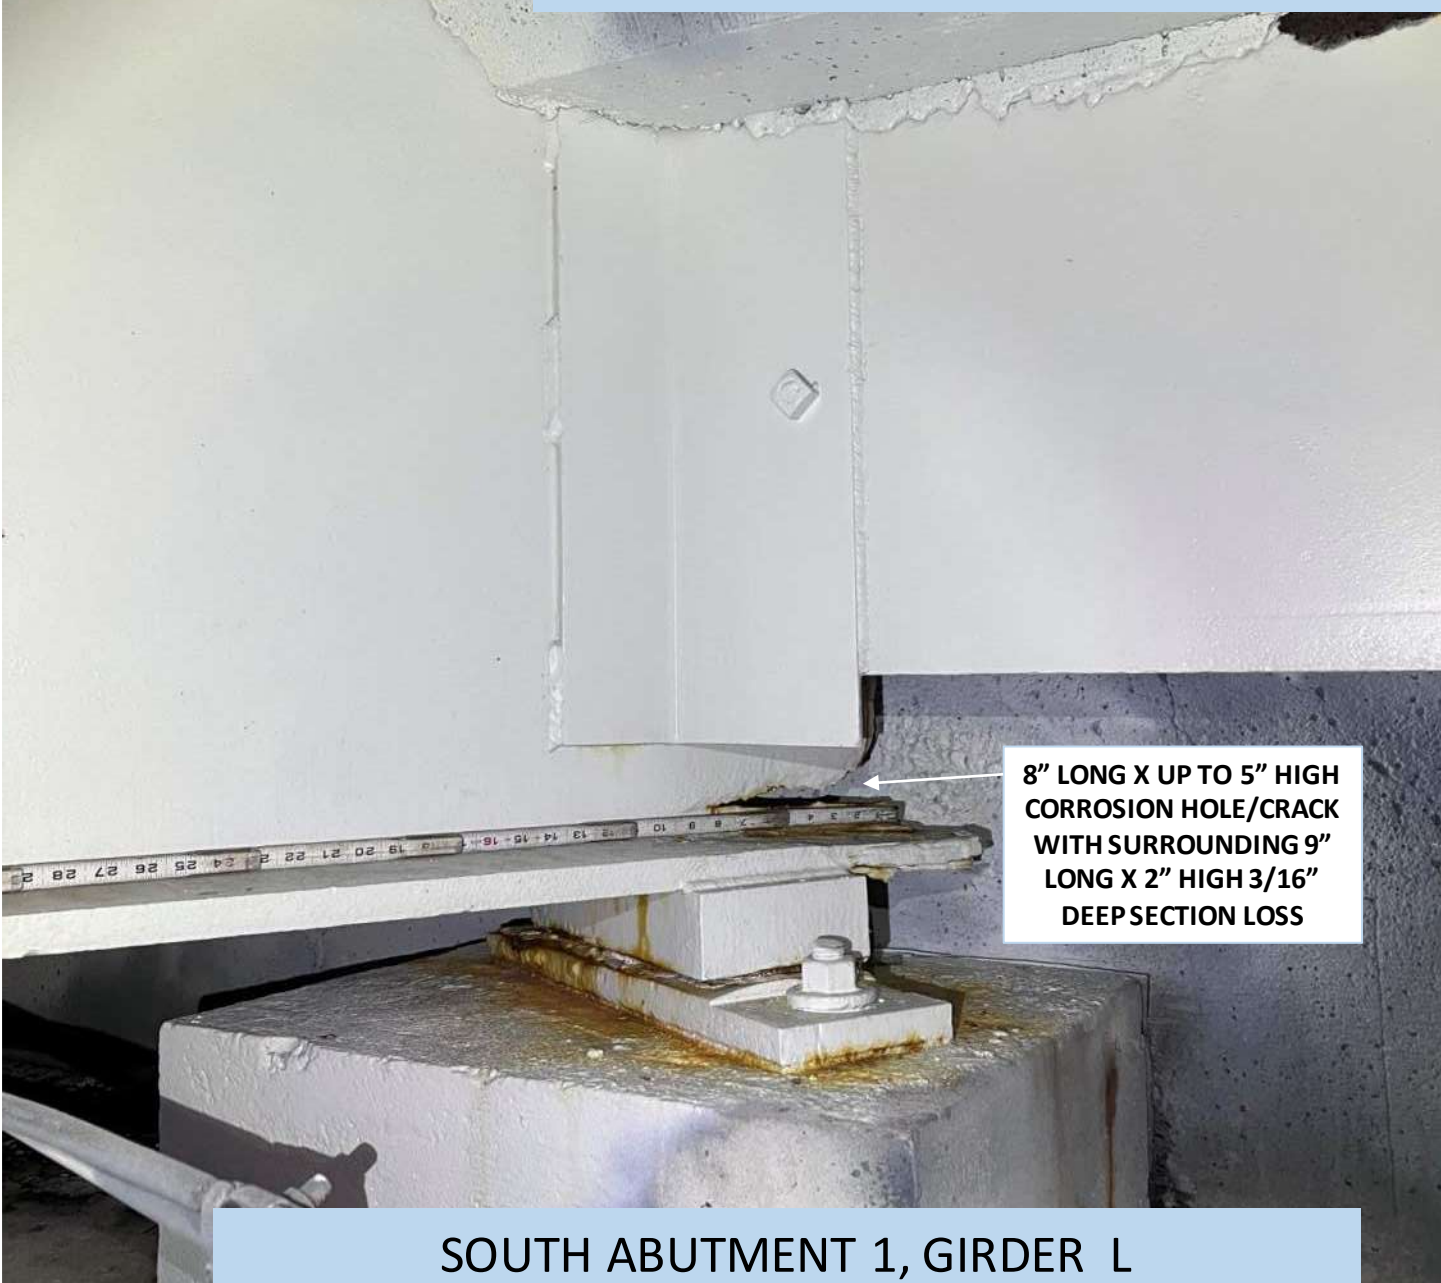
**8" LONG X UP TO 5" HIGH
CORROSION HOLE/CRACK
WITH SURROUNDING 9"
LONG X 2" HIGH 3/16"
DEEP SECTION LOSS**

**SOUTH ABUTMENT 1, GIRDER L
(WEST FACE, LOOKING EAST)**

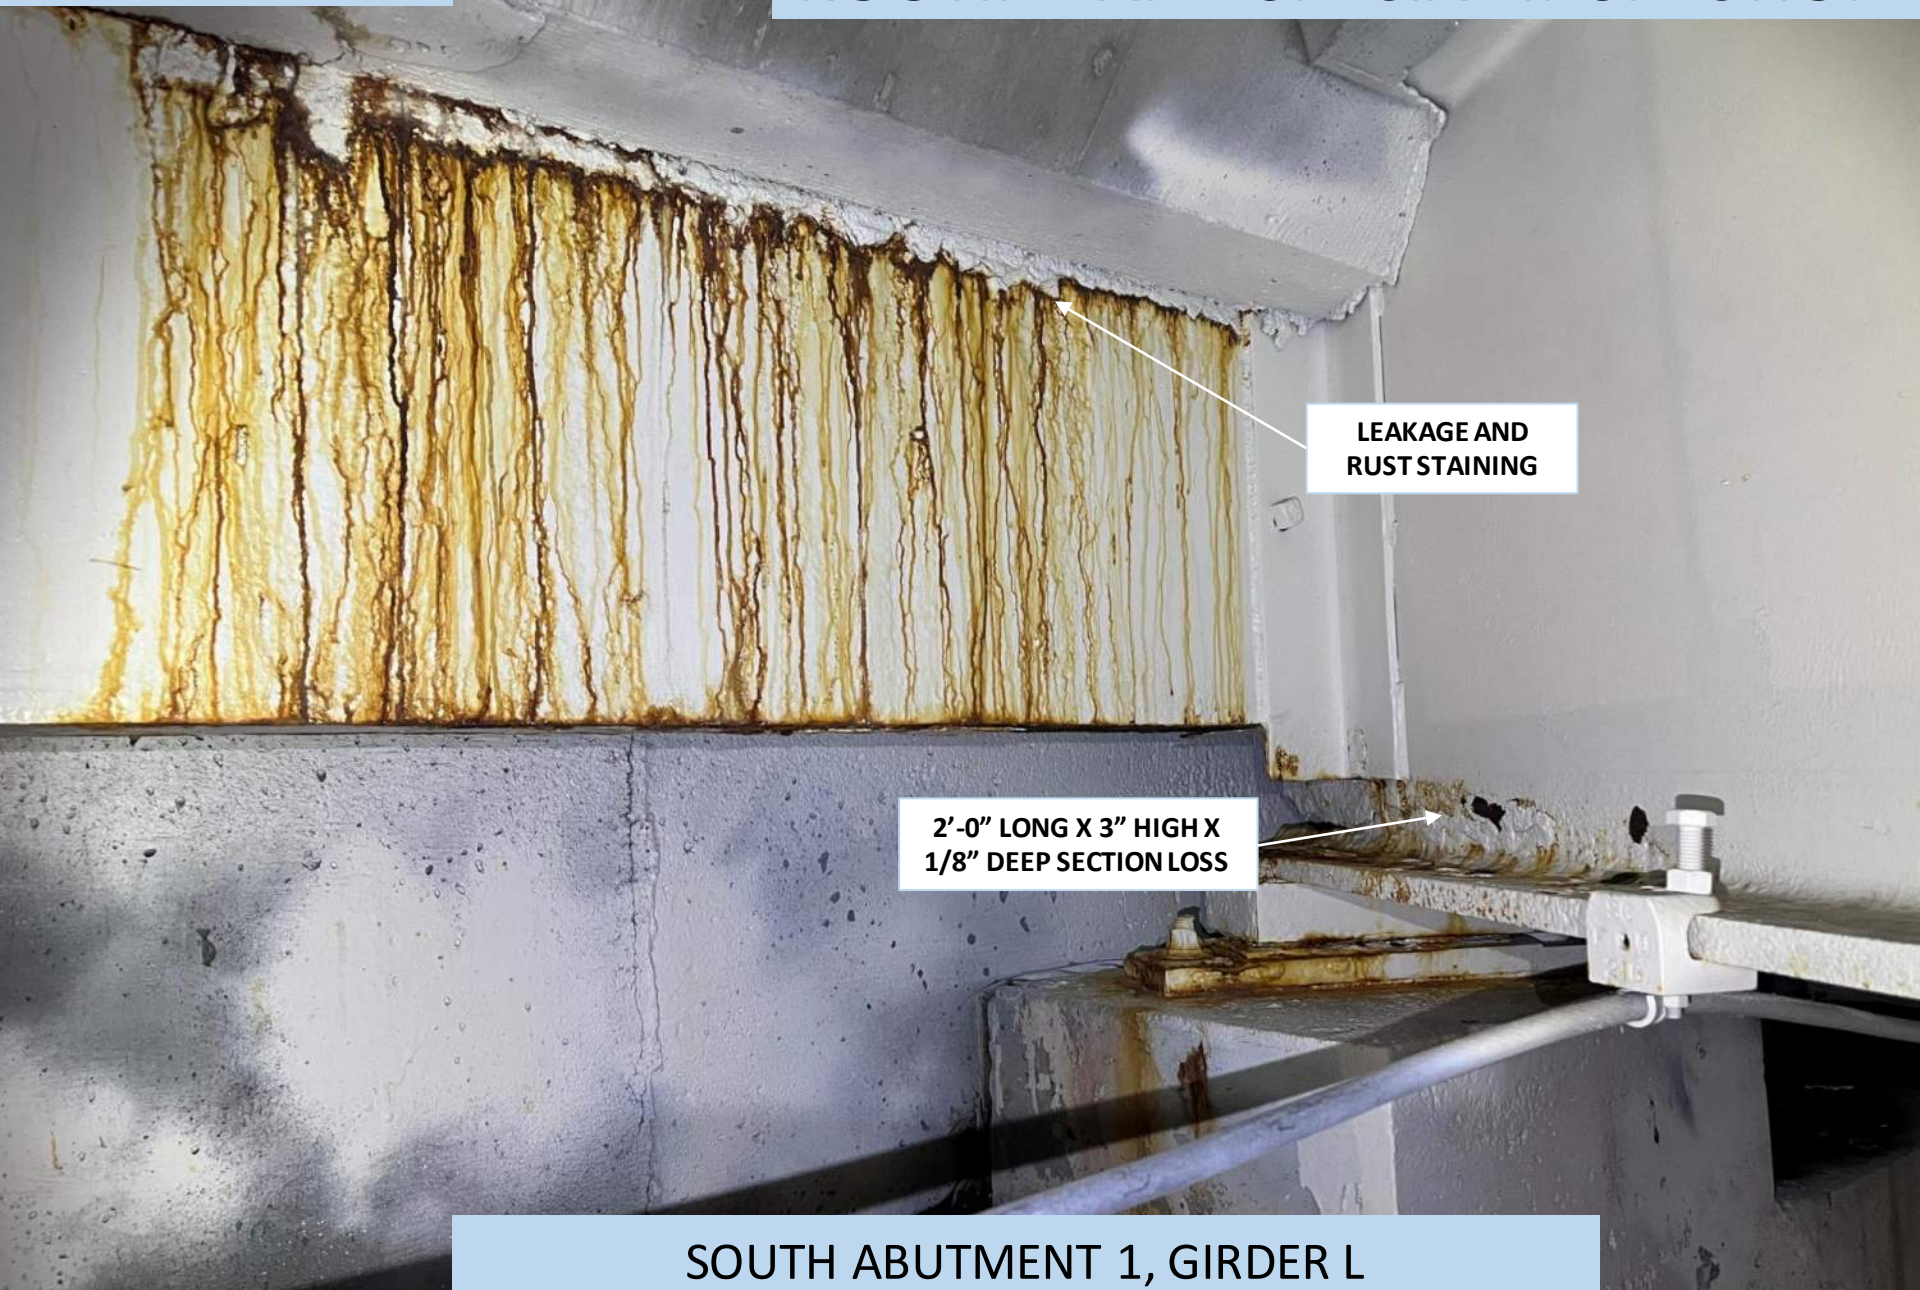
PHOTO #47

**LEAKAGE AND
RUST STAINING**

**2'-0" LONG X 3" HIGH X
1/8" DEEP SECTION LOSS**

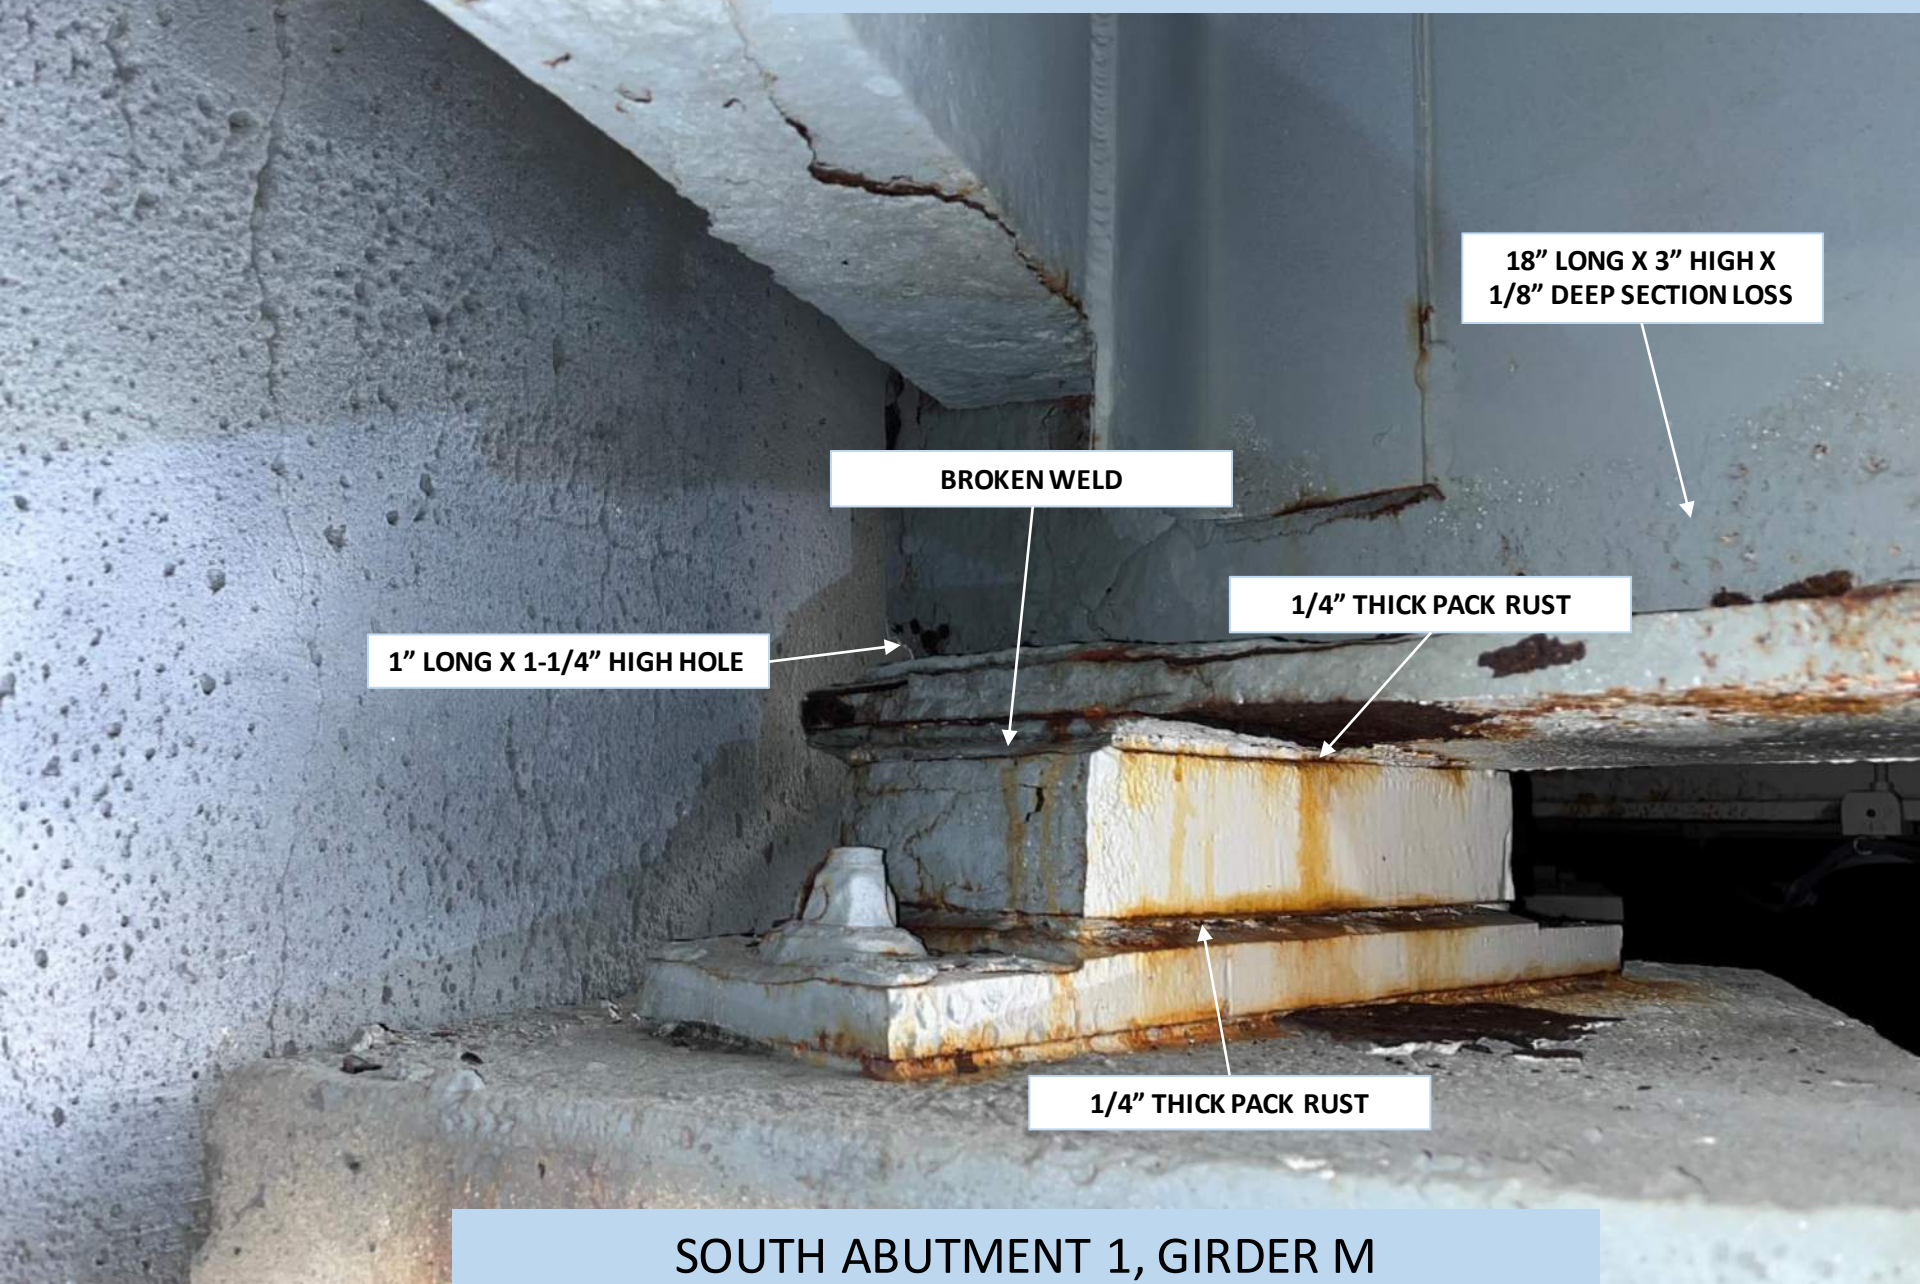
1" LONG X 1-1/4" HIGH HOLE

BROKEN WELD

1/4" THICK PACK RUST

**SOUTH ABUTMENT 1, GIRDER M
(EAST FACE, LOOKING WEST)**

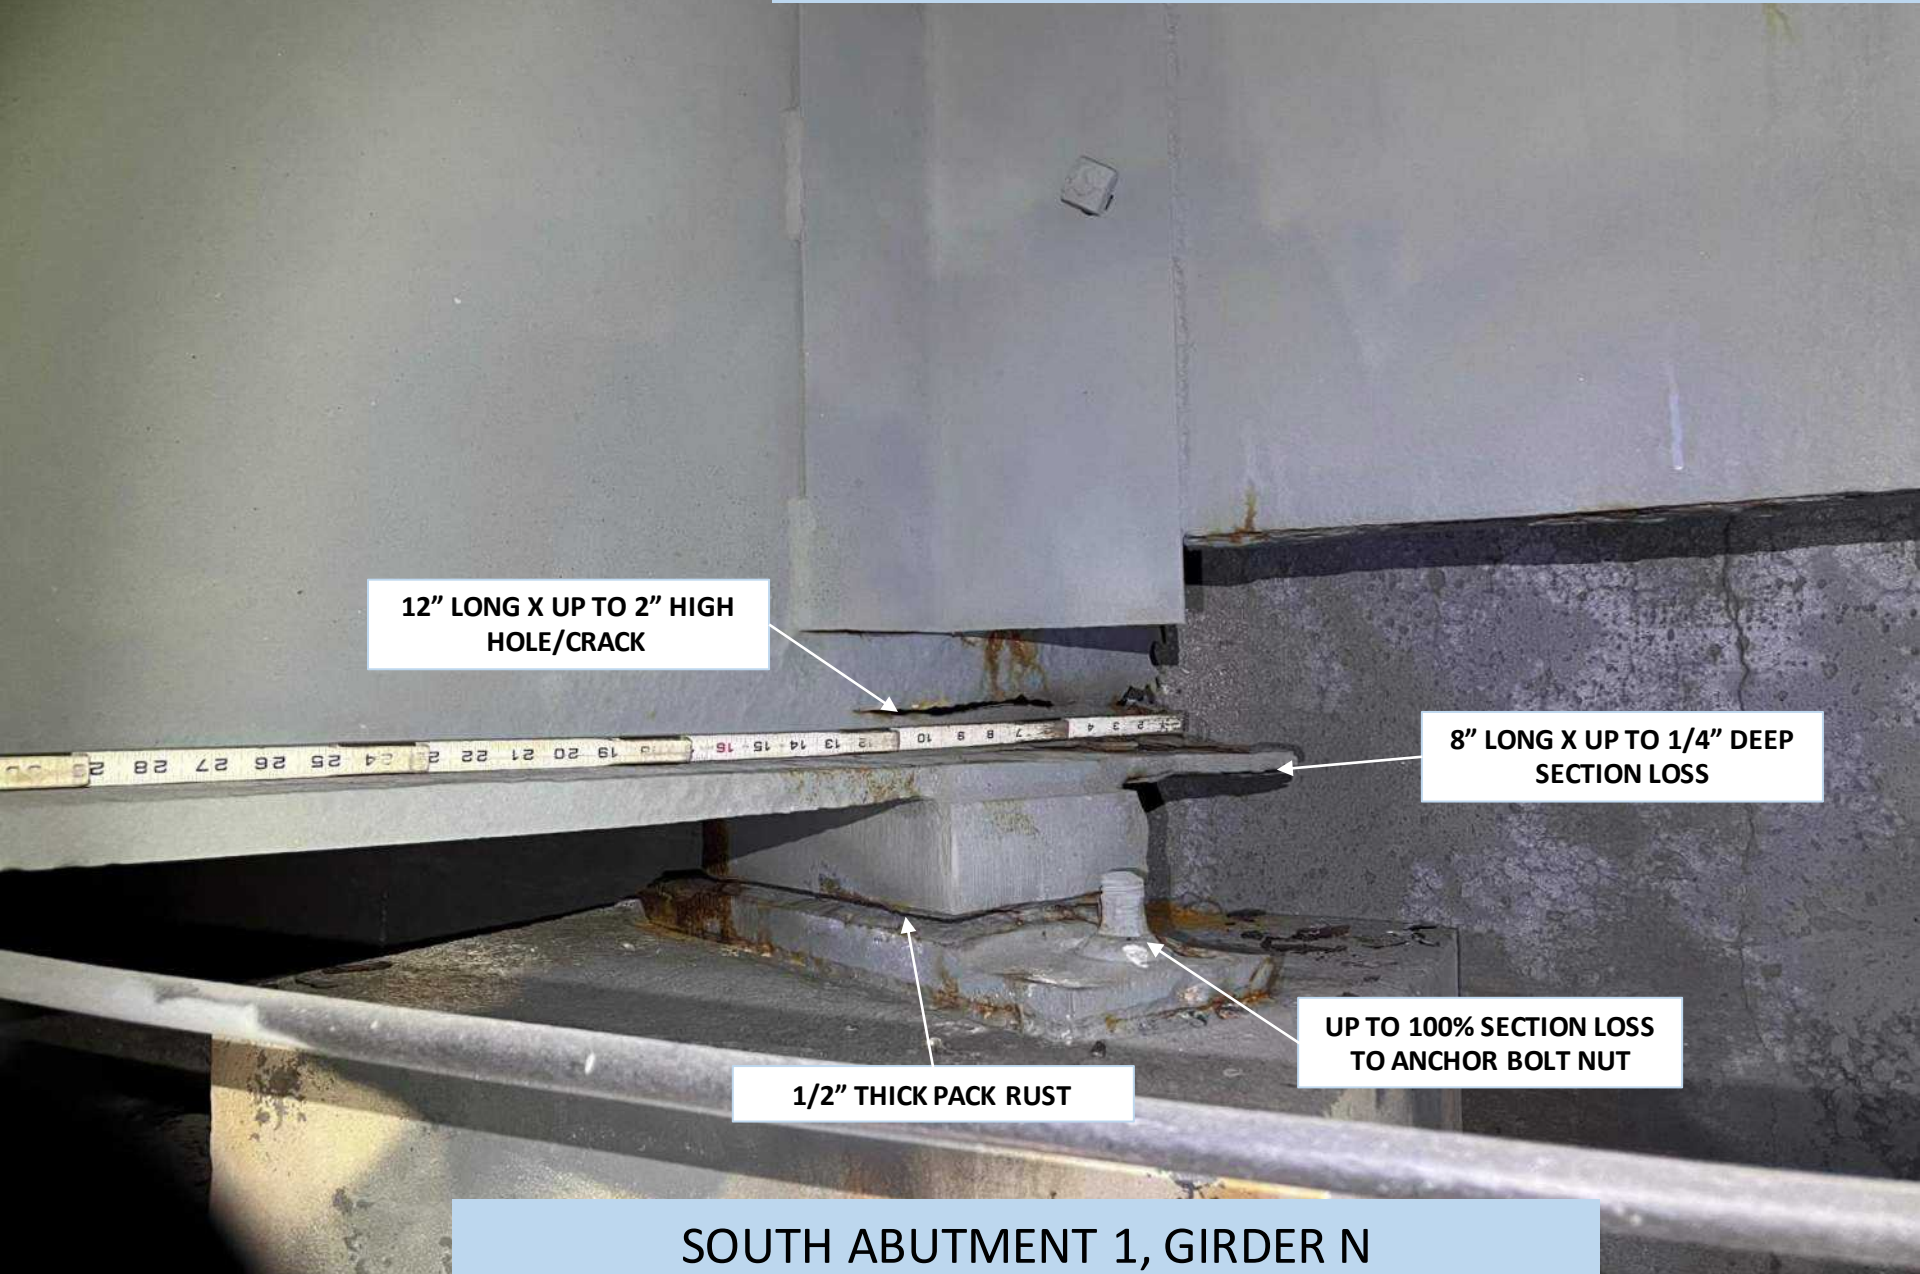
**12" LONG X UP TO 2" HIGH
HOLE/CRACK**

**8" LONG X UP TO 1/4" DEEP
SECTION LOSS**

**UP TO 100% SECTION LOSS
TO ANCHOR BOLT NUT**

**SOUTH ABUTMENT 1, GIRDER N
(WEST FACE, LOOKING EAST)**

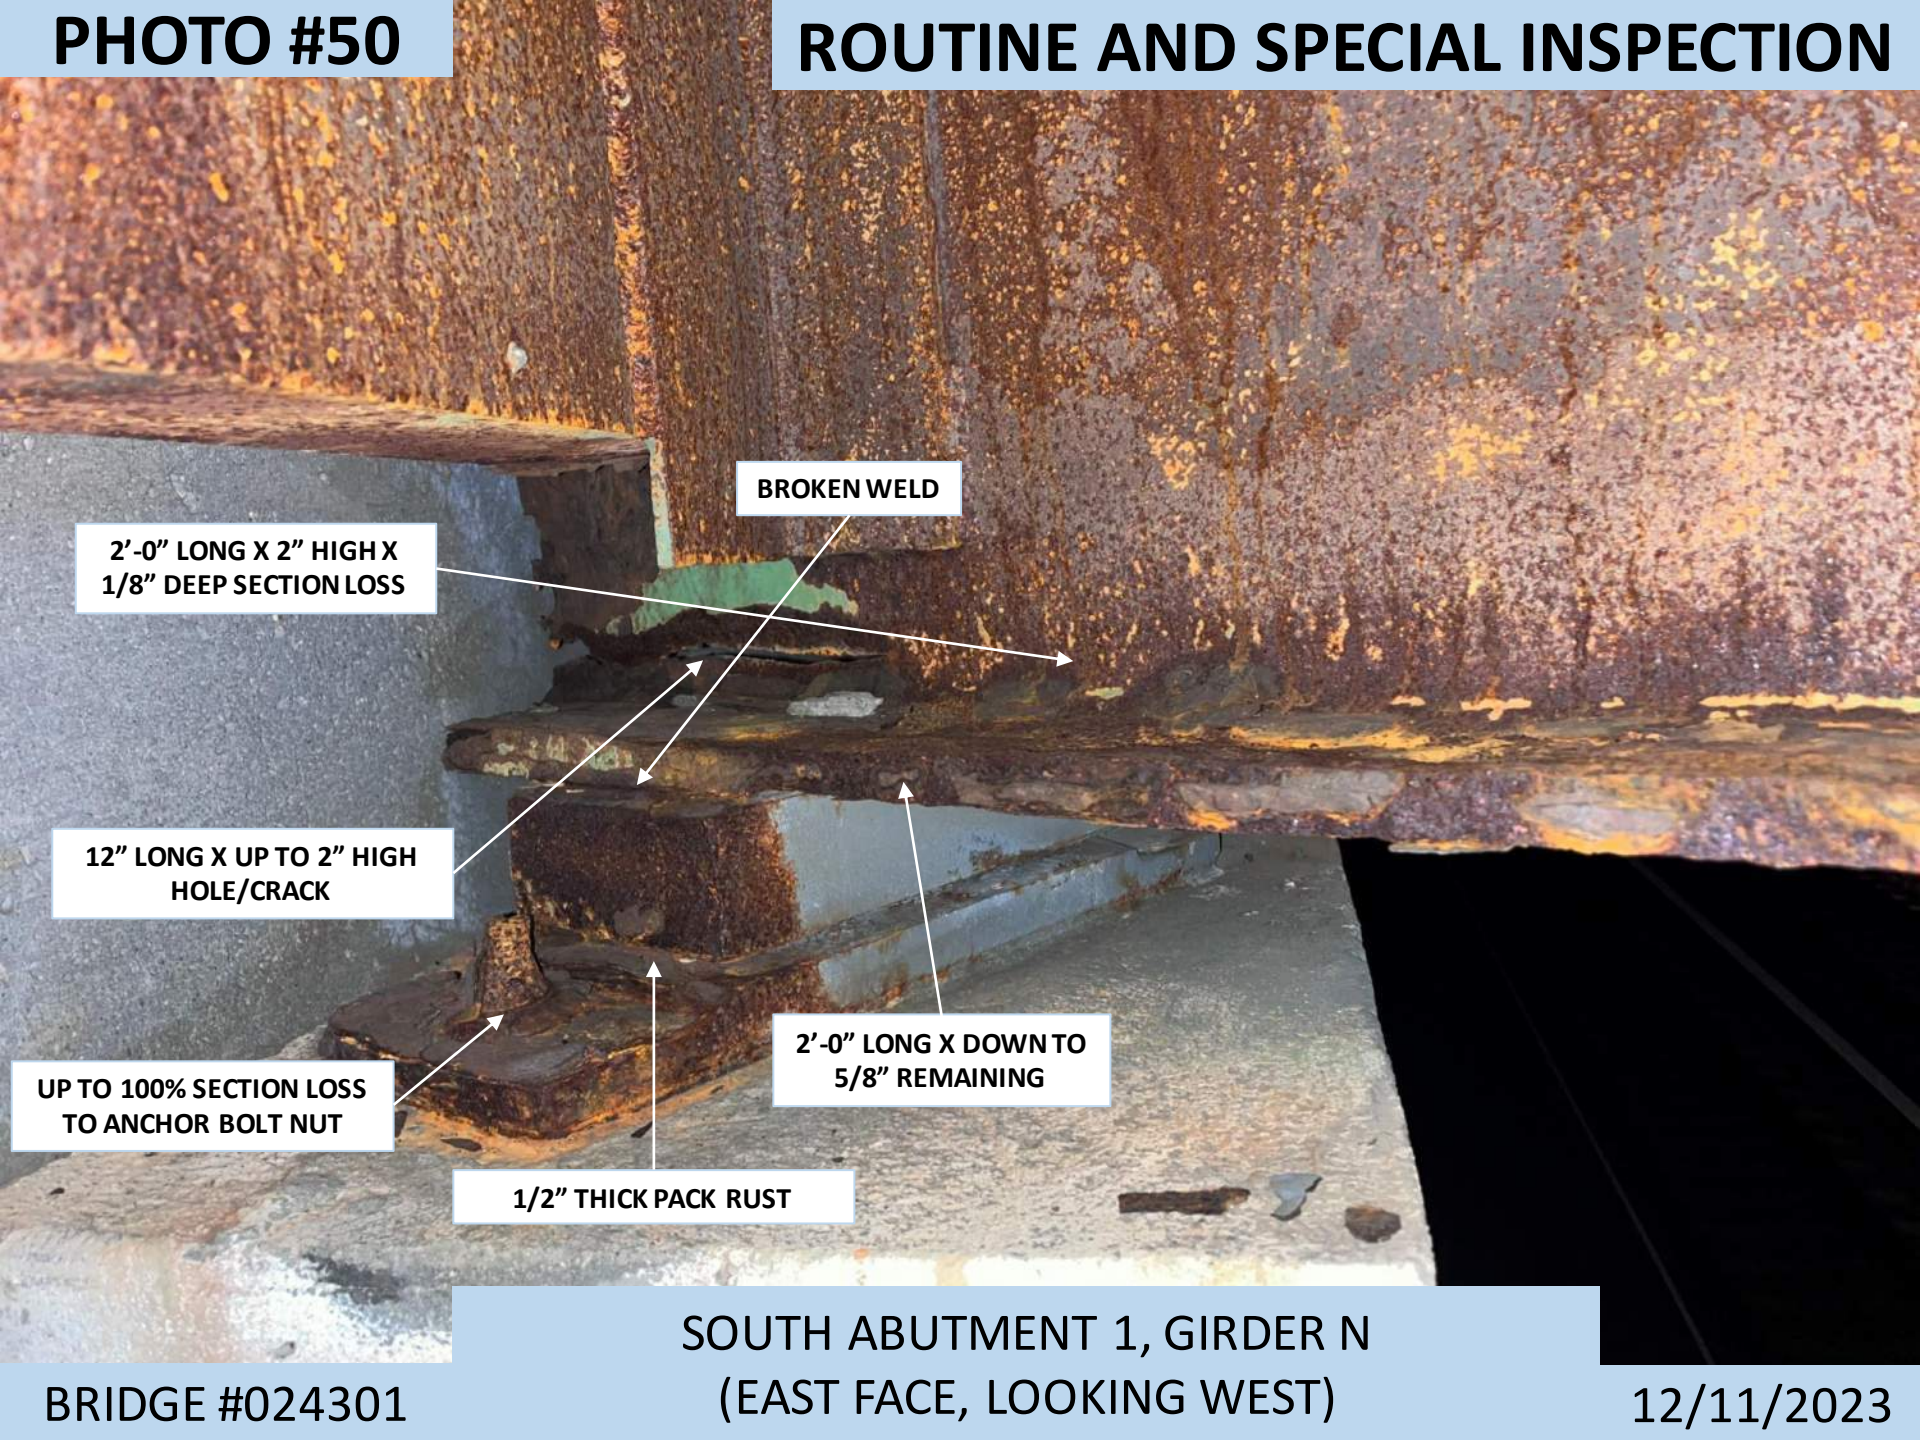
BROKEN WELD

**2'-0" LONG X 2" HIGH X
1/8" DEEP SECTION LOSS**

1/2" THICK PACK RUST

**SOUTH ABUTMENT 1, GIRDER N
(EAST FACE, LOOKING WEST)**

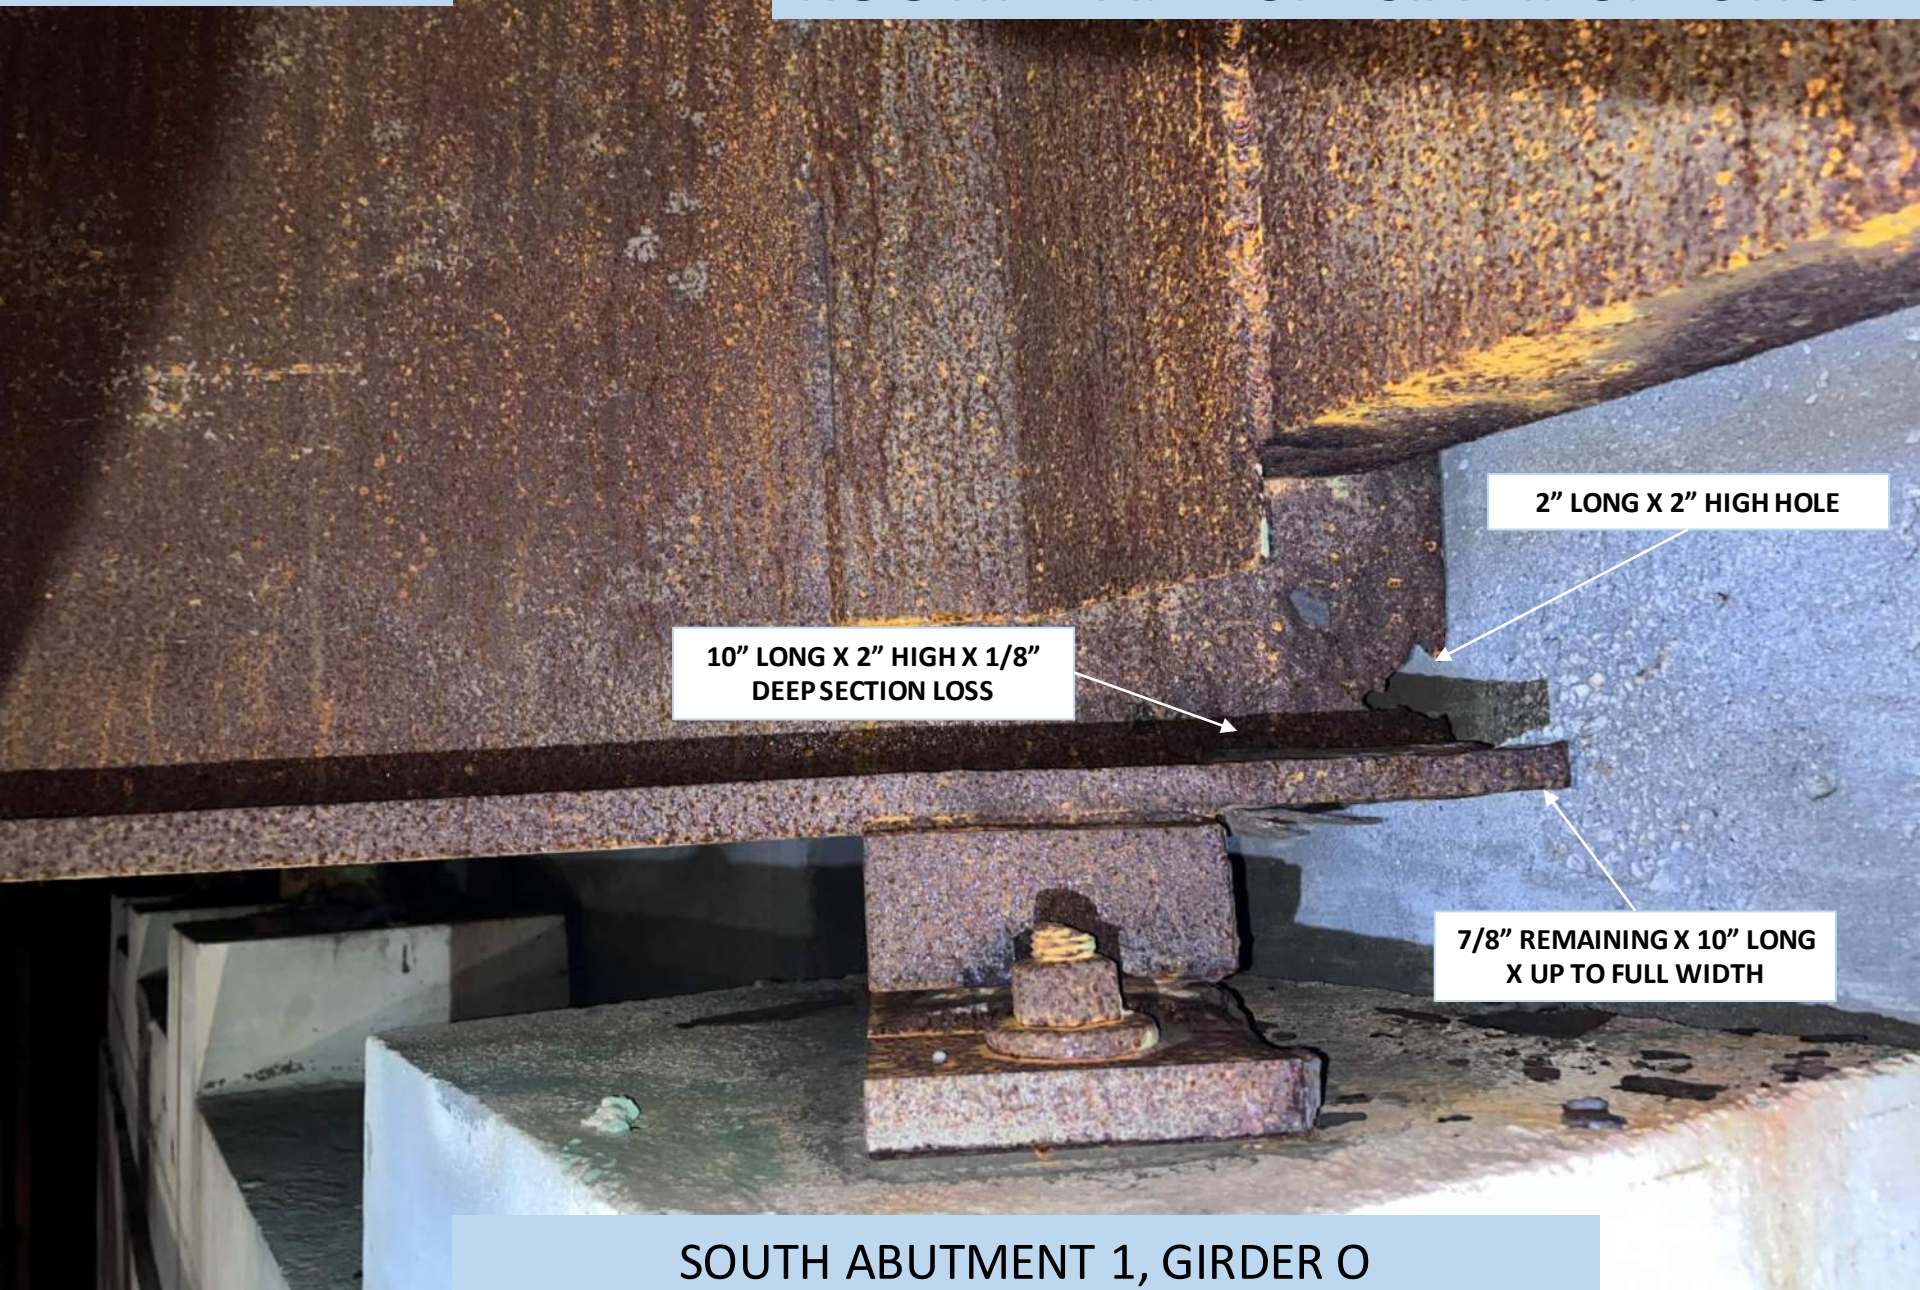
2" LONG X 2" HIGH HOLE

10" LONG X 2" HIGH X 1/8" DEEP SECTION LOSS

7/8" REMAINING X 10" LONG X UP TO FULL WIDTH

**SOUTH ABUTMENT 1, GIRDER O
(WEST FACE, LOOKING EAST)**
