NOTICE TO PROSPECTIVE BIDDERS
RI CONTRACT NO. 2024-CB-018 – ADDENDUM NO. 1

Add New Appendix to this Addendum No. 1. “Bridge Inspection Report” has been added.

SPECIAL INSPECTION SCOPE: The scope of the special inspection shall include the advanced deterioration of the beam ends including the web area beyond the end diaphragms, end diaphragms, fixed bearings and moveable bearings. The special inspection shall also include the AASHTO Fatigue Category E' welds at the transverse ends of the cover plates and the bottom flanges of the beams. If any cracks are observed at these weld details, the RIDOT Bridge Ratings Section shall be notified.

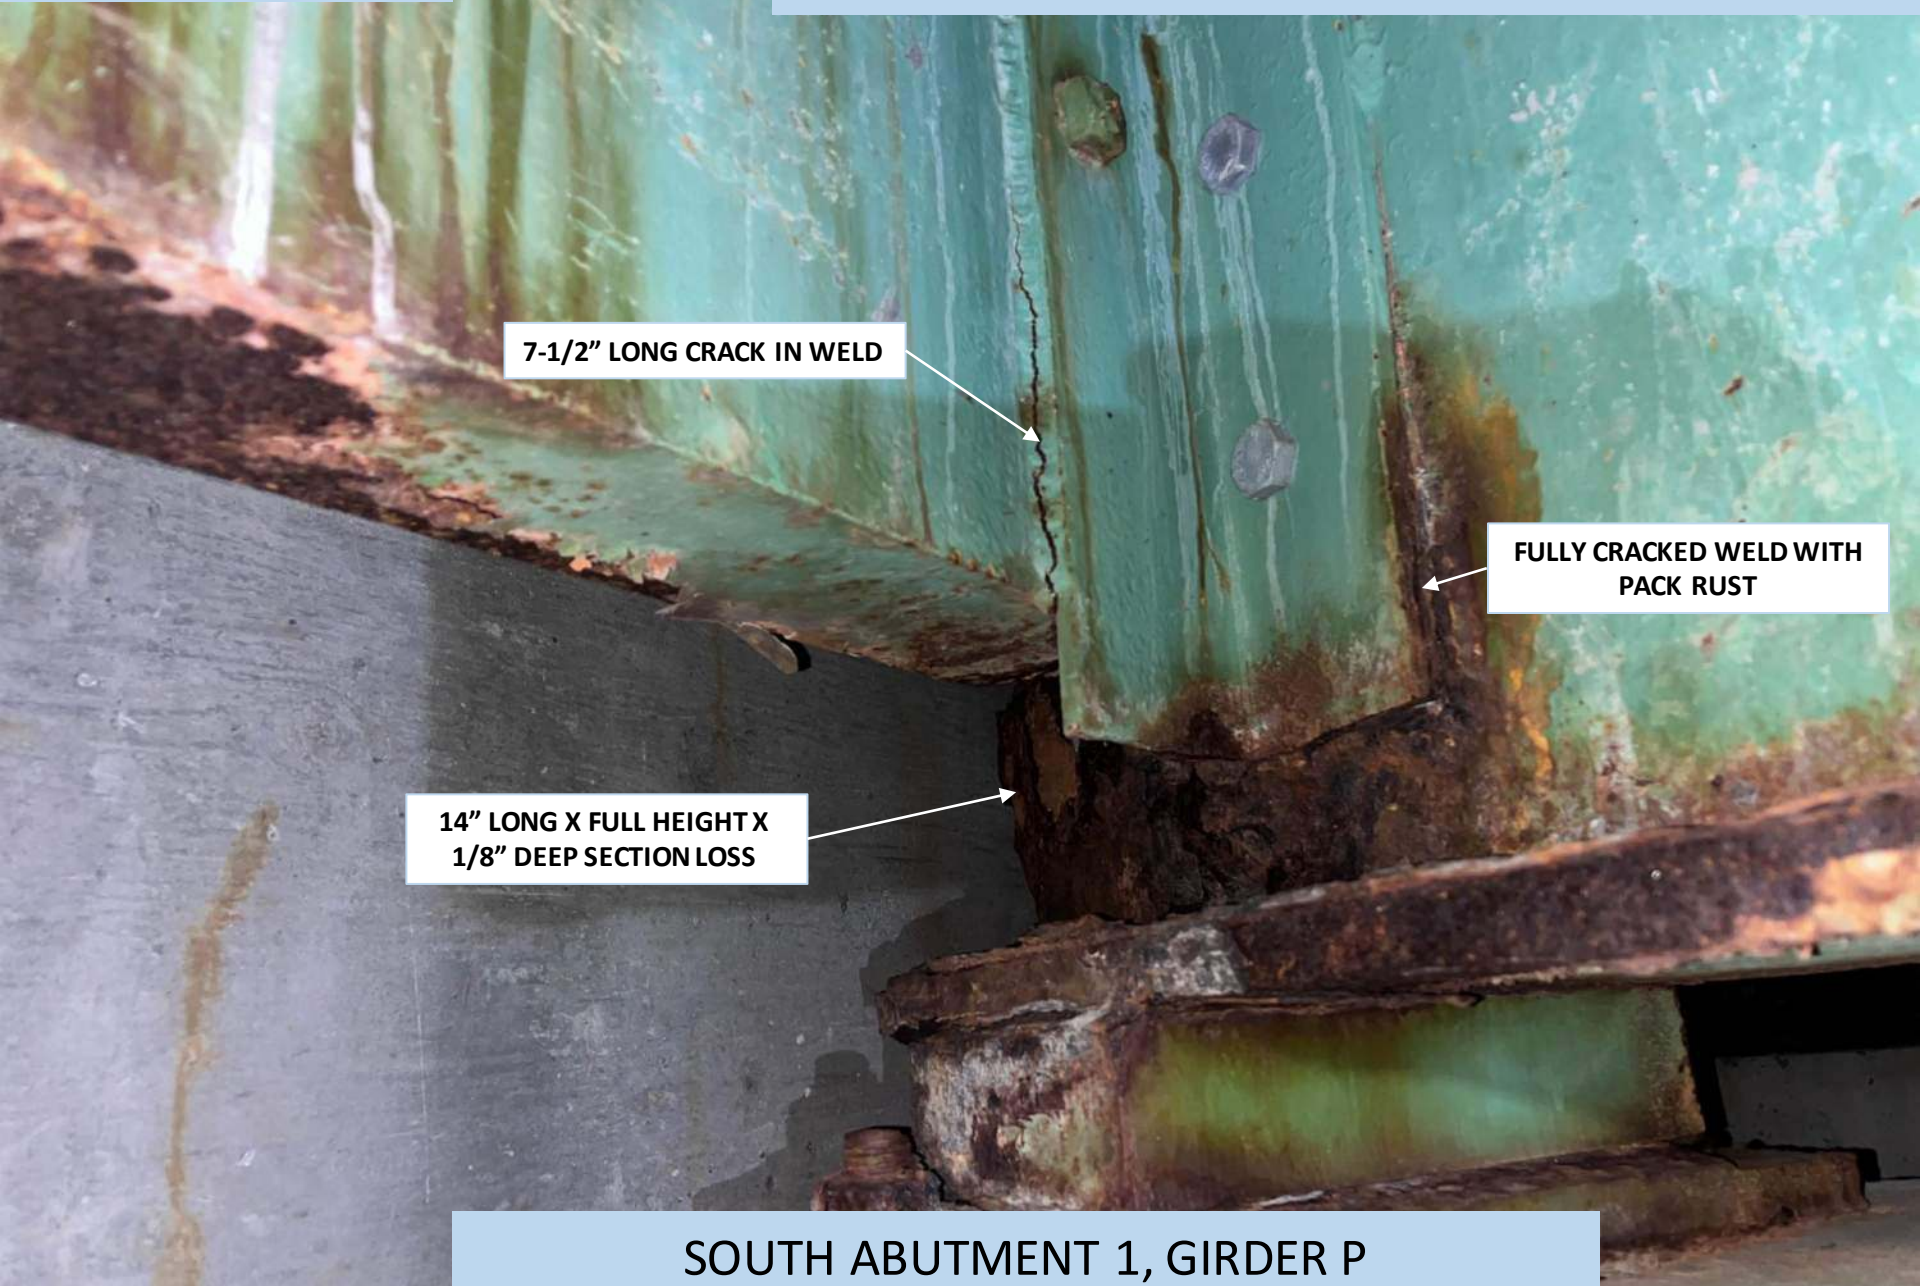
7-1/2" LONG CRACK IN WELD

**FULLY CRACKED WELD WITH
PACK RUST**

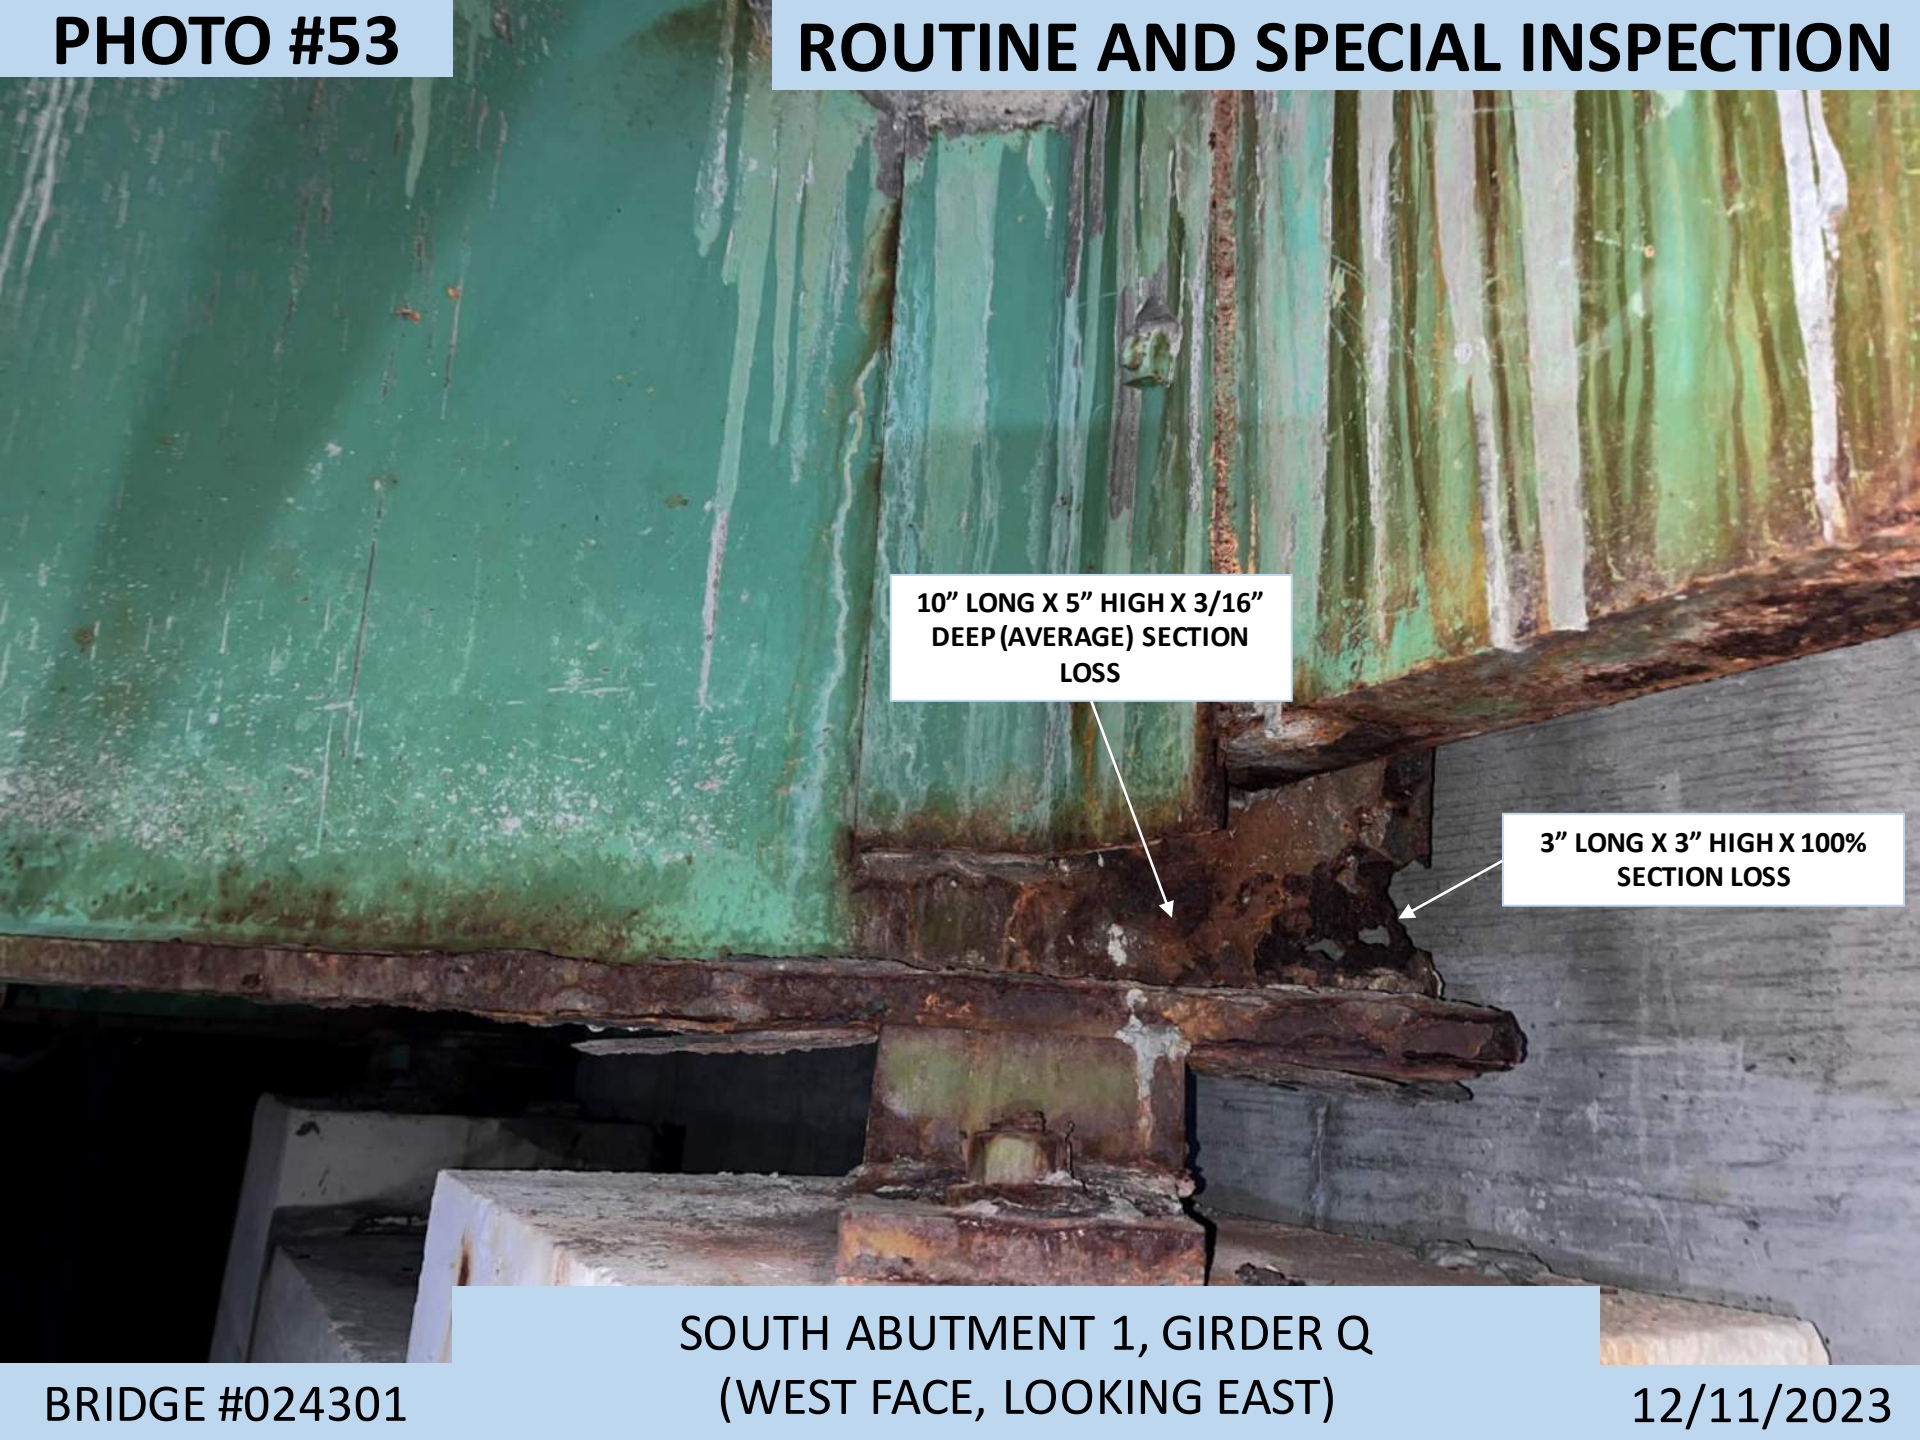
PHOTO #53

**10" LONG X 5" HIGH X 3/16"
DEEP (AVERAGE) SECTION
LOSS**

**3" LONG X 3" HIGH X 100%
SECTION LOSS**

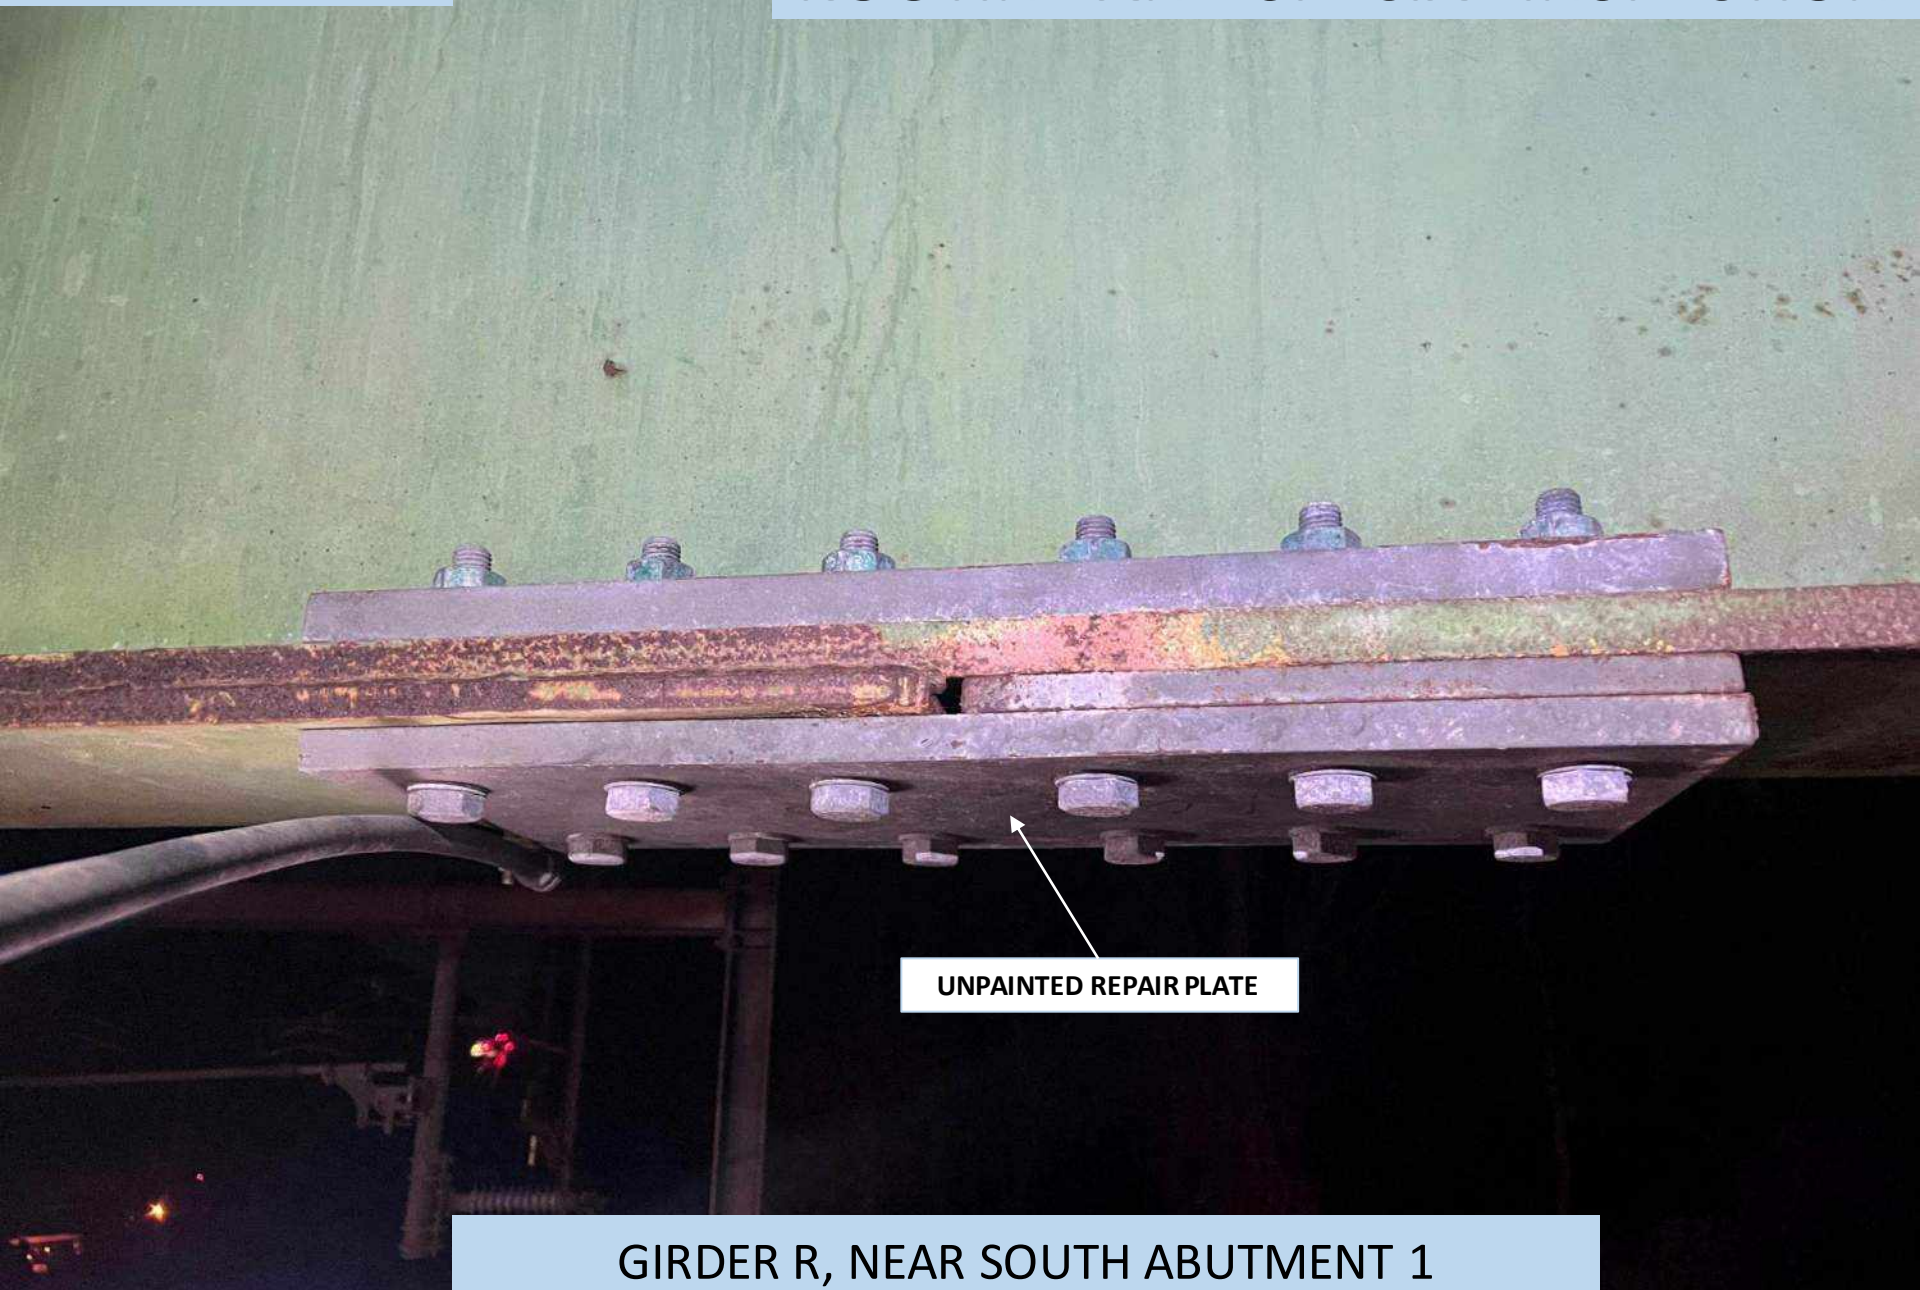
PHOTO #54

UNPAINTED REPAIR PLATE

**GIRDER R, NEAR SOUTH ABUTMENT 1
(WEST FACE, LOOKING EAST)**

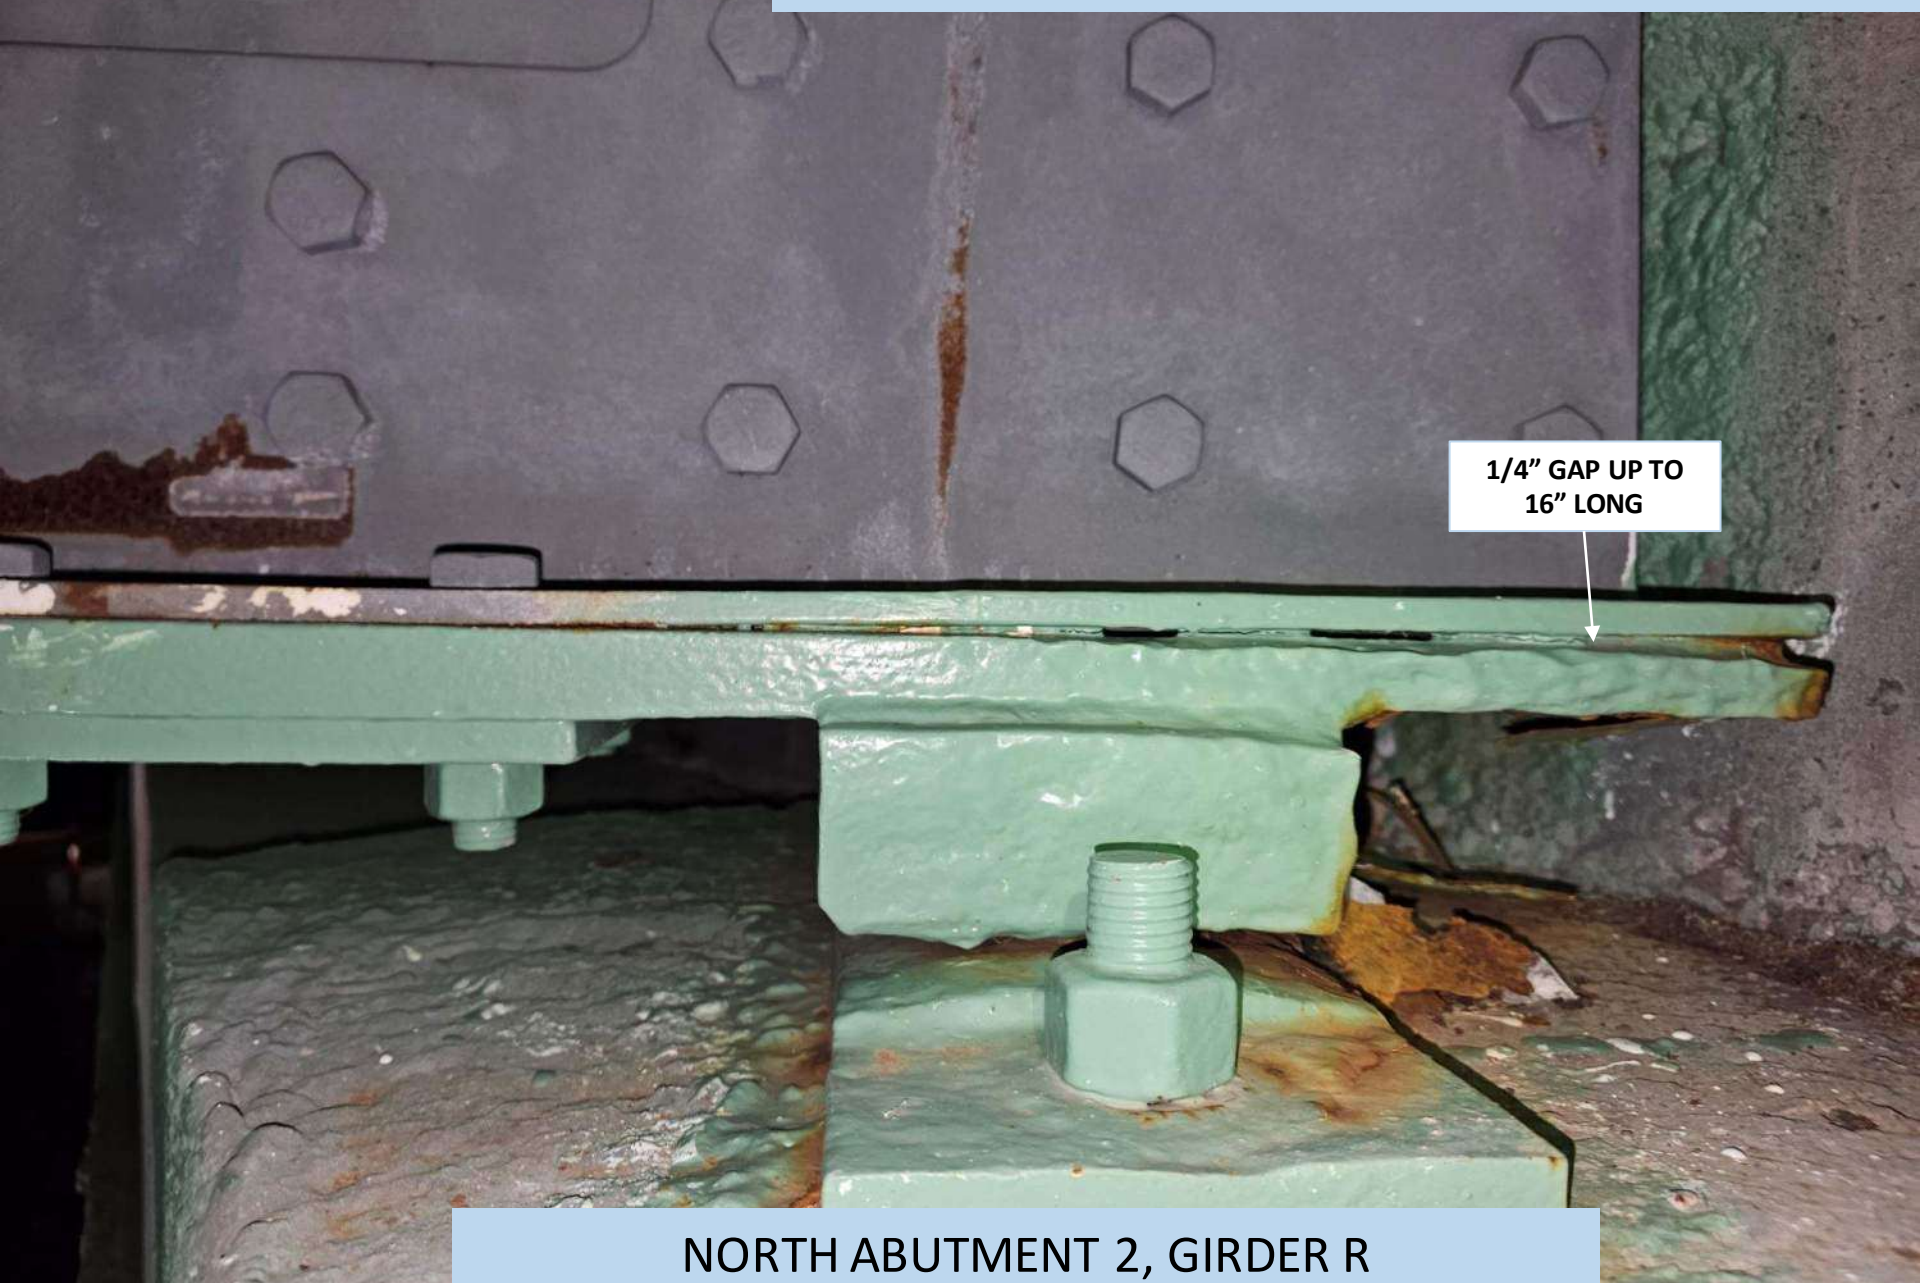
PHOTO #55

**1/4" GAP UP TO
16" LONG**

**NORTH ABUTMENT 2, GIRDER R
(EAST FACE, LOOKING NORTH WEST)**

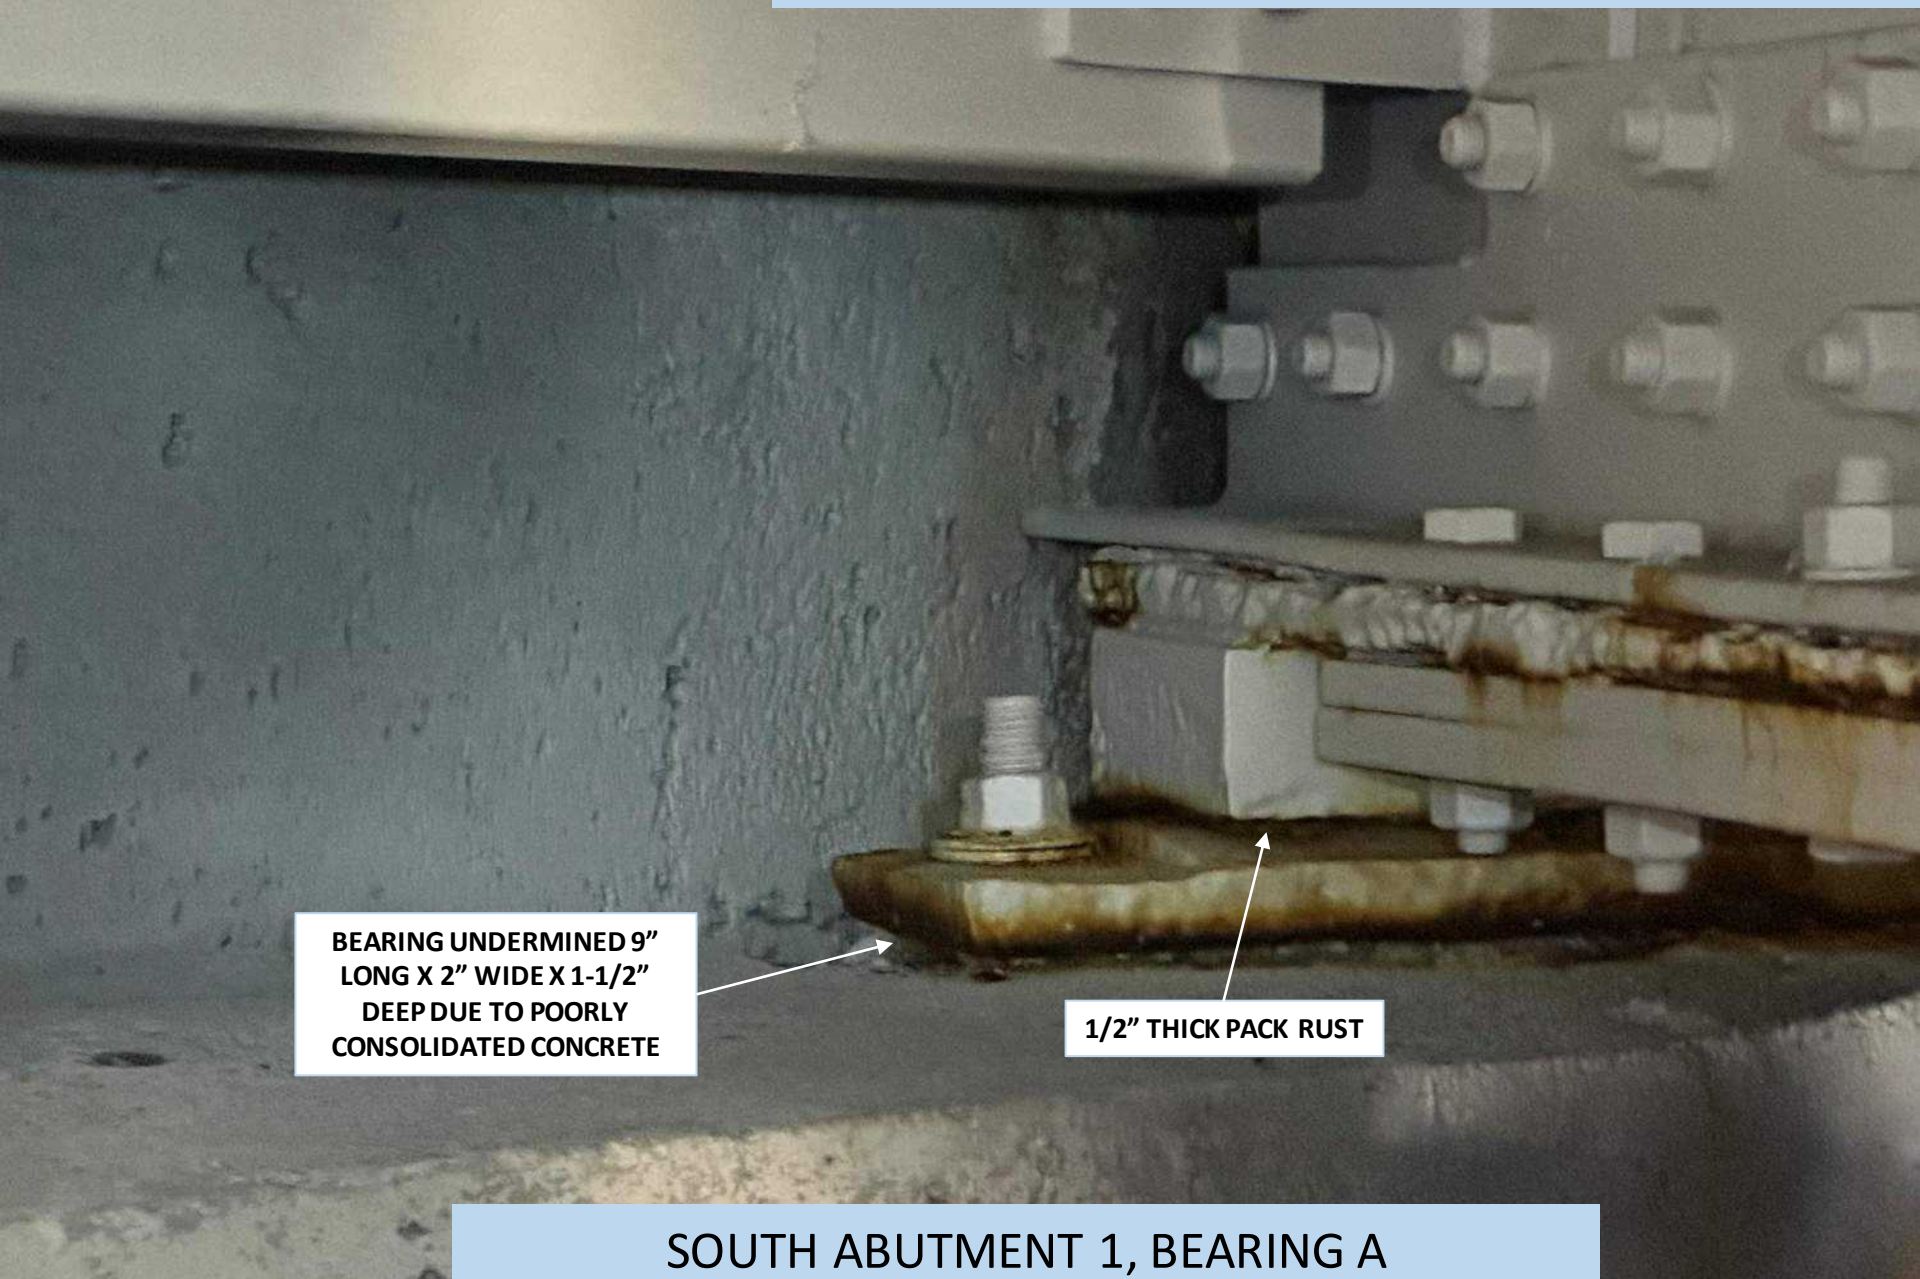
**BEARING UNDERMINED 9"
LONG X 2" WIDE X 1-1/2"
DEEP DUE TO POORLY
CONSOLIDATED CONCRETE**

1/2" THICK PACK RUST

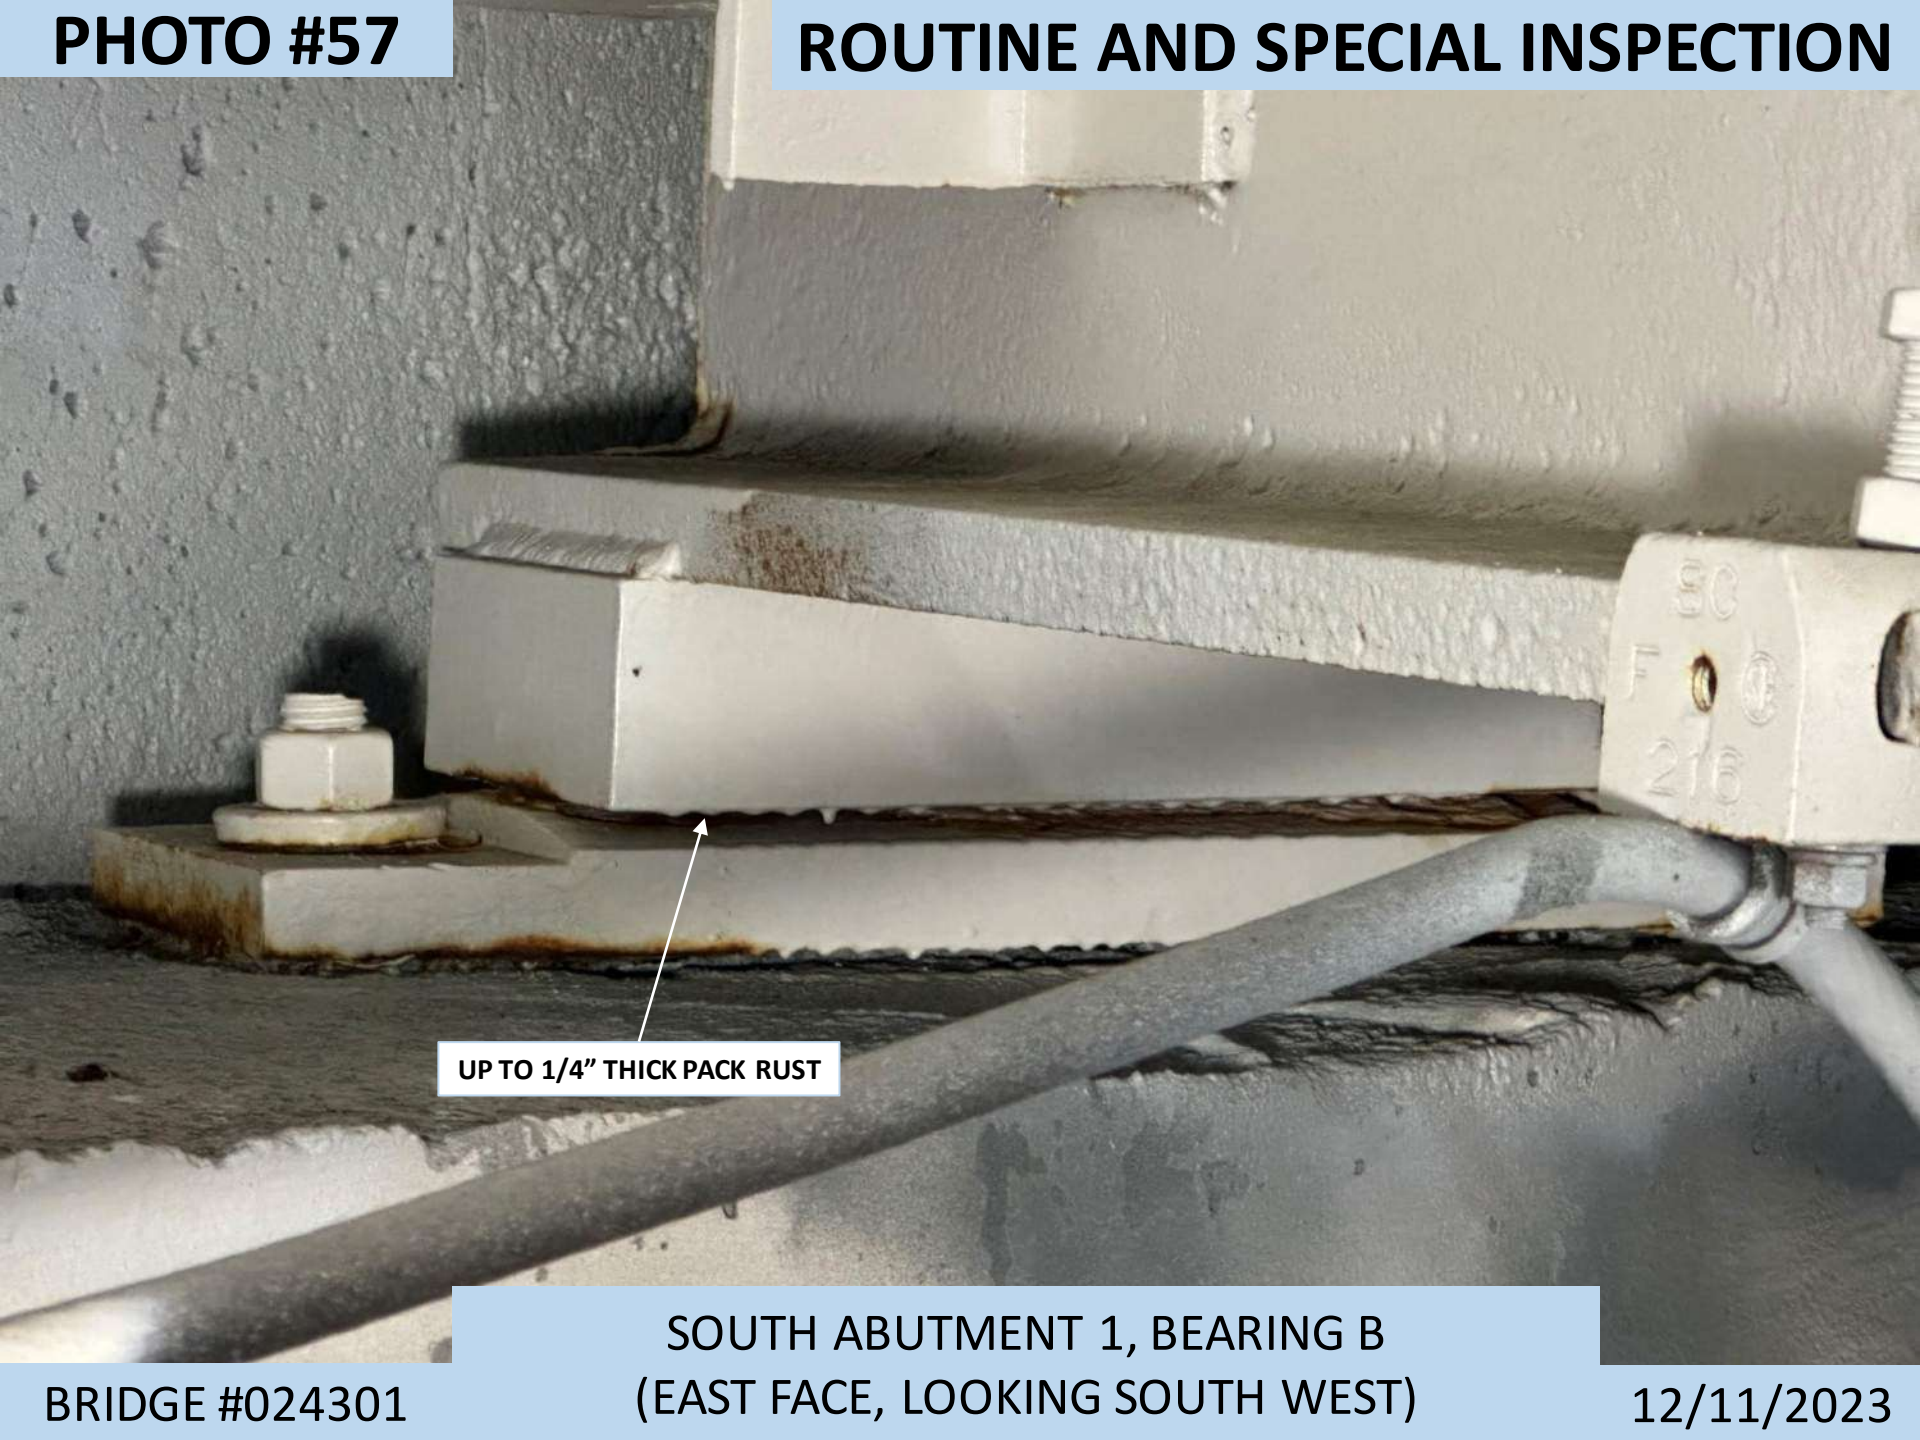
PHOTO #57

UP TO 1/4" THICK PACK RUST

**SOUTH ABUTMENT 1, BEARING B
(EAST FACE, LOOKING SOUTH WEST)**

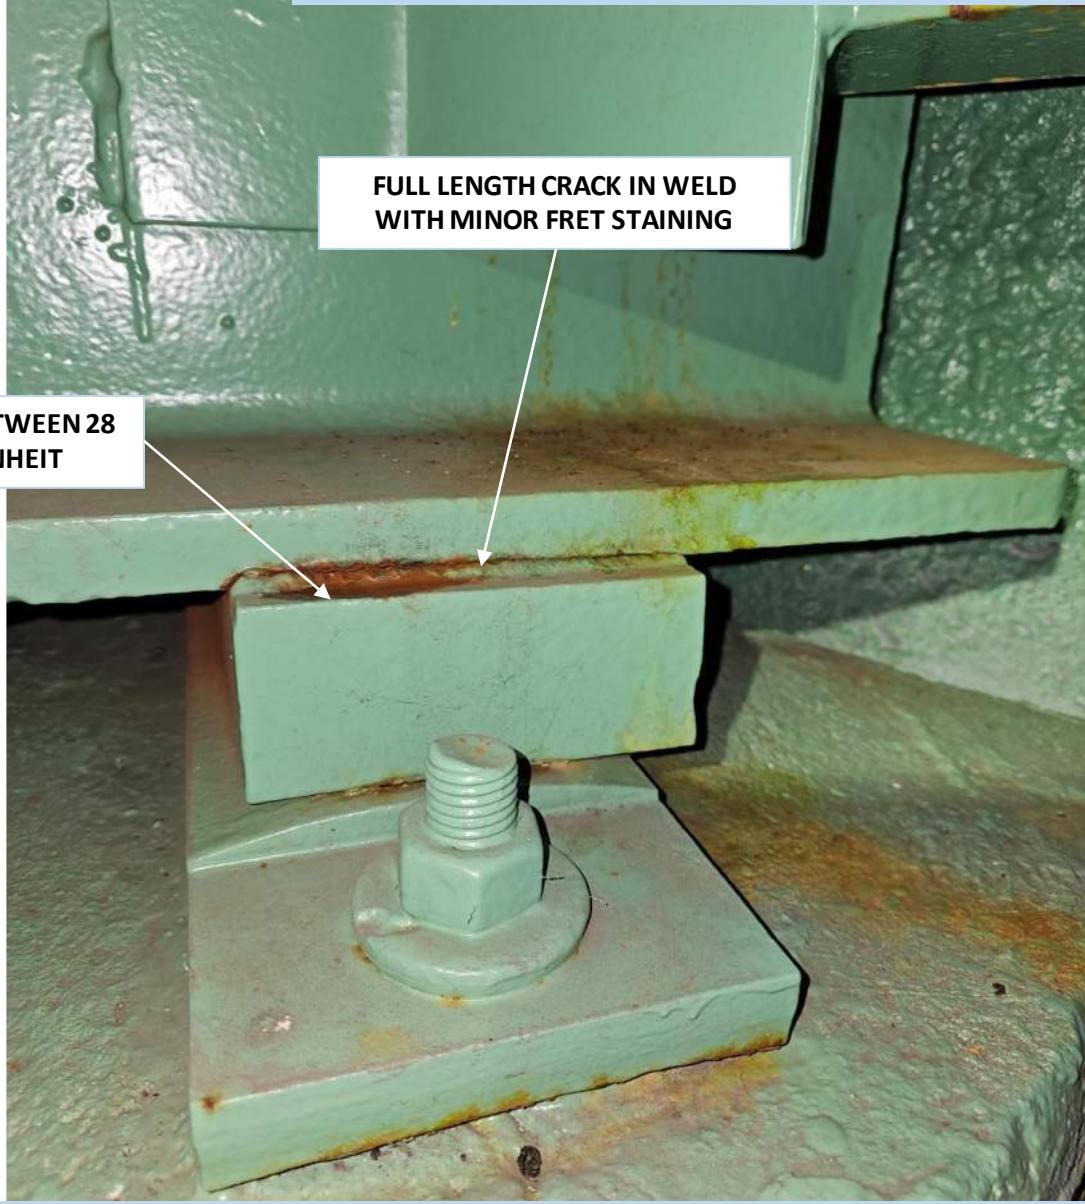
**FULL LENGTH CRACK IN WELD
WITH MINOR FRET STAINING**

**BEARING EXPANDED 3/4" BETWEEN 28
AND 36 DEGREES FAHRENHEIT**

**BEARING 'F' AT NORTH ABUTMENT 2
(EAST FACE, LOOKING WEST)**

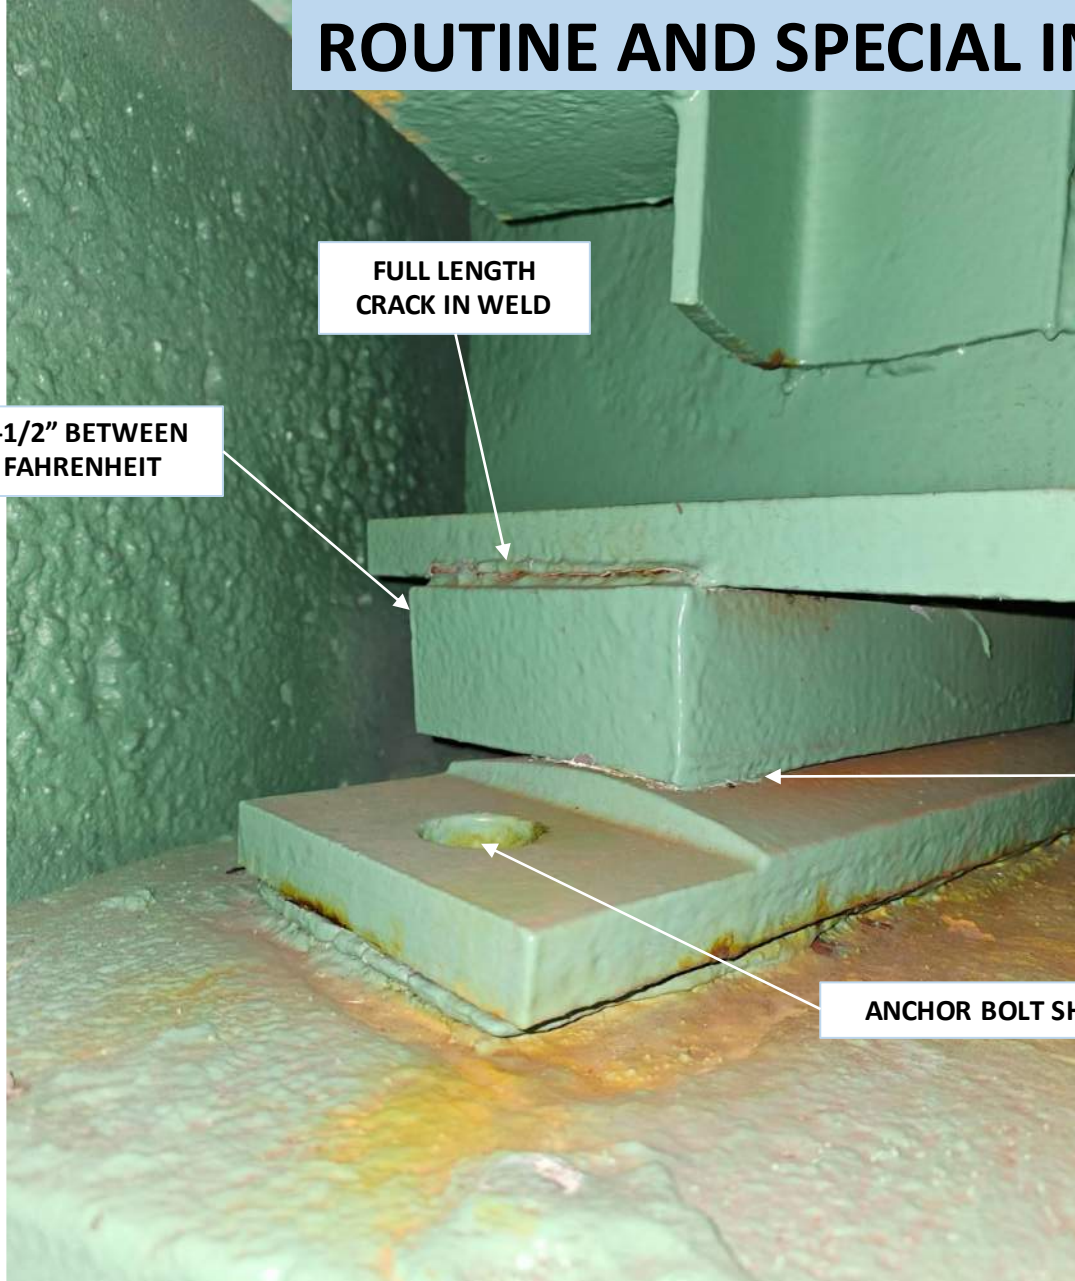
**FULL LENGTH
CRACK IN WELD**

**BEARING EXPANDED 1-1/2" BETWEEN
28 AND 36 DEGREES FAHRENHEIT**

BEARING 'G' AT NORTH ABUTMENT 2

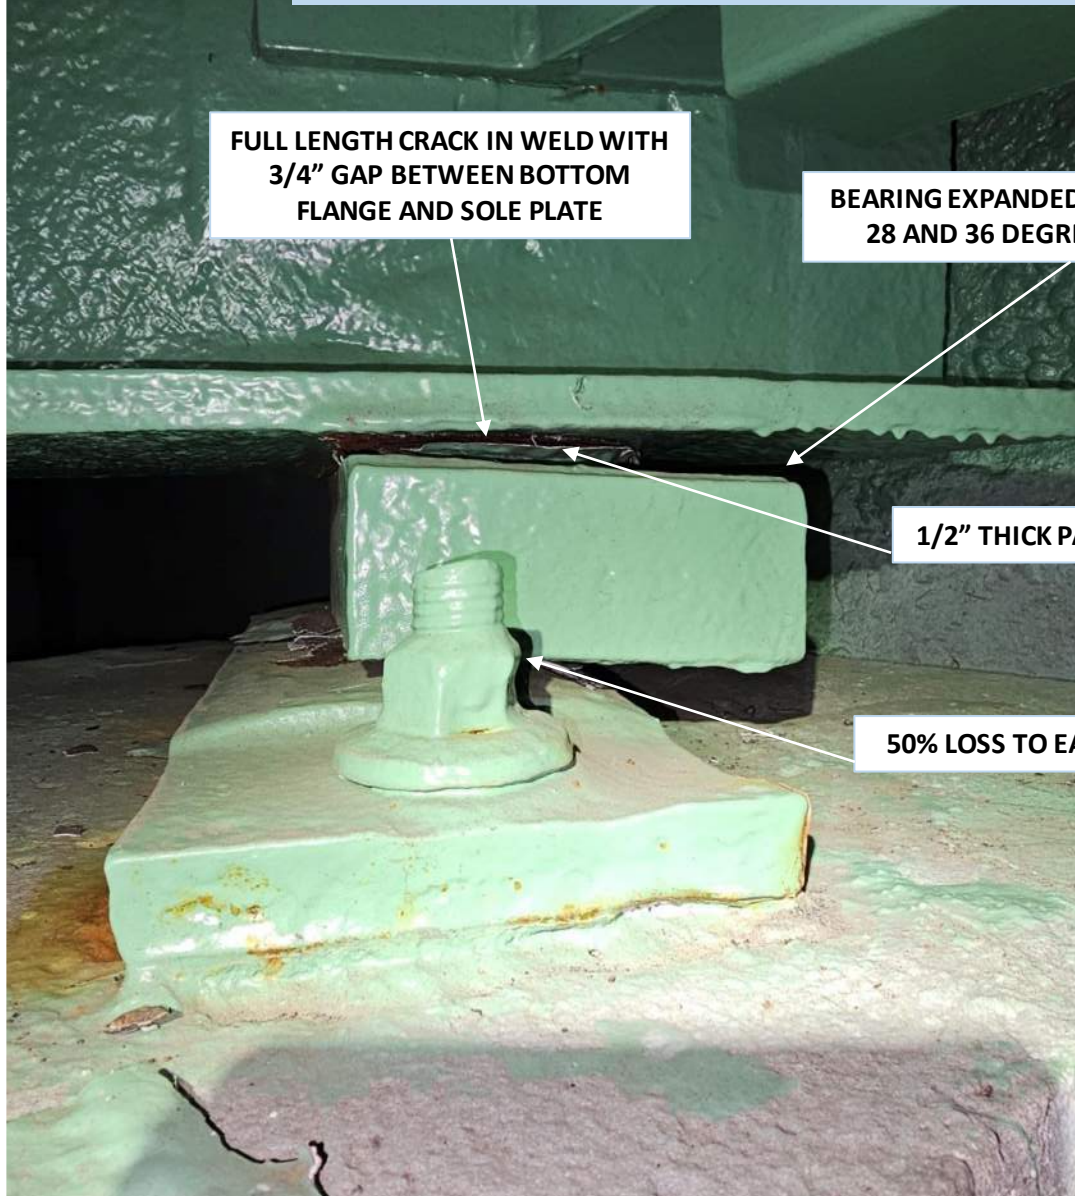
**FULL LENGTH CRACK IN WELD WITH
3/4" GAP BETWEEN BOTTOM
FLANGE AND SOLE PLATE**

**BEARING EXPANDED 2-1/16" BETWEEN
28 AND 36 DEGREES FAHRENHEIT**

50% LOSS TO EAST ANCHOR BOLT NUT

**BEARING 'H' AT NORTH ABUTMENT 2
(EAST FACE, LOOKING WEST)**

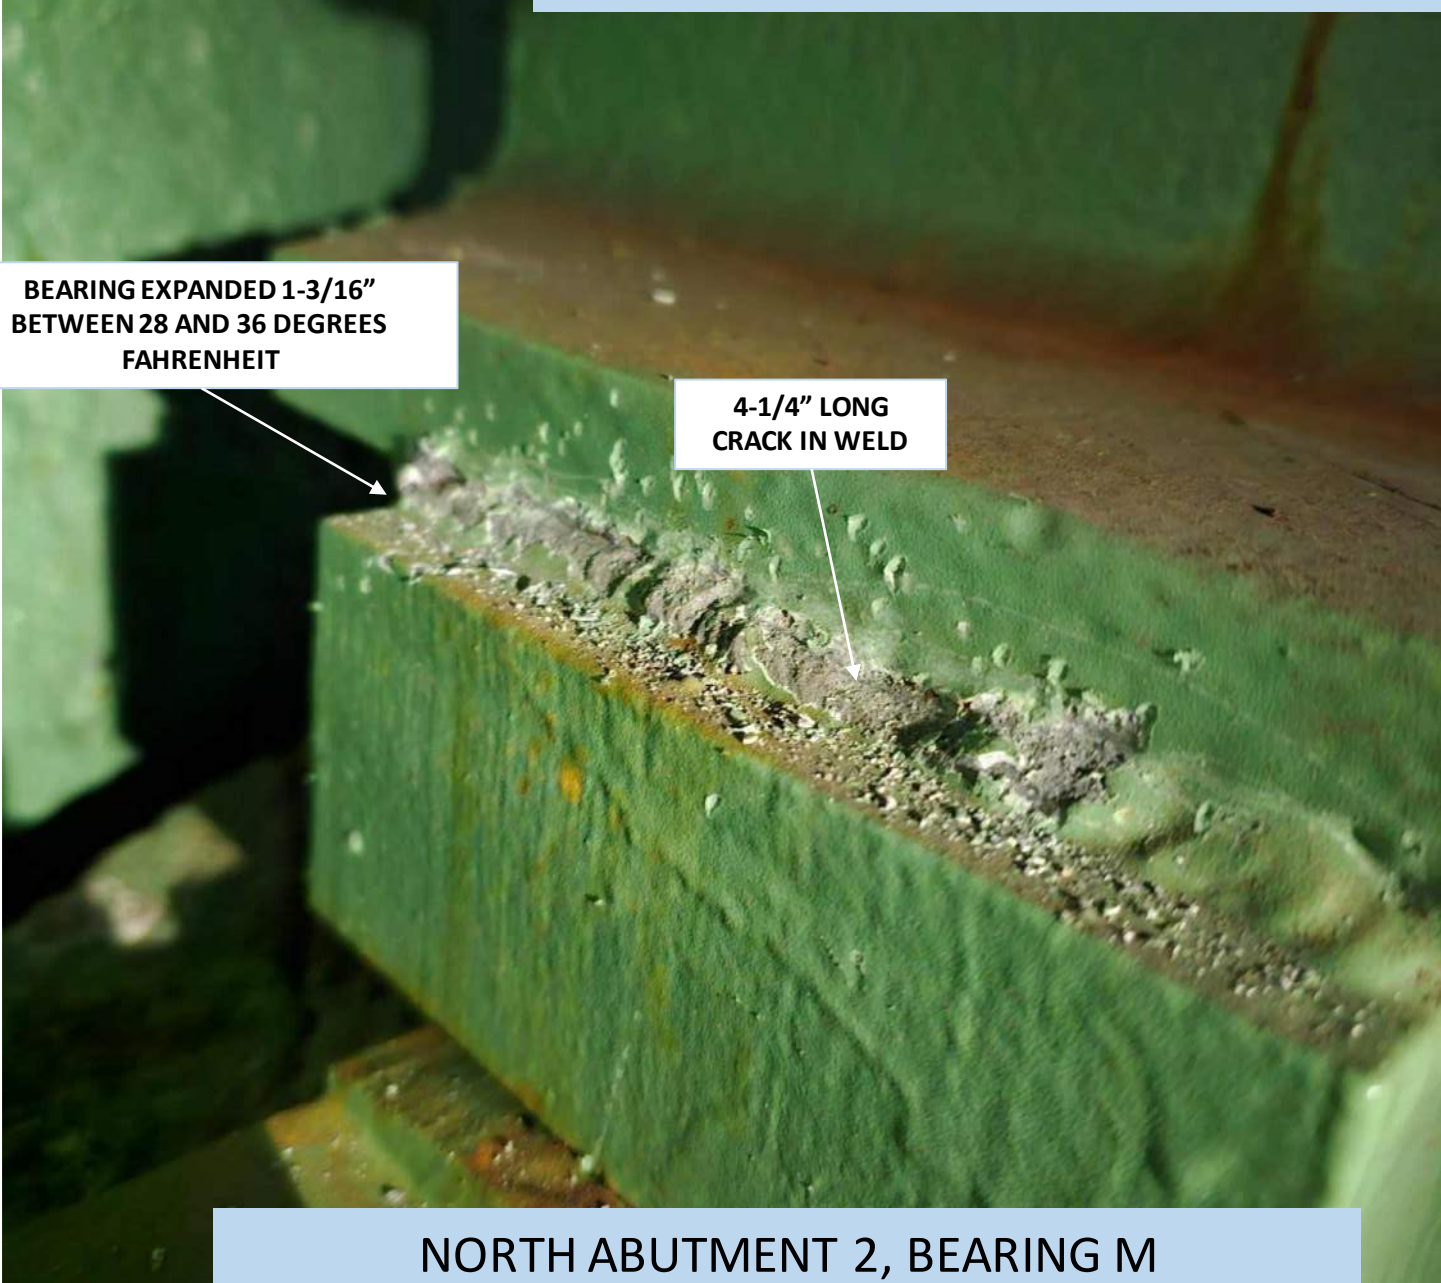
**BEARING EXPANDED 1-3/16"
BETWEEN 28 AND 36 DEGREES
FAHRENHEIT**

**4-1/4" LONG
CRACK IN WELD**
