NOTICE TO PROSPECTIVE BIDDERS
RI CONTRACT NO. 2024-CB-018 – ADDENDUM NO. 1

Add New Appendix to this Addendum No. 1. “Bridge Inspection Report” has been added.

SPECIAL INSPECTION SCOPE: The scope of the special inspection shall include the advanced deterioration of the beam ends including the web area beyond the end diaphragms, end diaphragms, fixed bearings and moveable bearings. The special inspection shall also include the AASHTO Fatigue Category E' welds at the transverse ends of the cover plates and the bottom flanges of the beams. If any cracks are observed at these weld details, the RIDOT Bridge Ratings Section shall be notified.

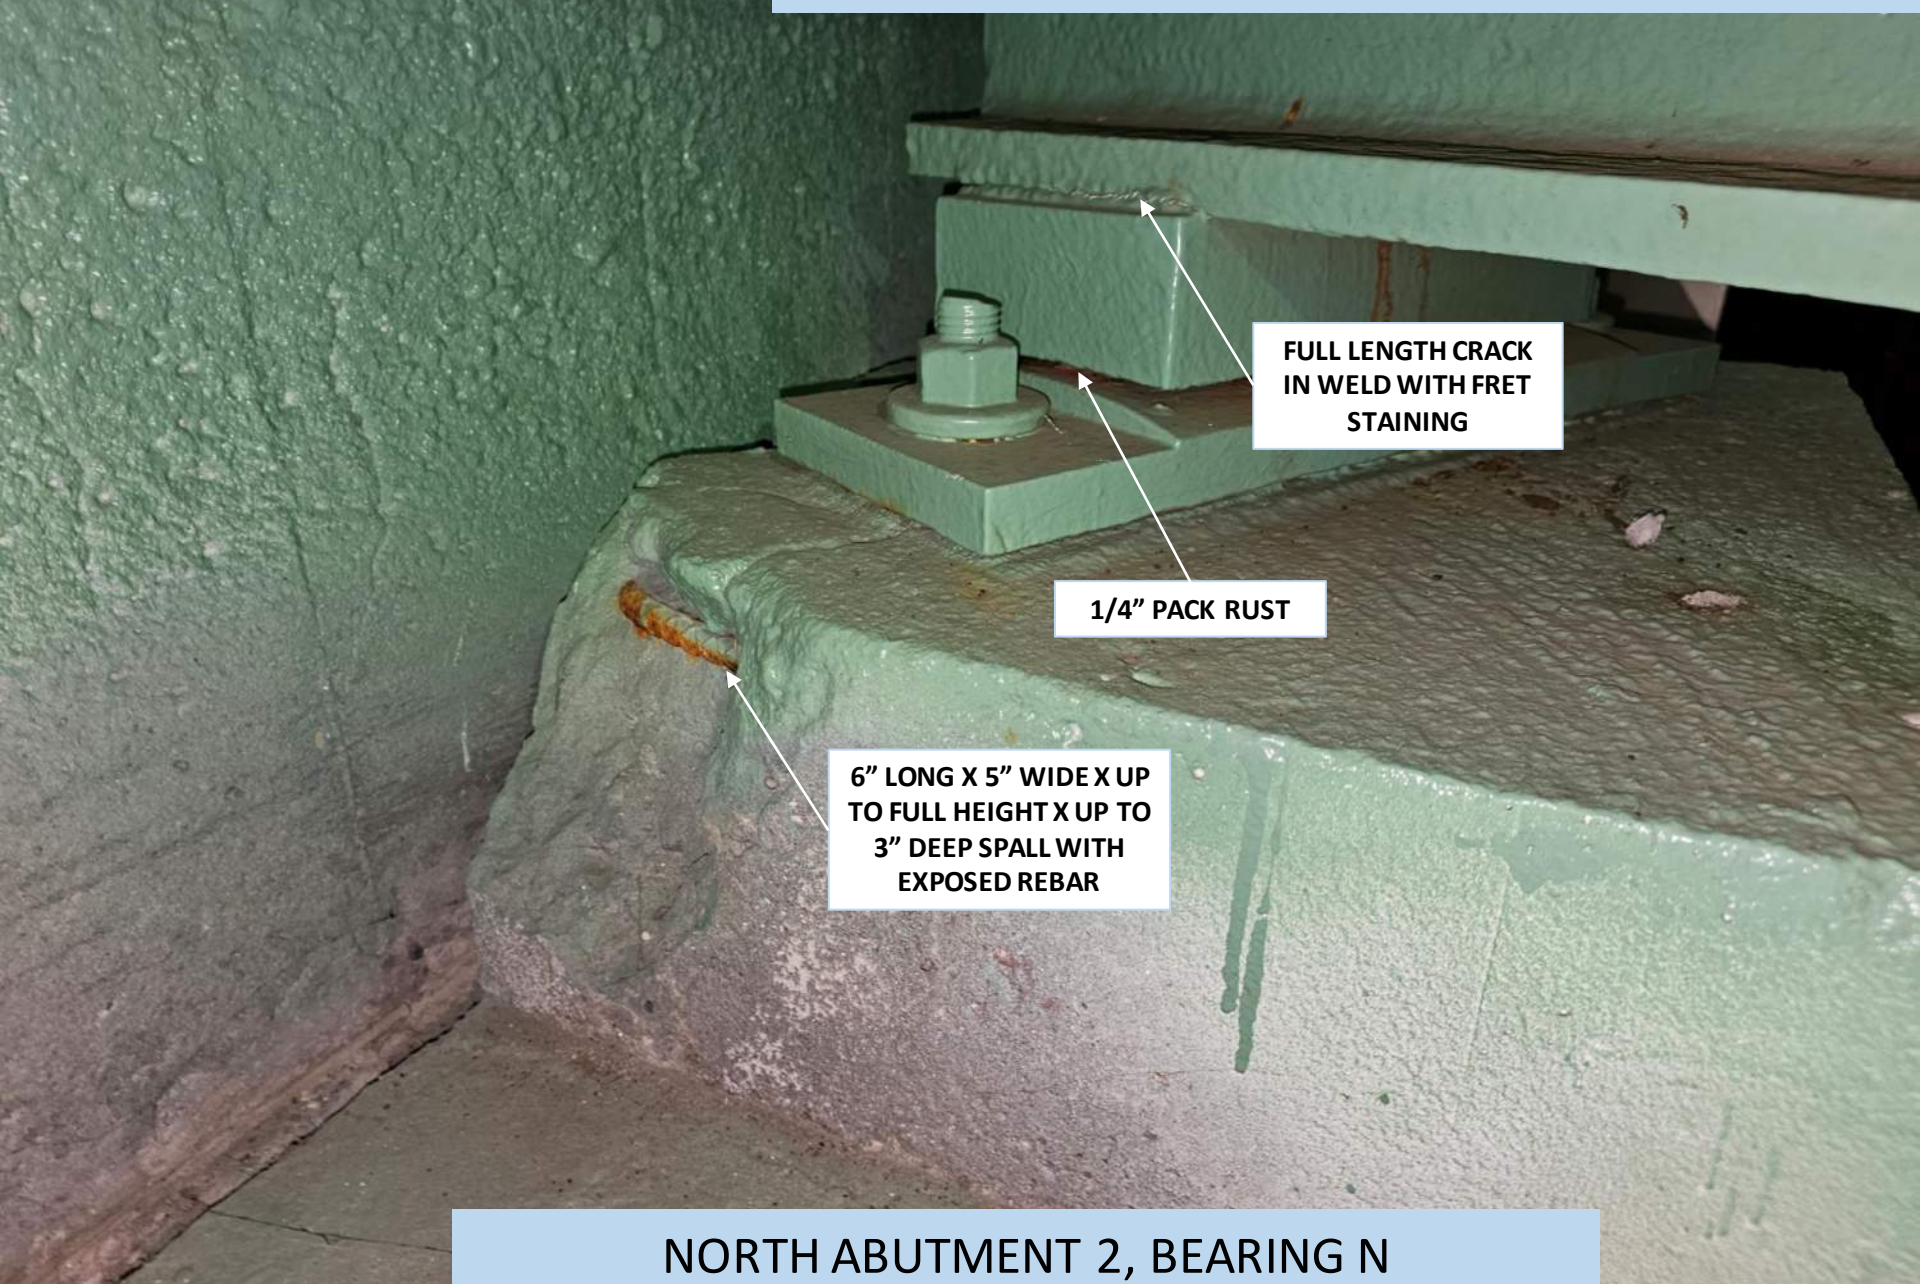
PHOTO #64

**FULL LENGTH CRACK
IN WELD WITH FRET
STAINING**

1/4" PACK RUST

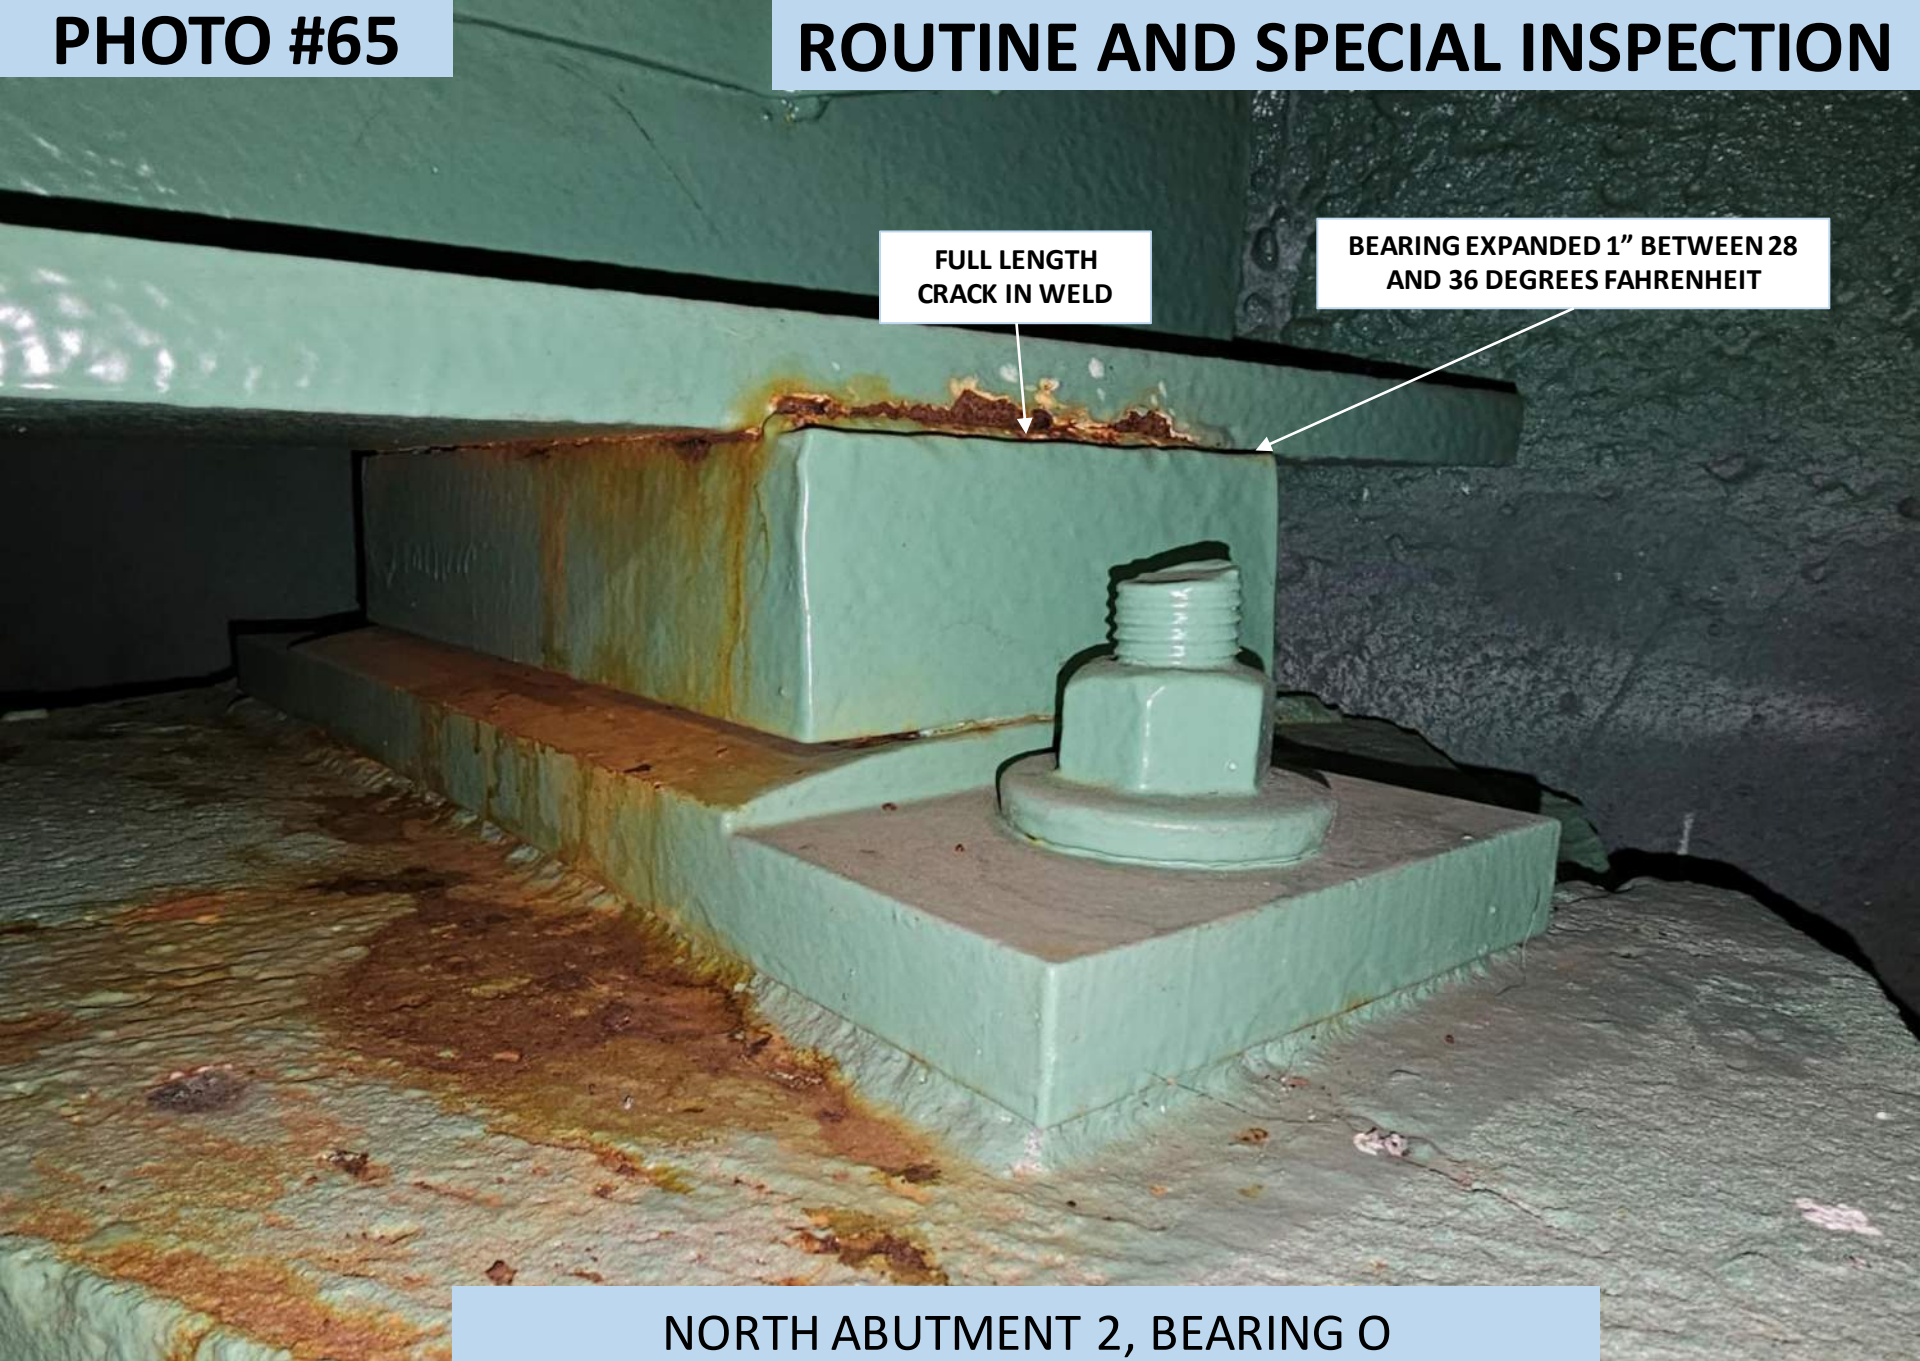
PHOTO #65

**FULL LENGTH
CRACK IN WELD**

**BEARING EXPANDED 1" BETWEEN 28
AND 36 DEGRES FARENHEIT**

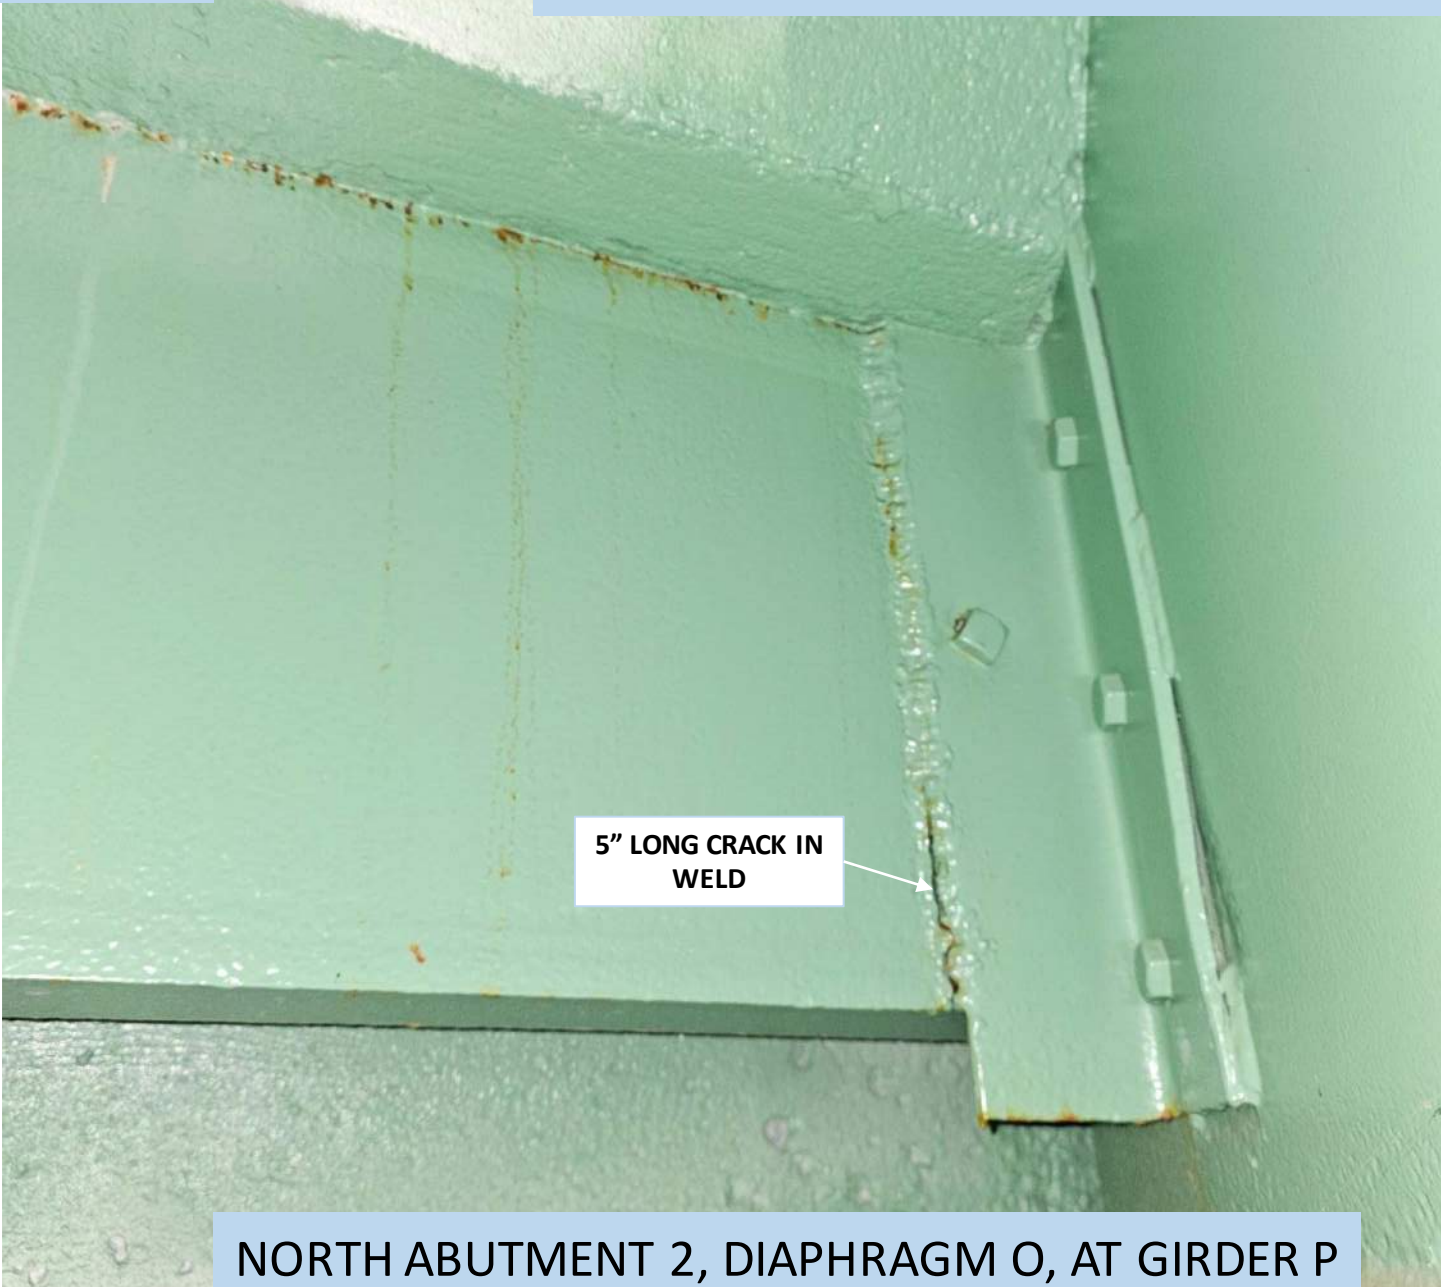
PHOTO #66

**5" LONG CRACK IN
WELD**

**NORTH ABUTMENT 2, DIAPHRAGM O, AT GIRDER P
(LOOKING NORTH)**

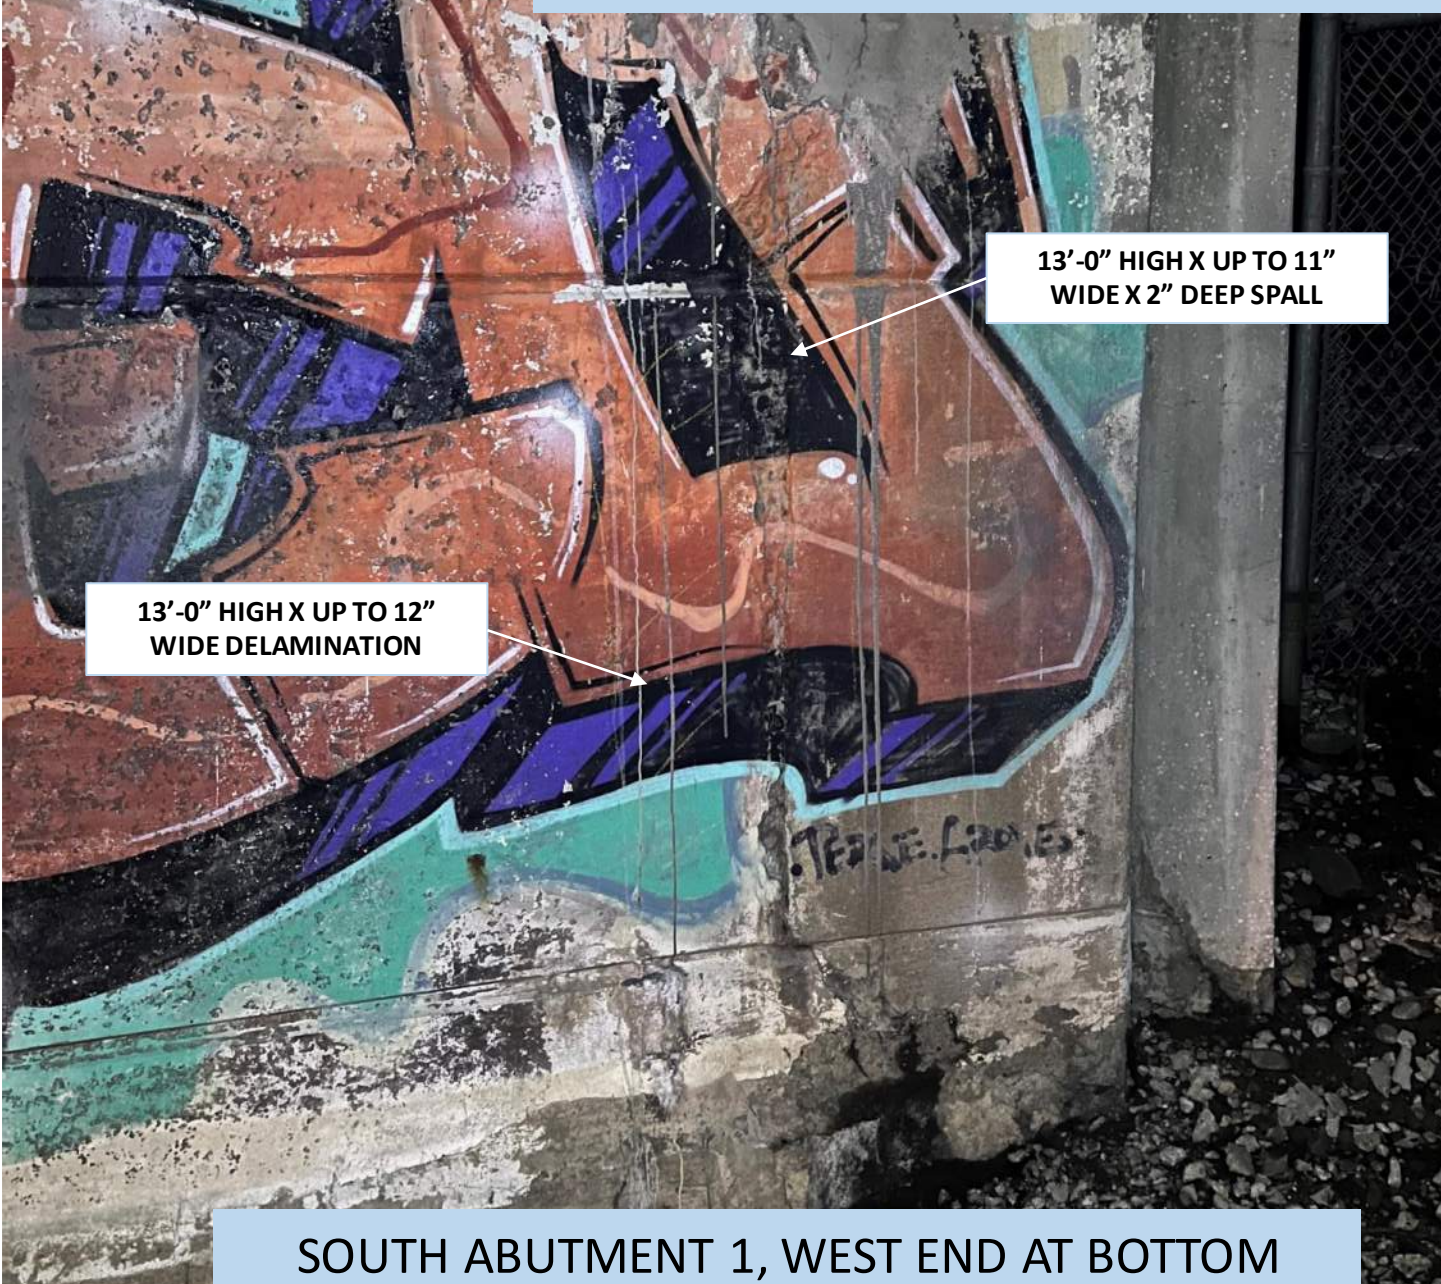
**13'-0" HIGH X UP TO 11"
WIDE X 2" DEEP SPALL**

**13'-0" HIGH X UP TO 12"
WIDE DELAMINATION**

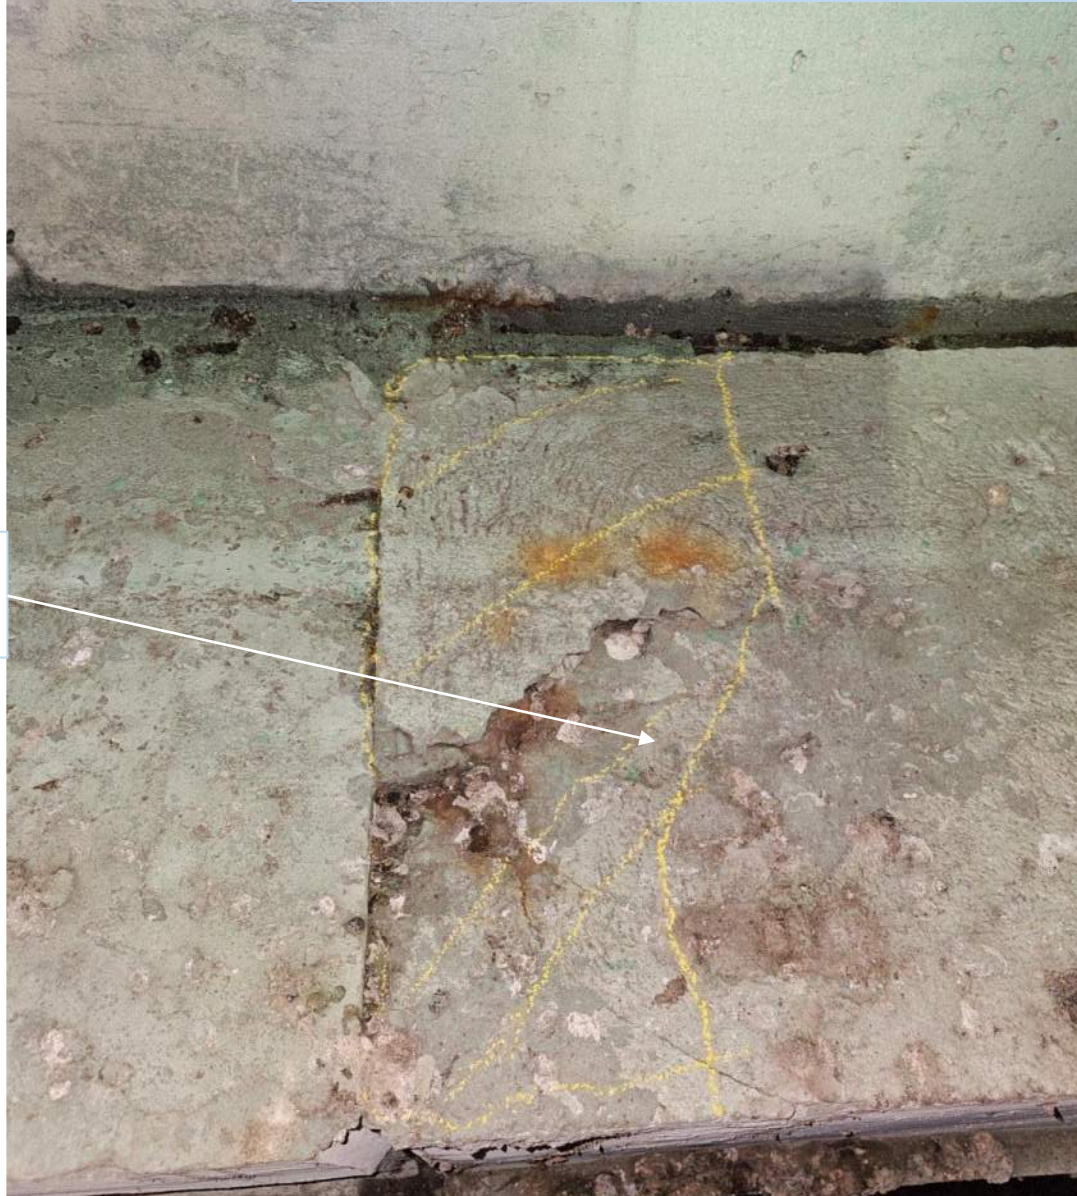
**FULL WIDTH x 10" LONG
HOLLOW AREA WITH 1/2"
DEEP SPALLING**

**SOUTH ABUTMENT 1, BAY D, BEAM SEAT
(LOOKING SOUTH)**

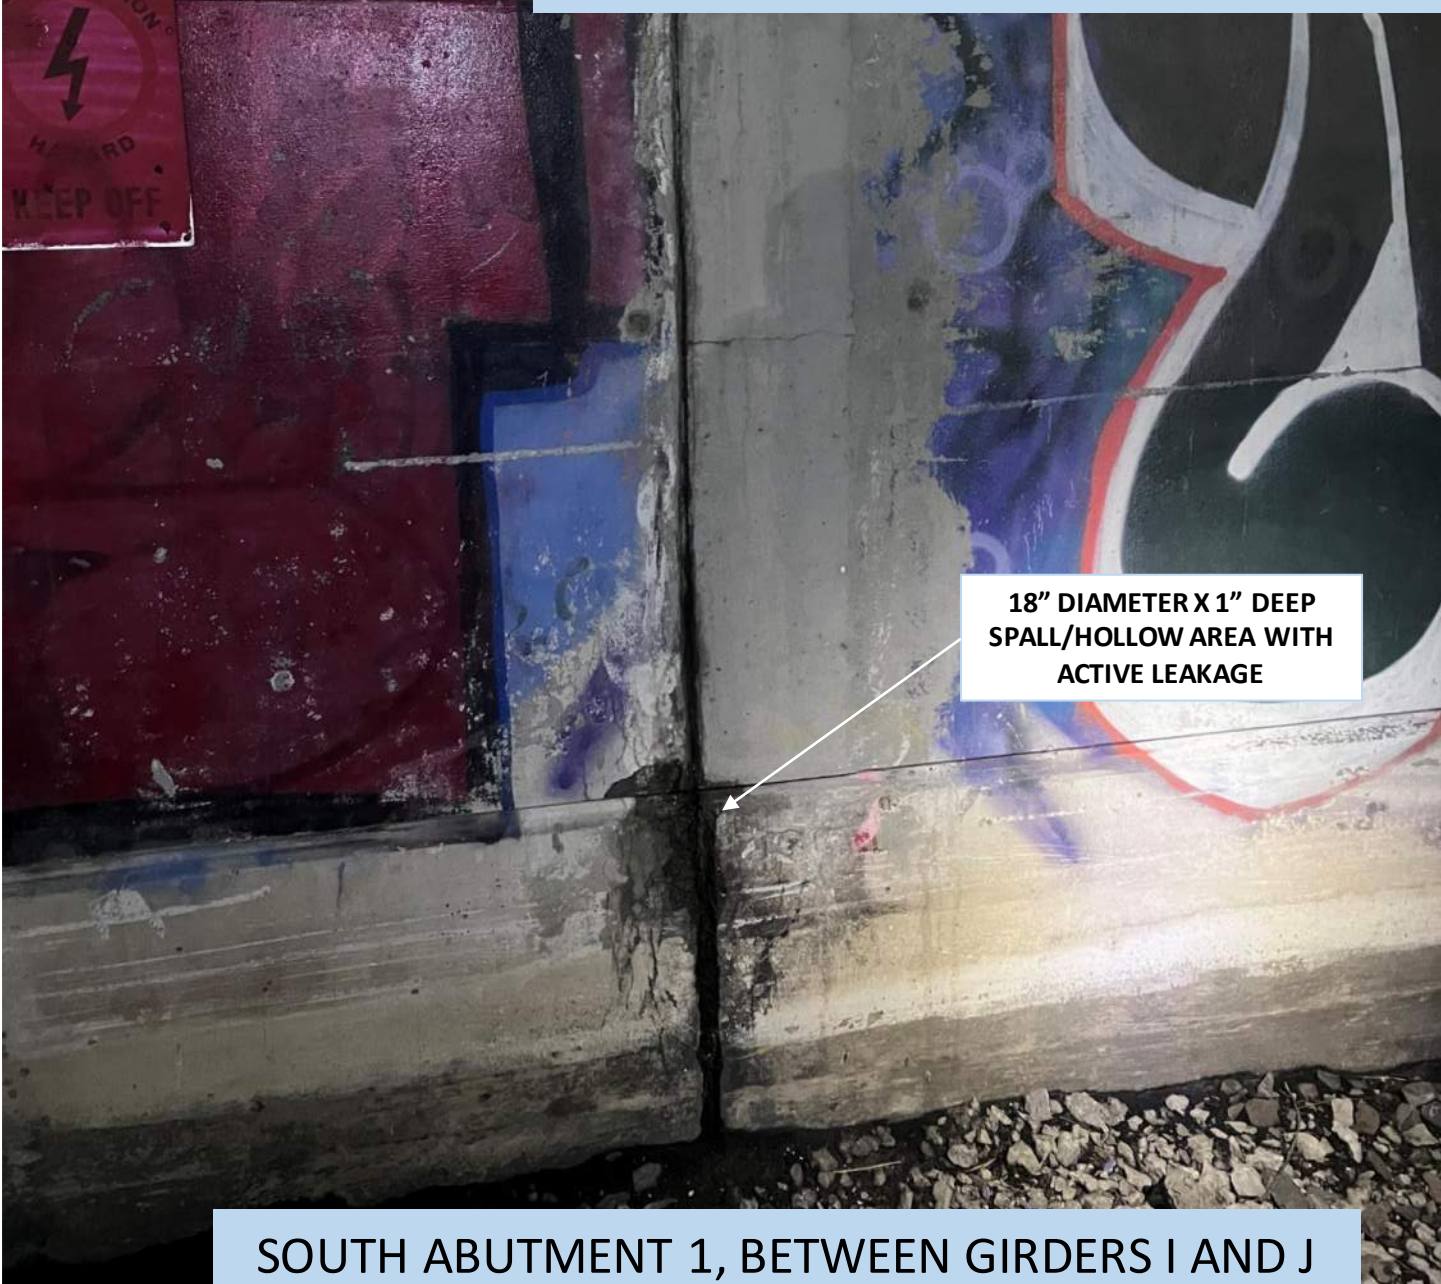
PHOTO #71

**18" DIAMETER X 1" DEEP
SPALL/HOLLOW AREA WITH
ACTIVE LEAKAGE**

**SOUTH ABUTMENT 1, BETWEEN GIRDERS I AND J
(LOOKING SOUTH)**

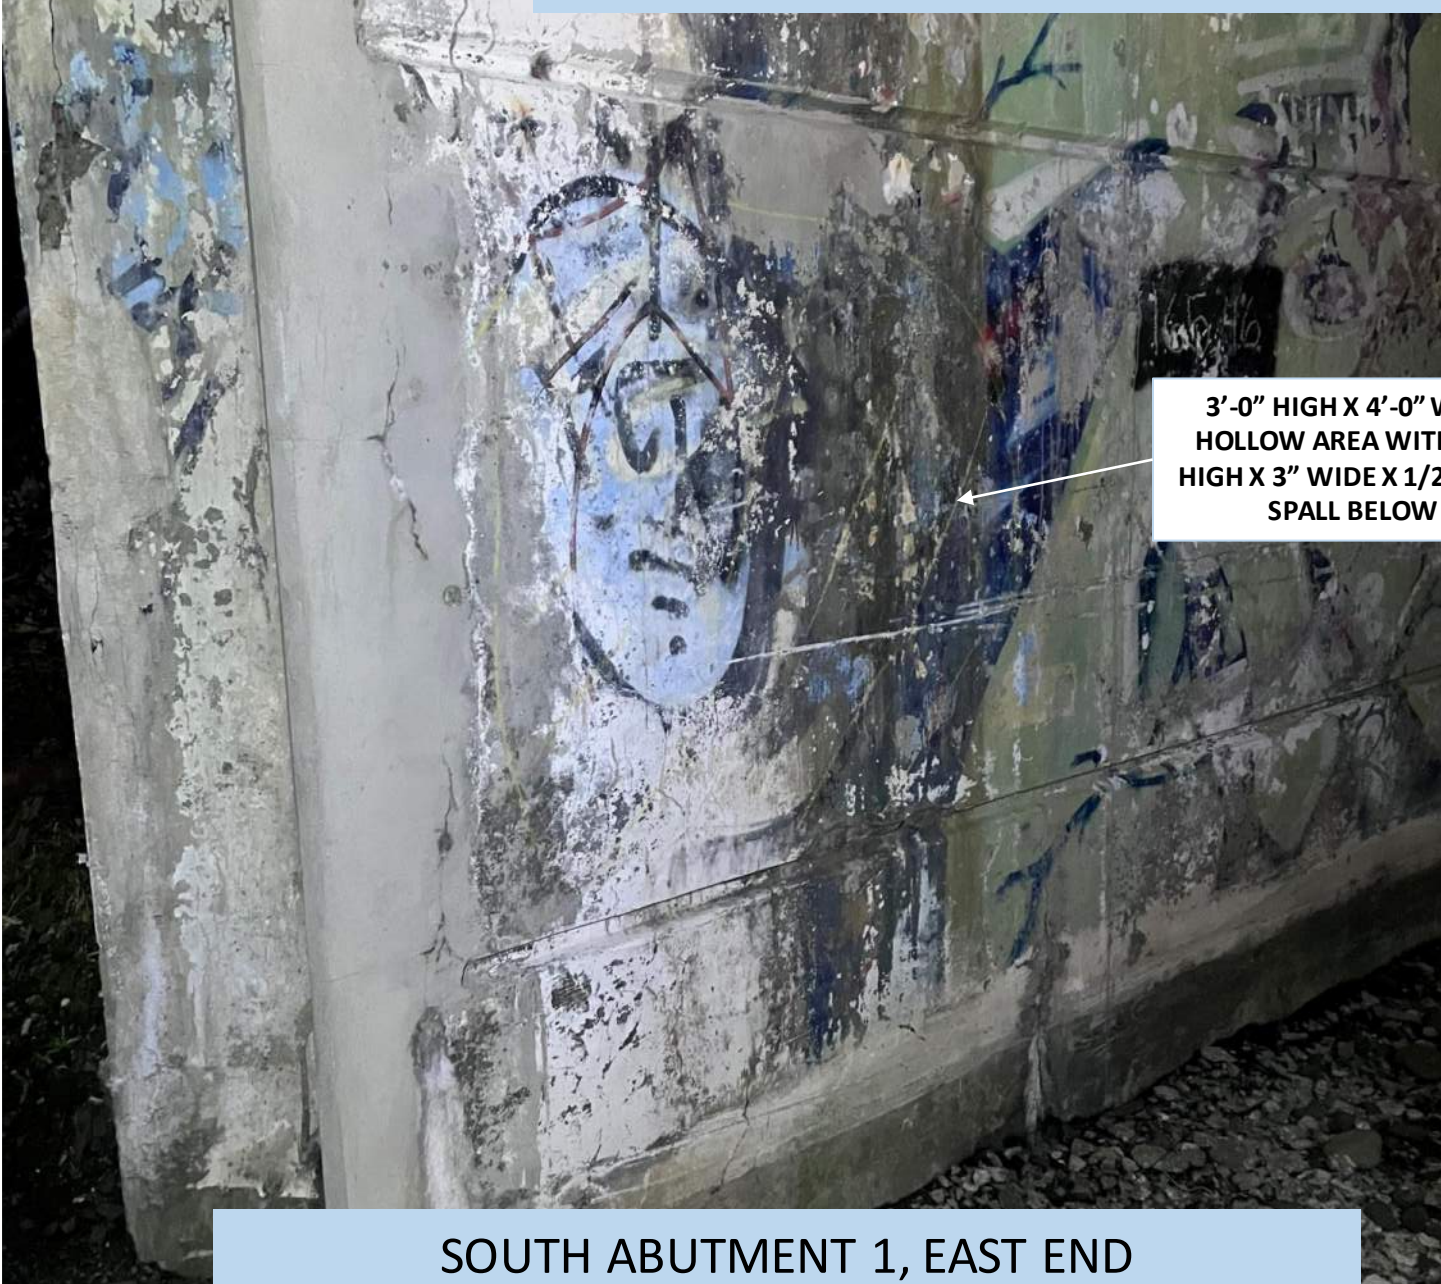
**3'-0" HIGH X 4'-0" WIDE
HOLLOW AREA WITH A 5"
HIGH X 3" WIDE X 1/2" DEEP
SPALL BELOW**

**SOUTH ABUTMENT 1, EAST END
(LOOKING SOUTH)**

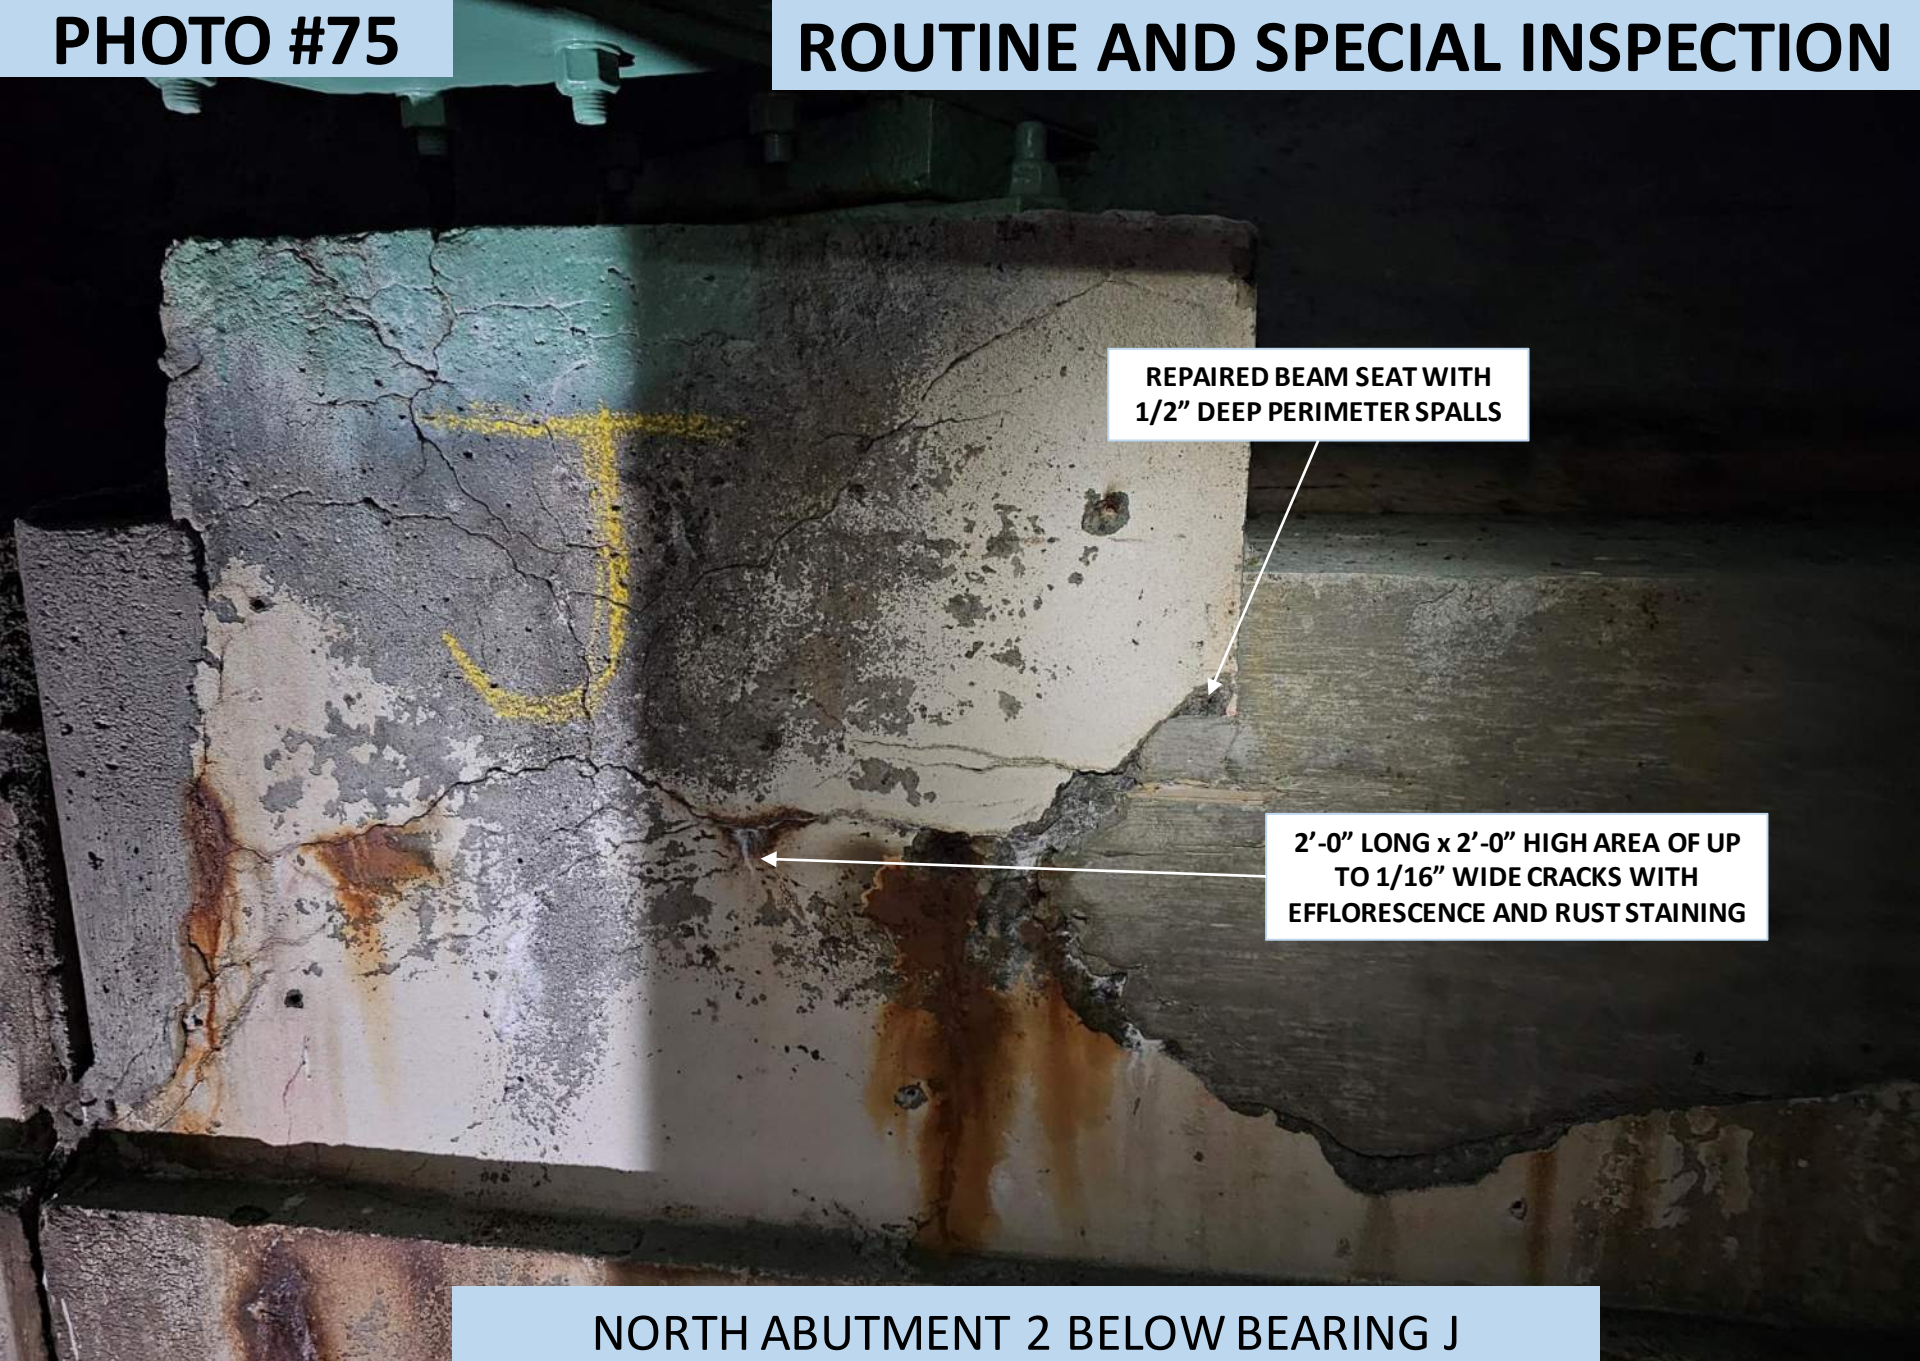
REPAIRED BEAM SEAT WITH
1/2" DEEP PERIMETER SPALLS

2'-0" LONG x 2'-0" HIGH AREA OF UP
TO 1/16" WIDE CRACKS WITH
EFFLORESCENCE AND RUST STAINING

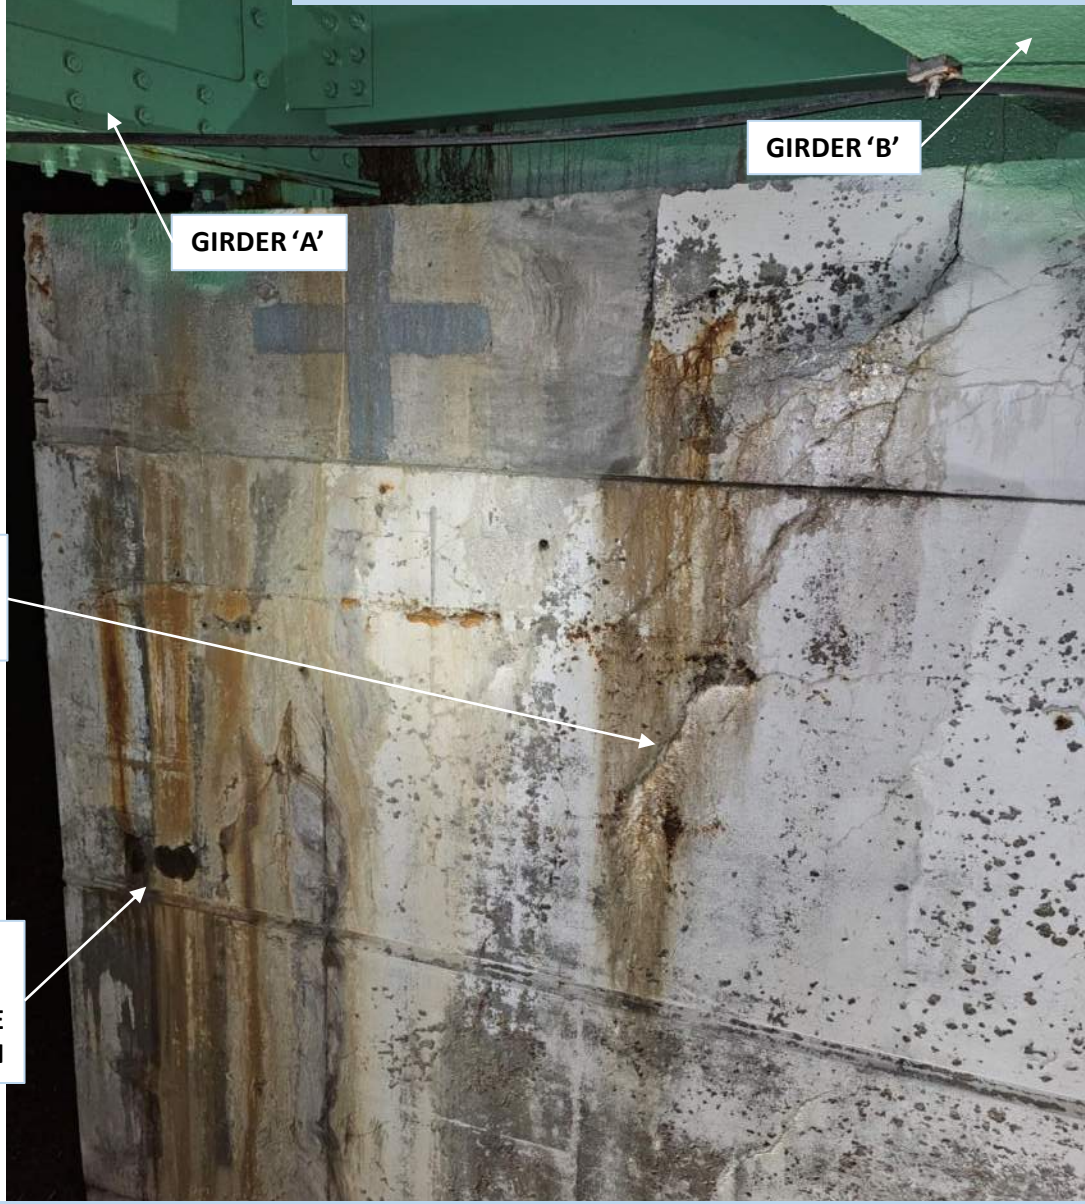
HAIRLINE DIAGONAL CRACKS WITH EFFLORESCENCE, RUST STAINING AND LEAKAGE

PARTIALLY REPAIRED WITH ISLOATED MAP CRACKING REMAINING: UP TO 6'-0" WIDE x FULL HEIGHT DELAMINATION

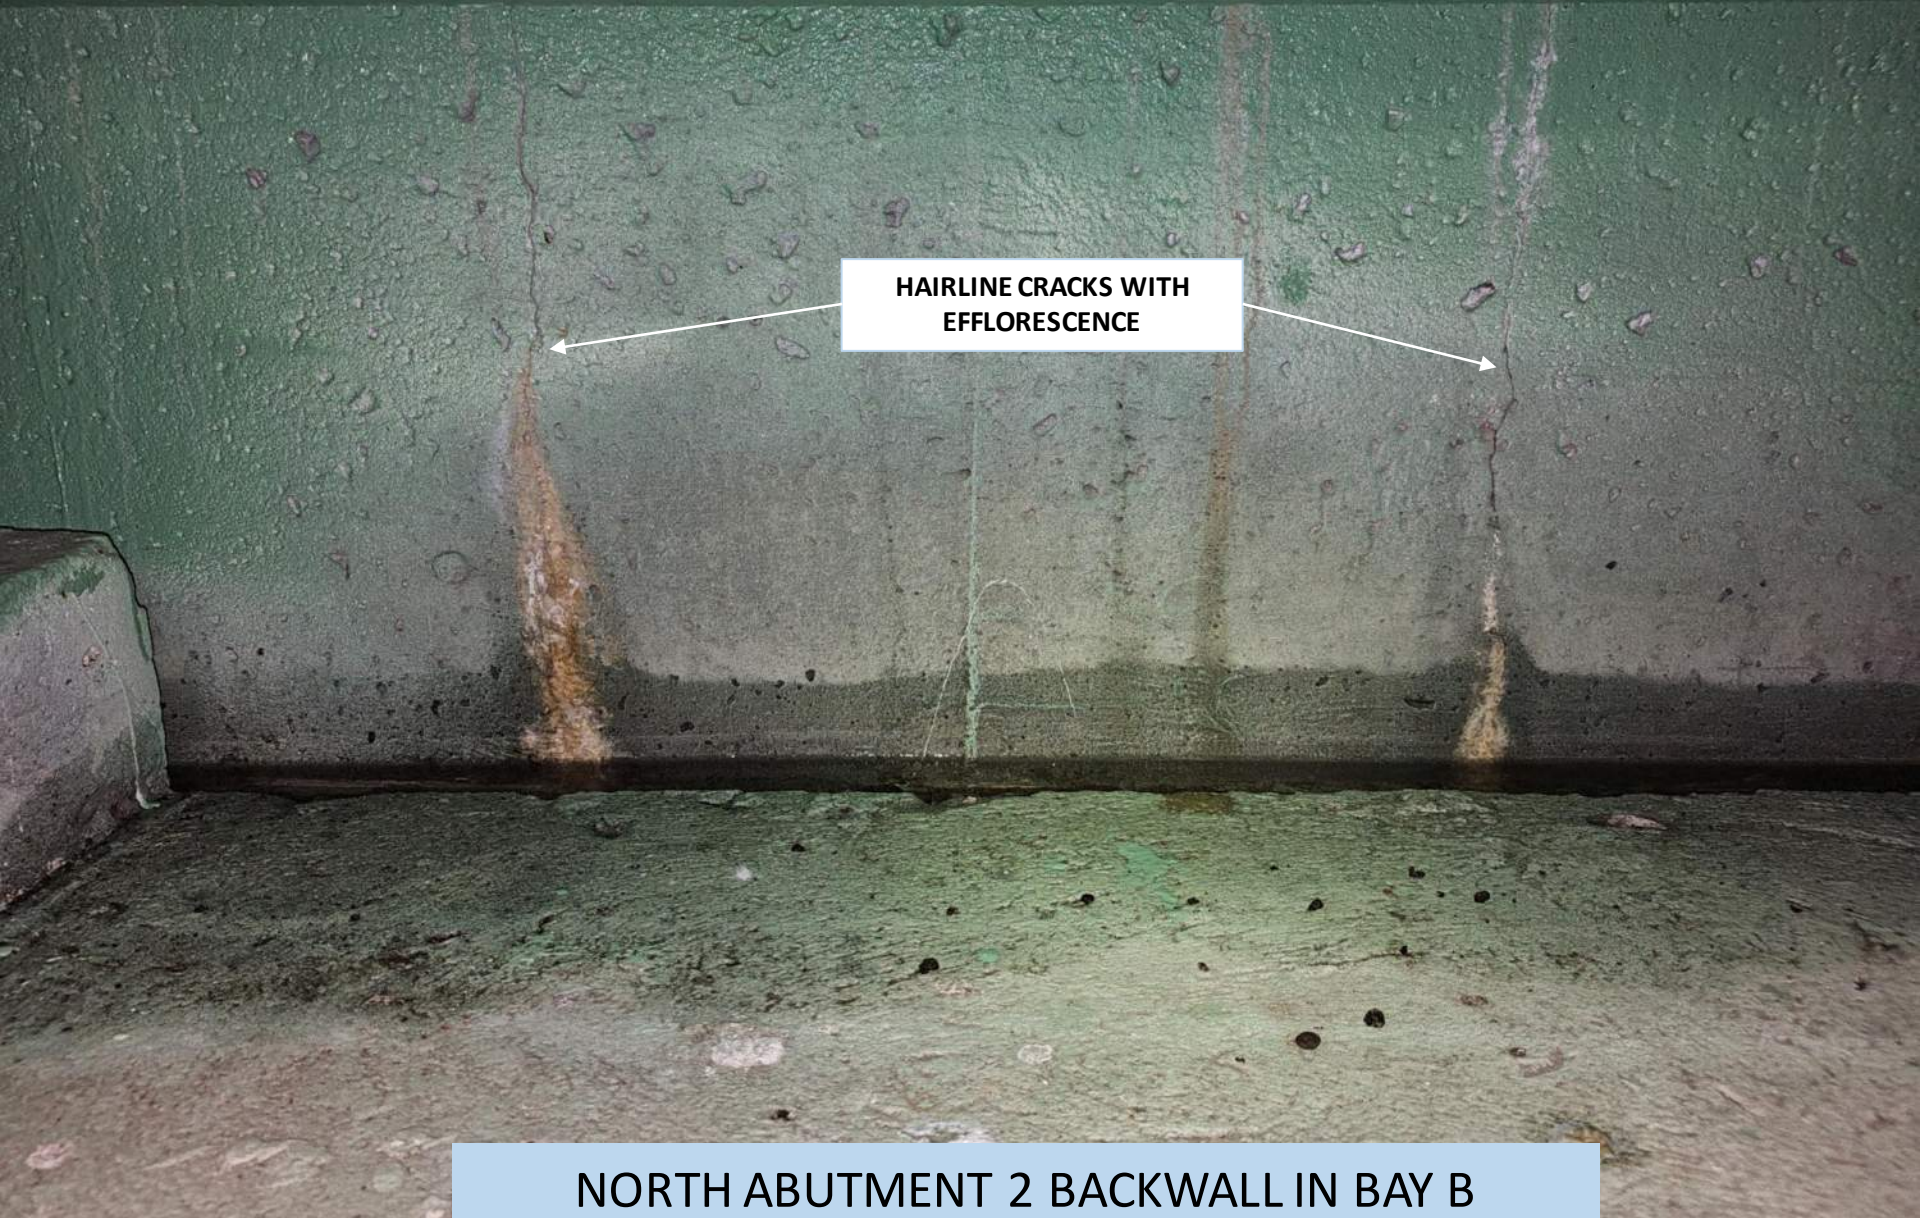
PHOTO #77

**HAIRLINE CRACKS WITH
EFFLORESCENCE**

**NORTH ABUTMENT 2 BACKWALL IN BAY B
(LOOKING NORTH)**

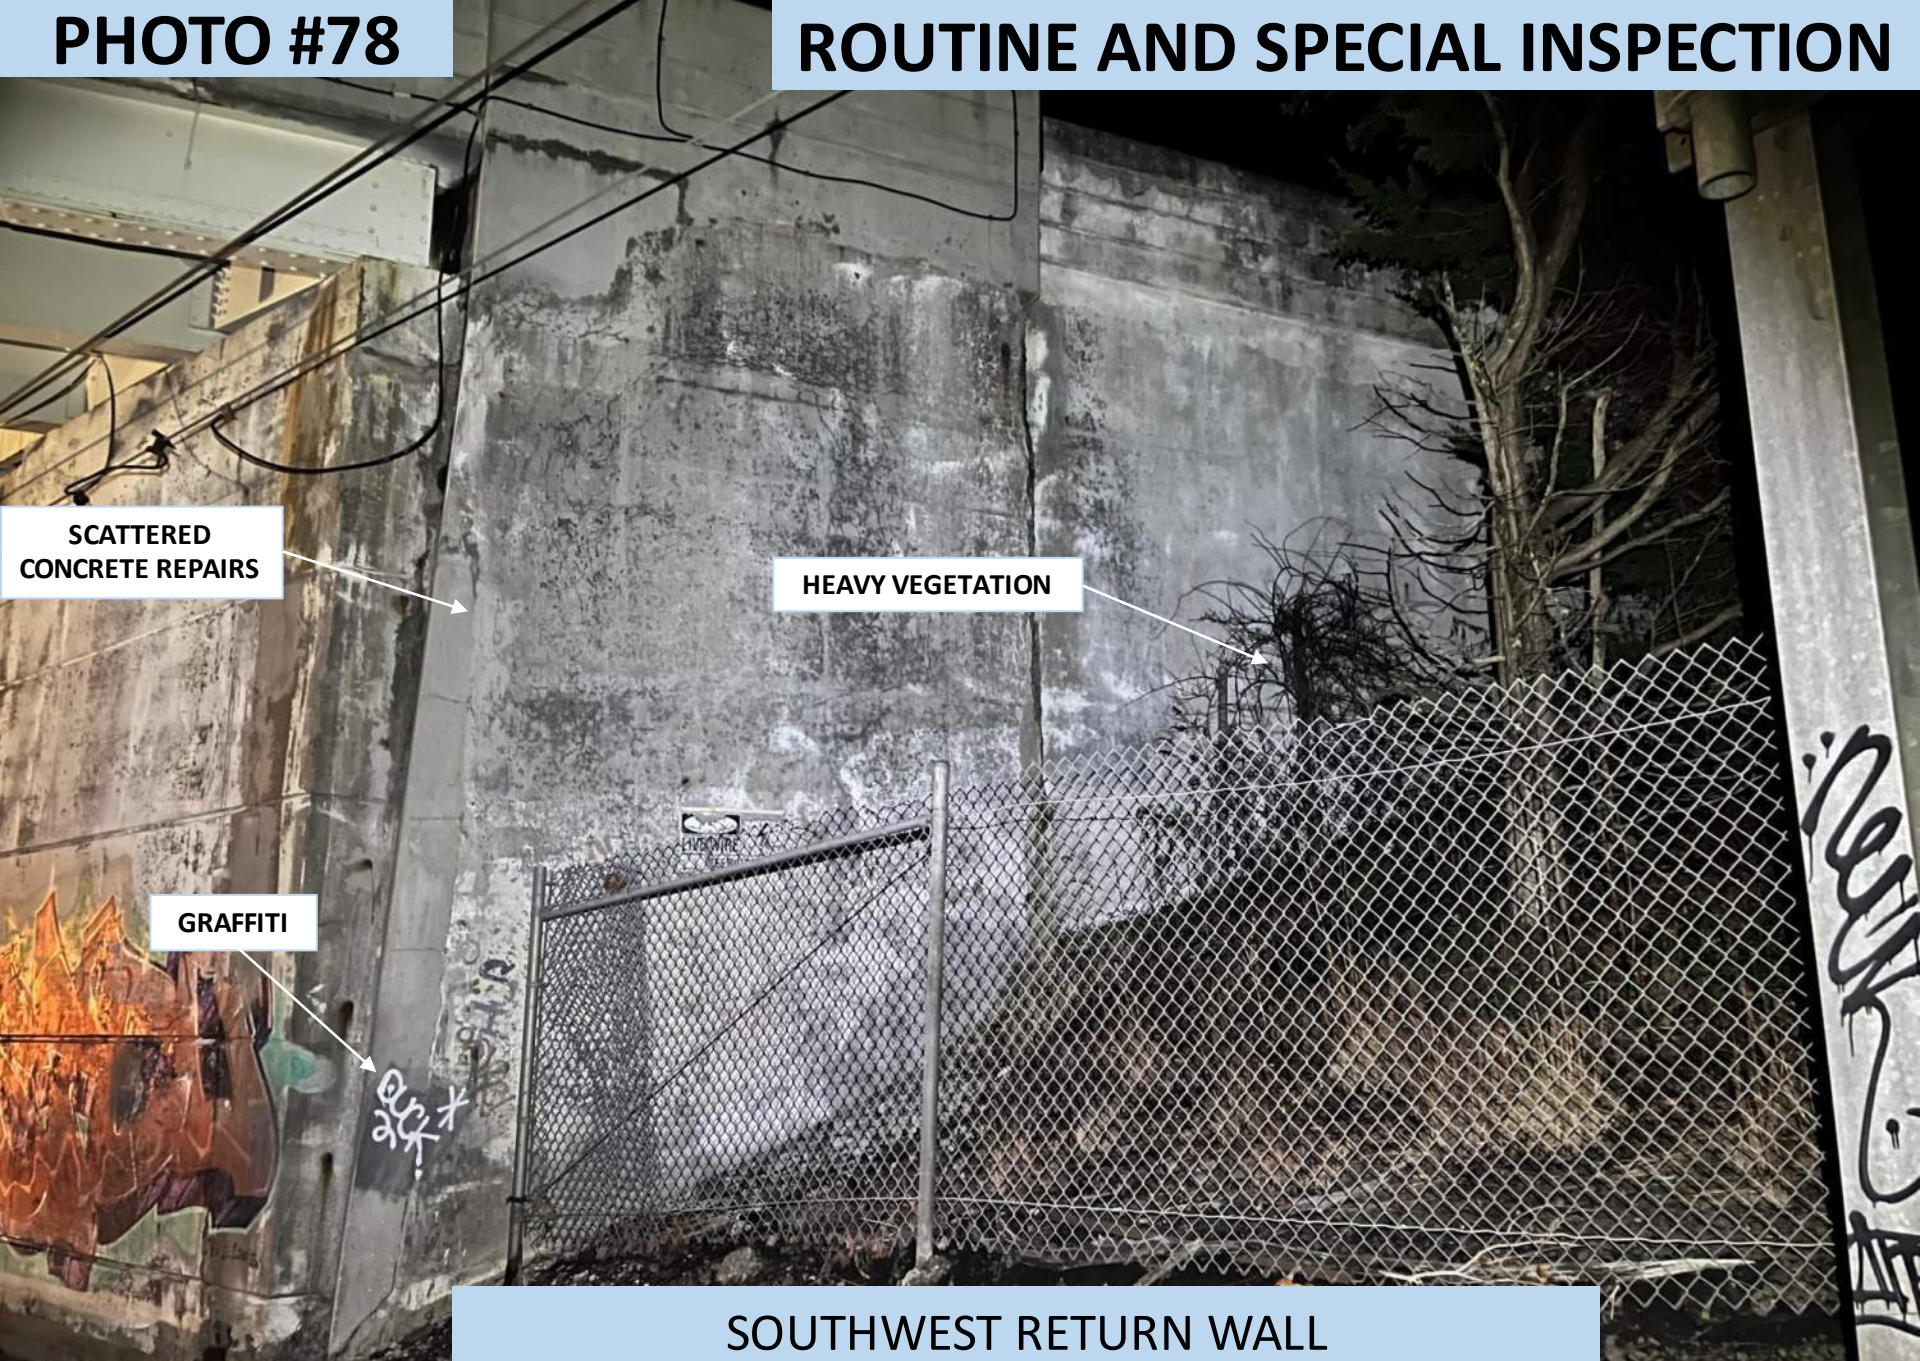
**SCATTERED
CONCRETE REPAIRS**

HEAVY VEGETATION

GRAFFITI
