NOTICE TO PROSPECTIVE BIDDERS
RI CONTRACT NO. 2024-CB-018 – ADDENDUM NO. 1

Add New Appendix to this Addendum No. 1. “Bridge Inspection Report” has been added.

SPECIAL INSPECTION SCOPE: The scope of the special inspection shall include the advanced deterioration of the beam ends including the web area beyond the end diaphragms, end diaphragms, fixed bearings and moveable bearings. The special inspection shall also include the AASHTO Fatigue Category E' welds at the transverse ends of the cover plates and the bottom flanges of the beams. If any cracks are observed at these weld details, the RIDOT Bridge Ratings Section shall be notified.

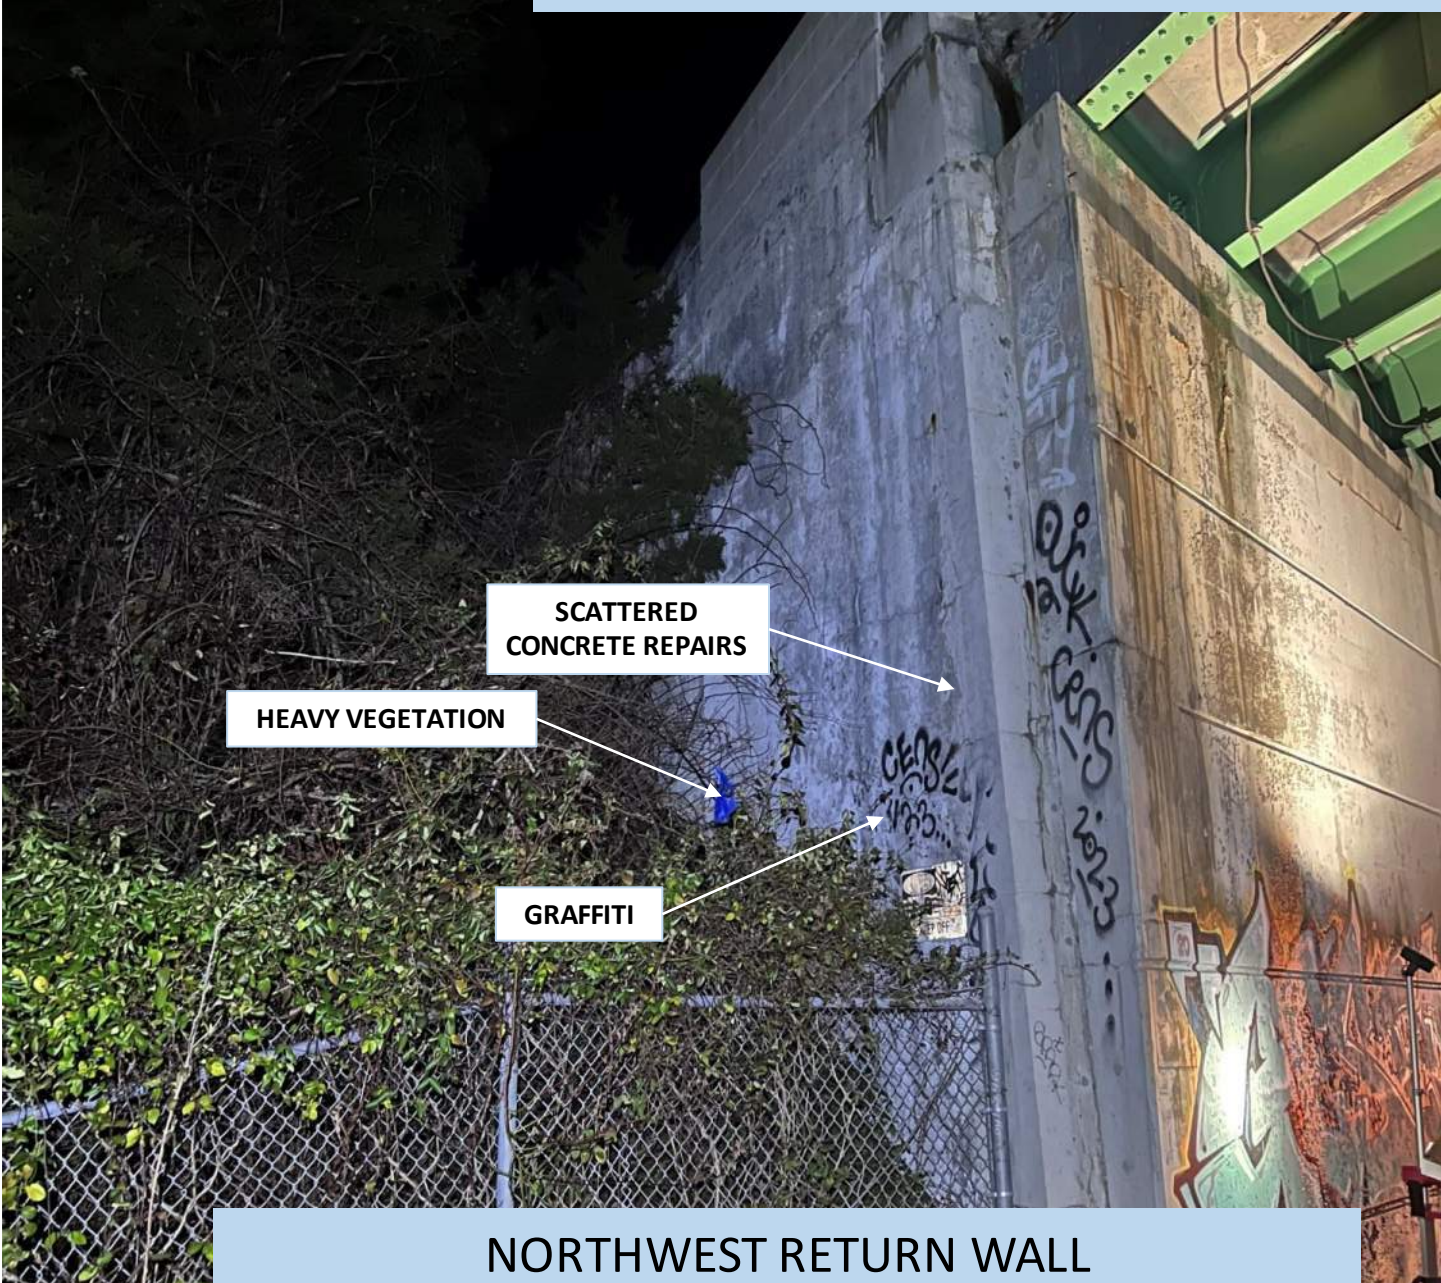
HEAVY VEGETATION

**SCATTERED
CONCRETE REPAIRS**

GRAFFITI

**NORTHWEST RETURN WALL
(LOOKING NORTH EAST)**

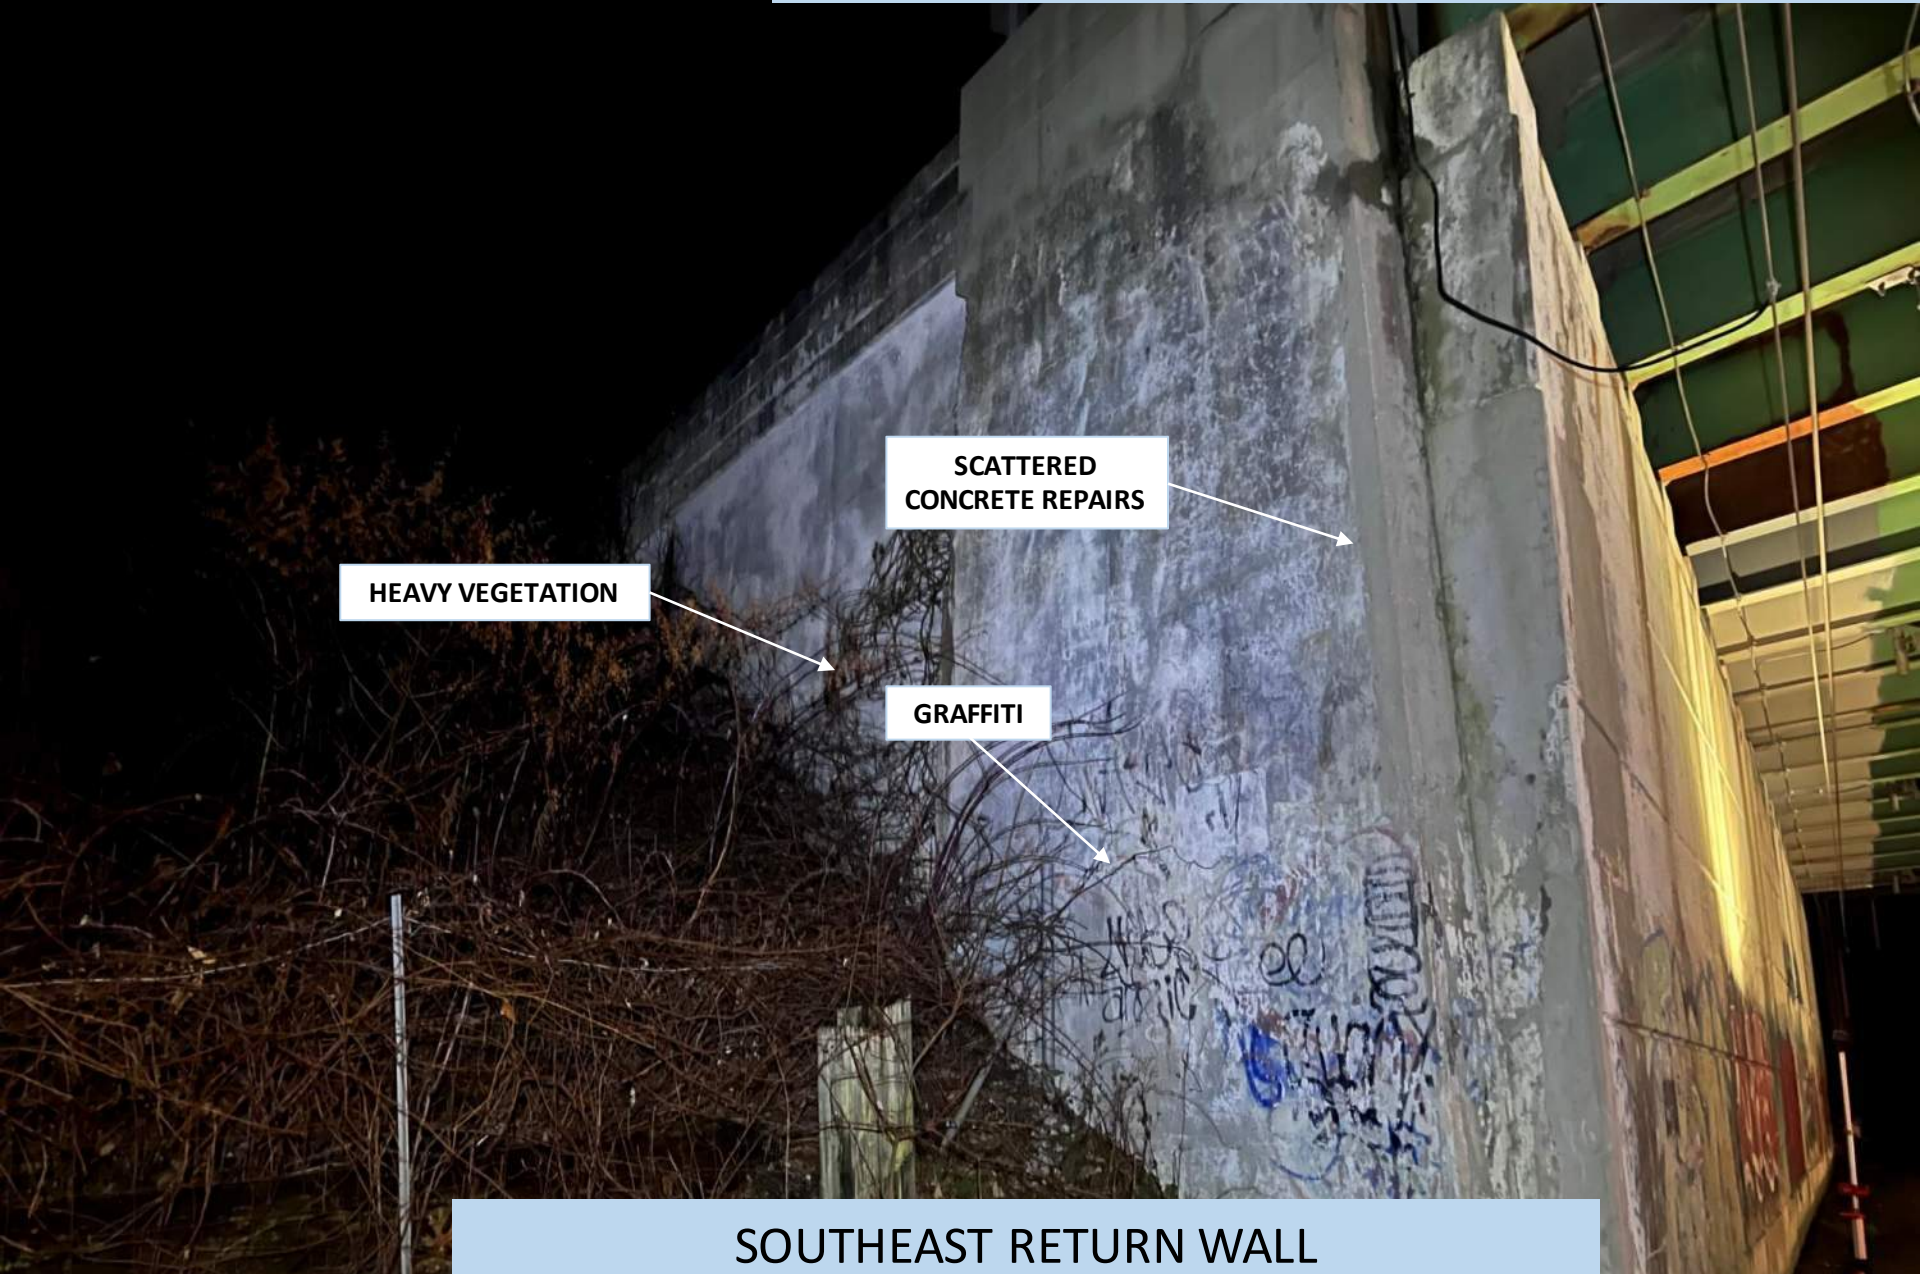
HEAVY VEGETATION

**SCATTERED
CONCRETE REPAIRS**

GRAFFITI

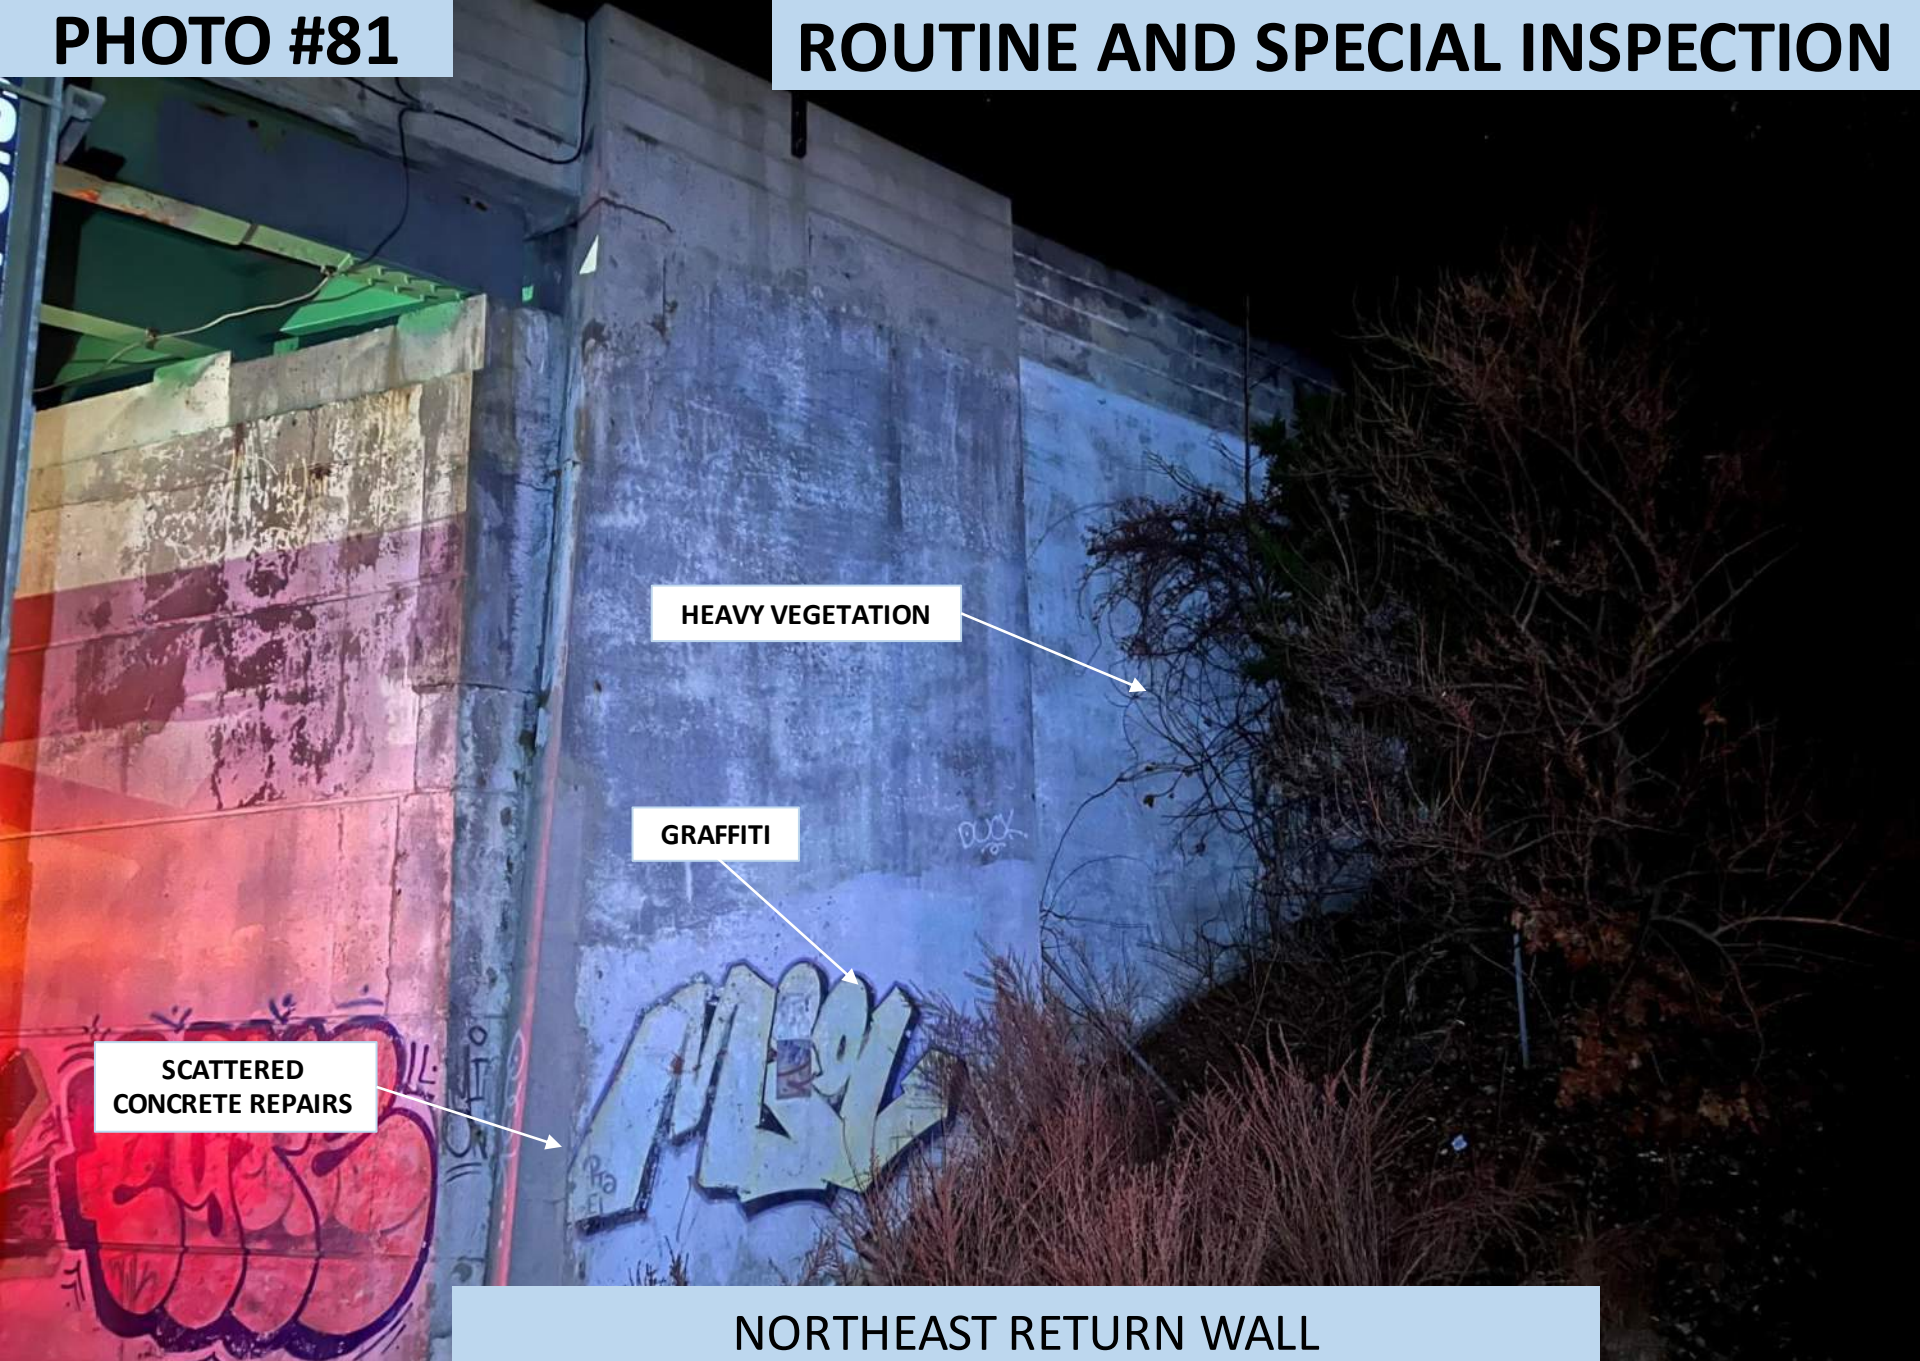
HEAVY VEGETATION

GRAFFITI

**SCATTERED
CONCRETE REPAIRS**

**NORTHEAST RETURN WALL
(LOOKING NORTH WEST)**
