STRUCTURES INSPECTION FIELD REPORT

2-DIST 05 B.I.N. 45E

ROUTINE INSPECTION

CITY/TOWN MARION=WAREHAM		8.-STRUCTURE NO. M05001-45E-DOT-NBI	11-Kilo. POINT 066.300	41-STATUS A:OPEN	90-ROUTINE INSP. DATE OCT 12, 2016
07-FACILITY CARRIED US 6 WAREHAM ST		MEMORIAL NAME/LOCAL NAME	27-YR BUILT 1929	106-YR REBUILT 1957	YR REHAB'D (NON 106) 0000
06-FEATURES INTERSECTED WATER WEWEANTIC RIVER		26-FUNCTIONAL CLASS Urban Minor Arterial	DIST. BRIDGE INSPECTION ENGINEER G. Simpson		
43-STRUCTURE TYPE 204 : Concrete continuous Tee Beam		22-OWNER State Highway Agency	21-MAINTAINER State Highway Agency	TEAM LEADER Gonsalves	
107-DECK TYPE 1 : Concrete Cast-in-Place		WEATHER CLEAR	TEMP. (air) 15°C	TEAM MEMBERS J. MARMELO, M. MARSHALL

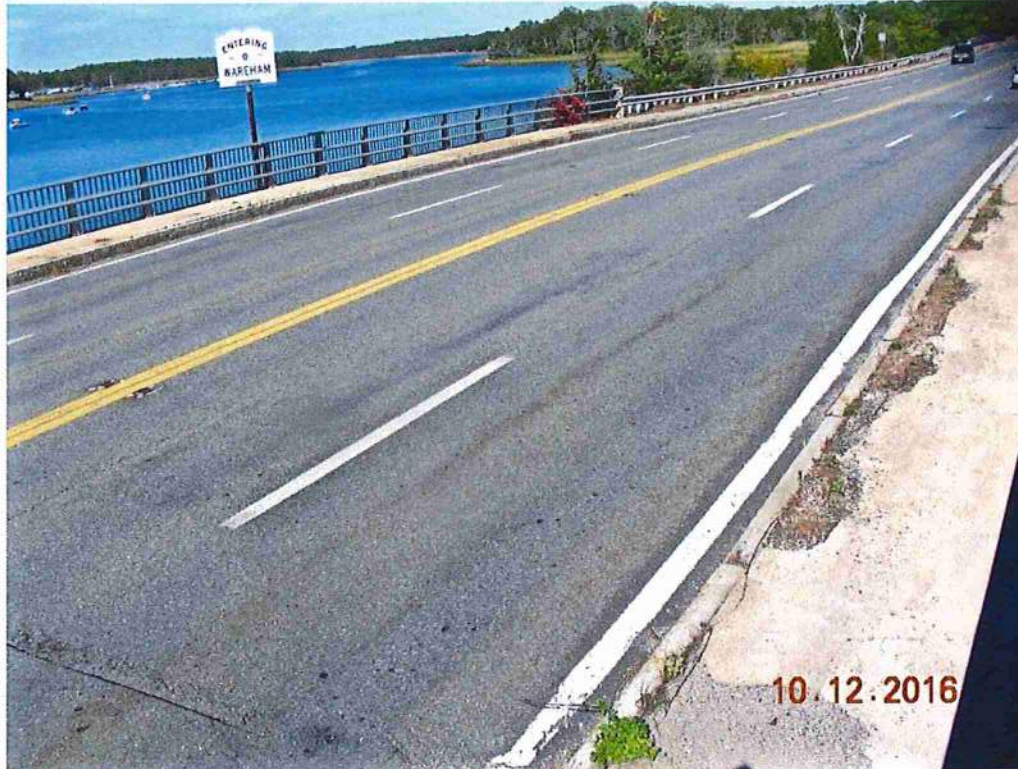
See photo 1 for general topside. Wearing surface has random unsealed cracking throughout, delamination along both gutterlines  $\leq 1'$ W, rutting in all wheel paths, and transverse/alligator cracking along both sawcuts. Westbound right lane adjacent to west abutment has a settled patch, 3' diameter x 3/4"D, see photo 2. Each right lane adjacent to east abutment has a settled patch,  $\leq 2.5'$  diameter x 1/2"D, see photo 3.

Photo 1: General wearing surface looking northeast

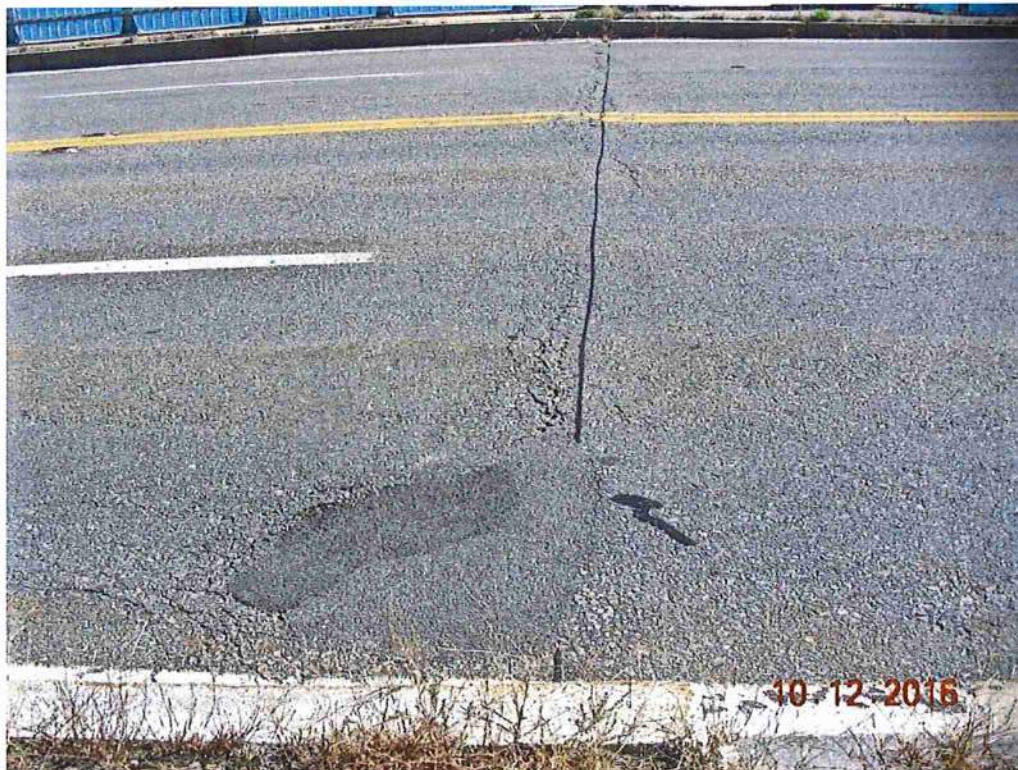
The approaches have longitudinal, transverse, and random cracking scattered throughout. There is some alligator cracking adjacent to both abutment sawcut joints, see photos 2 & 3.

Photo 2: Over west abutment looking south, rutting in travel lanes & settled patch in WB right lane

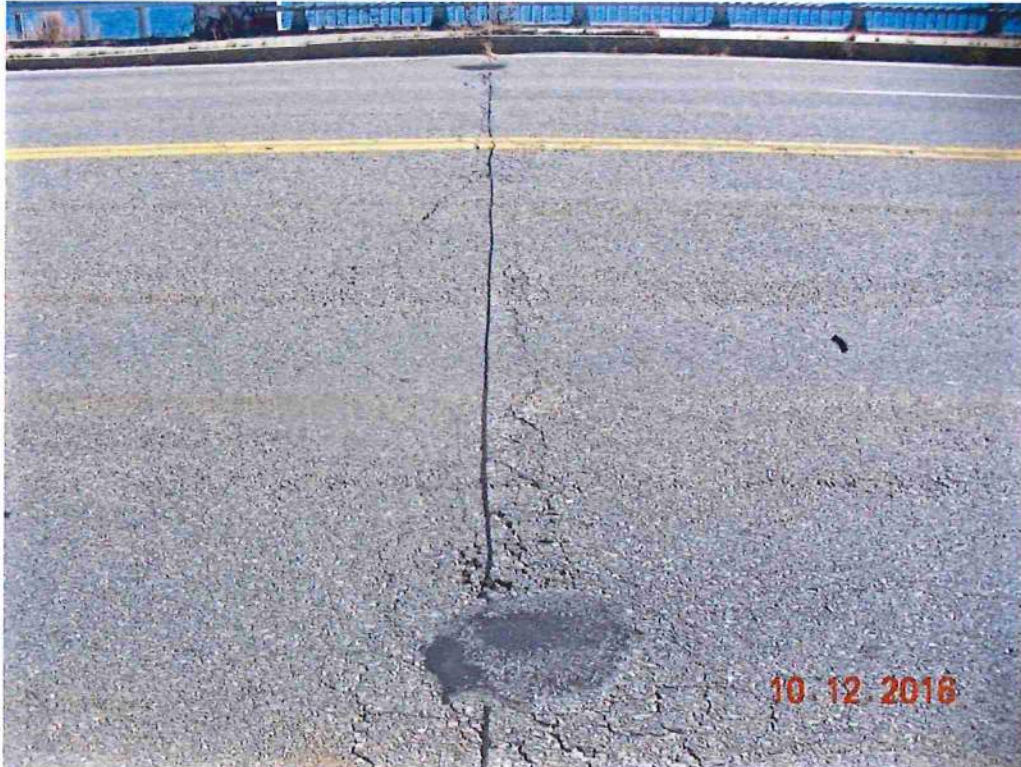
**Photo 3:** Over east abutment looking south, minor rutting in travel lanes & 2 settled patches in each right lane

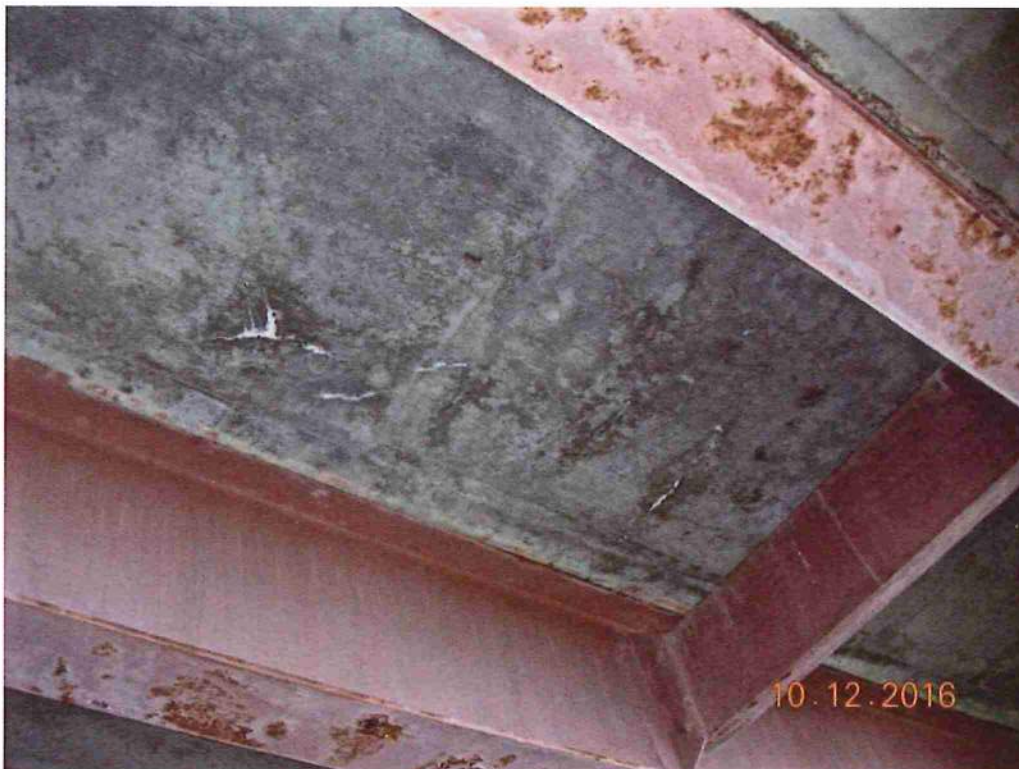
Original Tee beam section of bridge exhibits scattered hairline to narrow longitudinal cracking with moderate to heavy efflorescence & staining, heaviest in bays 1 & 2. The deck soffit below the north sidewalk has transverse and longitudinal cracking with efflo throughout, with worst condition at the east abutment, 3' diameter spall with exposed rebar & void, see photo 9. Tee bay 2 has heavy cracking with efflo and dampness, particularly at the concrete beam interface, see photo 6. 1957 widening of the bridge has areas of cracking with surface scale, chloride and rust staining throughout, see photos 4 & 5.

**Photo 4:** Span 1 Steel Bay 2 looking east, typical minor cracking w/ efflo

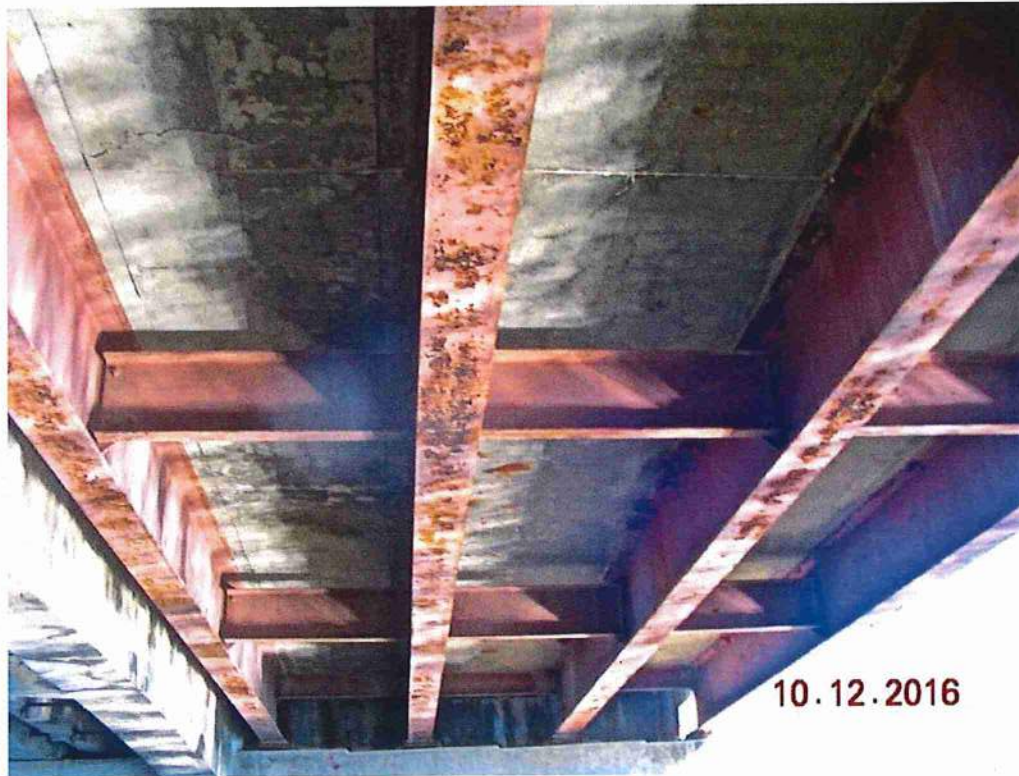
The steel beams in the 1957 bridge widening have scattered areas of failed paint with minor corrosion & scattered pack rust along exterior face of top flange at Beam 4, see photos 5 & 20.

S/A - The 24 year old paint system is chalky with scattered peeling and flaking throughout, especially the exterior face of steel beam 4, see photos 5 & 22.

**Photo 5:** Span 2 Steel beam bays looking east, minor delams/cracking & corrosion to bottom flanges

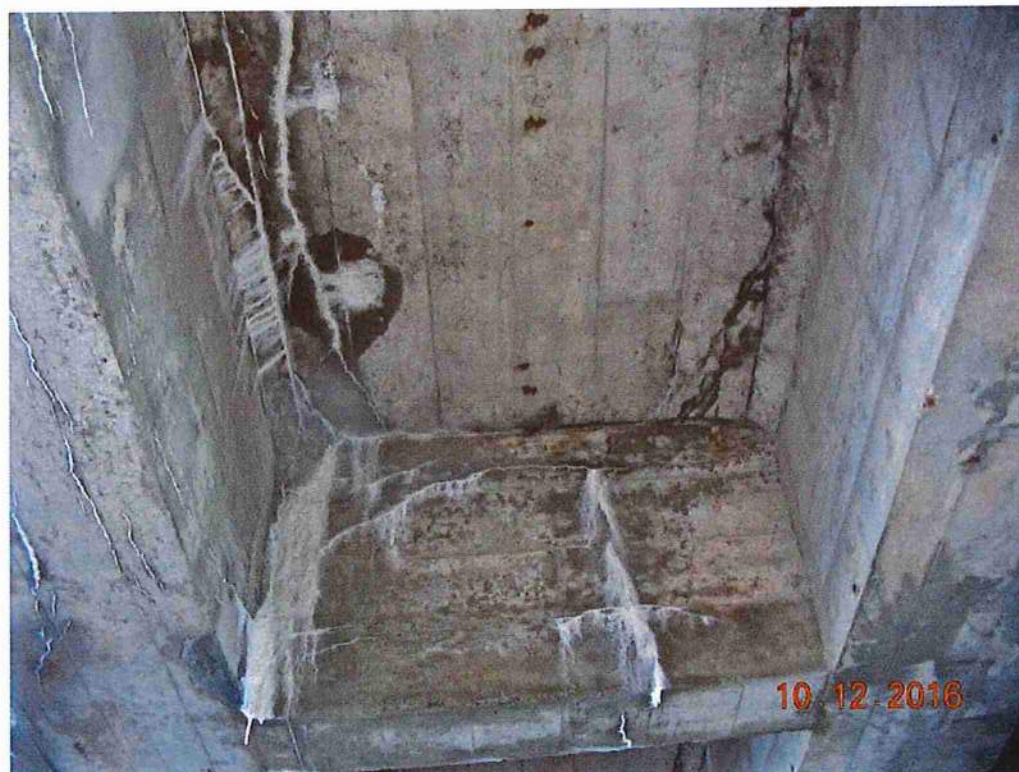
The concrete diaphragms have repairs throughout, and cracks with heavy efflo in tee bays 1 and 2, see photo 6.

**Photo 6:** Span 2 Tee Bay 2 looking east, typical cracking w/ efflo

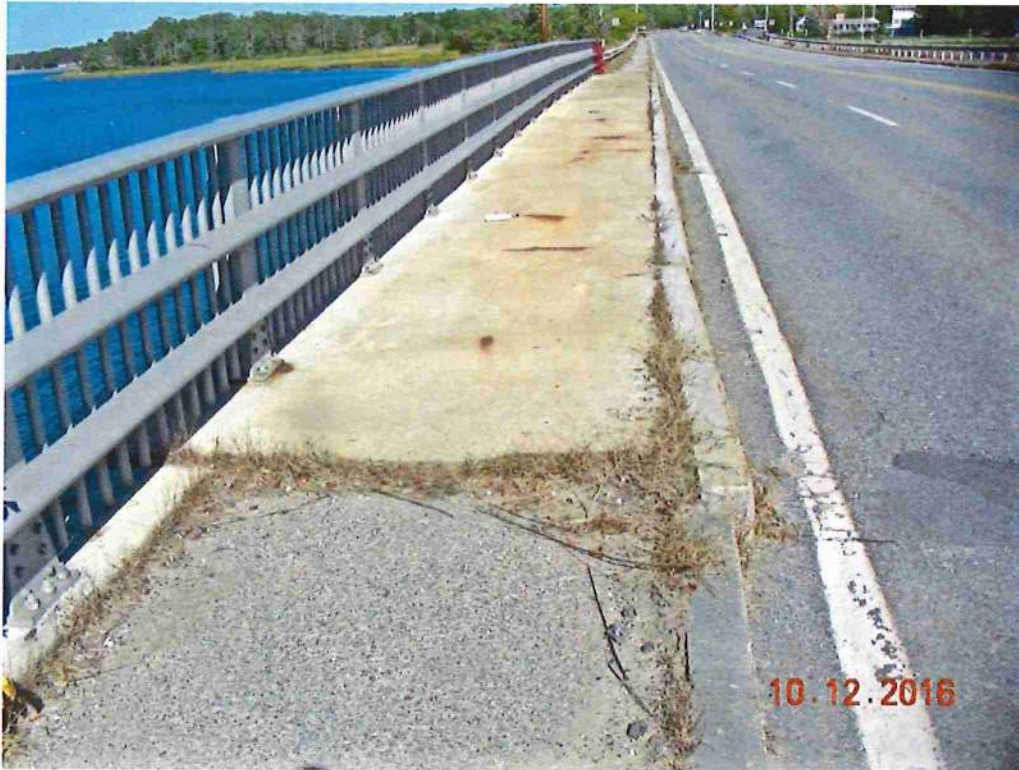
The northwest end of the curb is rotated towards the roadway  $\leq 3'$  with a debris impacted gap with the sidewalk, see photo 7.

The approach sidewalks are settled up to 3 inches with weed growth, see photo 7.

**Photo 7:** North sidewalk looking east, curb displaced towards roadway & approach sidewalk/curb settlement

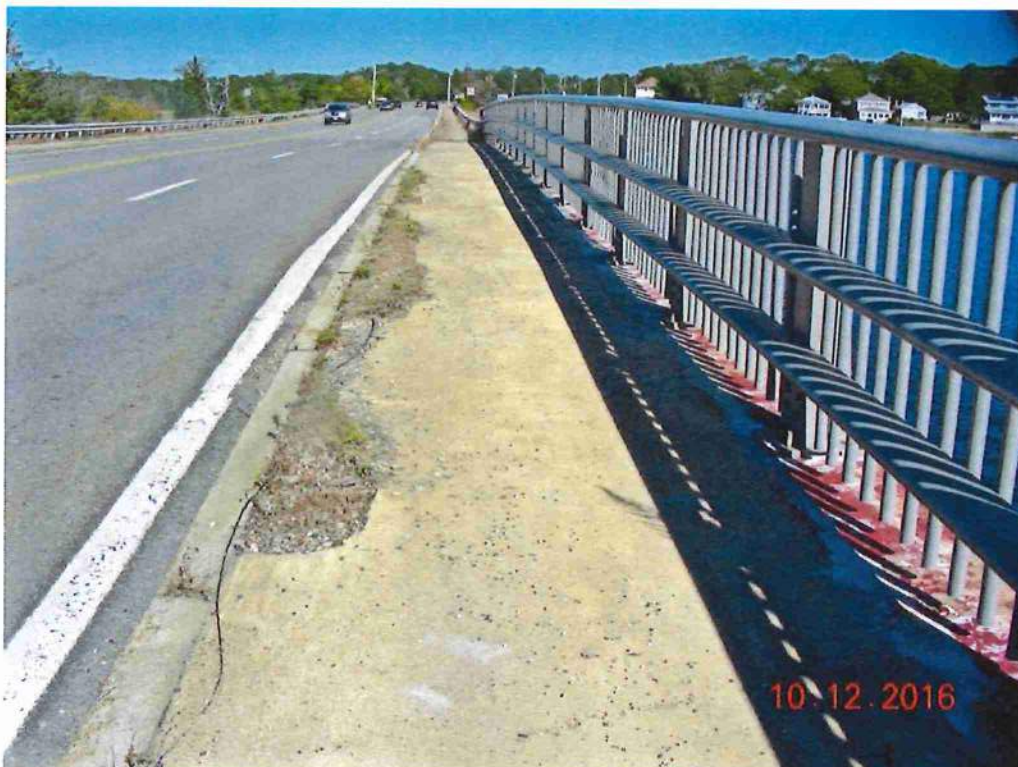
The south sidewalk has a large debris impacted spall/scale section along curb  $\leq 40'$ L x 1.5'W x  $\leq 6'$ "D, see photo 8. The south fascia of south sidewalk has a minor spall over the pier. The north sidewalk in span 2 has some transverse cracks with scattered spot rust. Also see items 58.2 and 58.4.

**Photo 8:** South sidewalk looking east, debris impacted scaling/spalling along curb

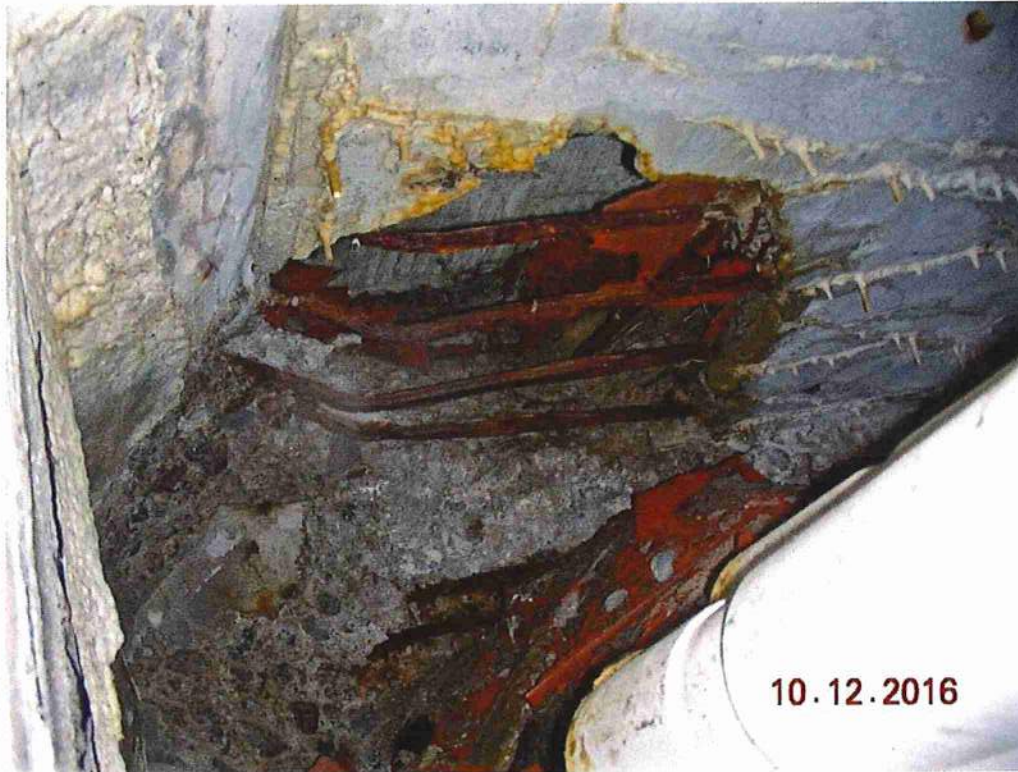
There are several abandoned PVC conduit pipes that are disconnected at the end of bay 1, see photo 9. The original utility diaphragms in span 1 tee bay 1 have severe corrosion, however there are supplemental galvanized diaphragms, see photo 12. The abandoned steel conduit in Tee bay 5 has areas of 100% section loss at both abutments. The concrete encased utility box in Tee bay 5 that scattered delaminations & spalls.

Photo 9: North sidewalk soffit at east abutment, heavy spalling w/ exposed rebar & void

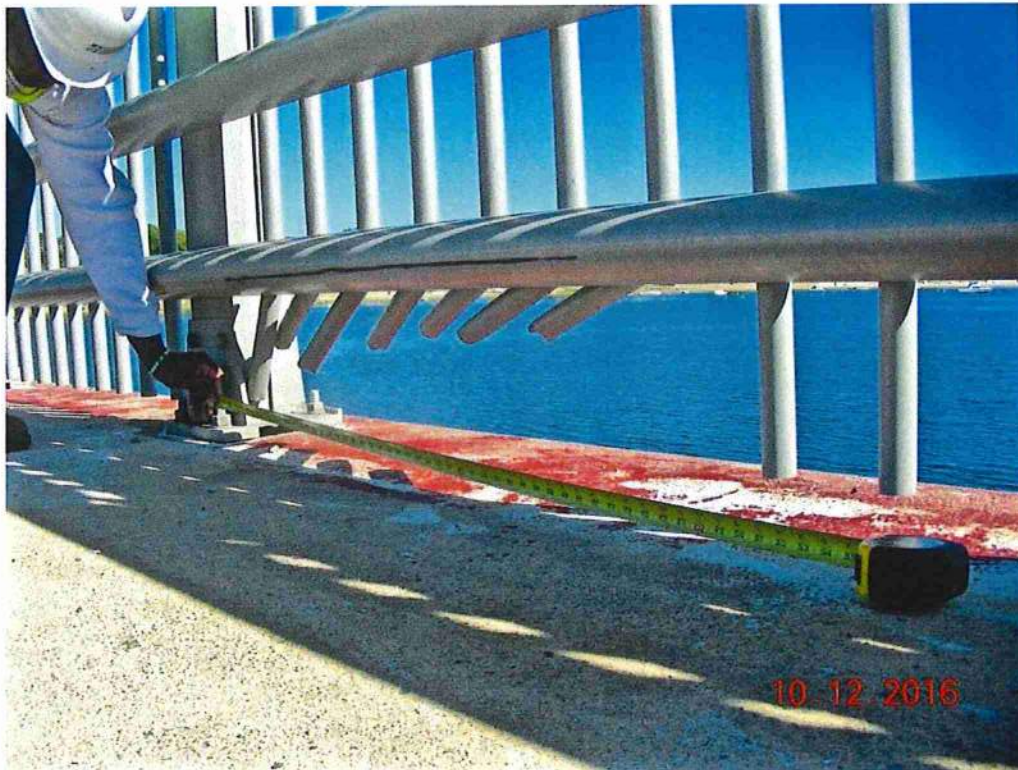
South rail, 6th section from the east 7 bent/broken lower pickets, see photo 10. South rail, 4th post from the west an anchor nut is missing from the base. Town line sign attached to north rail at midspan, loose fasteners & areas of 100% section loss at base, see photo 11.

Photo 10: South rail 6th section from east abutment, bent lower sections of pickets

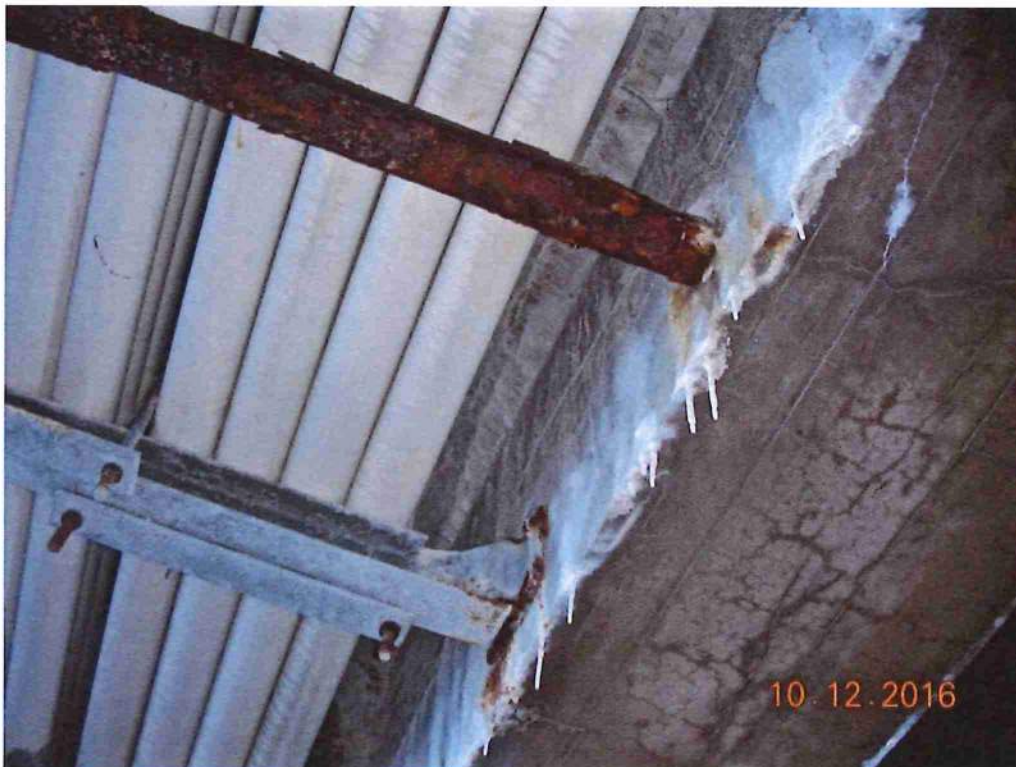
Photo 12: Span 1 Tee Bay 1, corrosion to utility support

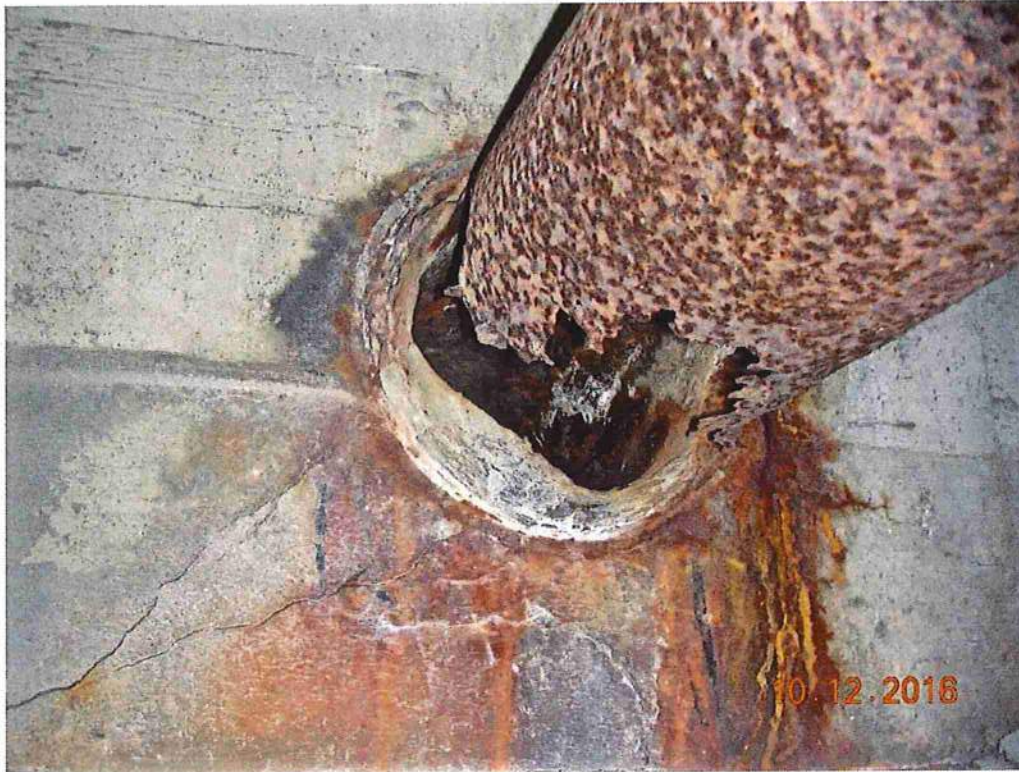
**Photo 13:** Tee Bay 5 at west abutment, area of 100% section loss to unused utility conduit

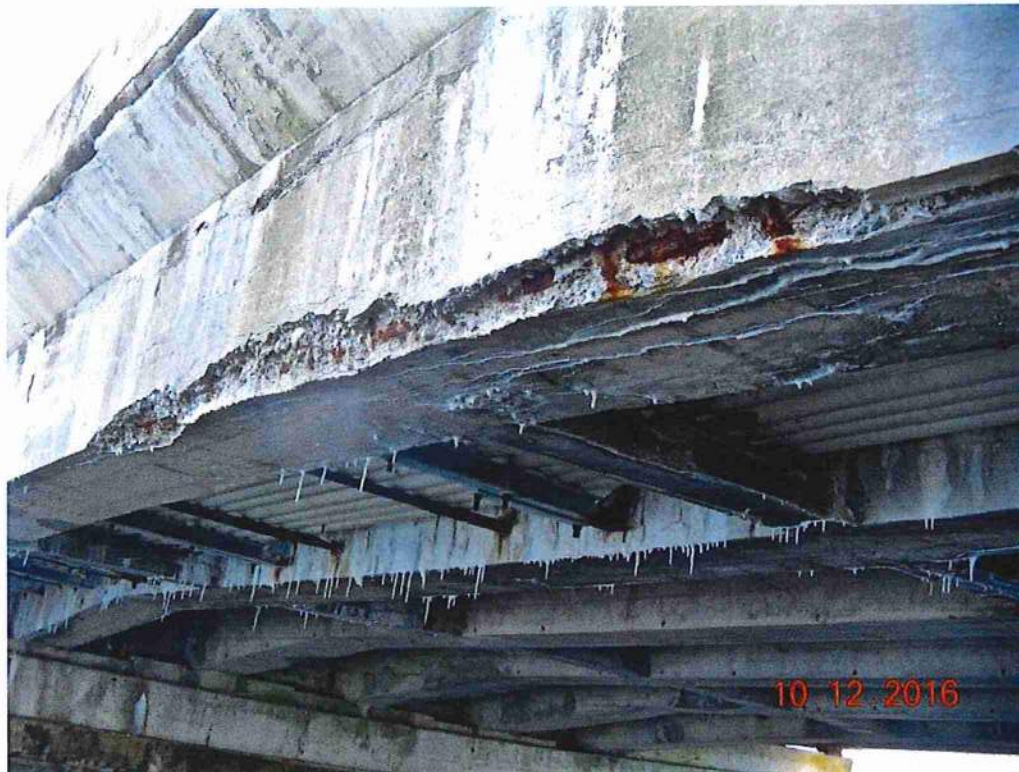
The north face of tee beam 1 in both spans has cracking with efflo throughout, see photo 16. There is a full length repair that is spalling/scaling along about 75% of the length of the repair. Tee Beam 1, span 1 has a 4' long spall by 3" high and wide with exposed rebar, see photo 14. Tee beams 1 and 2 have cracking throughout with heavy dripping efflo with of areas of deteriorating concrete, see photo 15, 17 & 18. Tee beams 5 and 6 have some random cracks, delams and spalls. The south face of tee beam 6 in span 2 has scattered patches that are in satisfactory condition, see photo 19.

**Photo 14:** Span 1 Tee Beam 1 looking east, spalling w/ exposed rebar

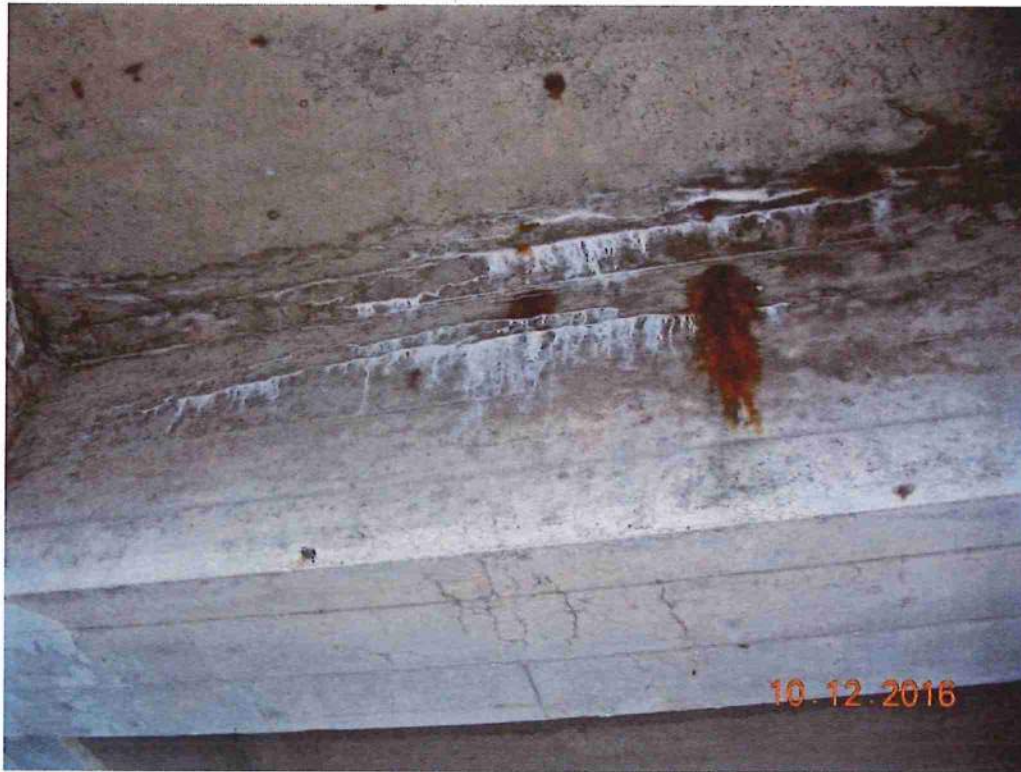
Photo 15: Span 1 Tee Beam 2 north face, horizontal cracking w/ efflo & rust bleed

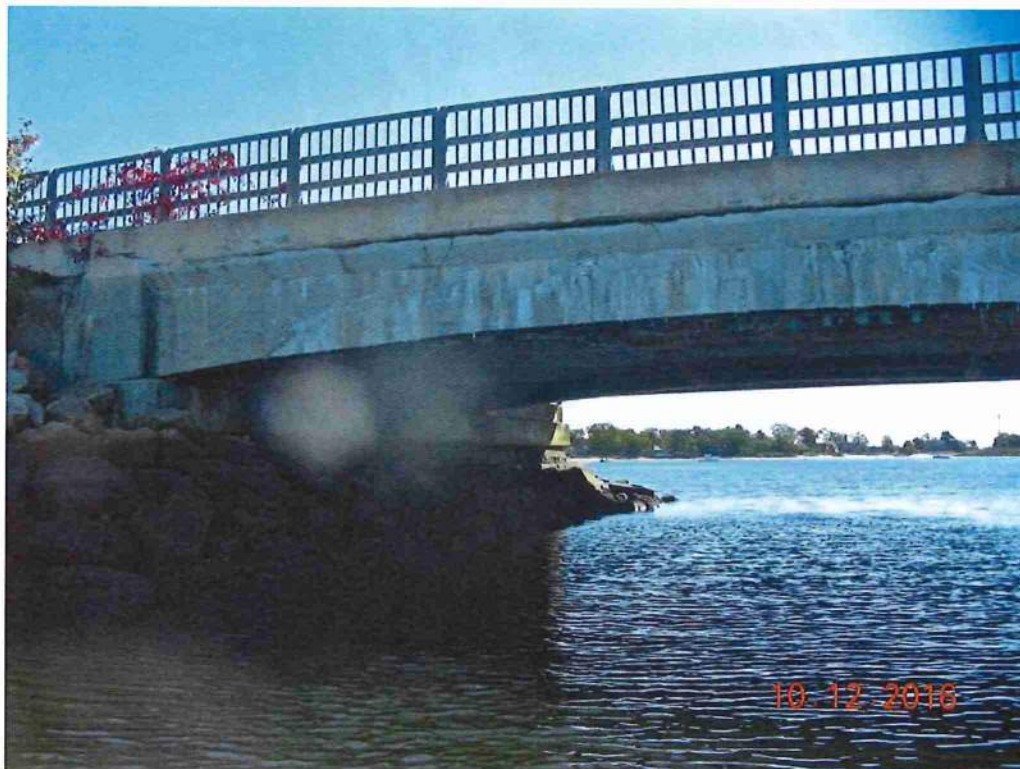
Photo 16: Span 2 Tee Beam 1 north face, horizontal & diagonal cracking w/ efflo

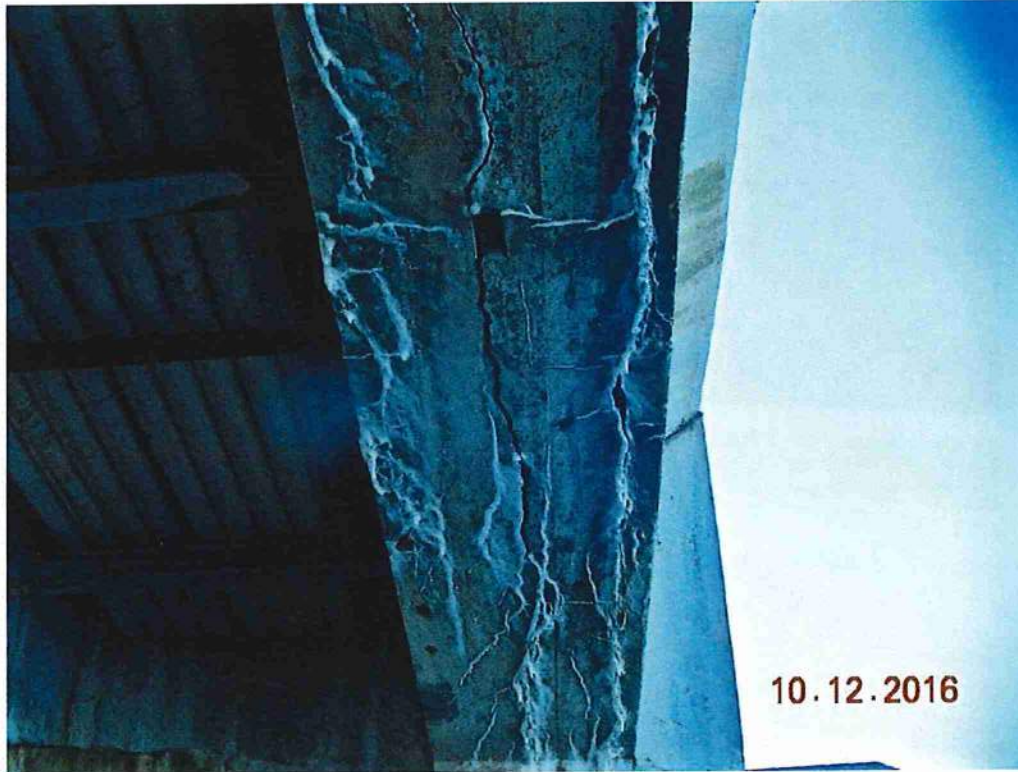
Photo 17: Span 2 Tee Beam 1 looking west, longitudinal cracking w/ efflo

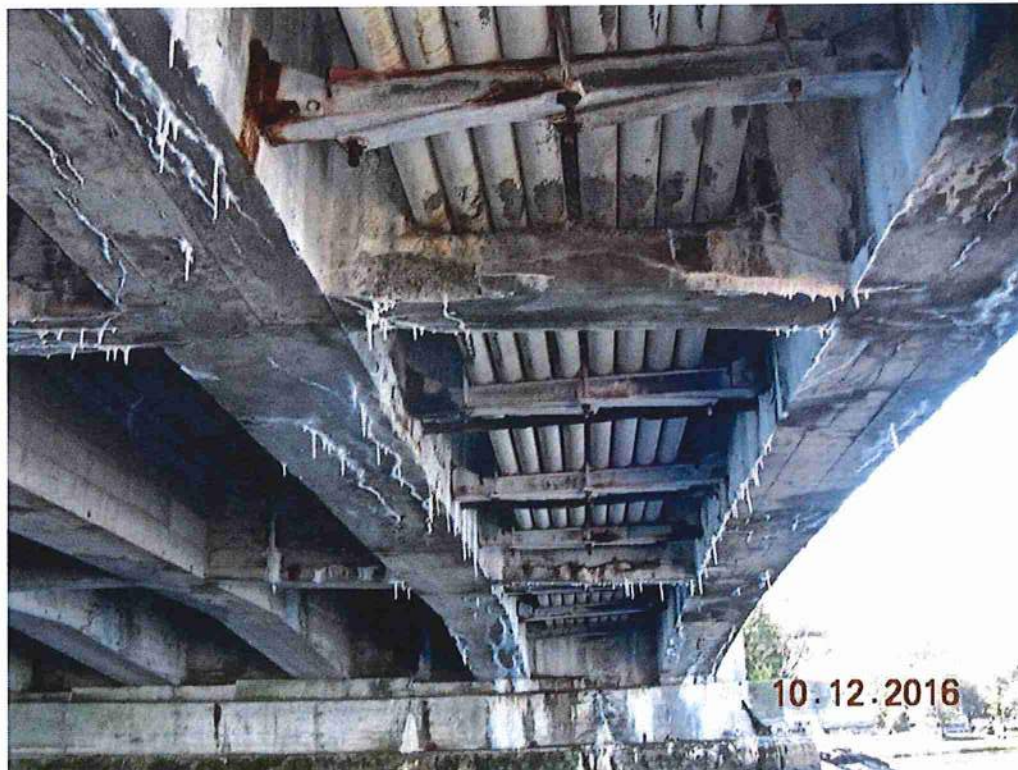
Photo 18: Span 2 Tee Beams 1 & 2 looking west, longitudinal cracking w/ efflo

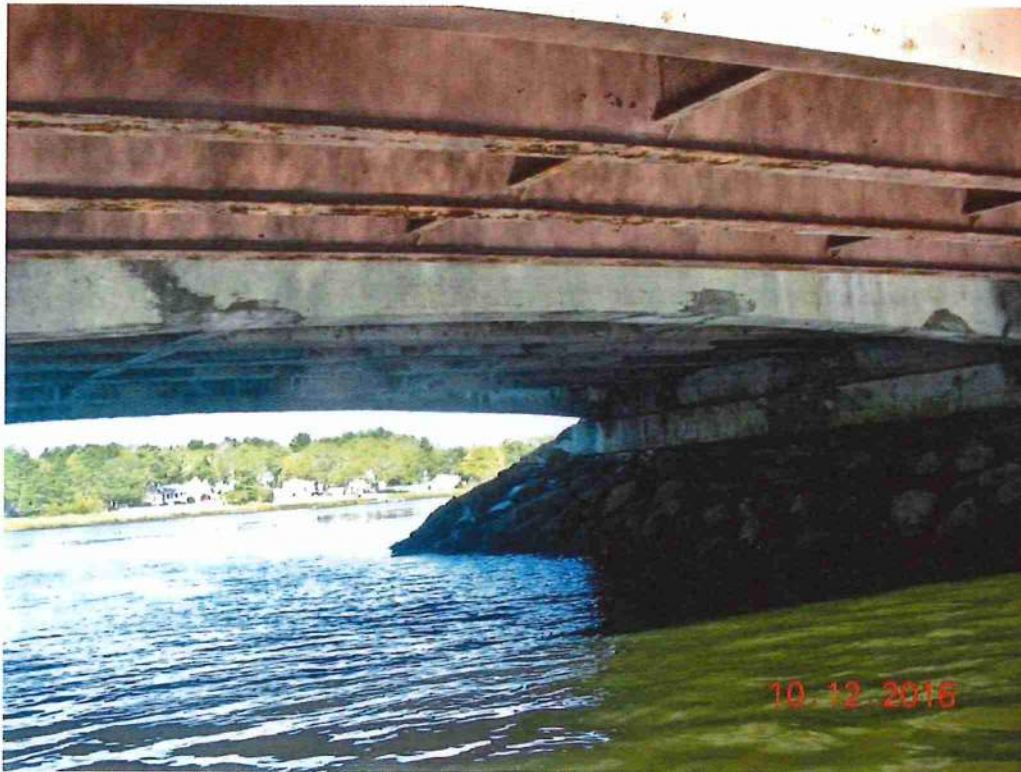
Photo 19: Span 2 Tee Beam 6 south face, patches

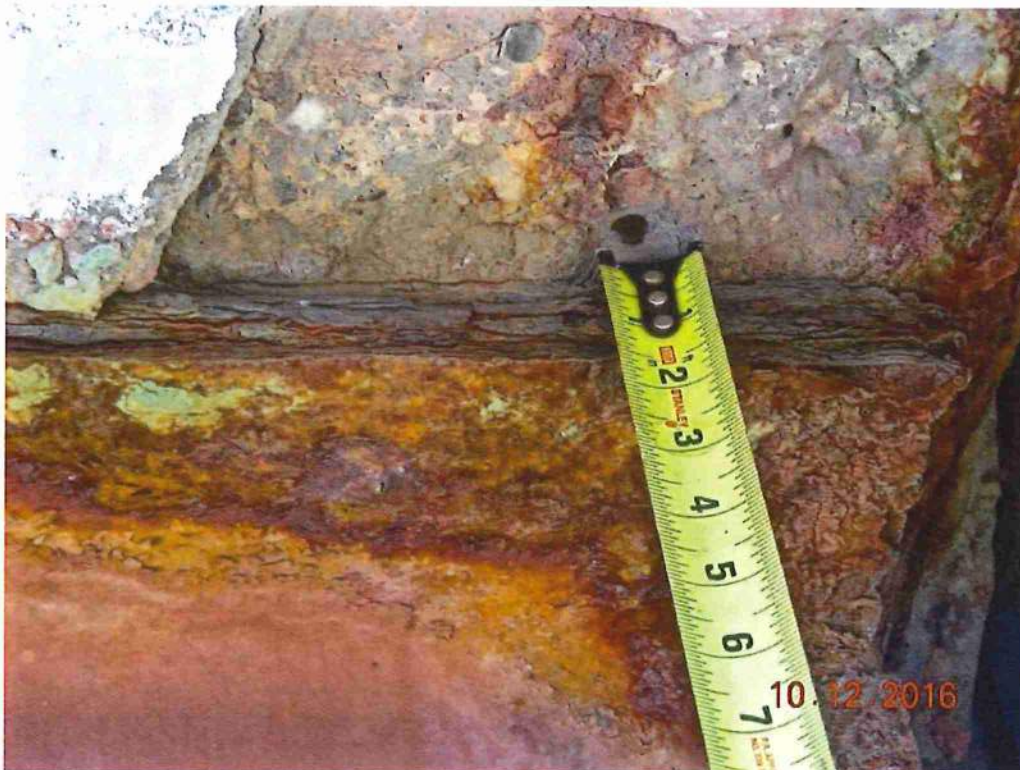
Photo 20: Span 2 Steel Beam 4 at east abutment, south top flange pack rust

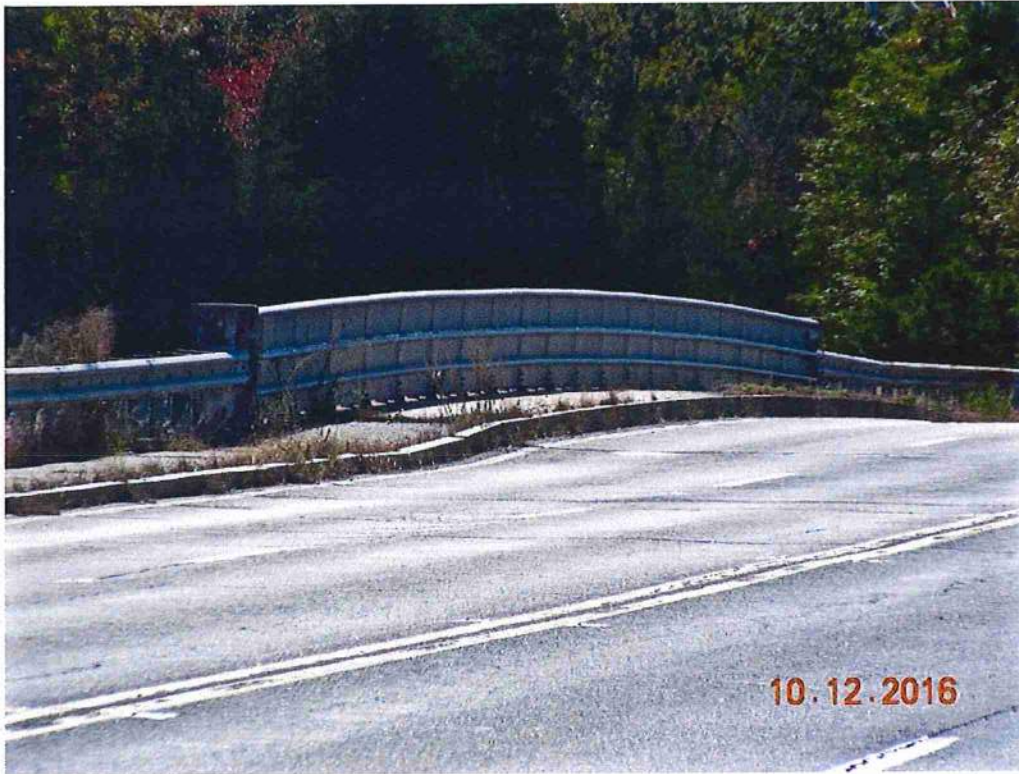
Visible positive camber in both rails, see photo 21.

Photo 21: South rail looking west, positive camber

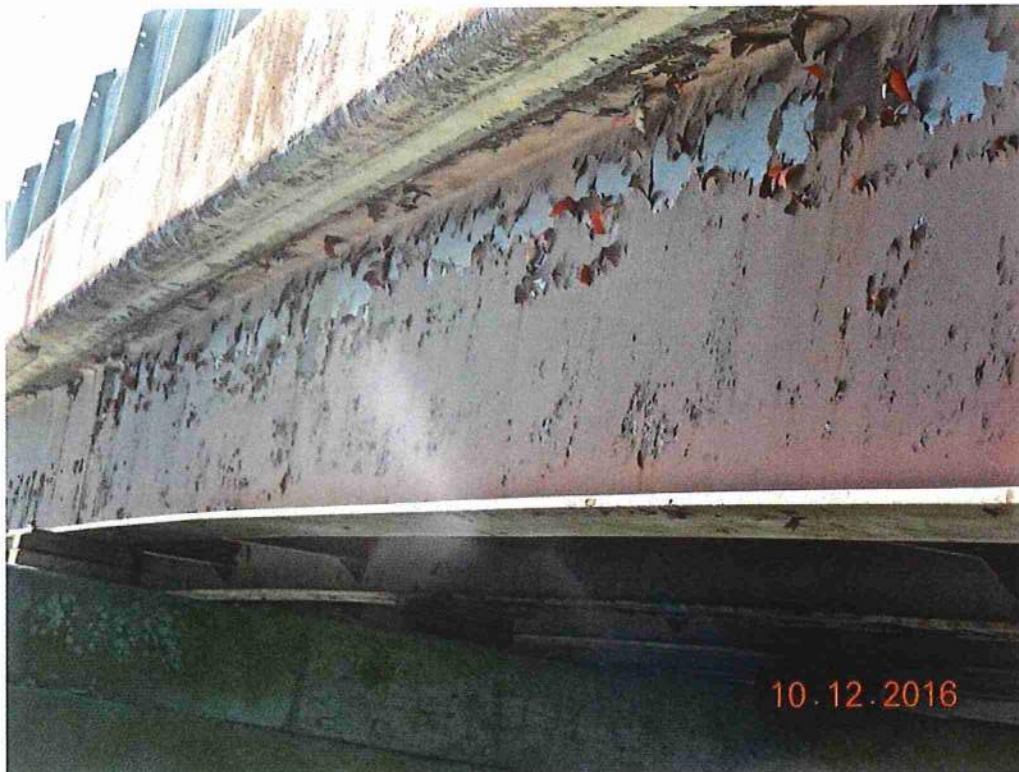
Photo 22: Span 2 Steel beam 4 looking west, paint failure

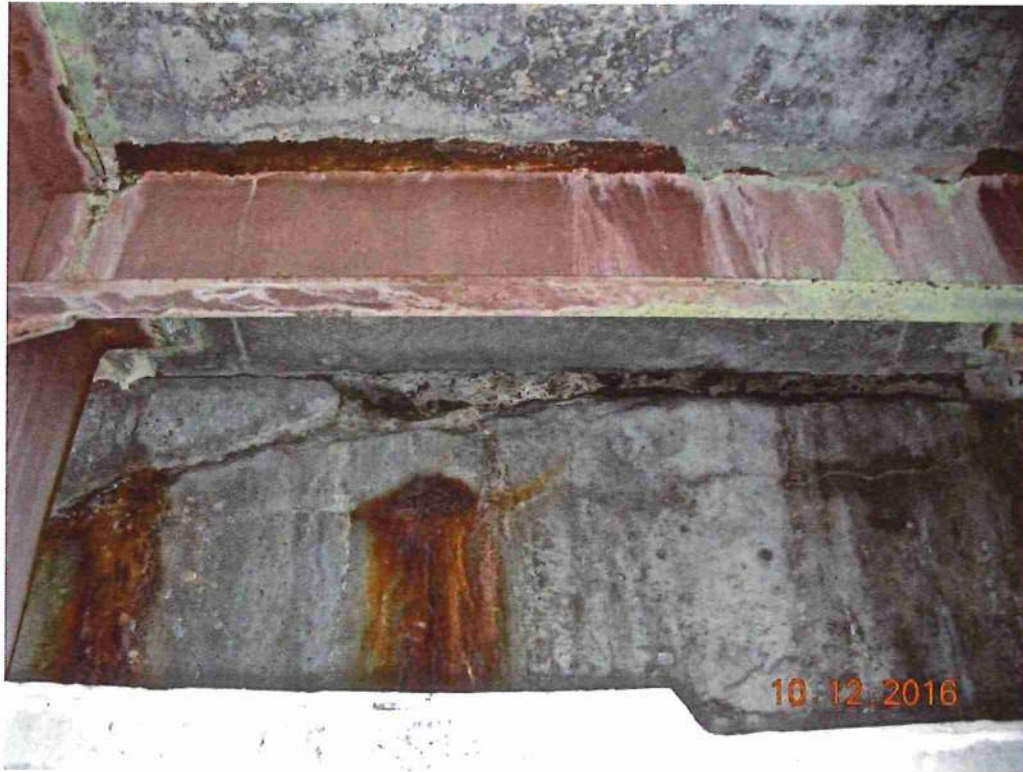
Scattered cracks with efflo. and/or rust stains. There is spall/scale area at steel bay 1 at east abutment, see photo 23.

Photo 23: Steel Bay 1 at east abutment, backwall spalling/cracking w/ rust bleed

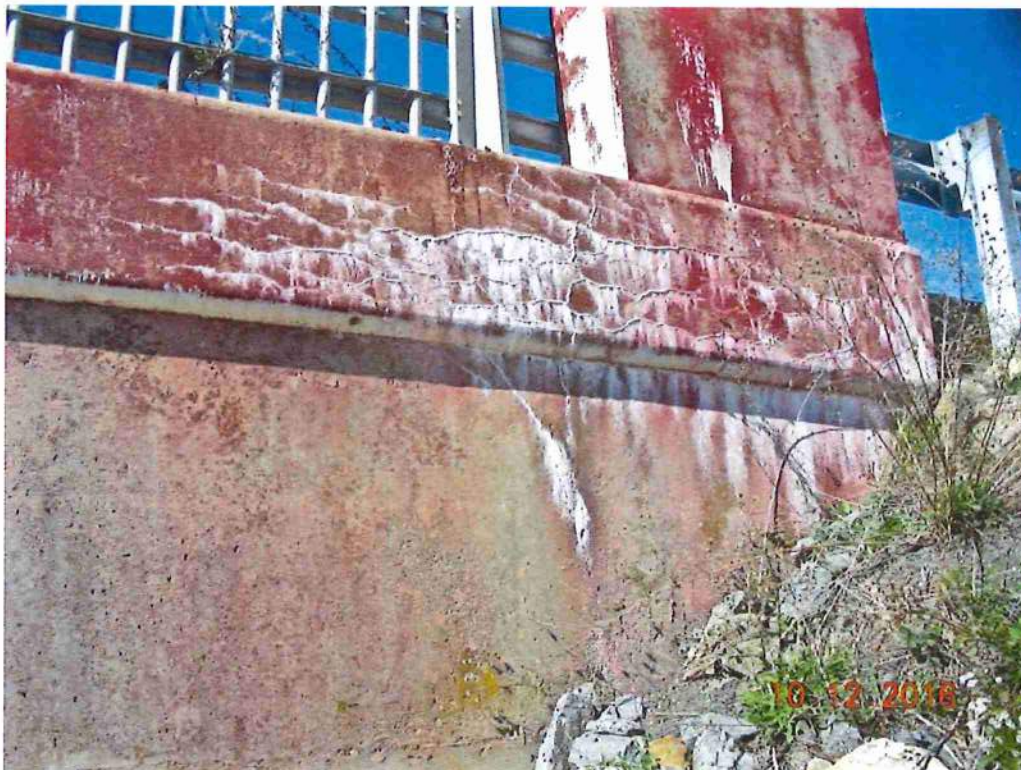
Minor cracks with efflo. and a patch at the northwest. Heavy horizontal cracking with efflo at southeast, see photo 24.

Photo 24: Southeast wingwall, horizontal cracking w/ efflo

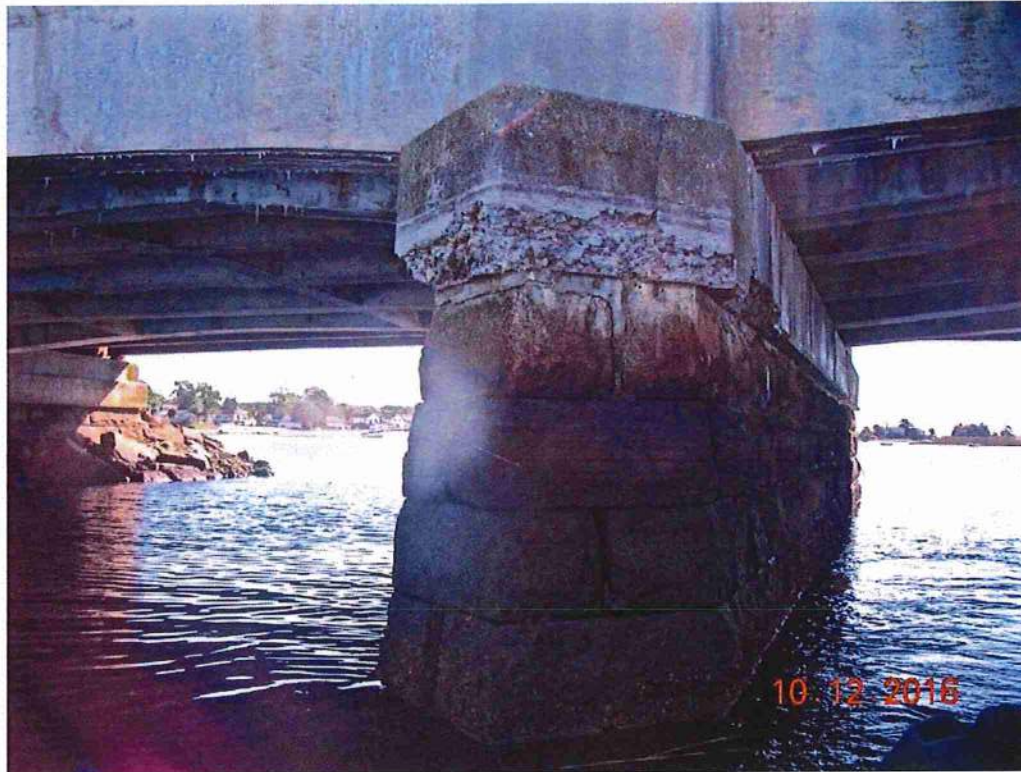
Scattered full height vertical cracks  $\leq 1/8"$ W, minor cover spalls with rust bleed to exposed soffit, and a large spall/scale area  $\leq 3.5"$ D at the north nosing from bay 1 west face to bay 1 east face, see photos 25-28, & 31.

S/A - Majority of the pointing is missing below the top course of granite and daylight can be seen in some joints, see photos 25-27, & 29-31. See the most recent Routine Underwater Inspection Report dated 10/7/2015 for S/A Deficiency.

**Photo 25:** North nose of pier, cap spalling

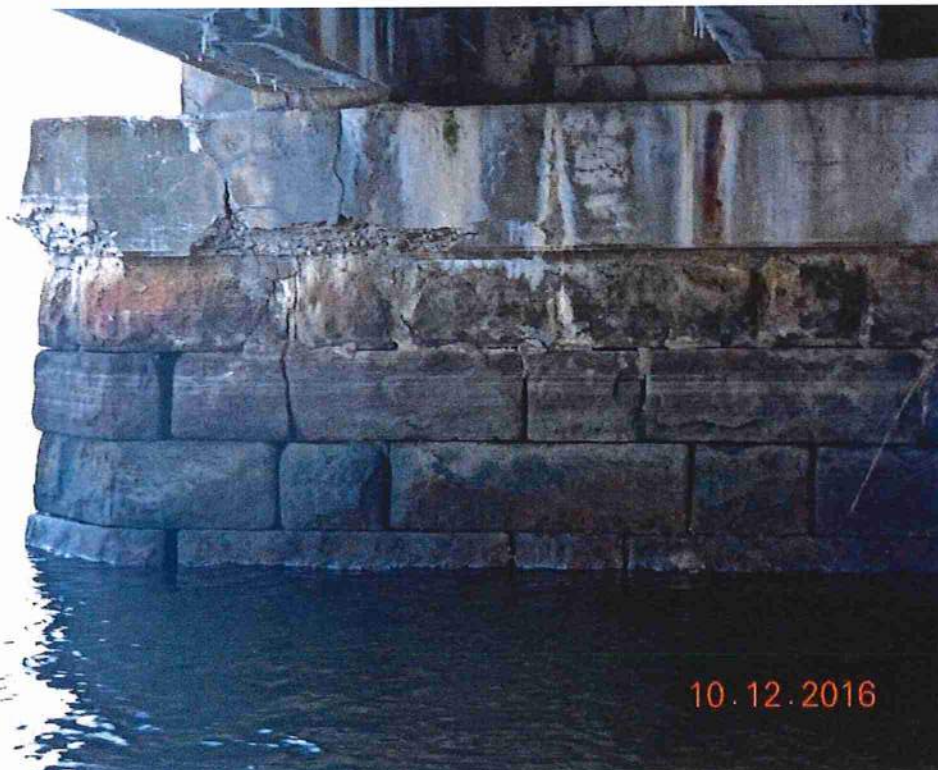
There are scattered full height vertical cracks to granite stones, see photos 26 & 29. Also see item 60.2.e.

**Photo 26:** Northwest end of pier, cap spalling & cracked stones in wall

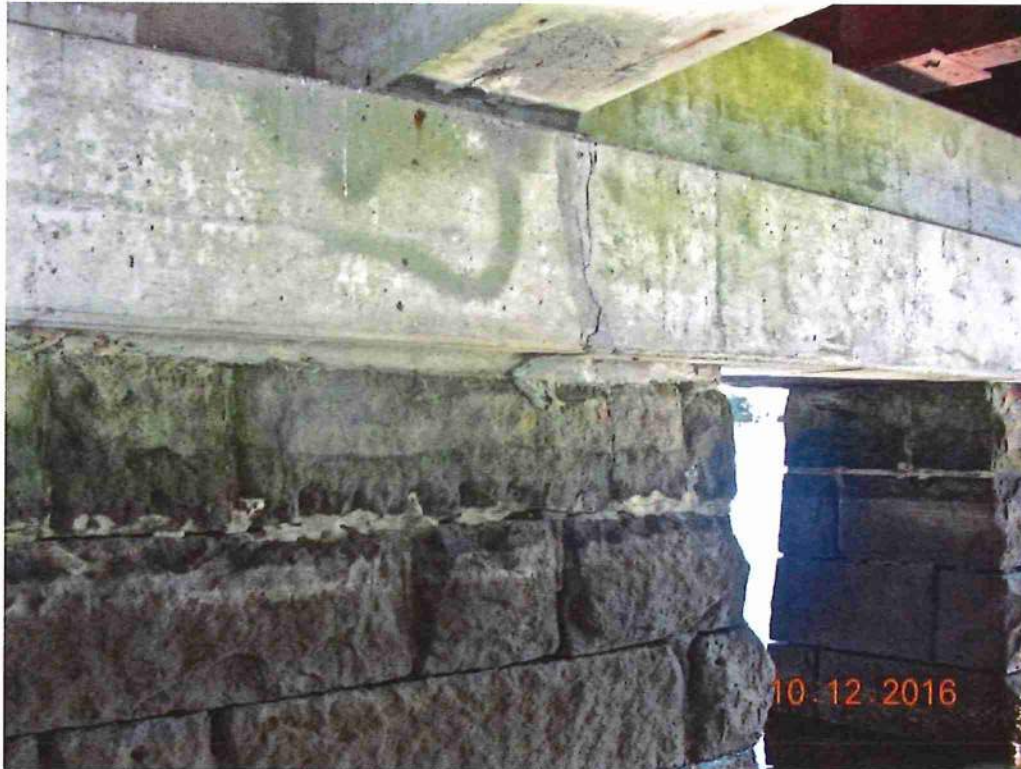
Photo 27: Pier cap west face below Tee Beam 6, vertical crack

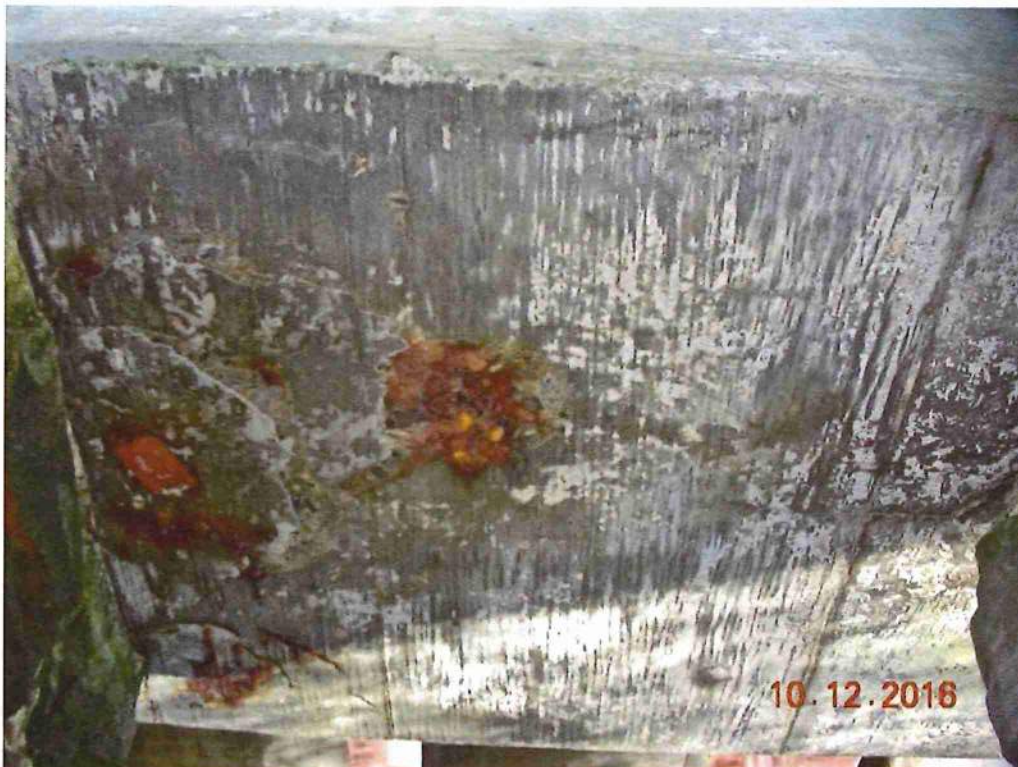
Photo 28: Pier cap soffit below Steel Bay 1, cover spalls w/ rust bleed
