STRUCTURES INSPECTION FIELD REPORT

2-DIST 05 B.I.N. 45E

ROUTINE INSPECTION

CITY/TOWN MARION=WAREHAM		8.-STRUCTURE NO. M05001-45E-DOT-NBI	11-Kilo. POINT 066.300	41-STATUS A:OPEN	90-ROUTINE INSP. DATE OCT 12, 2016
07-FACILITY CARRIED US 6 WAREHAM ST		MEMORIAL NAME/LOCAL NAME	27-YR BUILT 1929	106-YR REBUILT 1957	YR REHAB'D (NON 106) 0000
06-FEATURES INTERSECTED WATER WEWEANTIC RIVER		26-FUNCTIONAL CLASS Urban Minor Arterial	DIST. BRIDGE INSPECTION ENGINEER G. Simpson		
43-STRUCTURE TYPE 204 : Concrete continuous Tee Beam		22-OWNER State Highway Agency	21-MAINTAINER State Highway Agency	TEAM LEADER Gonsalves	
107-DECK TYPE 1 : Concrete Cast-in-Place		WEATHER CLEAR	TEMP. (air) 15°C	TEAM MEMBERS J. MARMELO, M. MARSHALL

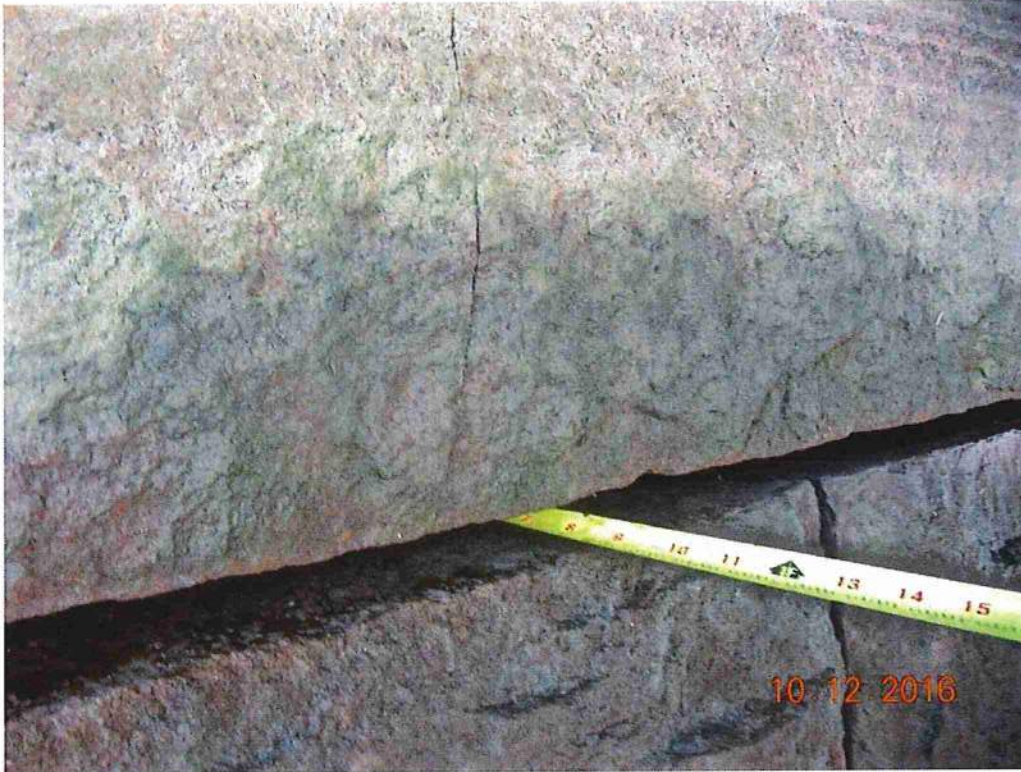
There are scattered full height vertical cracks to granite stones, see photos 26 & 29. Also see item 60.2.e.

S/A - Majority of the pointing is missing below the top course of granite and daylight can be seen in some joints, see photos 25-27, & 29-31. See the most recent Routine Underwater Inspection Report dated 10/7/2015 for S/A Deficiency.

**Photo 29:** Pier wall east face below Steel Bay 3, vertical crack in top course stone & missing mortar

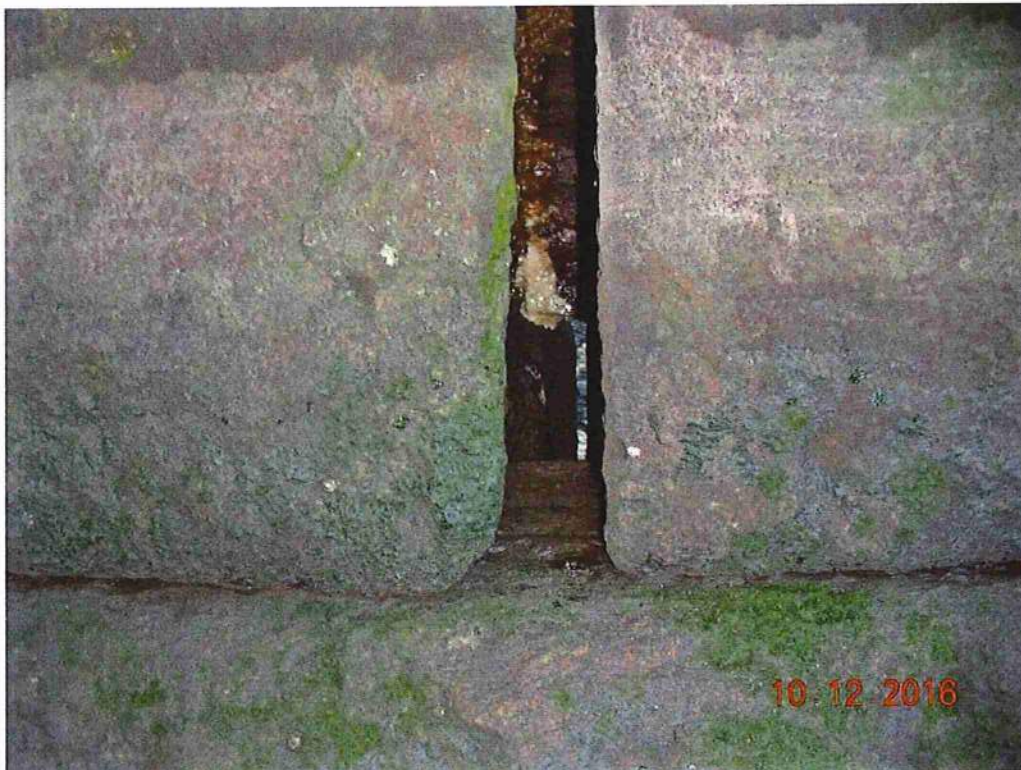
**Photo 30:** Northeast end of pier wall, void clear through second course

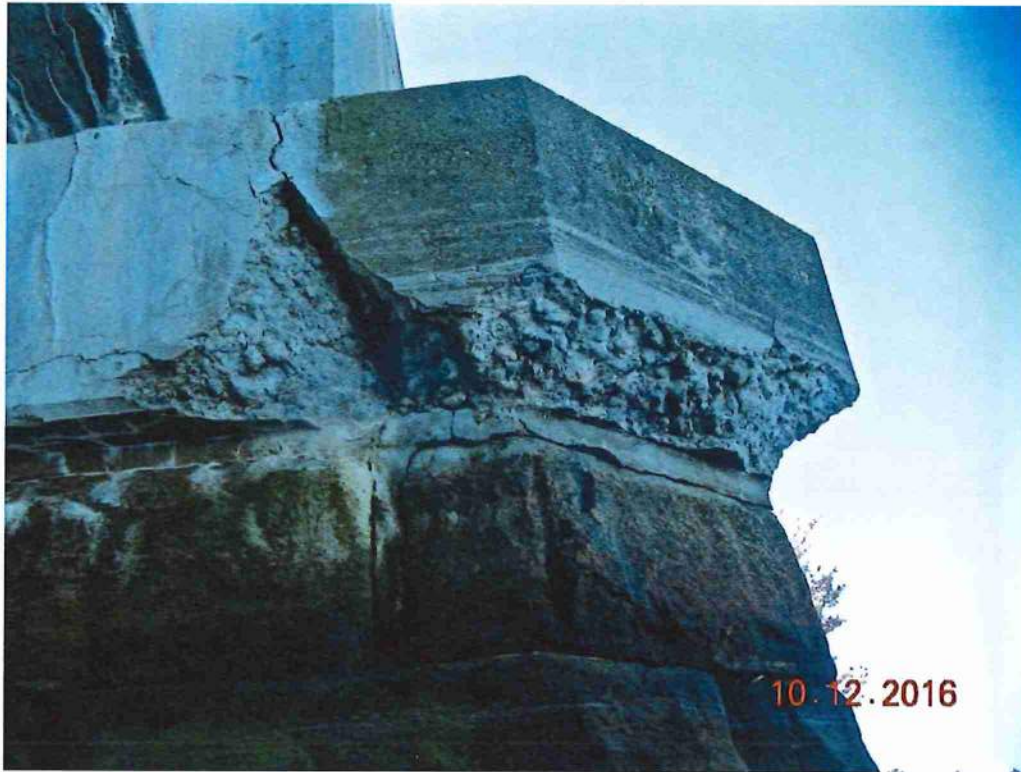
Scattered full height vertical cracks  $\leq 1/8"$ W, minor cover spalls with rust bleed to exposed soffit, and a large spall/scale area  $\leq 3.5"$ D at the north nosing from bay 1 west face to bay 1 east face, see photos 25-28, & 31.

Photo 31: Northeast nose of pier cap, spalling

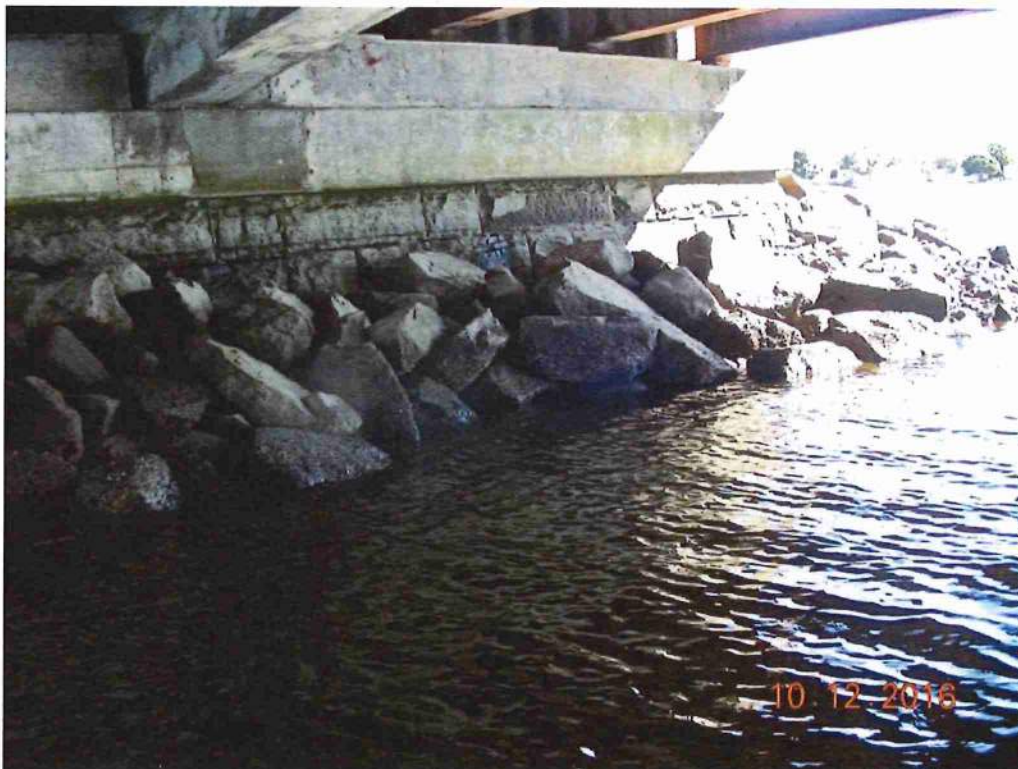
South half of rip-rap along east abutment has slumped & missing stones, see photo 32.

Photo 32: East abutment rip-rap south end, slumped & missing stones
