STRUCTURES INSPECTION FIELD REPORT

ROUTINE INSPECTION

W-06-016

| 07-FACILITY CARRIED US 6 MARION RD | MEMORIAL NAME/LOCAL NAME | 27-YR BUILT 1929 | 106-YR REBUILT 1957 | YR REHAB'D (NON 106) 0000 |

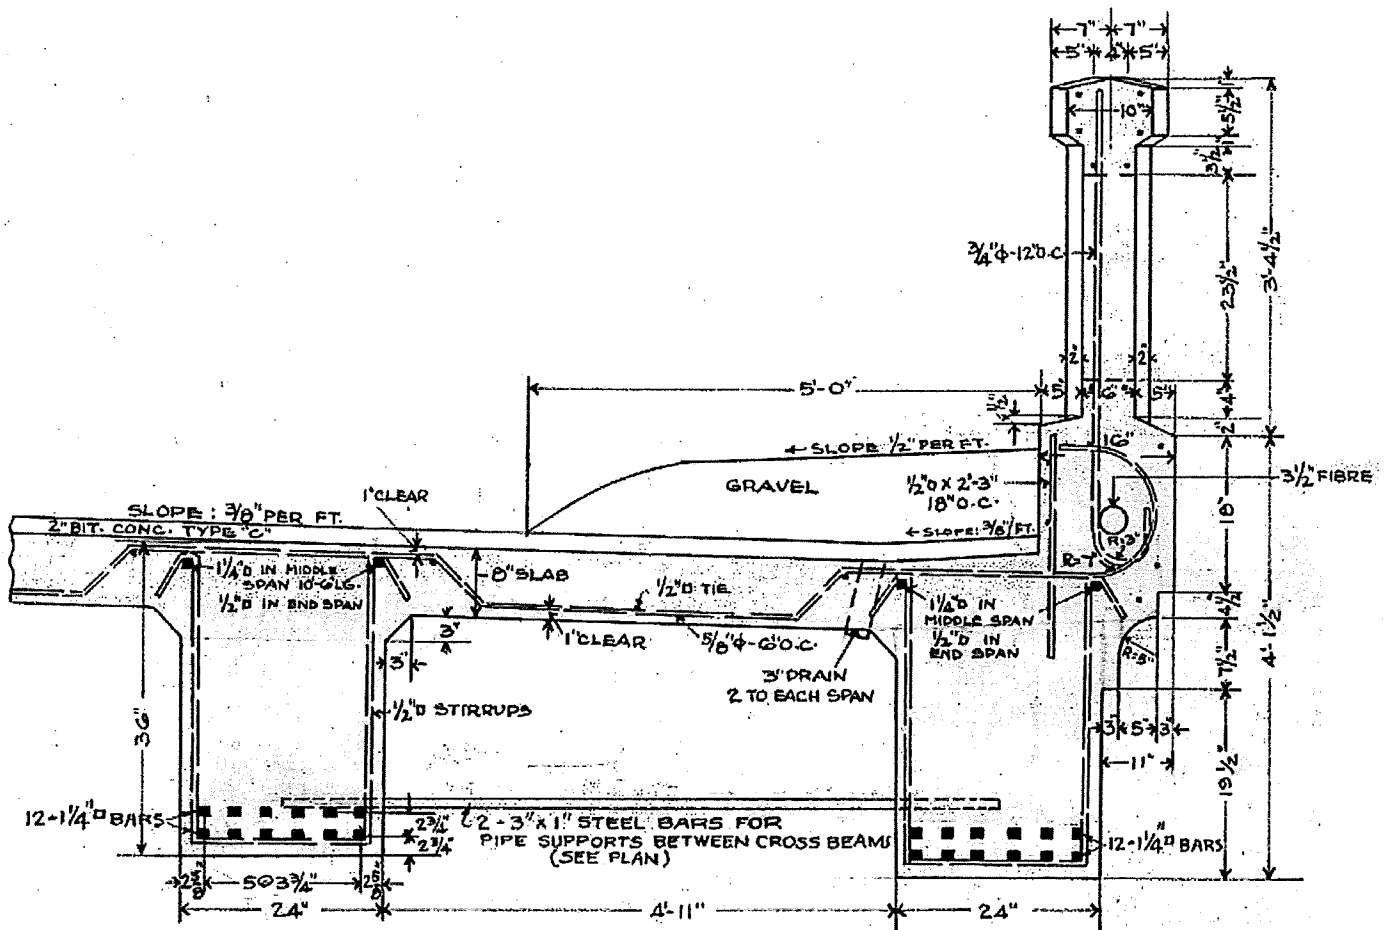
Sketch 5: 1929 Section view at midspan (not to scale). Typical deck and beam reinforcement

S/A - Beam 2 - Span 3 - As noted in item 58.2, full deck spall in span 3, bay 1, extends over and into the top of beam 2 exposing longitudinal rebar and top of stirrups for a length of 7 ft, see sketches 4 and 5 for additional detail. In addition, the north face near pier 2 has a full height spall by 4' L with exposed corroding rebar with associated deteriorated concrete, scale, delams and heavy efflo, see photo 45.

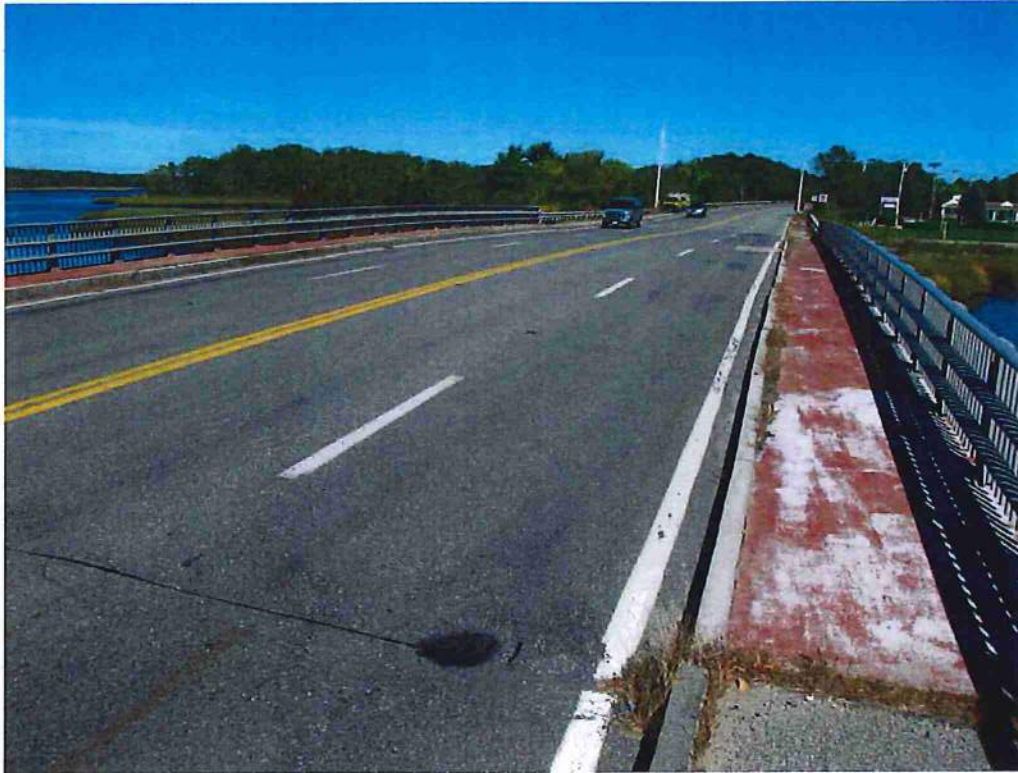
The bit. conc. has scattered longitudinal, transverse, and map cracking, see photo 1 for general topside. In the EB lane of span 3, near the pier 2, there is a full depth deck repair (4' wide by 12' long) with full width hairline transverse cracks with 1.5' spacing, see photo 2 for overview. There is minor rutting and heaving in the EB lane near the curb.

Photo 1: General topside looking east

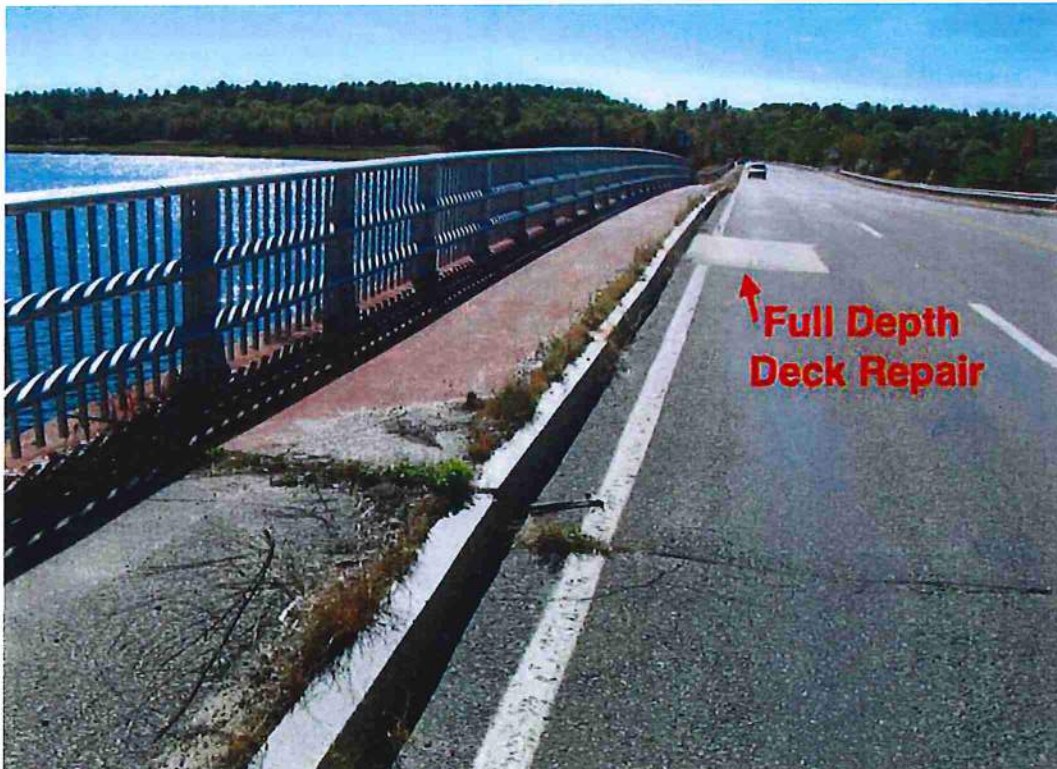
The south sidewalk has full length x $\leq 6"$ W x $\leq 10"$ D spalling/scaling with heavy weed growth along the back of curb, see photos 2 and 31.

Photo 2: Overview of south wearing surface and sidewalk looking west. Previous full depth deck repair in span 3, bay 2.

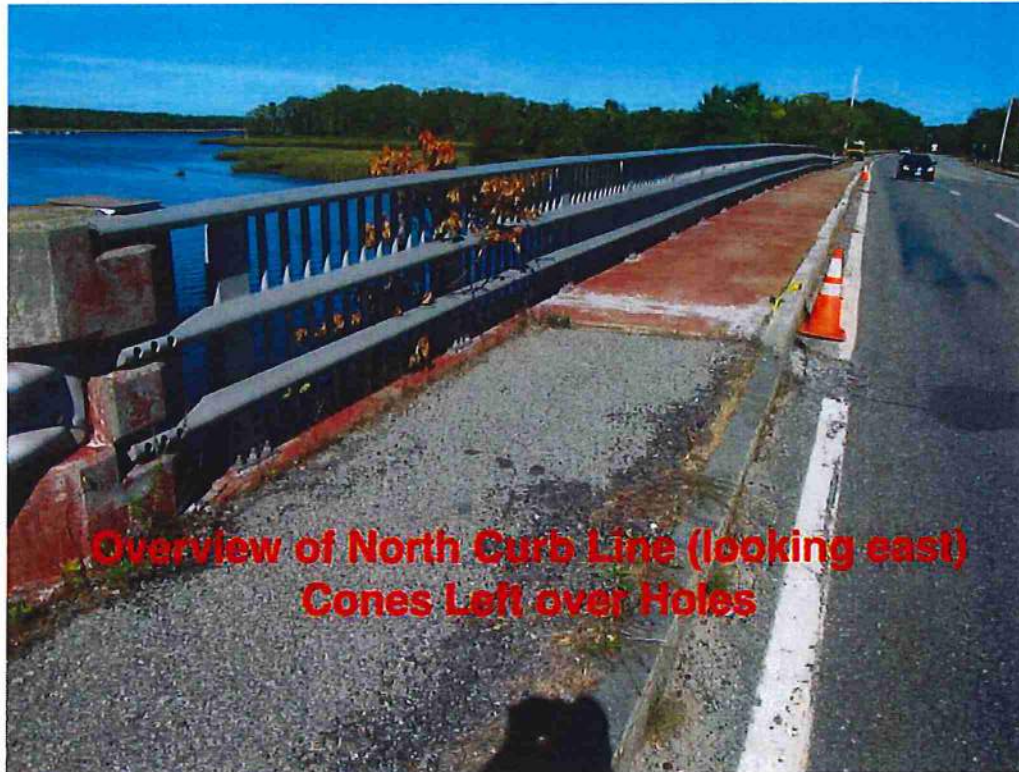
S/A - There are currently two holes along the north gutter line, each 8" wide by 1' long. One is located in span 1 and the other in span 3 adjacent to an old concrete patch. Surface holes coincide with voids below. See previous Item 58.1 (Wearing Surface) and General Comments.

Photo 3: Overview of north wearing surface and sidewalk looking east. Cones are located at holes in wearing surface

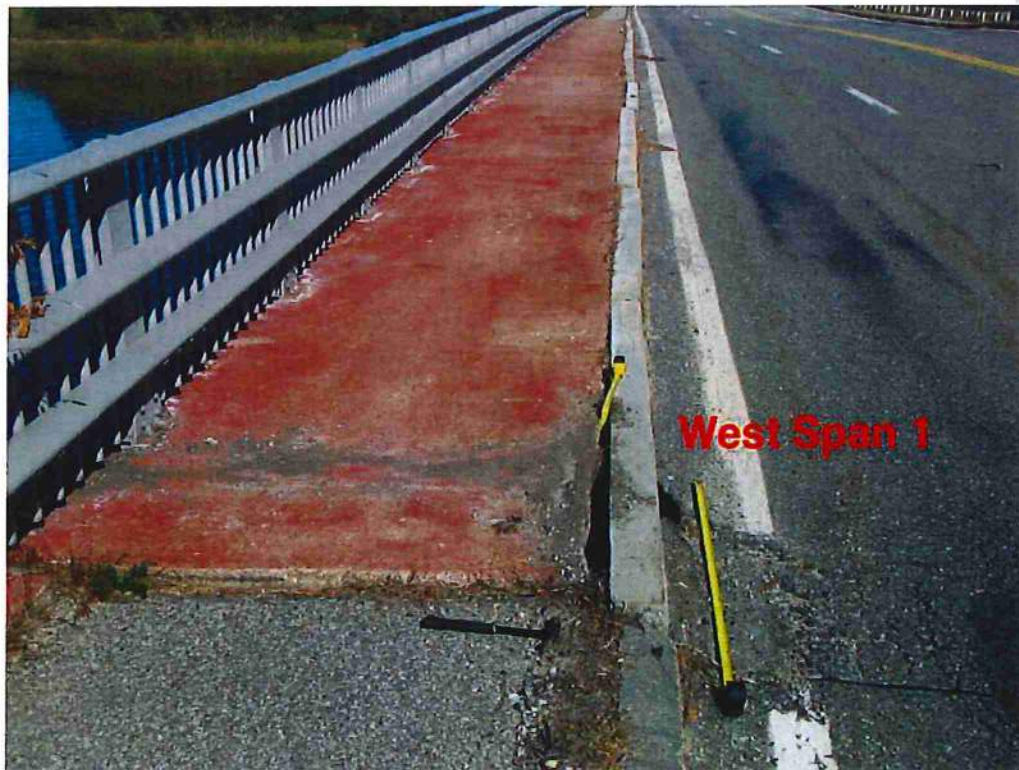
Photo 4: Close up of previous photo

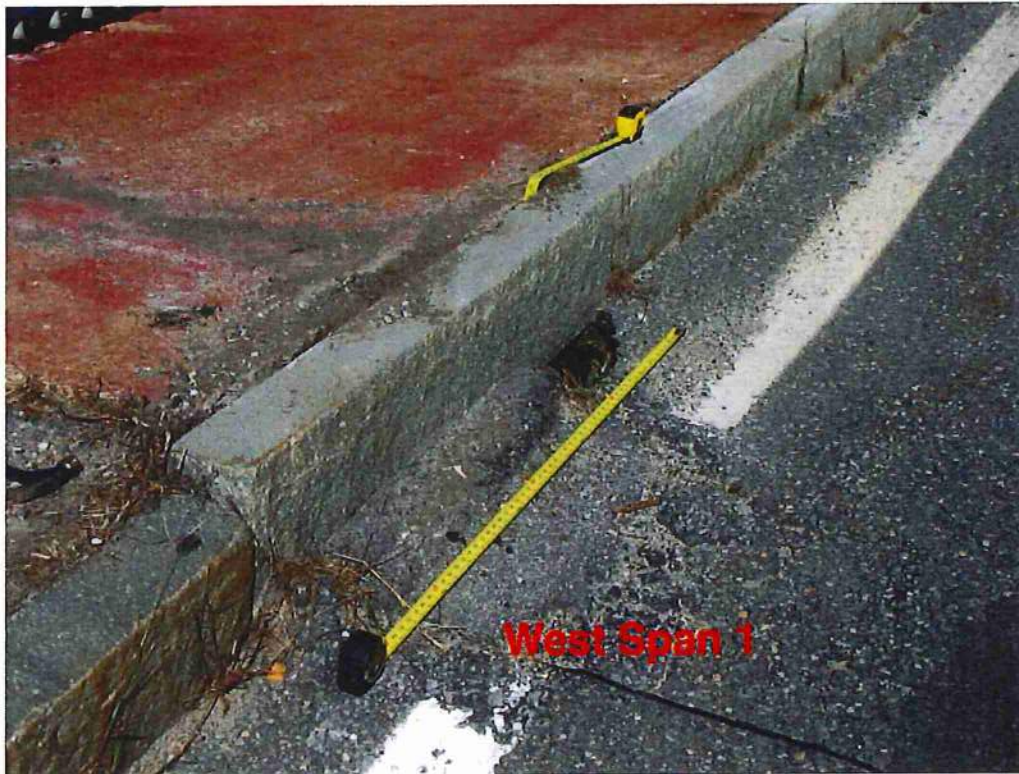
Photo 5: Close up of previous photos. Heaving in foreground with hole in background

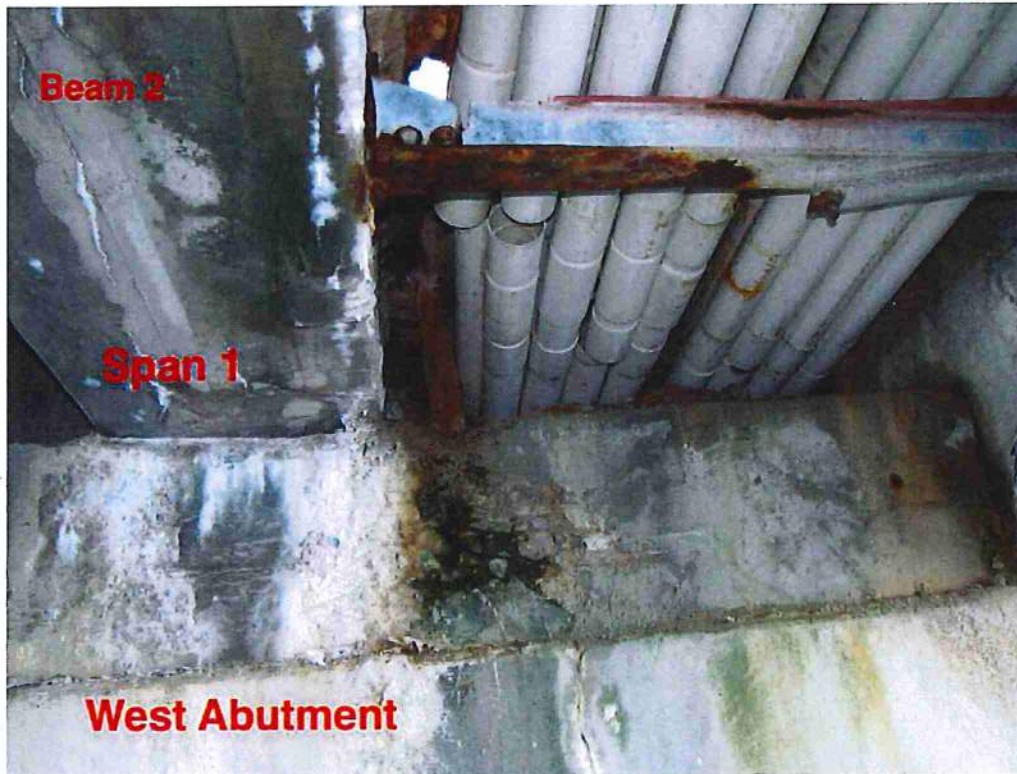
Photo 7: Underside of previous photo looking west. Span 1, bay 1 at west abutment

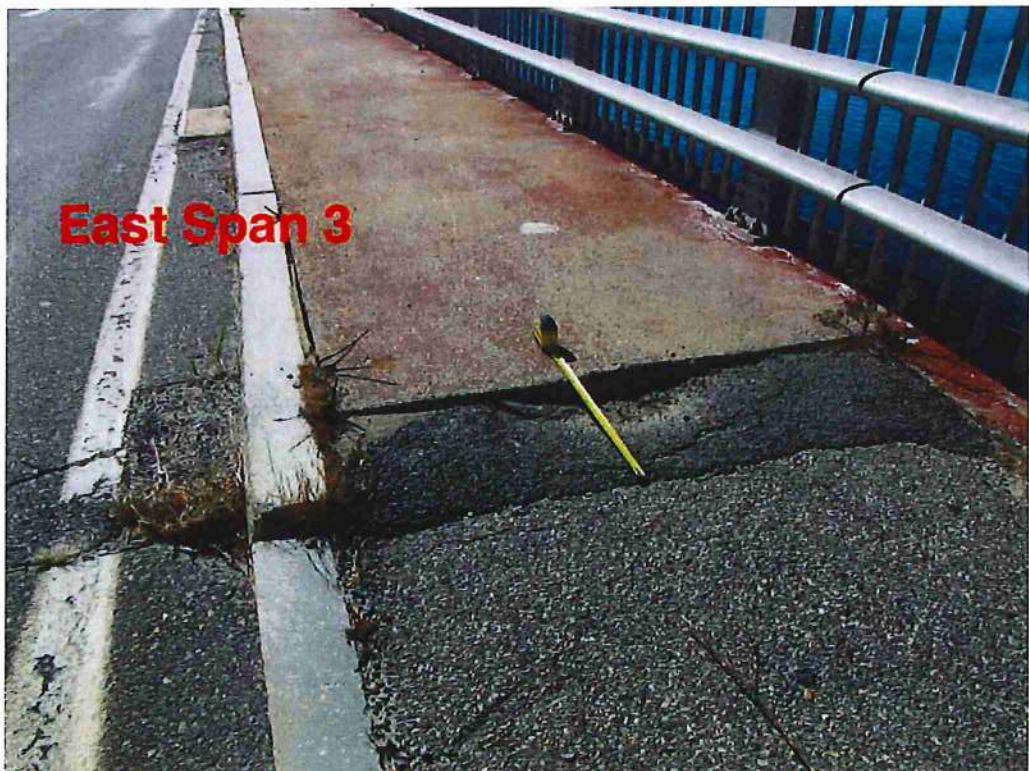
Photo 10: Overview of north wearing surface and sidewalk looking west. Approach sidewalk settlement up to 3" at middle. Previous concrete and asphalt patches in gutter

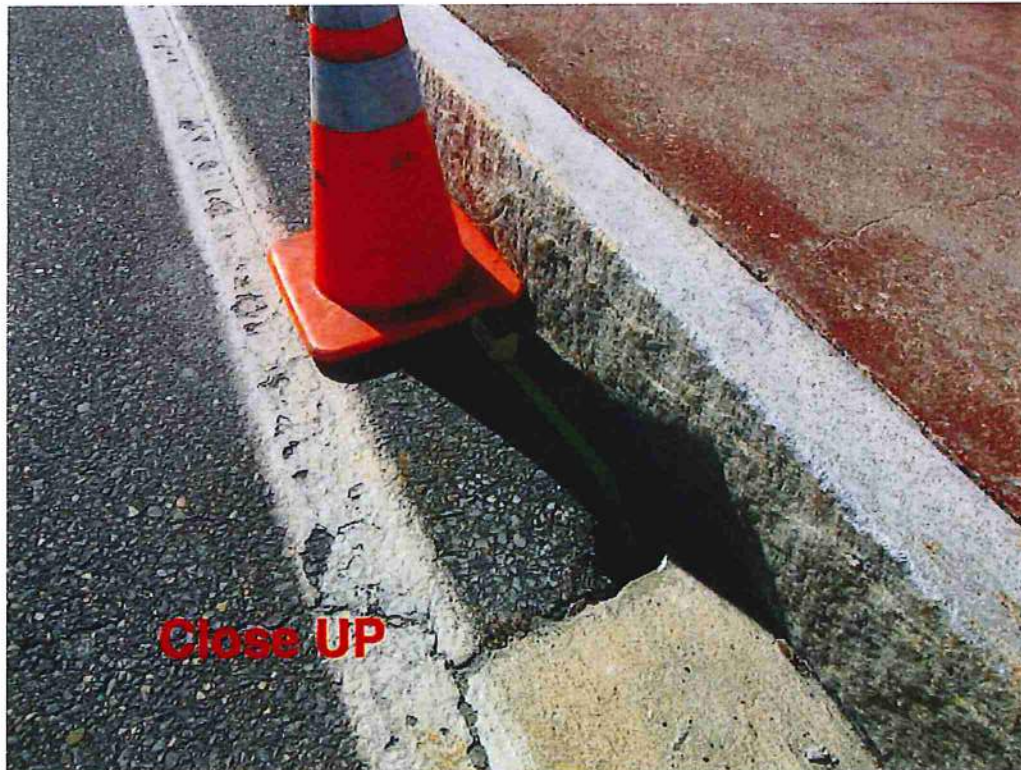
Photo 12: Close up of previous photo. Through hole to underside

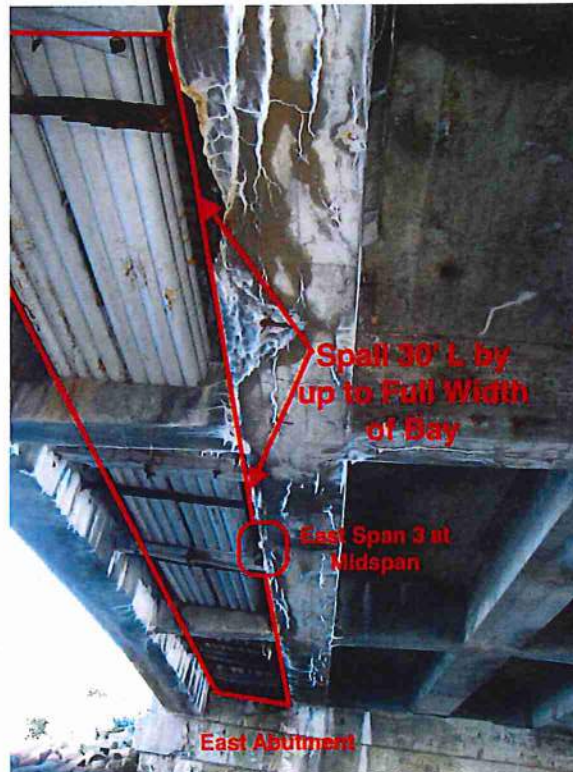
Photo 13: Underside of previous photos 10, 11 and 12 looking east. Span 3, bay 1, spall extending from midspan to east abutment

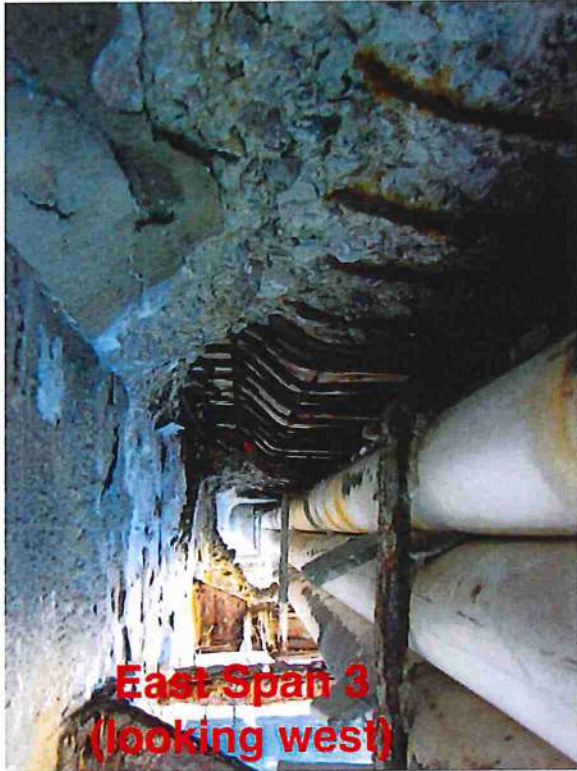
Photo 15: Span 3, bay 1, spall extending from east abutment to beyond midspan looking west

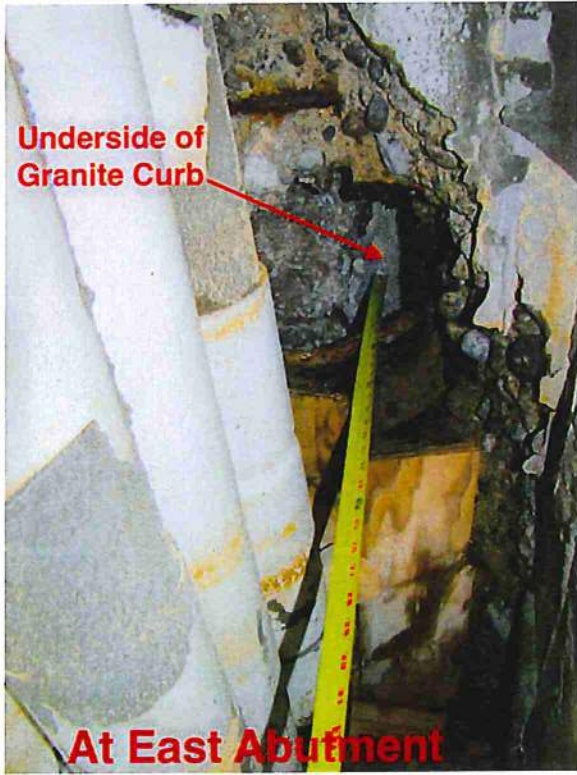
Photo 16: Span 3, bay 1, spall at east abutment extending up to expose bottom of curb

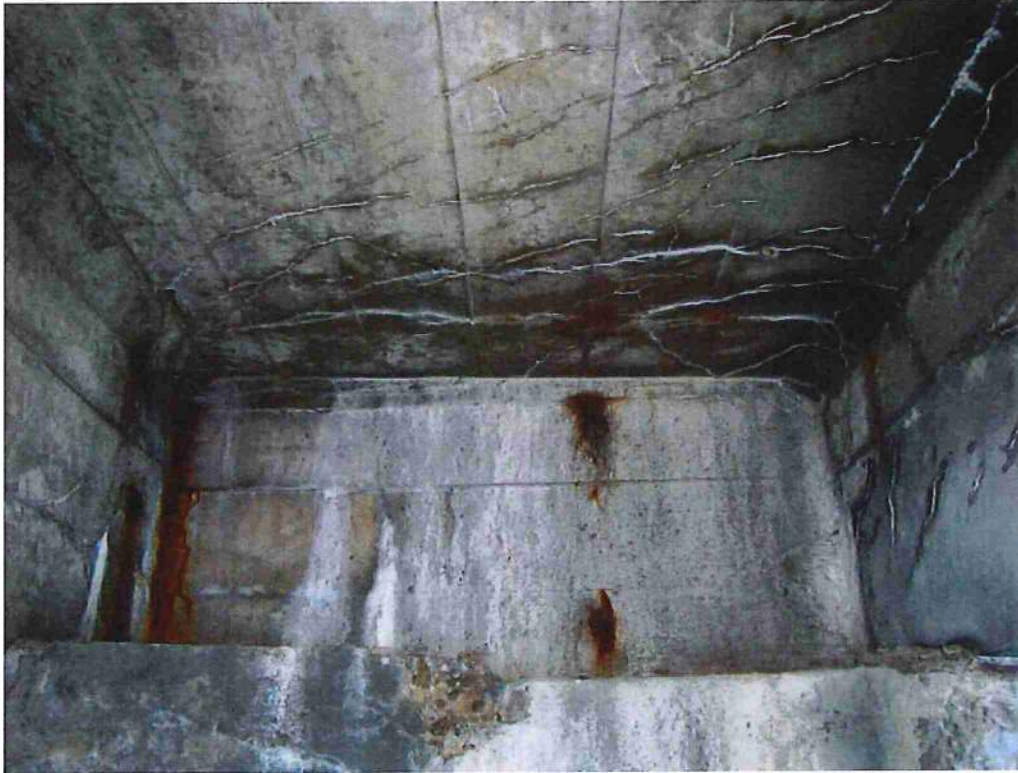
The original tee beam section of the deck has cover spalls, delaminations, some rust bleed, and repairs throughout. There are hairline cracks, particularly at interface of beams and deck with moderate to heavy efflo and dampness in bays 1 and 2, see photos 17 and 18 for examples. There are two areas that sound hollow, span 1, bay 2, at the west abutment and span 3, bay 2 at the east abutment, see photo 19 for example.

Photo 19: Span 1, bays 2 at west abutment

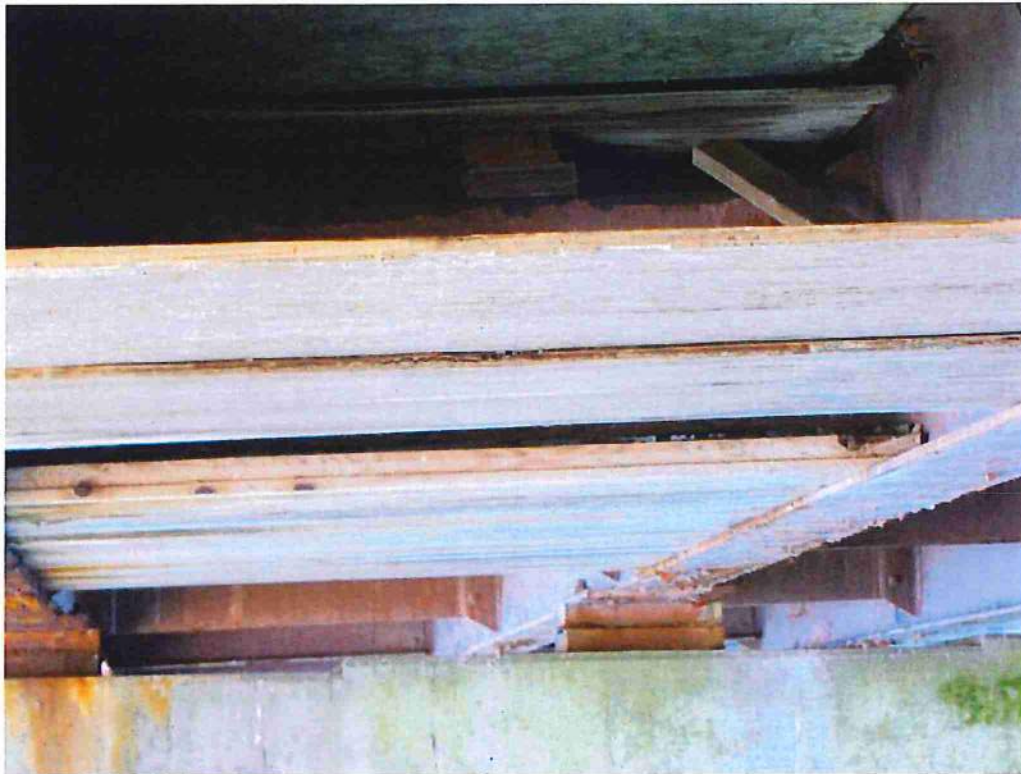
The south deck widening has areas of contamination, hairline map cracking, honeycombing with dampness, rust stains, and efflo see photos 15 & 16. In span 3, bay 2, near the pier, there is timber formwork left in place below a previous full depth deck repair, see photos 20 through 28.

Photo 27: Close up of photo 24. View of wood shielding and formwork left in place at bay 2. Formwork located below full depth deck repair

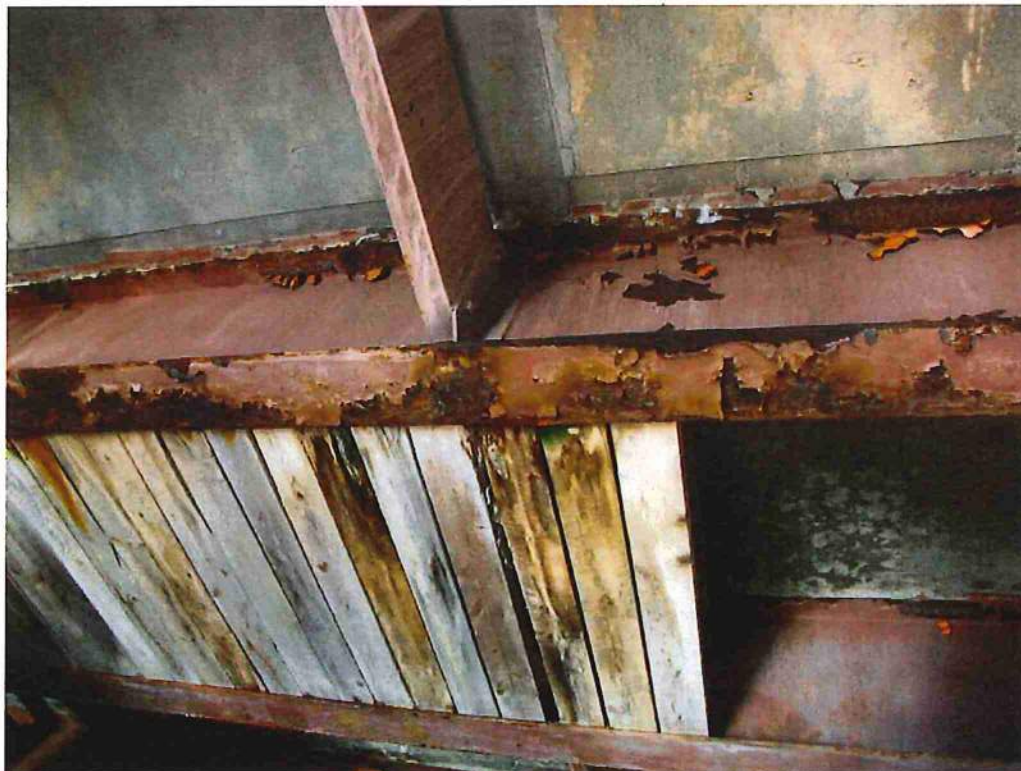
Beam 3 in span 3 has an area of web and bottom flange section loss ($\leq 1/8"$ at this time) below previous full depth deck repair, see photo 28 for overview.

Photo 28: Similar to previous photo. Beam 3 with active corrosion along bottom flange

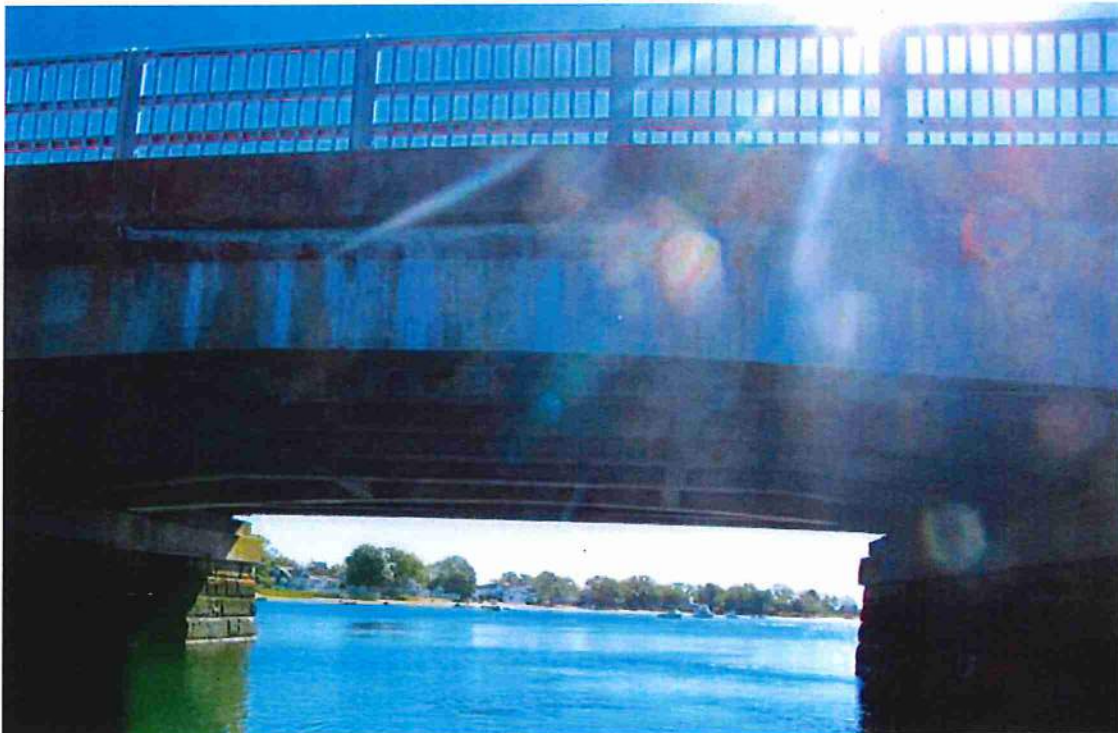
The north face above beam 1 in all spans has a full length repair that has disjointed longitudinal cracking with adjacent scaling, see photos 29 and 41 for overview. See photo 30 for worst area in span 2, where it is up to 5 inches high by 2 inches deep by 25' long.

Photo 30: Span 2 north face spall

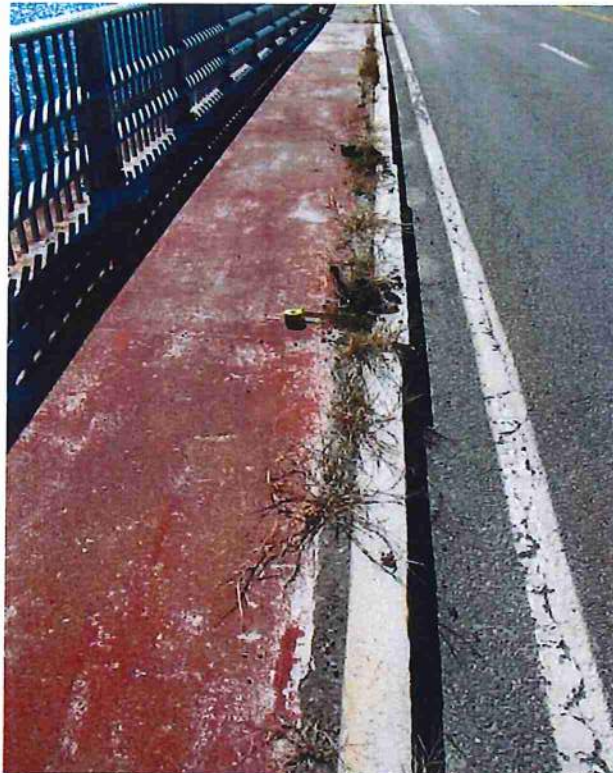
Photo 31: South sidewalk looking west

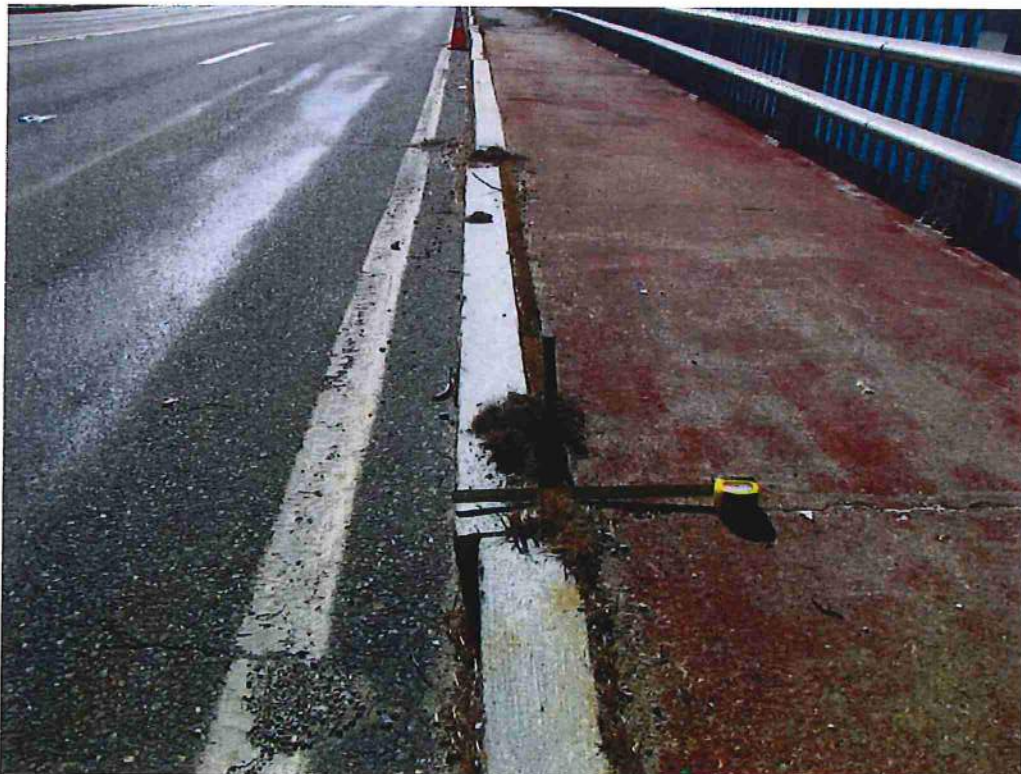
The north sidewalk has a similar condition, about 60% of the length by up to 3 inches wide and 10" deep, with several sections of curb separated, settled and/or rotating, see photo 32 for example. Isolated area of scale (4 sq ft) under rail in span 3, see photo 33.

Photo 32: North sidewalk, span 2 looking west

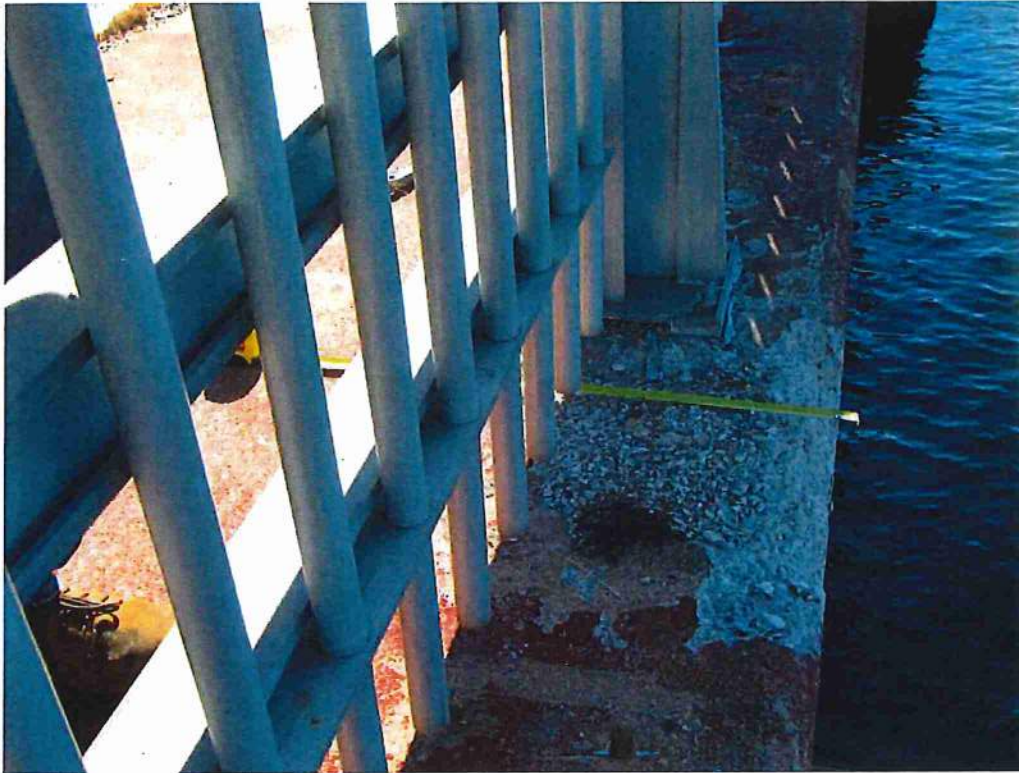
Photo 33: North sidewalk, span 3 north edge spall/scale

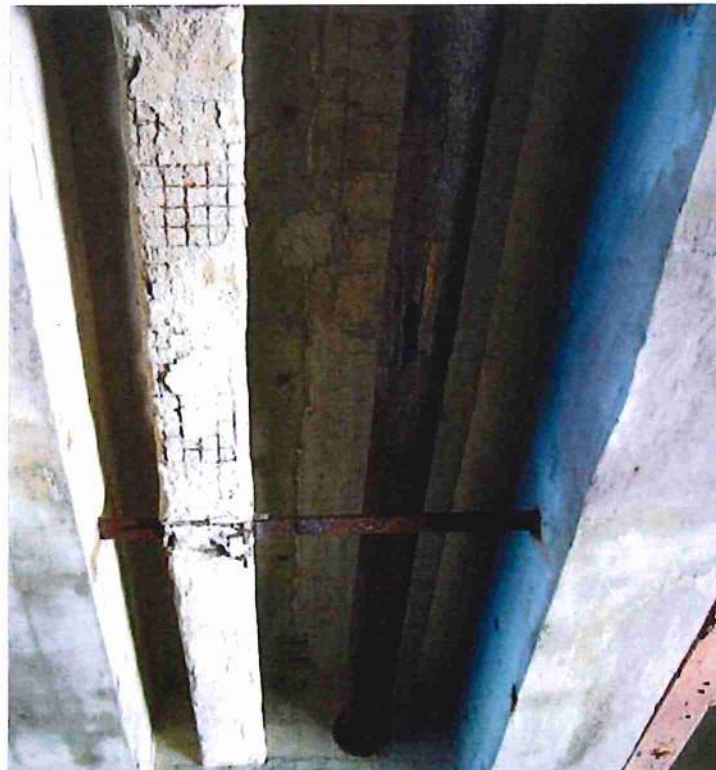
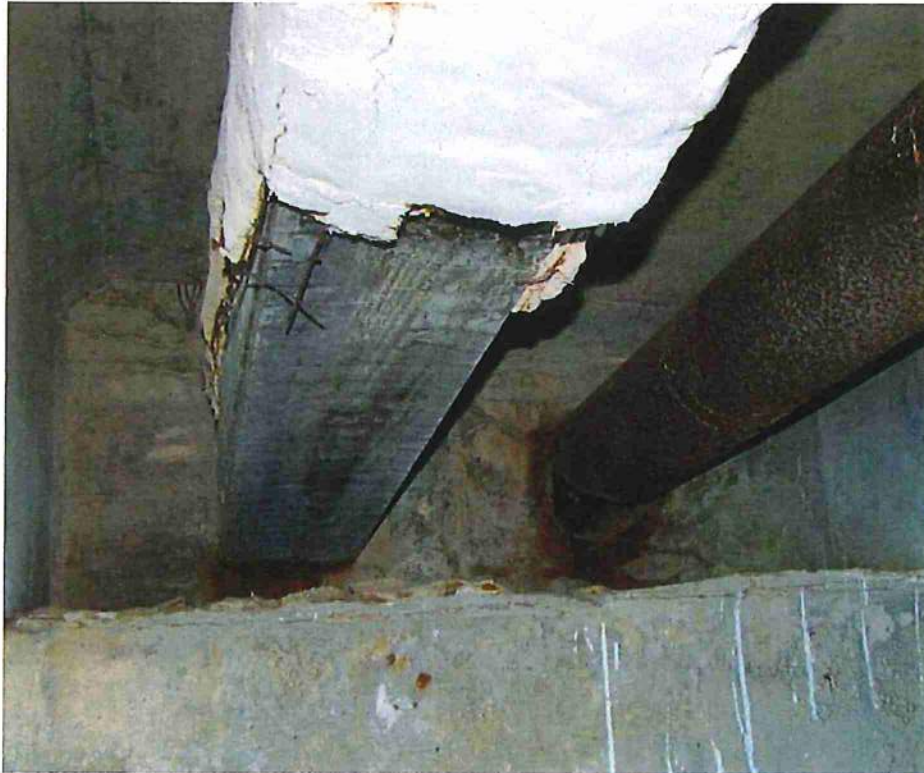
SP - Bay 5 in all spans has a steel utility pipe with severe corrosion and holes (possibly abandoned). Adjacent to this pipe is a concrete/wood encased utility with scale and spalls scattered throughout, see photos 34 and 35.

Photo 34: Span 2, bay 5 utilities. Utility pipe on right with holes, apparently abandoned

Photo 35: Same utilities as previous photo, span 3 at east abutment. Utility pipe on right with a hole, apparently abandoned

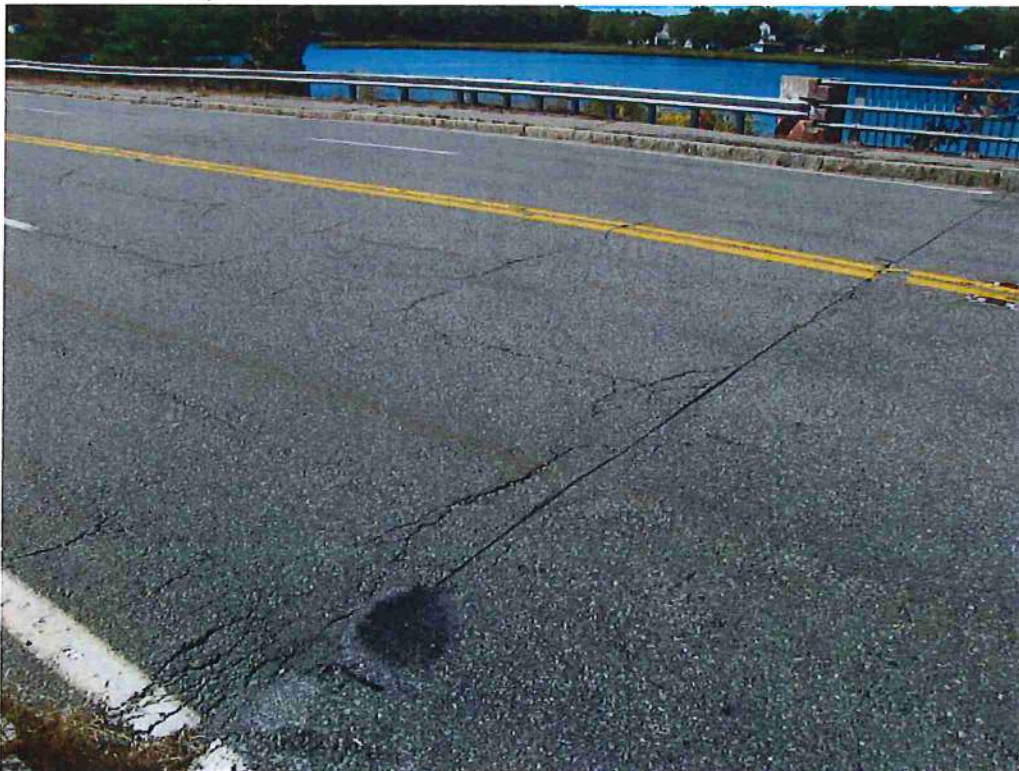
Both have longitudinal cracking up to 1" wide with irregular transverse cracking throughout and at the sawcuts where the bit. conc. is beginning to break up in the EB lane, see photo 36 for typical overview.

Photo 36: Overview of west approach pavement and sawcut joint. East approach pavement and sawcut joint is similar

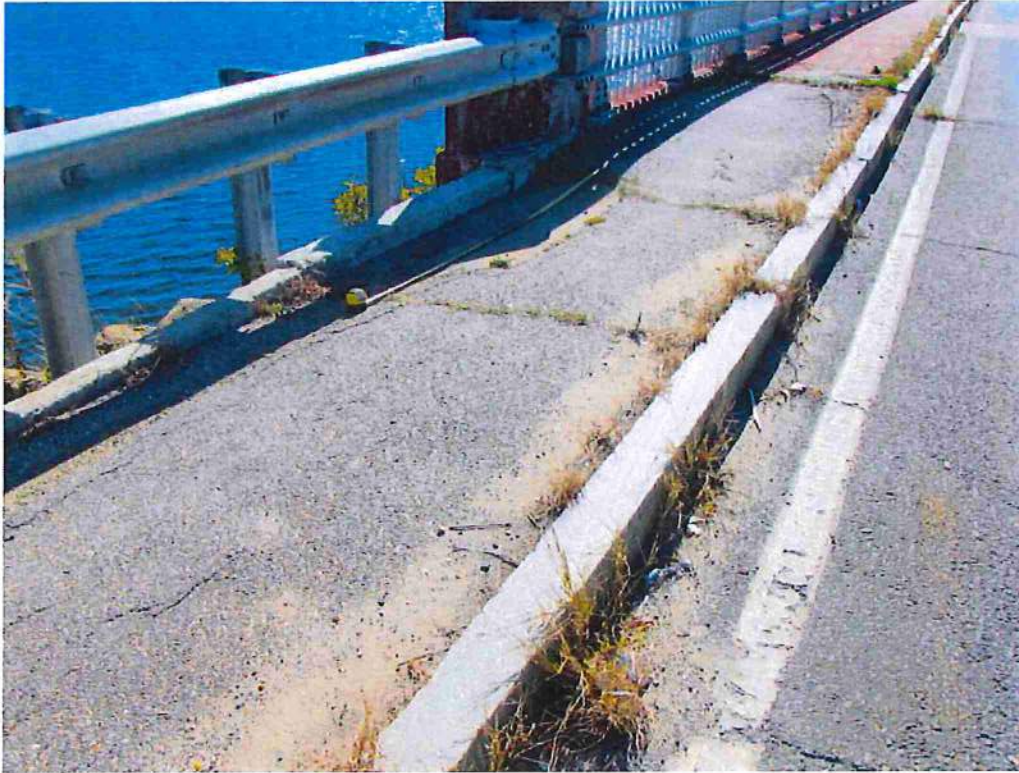
The SE sidewalk has a repair that has settled approx 6 inches near the end post, see photo 37 for overview.

Photo 37: Overview of SE approach sidewalk

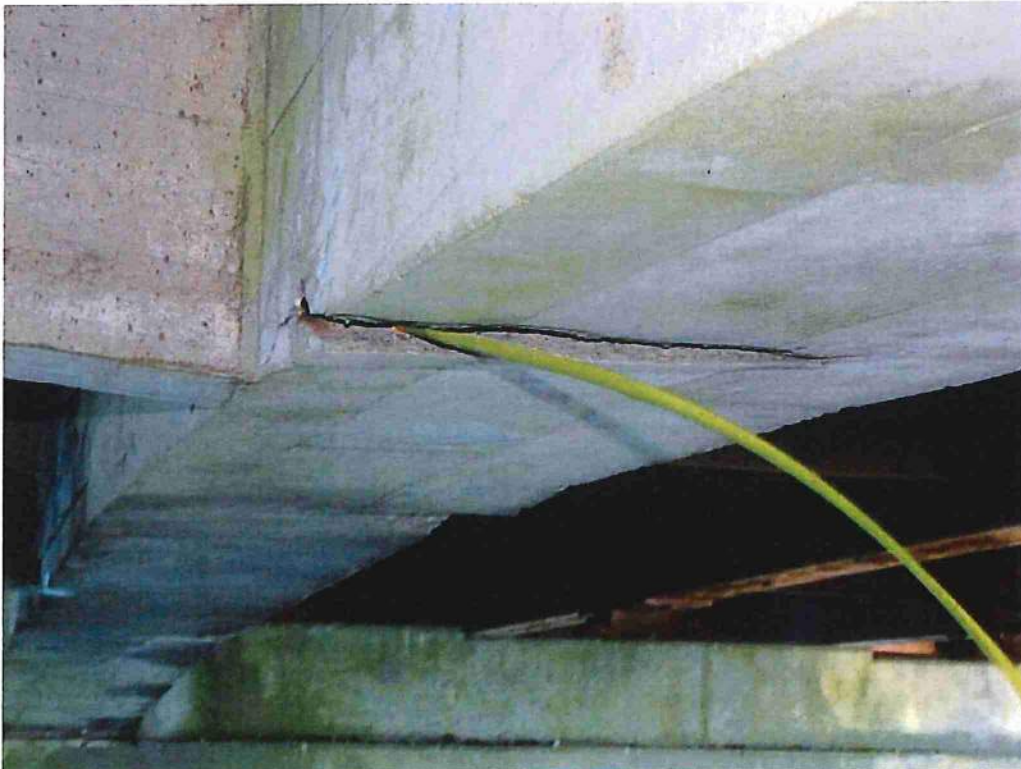
1929 Tee Beams - Beams 3 through 6 have numerous repairs, minor to moderate spalls with exposed rebar, delaminations, and minor rust stains throughout the concrete reinforced tee beams, see photos 18, 40, and 44 for examples.

Photo 40: Span 1, BM 6 at midspan. spall with adjacent delam

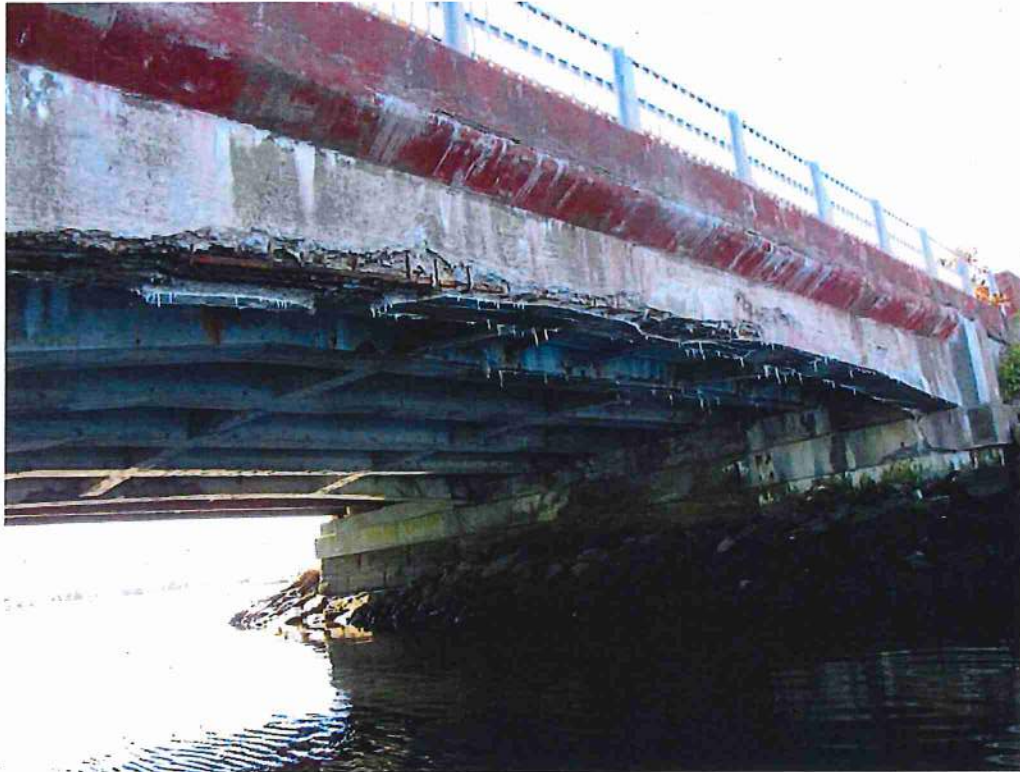
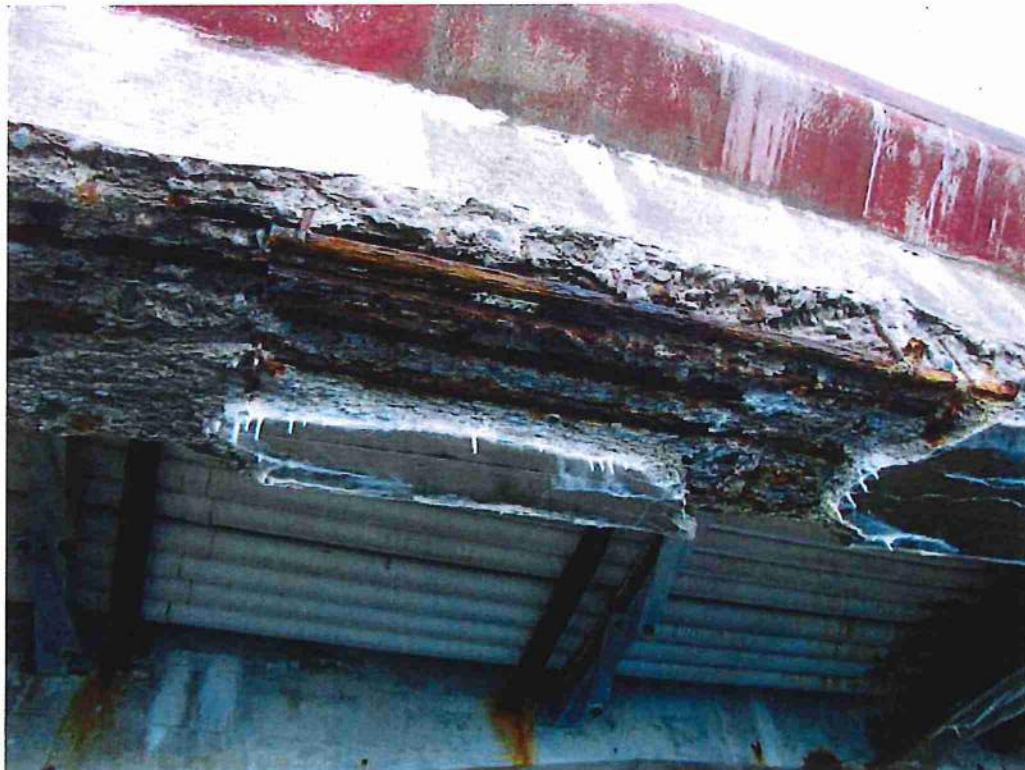
S/A - Beam 1 - Span 1 - The north face and bottom has a large series of spalls (up to full width by 20' L by 8" H) with exposed corroding rebar with section loss, in some areas debonded, and broken stirrups with associated deteriorated concrete, scale, delams and heavy efflo, see photos 41, 42, and 43.

Photo 41: Overview BM 1, span 1, north face and bottom

Photo 42: Close up of previous photo

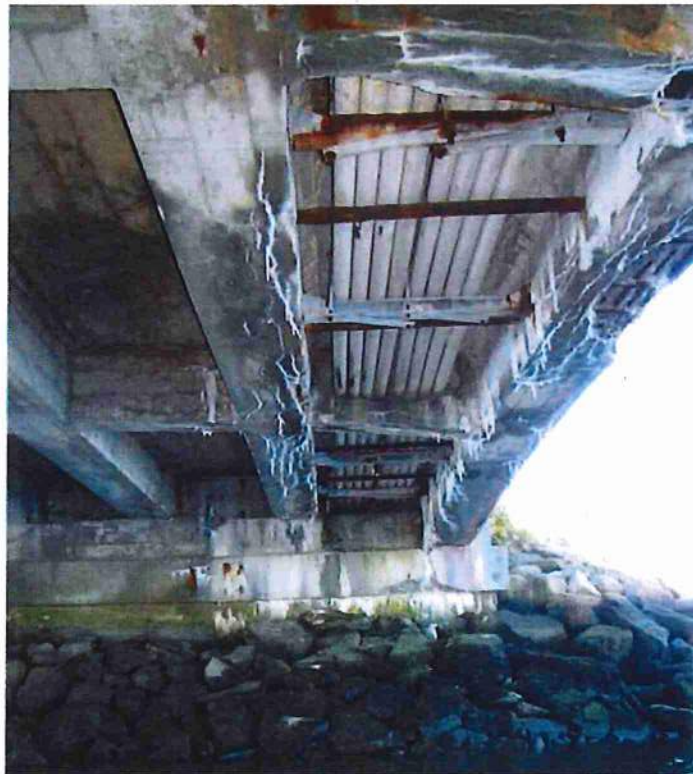
Beams 1 and 2 have horizontal and longitudinal cracking with moderate to heavy efflorescence throughout all 3 spans, see photos 43 and 44 for examples. Beam 2, span 2 has an isolated full width bottom spall by 3' L by 2" D located near midspan with associated deteriorated concrete, scale, delams and heavy efflo, see photo 44.

Photo 43: Underside of BM 2 and 1 (L to R), span 1 looking west

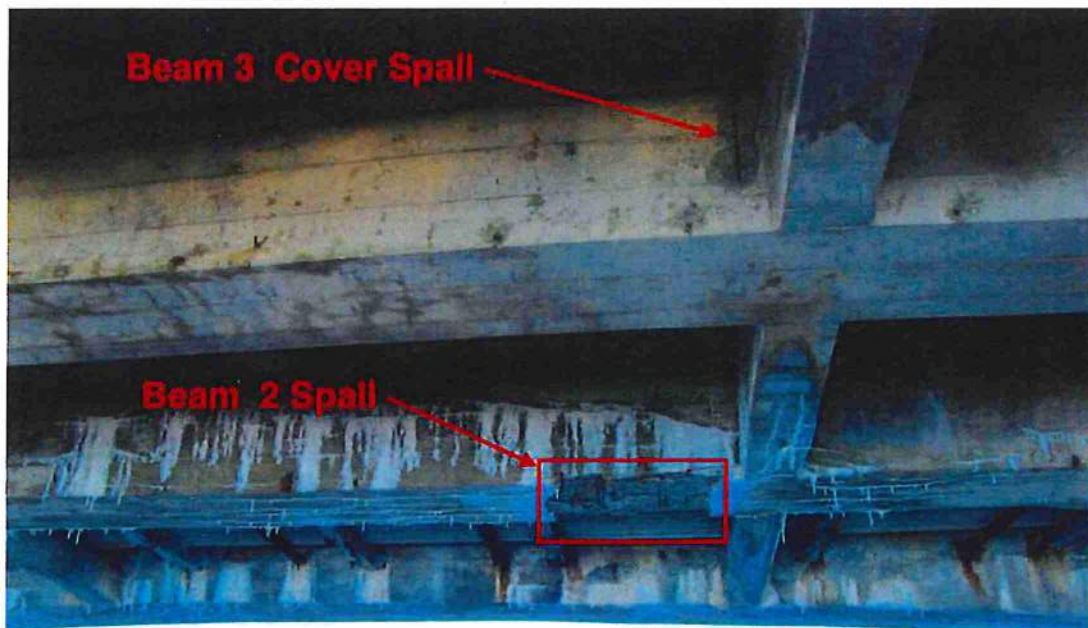
Photo 44: Underside of span 2 at midspan looking north. BM 3 in foreground and BM 2 with spall in background
