STRUCTURES INSPECTION FIELD REPORT

ROUTINE INSPECTION

W-06-016

| 07-FACILITY CARRIED US 6 MARION RD | MEMORIAL NAME/LOCAL NAME | 27-YR BUILT 1929 | 106-YR REBUILT 1957 | YR REHAB'D (NON 106) 0000 |

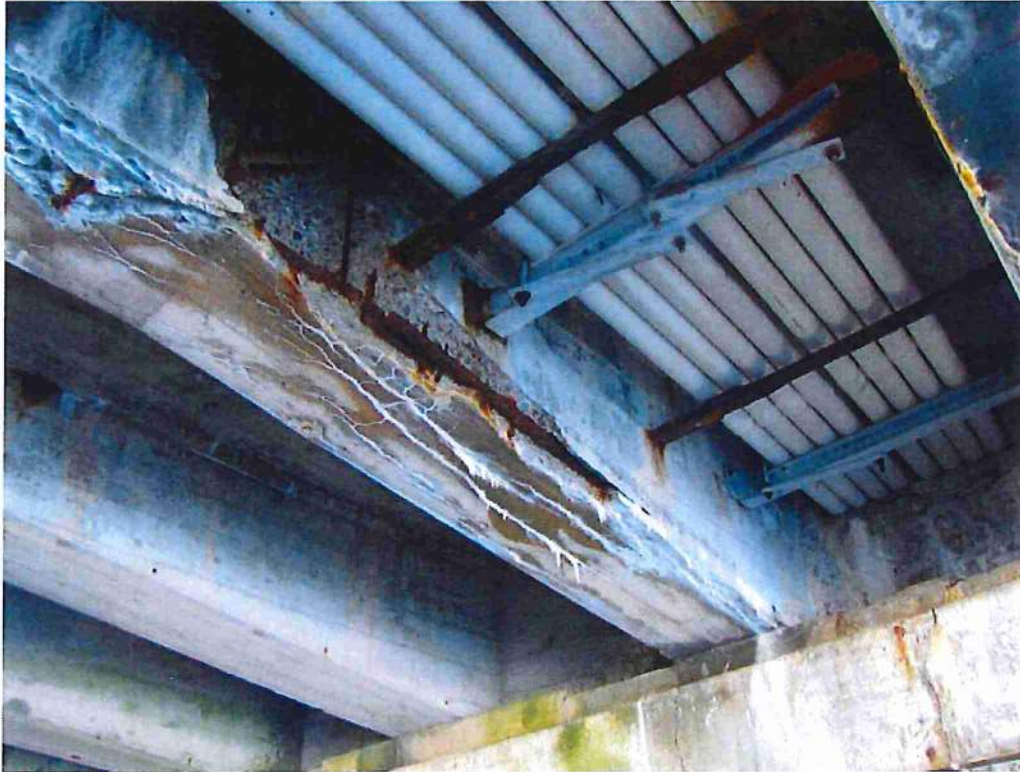
S/A - Beam 2 - Span 3 - As noted in item 58.2, full deck spall in span 3, bay 1, extends over and into the top of beam 2 exposing longitudinal rebar and top of stirrups for a length of 7 ft, see sketches 4 and 5 for additional detail. In addition, the north face near pier 2 has a full height spall by 4' L with exposed corroding rebar with associated deteriorated concrete, scale, delams and heavy efflo, see photo 45.

Photo 45: Span 3, BM 2 near pier 2, full height spall with exposed and debonded rebar at bottom edge

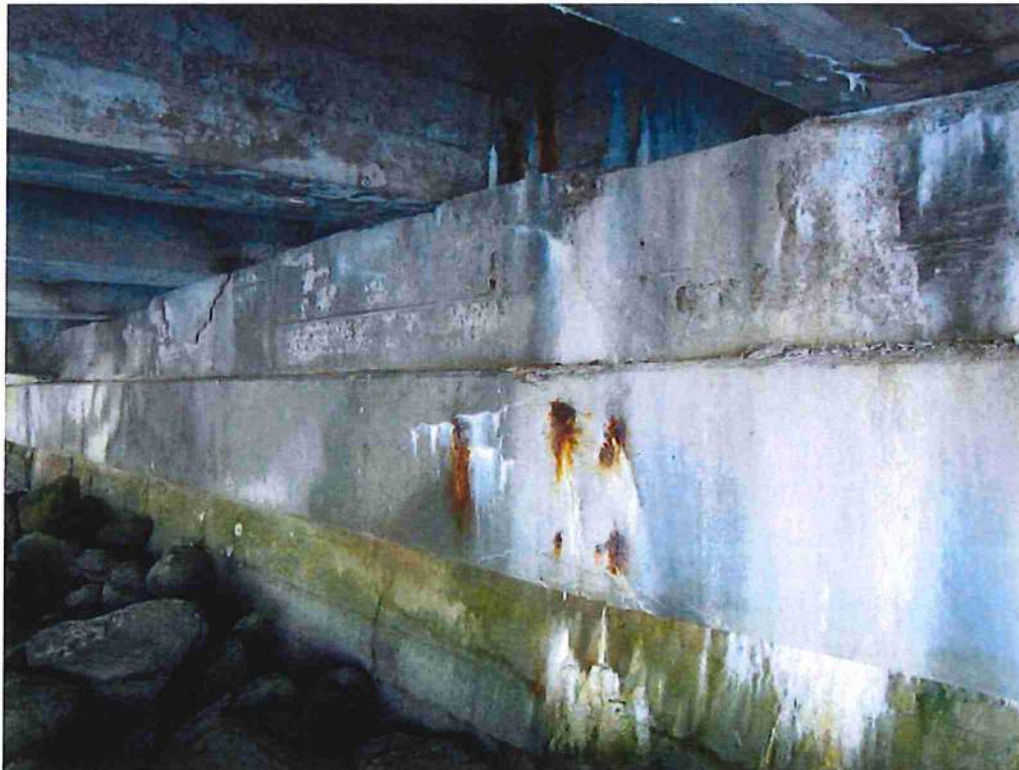
See item 60.1b for photos and details. In addition see photo 46 for overview of west abutment with patches, map cracking with rust bleed, delams and efflo.

Photo 46: Overview of west abutment

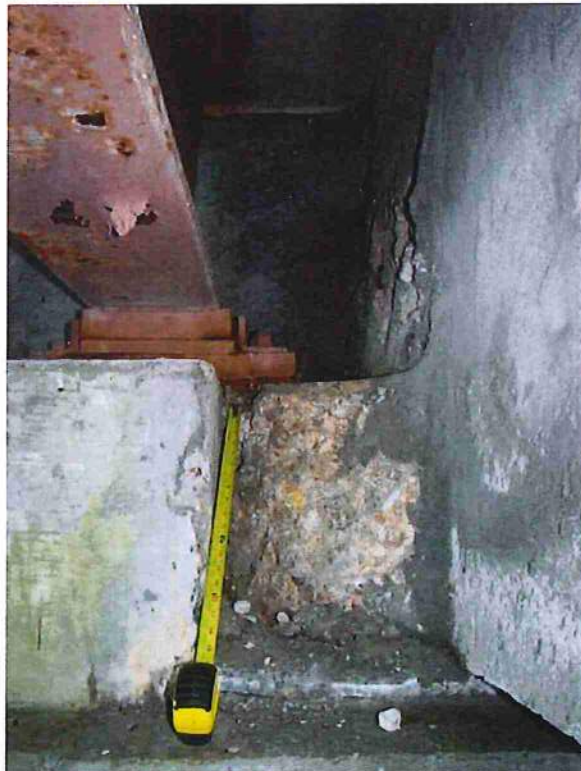
The seats have repairs, cracks and map cracking, and minor scale. The north end of the west seat has map cracking with heavy efflo., rust stains and scale between Beams 1 - 3, and a spall \approx 4ftL x 3 in D x full height under Beam 1, see photo 47. The north end of the east seat is similar, see photo 49. The east bridge seat under Beam 6, has a spall \approx 3ft x 7in x 2in D with vertical cracks \leq 1/8in wide under tee Beam 6 and steel Beam 1, see photo 50. The west bridge seat under steel Beam 1, has a full height spall/scale that is up to the bearing, see photo 48.

Photo 48: West abutment, at BM1 (South extension). Spall extends back to masonry plate

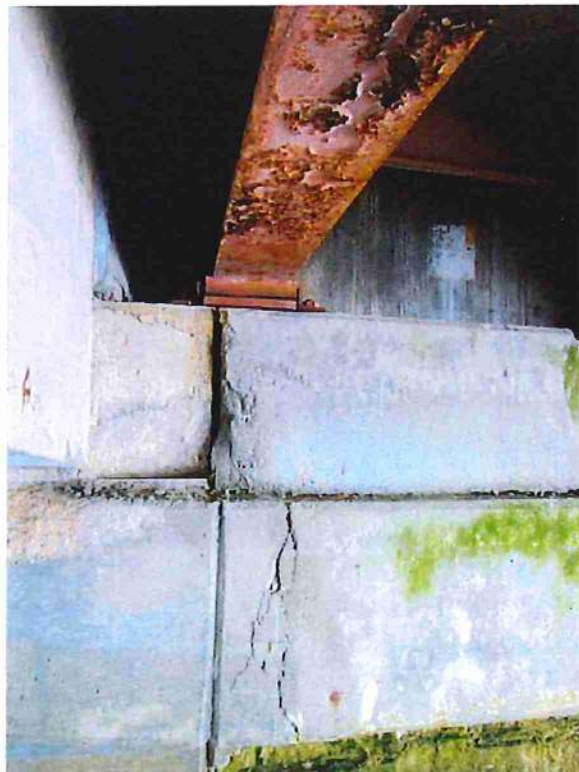
Photo 50: East abutment, at BM1 (South extension). Vertical irregular cracking

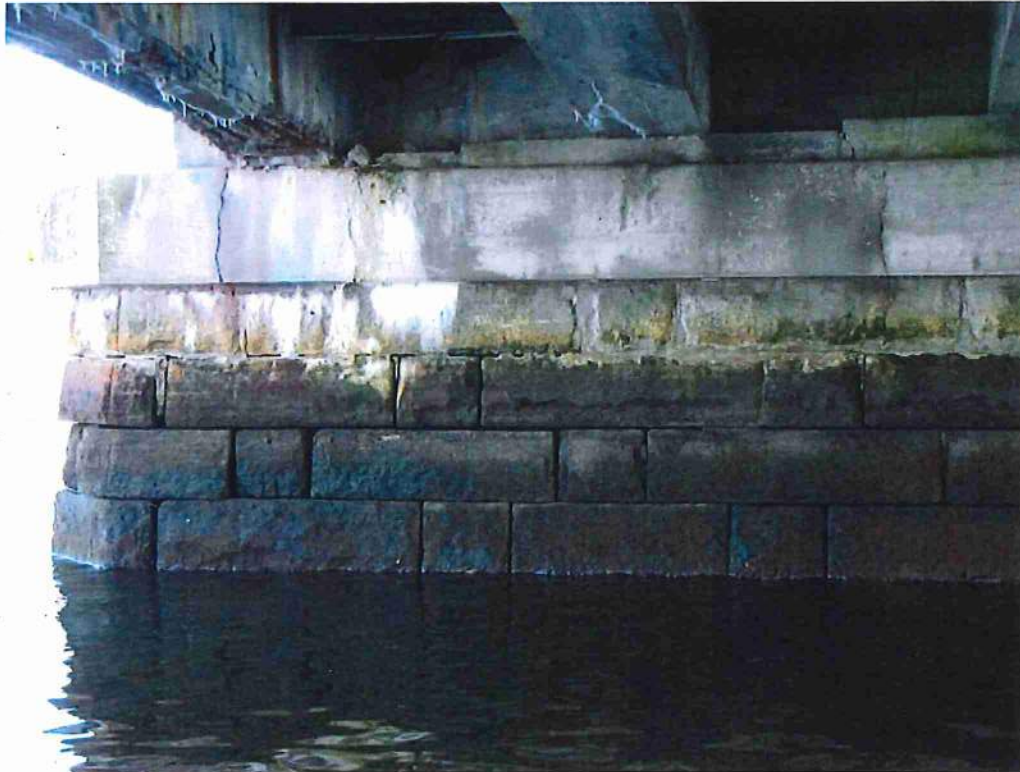
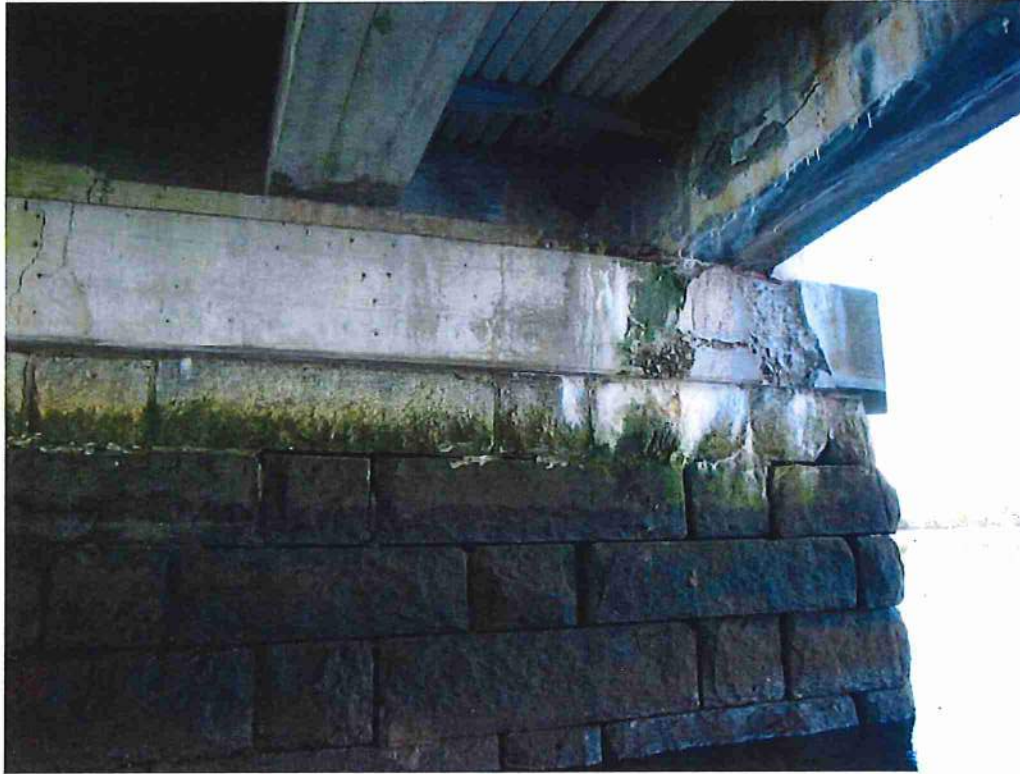
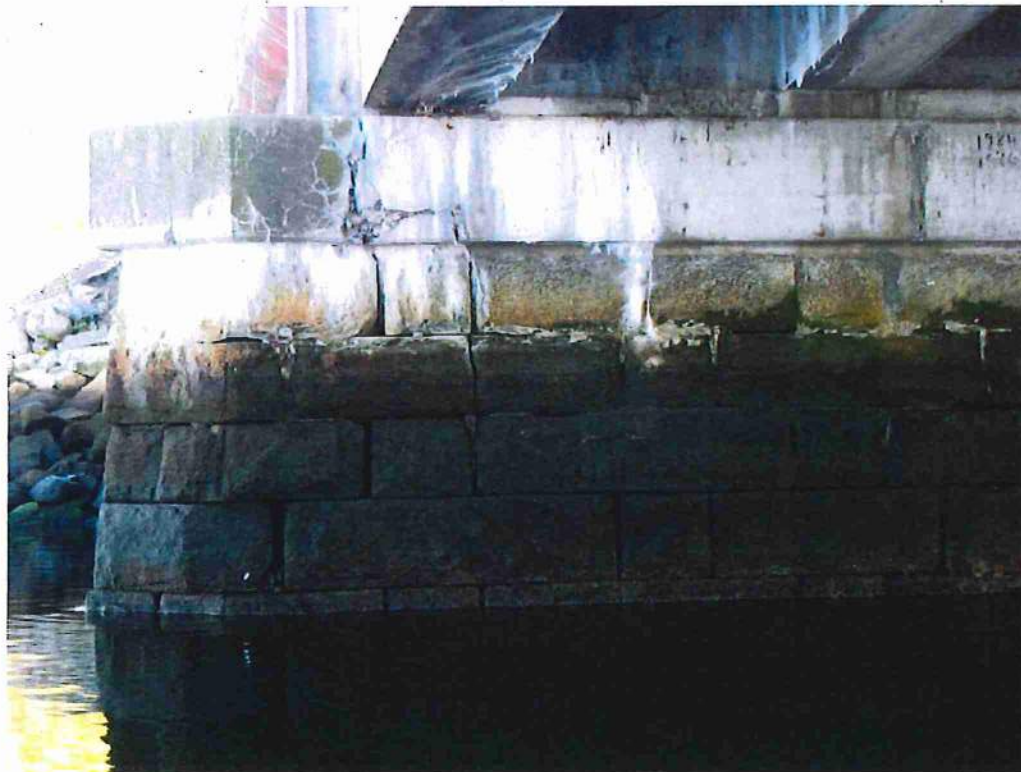
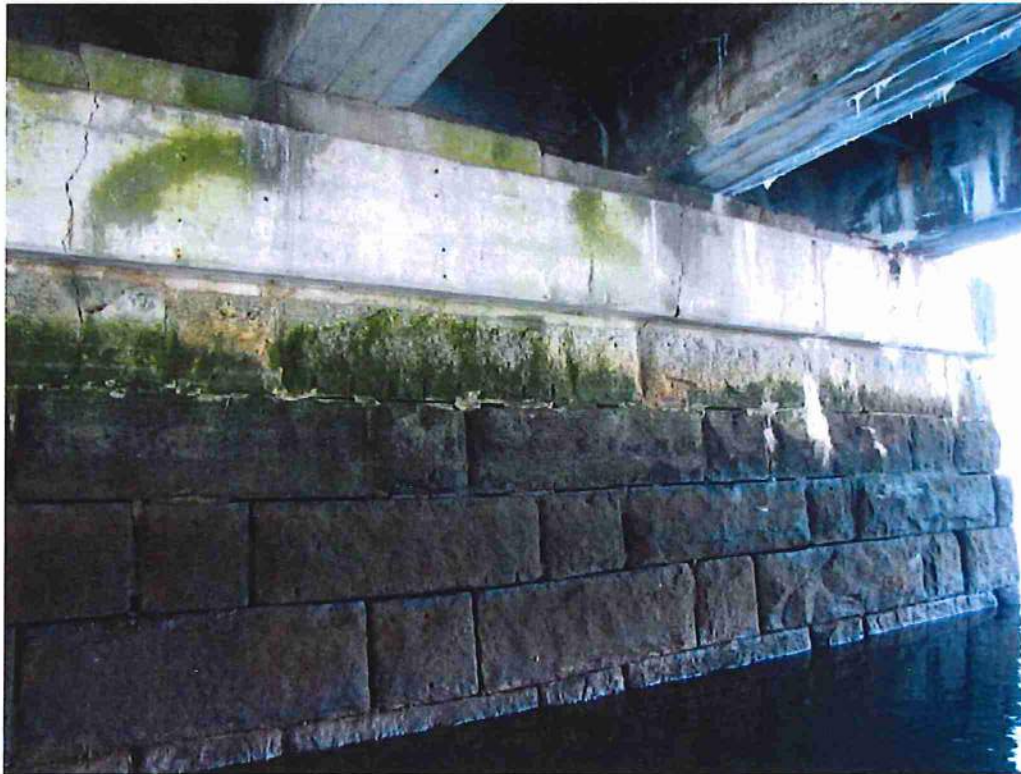
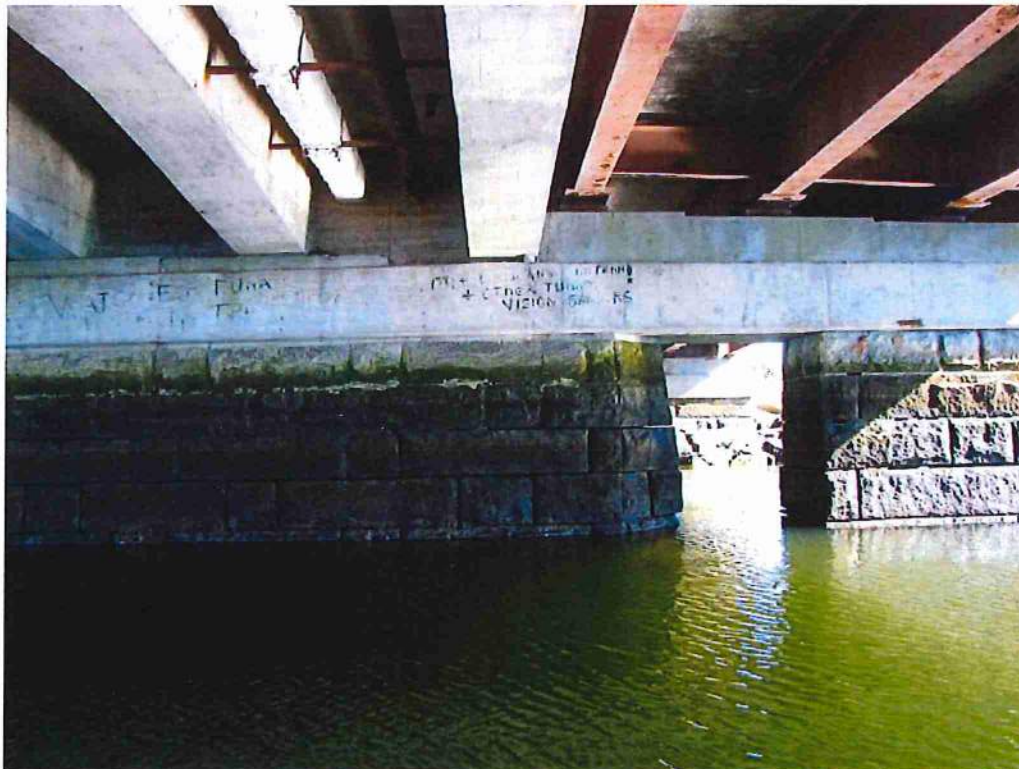
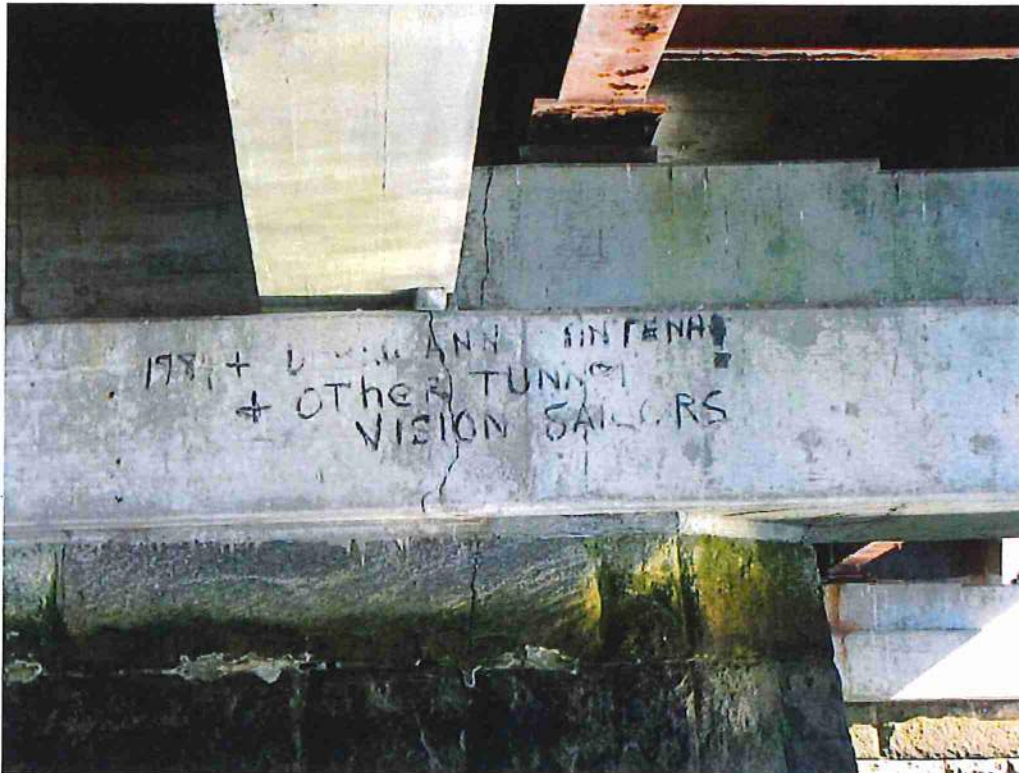
Both concrete caps have many vertical cracks, hairline to 1/4 inch wide. Some cracks extend through the granite blocks below. In addition the north ends of both piers have scale/spall, map cracking, and associated delam with heavy efflo, see photos 51 through 57.

Some of the cracks in the caps extend through the top blocks with evidence of settlement at the north ends of both piers and at the pier 2 widening at pier 2. Except for the joints between the two top courses of granite, most of the pointing is gone in the tidal range, see photos 51 through 57 and 60 & 61.

Photo 51: Overview of pier 1, NW. Vertical cracks in cap. Missing pointing

Photo 53: Close up of previous photo at NE end of pier. Missing pointing

Photo 54: Overview of pier 2, NW. Vertical cracks in cap and into blocks below. Missing pointing

Photo 55: Overview of pier 2, NE. Vertical cracks in cap. Missing pointing

Photo 56: Overview of pier 2 and south widening pier (L to R), west face. Missing pointing

Photo 57: Close up of previous photo. Cracks in cap extending down into first block

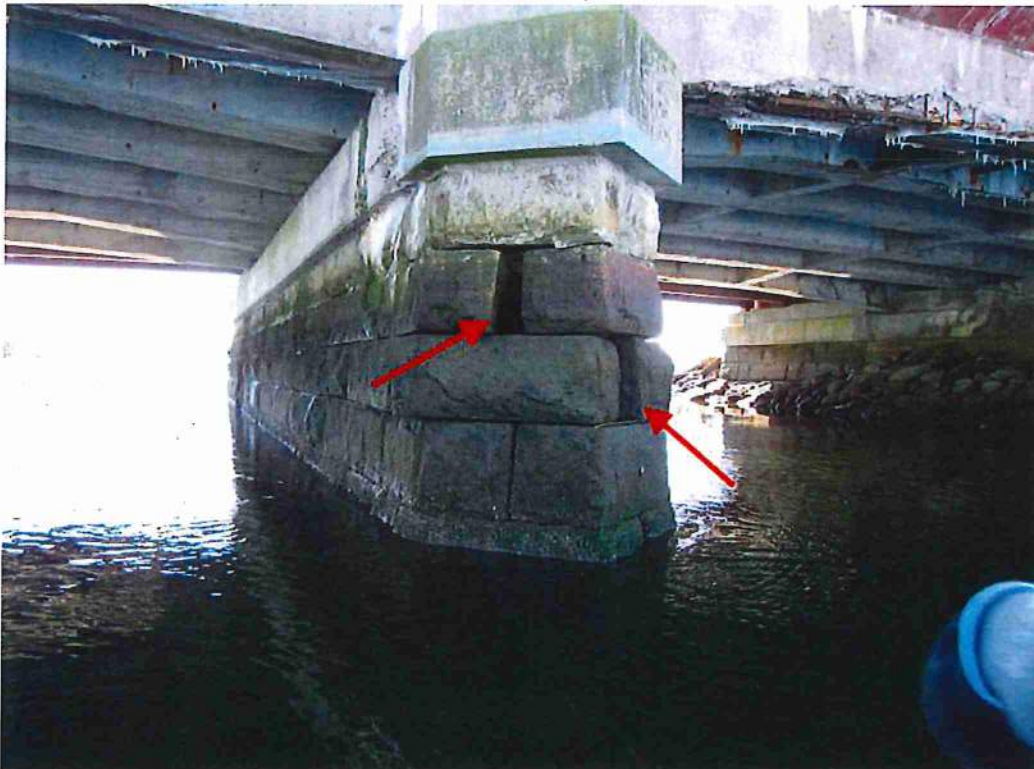
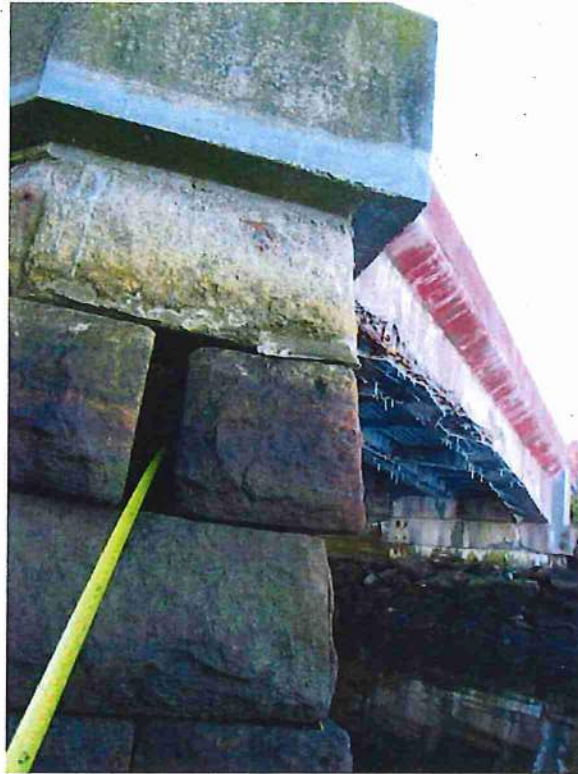
Photo 58: Overview of north nose of pier 1. Notable shift in 2nd and 3rd course blocks

Photo 59: Close up of previous photo. Gap up to several inches wide

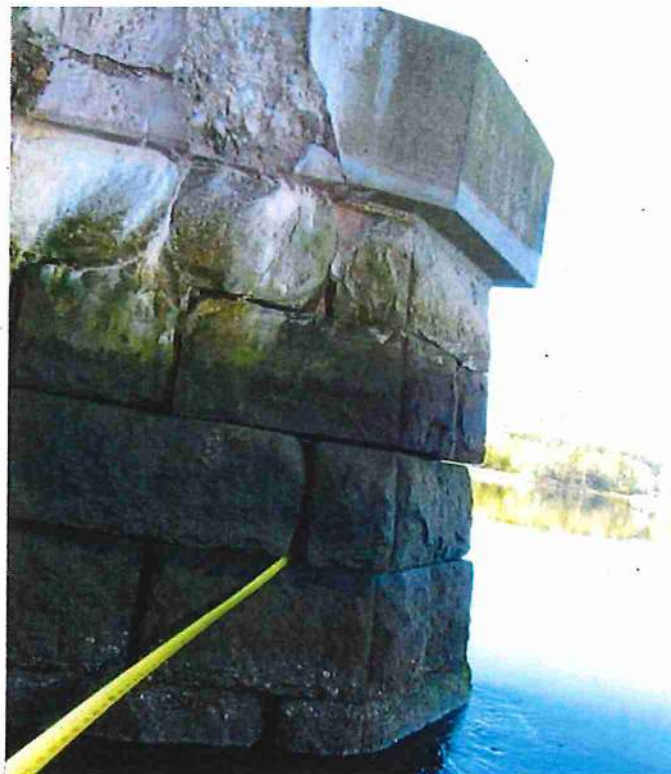
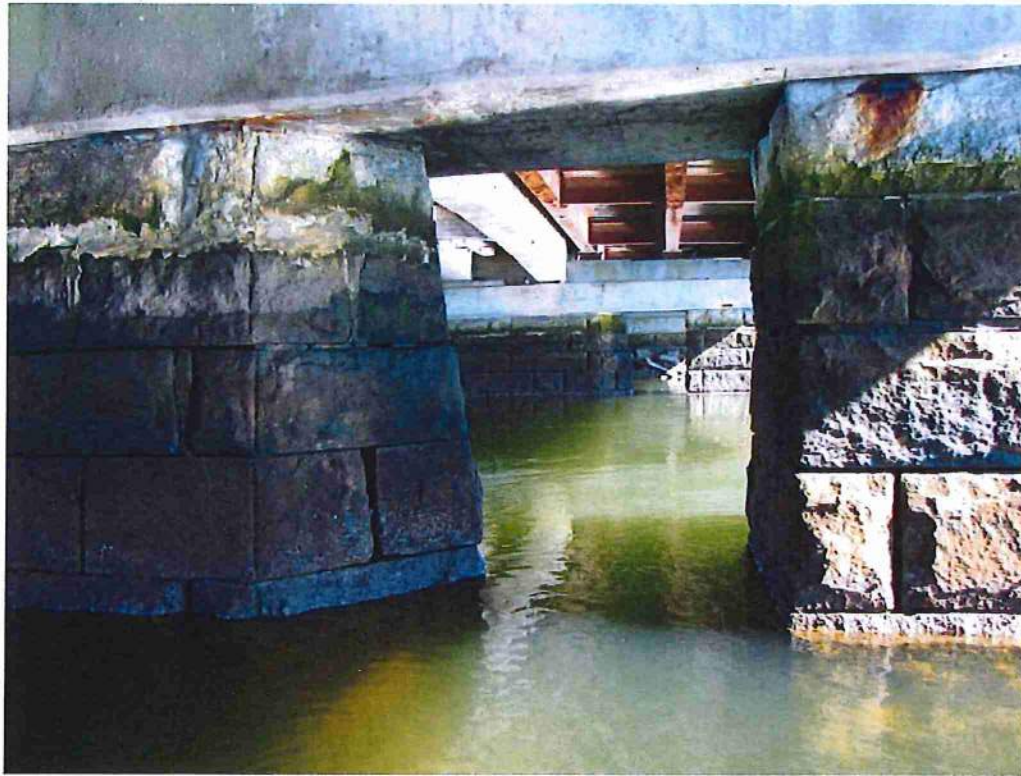
Photo 60: Pier 1, NE face - Typical of missing mortar and pointing

Photo 61: Pier 1 and south extension pier, west face. Missing pointing

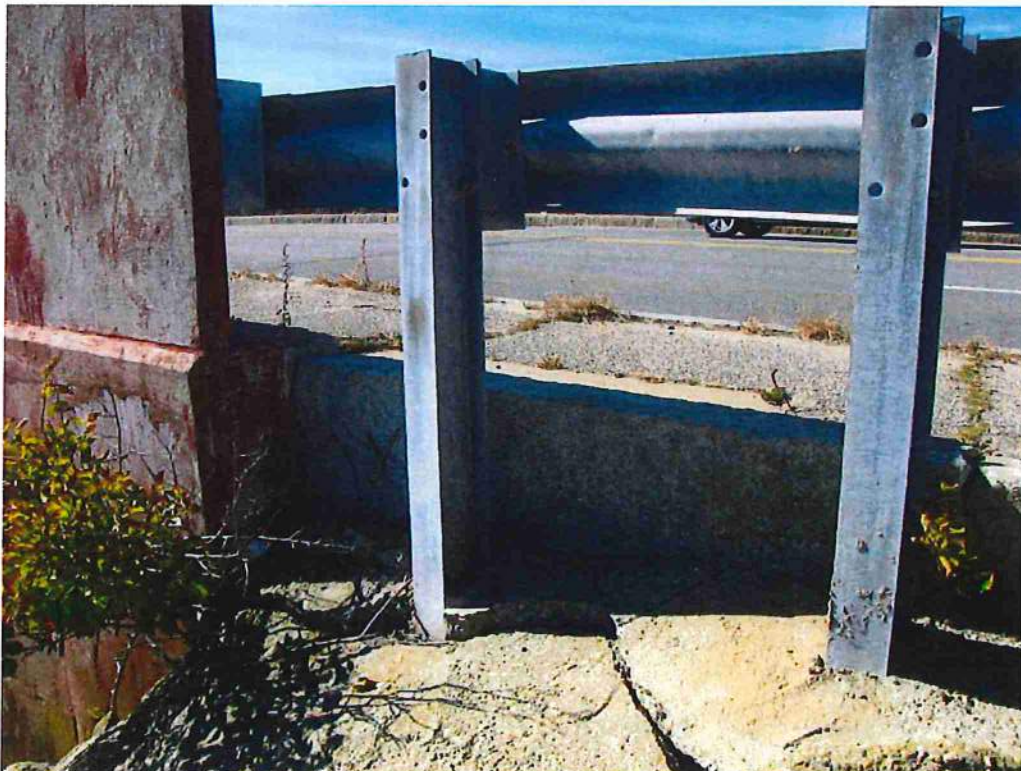
The SE transition has concrete at the base of the posts that is settled and cracked, see photo 62.

Photo 62: SE transition concrete at base of posts is settled and cracked
