**UNDERWATER OPERATIONS TEAM**  
**ROUTINE UNDERWATER INSPECTION REPORT**

BR. DEPT. NO.  
W-06-016

CITY/TOWN <b>WAREHAM</b>		8-STRUCTURE NO. <b>W06016-45K-DOT-NBI</b>		LEVEL OF INSPECTION <b>II</b>	93B-DATE INSPECTED <b>MAY 16, 2023</b>
07-FACILITY CARRIED <b>US 6 MARION RD</b>		ACCESS TO BRIDGE <b>EMBANKMENT</b>		UNDERWATER OPERATIONS ENGINEER <b>WILLIAM J. COLLERAN</b>	
06-FEATURES INTERSECTED <b>WATER WEWEANTIC RIVER</b>		DEPTH <b>10 m</b>	VISIBILITY <b>0.3 m</b>	TEAM LEADER (DIVE MASTER) <b>WILLIAM FERRY</b>	Report submitted by:
BOTTOM CONDITION <b>GRAVEL &amp; BOULDERS</b>		CURRENT <b>TIDAL/SWIFT</b>	TEAM MEMBERS <b>W. J. COLLERAN, J. A. MANKOWSKY, Z. GIKAS</b>

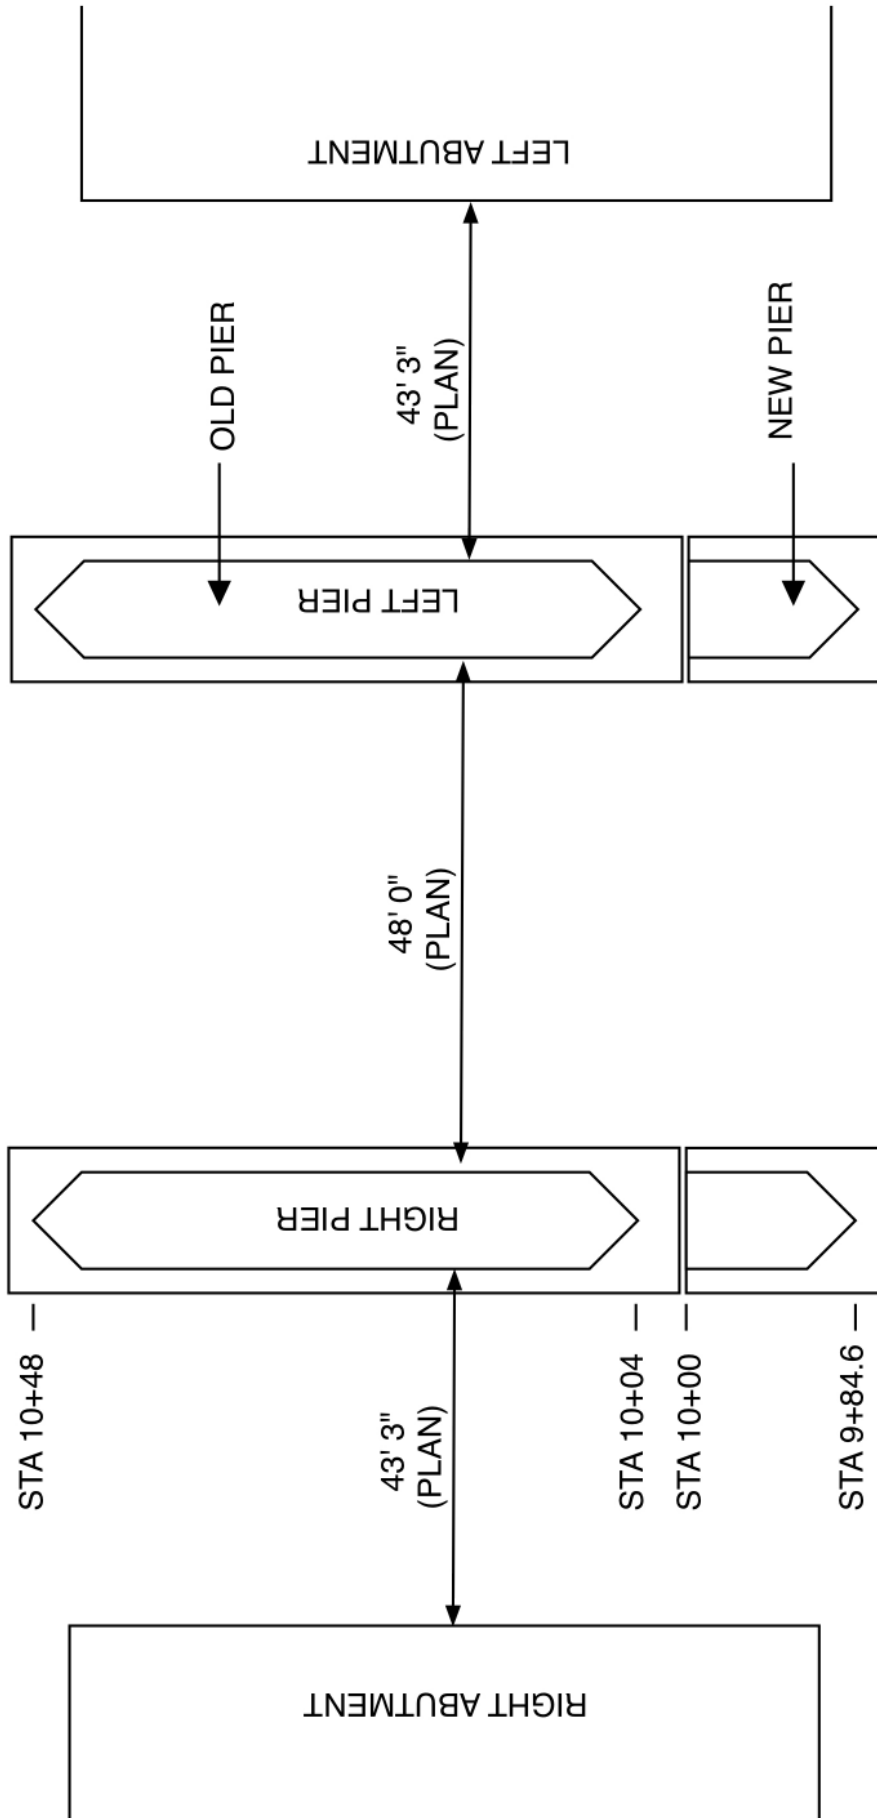
Sketch 1: PLAN VIEW - NOT TO SCALE

This structure is a three span bridge dated 1956. When the bridge was widened new piers were added at the downstream ends of the existing piers. The two sections of pier have a common concrete pier cap. See attached sketch on Page 7.

- 1) Orientation - Abutments and piers are labeled left and right when facing downstream.
- 2) Sta 10+00 is at the upstream face of the new section of the pier. See sketch on Page 6.

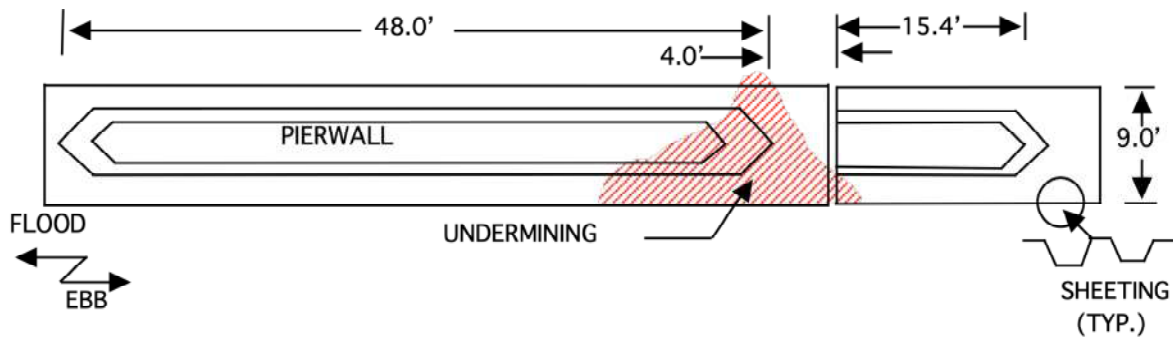
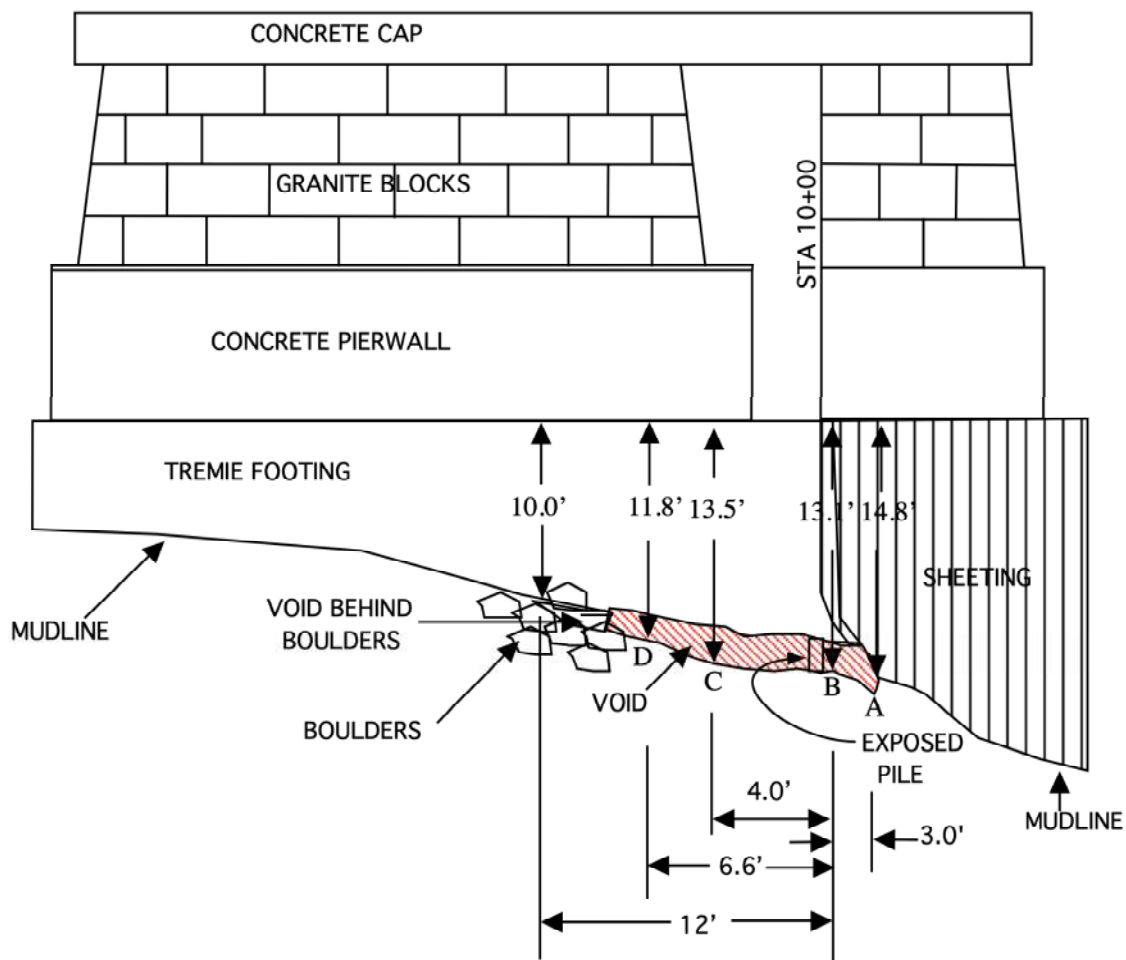
**Sketch 2: LEFT PIER PLAN VIEW & RIGHT SIDE ELEVATION VIEW - NOT TO SCALE**

There is undermining at the downstream end of the right face of the old section of the pier and continuing into the new section. For measuring purposes Sta 10+00 is at the upstream face of the new section of the pier (See Sketch). The undermining extends 3' downstream of Sta 10+00 where it meets steel sheeting. The undermining extends 12' upstream of Sta 10+00 where it is covered by boulders. The penetration from Sta 10+10 to 10+12 is behind boulders. The maximum height of the undermining is 1.4' and the maximum penetration is 8.0'. The total width of the footing is approximately 9' (penetration extends beyond the footing approximately 1.2'). Penetration into soil had been up to 13.6' during previous inspections. See Undermining Monitoring Chart on Page 8. This undermining may have been caused by a washout of concrete laitance in addition to a scouring out of bottom materials.

There is undermining at the downstream end of the right face of the old section of the pier and continuing into the new section. For measuring purposes Sta 10+00 is at the upstream face of the new section of the pier (See Sketch). The undermining extends 3' downstream of Sta 10+00 where it meets steel sheeting. The undermining extends 12' upstream of Sta 10+00 where it is covered by boulders. The penetration from Sta 10+10 to 10+12 is behind boulders. The maximum height of the undermining is 1.4' and the maximum penetration is 8.0'. The total width of the footing is approximately 9' (penetration extends beyond the footing approximately 1.2'). Penetration into soil had been up to 13.6' during previous inspections. See

Undermining Monitoring Chart on Page 8. This undermining may have been caused by a washout of concrete laitance in addition to a scouring out of bottom materials.
