Parker River Restoration Project – Site Photographs

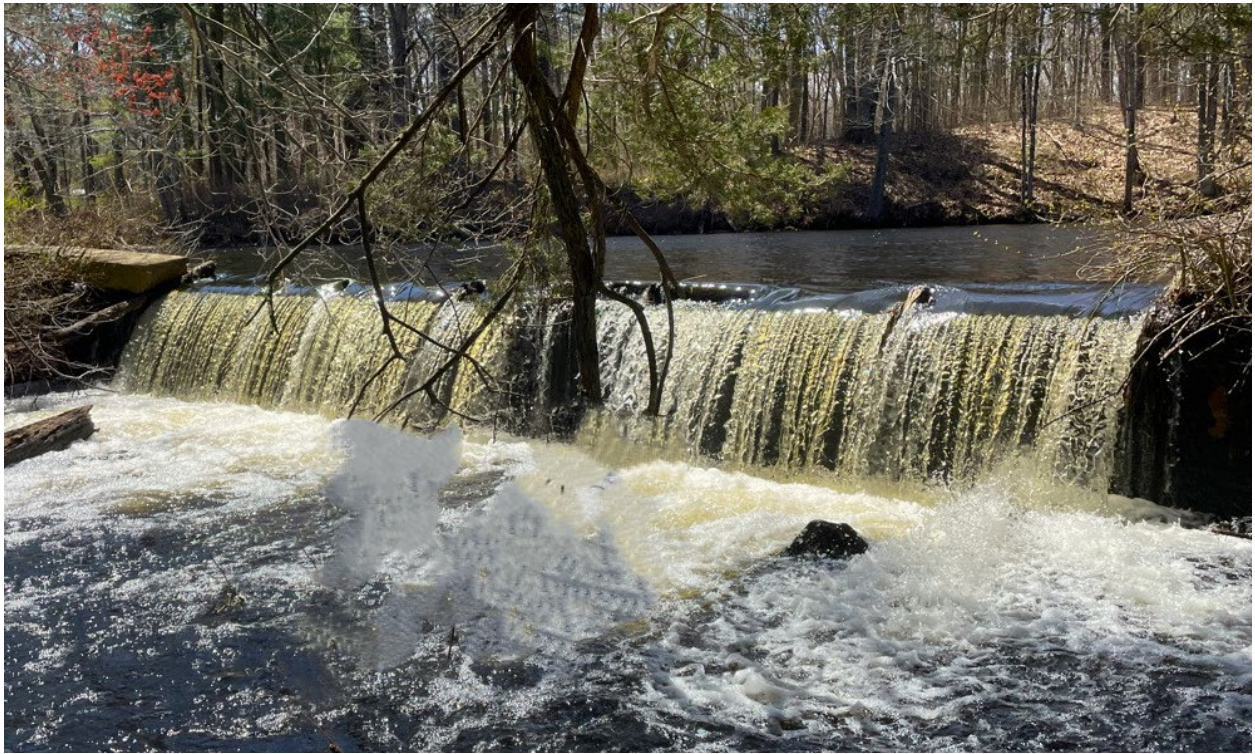
Spillway from downstream during spring high flow

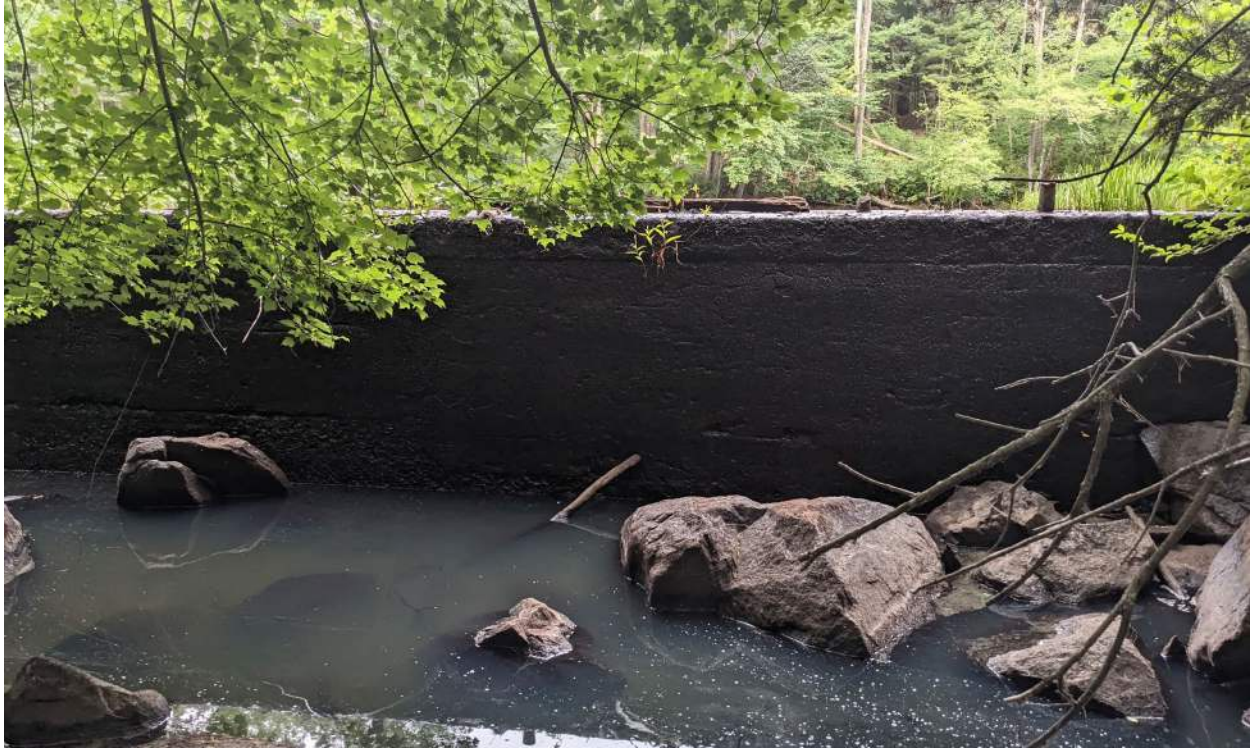
Spillway from downstream during summer low flow

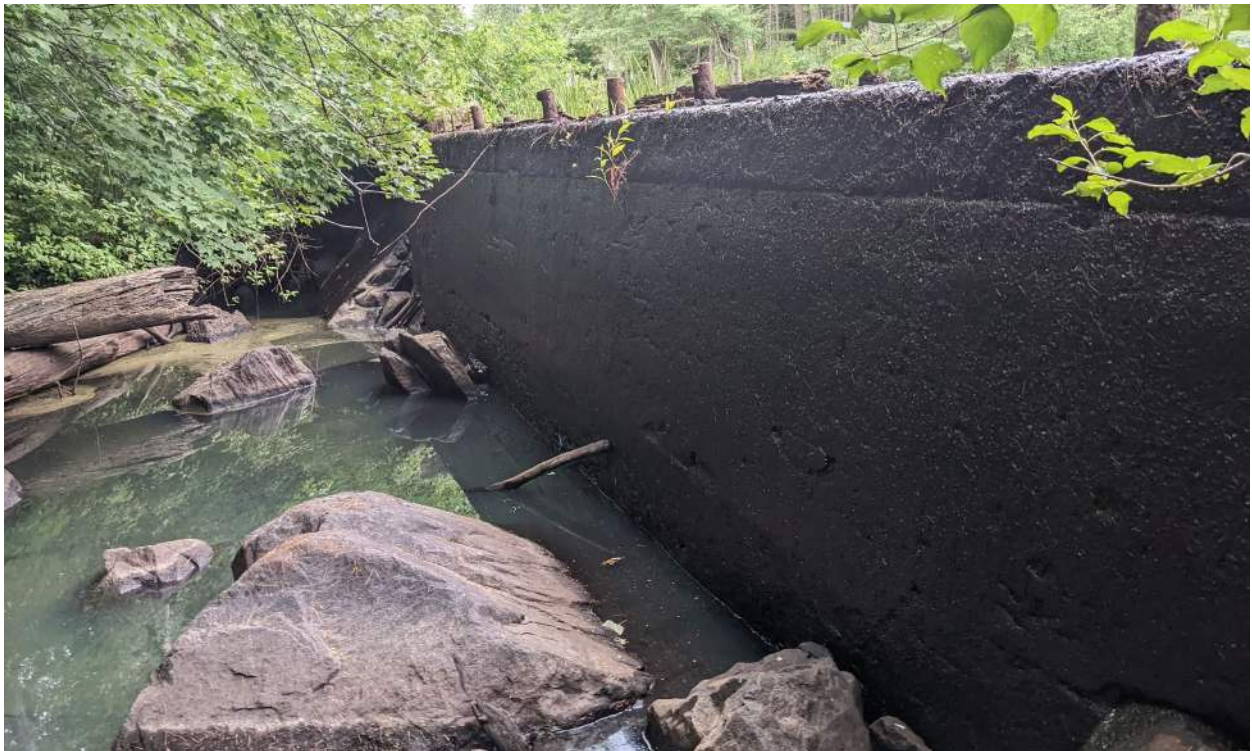
Spillway from left (north) abutment

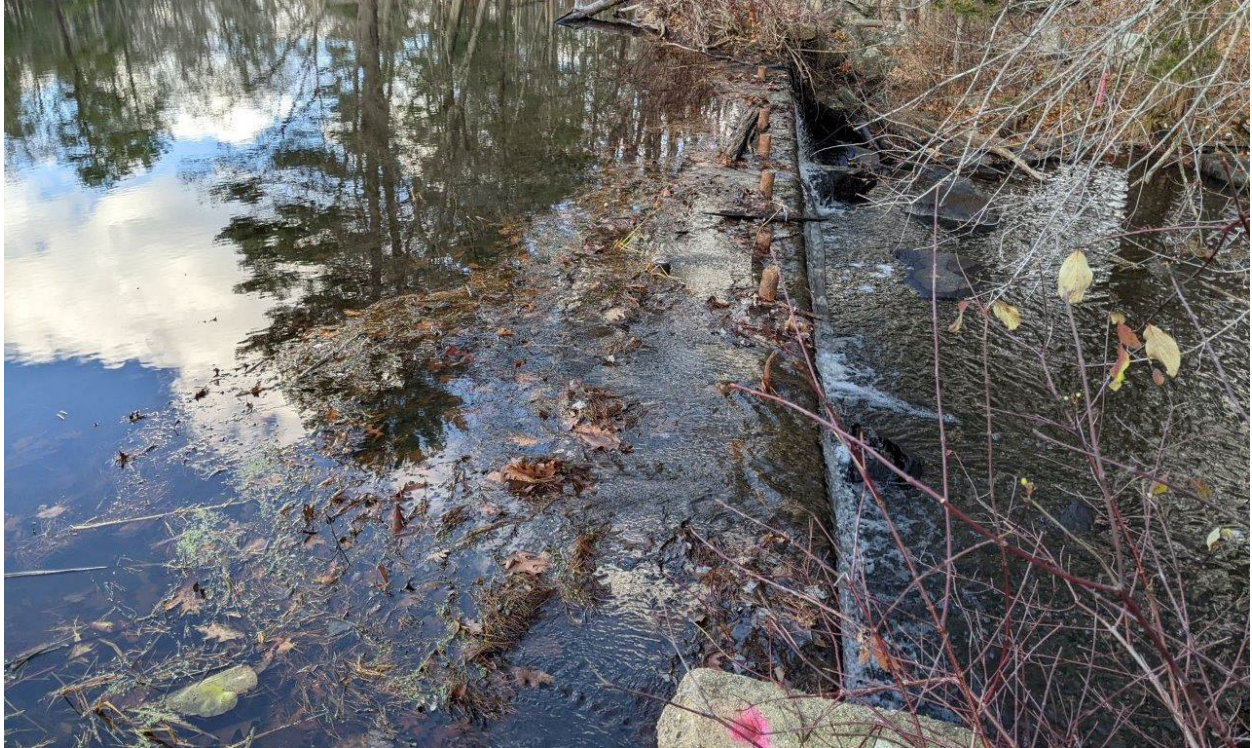
Spillway from right (south) abutment

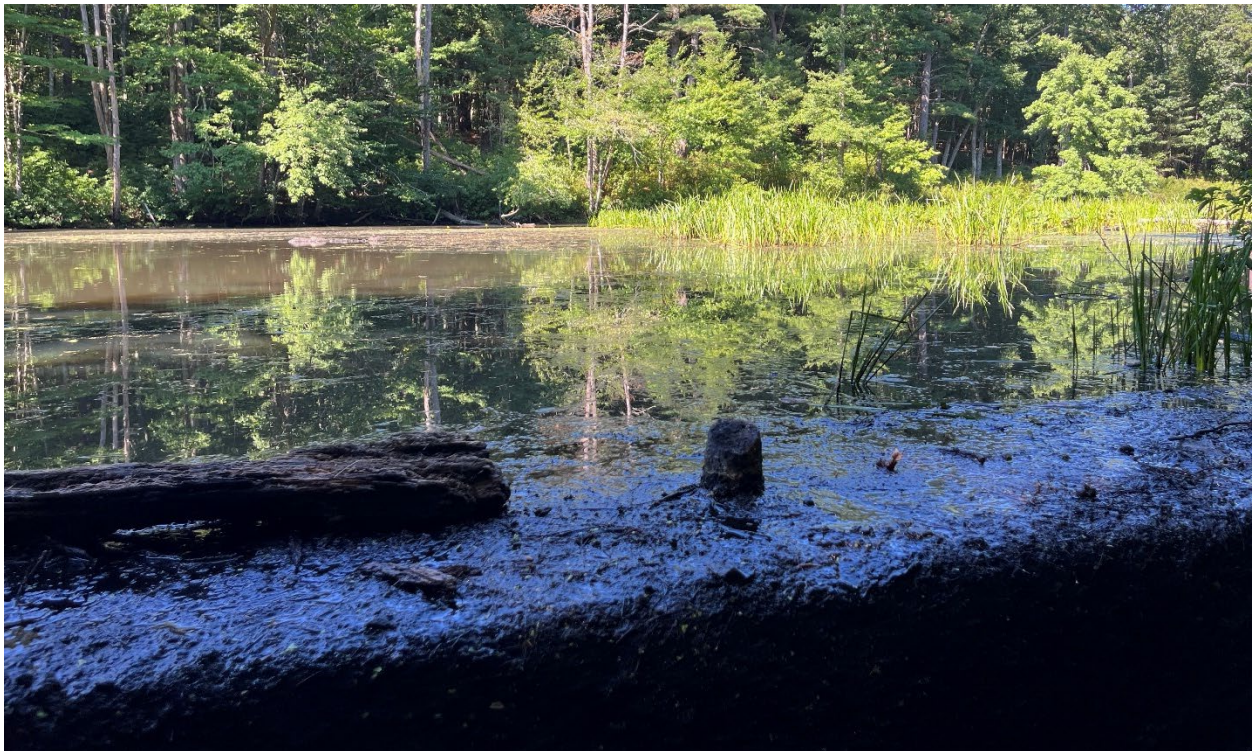
Impoundment from spillway

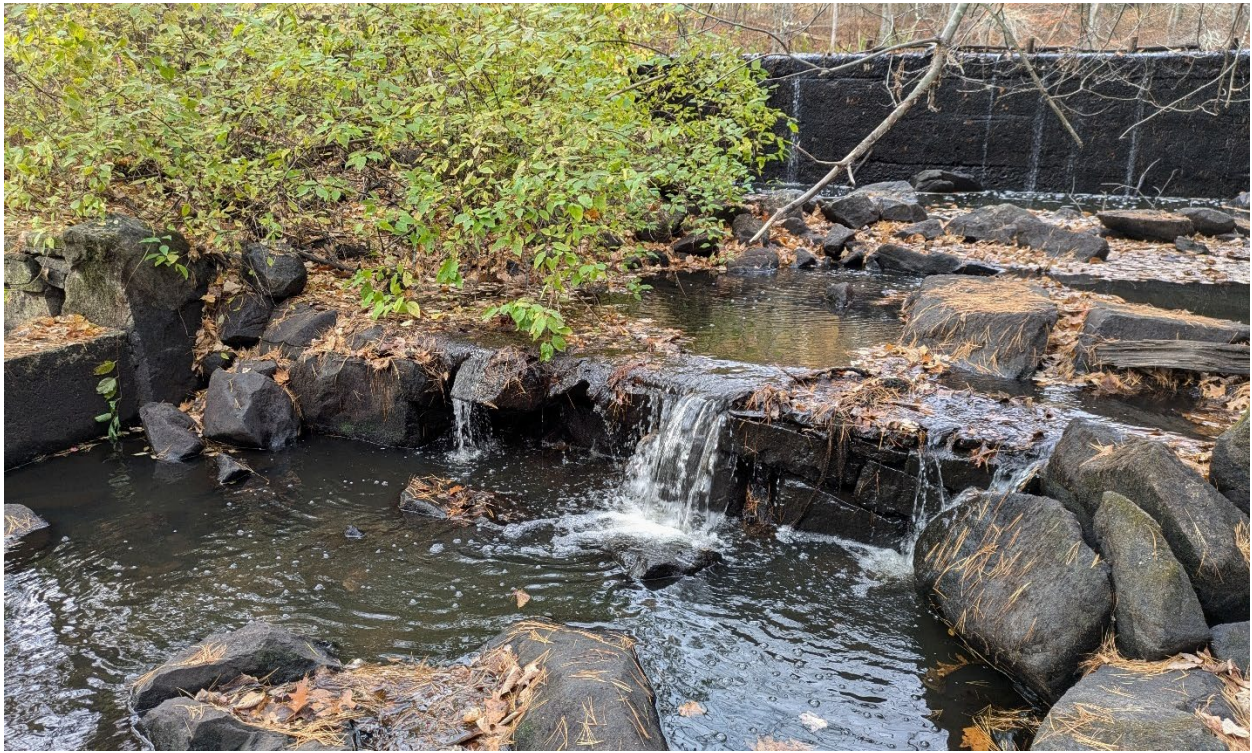
South masonry fish weir with spillway in background and fishway entrance at left

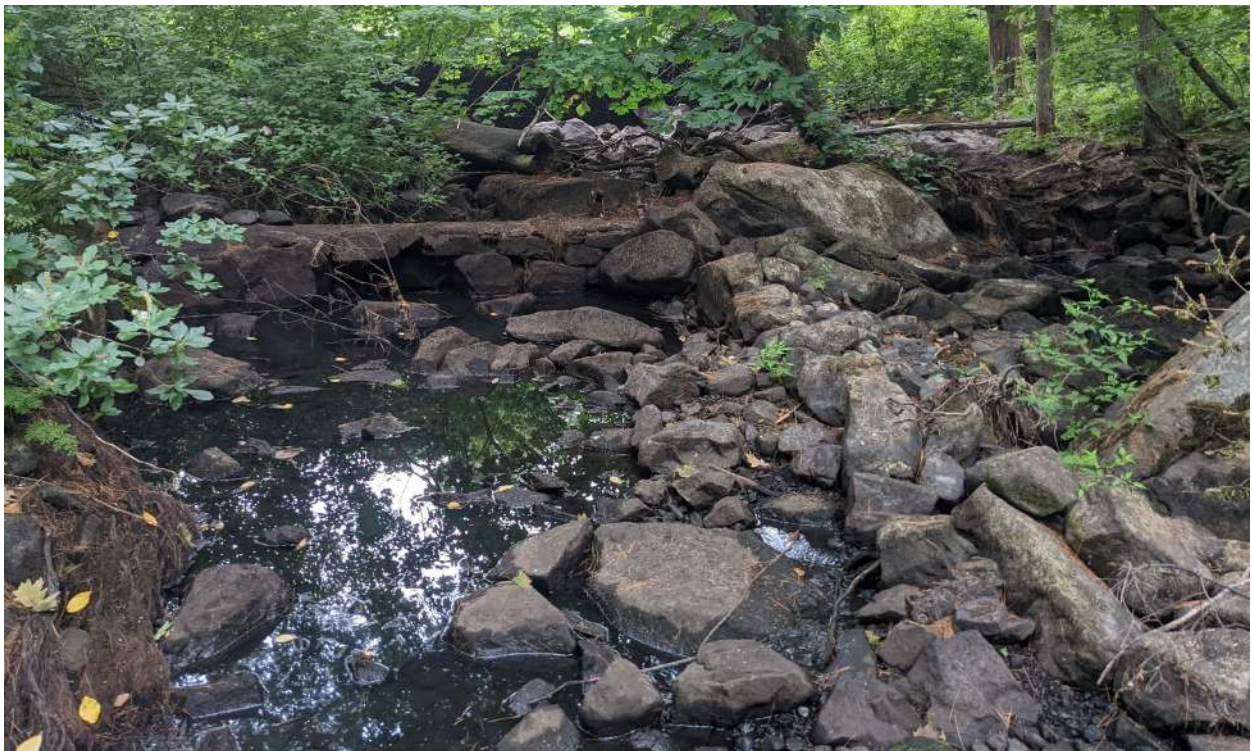
Looking upstream at both fish weirs (south masonry weir on left and north earthen weir on right beyond boulder)

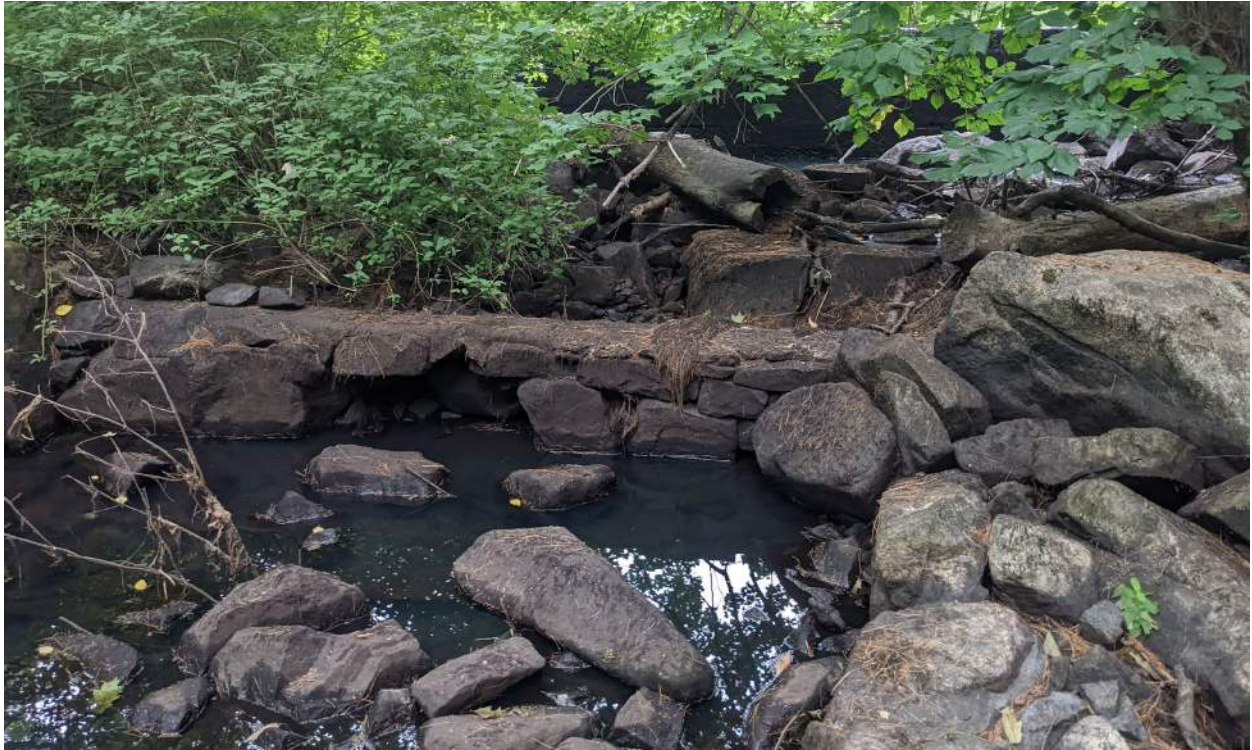
South masonry fish weir with spillway in background

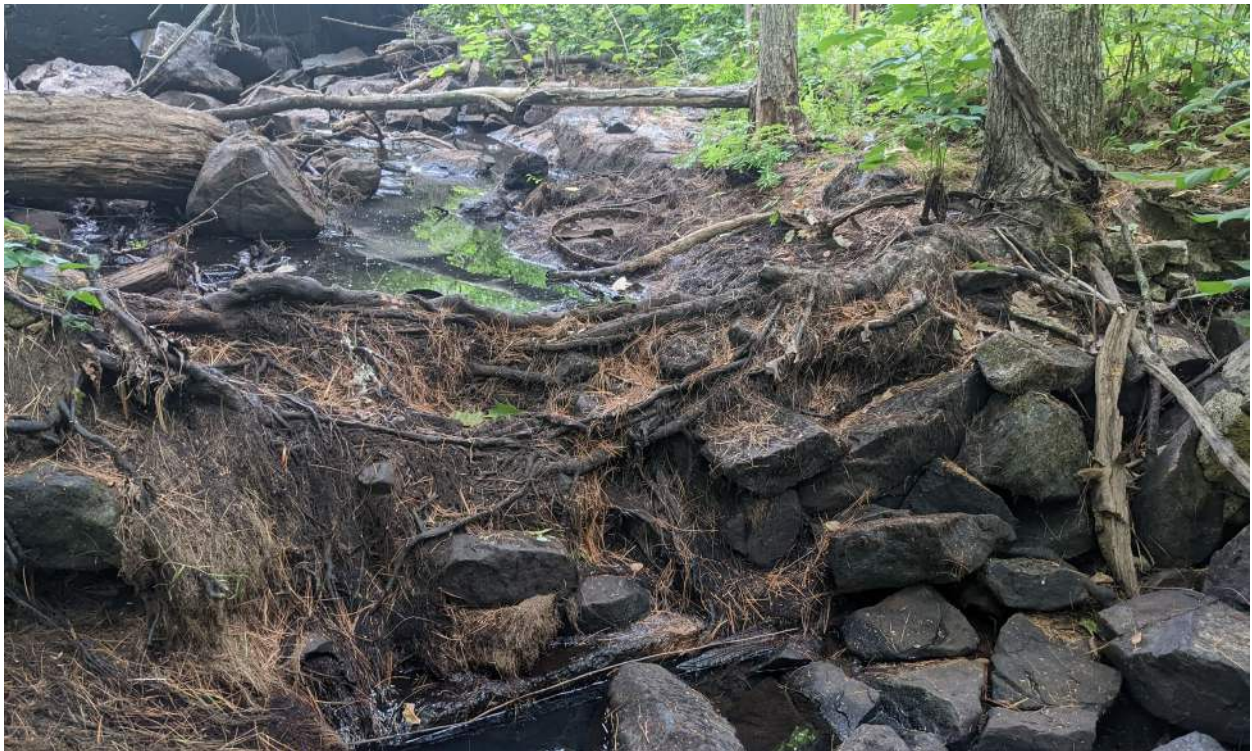
North earthen fish weir with spillway in background

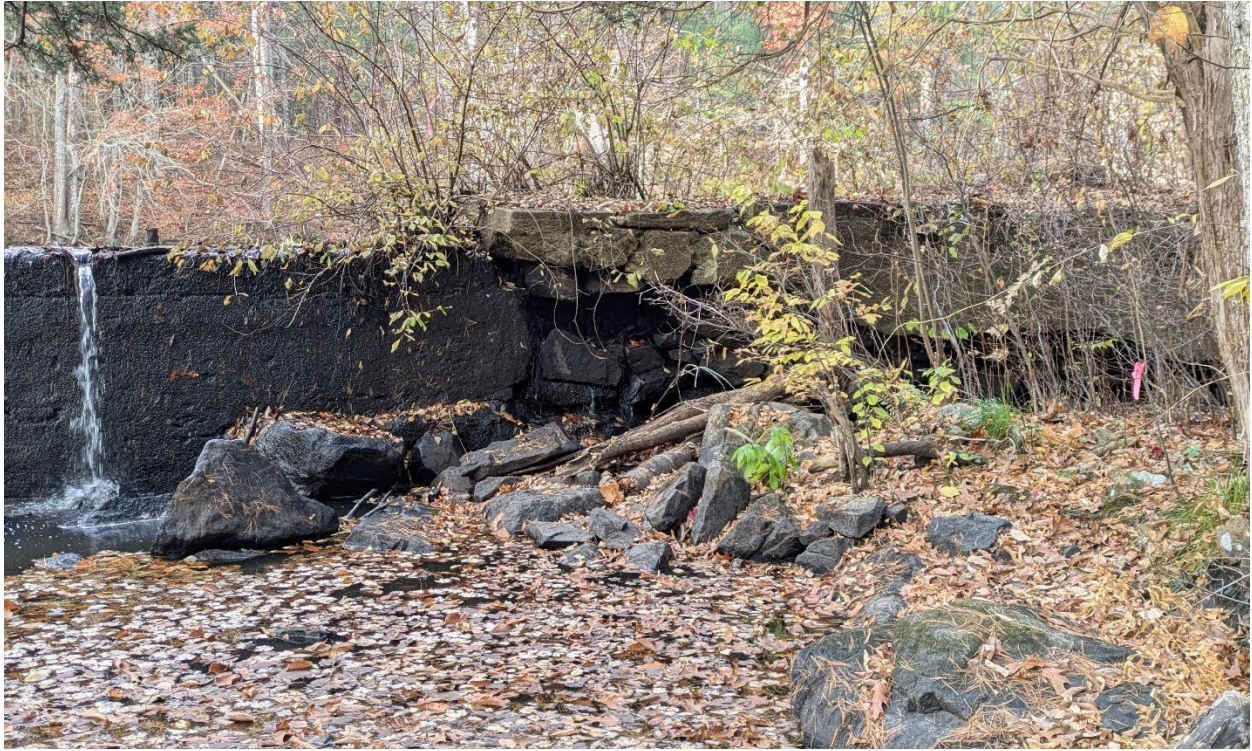
Left (north) abutment from downstream

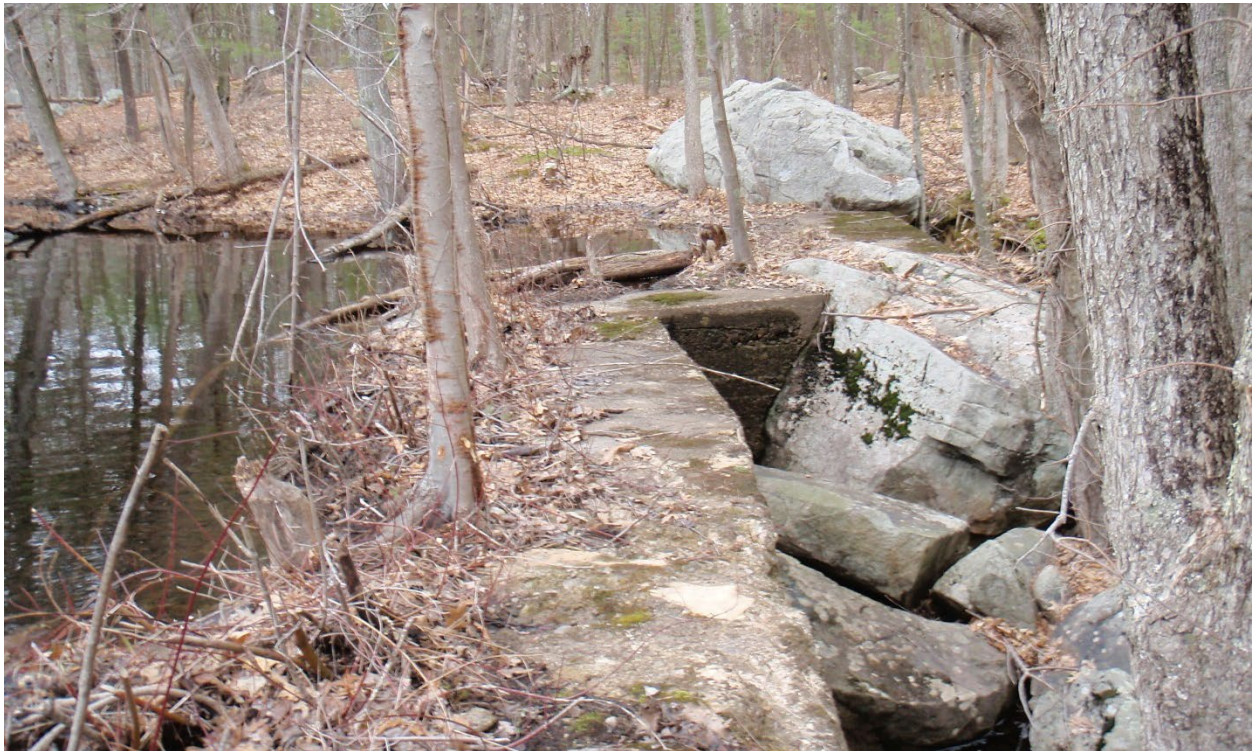
Left (north) abutment from spillway

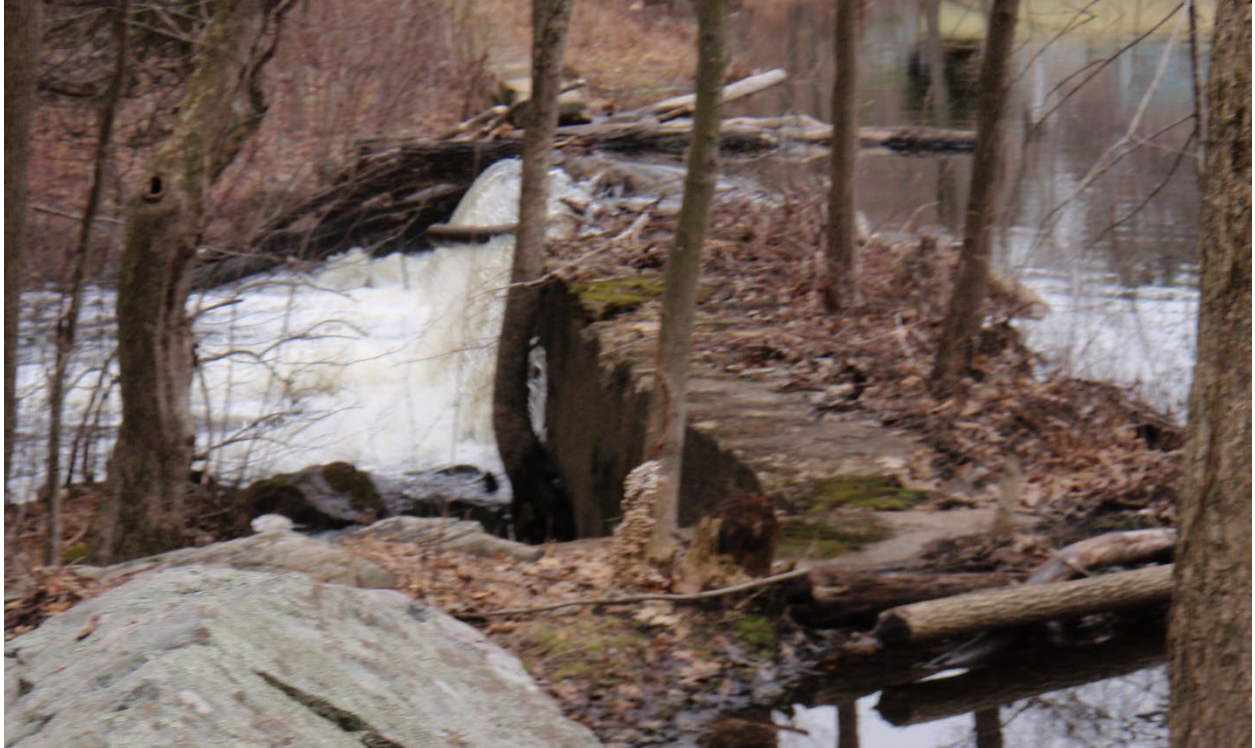
Left (north) abutment from north end of abutment, looking toward spillway

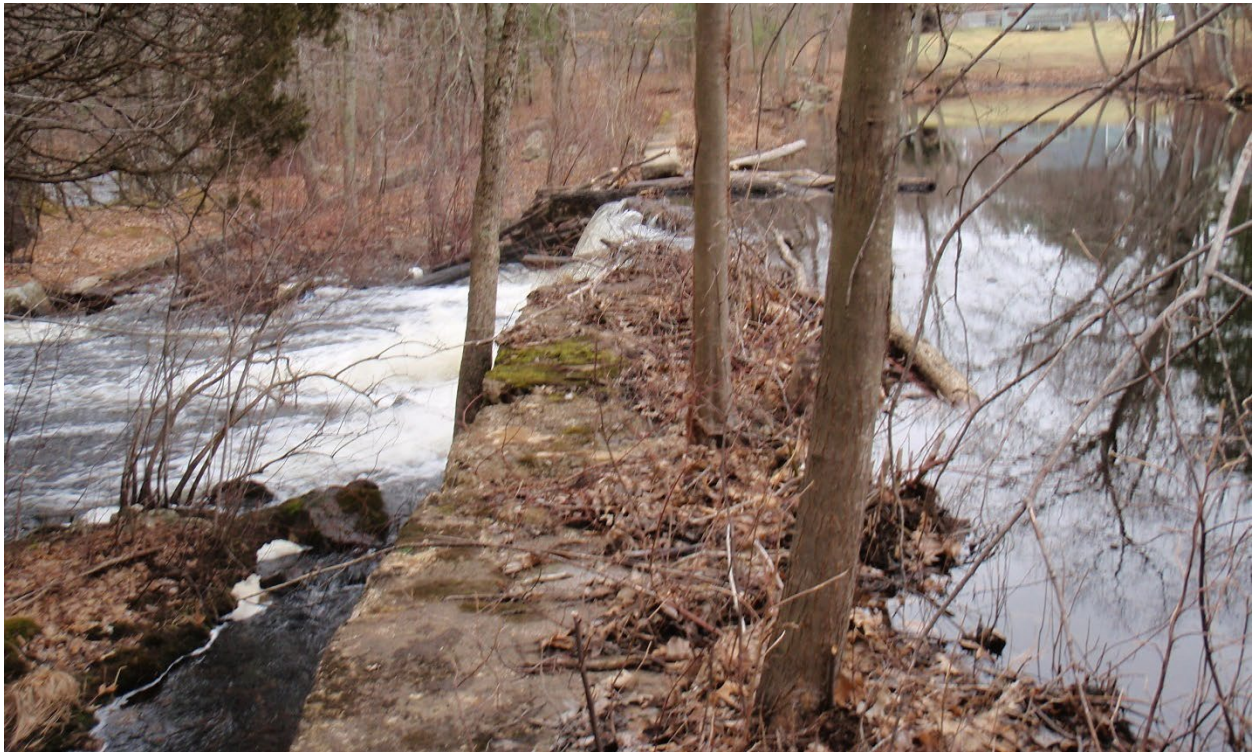
Left (north) abutment from midpoint of abutment, looking toward spillway

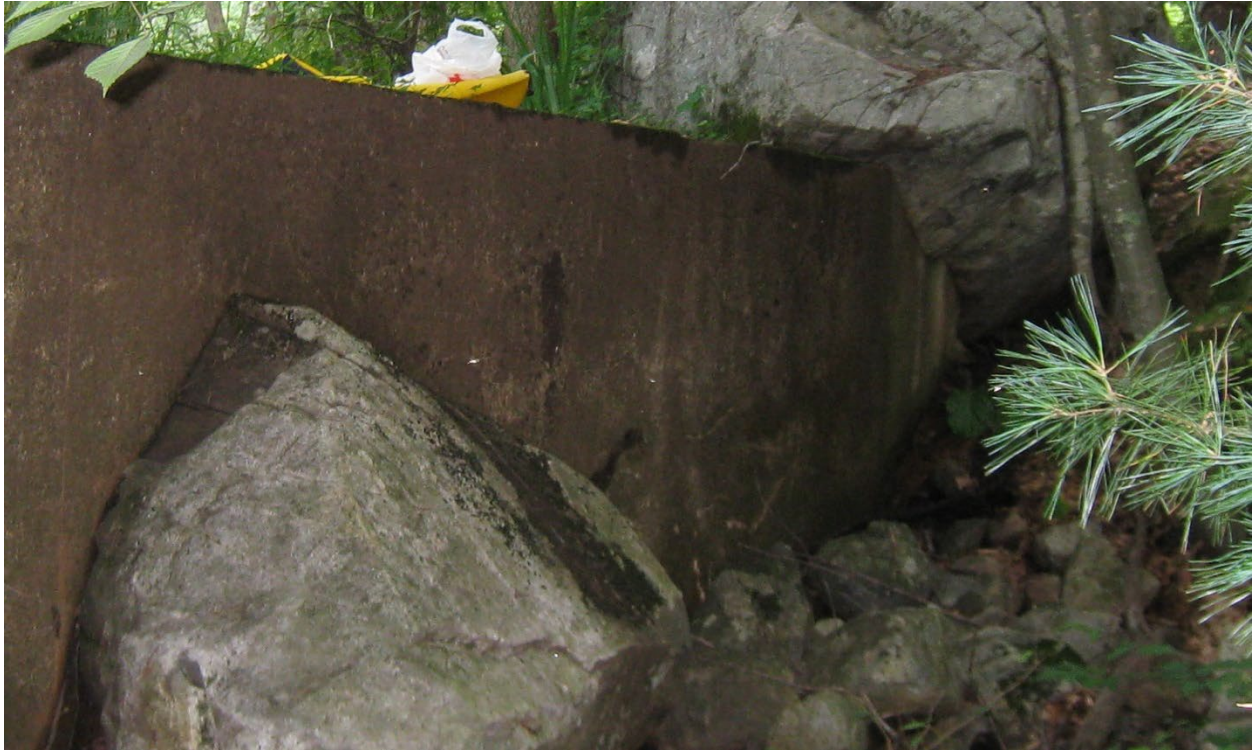
Left (north) abutment from downstream face, looking northwest

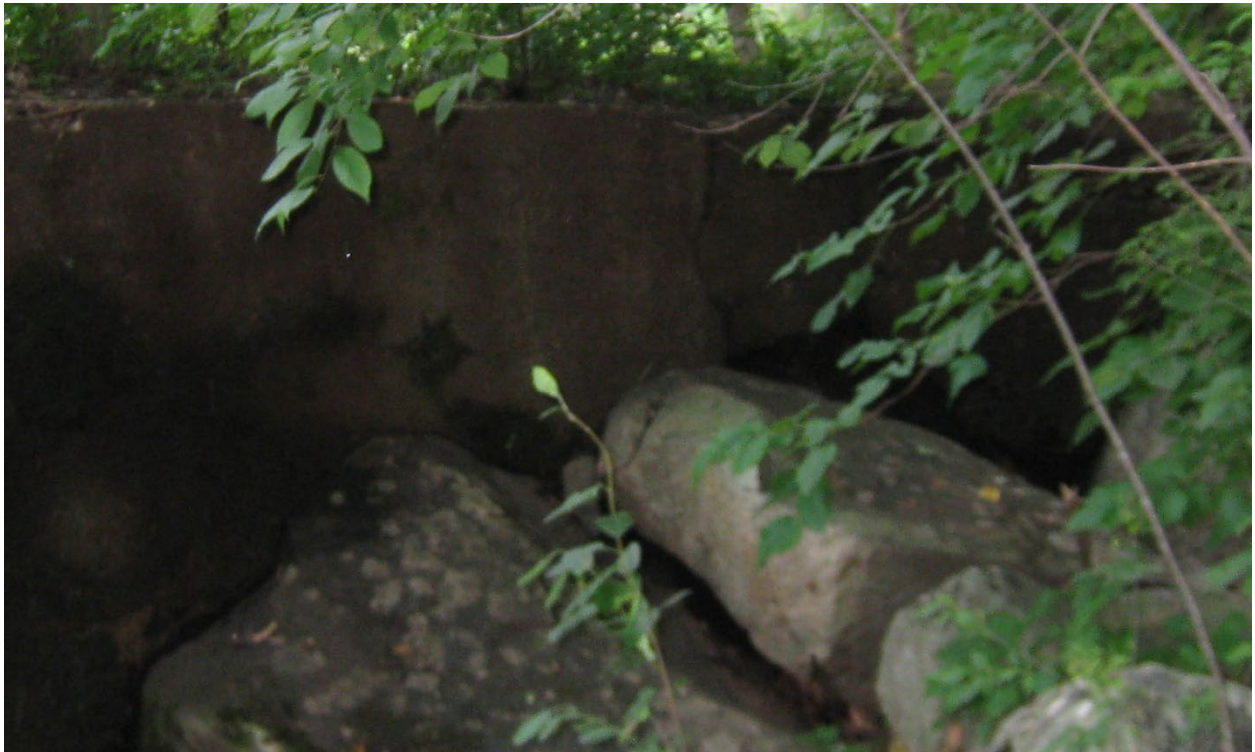
Left (north) abutment from downstream face, looking northwest

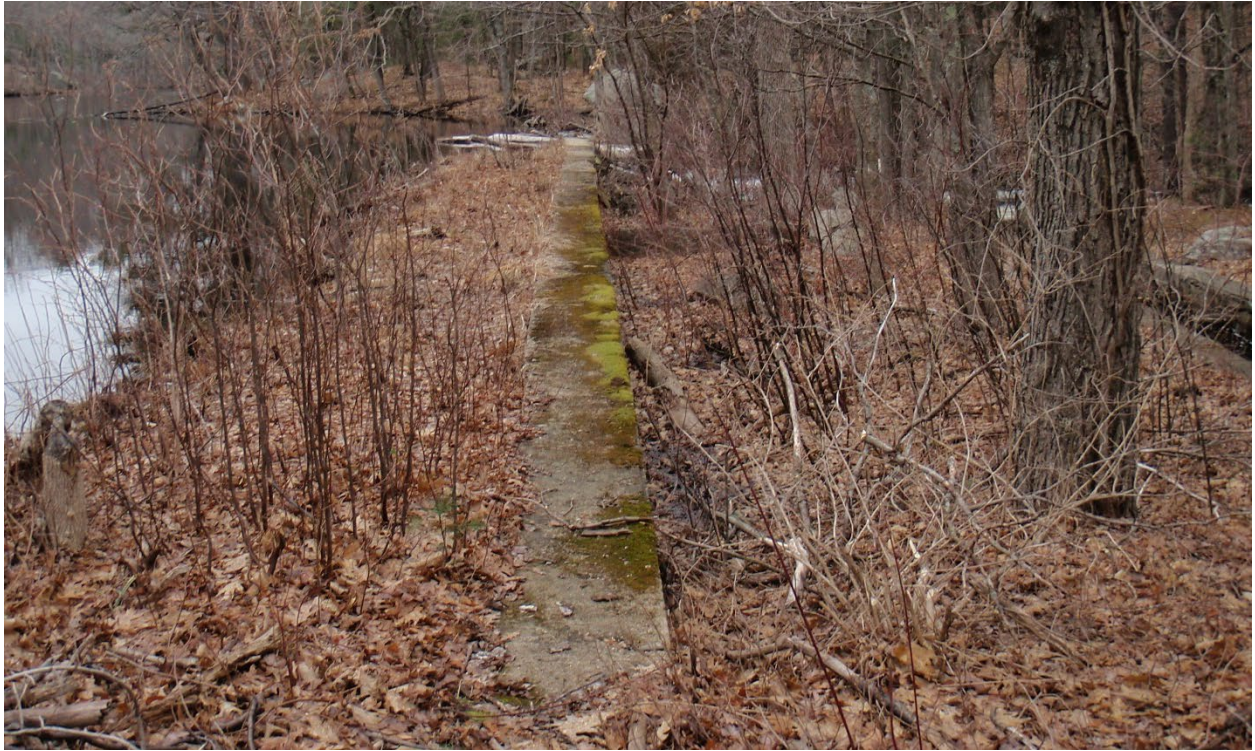
Right (south) abutment, looing northwest toward spillway

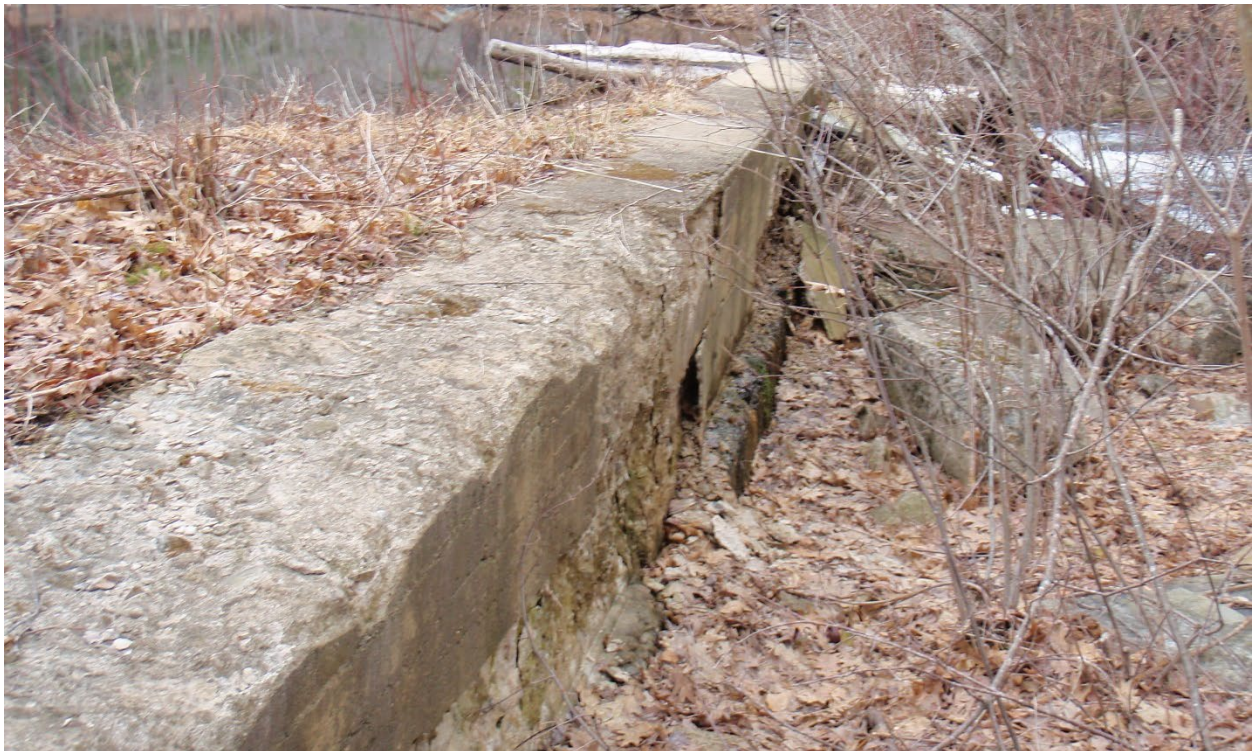
Right (south) abutment, looing northwest toward spillway

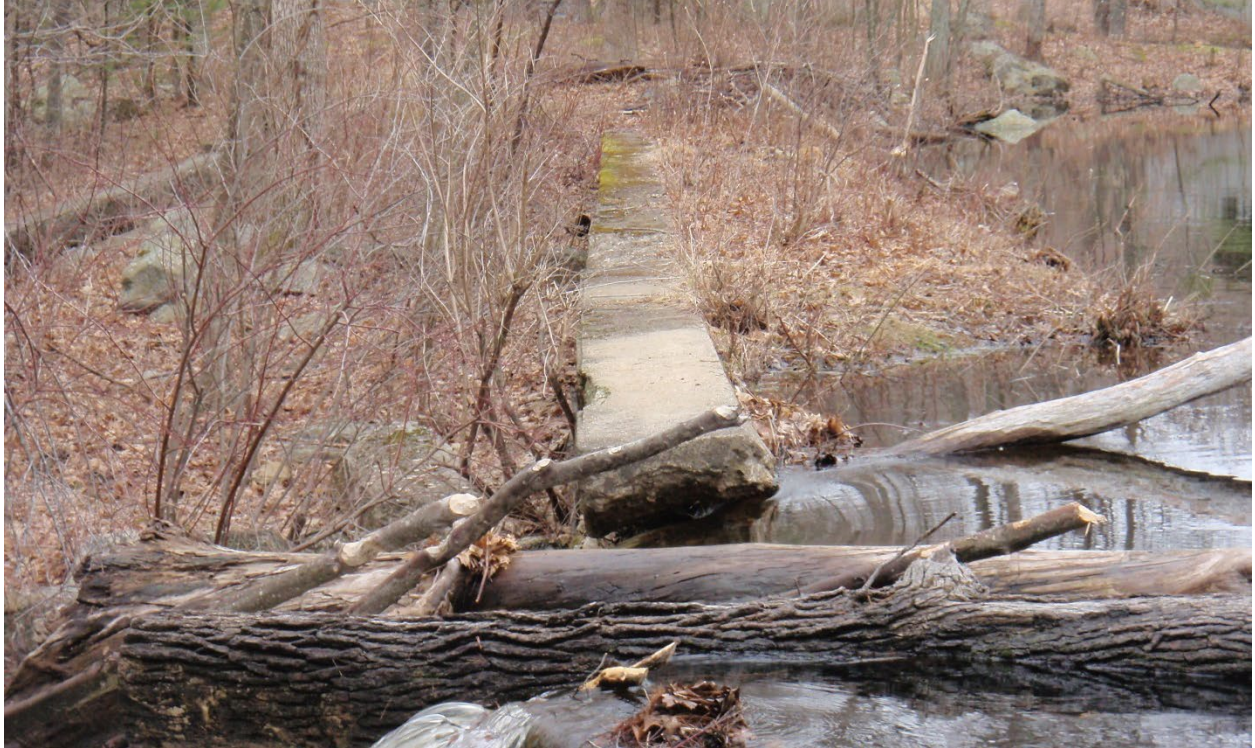
Right (south) abutment, looing southeast from spillway

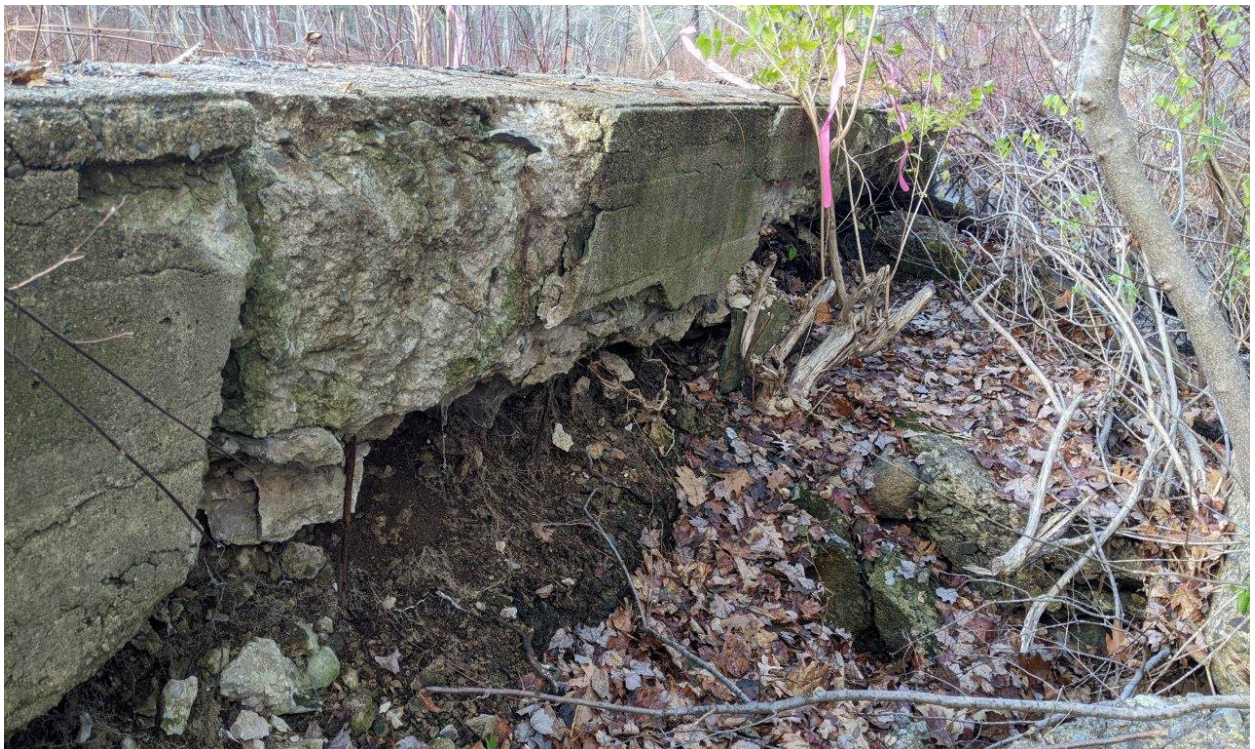
Right (south) abutment deterioration, looking northwest toward spillway

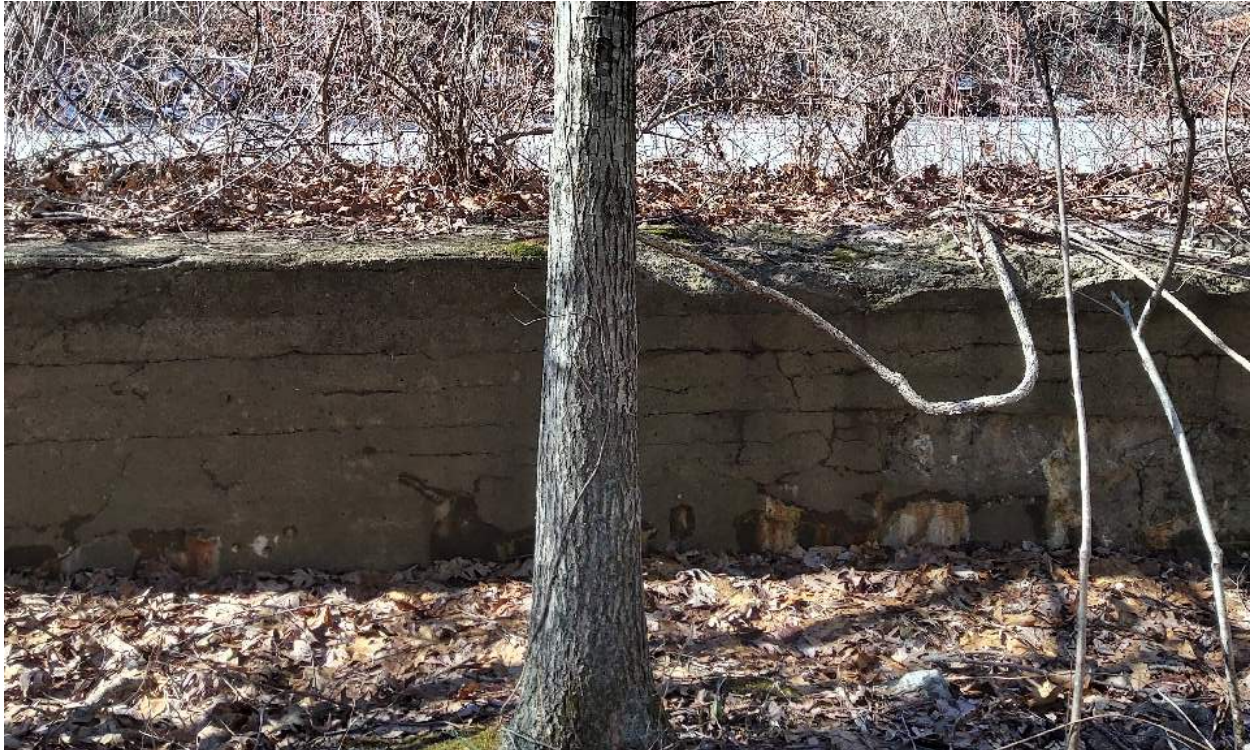
Right (south) abutment, looking west (impoundment in background)

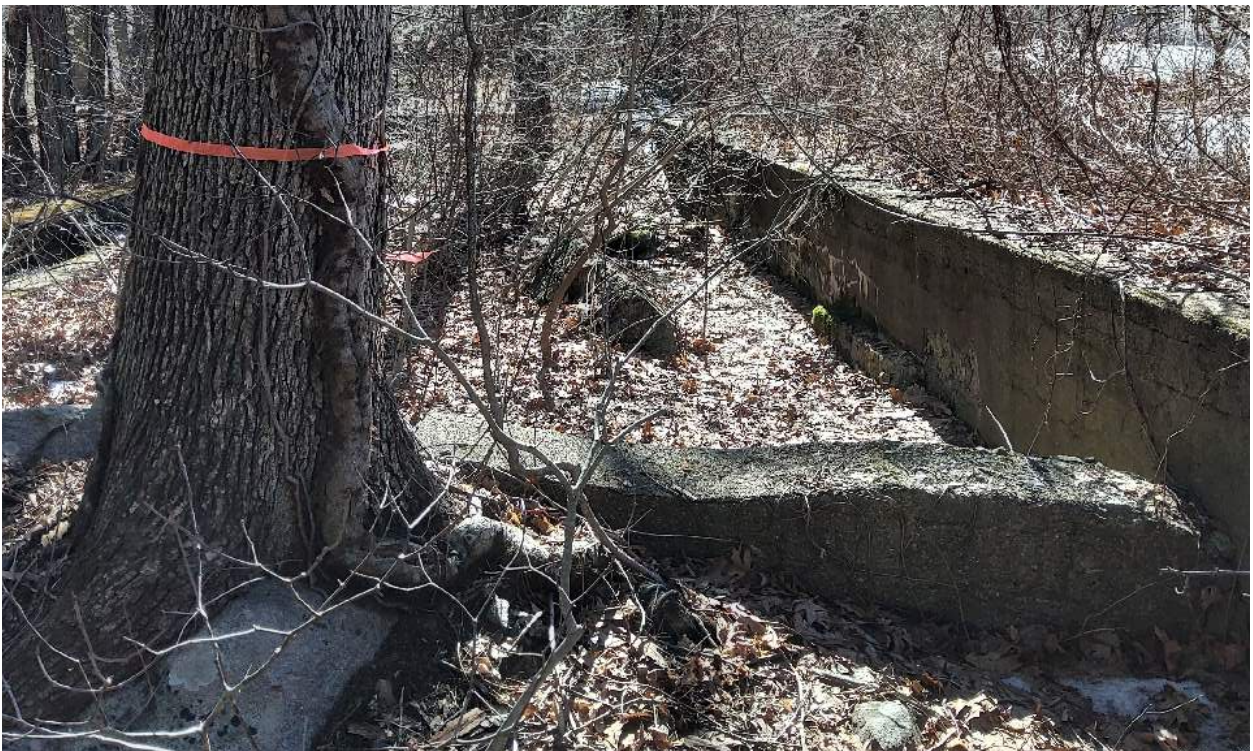
Right (south) abutment, looking southeast (note large tree was not removed)

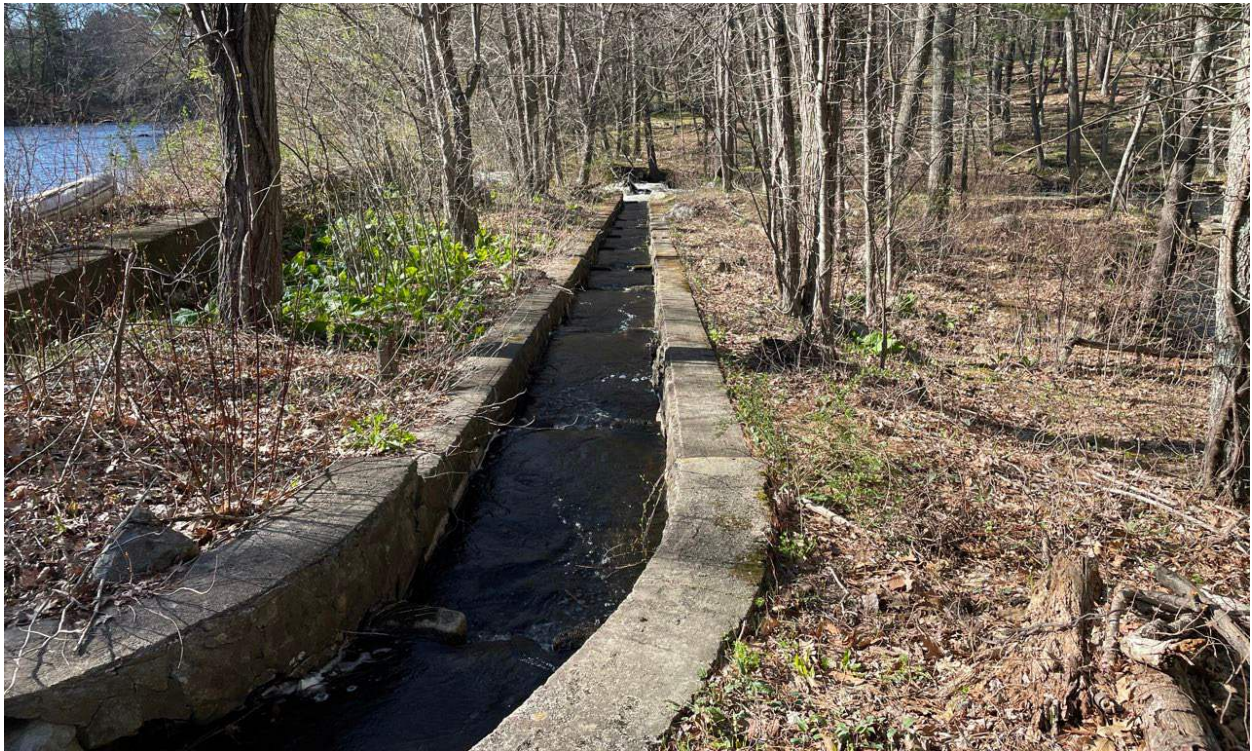
Fishway, looking north (downstream)

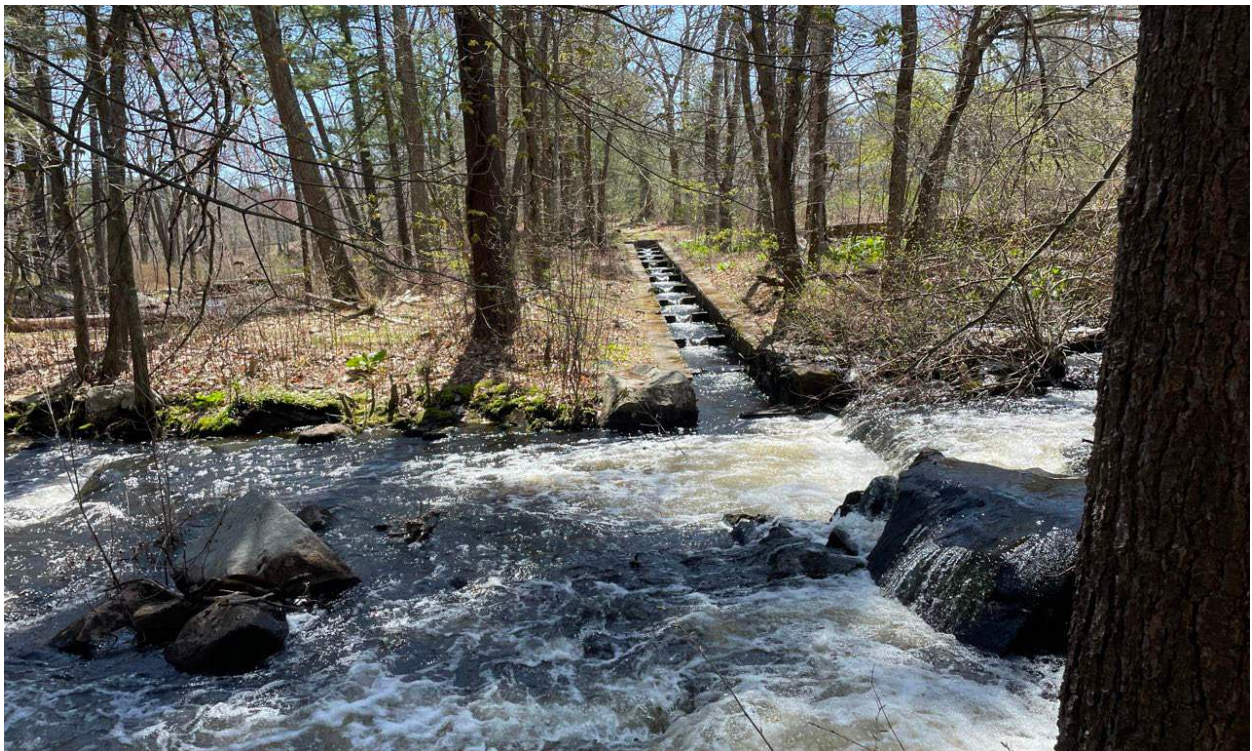
Fishway, looking southeast from river left bank (note proposed sediment stockpile area at left and fish weir at right)

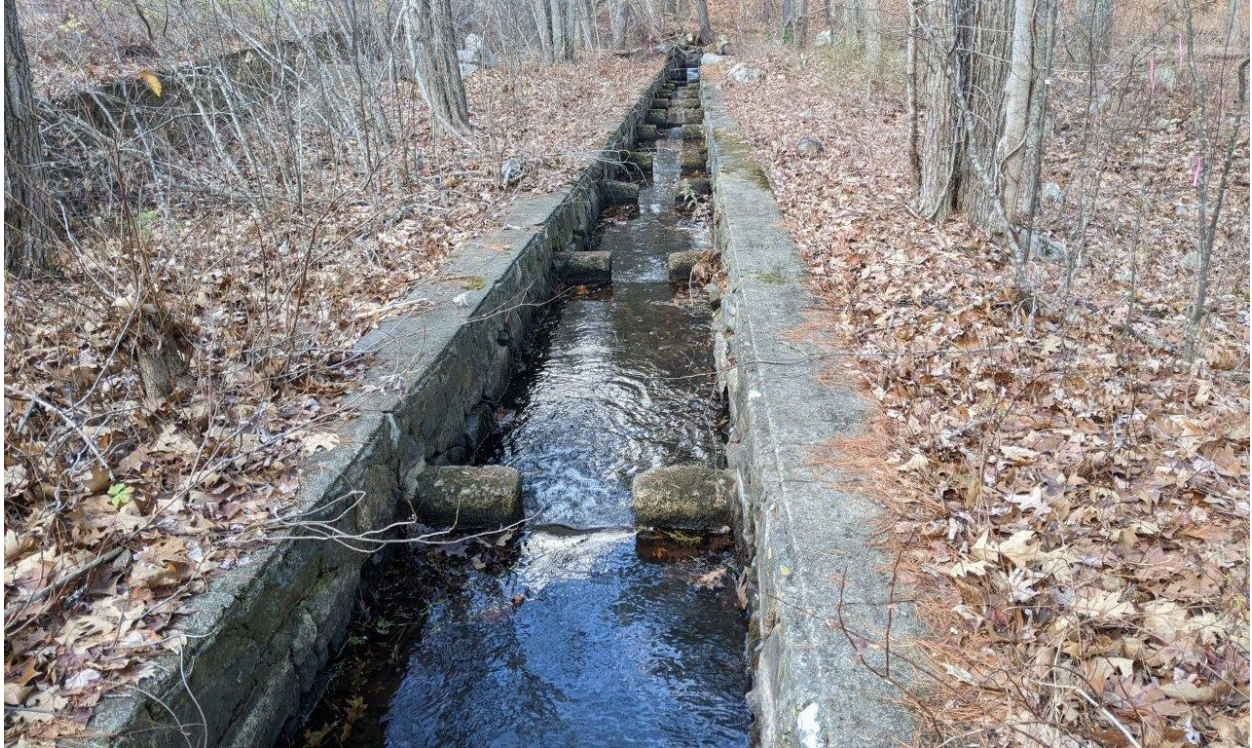
Fishway, looking northwest (downstream)
