Parker River Restoration Project – Site Photographs

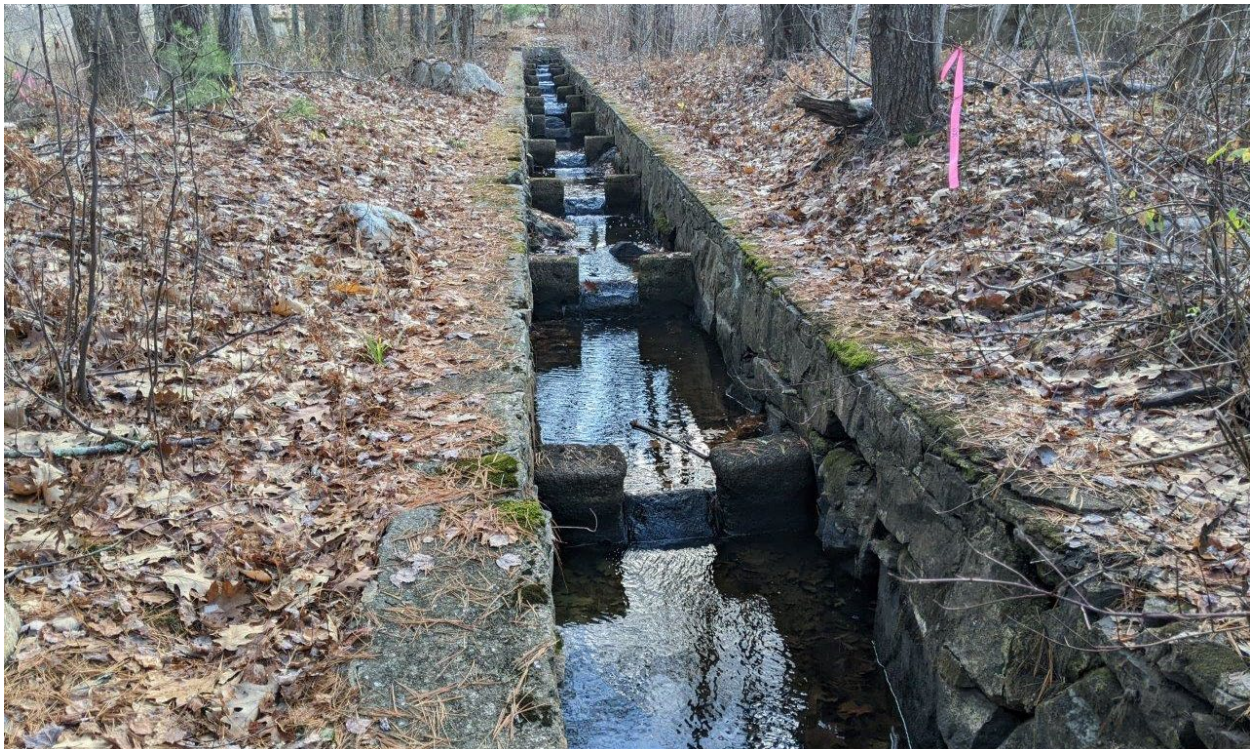
Fishway, looking southeast (upstream)

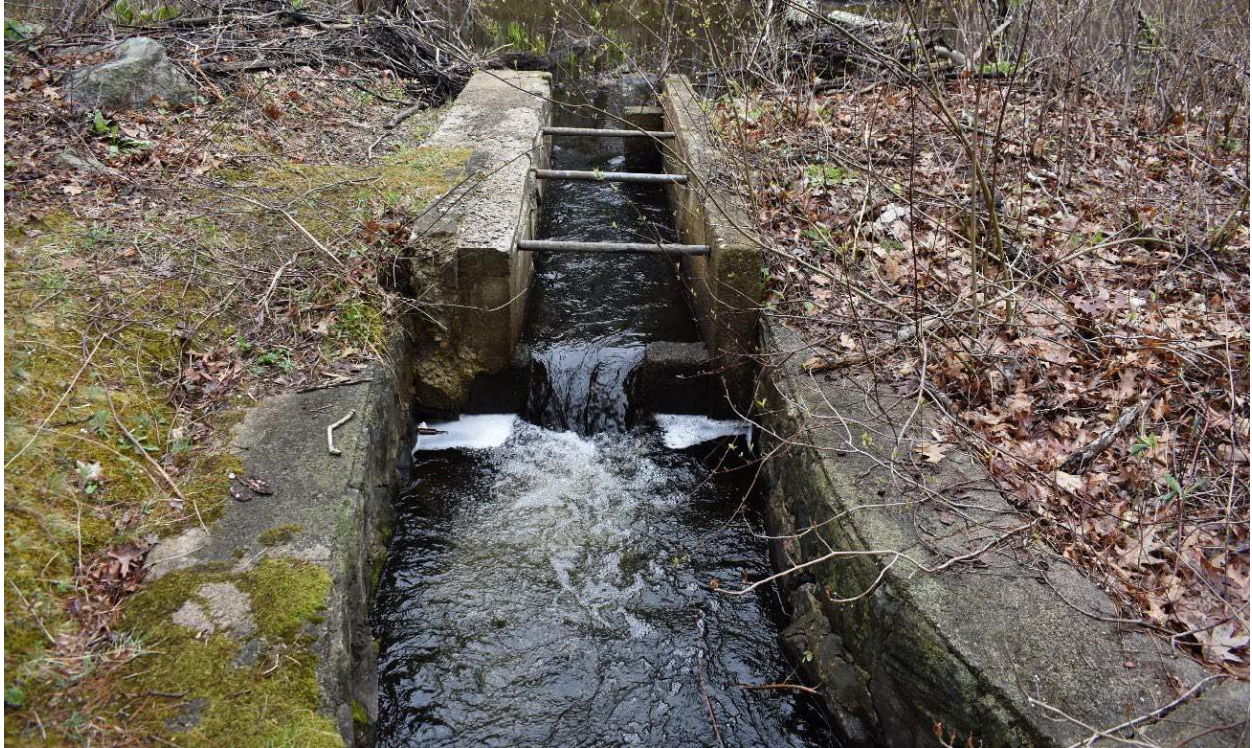
Upstream fishway exit into impoundment (looking southwest)

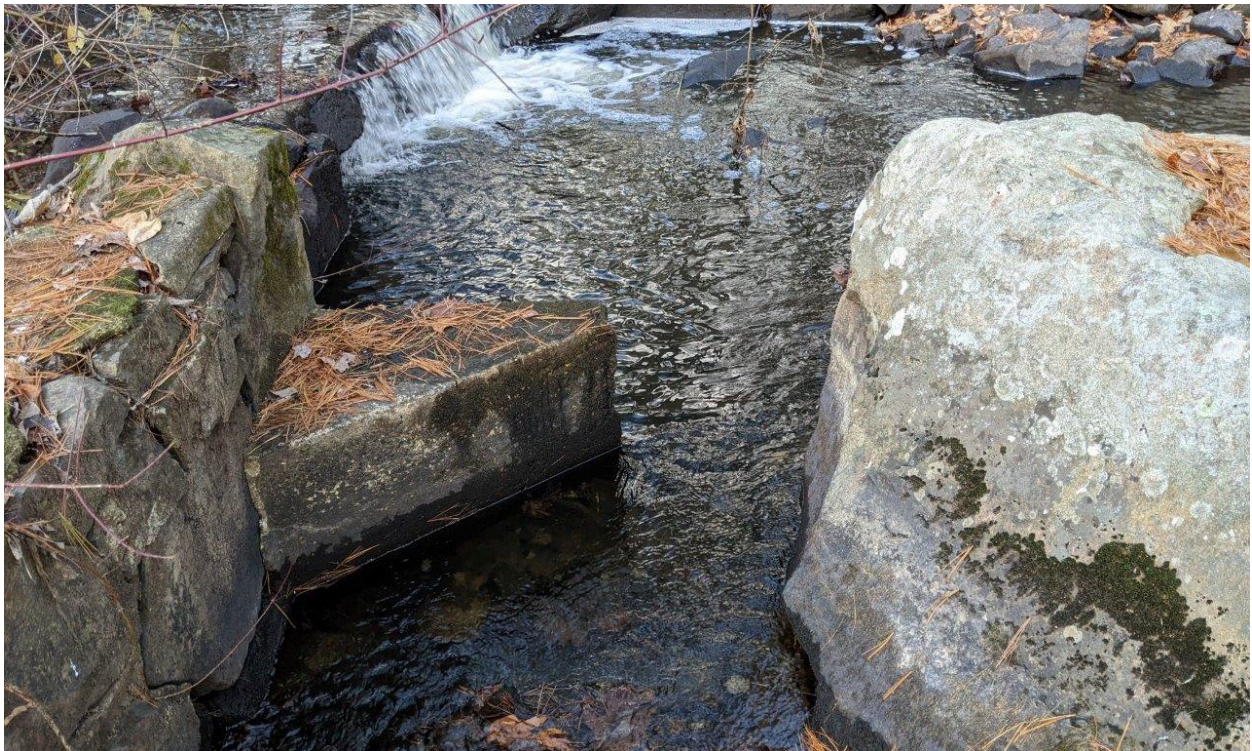
Downstream fishway entrance (looking northwest, note fish weir in background at left)

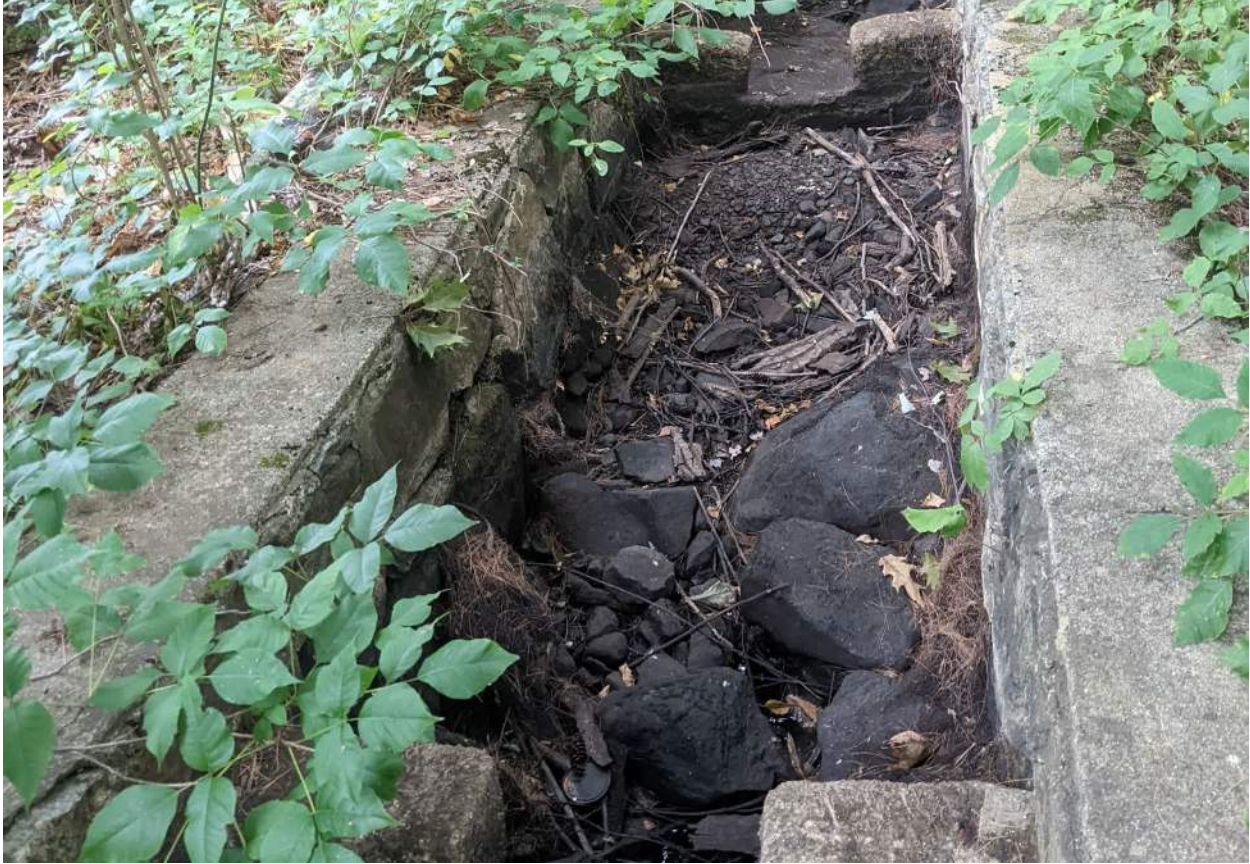
Dewatered fishway showing bottom substrate

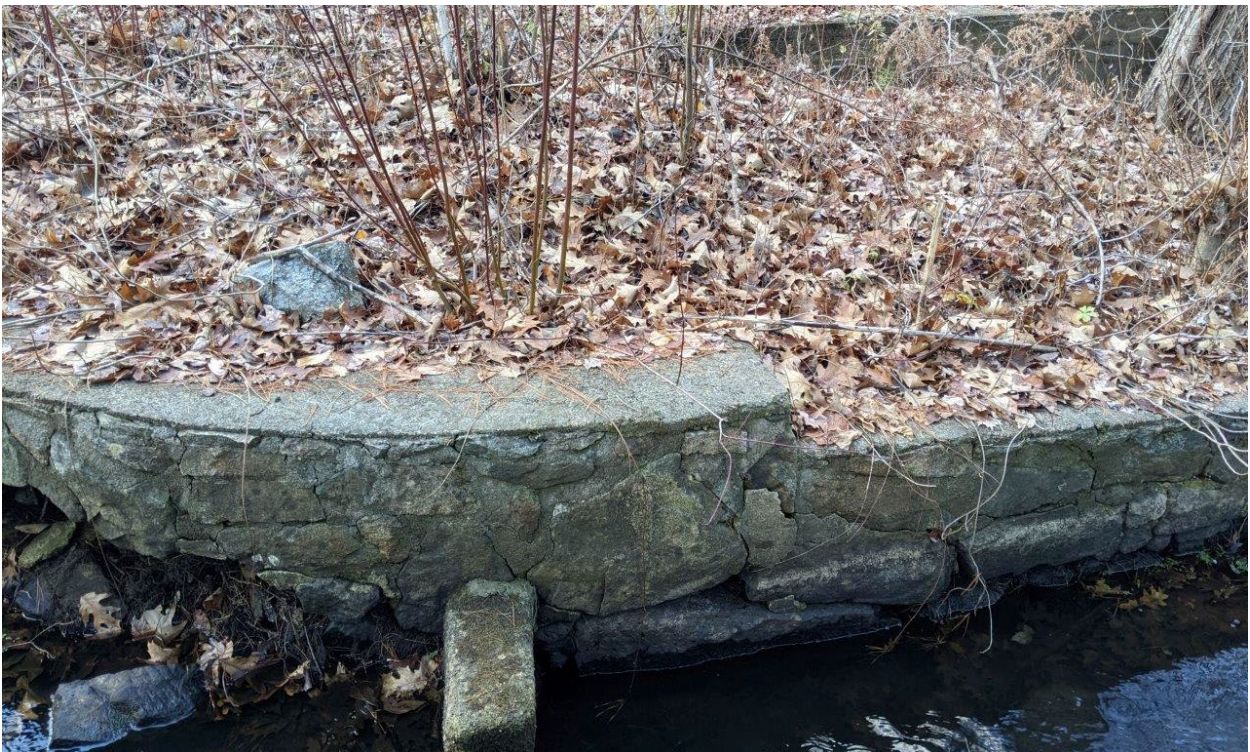
Fishway masonry wall detail

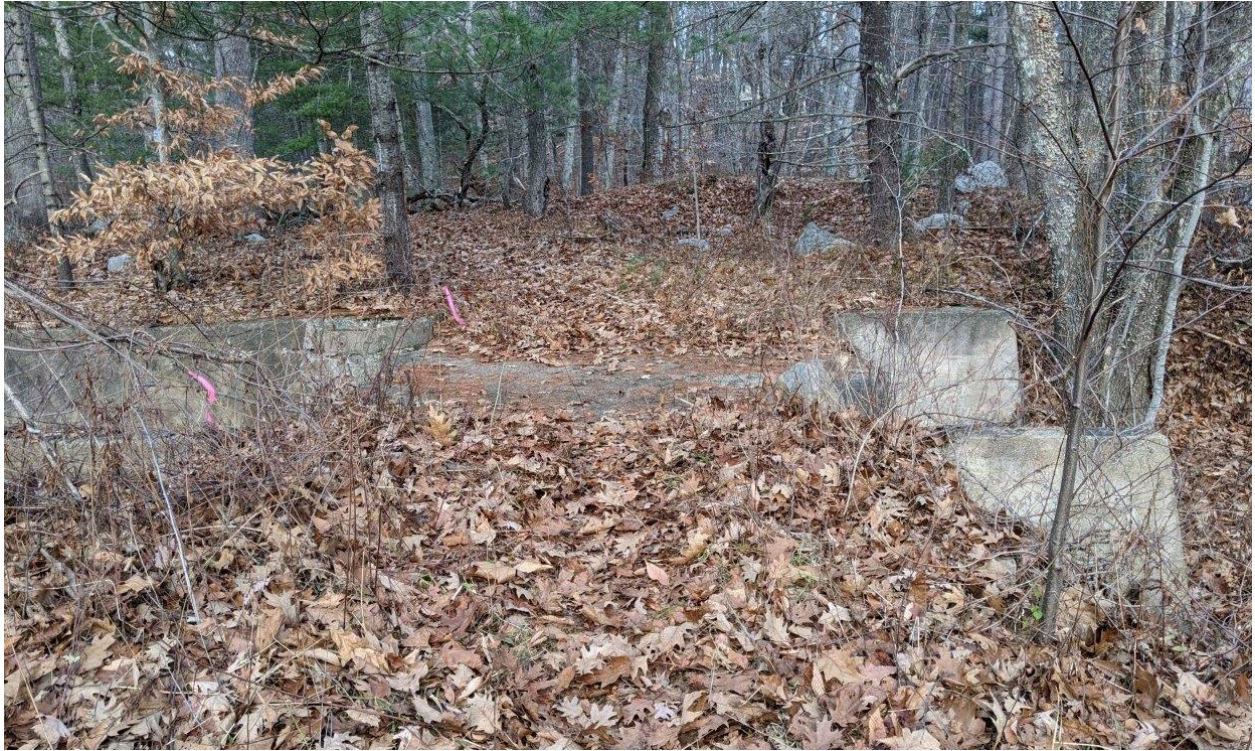
Former mill intake, looking north

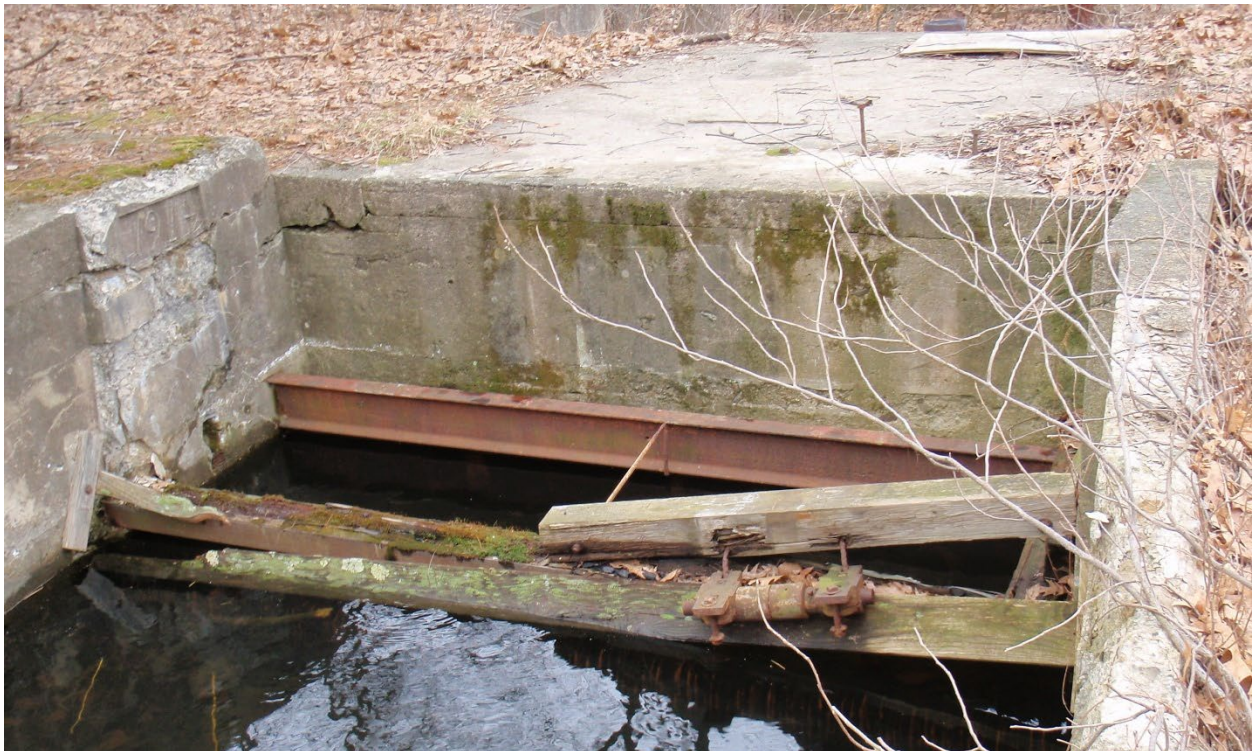
Former headgate/trashrack structures and headwall

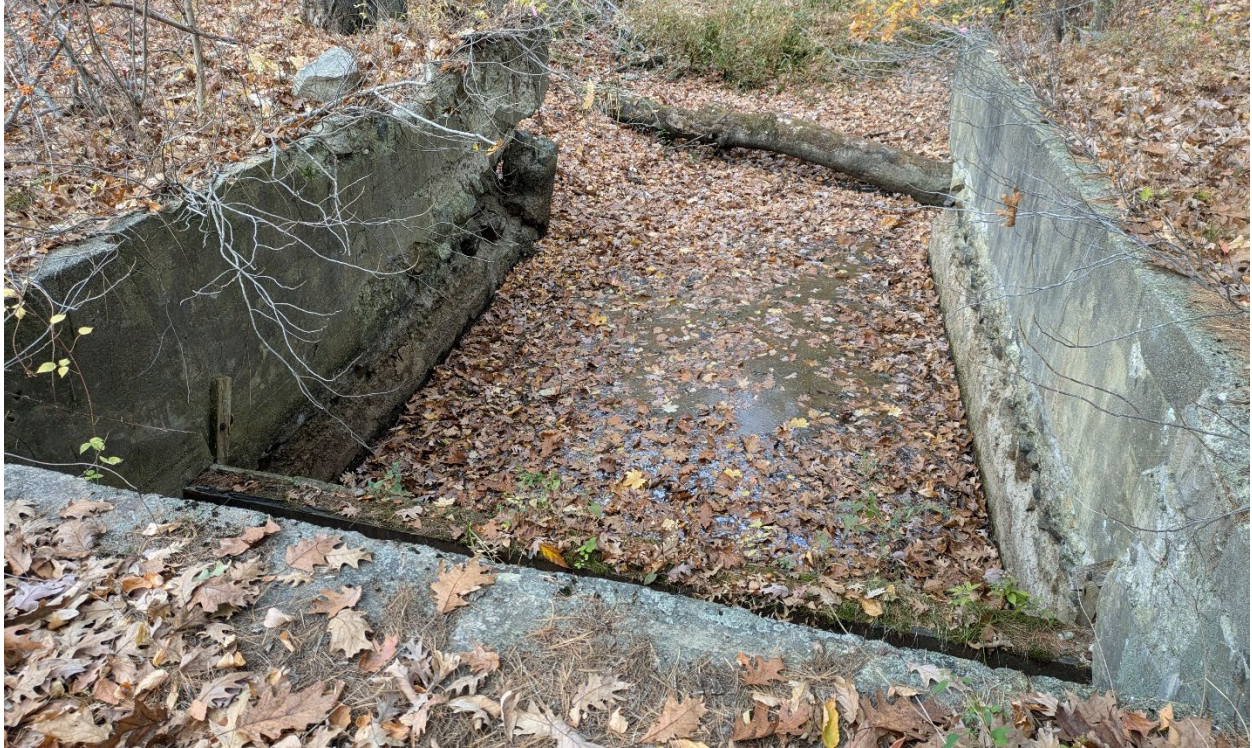
Former mill intake entrance, looking west

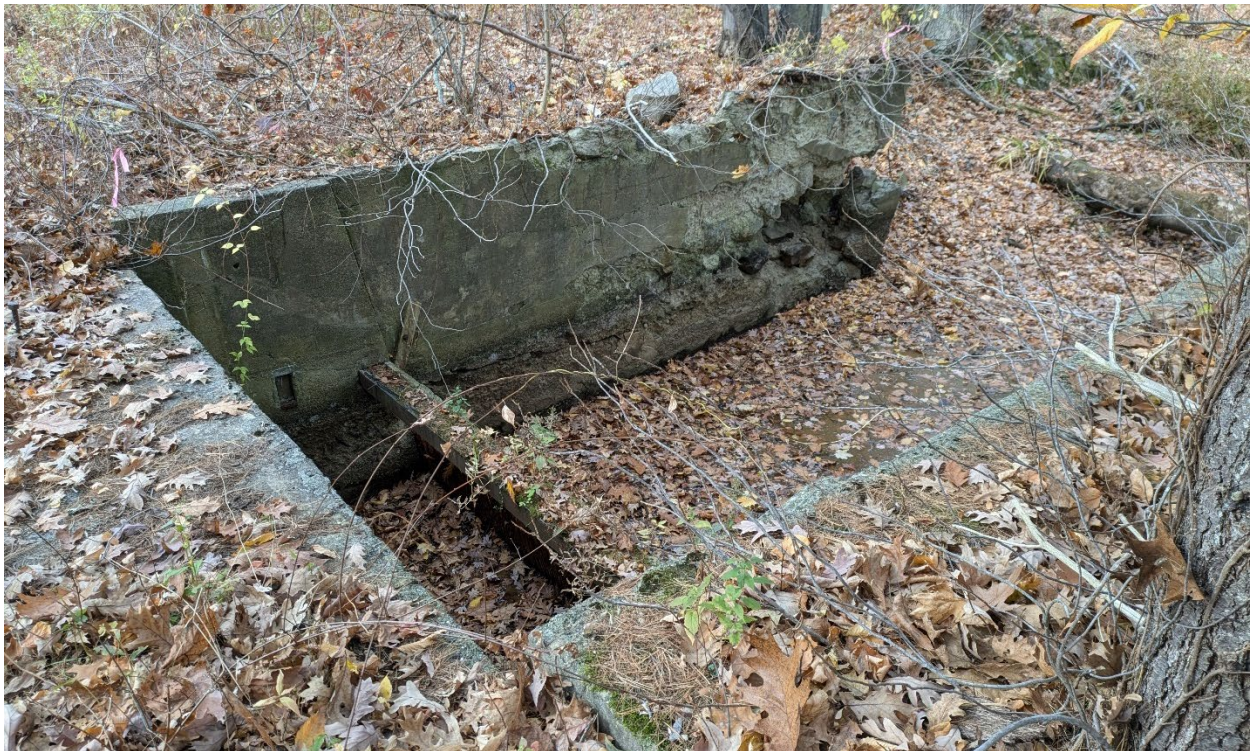
Former mill intake entrance, south wall

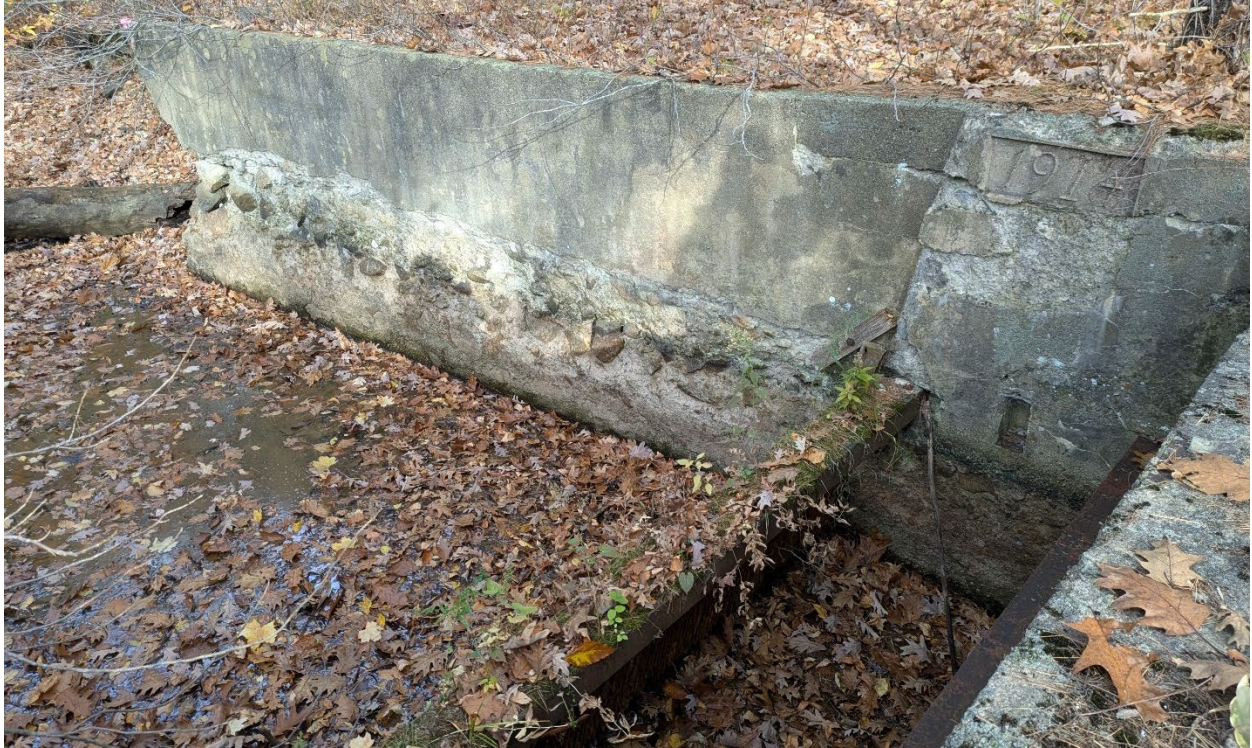
Former mill intake entrance, north wall

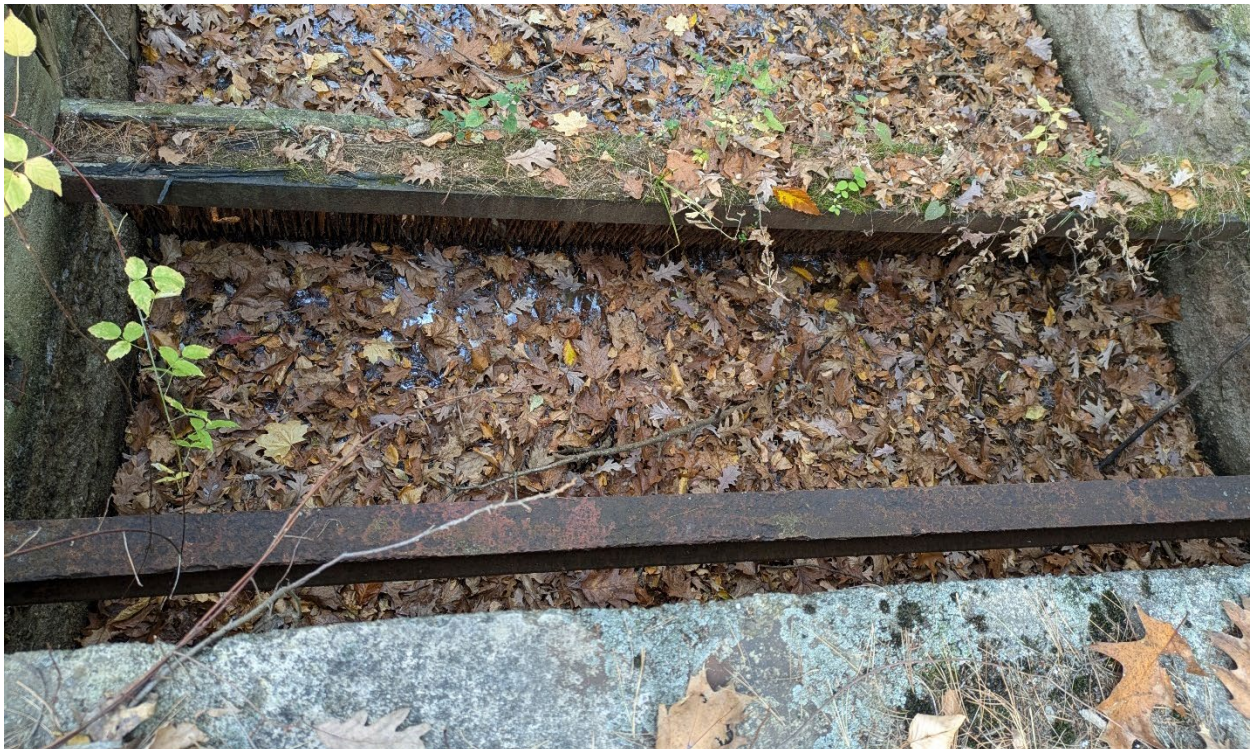
Former headgate/trashrack structures

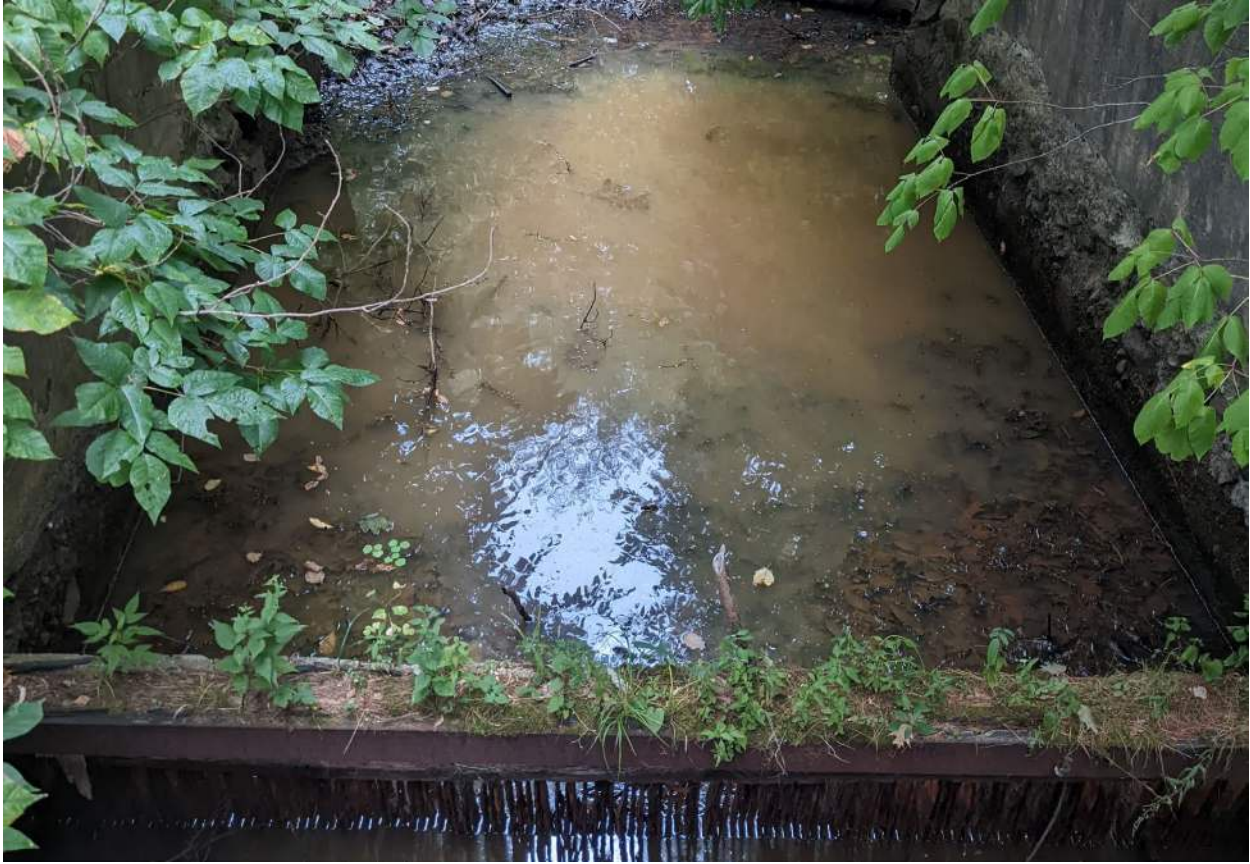
Trashrack and channel bottom during drought conditions

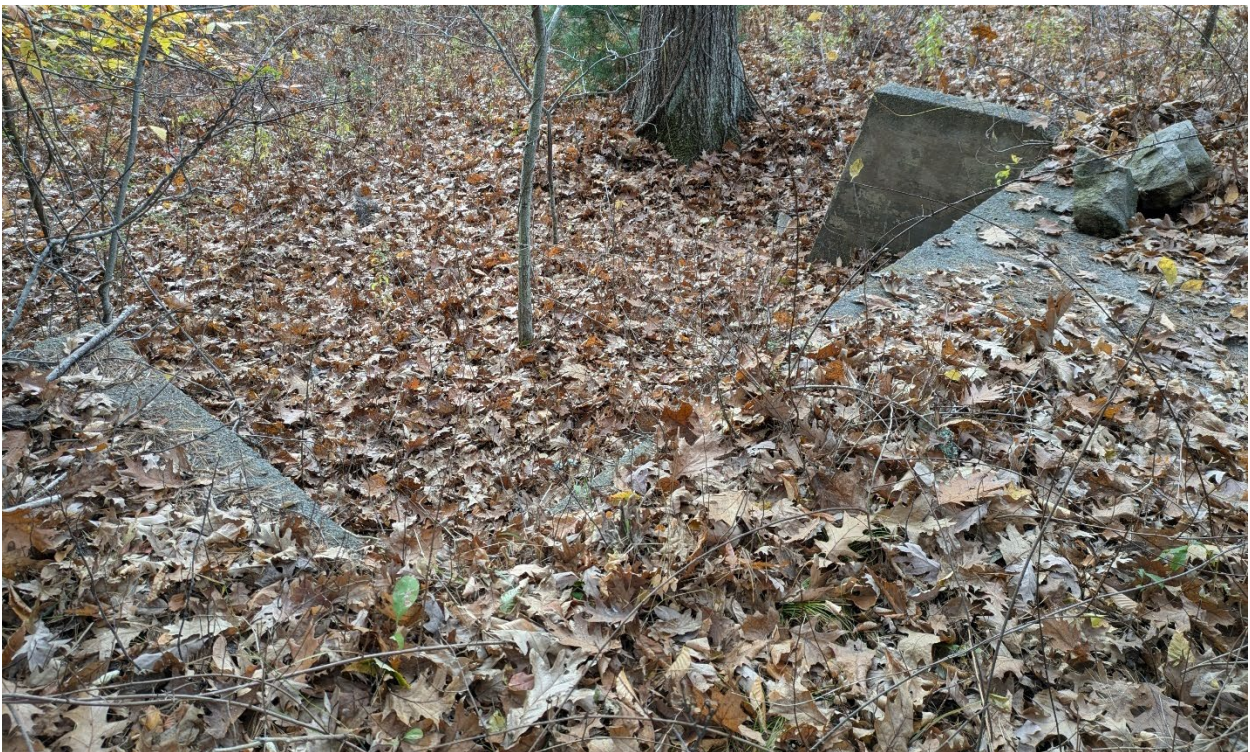
Former mill intake exit (filled)

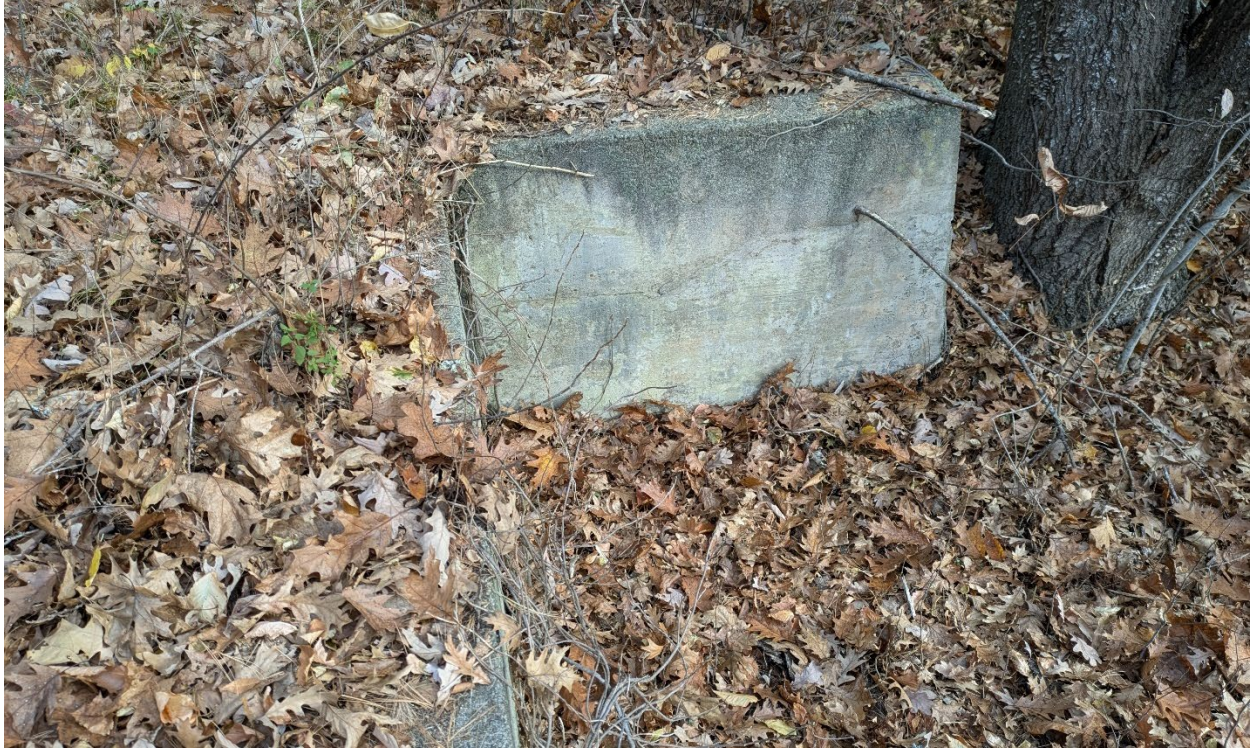
Former mill intake exit, north wall

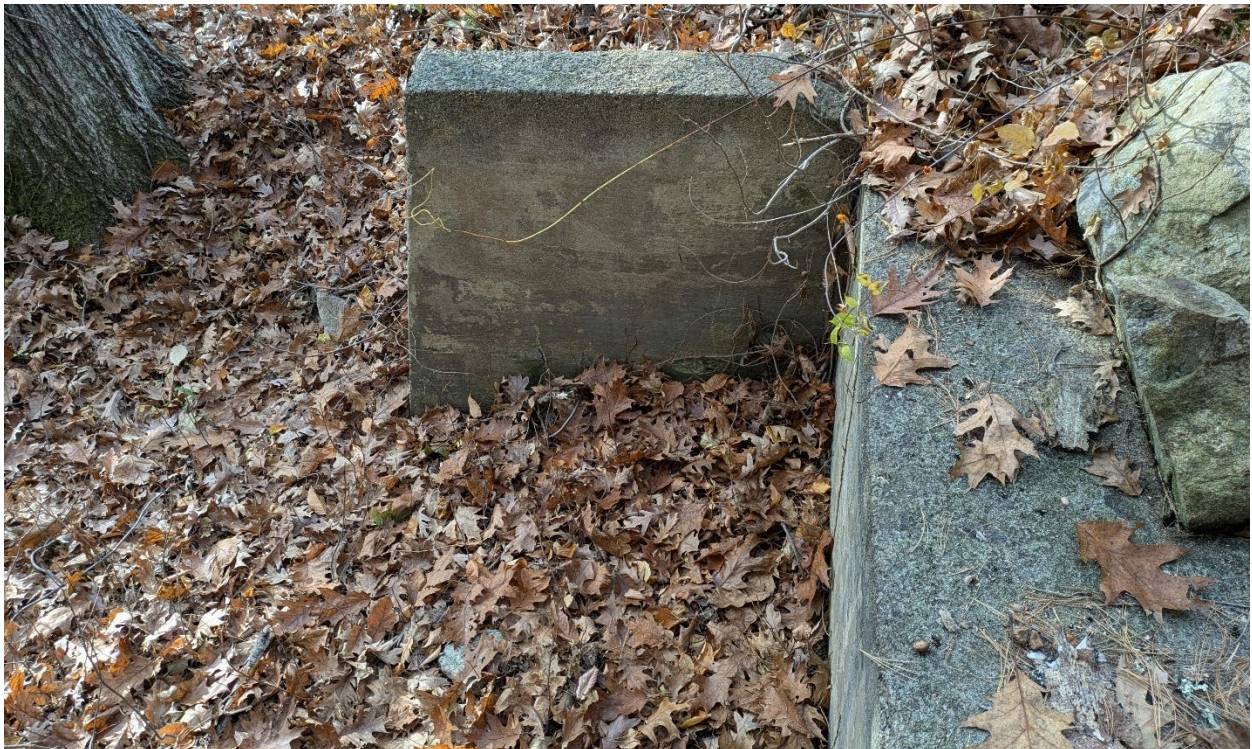
Former mill intake exit, south wall

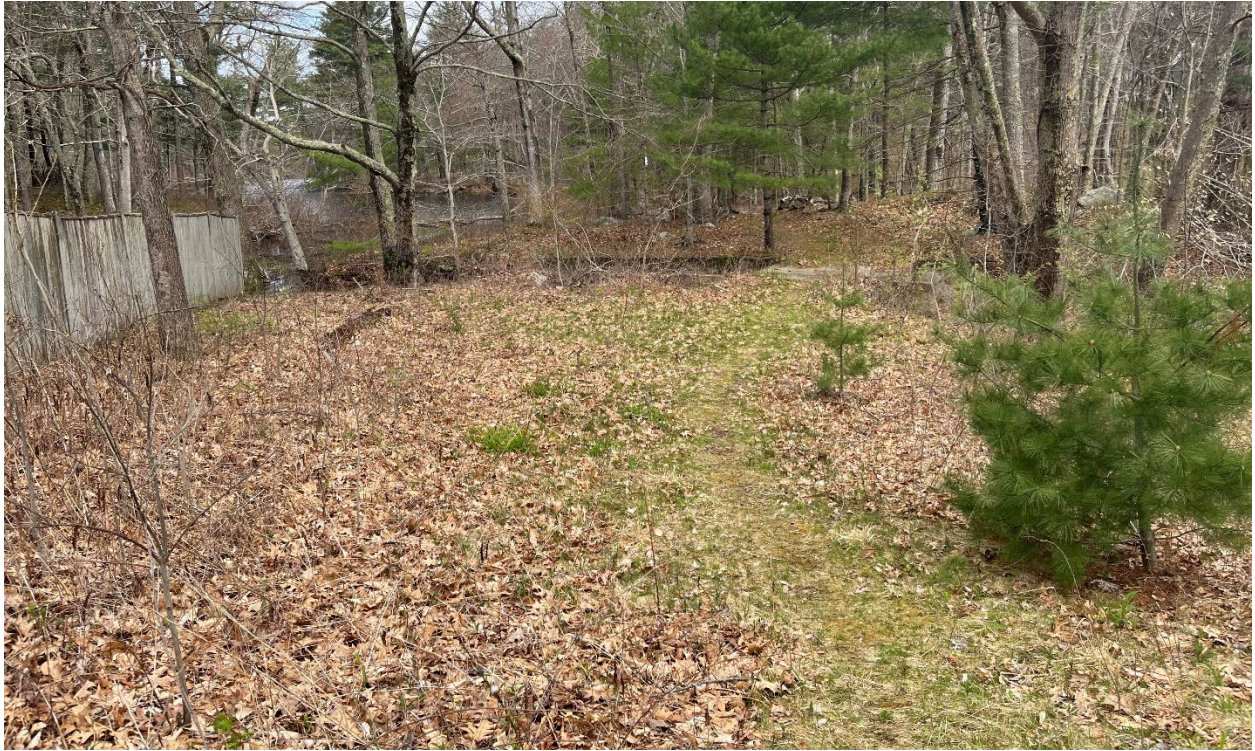
Existing footpath / proposed access route (looking north toward mill intake; note fence sections to be removed)

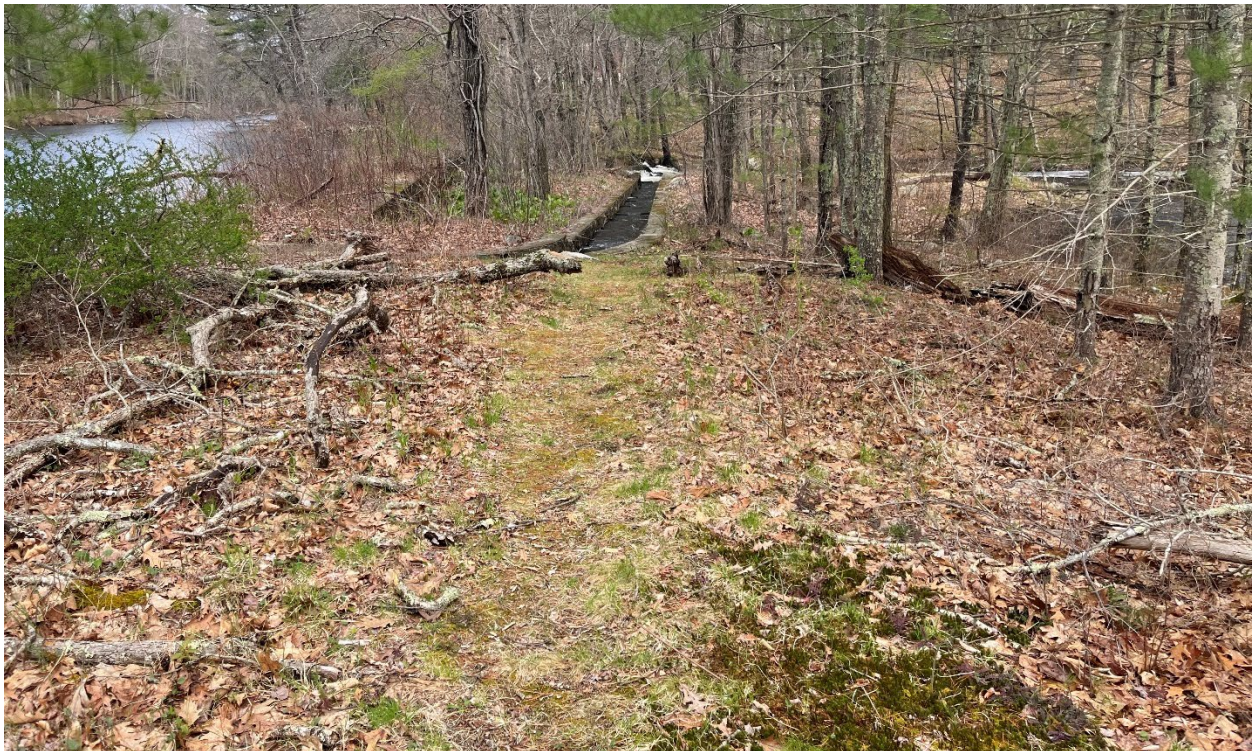
Existing footpath / proposed access route (looking north from intake toward fishway)

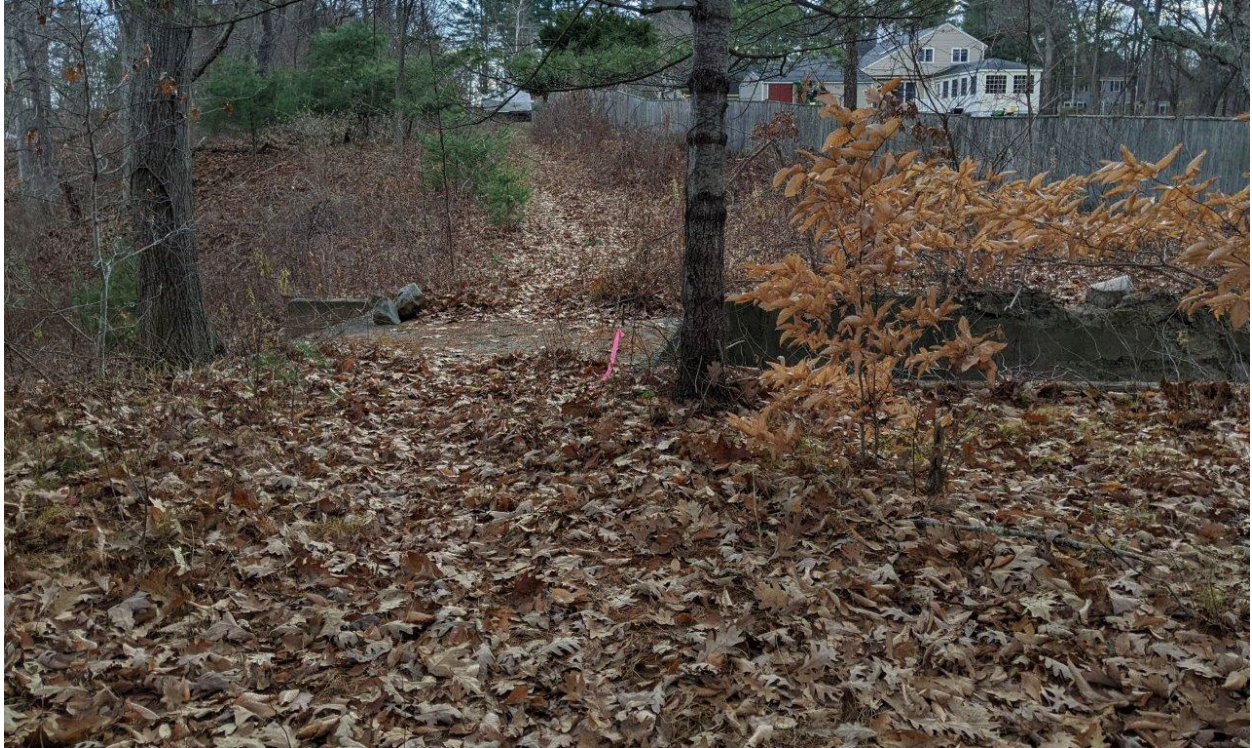
Existing footpath / proposed access route (looking south across intake toward Larkin Road)

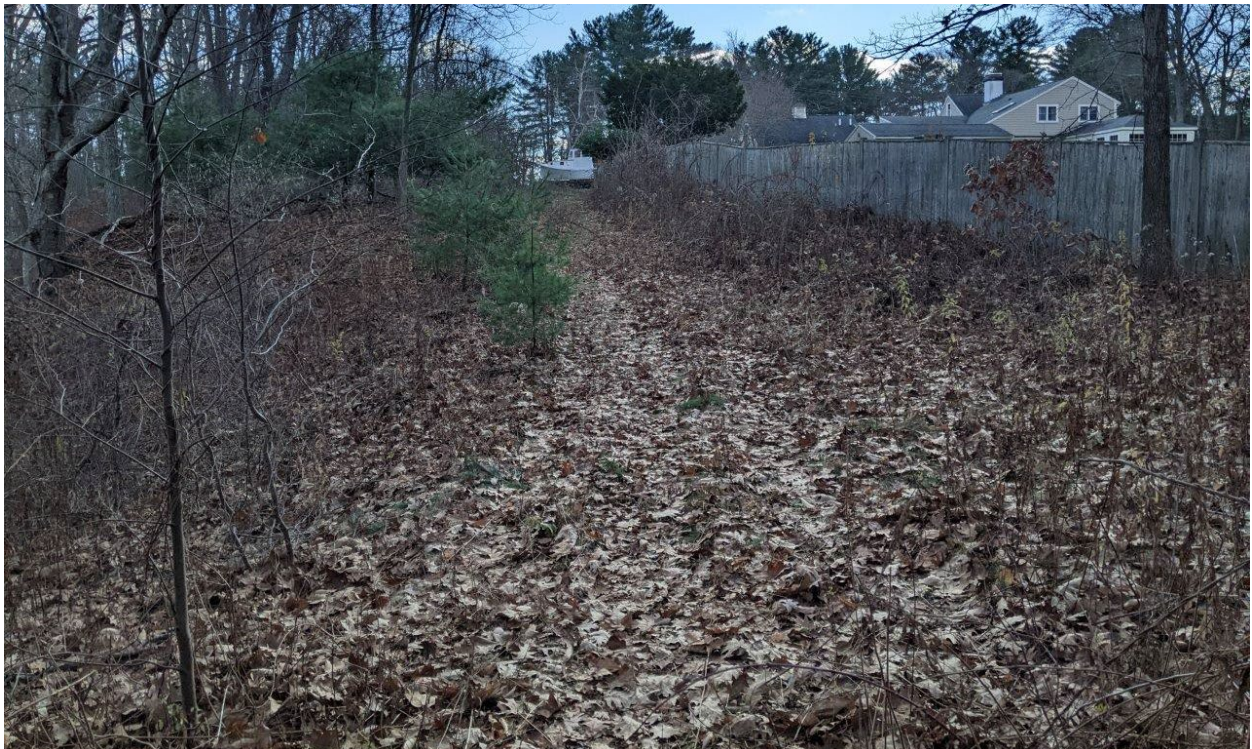
Existing footpath / proposed access route (looking south from mill intake toward Larkin Road)

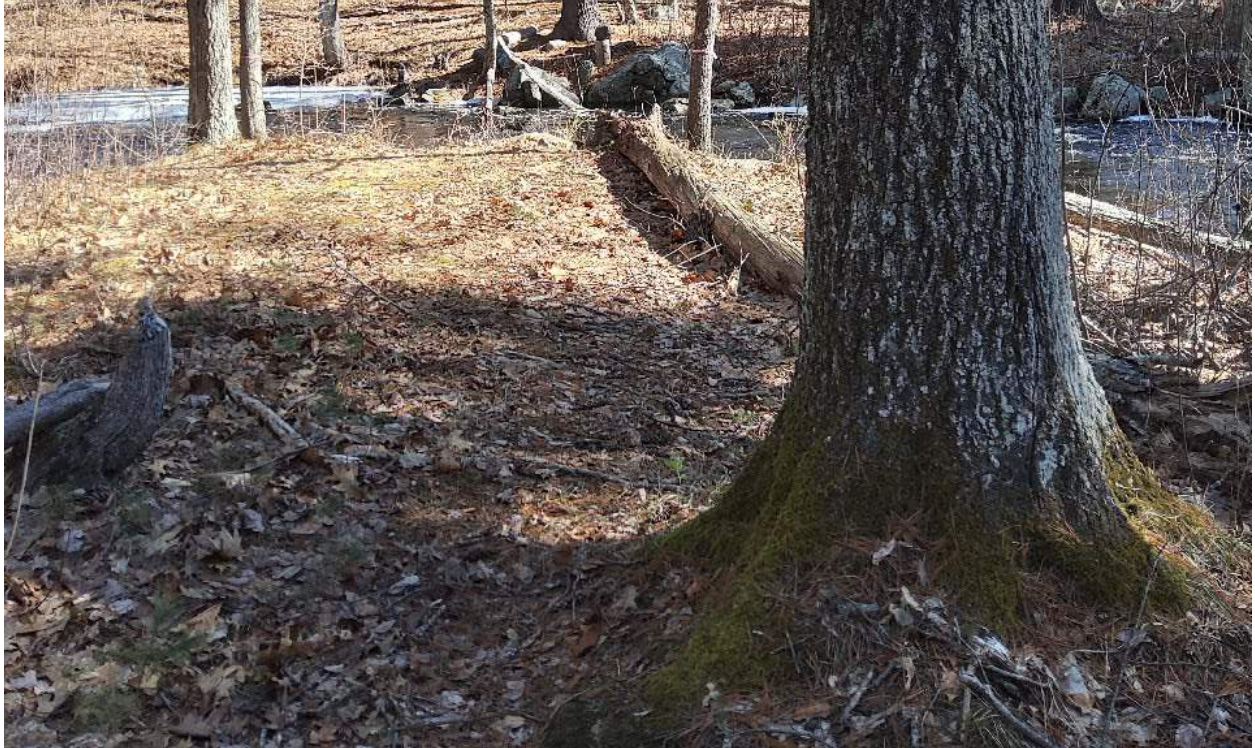
Proposed sediment stockpiling/dewatering area (looking north)

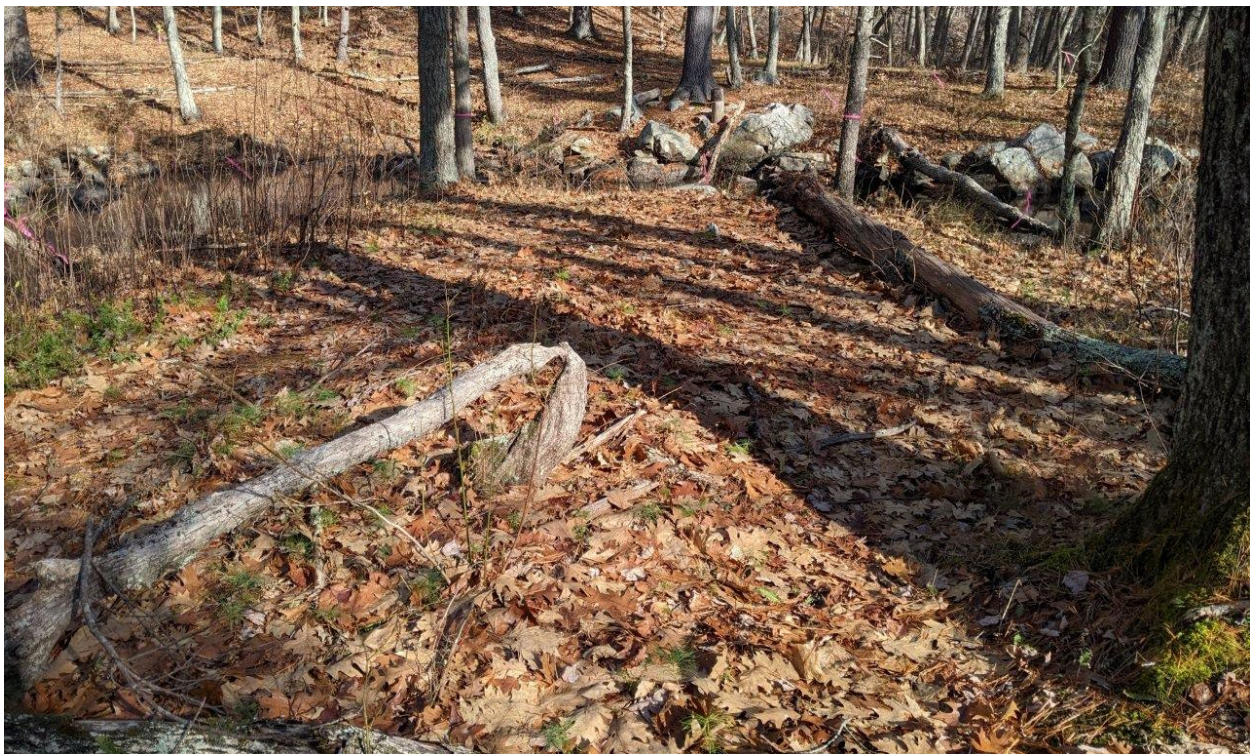
Proposed sediment stockpiling/dewatering area (looking north)

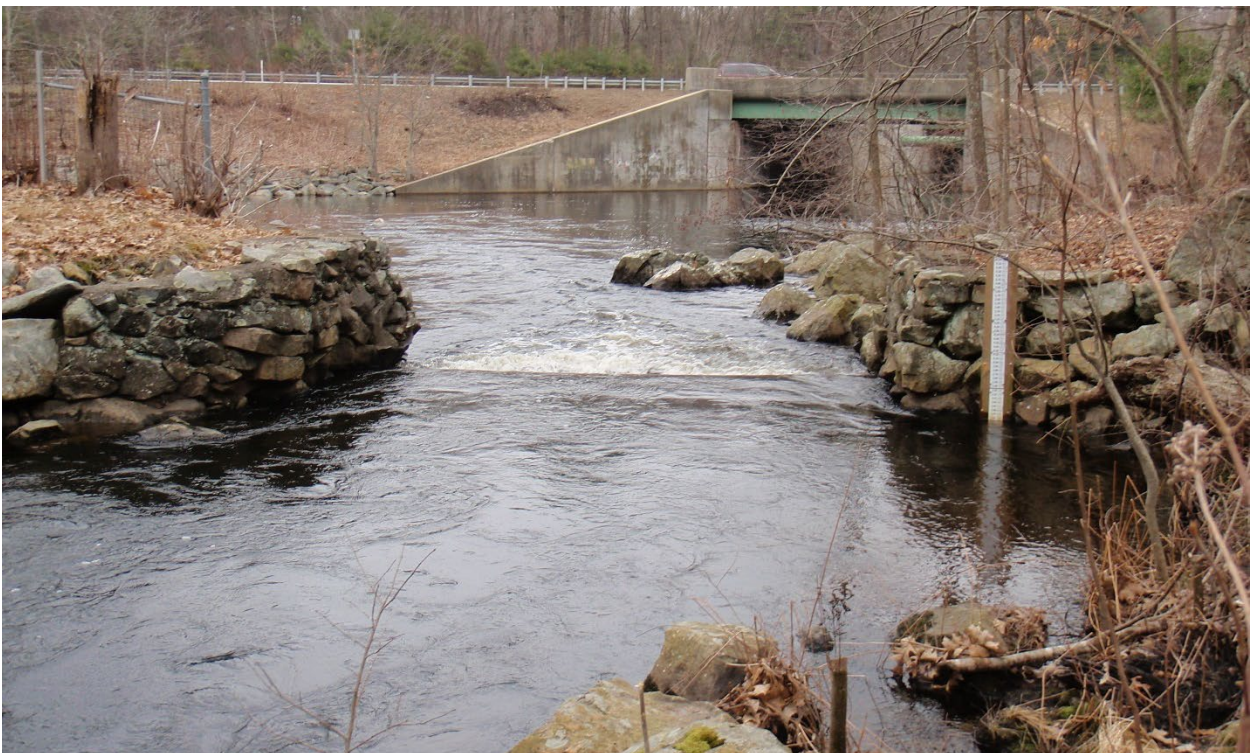
Weir, looking downstream (I-95 bridge in background)

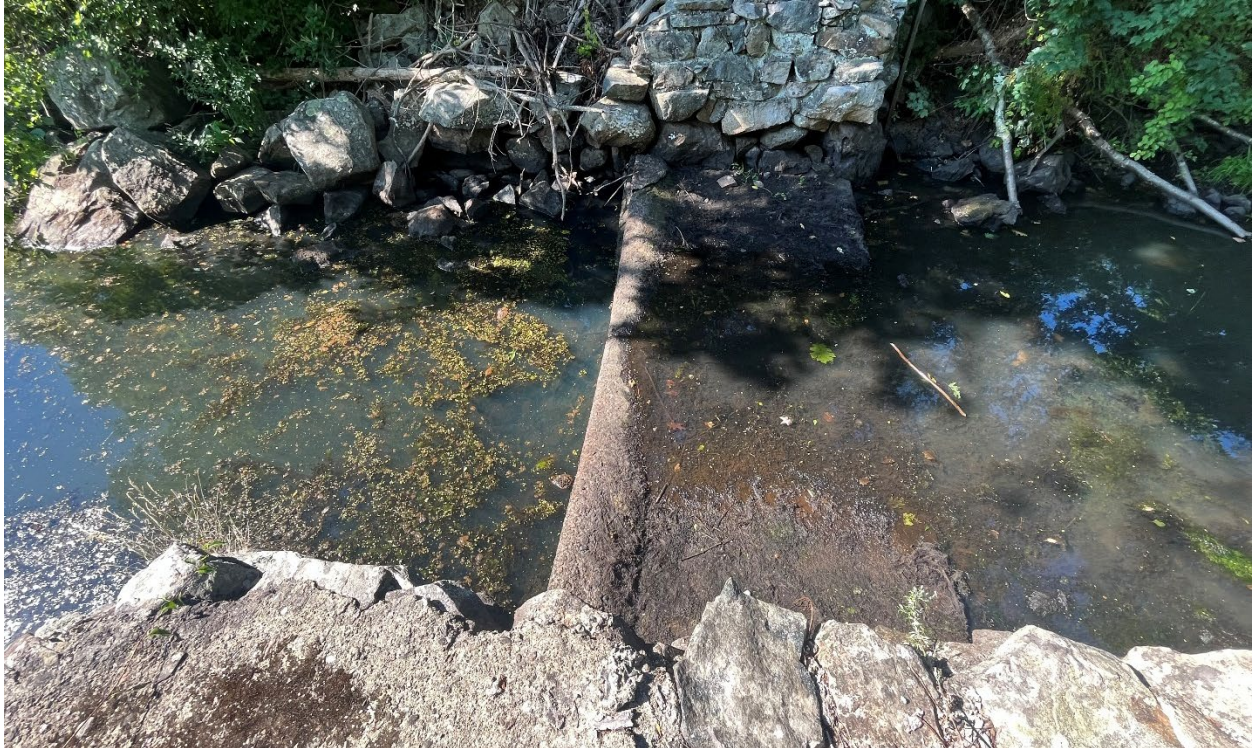
Concrete weir from left (northeast) abutment during drought conditions

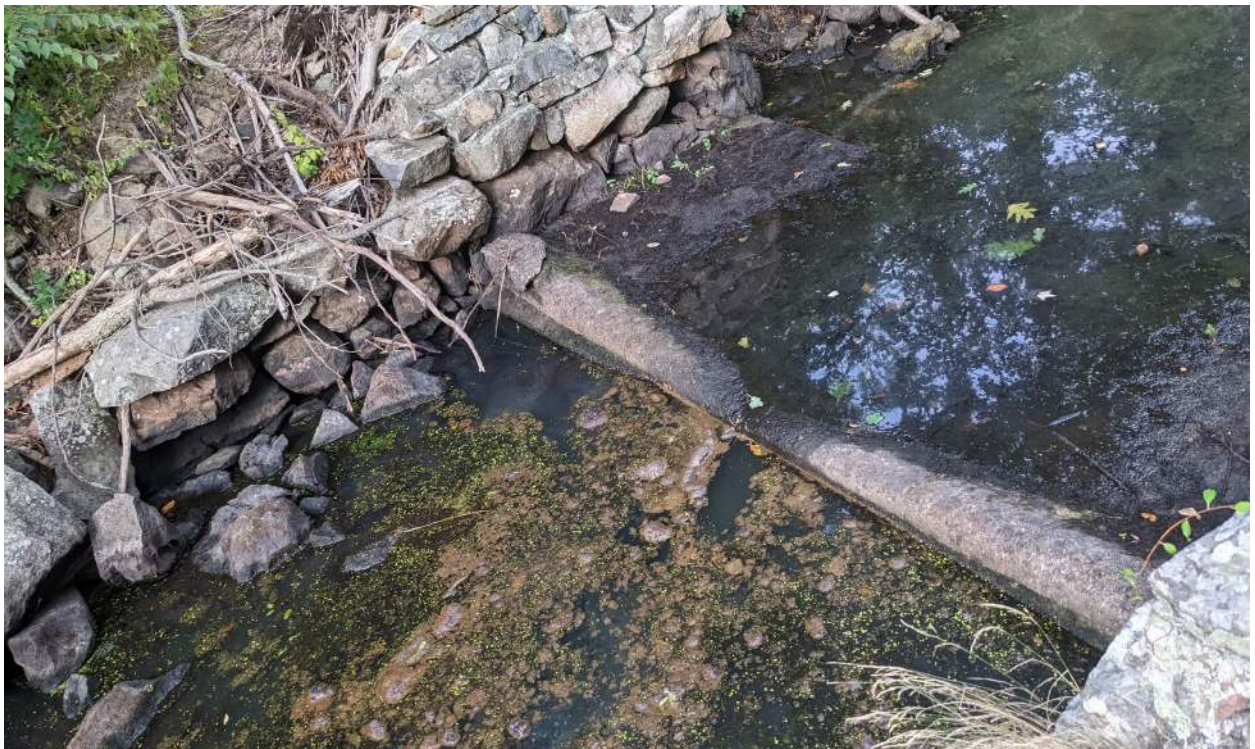
Concrete weir from left (northeast) abutment during drought conditions, looking west
