Parker River Restoration Project – Site Photographs

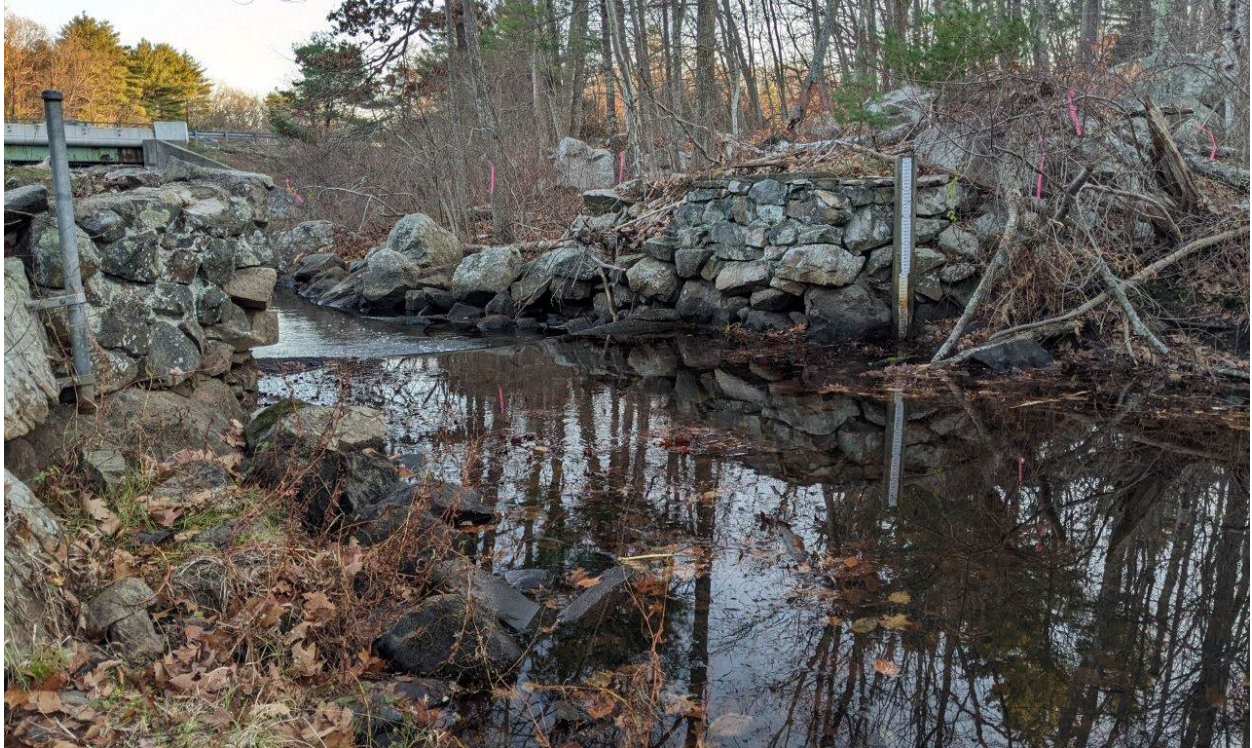
Weir abutments, looking downstream (note stream gaging equipment at left and right)

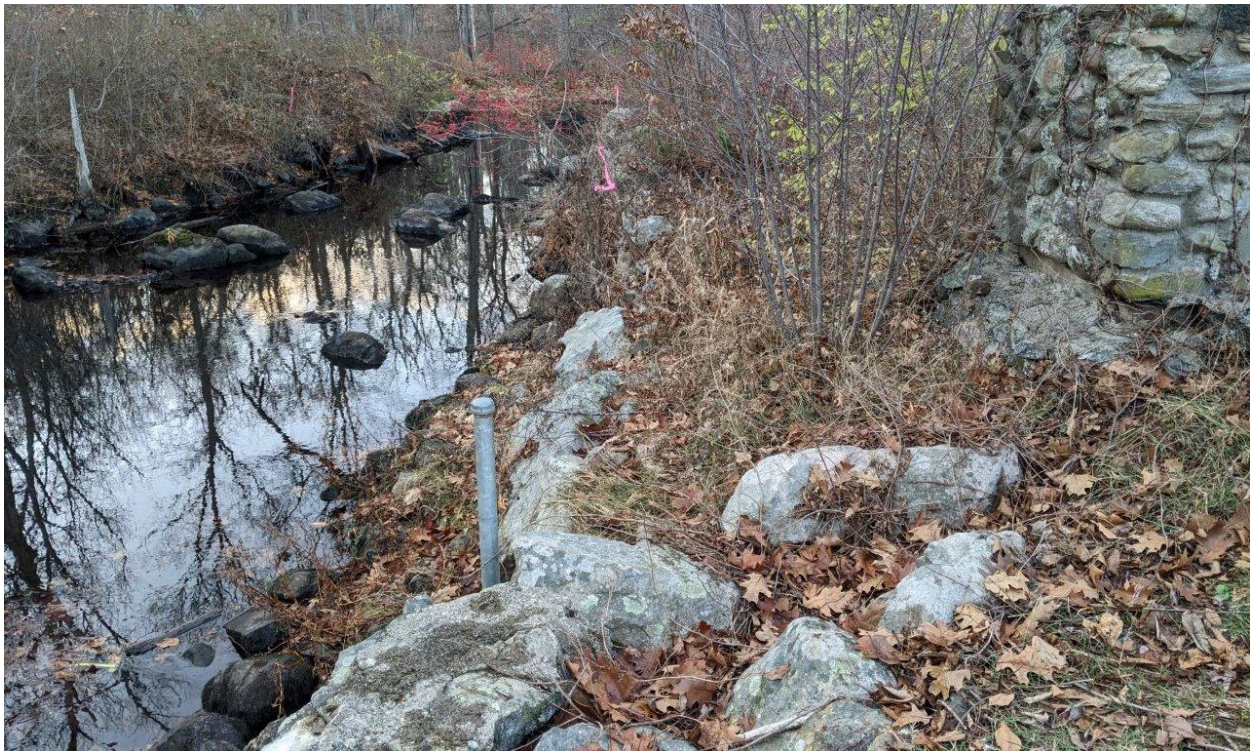
Looking upstream from northeast weir abutment (gage building at right)

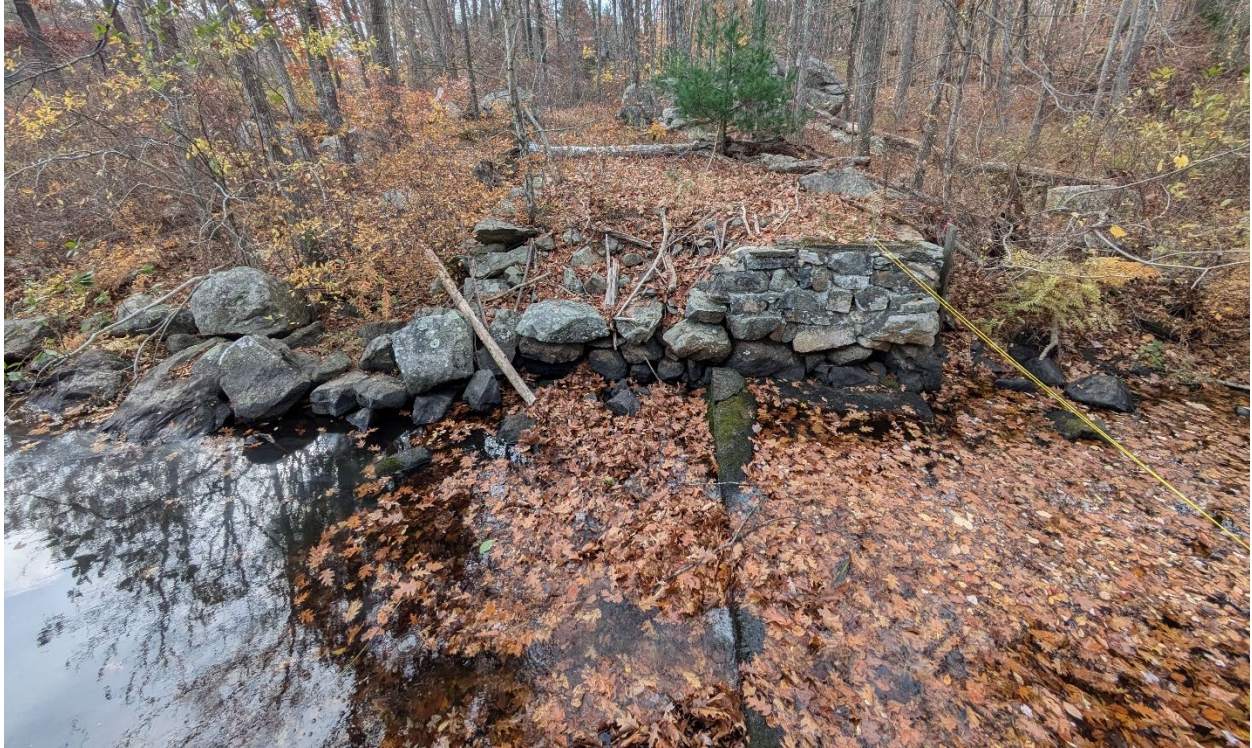
Right (southwest) abutment from left (northeast) abutment)

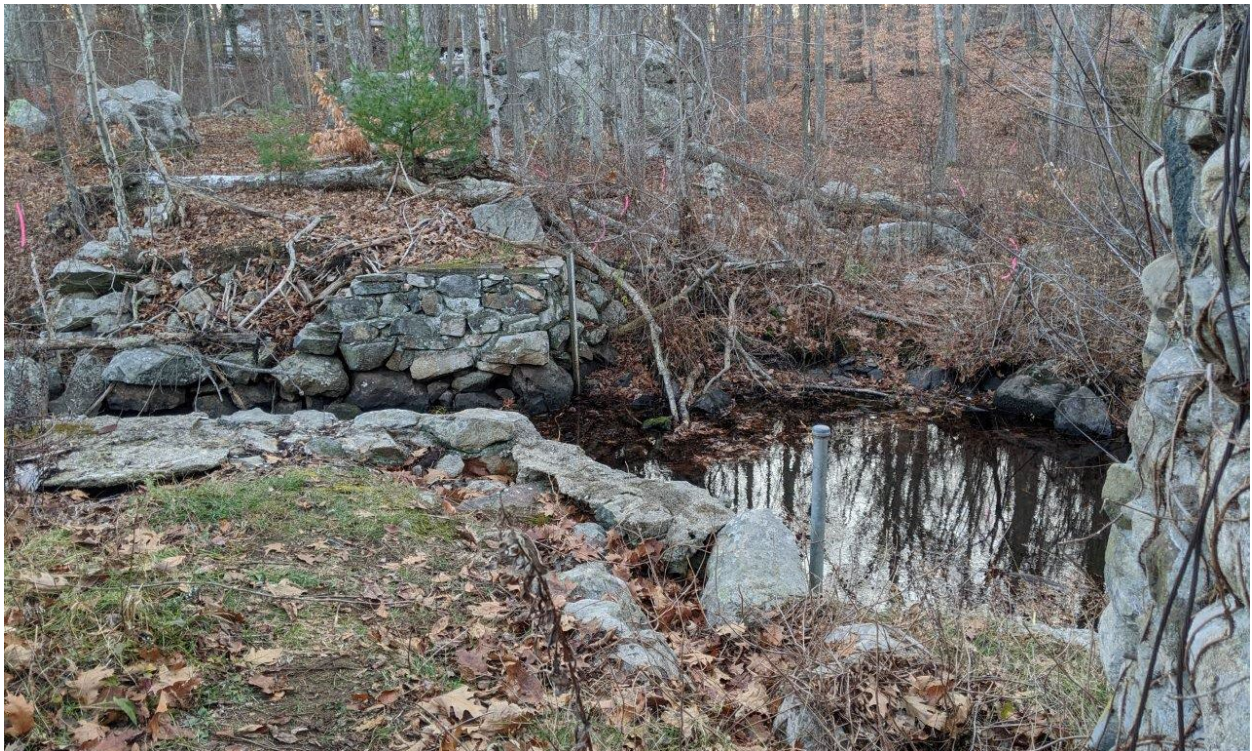
Bank access area from gage building, looking south

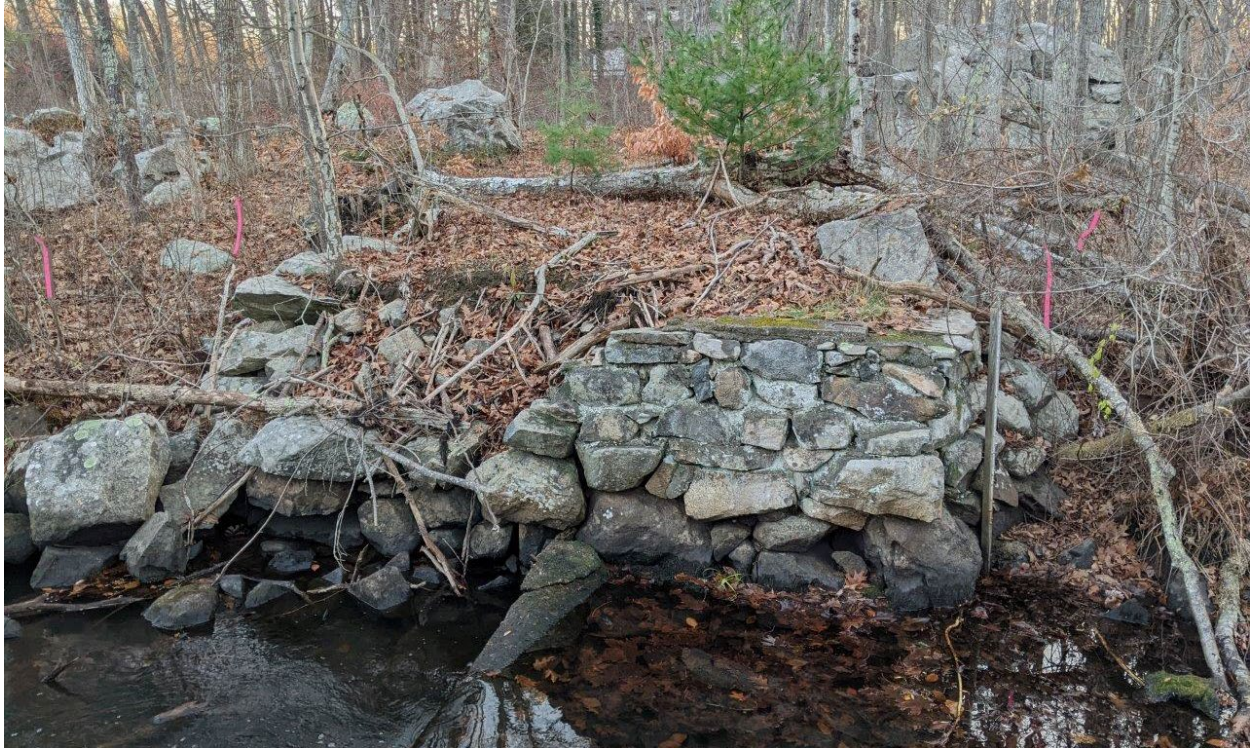
Right (southwest) abutment

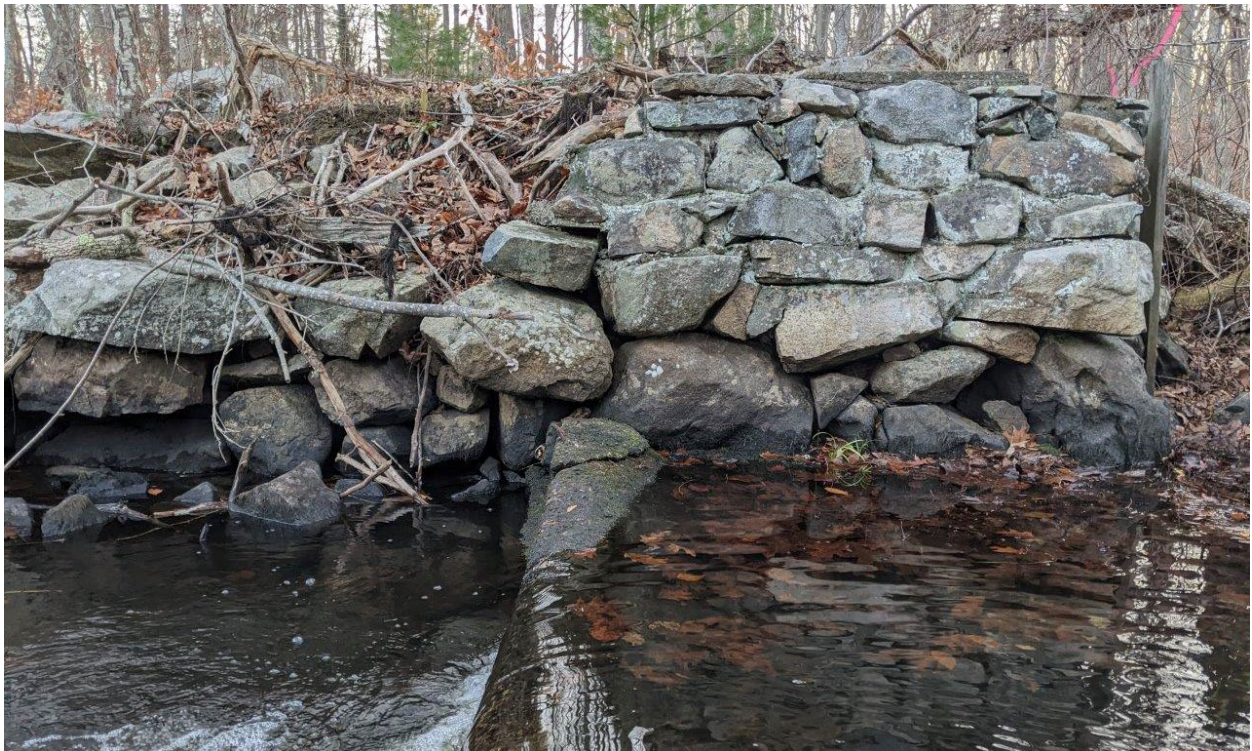
Right (southwest) abutment detail

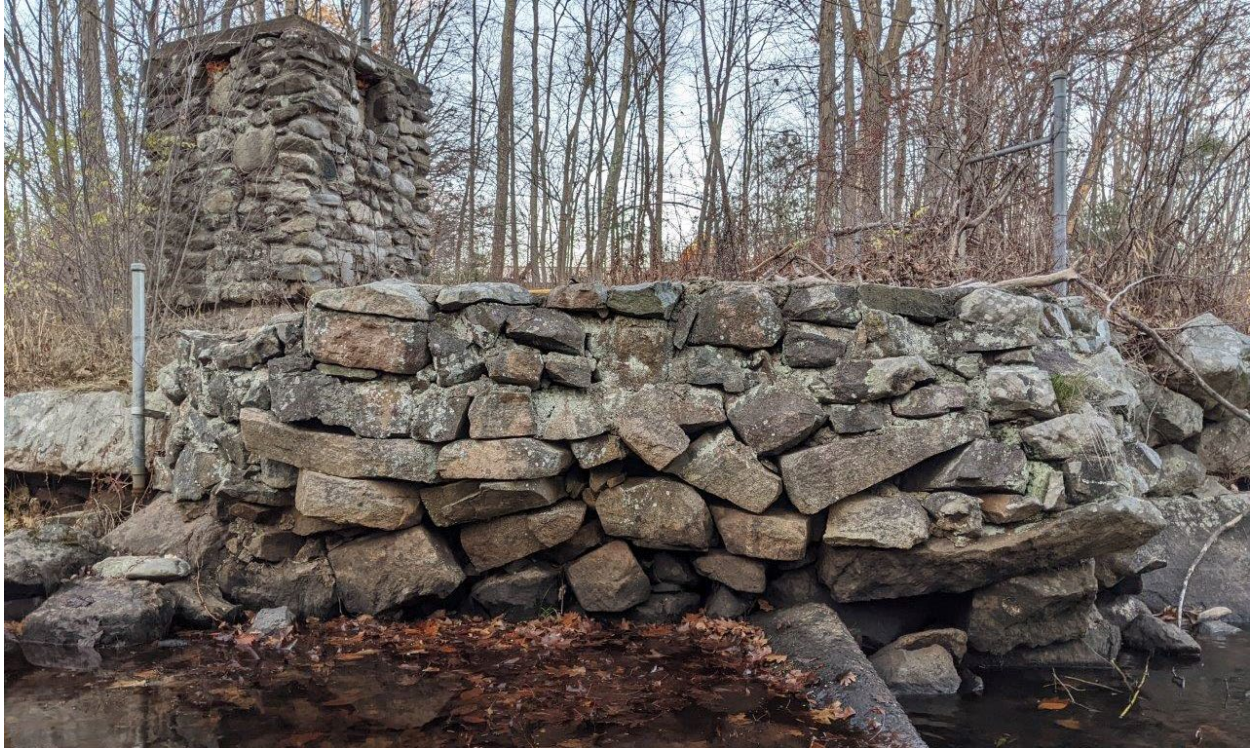
Left (northeast) abutment (gage building in background)

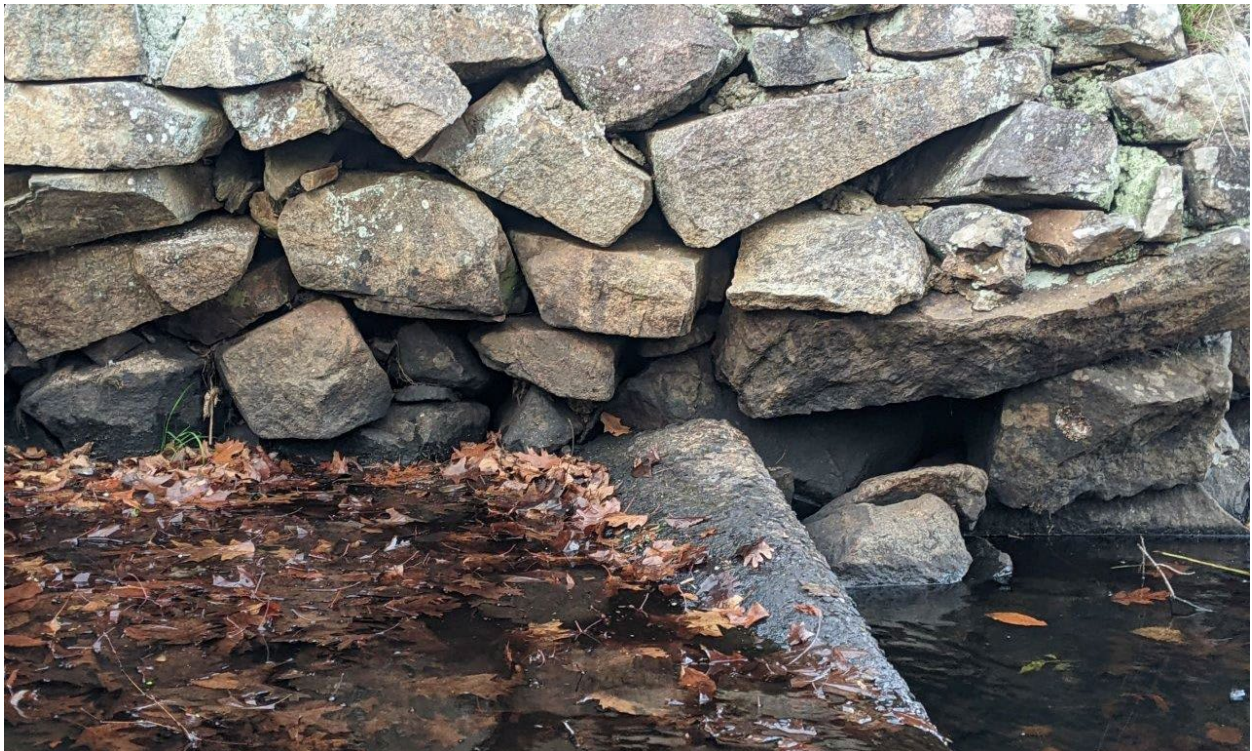
Left (northeast) abutment detail

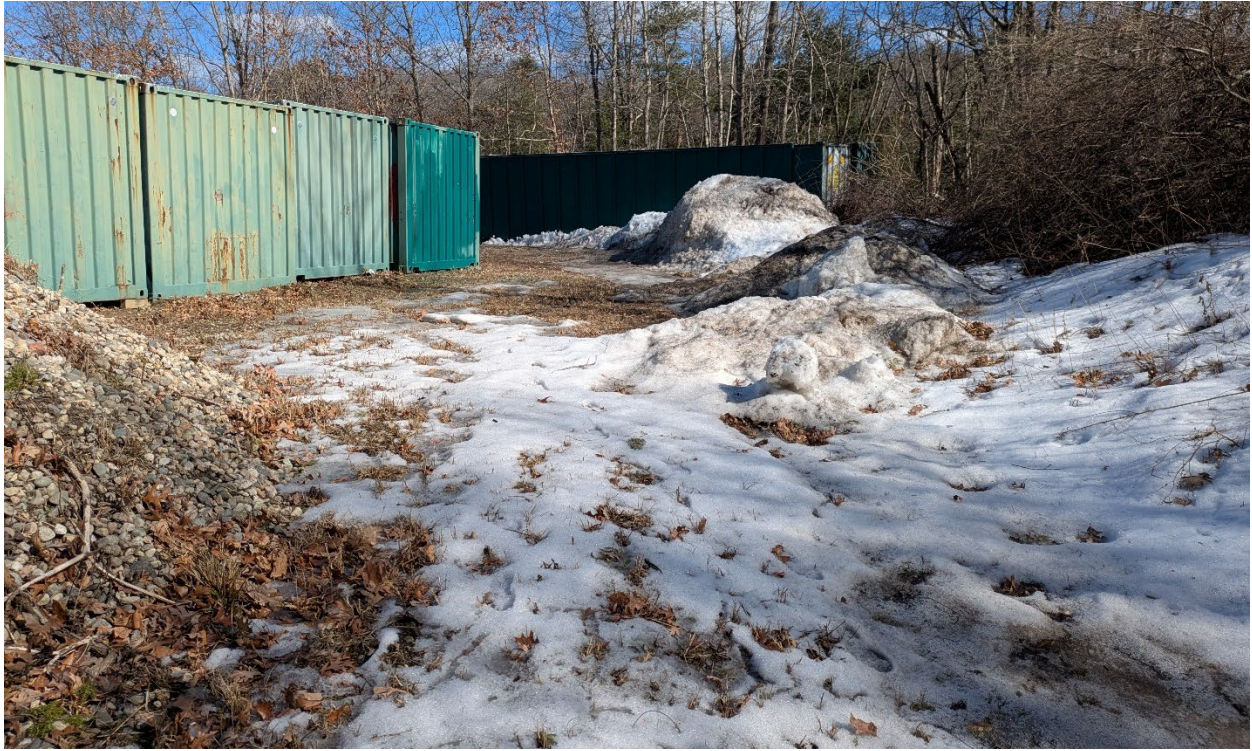
Proposed upper staging area at south end of 12 Kent Way lot, looking east

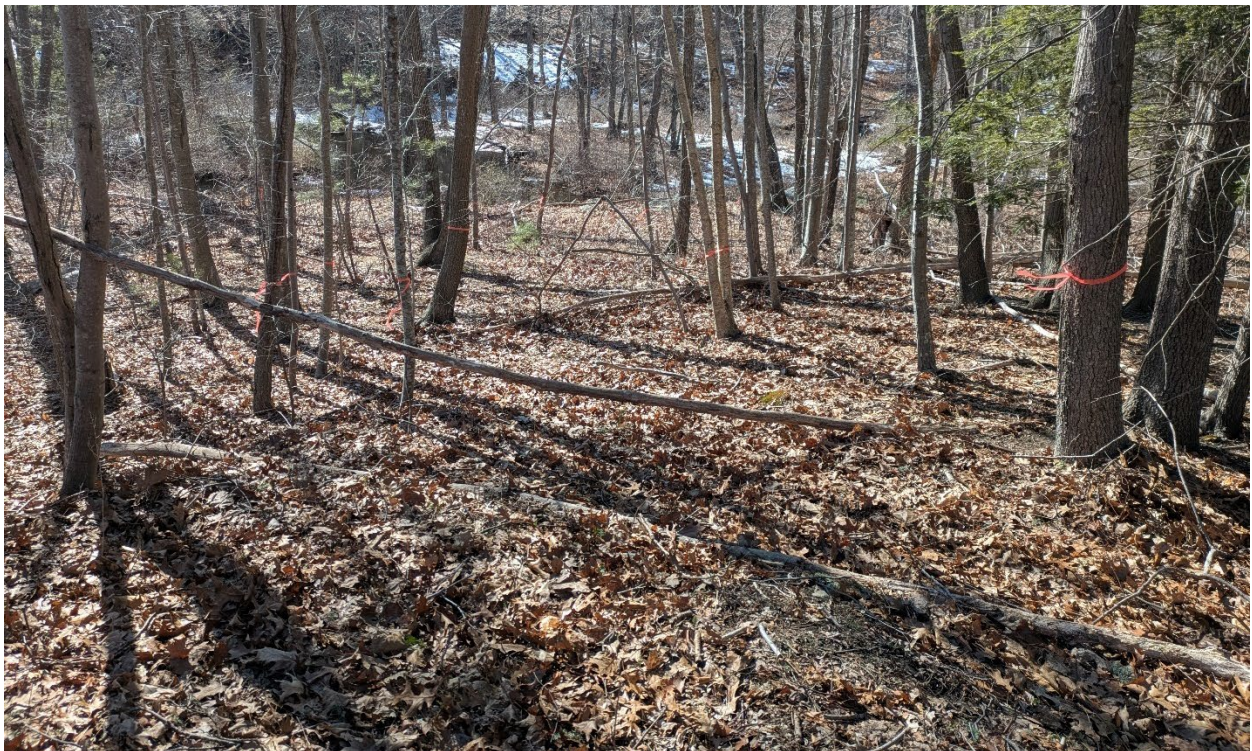
Proposed access route from upper staging area, looking southwest toward river (note flagged trees were removed)

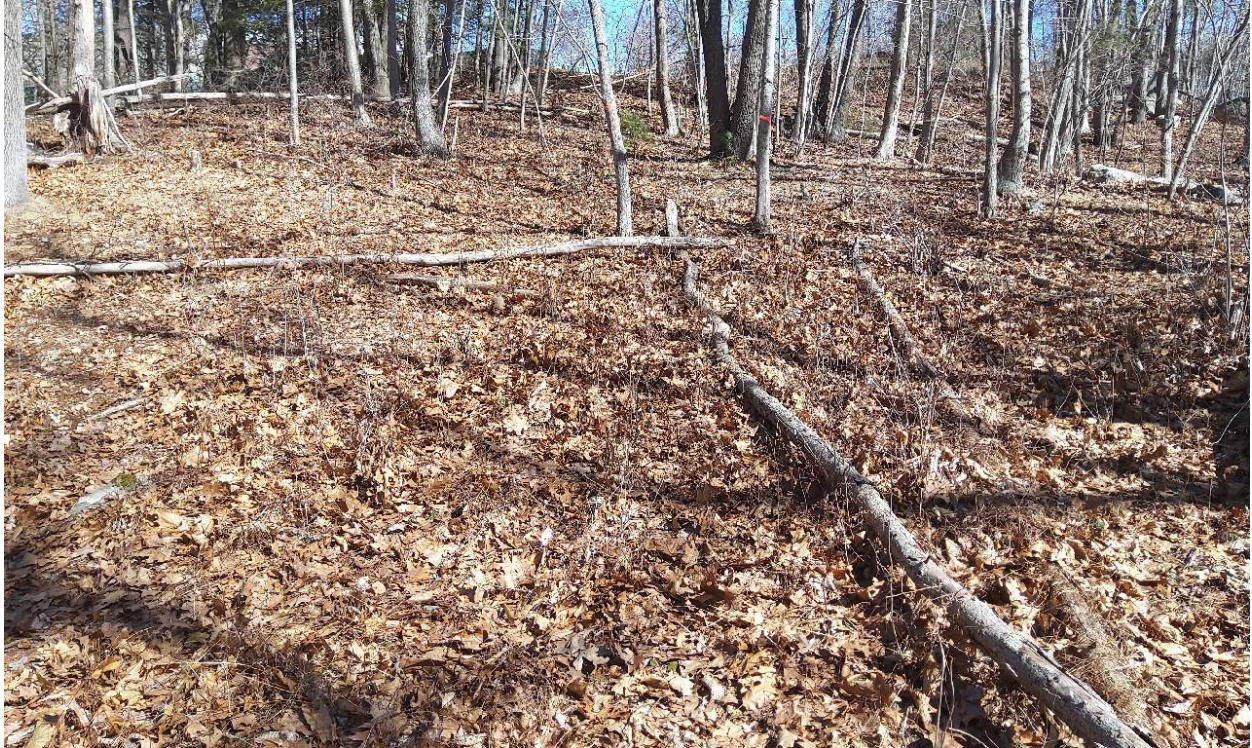
Proposed access route, looking northeast/uphill from proposed lower staging/sediment stockpiling area

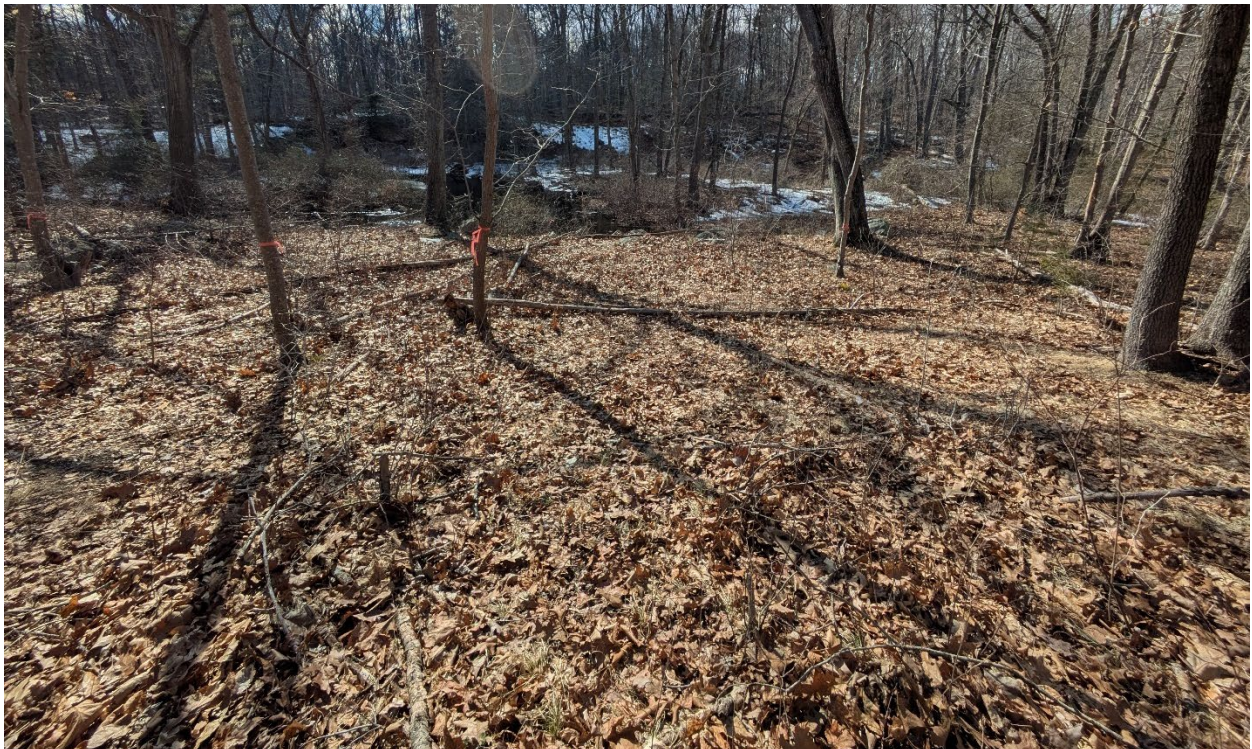
Proposed lower staging/sediment stockpiling area, looking southwest toward river (flagged trees removed)

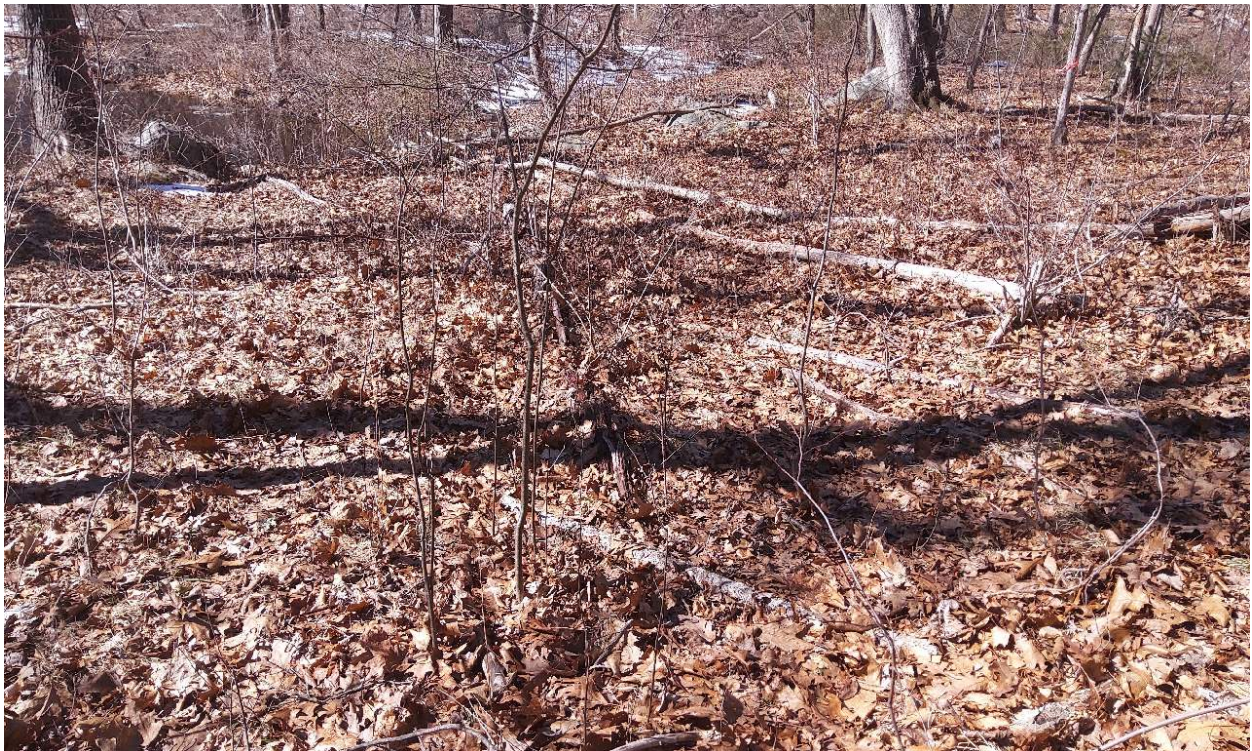
Proposed lower staging/sediment stockpiling area, looking northwest from stone wall enclosure

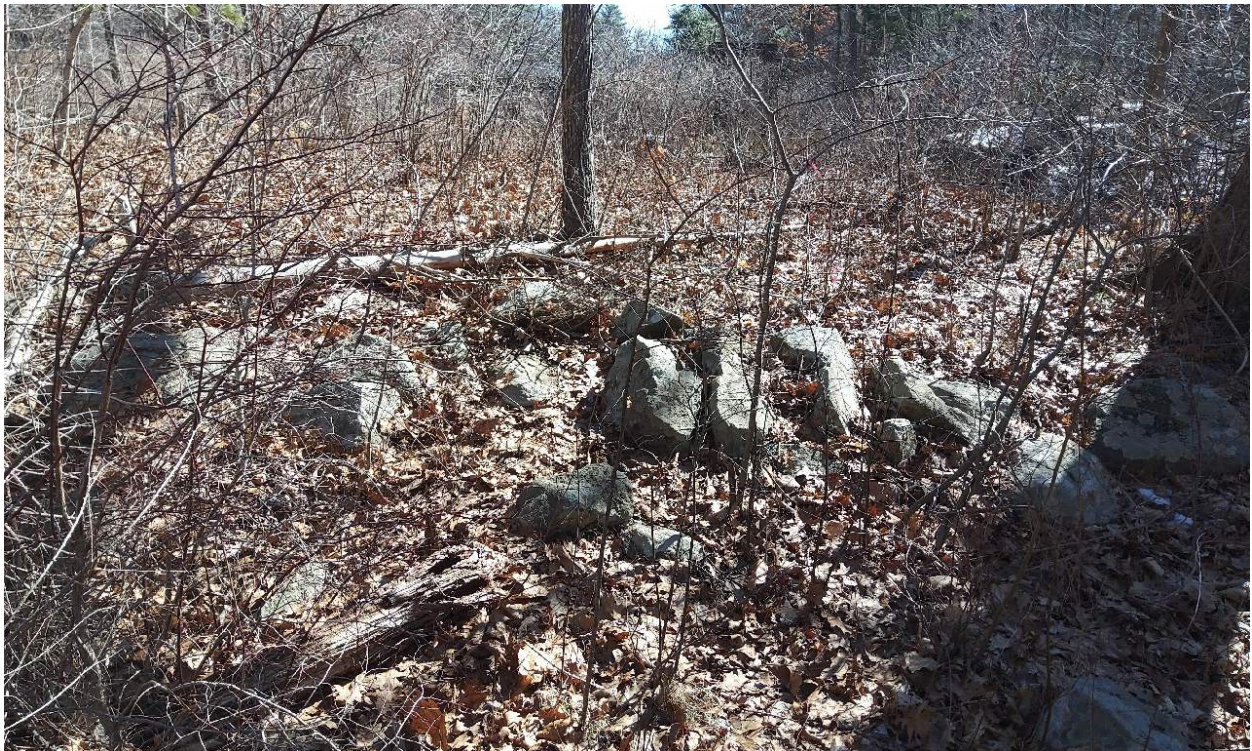
Proposed access route through stone wall enclosure (stones are not to be disturbed)

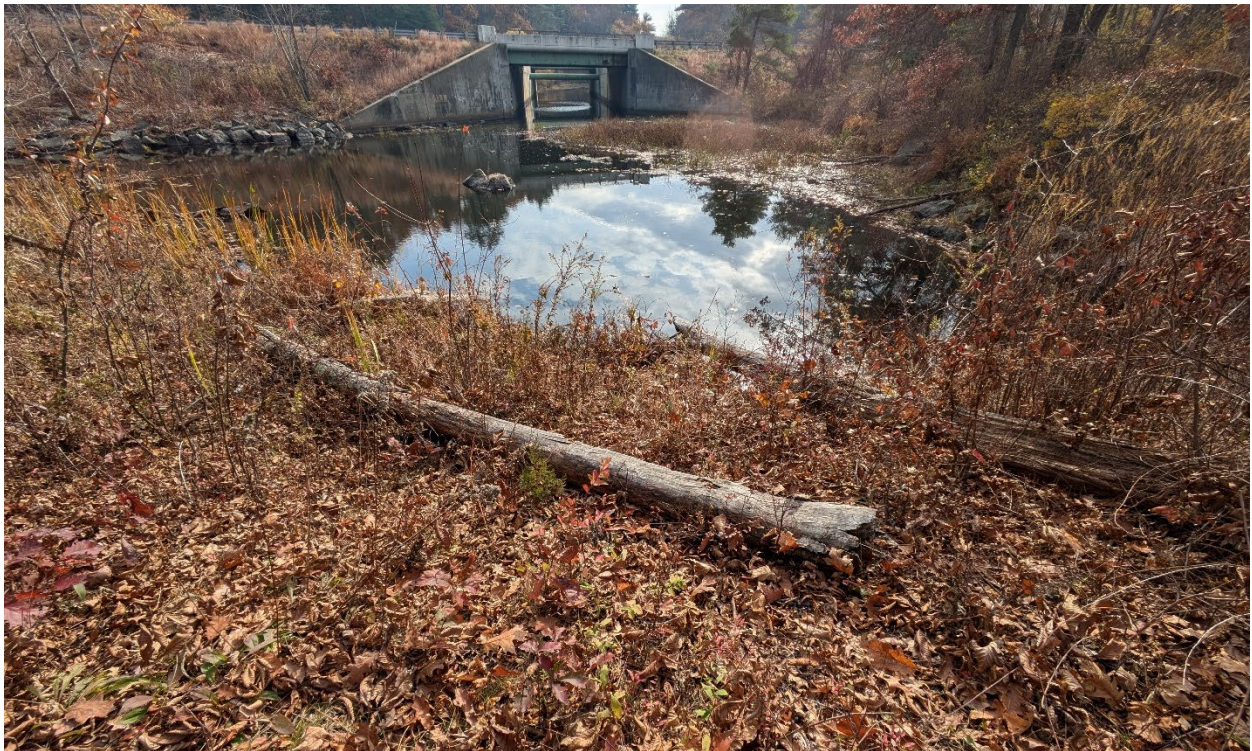
Looking southeast from fence over proposed ramp location toward bridge

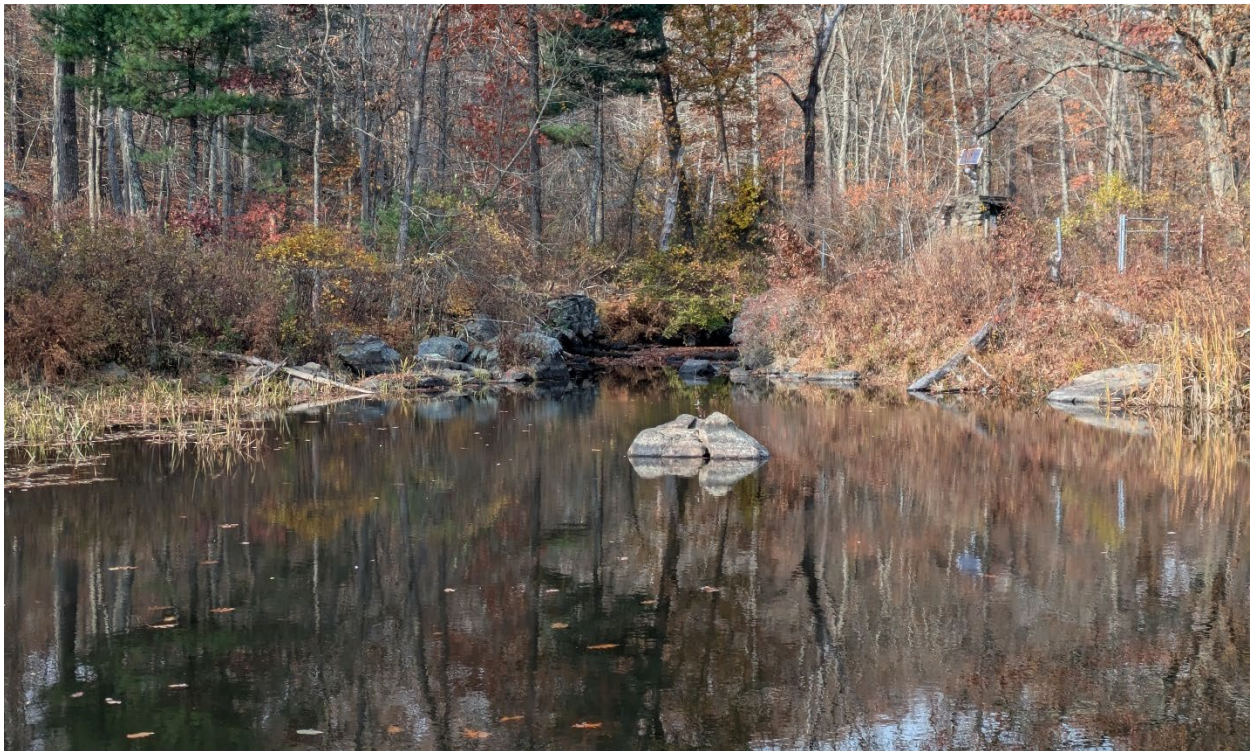
Looking upstream from bridge toward weir (proposed ramp location on right)

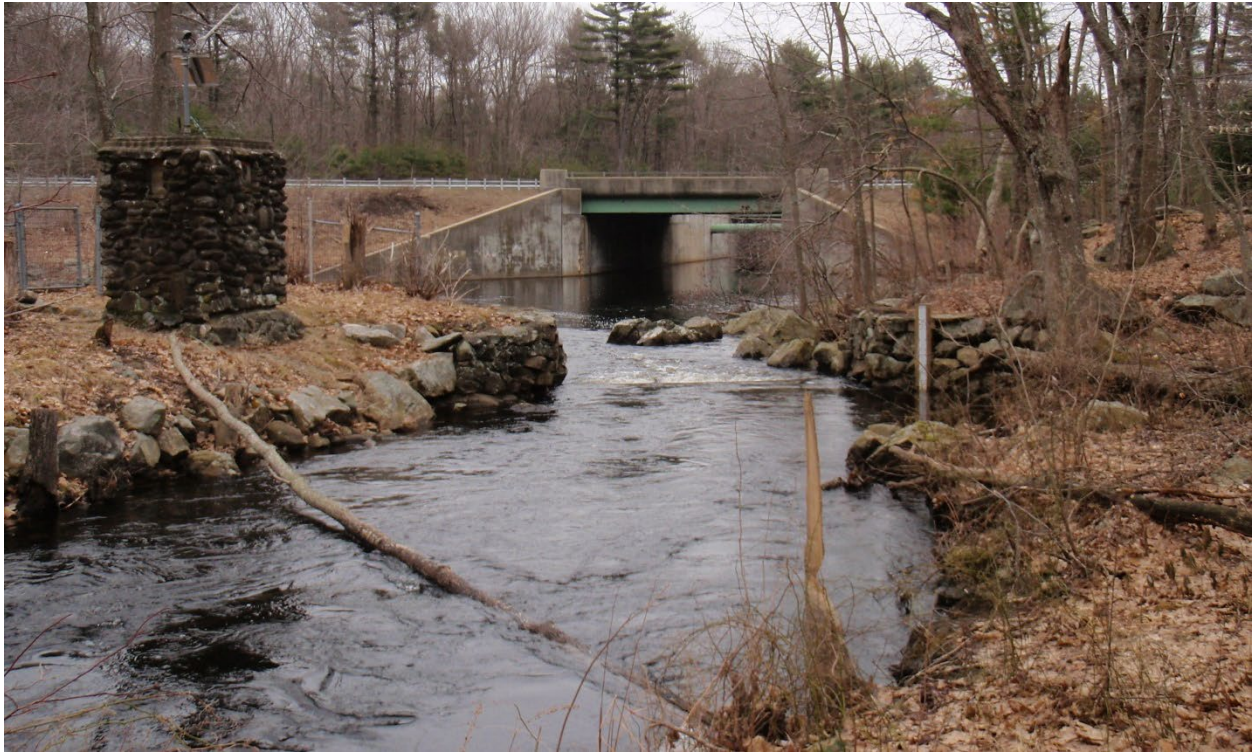
Looking downstream across USGS gage site and weir toward upstream face of bridge

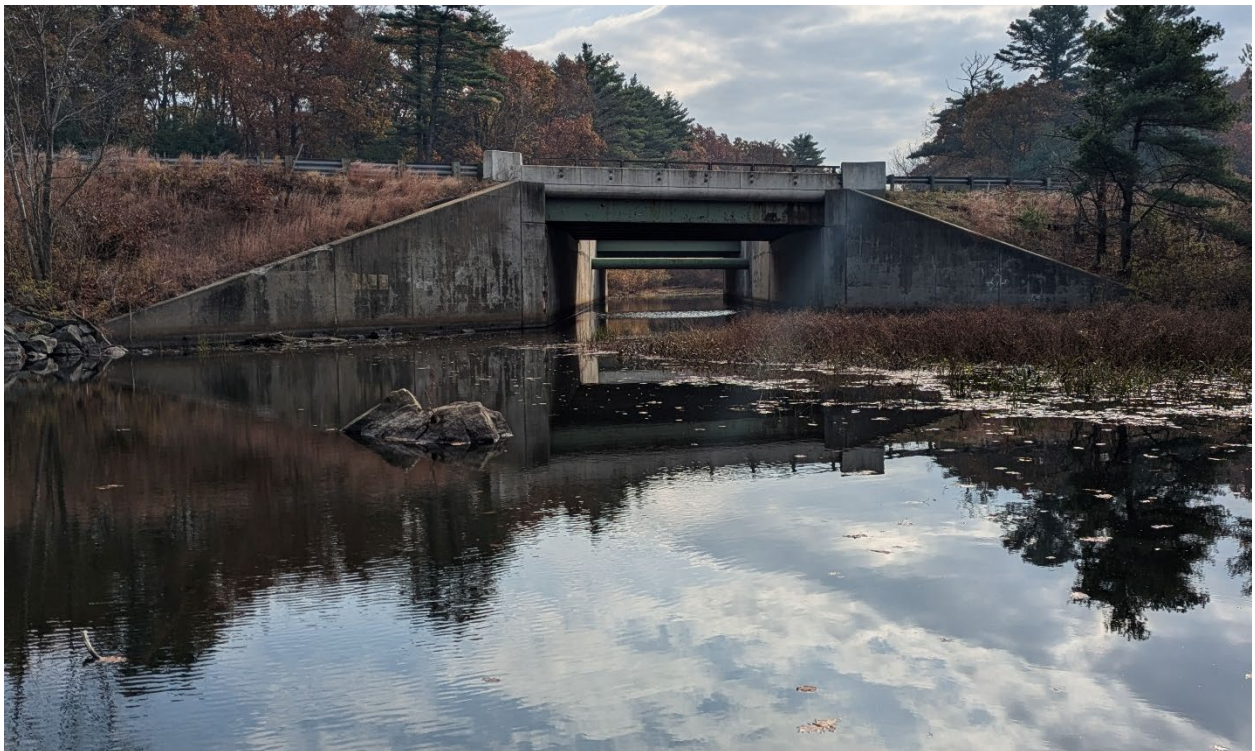
Upstream face of bridge

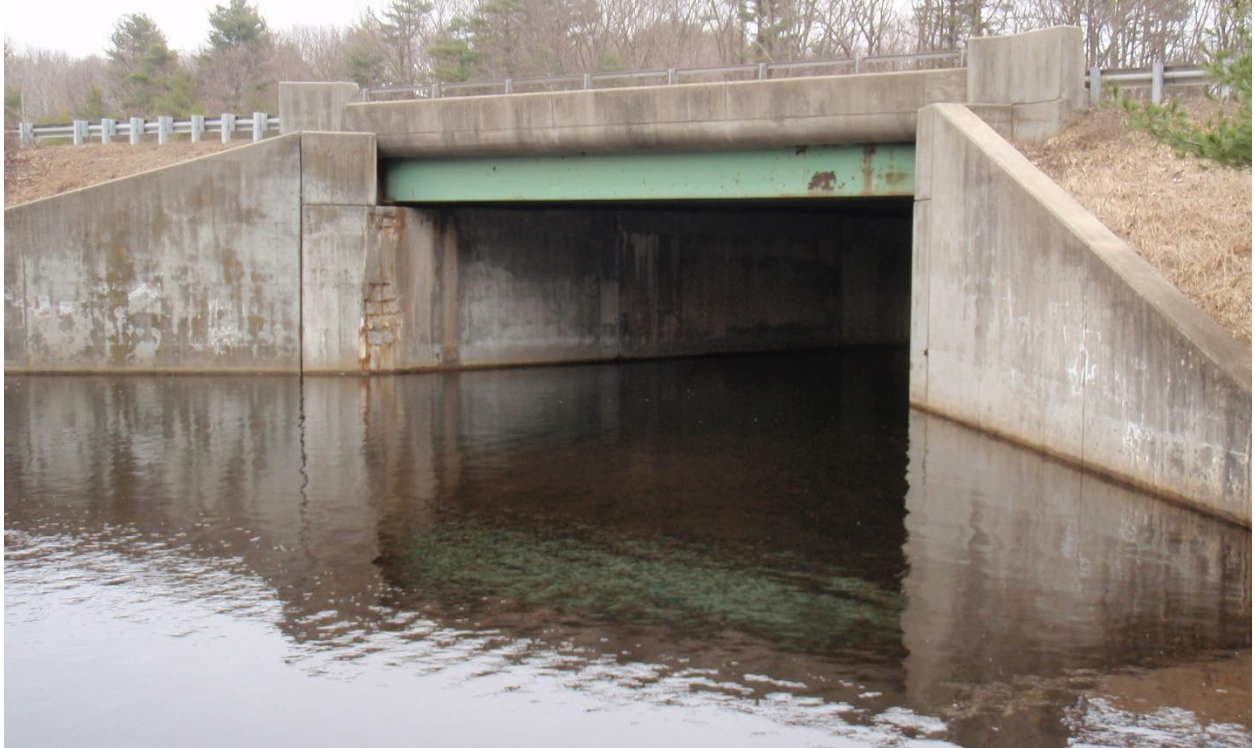
Upstream face of bridge

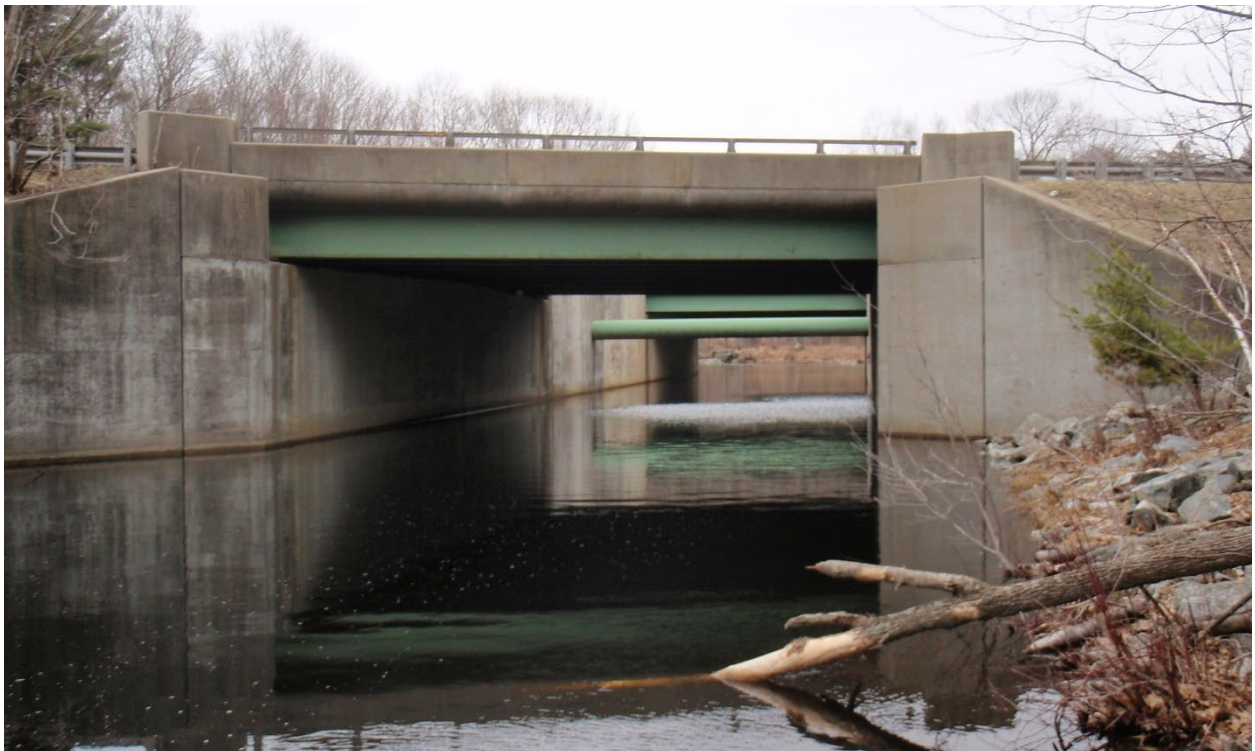
Downstream face of bridge

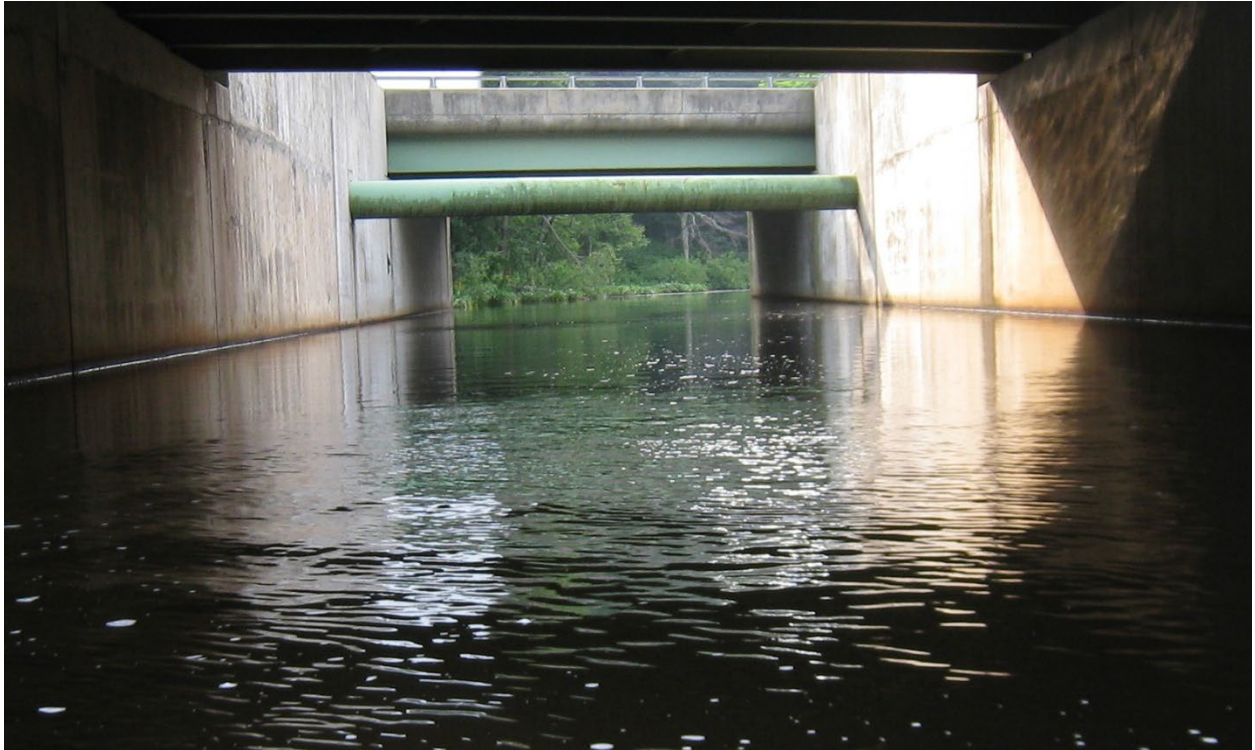
Interior of bridge

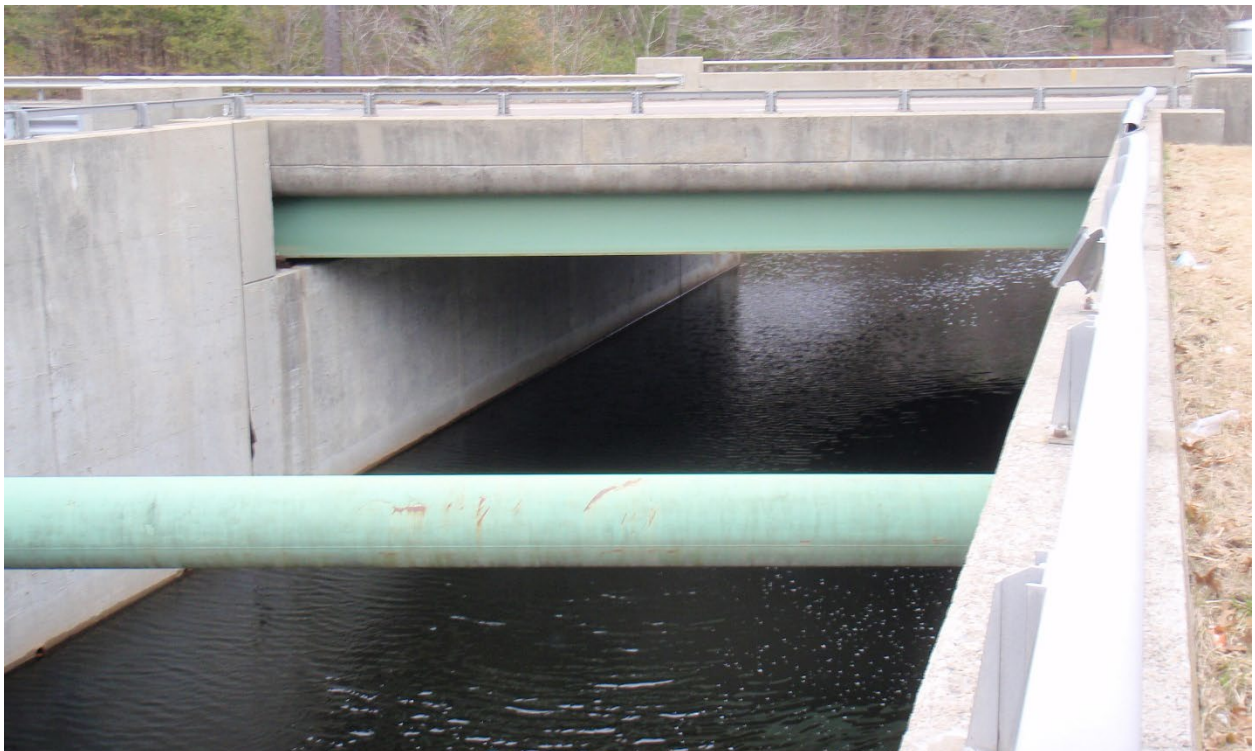
Interior of bridge, viewed from highway median
