BRIDGE NO.00848

77830 - UNION
ROUTE 89
over
INTERSTATE 84

Routine Inspection

10/10/2023

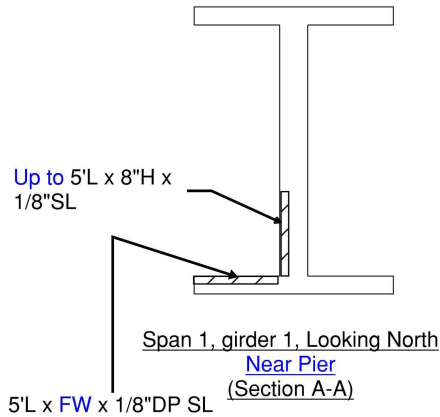
Section Loss Details - Span 1
N.T.S.

Bottom FL SL Calculation:
 $SL = (8.8'')(1/8'') = 1.1 \text{ in}^2$
 $Orig = (18'')(1'') = 18 \text{ in}^2$
 $(1.1 / 18)(100) = 6.11\%$

Note:
All losses have laminated rust

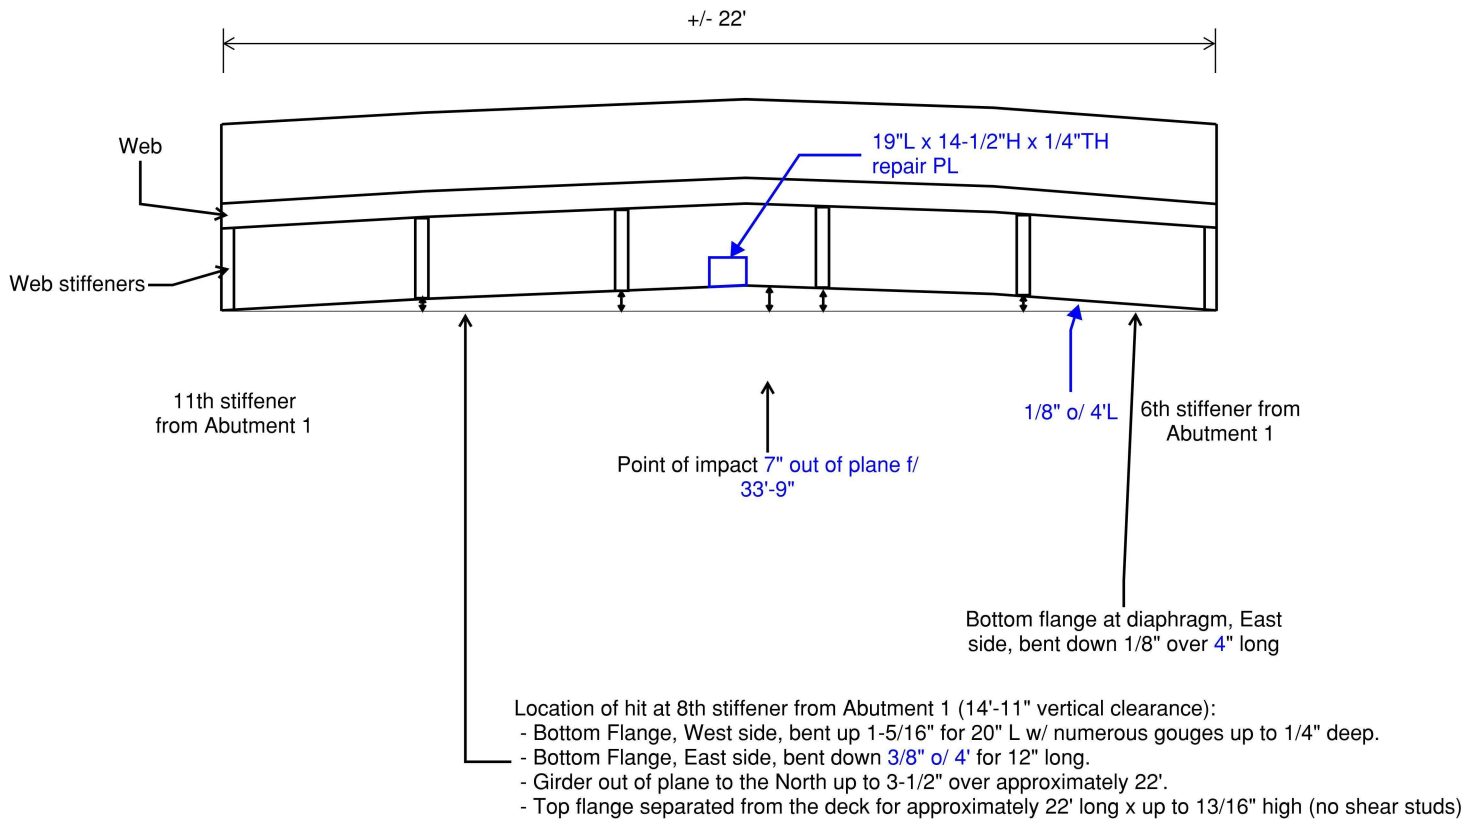
Decreased from '7' to '5'.
	See Underside of Deck & Framing General Notes sketch, Underside of Deck & Framing sketches, Girder 1 Collision Damage Detail (Plan View) and Photos 31 & 32.
Member Alignment: 5	- Random girder bottom flanges are wavy - Also, see Items "Bearing Devices" and "Collision Damage" above
	Rating decreased from '7' to '5'.
	See Underside of Deck & Framing General Notes sketch, Underside of Deck & Framing sketches and Photos 31-33.
Deflection Under Load: N	(N) Normal; (E) Excessive
Vibration Under Load: N	(N) Normal; (E) Excessive
Stand Pipes: N	
Catwalks: N	
Movable Inspection System: N	
Barrel Ladders: N	
Are Barrel Ladders OSHA Compliant? NA

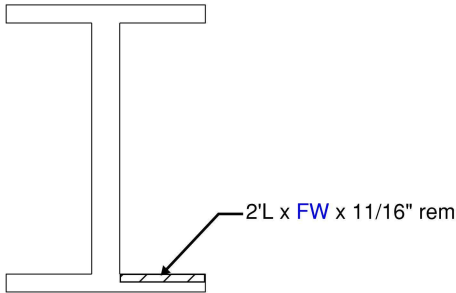
Span 2, girder 1, Looking North
(Section A-A)

Bottom FL SL Calculation:
 $SL = (8.8'')(3/16'') = 1.65 \text{ in}^2$
 $Orig = (18'')(7/8'') = 15.75 \text{ in}^2$
 $(1.65 / 15.75)(100) = 10\%$

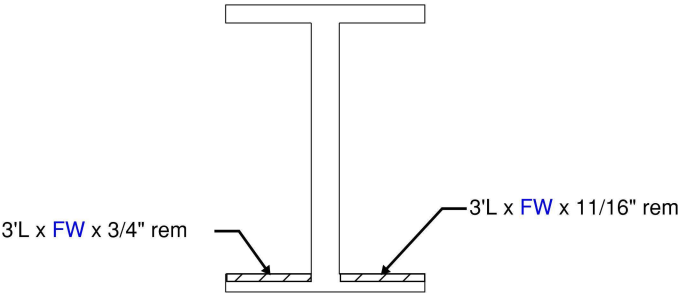
Span 2, girders 2-4, Looking North
(Section B-B)

Bottom FL SL Calculation:
 $SL = (8.8'')(3/16'') + (8.8'')(1/8'') = 2.75 \text{ in}^2$
 $Orig = (18'')(7/8'') = 15.75 \text{ in}^2$
 $(2.75 / 15.75)(100) = 17\%$

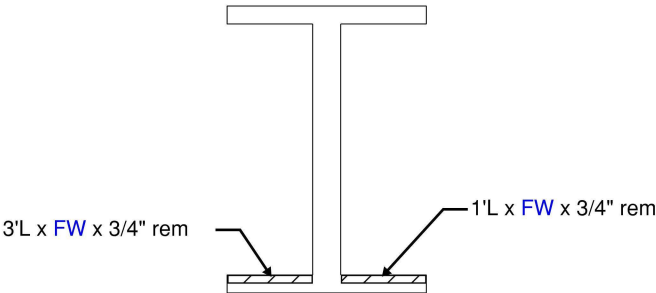
Span 2, girders 5, Looking North
(Section C-C)

Bottom FL SL Calculation:
 $SL = (8.8'')(1/8'') + (8.8'')(1/8'') = 2.2 \text{ in}^2$
 $Orig = (18'')(7/8'') = 15.75 \text{ in}^2$
 $(2.2 / 15.75)(100) = 13.9\%$

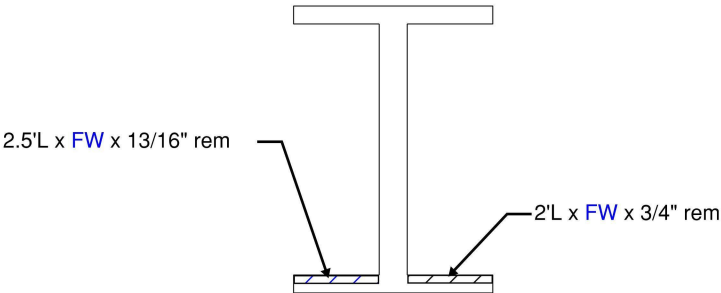
Span 2, girder 6, Looking North
(Section D-D)

Bottom FL SL Calculation:
 $SL = (8.8'')(1/8'') + (8.8'')(1/16'') = 1.65 \text{ in}^2$
 $Orig = (18'')(7/8'') = 15.75 \text{ in}^2$
 $(1.65 / 15.75)(100) = 10\%$

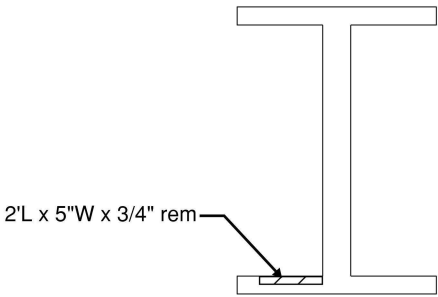
Span 2, girder 7, Looking North
(Section E-E)

Bottom FL SL Calculation:
 $SL = (5'')(1/8'') = 0.625 \text{ in}^2$
 $Orig = (18'')(7/8'') = 15.75 \text{ in}^2$
 $(0.625 / 15.75) (100) = 4\%$

2'L x 5"W x 3/4" rem

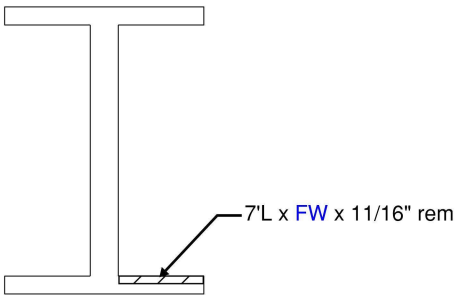
Span 2, girder 2, Looking North
(Section F-F)

Bottom FL SL Calculation:
 $SL = (8.8'')(3/16'') = 1.65 \text{ in}^2$
 $Orig = (18'')(7/8'') = 15.75 \text{ in}^2$
 $(1.65 / 15.75) (100) = 10\%$

7'L x FW x 11/16" rem

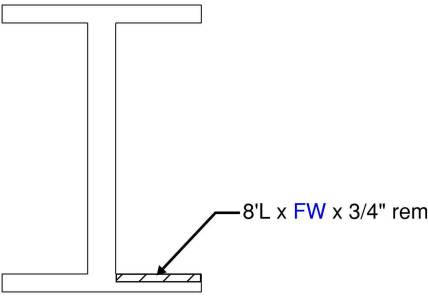
Span 2, girder 3, Looking North
(Section G-G)
(three closely spaced locations
within 8'L area)

Bottom FL SL Calculation:
 $SL = (7.5'') * (1/8'') = 0.938 \text{ in}^2$
 $Orig = (18'')(7/8'') = 15.75 \text{ in}^2$
 $0.938 / 15.75 * (100) = 6\%$

8'L x FW x 3/4" rem

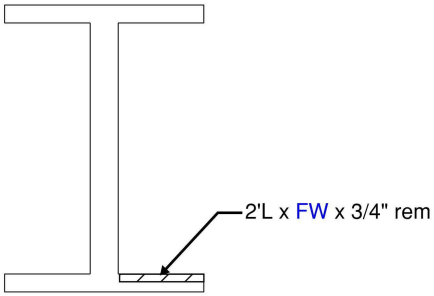
Span 2, girder 6, Looking North
(Section H-H)

Bottom FL SL Calculation:
 $SL = (8.8'')(1/8'') = 1.1 \text{ in}^2$
 $Orig = (18'')(7/8'') = 15.75 \text{ in}^2$
 $(1.1 / 15.75) (100) = 7\%$

2'L x FW x 3/4" rem

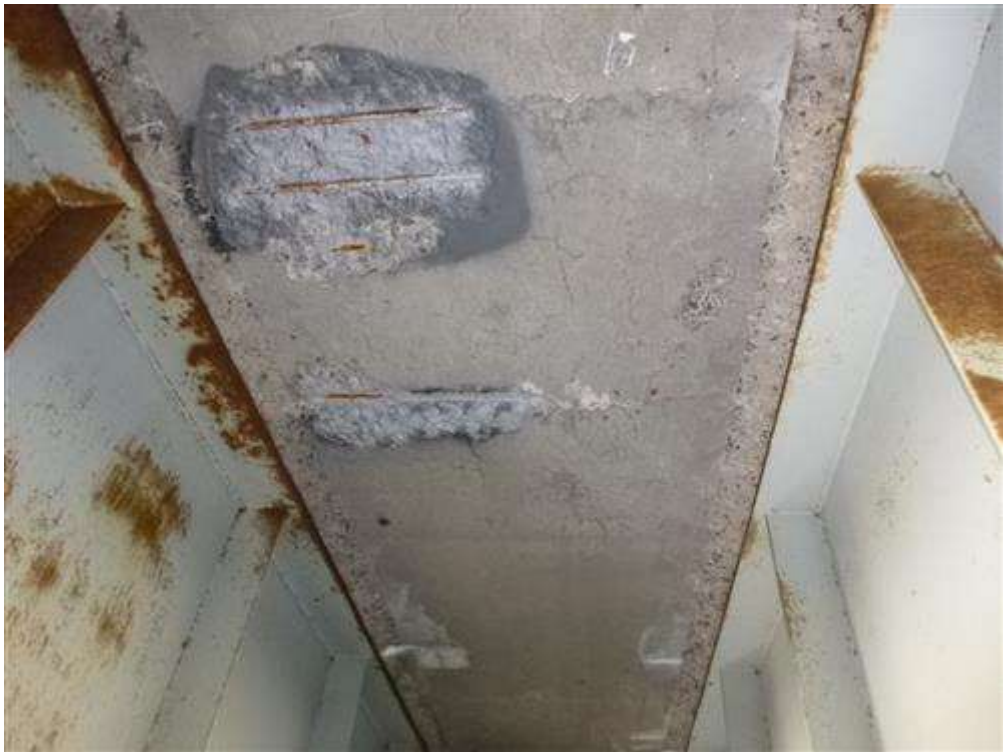
Photo Number: 10

The underside of the concrete deck:
 - Random spalls up to 2'-6" long x 4'-6" wide x 4" deep, some spalls have adjacent 6" wide hollow areas and/or concrete inside the spall is hollow (over road) and the spalls are typically coated but exposed rebar has some re-rusting (Photos 10 & 11).

Span 2, bay 3, panel 3. Note spalls with exposed rebar and adjacent hollow areas.

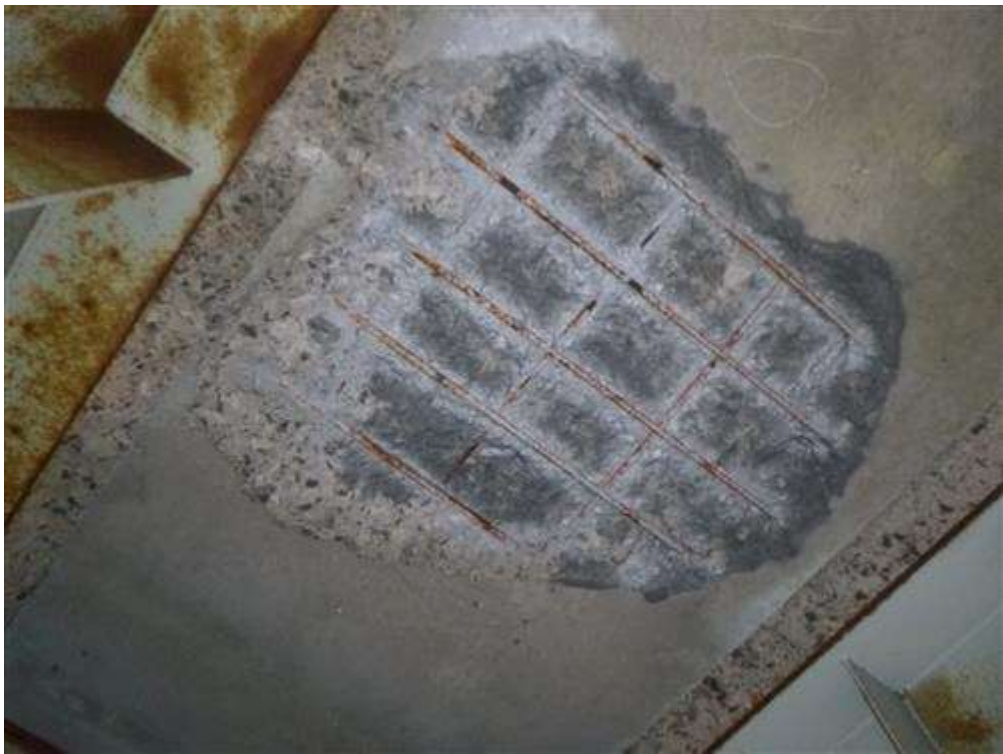
Photo Number: 11

Span 2, bay 3, panel 2. Note spall with debonded rebar.

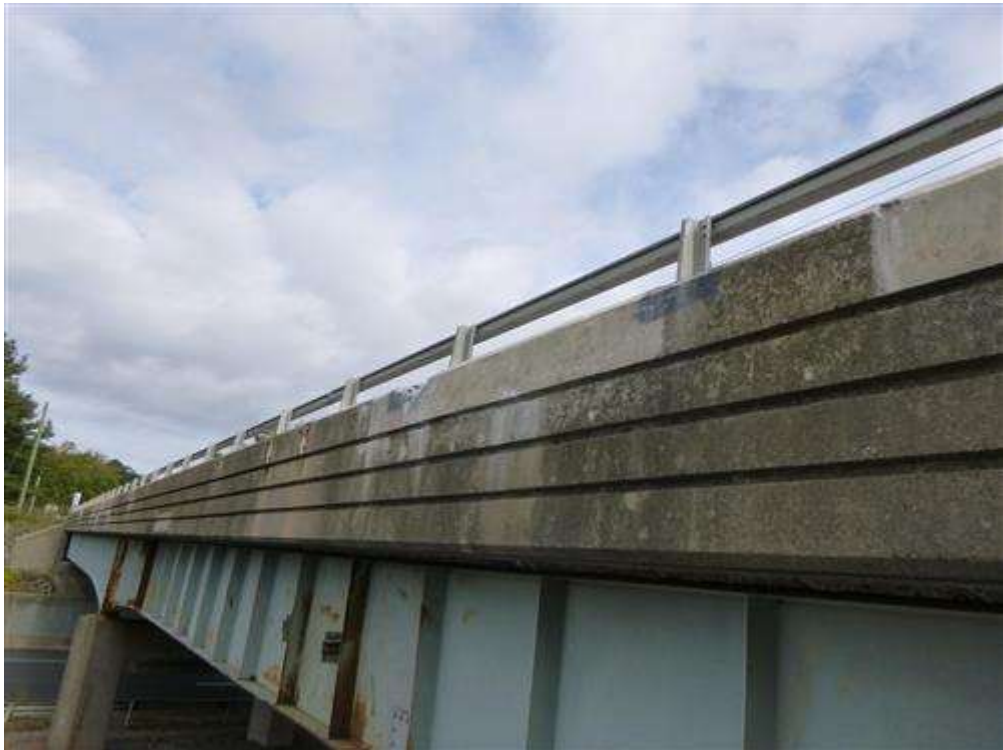
Photo Number: 15

Span 1, west parapet near abutment 1 with hollow area.

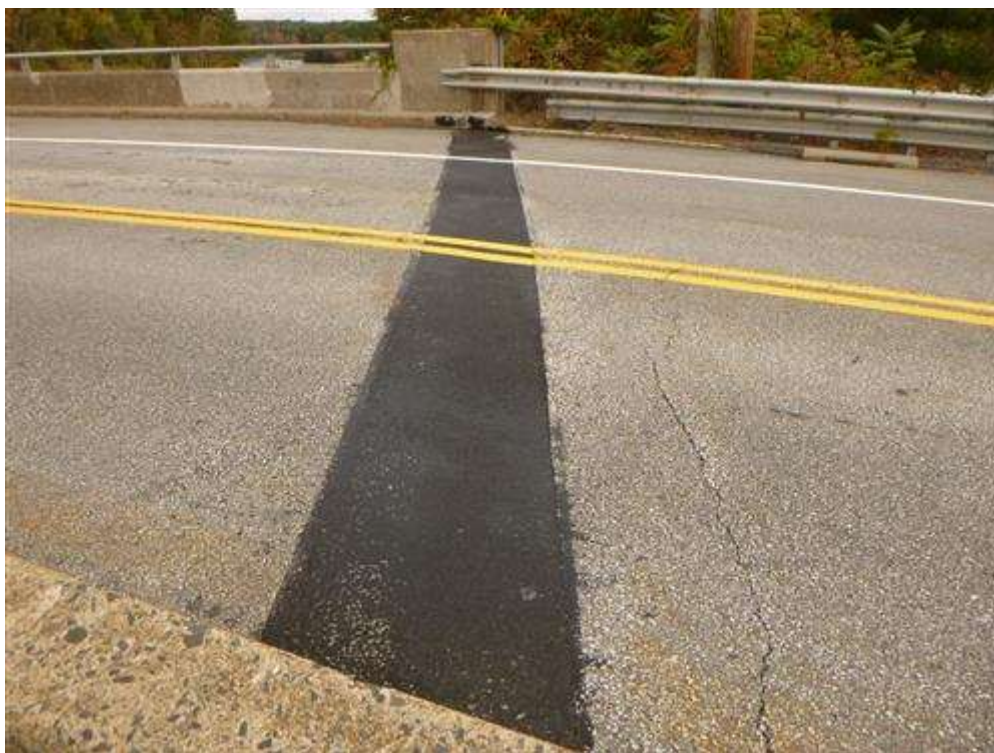
Photo Number: 17

Asphaltic plug joint at abutment 1, looking east. Note the adhesion crack.

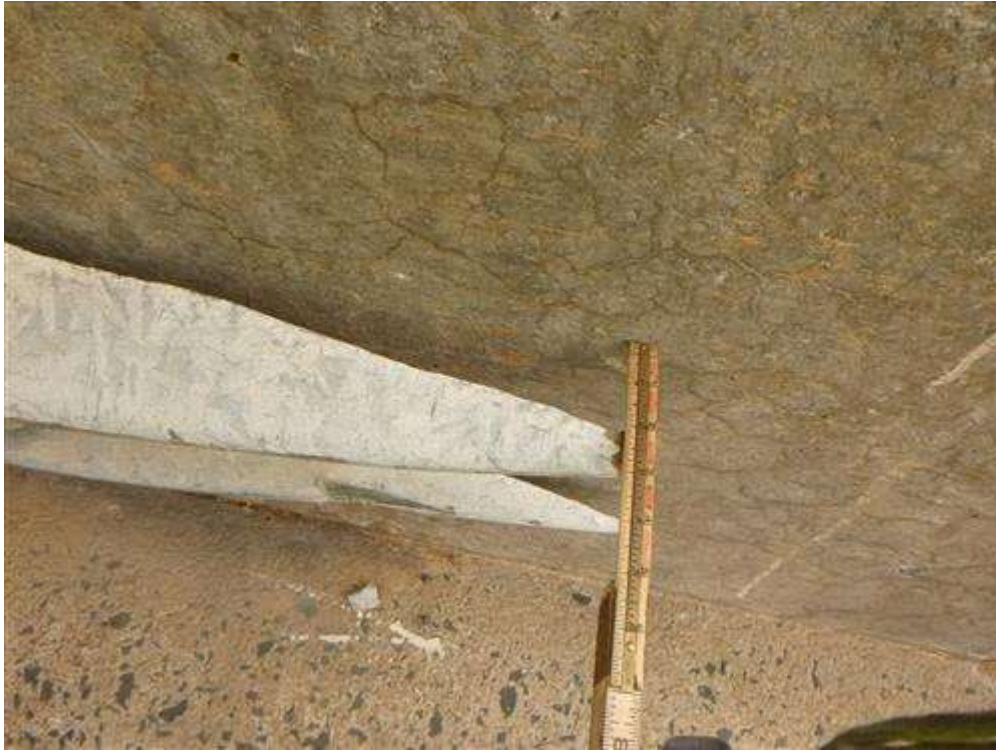
Photo Number: 19

- All transitions has up to 2" gap between parapet and approach guide rail (Photo 19).
		See Top of Deck General Notes sketch and Top of Deck sketch.
Approach Pavement:	6	Bituminous approach pavement: - The northeast approach pavement has a 12' long x 3/4" wide transverse crack. - The southeast approach pavement has a 20' long x 3/4" wide transverse crack. - Rating decreased from '7' to '6'.
		See Top of Deck General Notes sketch, Top of Deck sketch and photos 4-5.
Approach Embankment:	8	
<u>Traffic Safety Features</u>		
Bridge Railings:	0	Do not meet standards for Non-NHS structures (safety walk).
Transitions:	0	Do not meet R-B 350 standards (rub rails not attached to parapet).
Approach Guardrails:	0	Do not meet R-B 350 Standards (steel blockouts and weak posts).
Approach Guardrail Ends:	0	Do not meet R-B 350 Standards (transition to ground within clear zone).

Northeast transition with a gap, typical.

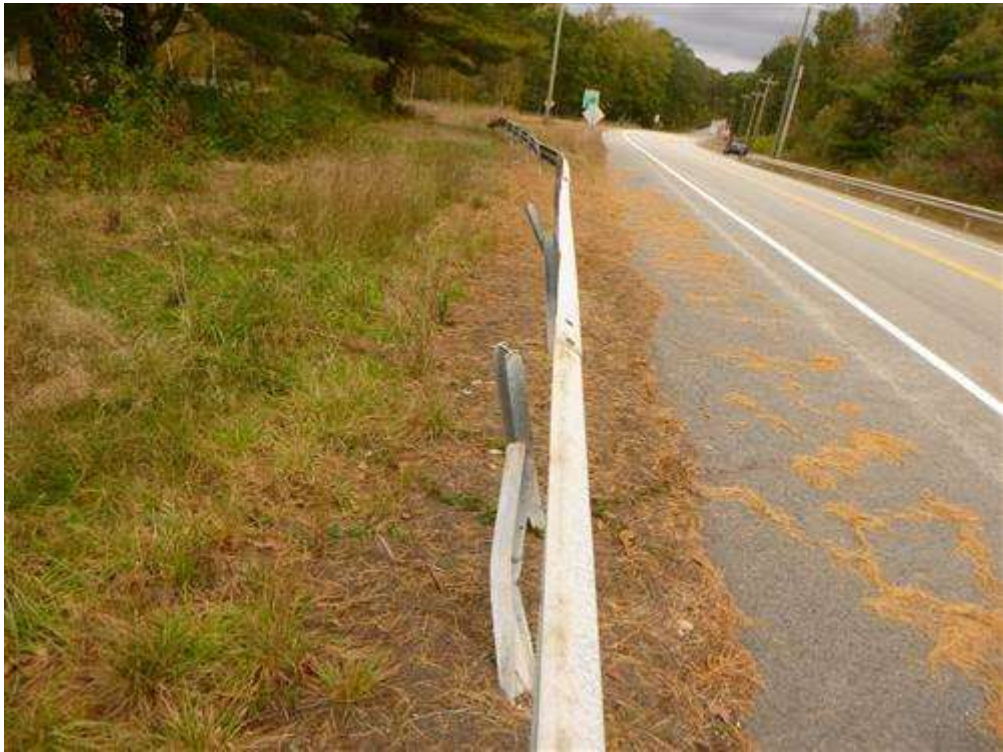
Photo Number: 21

Approach Slab: N	None per available plans.
Relief Joints: N	
Approach Guide Rail: 6	Steel W-beam guide rail with weak posts: - Random areas up to 20' long with collisions damage and up to four (4) bent/disconnected posts (Photos 20 & 21). - The northwest guide rail has a 3/4" long tear.

Northwest approach guide rail, looking north. Note the collision damage and disconnected posts

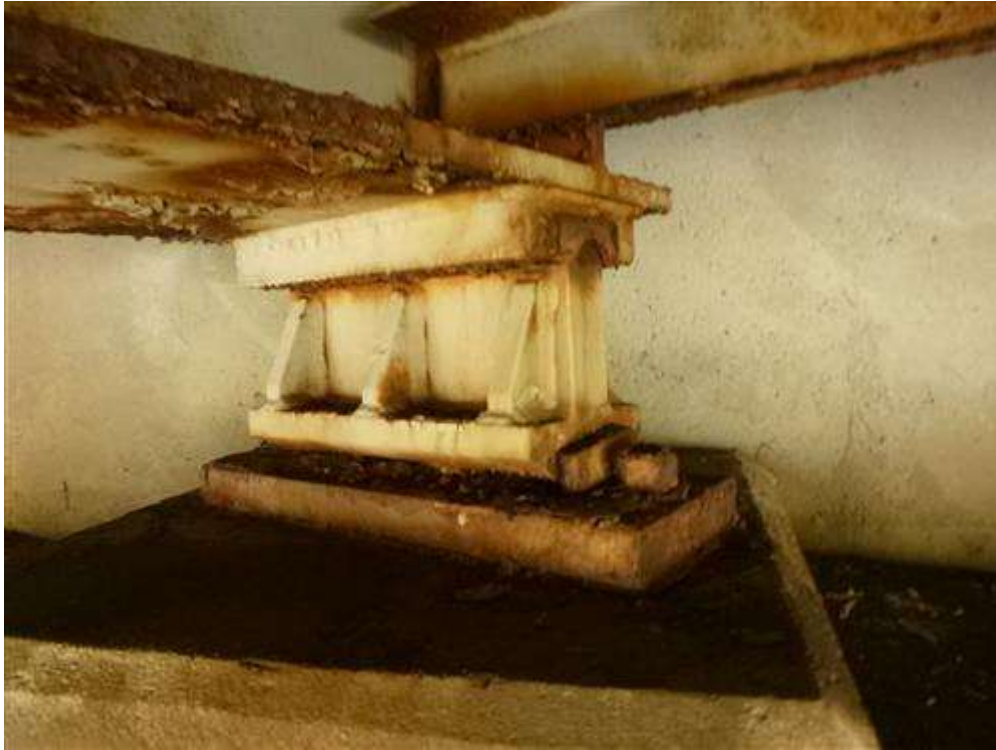
Photo Number: 23

Span 1, girder 4 at abutment 1. Note rocker bearing with laminated rust and missing keeper block on the west elevation.

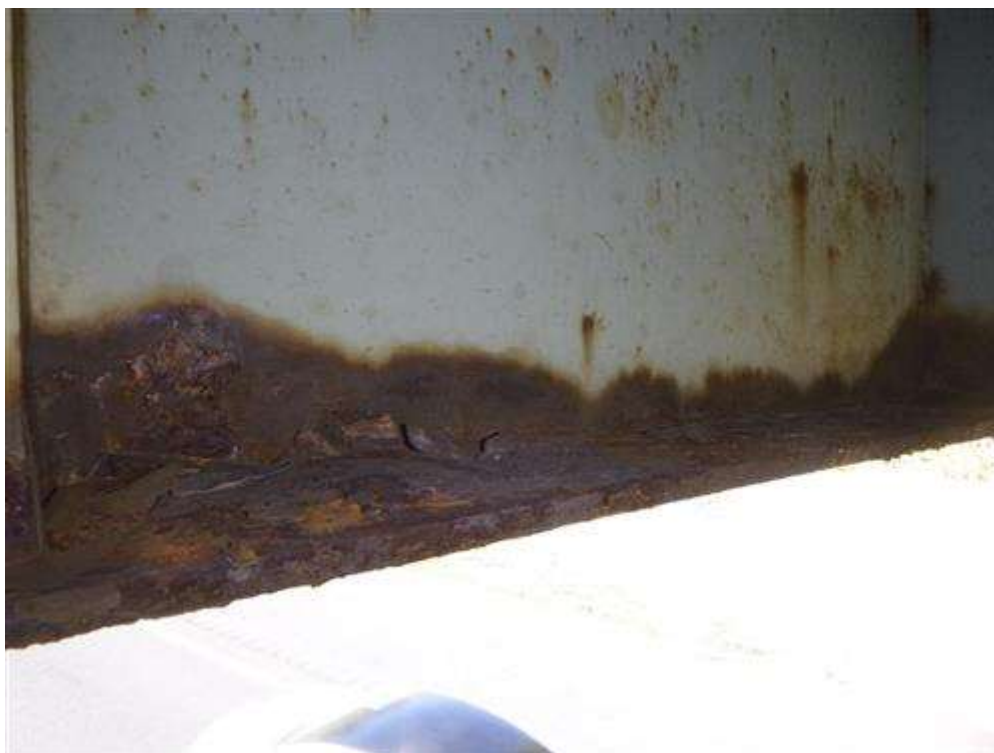
Photo Number: 25

Span 2, girder 2, east elevation near panel 4. Note laminated rust and section loss at bottom flange.

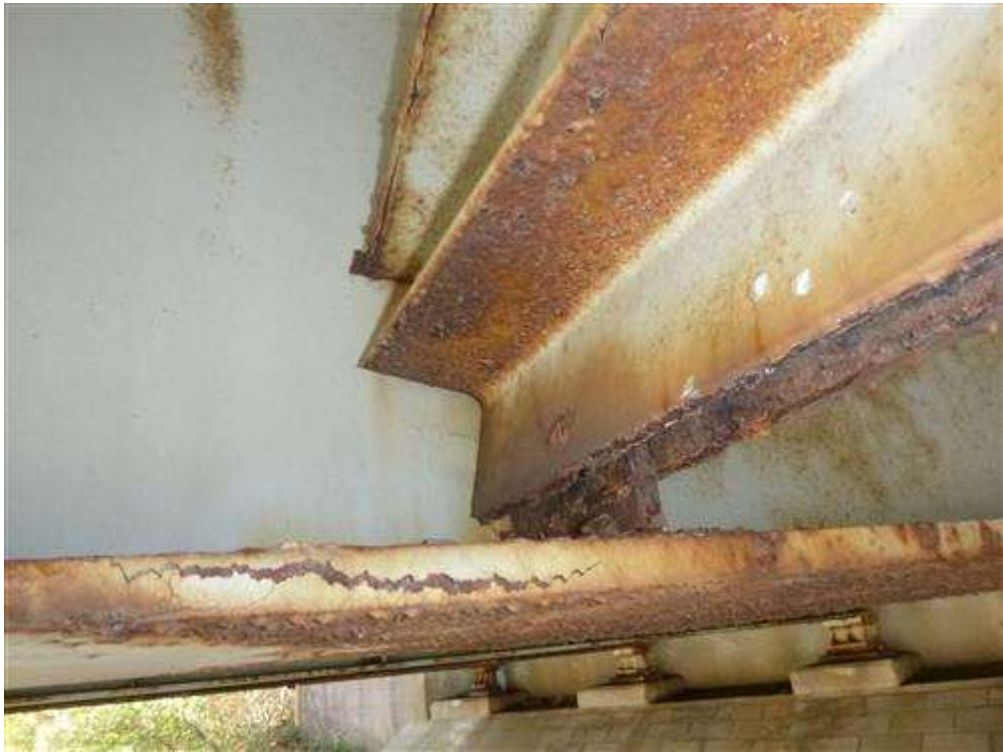
Photo Number: 27
Span 1, bay 2, first intermediate diaphragm. Note deformed/bent lower members and broken overhead welds due to pack rust. Photo Taken: 10/17/2023

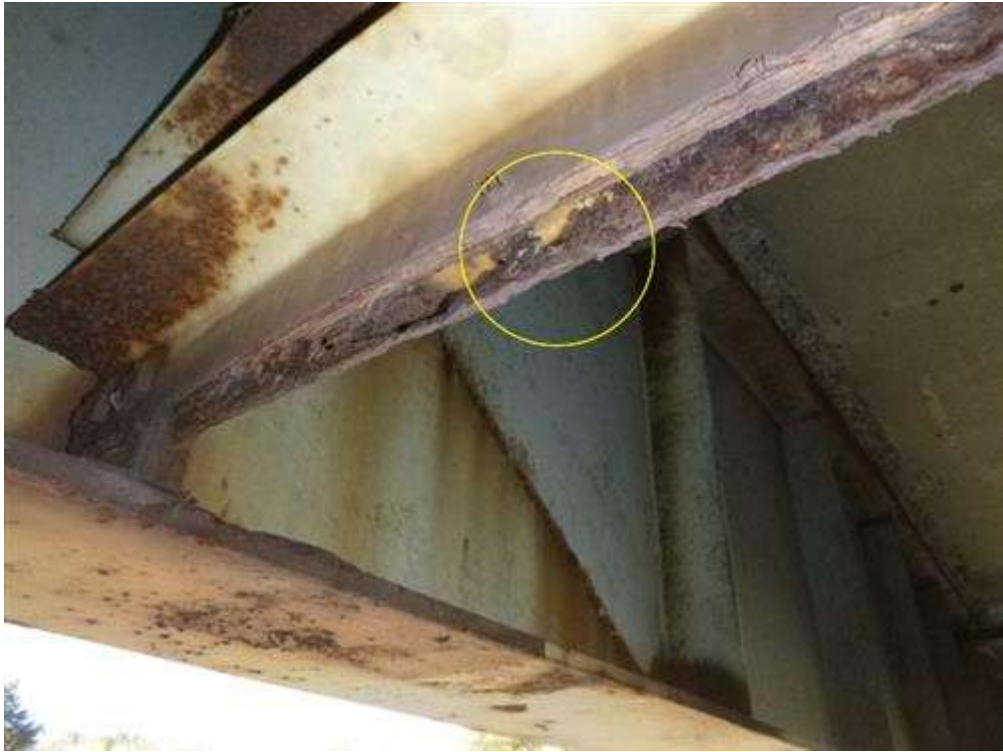
Photo Number: 28
Span 2, bay 1, second diaphragm with a rusted through hole in the lower angle. Photo Taken: 10/17/2023

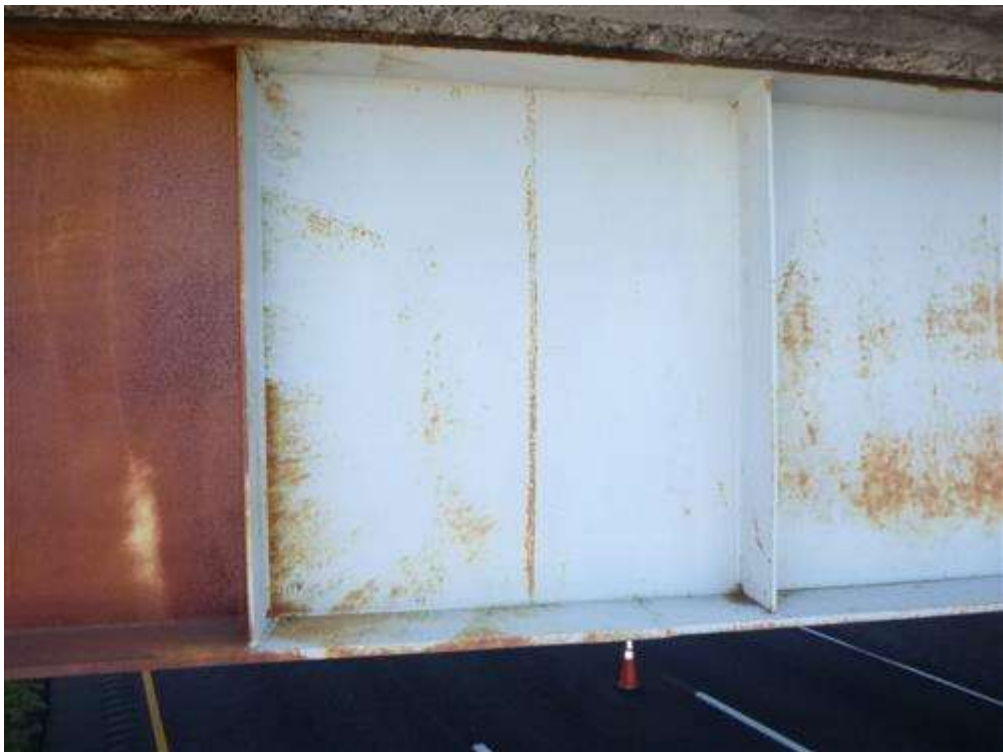
Photo Number: 29

Span 1, girder 1, looking west. Note the web and bottom flange splice welds not ground smooth, typical.

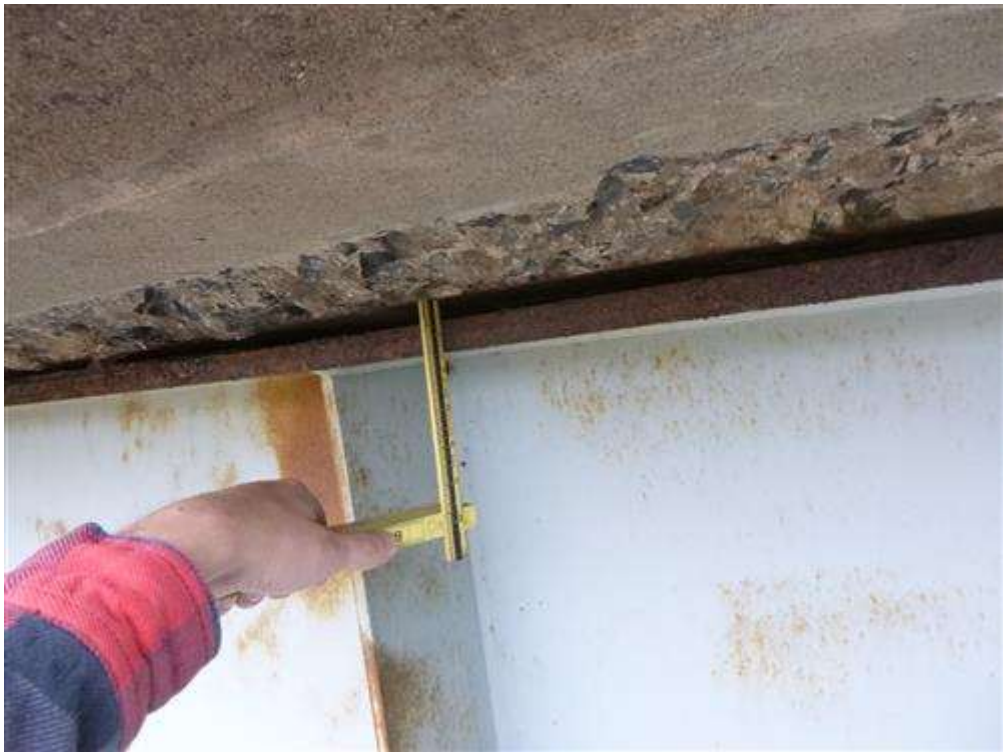
Photo Number: 30

Span 1, girder 1, west elevation above collision damage. Note the gap between girder top flange and deck.

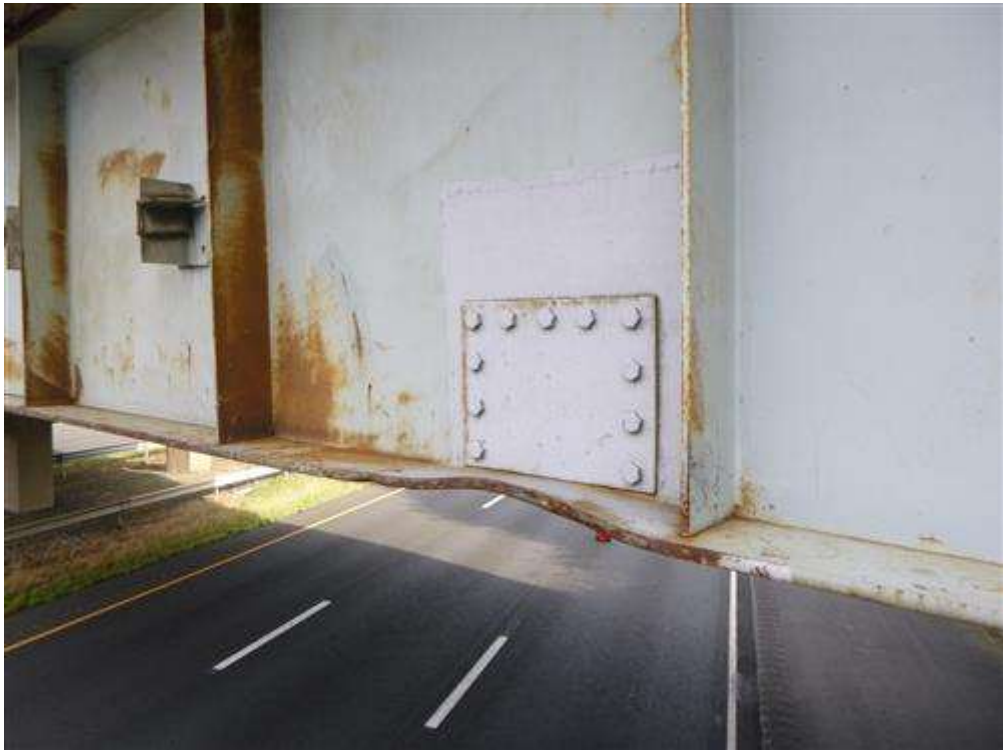
Photo Number: 31

Span 1, girder 1 west elevation web with repair plate at the collision damage.

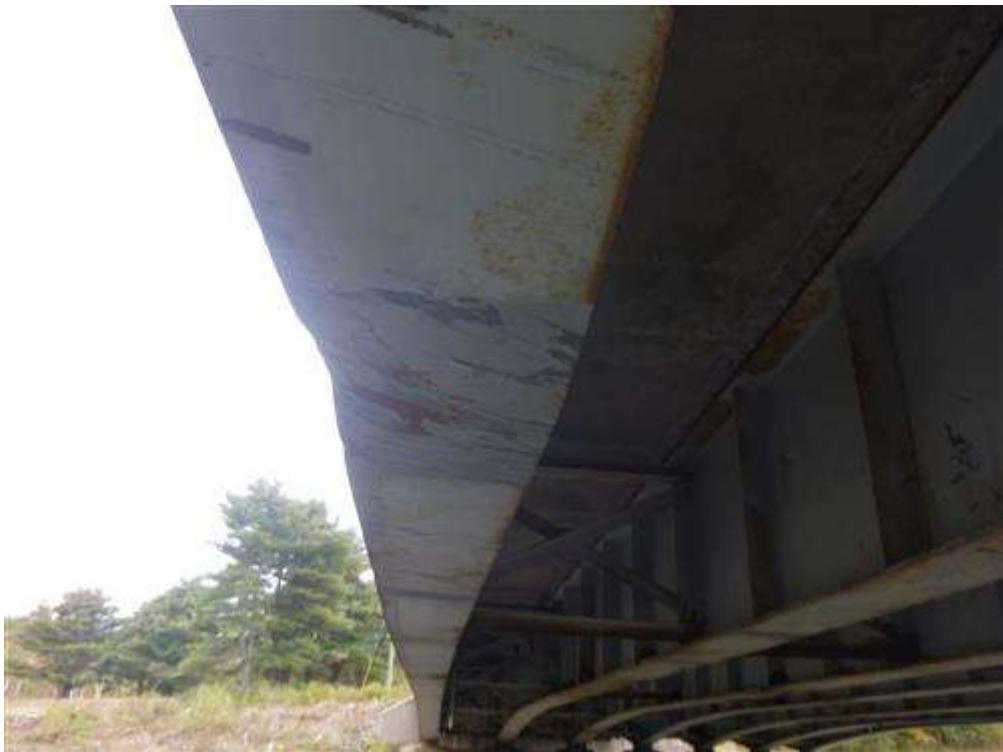
Photo Number: 33

Span 1, girder 1 underside of bottom flange at the collision damage.

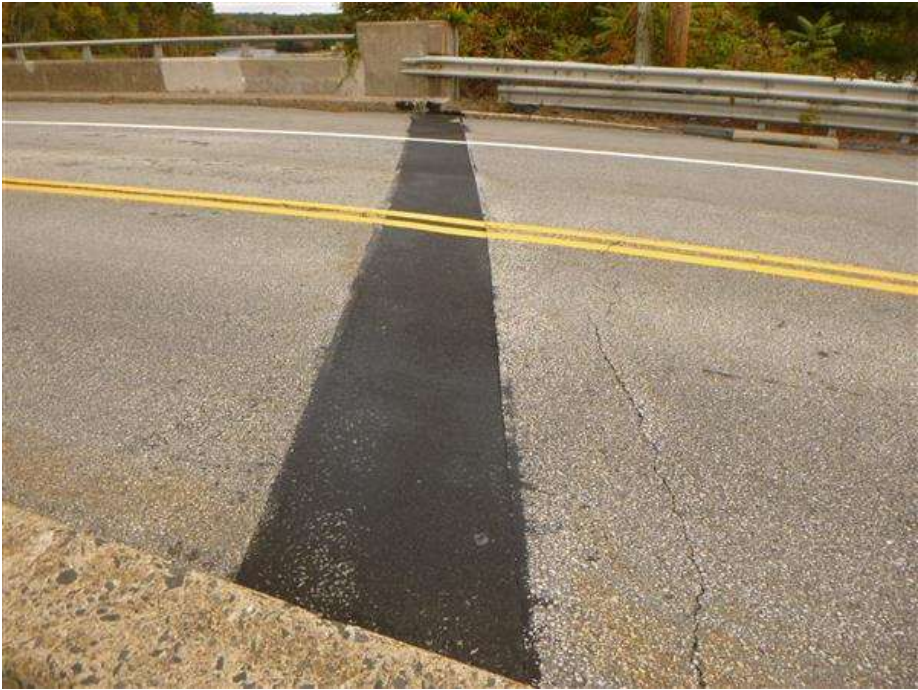
Status:	Bridge Maintenance Garage	Assigned To:	District_1 Bridge	Work Item ID:	00848-2023-0017
Date Issued:	11/09/2023	Priority:	Routine Repair		
Deficiency:	Deck Joint				
Structural Component:	Deck				
Comments:	Adhesion cracks up to full length x 3/4" wide at both abutments.

Asphaltic plug joint at abutment 1, looking east. Note the adhesion crack.

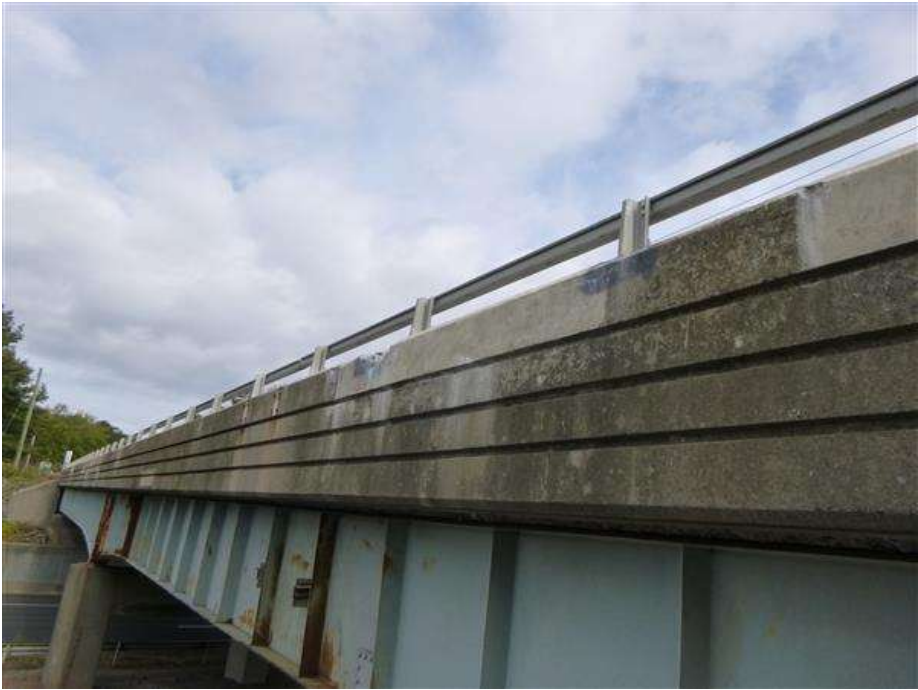
- Span 1, west fascia parapet with (2) hollow areas on the outside face up to 3' long x 1' high over the right lane/shoulder near abutment 1.
- Span 2, east fascia parapet with hollow area on the outside face 6" long x 1' high over the right shoulder near abutment 2.

Span 1, west parapet near abutment 1 with hollow area.

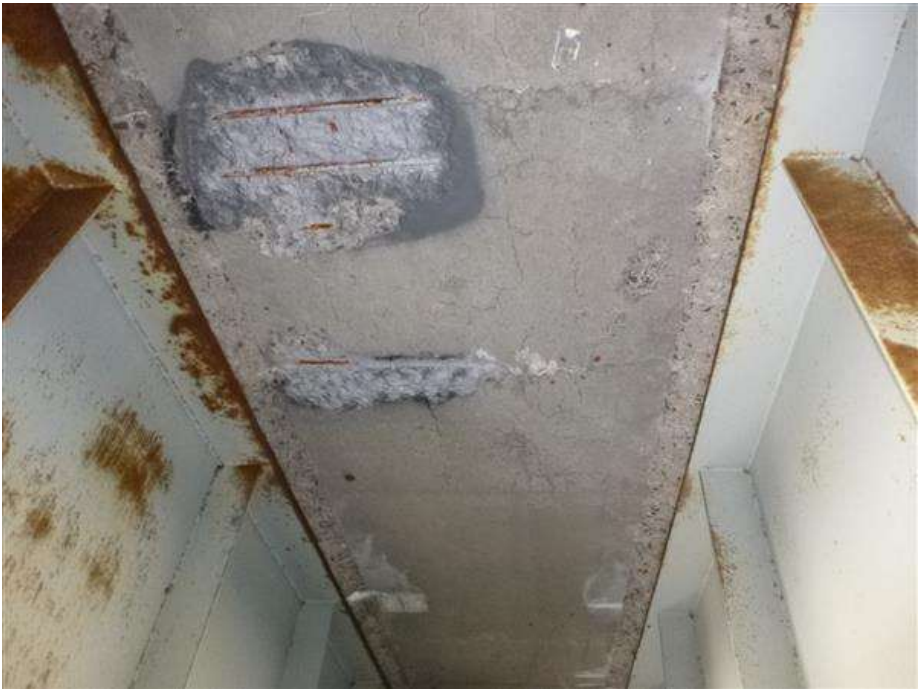
Span 2, bay 3, panel 3. Note spalls with exposed rebar and adjacent hollow areas.

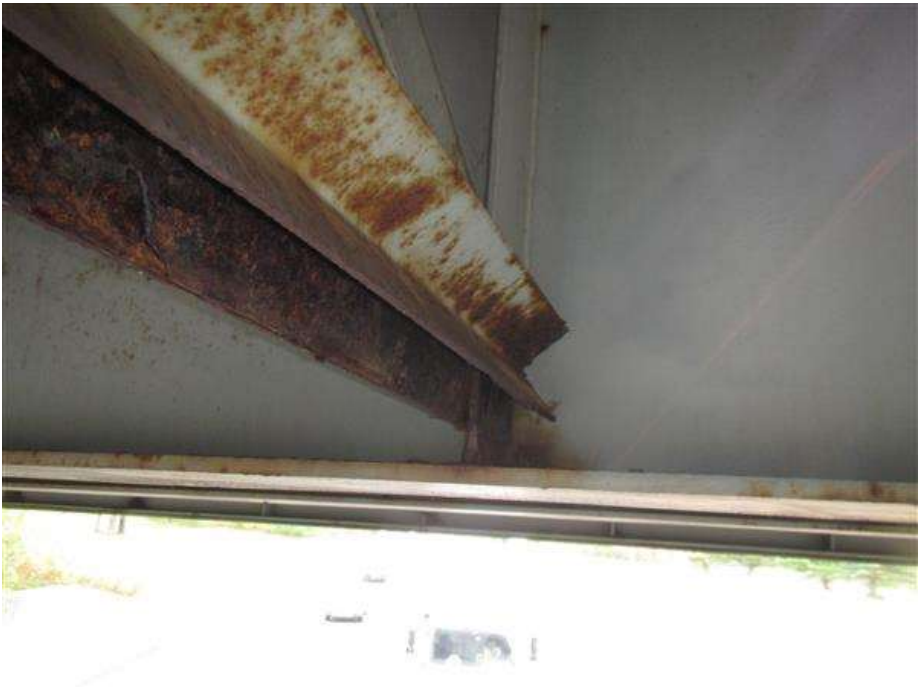
Status:	Bridge Maintenance Garage	Assigned To:	District_1 Bridge	Work Item ID:	00848-2019-0010
Date Issued:	12/31/2019	Priority:	Priority Repair		
Deficiency:	Welds/ Cracks				
Structural Component:	Superstructure				
Comments:	Top and overhead horizontal welds are cracks/broken between cross frame bottom angles and web stiffeners; some members are lifted up/rotated up to 2.5". One of two lower horizontal angles of cross frames supported by two square steel plates welded to the top of the angles. These locations are as follows:				
	Span 1:				
	- Bay 2, diaphragms 2, 3 & 6				
	- Bay 3, diaphragm 3				
	- Bay 4, diaphragm 3				
	- Bay 5, diaphragm 3				
	Span 2:				
	- Bay 4, diaphragm 3				
	- Bay 5, diaphragm 6				
	Repair broken cross frames ,clean and paint.				
Date Completed:		Actual Quantity:

Span 1, bay 5, third intermediate diaphragm: Deformed/bent lower members and broken overhead welds due to impacted rust (rust removed).

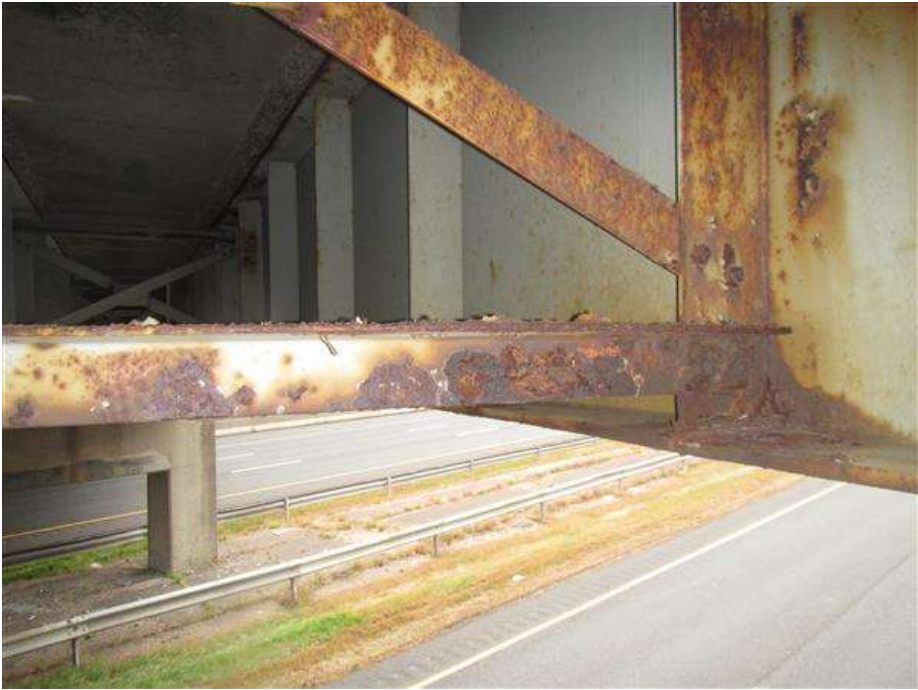
Span 2, bay 1, 4th diaphragm with a rusted through hole in the lower angle.

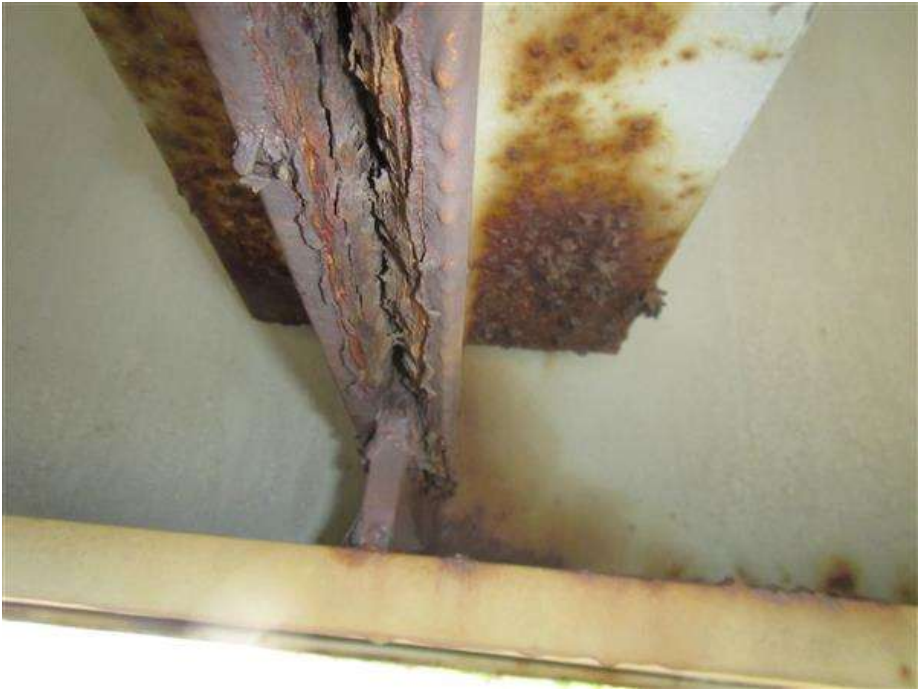
Typical impacted rust between lower intermediate diaphragm members. Also, note and broken overhead weld (typical condition).

Repair /clean and paint.

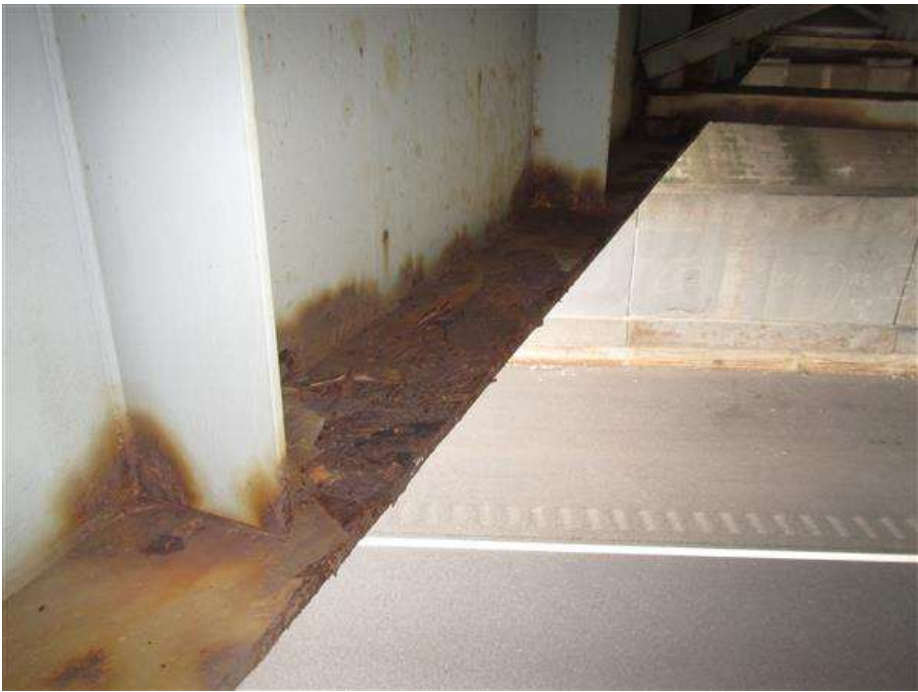
Span 2, girder 2, east elevation at panel 4: Laminated rust and section loss at bottom flange.

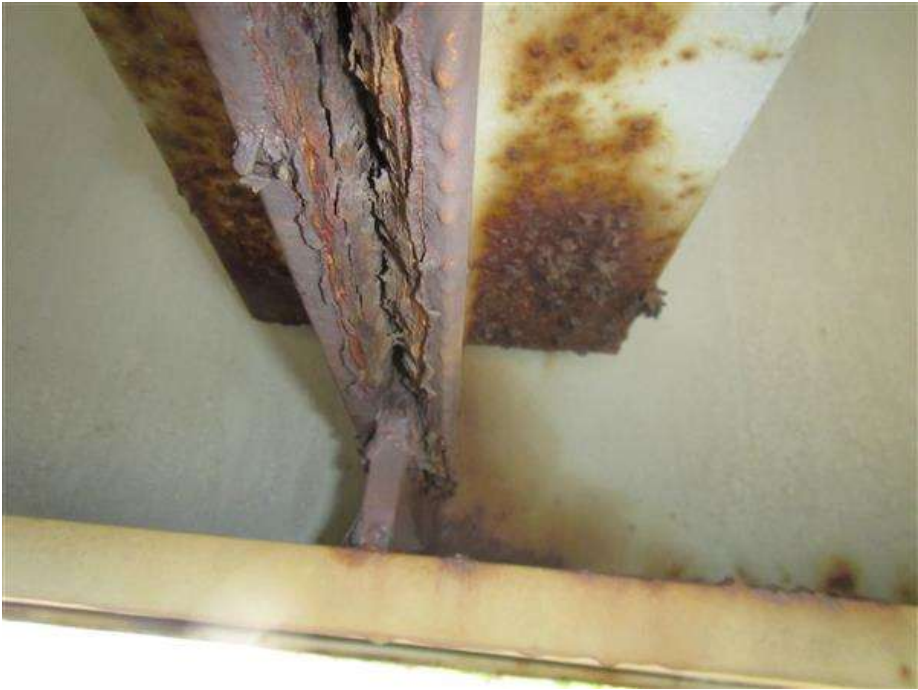
Typical impacted rust between the components of the lower intermediate diaphragm member.
