Subject: On-Call Asbestos, Lead, Air Quality & Demolition Compliance  
Agreement No. 10.04-02 (23)  
HazMat Inspection – Replacement of Bridge No. 02698, Route 149 over Dykas Brook  
East Haddam, CT  
ConnDOT Assignment No. 524-8221  
ConnDOT Project No. 40-148  
TRC Project No. 501871.8221.0710

TRC performed a limited hazardous materials site investigation associated with the replacement of Bridge No. 02698, Route 149 over Dykas Brook in East Haddam, CT.

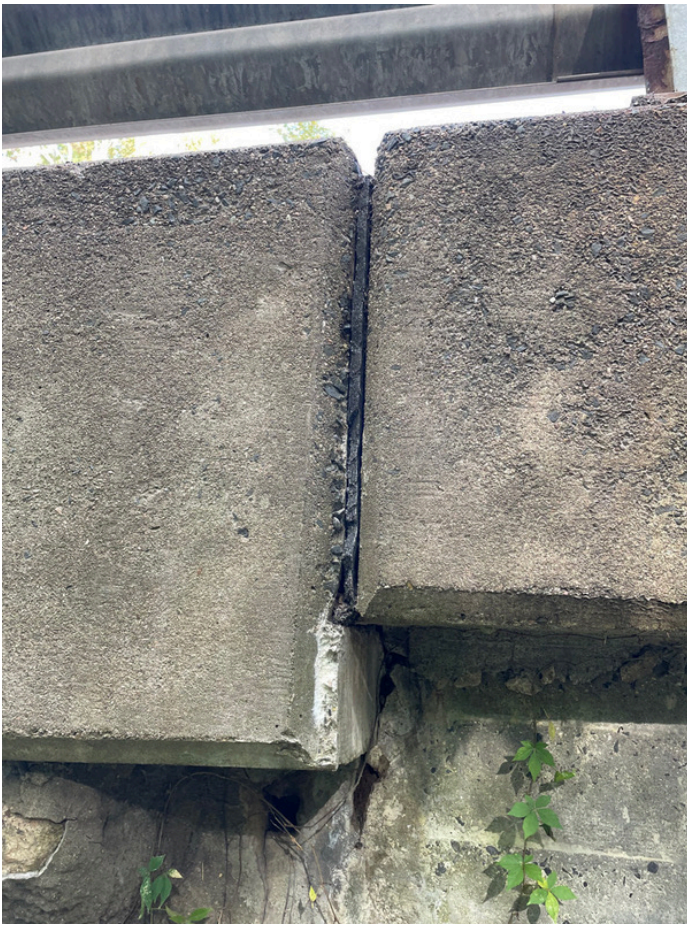
## Representative Photos

All suspect asbestos-containing materials (black asphalt filler in between concrete wall joints and black tar coating on concrete walls) identified and sampled at Bridge No. 02698 were determined to be non-ACM.

Sampled or Assumed?	Sampled
Material Acronym	AF1
Material Description	Asphalt filler in between the concrete walls
Material Color	Black

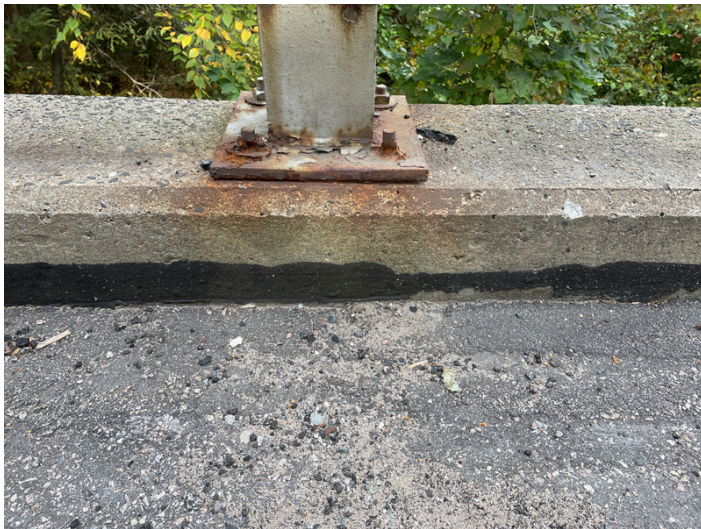
#### Representative Photos

Sampled or Assumed?	Sampled
Material Acronym	TC ▶ 1
Material Description	Tar coating on concrete walls
Material Color	Black

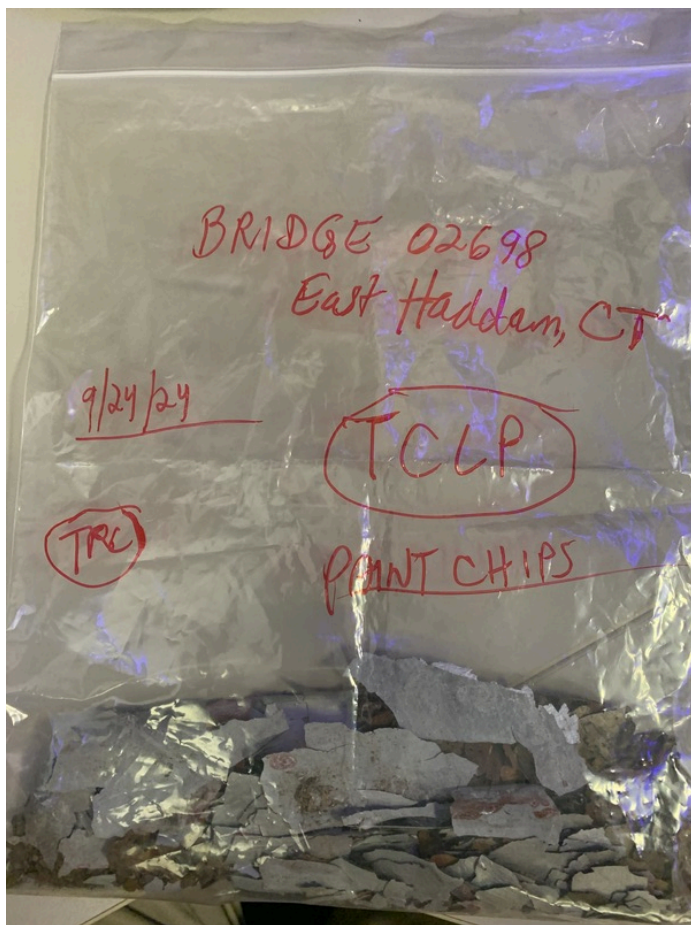
## TCLP/SPLP/Total Lead Photos

Results obtained from the TCLP waste stream sampling and analysis for leachable lead from the paint on the railings/railing support components characterized the paint waste stream at Bridge No. 02698 as **CTDEEP/RCRA hazardous waste**.

TCLP/SPLP/Total Lead Sample Description	Paint chips from railing and railing supports.
---	--
