ADDENDUM No. 1

LEE, LENOX AND PITTSFIELD

MassDOT Berkshire Line Civil Improvements

2018 CULVERT INSPECTION REPORTS 30 Pages

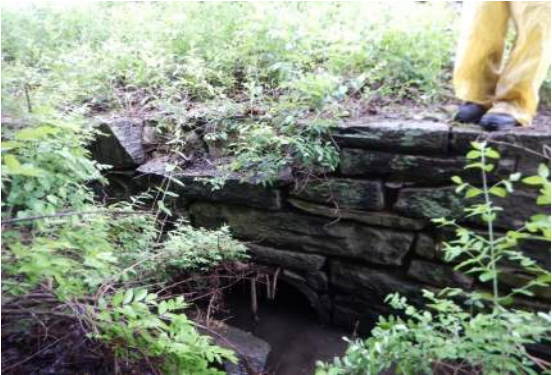
Photo 3

Comment: Displaced block from headwall in stream.

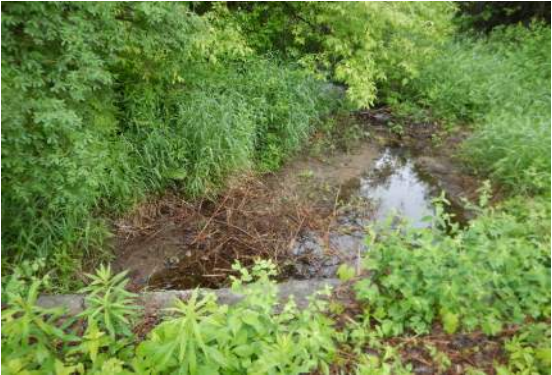
Photo 5

Comment: Slight erosion.

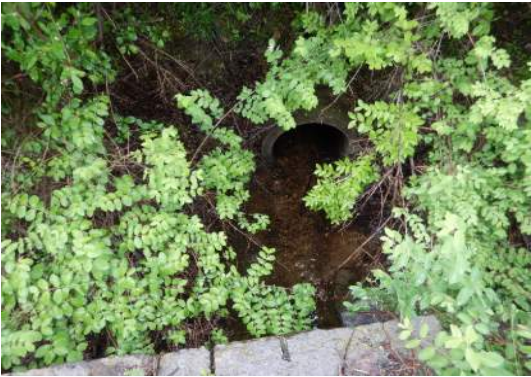
Photo 2

Comment: Culvert pipe for siding, just upstream.

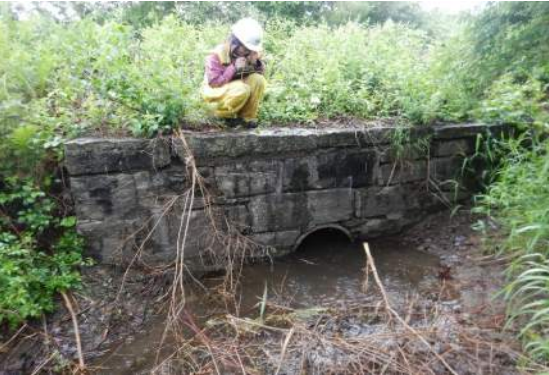
Photo 4

Comment: Cracked block, See Note 4.

4) Cracked block at south half of east headwall one course down from cap. Stone displaced at mud line 6" from East headwall. See Photo 4.

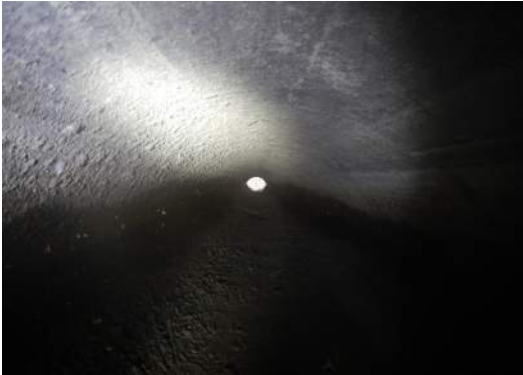
Photo 6

Comment: Slight surface rusting.

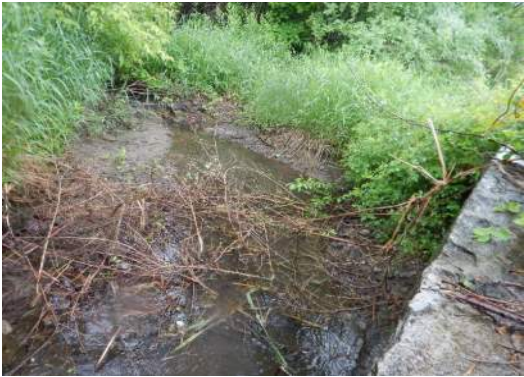
Comment: Minor drift. Slight stream bank erosion.

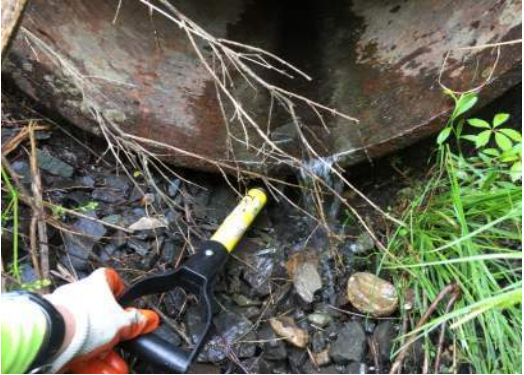
Photo 7

Description: East Culvert Pipe End

OVERAL CONDITION RATING: 4
CRITICAL FINDINGS: None
FOR IMMEDIATE ATTENTION: Repair open joints before. Protect east end of culvert from scour, consider installing headwall.
MAINTENANCE: Fill scour hole and undermining with stone and rip rap. Clear pipe. Repair rail profile dip. Perform track maintenance.

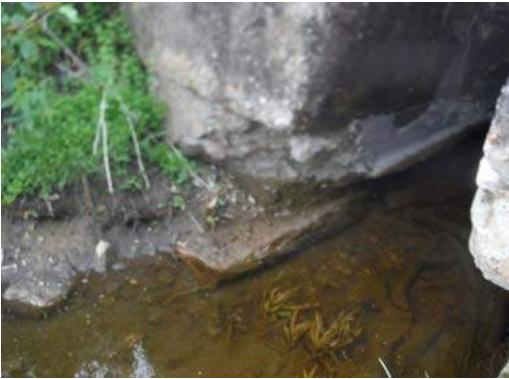
Photo 1

Description: North Abutment
Comment: Scour at bottom of stone

OVERAL CONDITION RATING: 6 - Satisfactory
CRITICAL FINDINGS:
FOR IMMEDIATE ATTENTION:
MAINTENANCE: Monitor culvert abutment movement, replace missing stone and shore culvert.

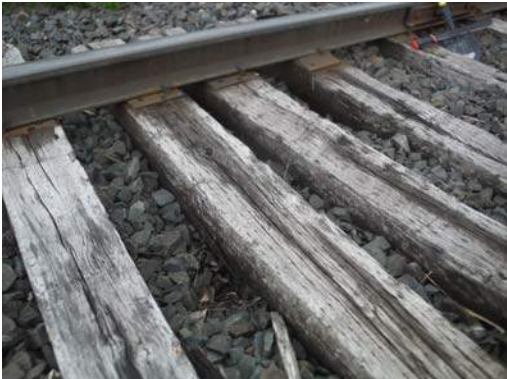
Photo 4

Description: Track Condition
Comment: Missing Ballast

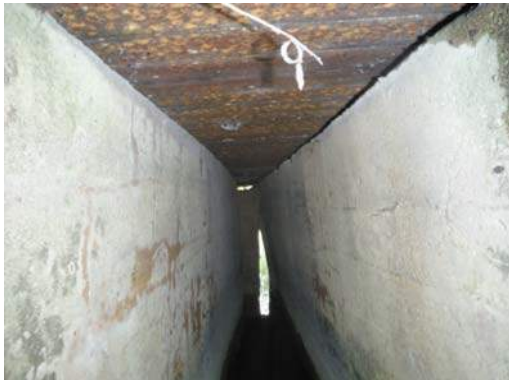
Photo 5

Description: Culvert Interior
Comment: Rotated Backwall at East End

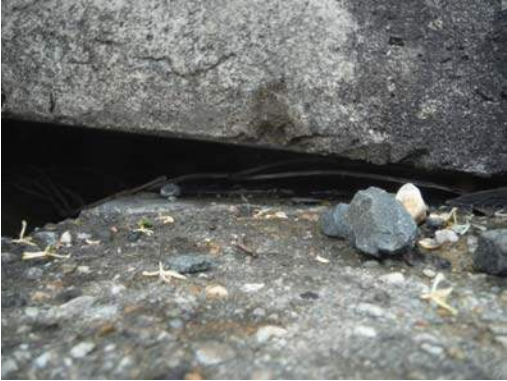
Photo 8

Comment: Missing Stone at North Aabutment

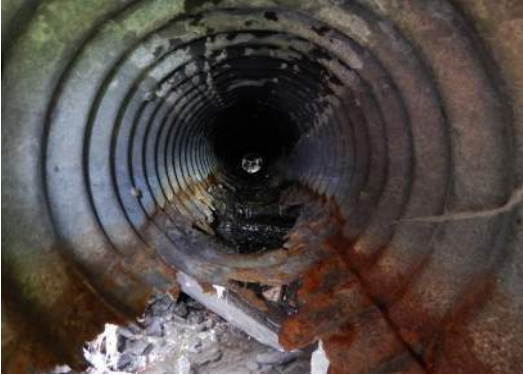
Photo 8

5) From 7 o'clock to 5 o'clock position, pipe has corrosion holes along full length. See photo 8.

Description: Typ. Culvert Interior
Comment: Corrosion holes

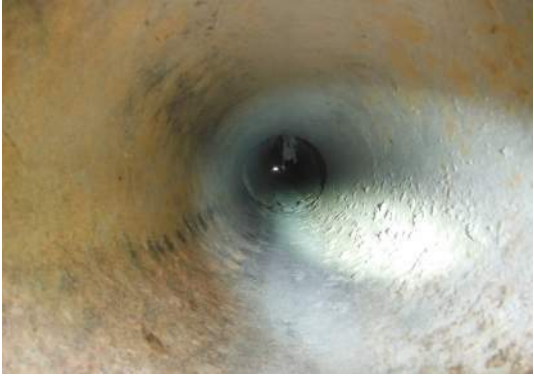
Comment: Note open joints in pipe

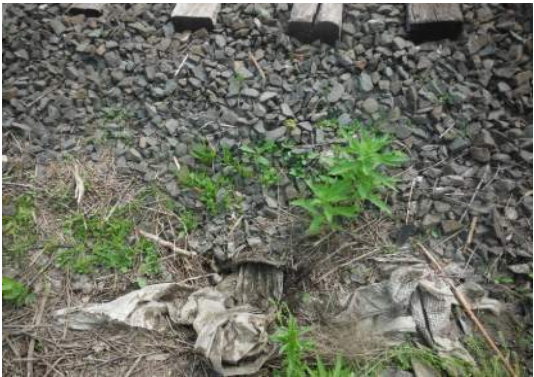
Comment: West entrance blocked

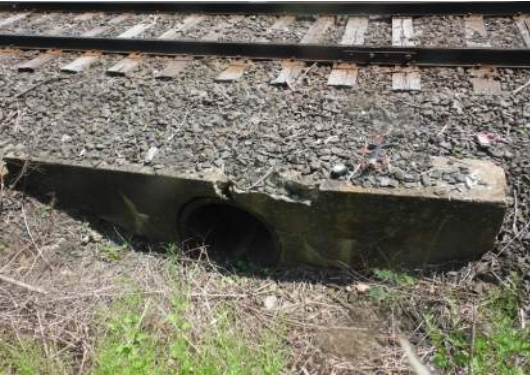
Photo 5

Comment: Concrete has cracks, edge spall, and delam.

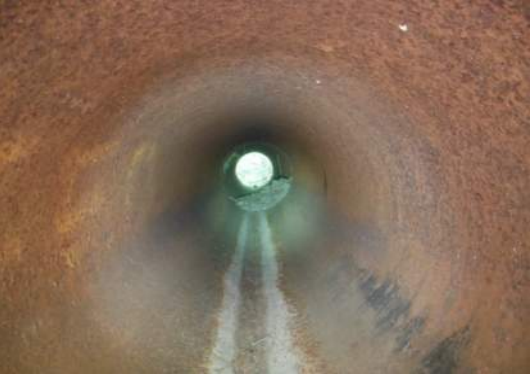
Photo 2

Comment: Subballast pile at open joint

MAINTENANCE: Adress settlement and subballast infiltration into pipe

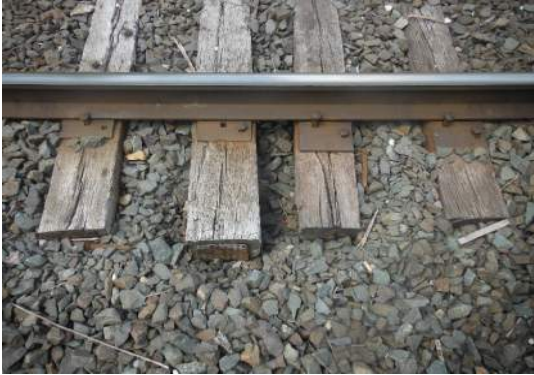
Photo 7

Description: Typ. Track/Top Side - East
Comment: Ballast settled under east end of tie

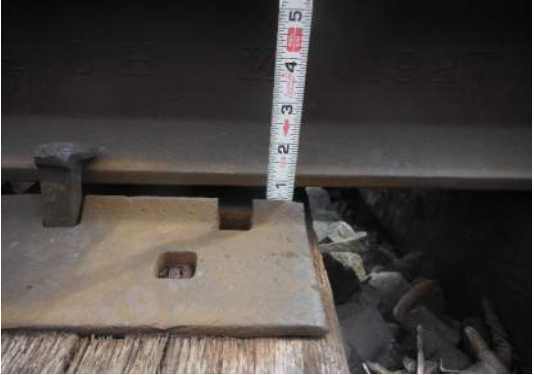
Photo 8

Description: Rail Elevation - East
Comment: East rail sits 3/4" high

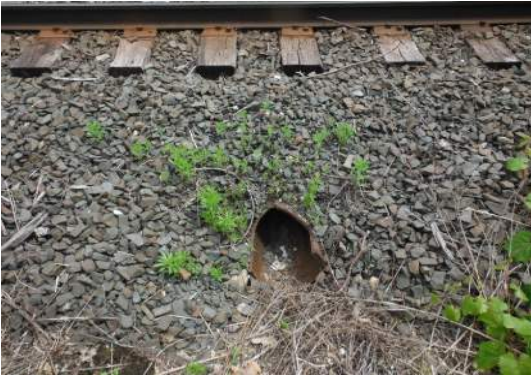
Photo 5

Comment: Pipe broken at top

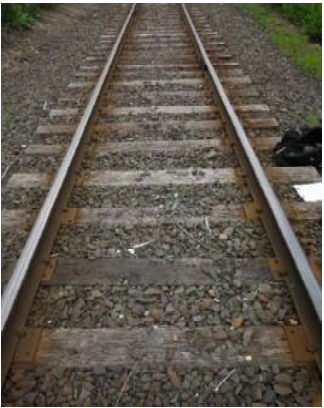
Photo 7

Comment: Ballast tight to ties

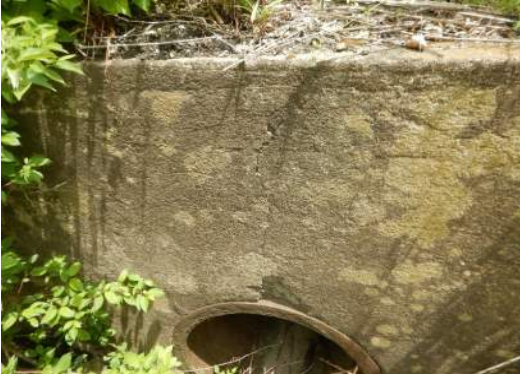
Photo 7

Description: West Headwall
Comment: Full height vertical crack

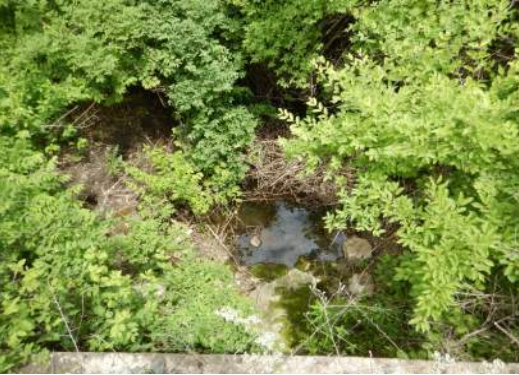
Photo 8

Description: East Channel
Comment: Severe degradation, steep banks

FOR IMMEDIATE ATTENTION: Repair scour under east headwall and repair riprap on stream bank

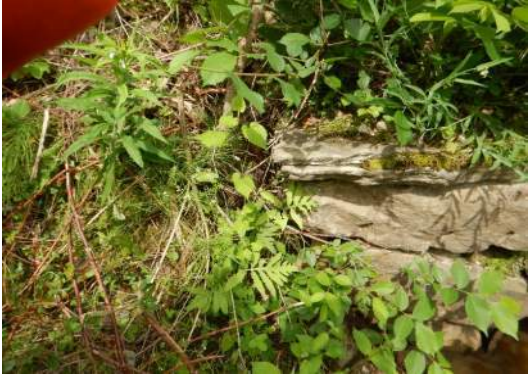
Photo 7

Description: East Headwall
Comment: Displaced stone 9" outward
