ADDENDUM No. 1

LEE, LENOX AND PITTSFIELD

MassDOT Berkshire Line Civil Improvements

RESPONSE TO BIDDERS' QUESTIONS	4 Pages
DOCUMENT A00801	Pages 17, 21, 107 and 108; Edits are in red.
2018 CULVERT INSPECTION REPORTS	30 Pages

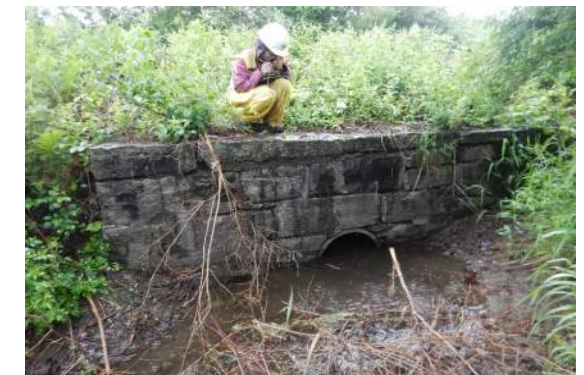
Photo 4

ITEM	CULVERT STRUCTURE	RATING: 6	REMARKS	PHOTO #
12	Abutment (N or E)	N		
13	Abutment (S or W)	N		
14	Head Walls - West	5	Loose and missing mortar. See Note 3.	3 & 8
15	Head Walls - East	5	See Note 4.	4
16	Wingwalls	N		
17	Ceiling Slab	N		
18	Invert Slab	N		
19	Walls	N		
20	Arch Ring	N		
21	Pointing	N		
22	Pipes/Circular Culverts	7	Slight surface rusting.	6
23	Apron	N

Comment: Cracked block, See Note 4.

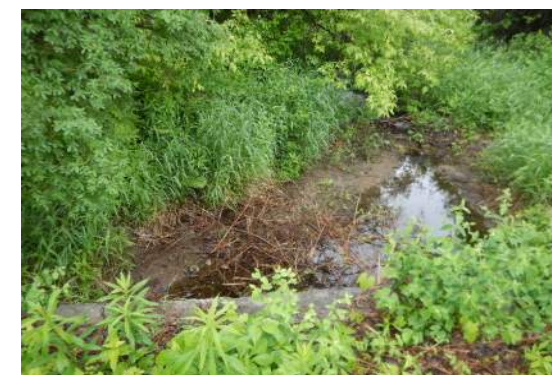
Photo 5

Comment: Slight erosion.

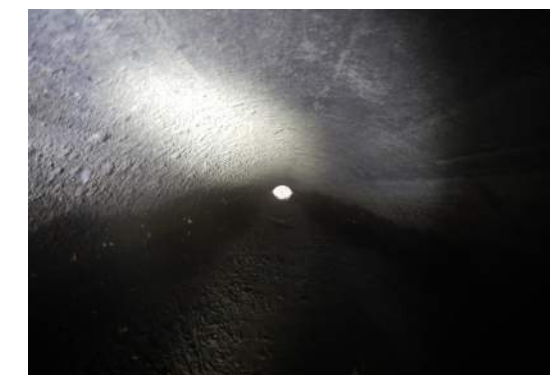
Photo 6

Comment: Slight surface rusting.

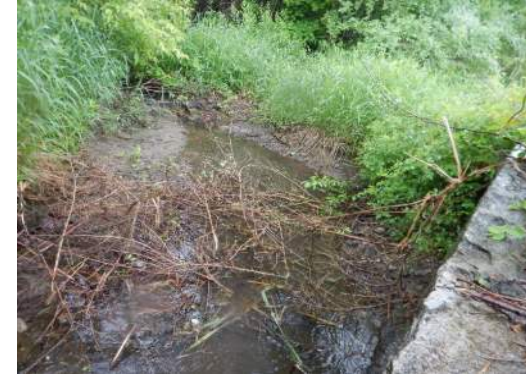
Photo 7

Description: East Stream Bed and Channel.
 Comment: Minor drift. Slight stream bank erosion.

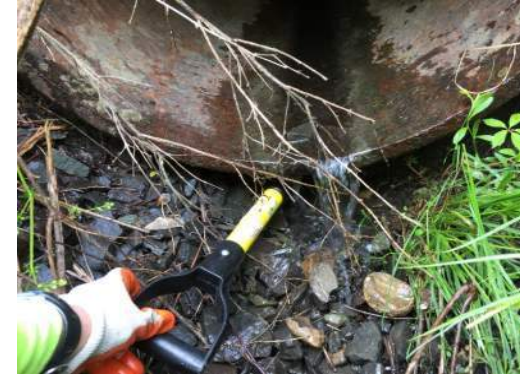
Photo 7

Comment: Undermining of pipe (east end).

FOR IMMEDIATE ATTENTION: Repair open joints before. Protect east end of culvert from scour, consider installing headwall.

MAINTENANCE: Fill scour hole and undermining with stone and rip rap. Clear pipe. Repair rail profile dip. Perform track maintenance.

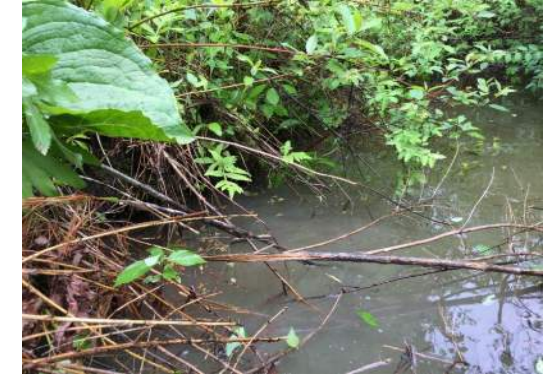
Photo 8

Comment: Degradation and local scour present.

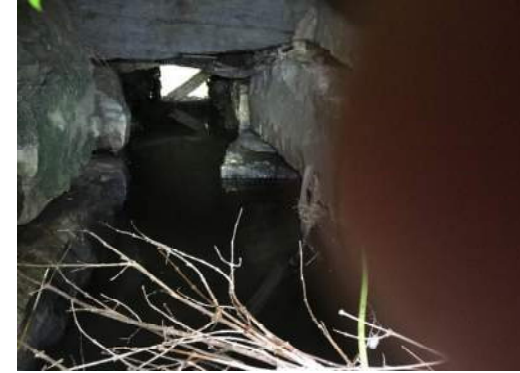
Photo 7

Description: Typical Culvert Interior (from west end)
Comment: Displaced walls and ceiling masonry.

FOR IMMEDIATE ATTENTION: Consider replacement or culvert lining. Correct track defects.

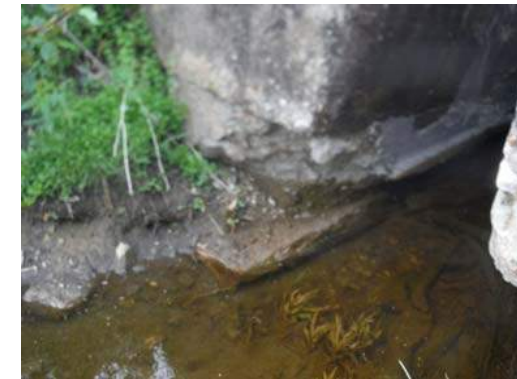
Photo 1

Description: North Abutment
 Comment: Scour at bottom of stone

MAINTENANCE: Monitor culvert abutment movement, replace missing stone and shore culvert.

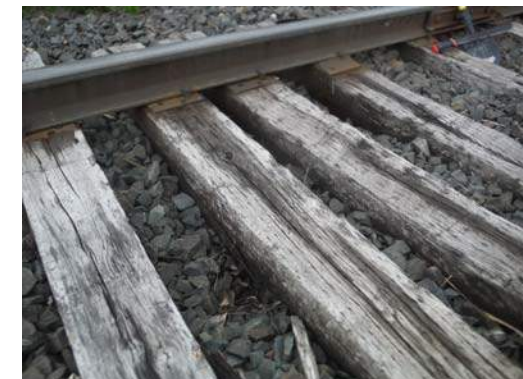
Photo 4

Description: Track Condition
 Comment: Missing Ballast

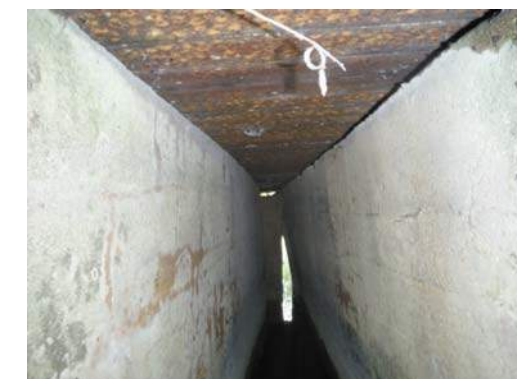
Photo 5

Description: Culvert Interior
 Comment: Rotated Backwall at East End

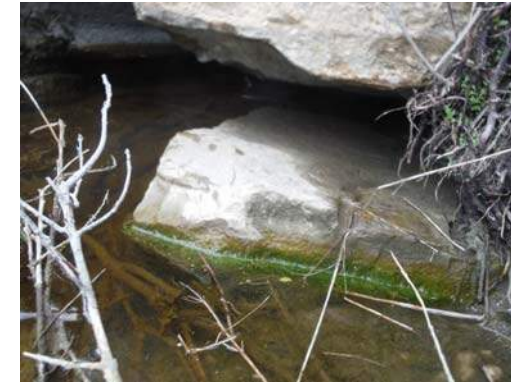
Photo 7

Description: West Inflow
 Comment: Missing Stone at South Abutment

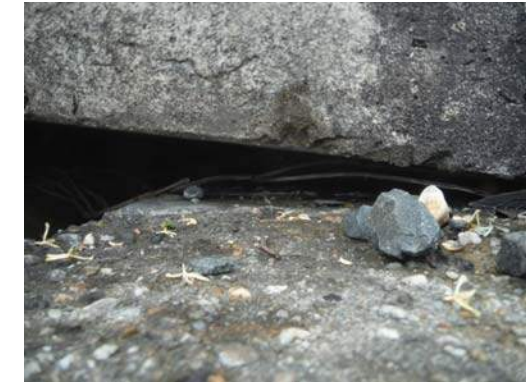
Photo 8

Description: Northeast Wingwall
 Comment: Missing Stone at North Abutment

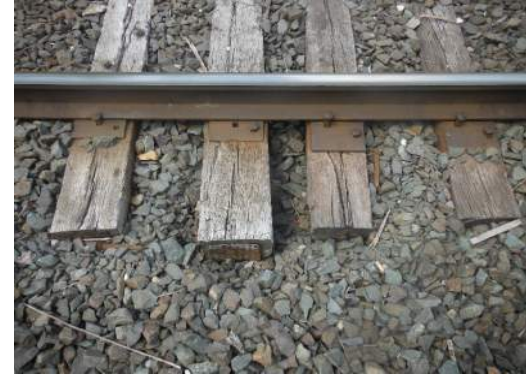
Photo 7

Description: Typ. Track/Top Side - East
 Comment: Ballast settled under east end of tie

MAINTENANCE: Adress settlement and subballast infiltration into pipe

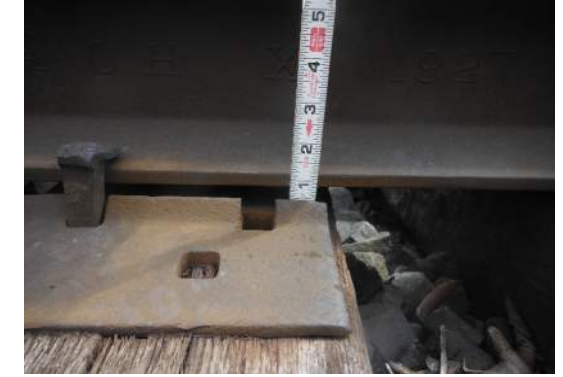
Photo 8

Description: Rail Elevation - East
 Comment: East rail sits 3/4" high

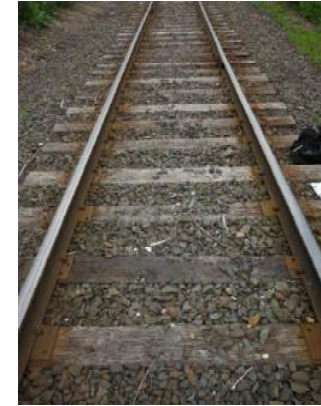
Photo 7

Comment: Ballast tight to ties

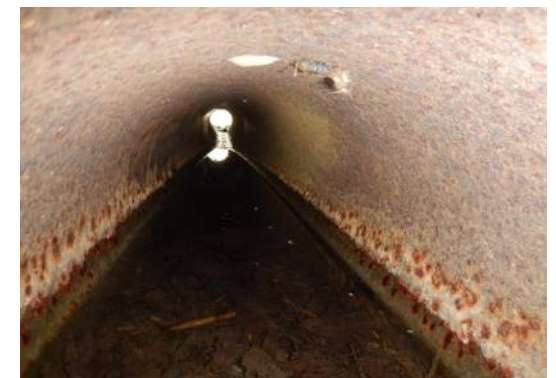
Photo 6

Comment: Minor surface rusting

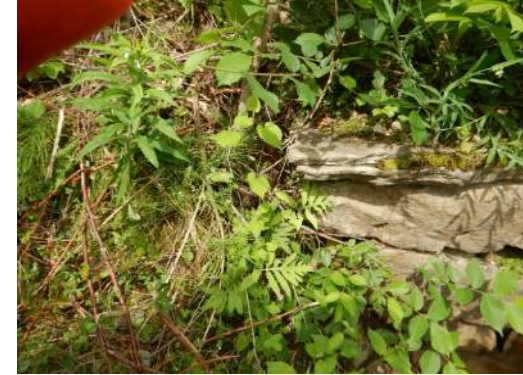
Photo 7

Description: East Headwall
 Comment: Displaced stone 9" outward
