Soil Corrosivity Results and Corrosion Evaluation Report

**Corrosion Evaluation Report
Weston Aqueduct Supply Main 3 (CP2)
Massachusetts Water Resource Authority**

**CorrTech Inc.
25 South Street
Hopkinton, MA 01748
Report No. 9301-FOR-03-3**

April 2023

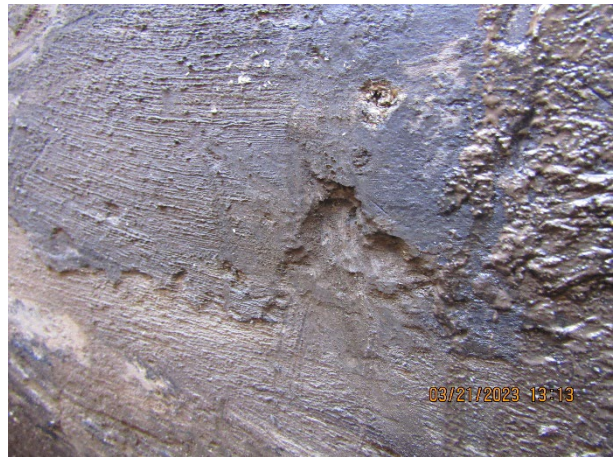
4 – Deepest Pitting in Pipe at Site 1

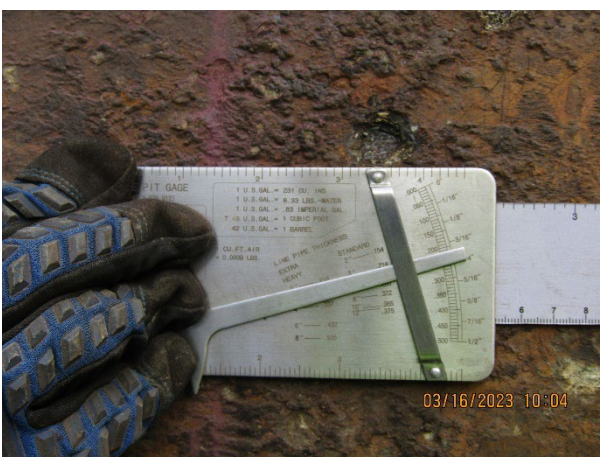
11 – Deepest pit in Springline

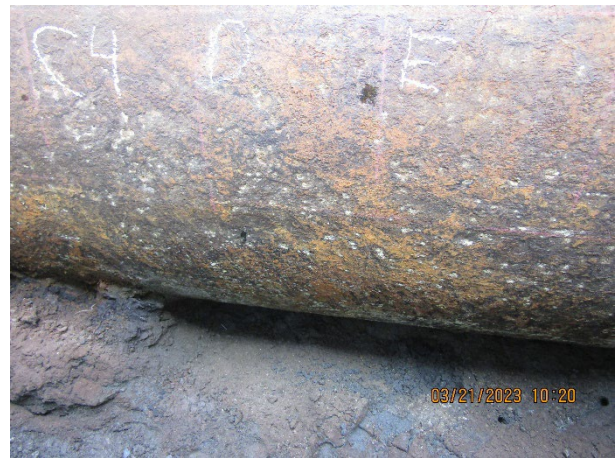
16 – Typical condition of Springline

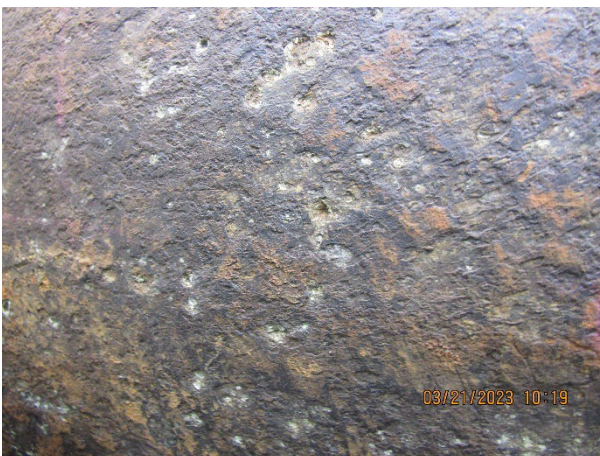
17 – Deepest pit in site 3

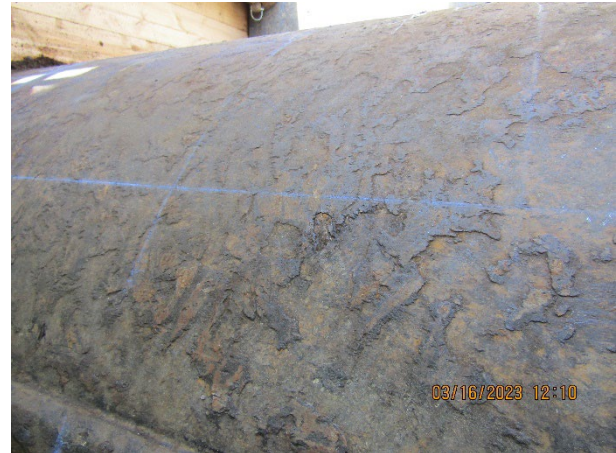
22 – Typical coating condition

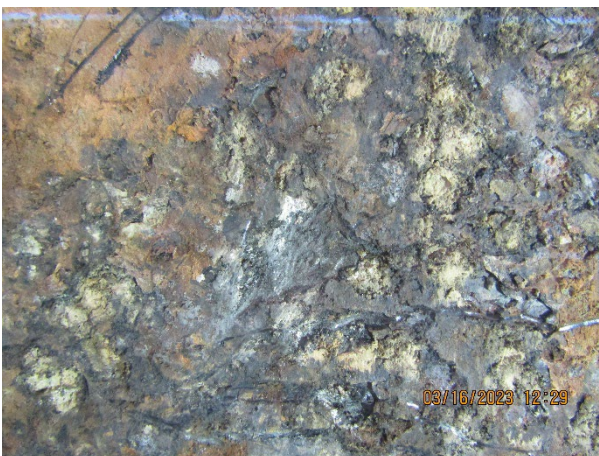
23 – Pitting in Springline

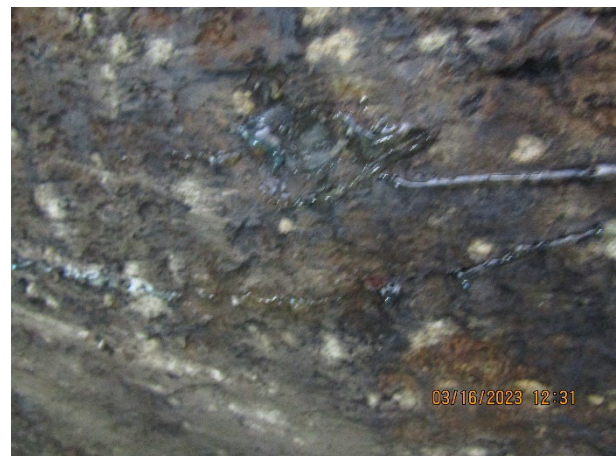
24 – Deepest pitting in Invert

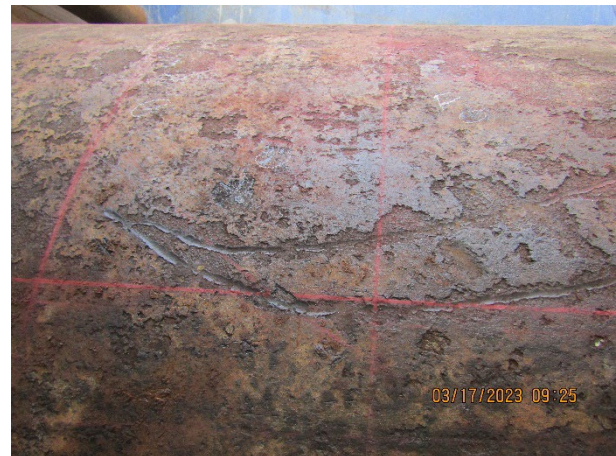
28 – Gashes in Springline coating

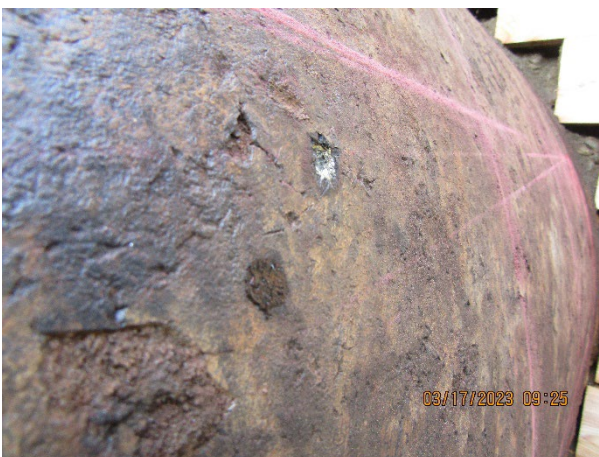
29 – Deepest pit in Springline of Site 5

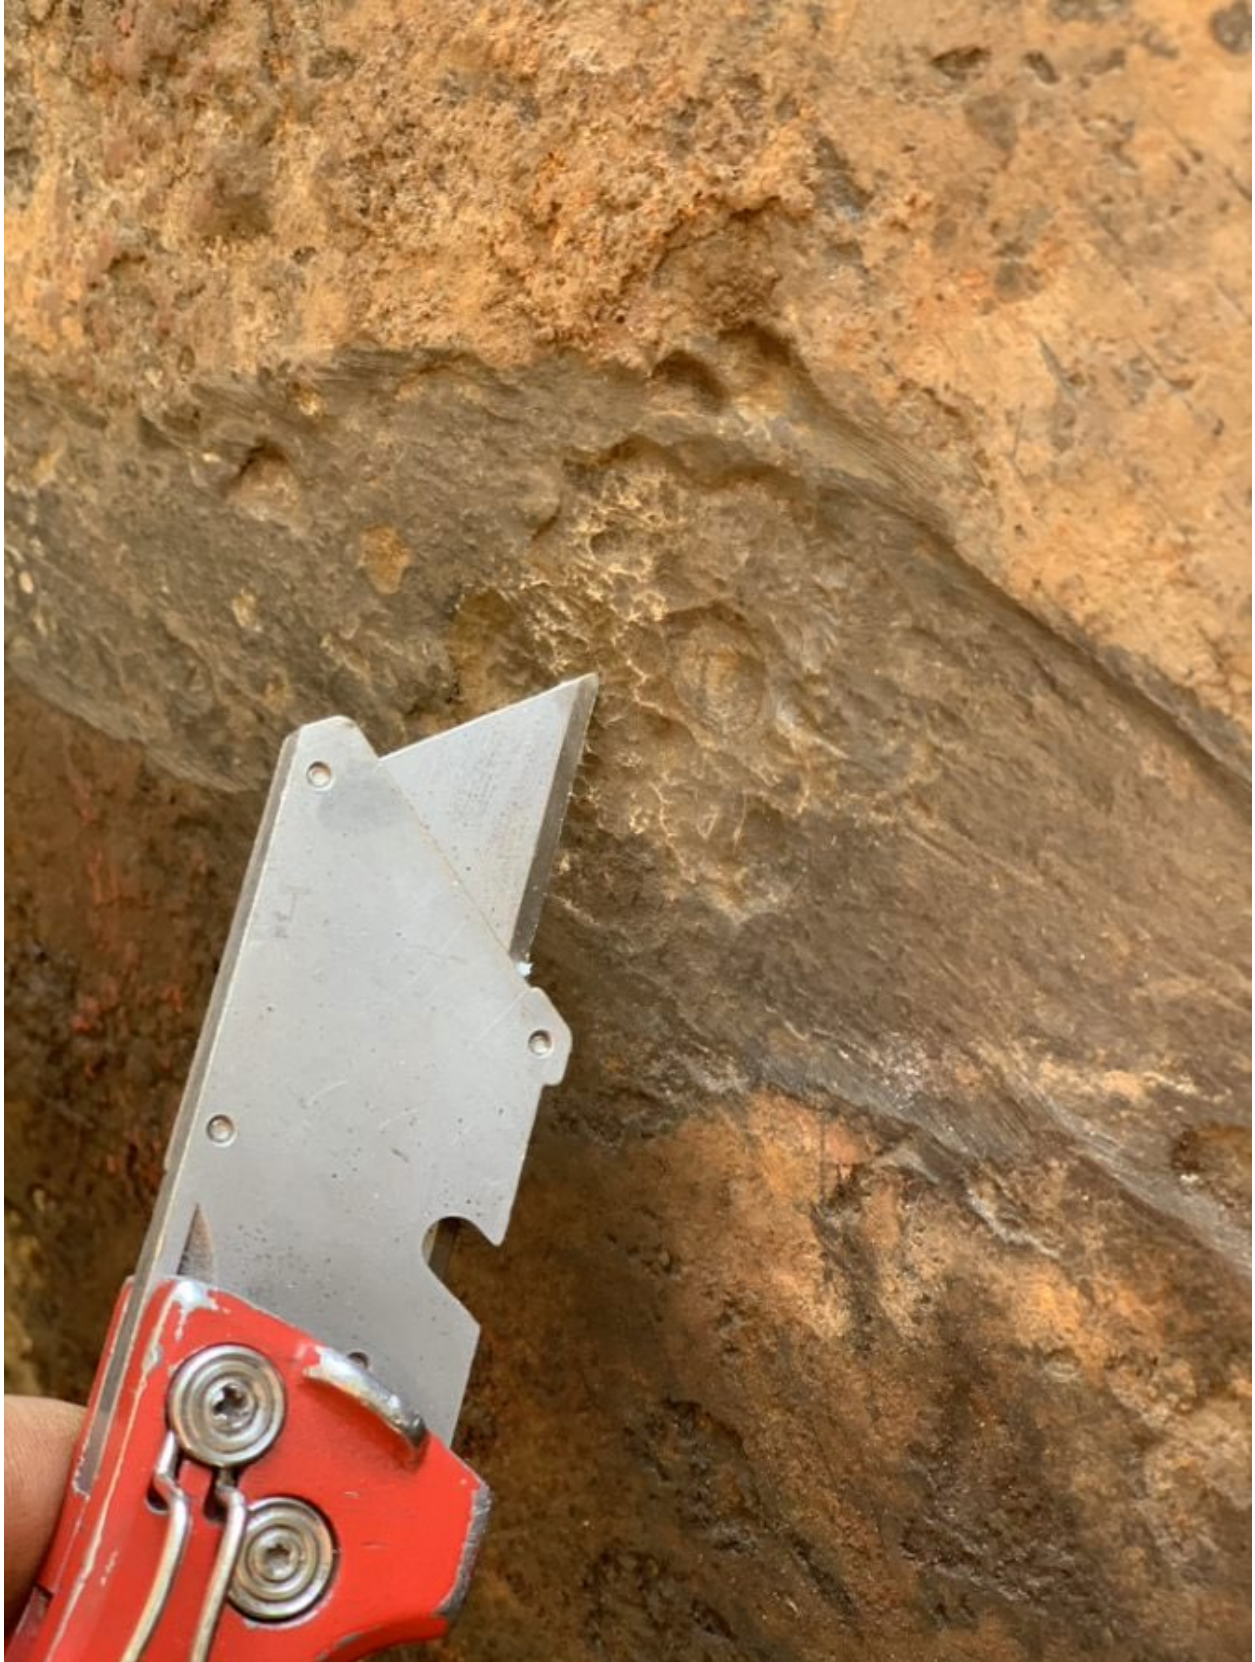
Site #3: Waverly Oaks Road: Notable Pit

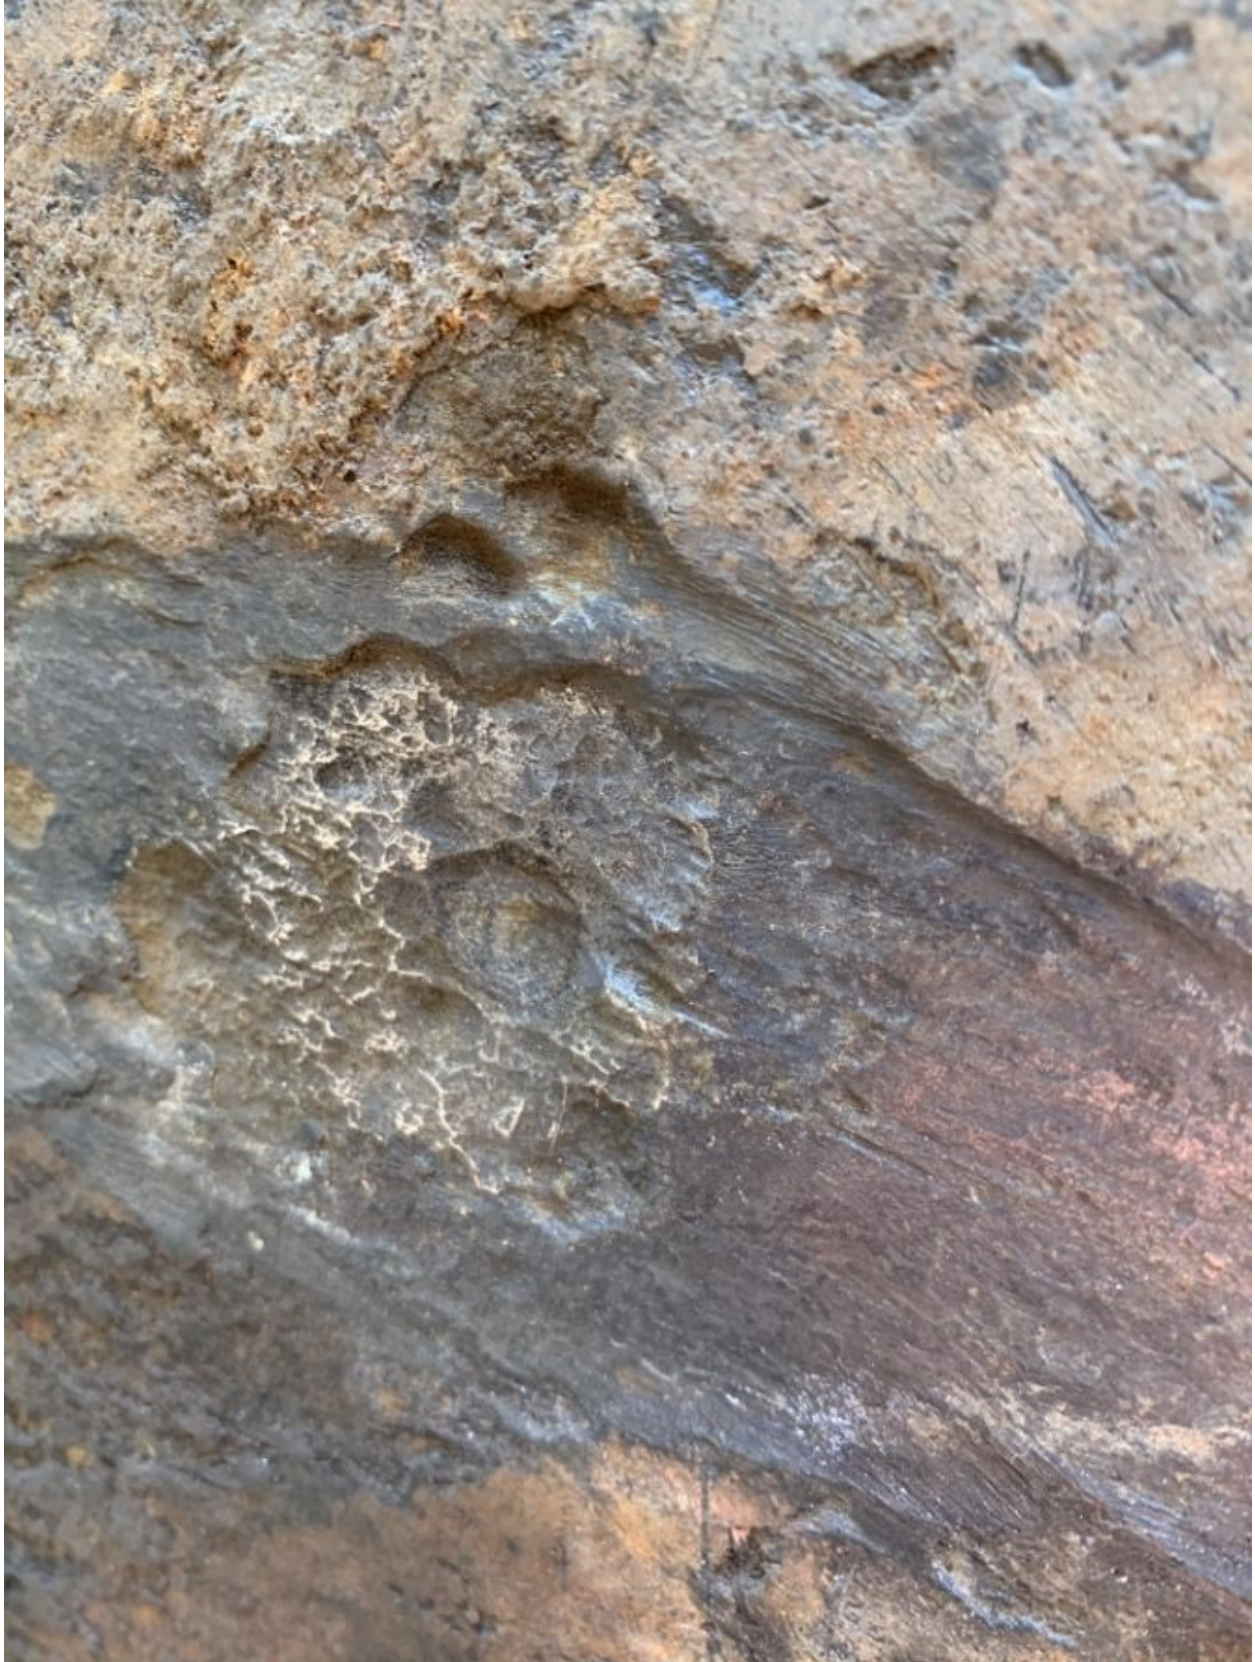
Site #3: Waverly Oaks Road: Notable Pit

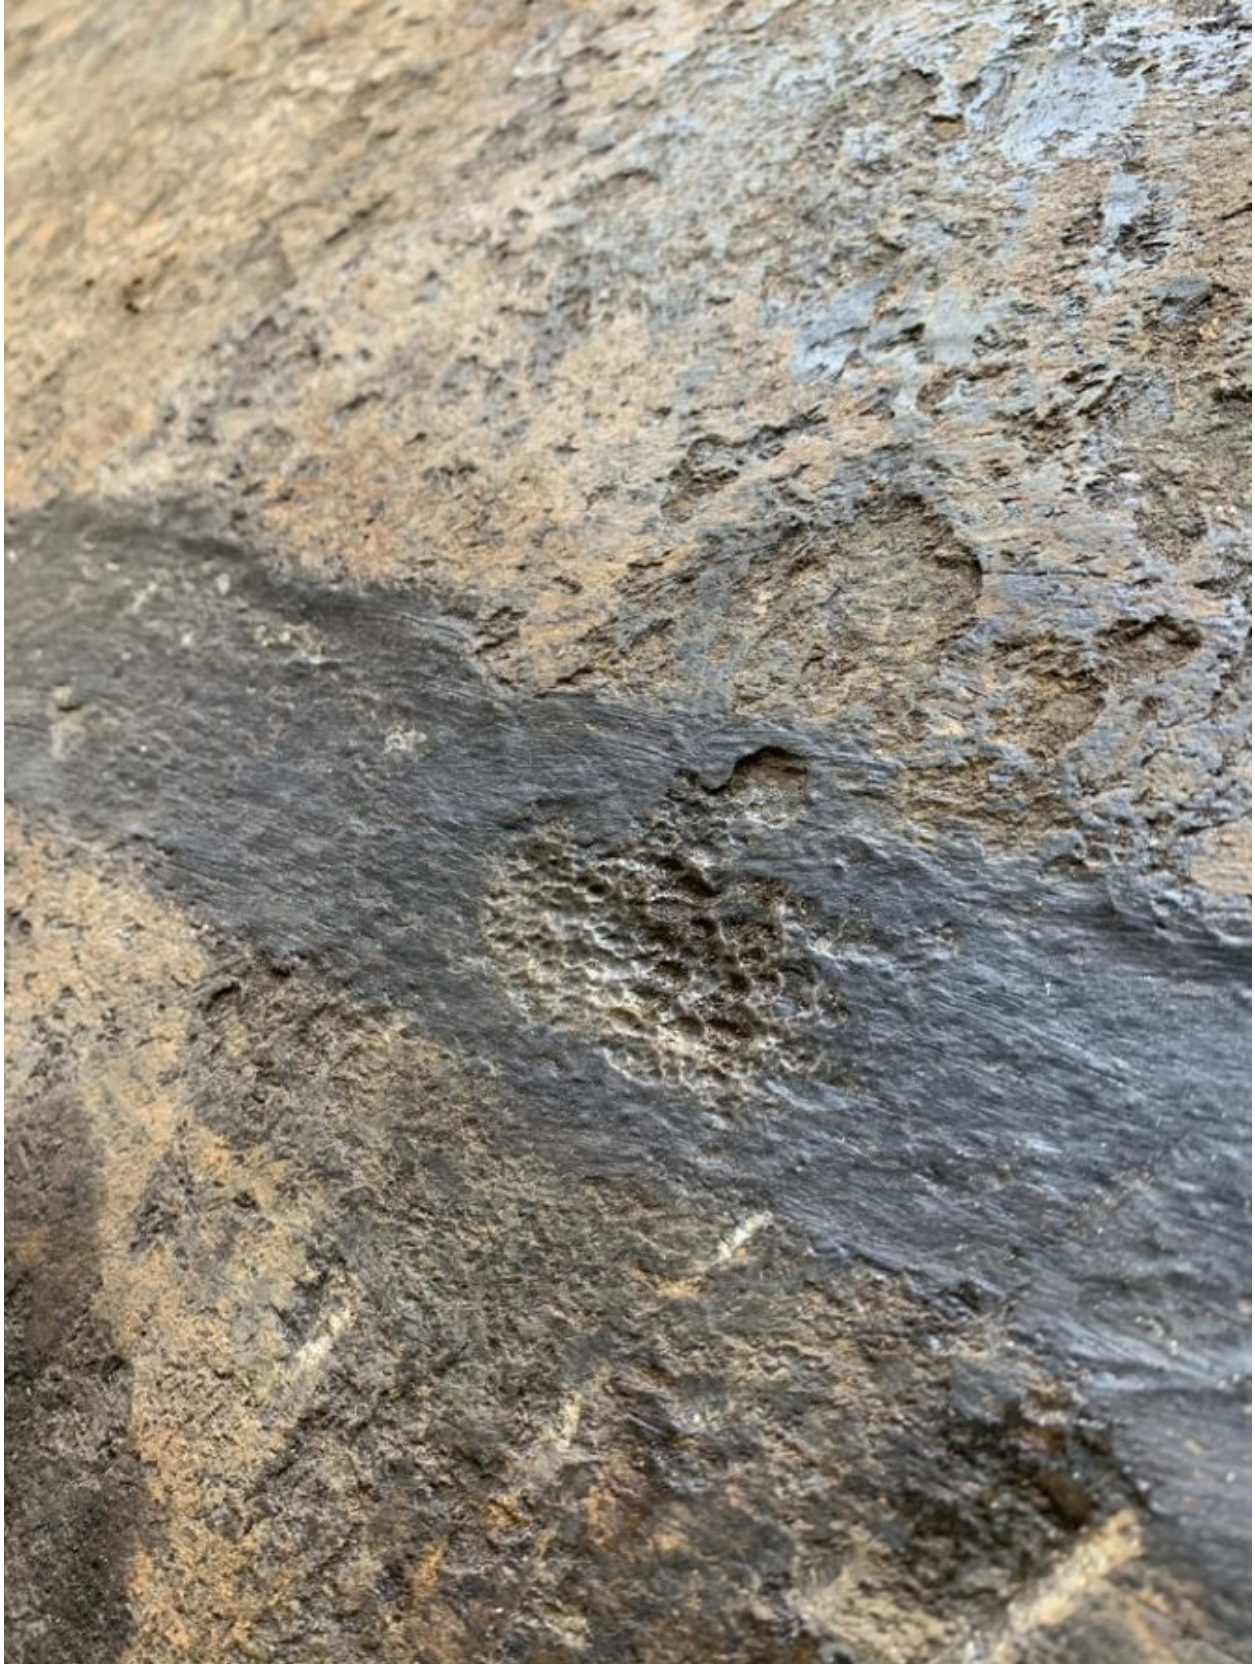
Site #3: Waverly Oaks Road: Notable Pit

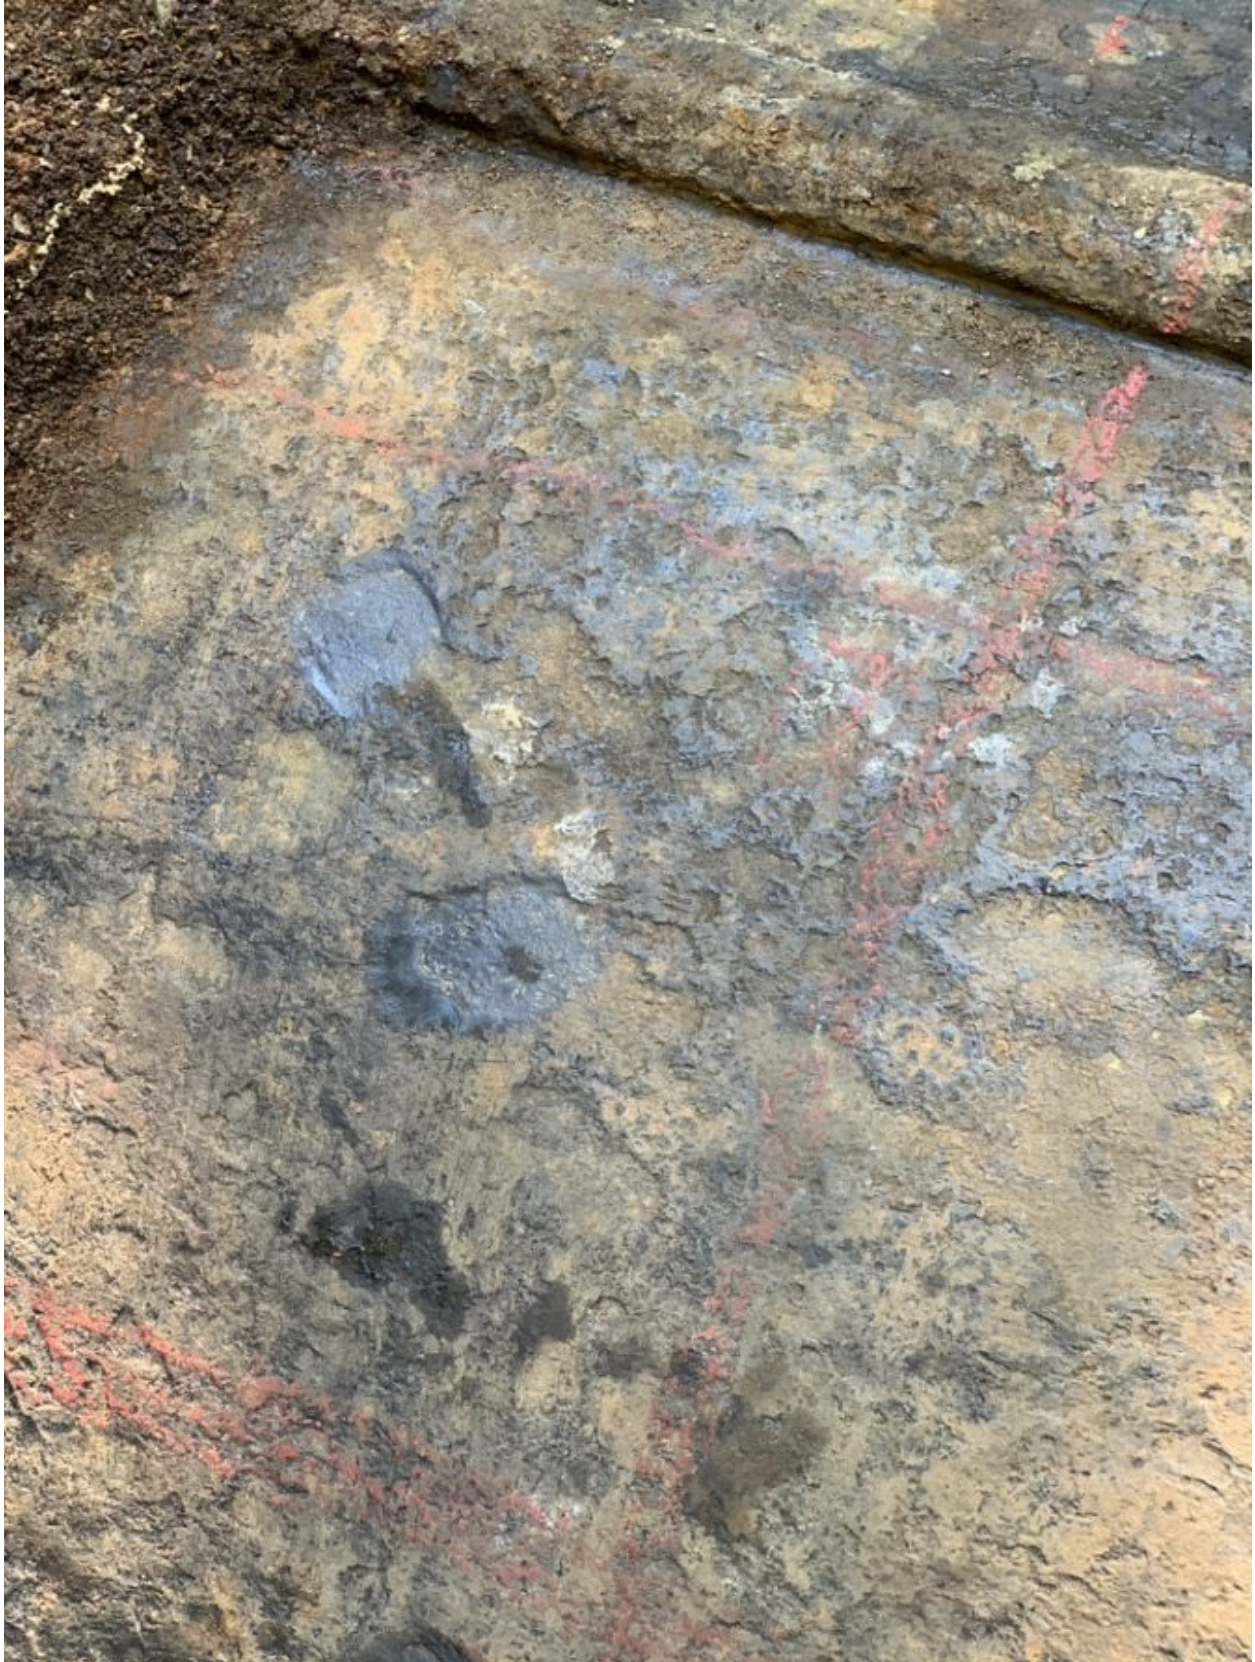
Site #3: Waverly Oaks Road: Coating De-lamination
