Paving & Bridge Deck Repairs - Fort Hill Road

City of Easthampton

Addendum No. 1

CITY/TOWN EASTHAMPTON	B.I.N. 0PQ	BR. DEPT. NO. E-05-015	8.-STRUCTURE NO. E05015-0PQ-MUN-NBI	INSPECTION DATE DEC 11, 2024
---------------------------------	----------------------	----------------------------------	---	--

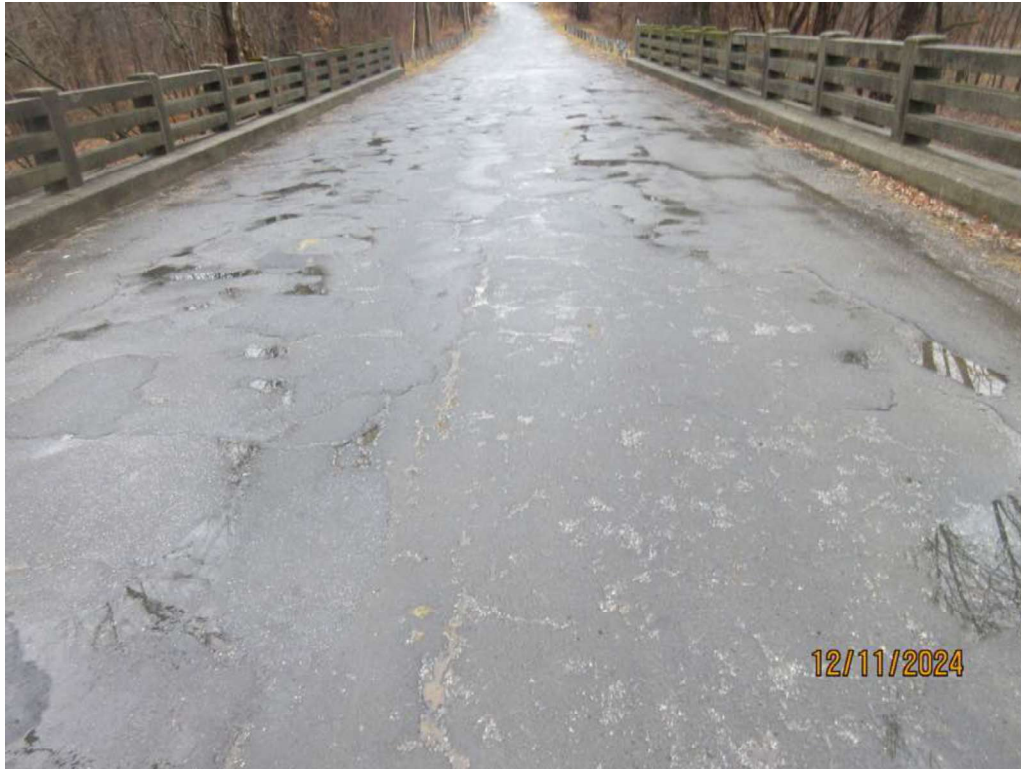
Hot Mix Asphalt (HMA) Wearing Surface has several HMA patches & a uneven profile. **See Photo 1.**

Photo 1: Wearing Surface has several HMA patches with an uneven profile.

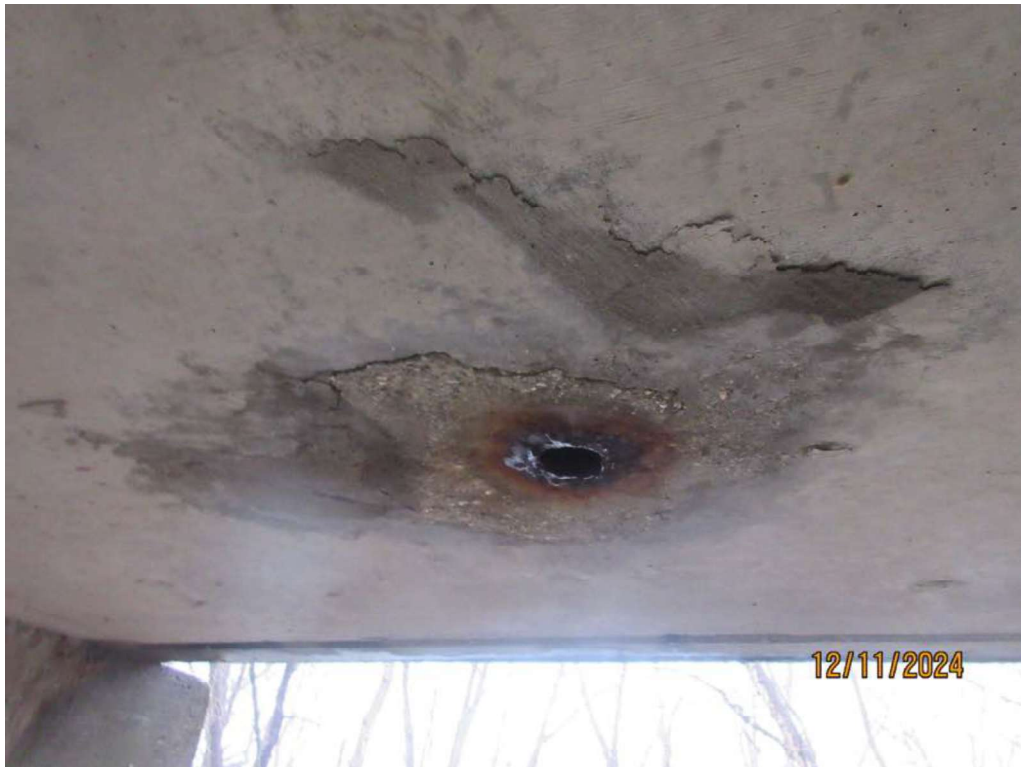
Drain undersides have rust around a few openings. **See Photo 2.**

Photo 2: Deck Underside, concrete around these drain pipes are delaminated with some having mortar patching.

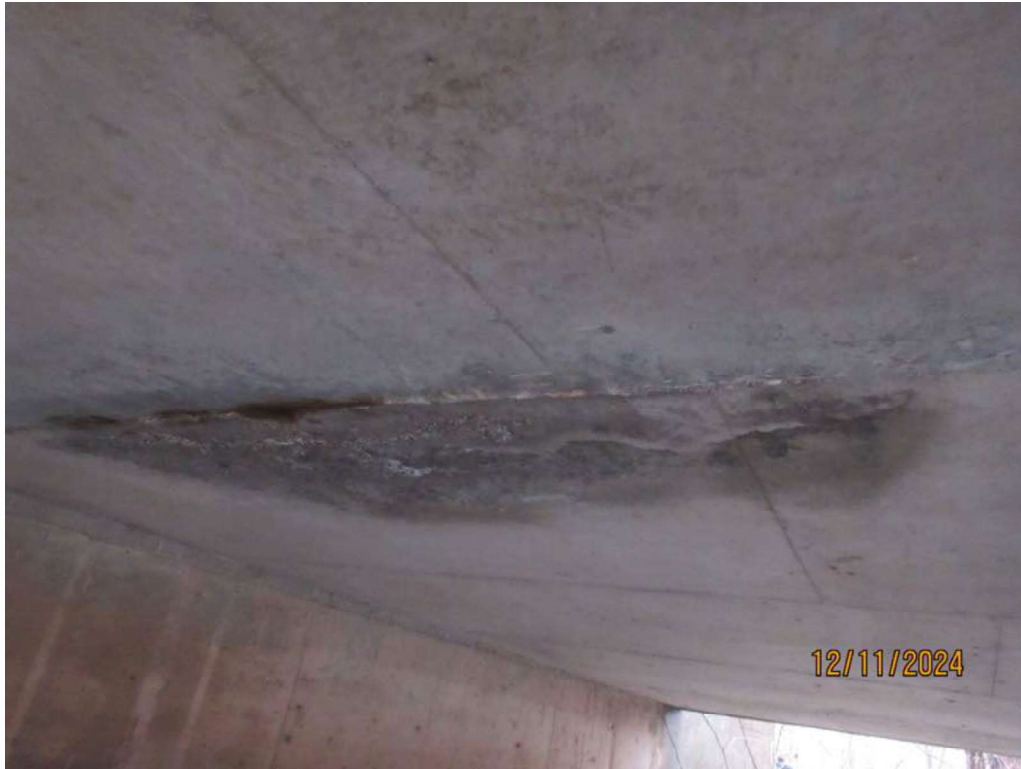
- Slab underside has efflorescence and rust staining.
- Center construction joint has a hollow area, 3' long x up to 18" wide. **See Photo 3.**
- Center construction joint has a longitudinal crack, hairline to 1/16" wide x 3' long.

Photo 3: Deck Underside, Span 1, has heavy efflorescence, rust staining & minor scaling. Center construction joint has a hollow area.

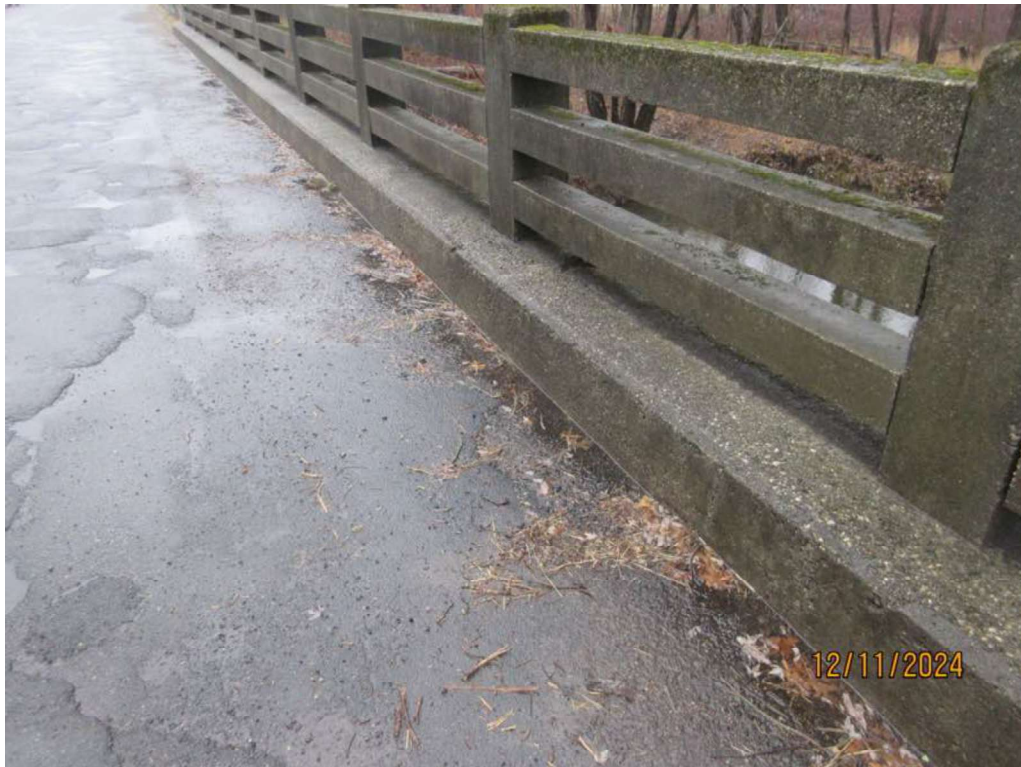
East & West Concrete Curbs have minor scaling and random vertical hairline cracks. **See Photo 4.**

Photo 4: East concrete curbs has minor scaling and random vertical hairline cracks.

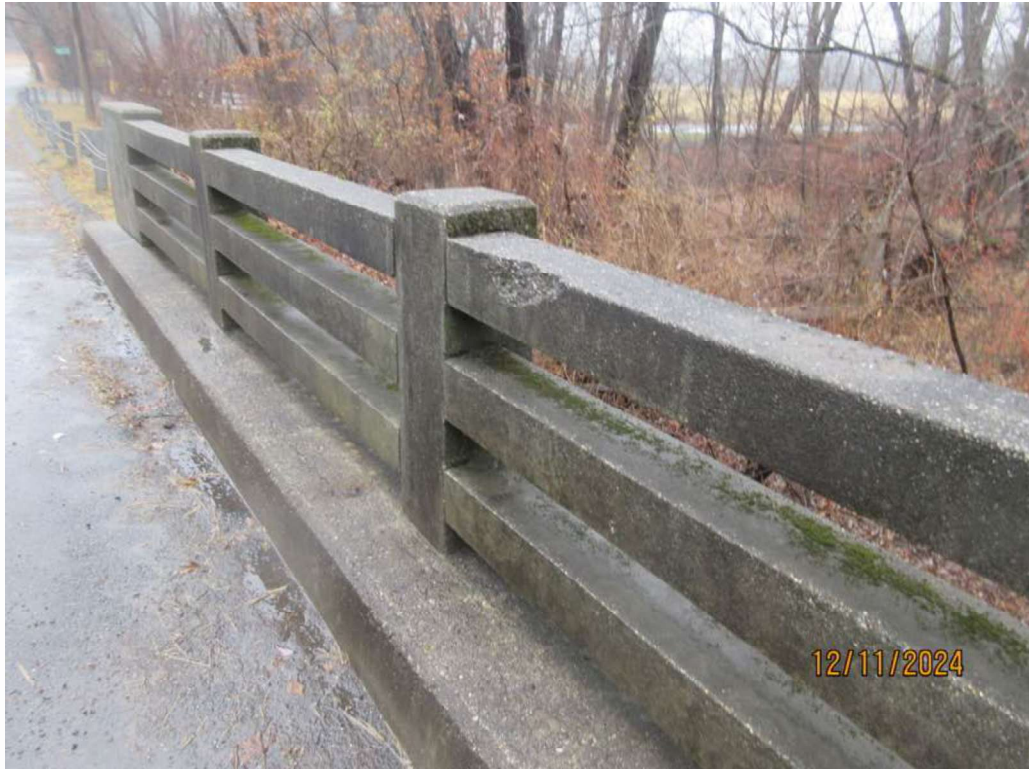
East & West Concrete Railings have minor spalls. **See Photo 5.**

Photo 5: East top Concrete Railings have minor spall.

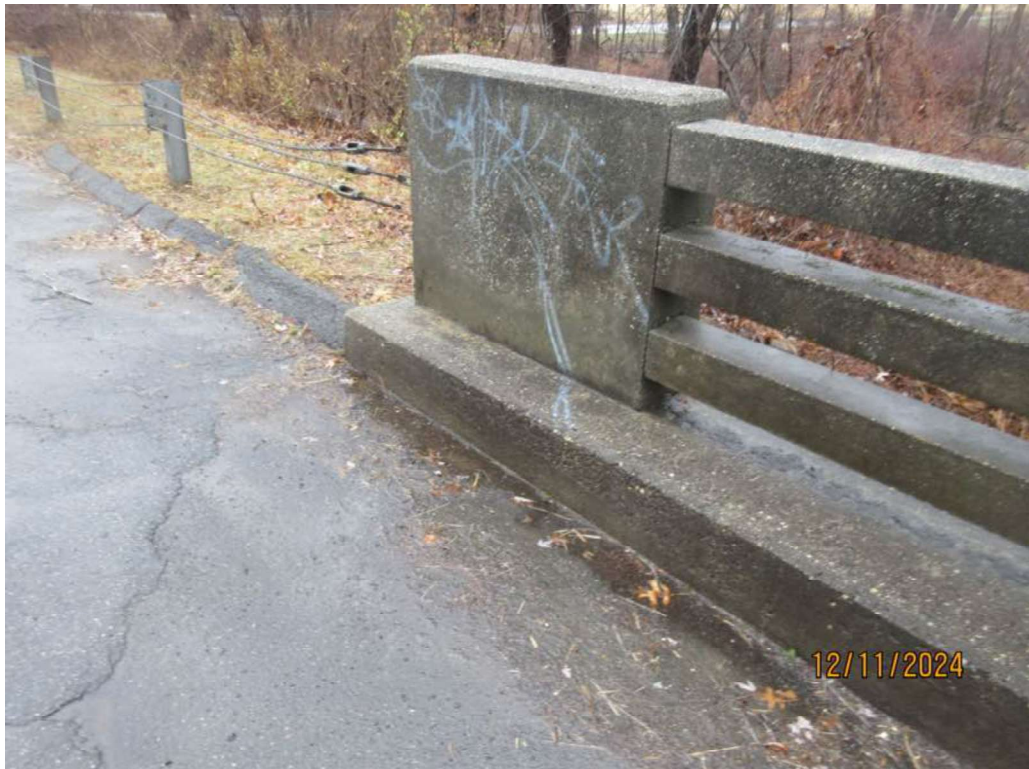
Northeast Concrete Endpost has been repaired. **See Photo 6.**

Photo 6: Northeast Concrete Endpost has been repaired.

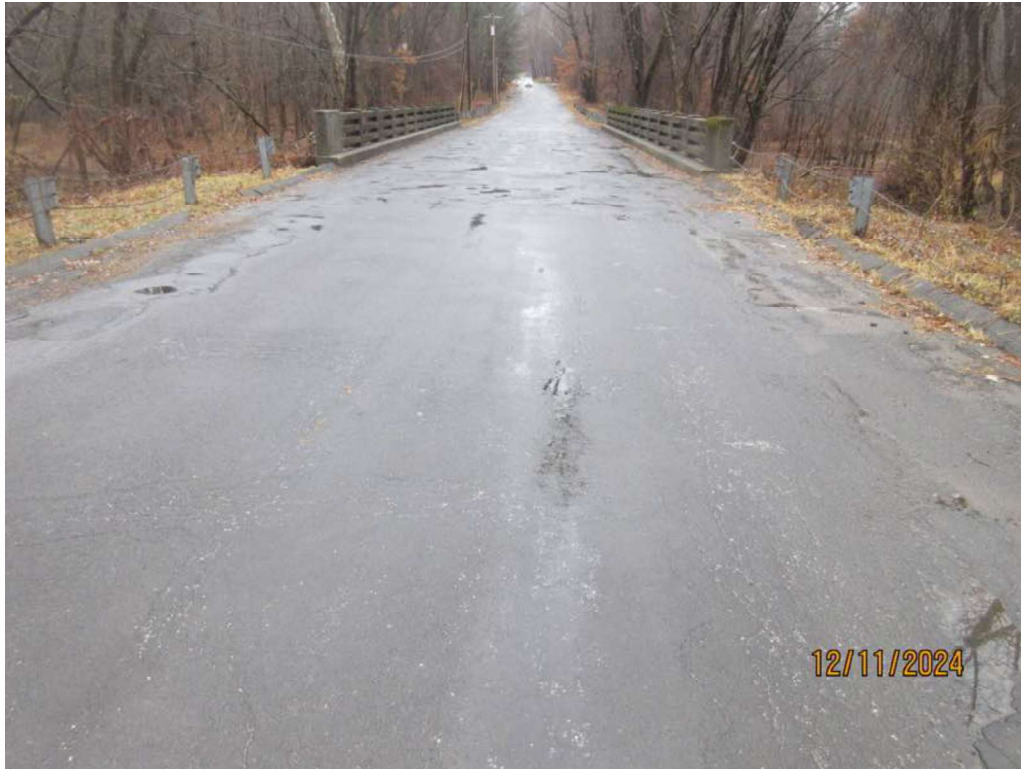
Photo 7: North Approach roadway has multi-cracking with several HMA patches with uneven profile.

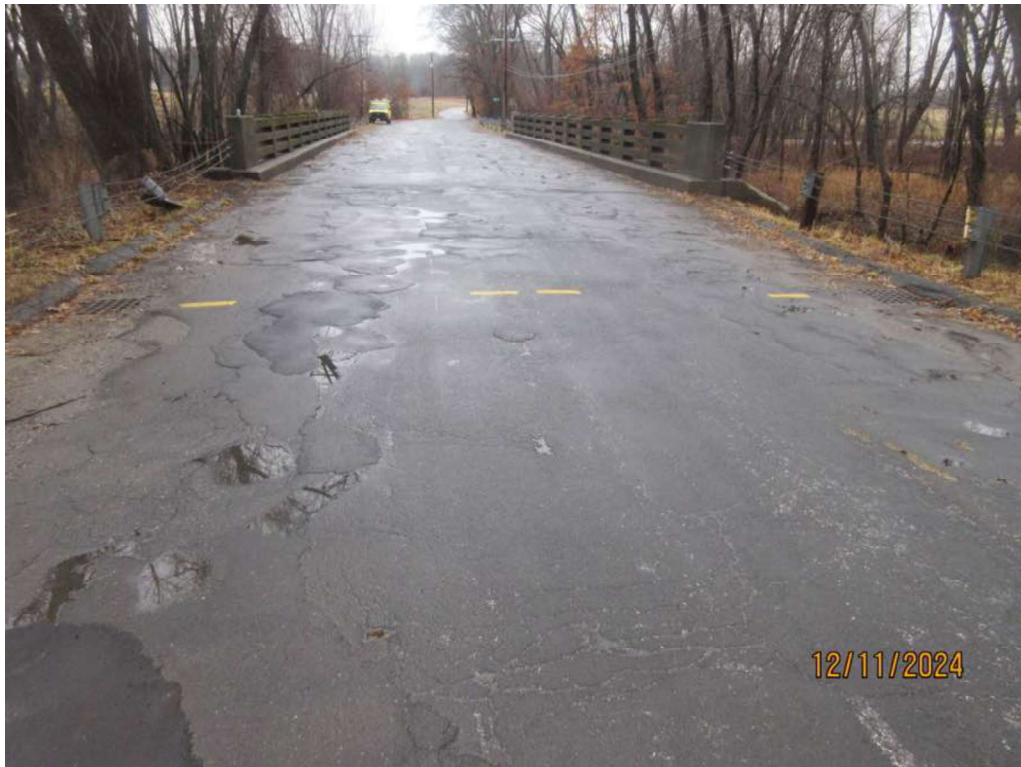
Photo 8: South Approach roadway has multi-cracking with several HMA patches with uneven profile.

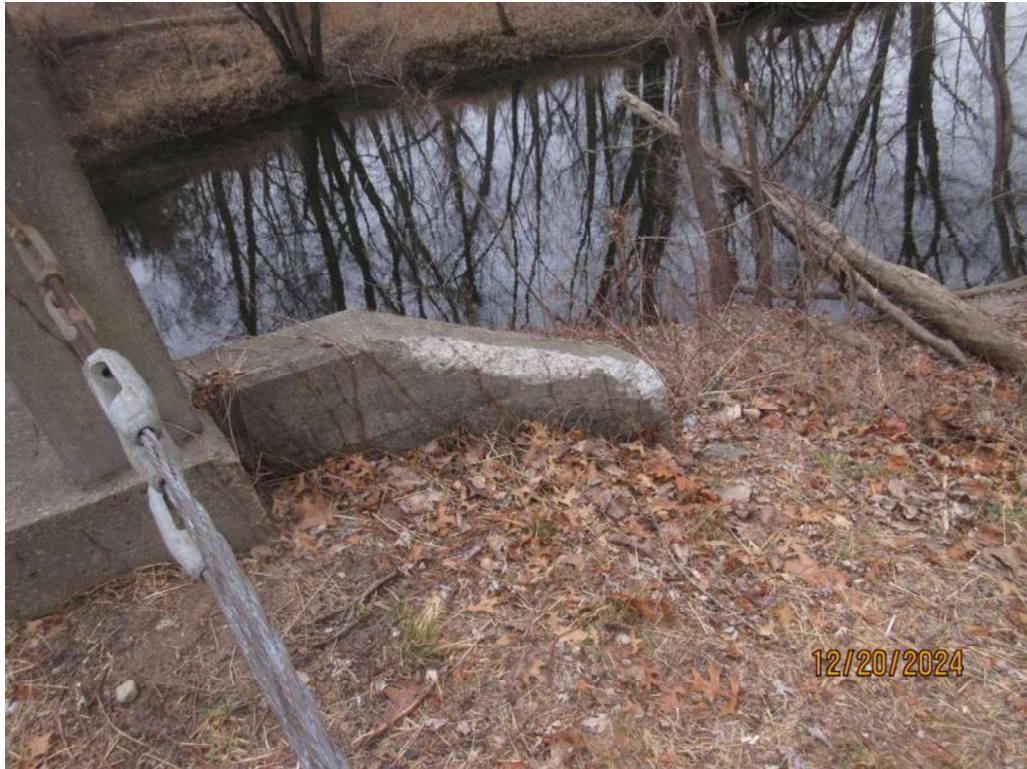
Photo 9: Southeast Wingwall is spalled 3' long x 6" wide x 6" deep.

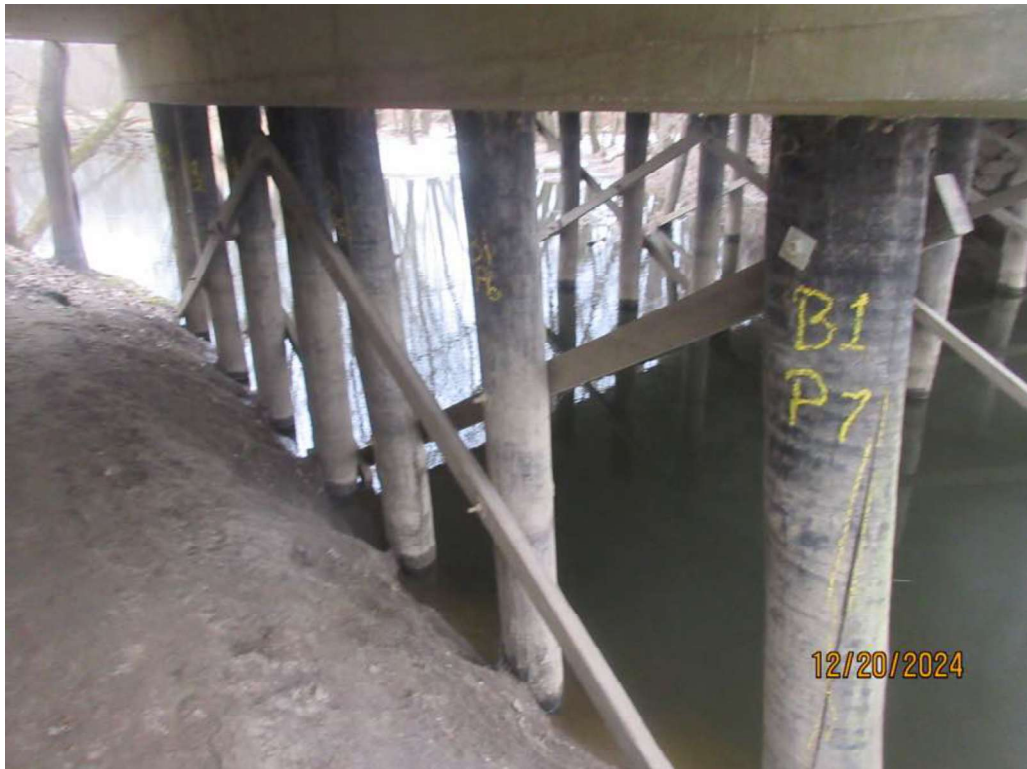
Photo 10: Bent 1 has deterioration.

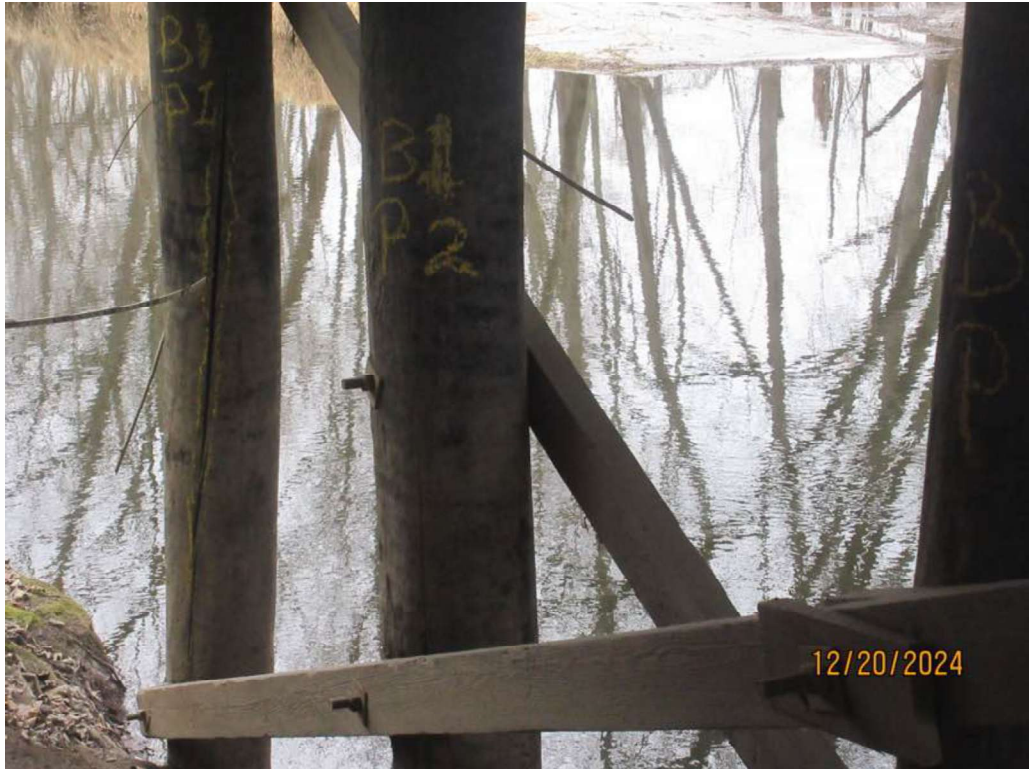
Photo 11: Bent 1, Pile 1, has split 1/2" wide x 5" deep x up to 8" high.

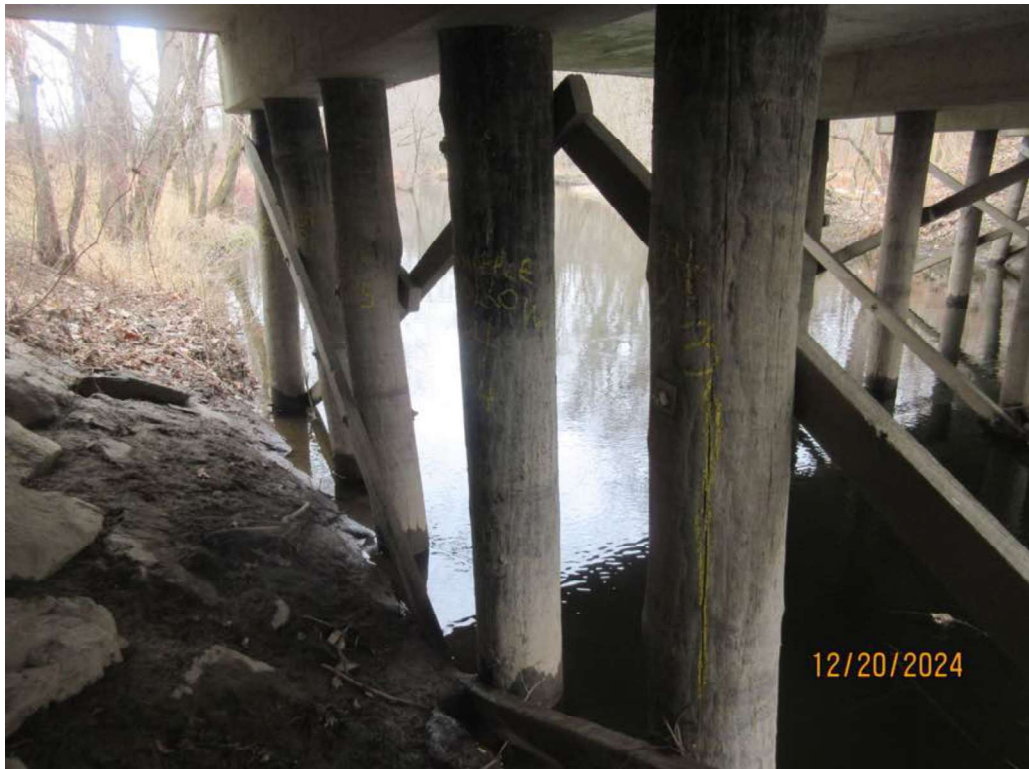
Photo 12: Bent 4, Pile 4 is hollow.

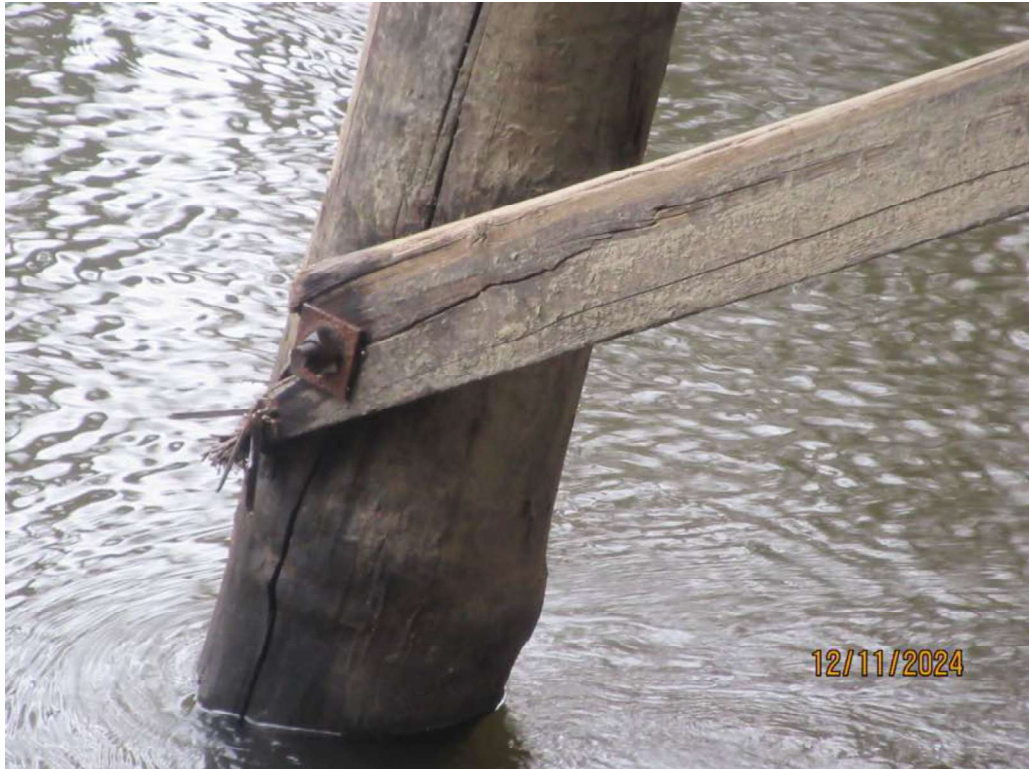
Photo 13: Bent 2, Pile 1 at lower bolt, brace is split.

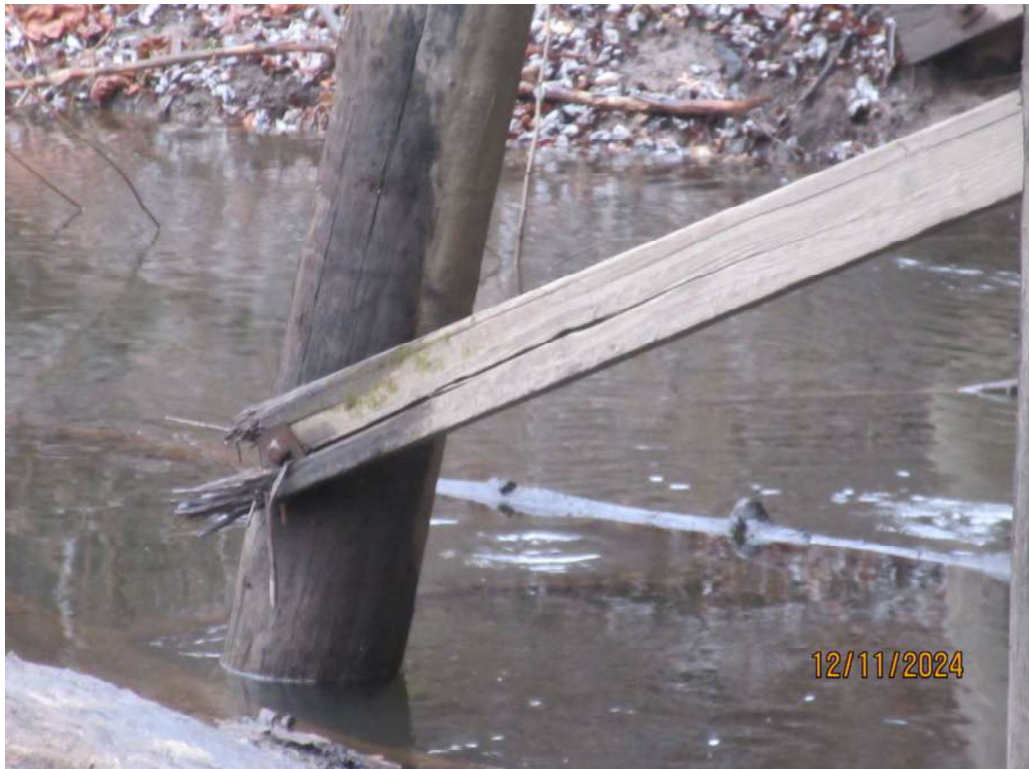
Photo 14: Bent 3, Pile 1, at lower bolt, the brace is split.

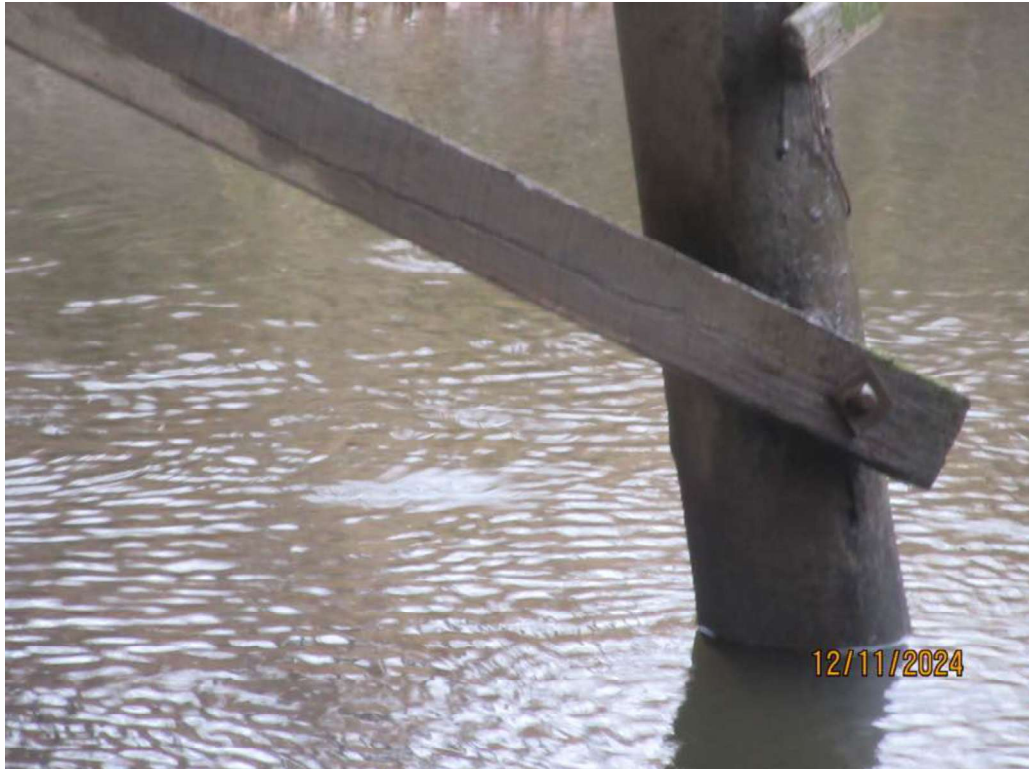
Photo 15: Bent 3, Pile 6, at lower bolt, the brace is split.

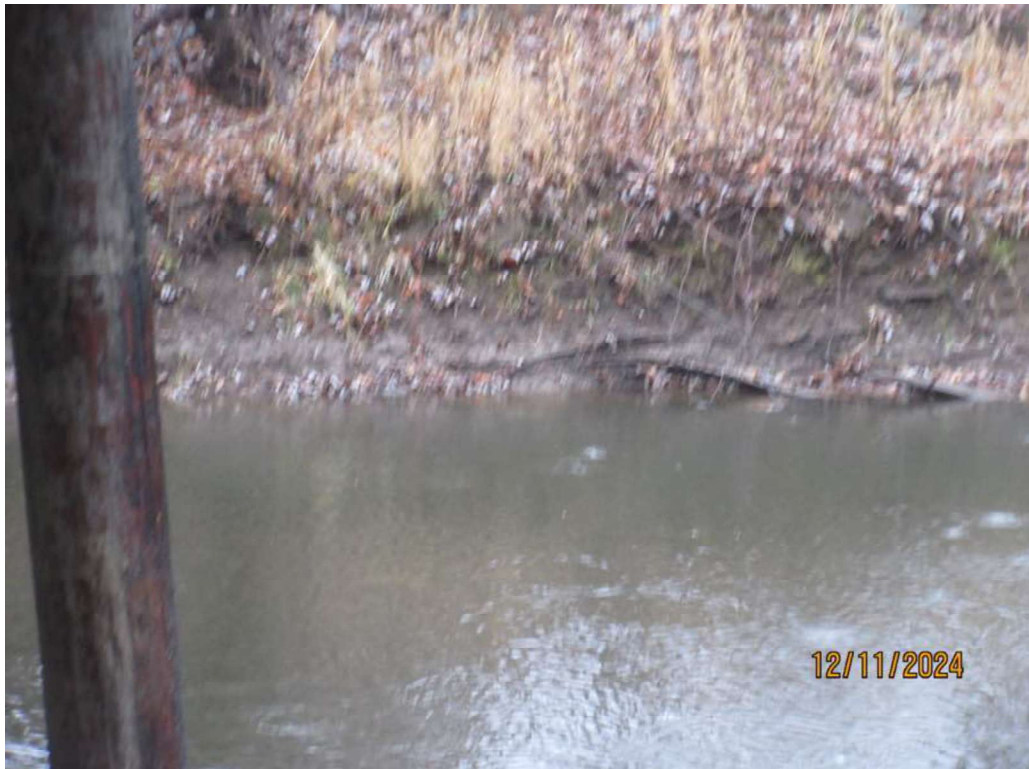
Photo 16: Northeast Embankment has erosion.

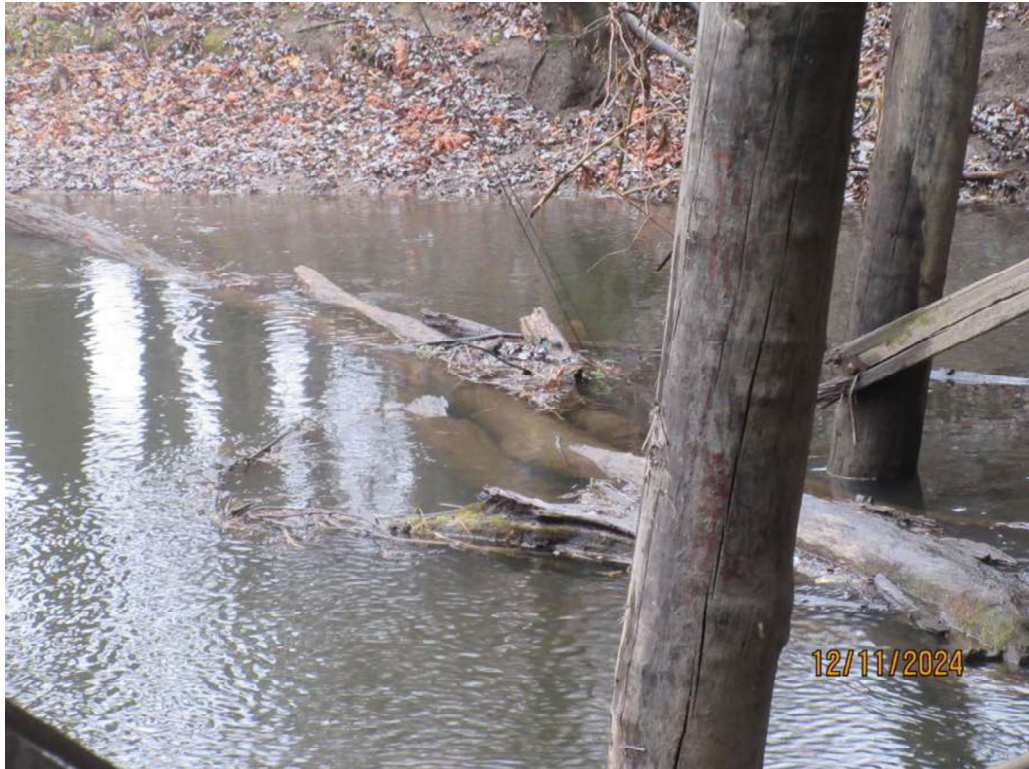
Photo 17: Logs built up against Bent 3.

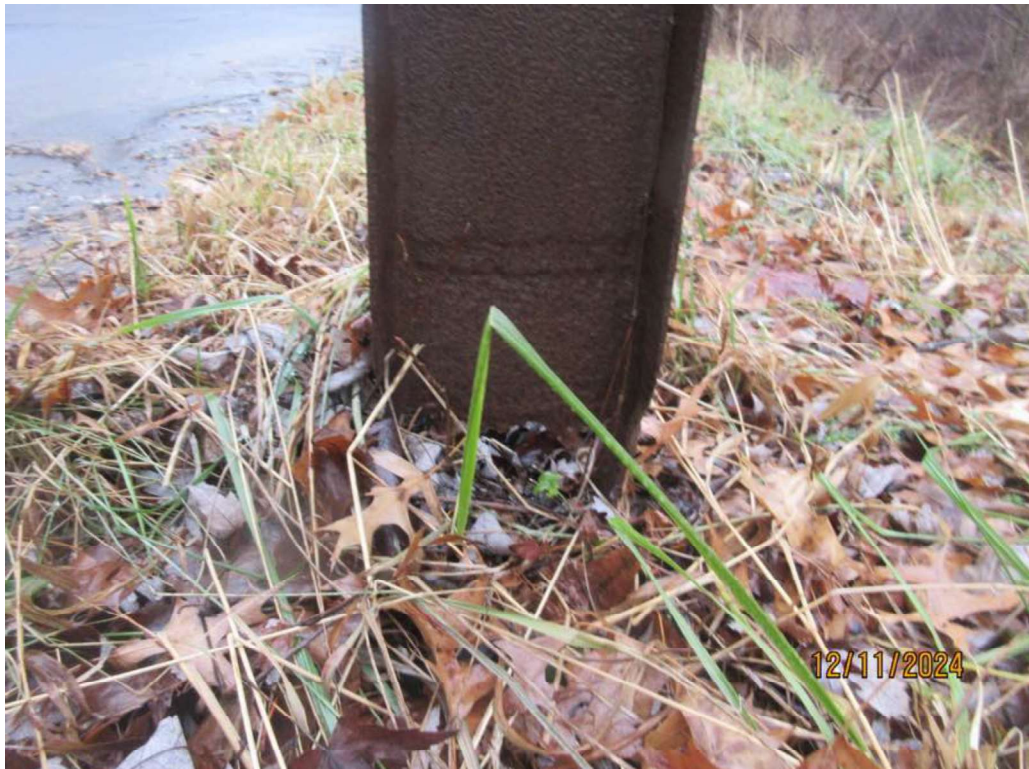
Photo 18: Southwest Approach guardrail post has hole in post at ground level.

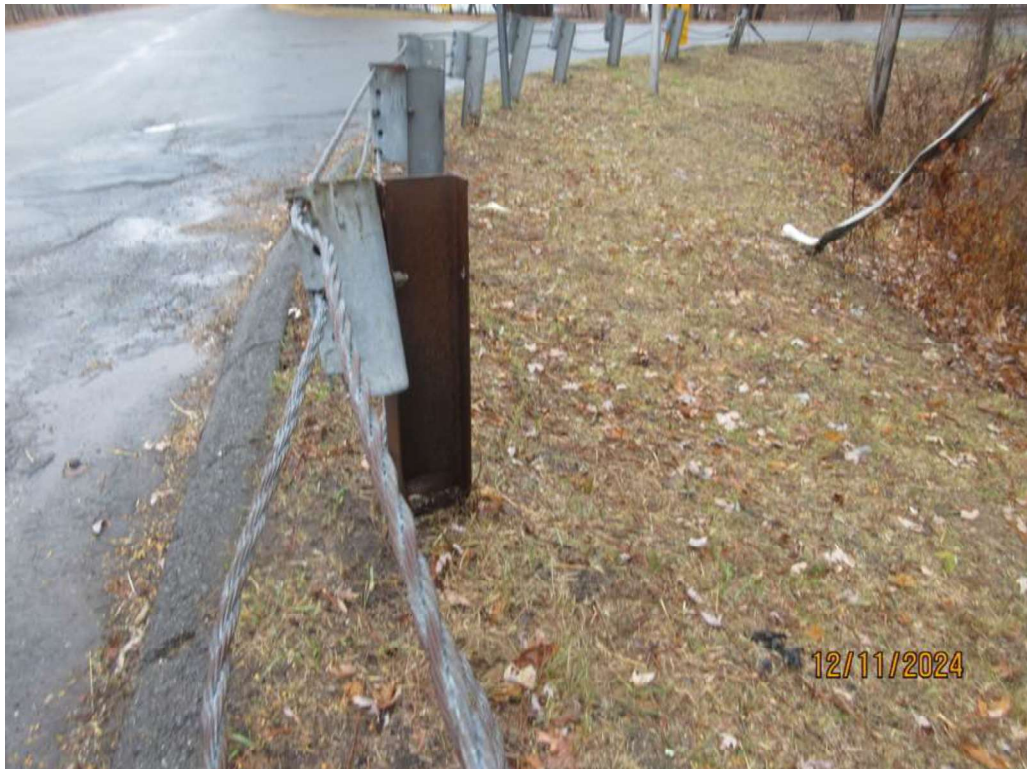
Photo 20: Northeast Approach guardrail post has rust hole at ground level.

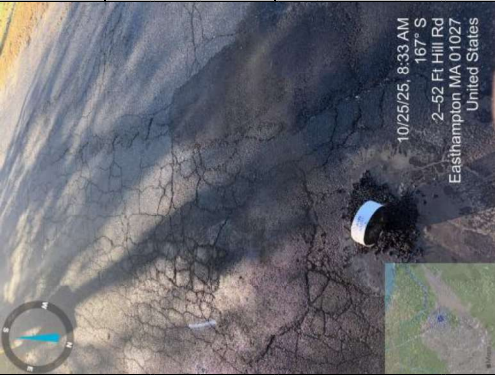
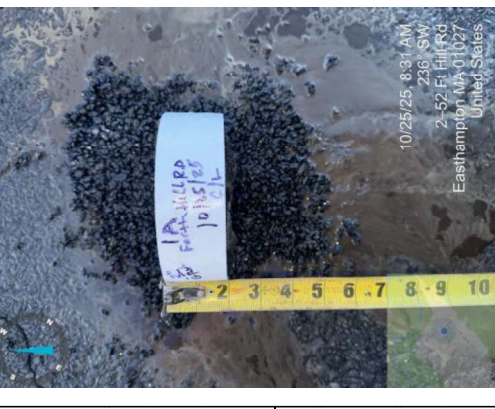
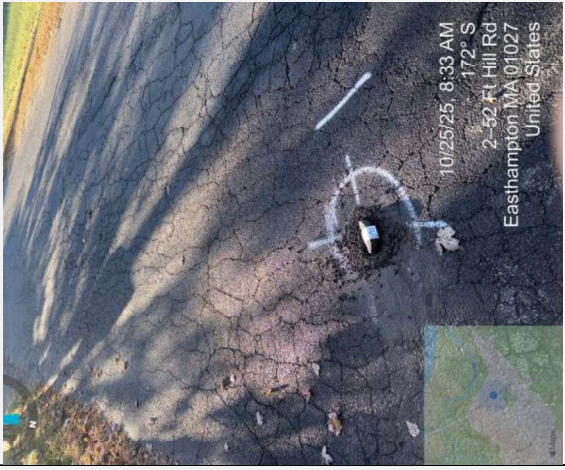
PC1A	PRE-CORE CONDITION	COURSE	THICK (INCH)	CATEGORY / USCS	CORE PHOTO	SAMPLE OBSERVATIONS		
<p>See Rendering for Approx. Location 4th Off Right edge</p> <p>HSQ</p>

<p>Signs Of Pavement Distress: Yes CORE Taken on Crack: Yes CORE Taken @ Patch Interface: No</p> <p>Top-Down Cracking: <input checked="" type="checkbox"/></p> <p>Bottom-Up Cracking: <input checked="" type="checkbox"/></p> <p>Evident Voids in Core: Yes - Wearing Surface Only</p> <p>Surface Interlayer Bond: N/A</p> <p>Soil Does Not Meet Structural Fill- Considered Free Draining</p> <p>AASHTO Soil Classification: A-1-a</p> <p>Base Layer Excavatable: Yes</p>		
FIELD OBSERVATIONS								
COMMENTS:								
<p>1. This core was taken along an area exhibiting significant fatigue cracking, approximately 4 feet off the right edge of the roadway while facing Clapp Street. The pavement thickness at this location was very thin with no intermediate layer, and the mix appeared to be a 9.5 mm surface course containing 3/8" stone aggregate. The sampled material and corresponding test results are included in the subsequent pages of this report. Laboratory analysis indicates the underlying material is slightly out of specification compared to MassDOT Gravel Borrow standards but is sufficiently close to be considered a suitable, free-draining structural subbase material, classified as A-1-a under AASHTO soil classification.</p>

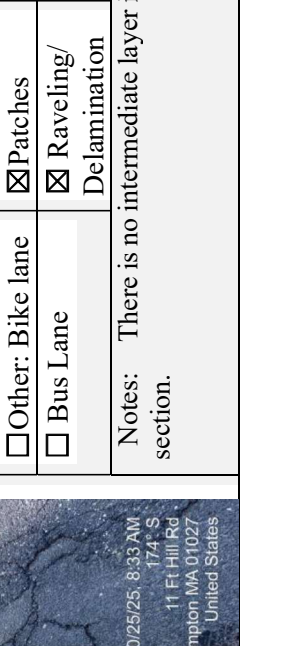
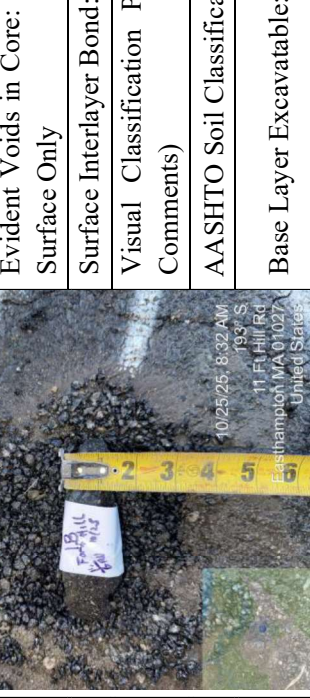
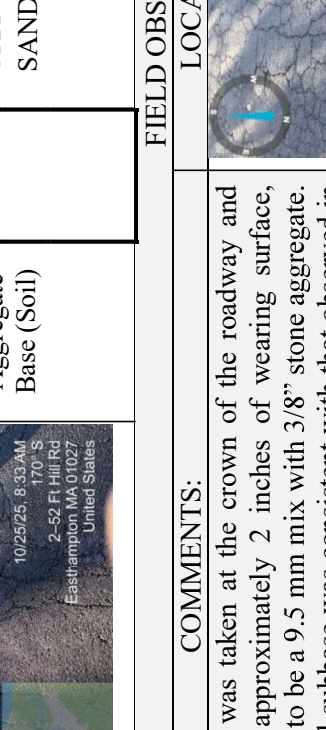
PC1B	PRE-CORE CONDITION	COURSE	THICK (INCH)	CATEGORY / USCS	CORE PHOTO	SAMPLE OBSERVATIONS
See Rendering for Approx. Location HSH Crown

Signs Of Pavement Distress: Yes
		HMA Intermediate Course(s) Maybe Cold Mix	'			CORE Taken on Crack: Yes
		Aggregate Base (Soil)	10"+	GRAVELLY SAND-SW		CORE Taken @ Patch Interface: No
						Top-Down Cracking: <input checked="" type="checkbox"/>
						Bottom-Up Cracking: <input checked="" type="checkbox"/>
						Evident Voids in Core: Yes - Wearing Surface Only
						Surface Interlayer Bond: N/A
						Visual Classification Performed (See Comments)
						AASHTO Soil Classification: N/A
						Base Layer Excavatable: Yes

COMMENTS:	LOCATION PHOTO	CONSIDERTIONS	FHWA DISTRESS ID
<p>1. This core was taken at the crown of the roadway and exhibited approximately 2 inches of wearing surface, appearing to be a 9.5 mm mix with 3/8" stone aggregate. The gravel subbase was consistent with that observed in Core No. 1A. All other observations remain applicable—specifically, the pavement thickness was insufficient, and the area exhibited significant fatigue cracking. The subbase material is anticipated to be suitable as a free-draining structural subbase. This core was taken in line with Core No. 1A to provide a cross-sectional indication of pavement thickness and confirm that the reduced depth was not limited to the shoulders. The total pavement section thickness at this location was approximately 1.5 inches.</p>

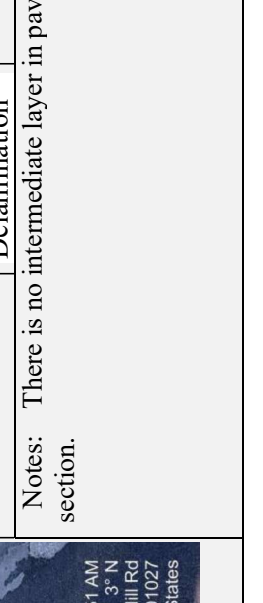
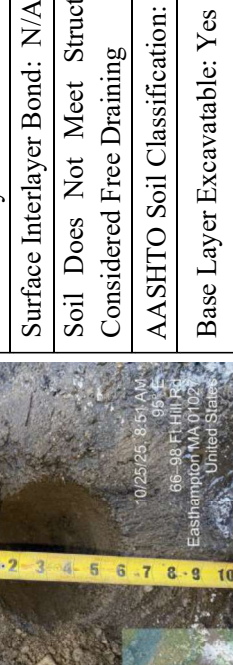
PC2A	PRE-CORE CONDITION	COURSE	THICK (INCH)	CATEGORY / USCS	CORE PHOTO	SAMPLE OBSERVATIONS
See Rendering for Approx. Location SHQ 8' off right edge

Signs Of Pavement Distress: Yes CORE Taken on Crack: No CORE Taken @ Patch Interface: No Top-Down Cracking: <input checked="" type="checkbox"/> Bottom-Up Cracking: <input checked="" type="checkbox"/> Evident Voids in Core: Yes - Wearing Surface Only Surface Interlayer Bond: N/A Soil Does Not Meet Structural Fill-Considered Free Draining AASHTO Soil Classification: A-1-b Base Layer Excavatable: Yes
		HMA Intermediate Course(s) Maybe Cold Mix	' ' ' '			
		Aggregate Base (Soil)	10"+	SILTY GRAVEL-GM

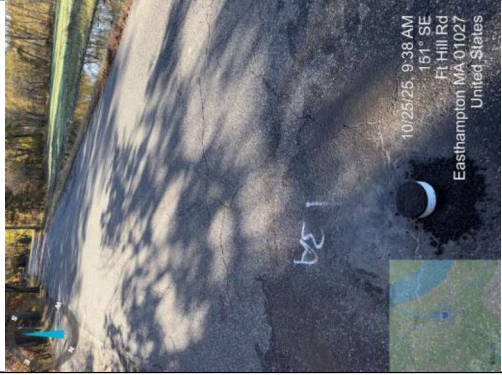
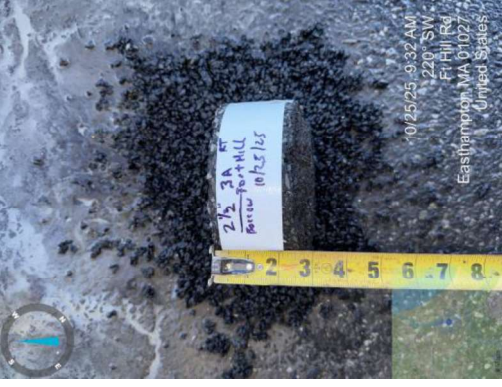
PC3A	PRE-CORE CONDITION	COURSE	THICK (INCH)	CATEGORY / USCS	CORE PHOTO	SAMPLE OBSERVATIONS
See Rendering for Approx. Location SHQ 5' off right edge

Signs Of Pavement Distress: Yes CORE Taken on Crack: Yes CORE Taken @ Patch Interface: No Top-Down Cracking: <input checked="" type="checkbox"/> Bottom-Up Cracking: <input checked="" type="checkbox"/> Evident Voids in Core: Yes - Wearing Surface Only Surface Interlayer Bond: N/A Sampled & Tested-asphalt rich material AASHTO Soil Classification: N/A Base Layer Excavatable: Yes
		HMA Intermediate Course(s) Maybe Cold Mix	' ' ' '			
		Aggregate Base (Soil)	8"+	ASPHALT COMPOSITE MATERAIL

FIELD OBSERVATIONS																					
COMMENTS:	CONSIDERATIONS																				
<p>1. This core was taken approximately 5 feet off the right shoulder while facing Clapp Street. The area exhibited the same random and fatigue cracking noted in prior locations. A corresponding soil sample was obtained from this location. The material appeared to consist of an asphalt-rich reclaimed borrow or millings. Laboratory testing of the soil sample was performed, and the results are provided in the subsequent section of this report. The pavement thickness at this location was approximately 2 1/2 inches, which is insufficient to adequately support traffic loading, even under relatively light vehicle demands.</p>	<p>LOCATION PHOTO</p>   <p>FHWA DISTRESS ID</p>

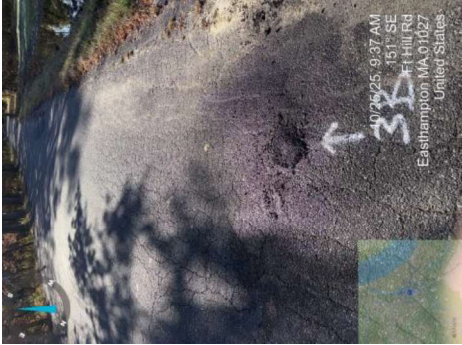
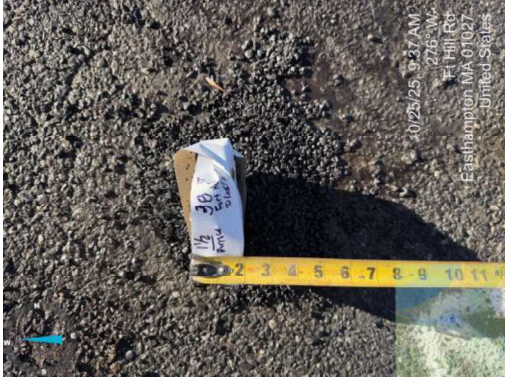
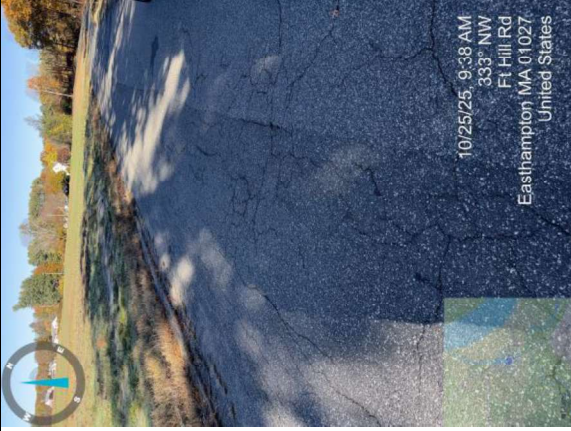
PC3B	PRE-CORE CONDITION	COURSE	THICK (INCH)	CATEGORY / USCS	CORE PHOTO	SAMPLE OBSERVATIONS
See Rendering for Approx. Location HSQ

Signs Of Pavement Distress: Yes
		HMA Intermediate Course(s) Maybe Cold Mix	' ' ' ' '			CORE Taken on Crack: Yes
		Aggregate Base (Soil)	8"+	ASPHALT COMPOSITE MATERAIL		CORE Taken @ Patch Interface: Yes
						Top-Down Cracking: <input checked="" type="checkbox"/>
						Bottom-Up Cracking: <input checked="" type="checkbox"/>
						Evident Voids in Core: Yes - Wearing Surface Only
						Surface Interlayer Bond: N/A
						Visual Classification Performed (See Comments)
						AASHTO Soil Classification: N/A
						Base Layer Excavatable: Yes

COMMENTS:	LOCATION PHOTO	CONSIDERTIONS	FHWA DISTRESS ID
1. This core was taken approximately 4 feet off the left shoulder while facing Clapp Street. The soil subbase material appeared consistent with that observed in Core No. 3A, consisting of an asphalt-rich reclaimed borrow or millings. The area exhibited significant fatigue cracking, largely attributable to the insufficient pavement thickness of approximately 1½ inches, which is inadequate to support even light vehicle loading. The observed subsurface conditions further confirm the limited structural capacity of this section.
