**BRIGHAM
STREET
CULVERT
FEASIBILITY
STUDY**

0234865.00
Town of Hudson, MA
July 2023

The purpose of this Report is to provide a description of the data collection and engineering evaluation to support the replacement of the existing culvert below Brigham Street as part of the Brigham Street Culvert Replacement Project (Project). Replacing the existing culvert with a new structure that does not lack structural deficiencies, is designed to provide increased flow capacity, and consistent with the Massachusetts Stream Crossing Standards to maximum extent practicable will provide a benefit to the wildlife in the area, provide a safety benefit to residents, and improve climate resilience. A map showing the location of the Project and the stream with cross sections used in the hydraulic model are provided in **Appendix A**.

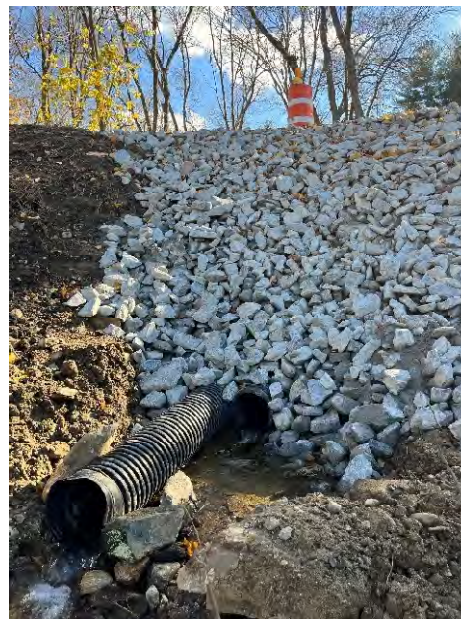
Photo 1: Downstream of Brigham Culvert Crossing

The existing upstream side of the Brigham Street culvert has a reinforced concrete slab headwall with an approximate span of 36-inches supported by vertical concrete sides and stone abutments with portions of the culvert reported to be constructed of stone masonry. Two corrugated HDPE pipes, one 70 foot long, 12-inch and one 75 foot long 15-inch were installed along the stream bed that convey flow from the unnamed stream in a northwesterly direction beneath Brigham Street (Photo 1). Within the extents of the evaluation, this culvert is considered the upstream culvert. This culvert is only temporary due to a previous structure failure. The culvert is undersized and is subject to neighboring residential property flooding.

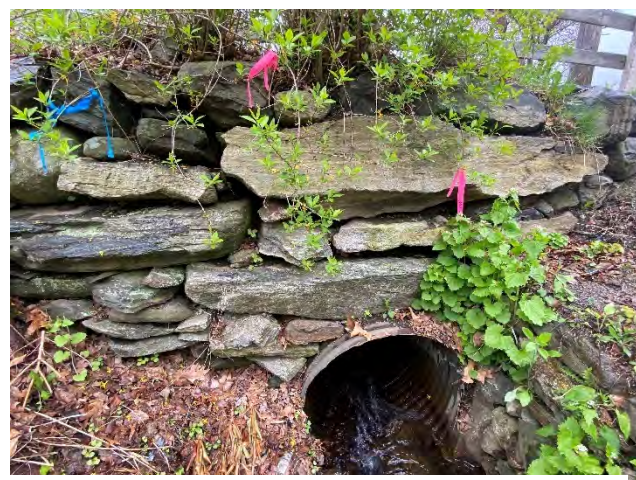
Photo 2: Upstream of Park Street Culvert Crossing

The Park Street culvert is located approximately 135 feet northwest downstream of the Brigham Street culvert. The culvert is a 36-inch Corrugated metal pipe, approximately 350 feet long and daylight to a wetland system which ultimately discharges to the Assabet River. The culvert and headwalls are in fair condition (Photo 2).

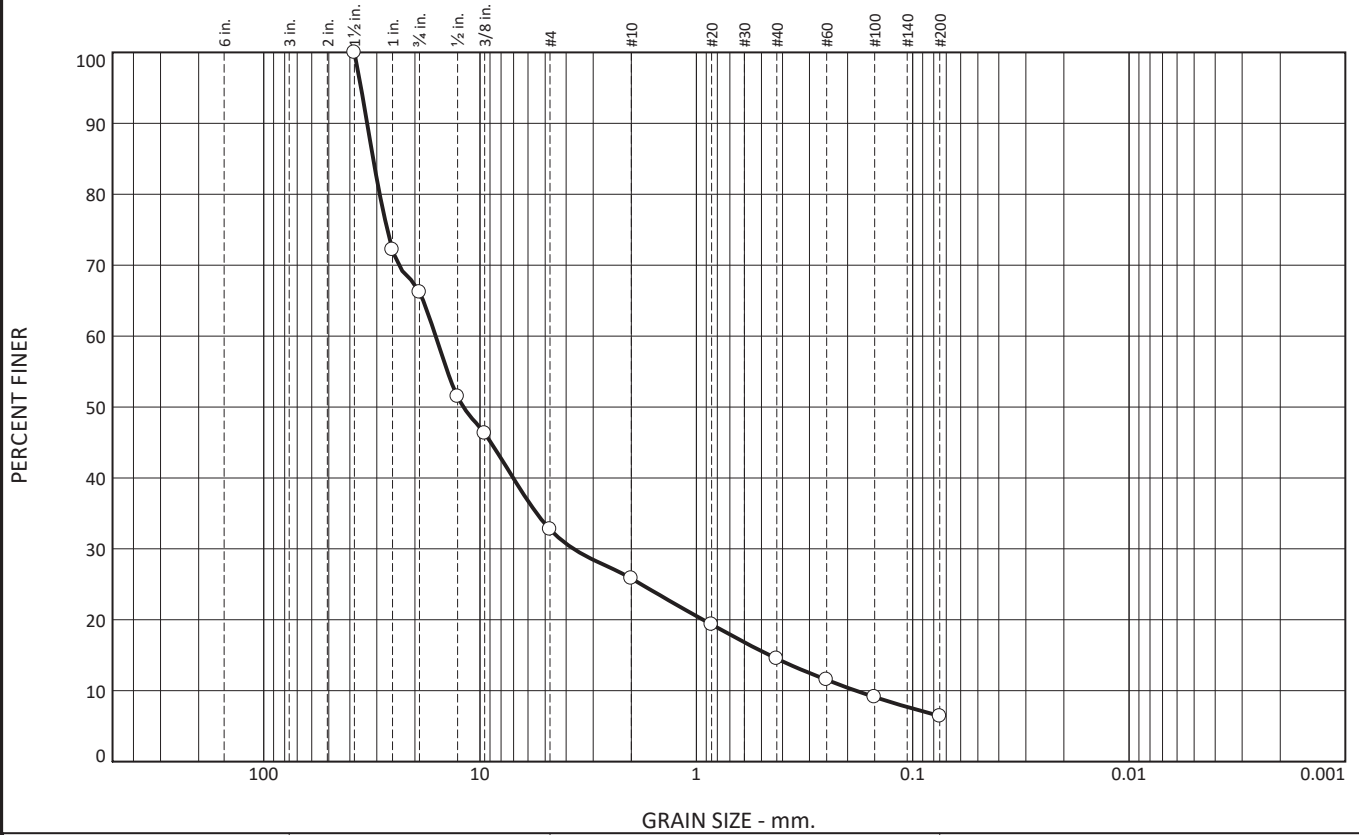
Particle Size Distribution Report

% +3"	% Gravel		% Sand			% Fines	
	Coarse	Fine	Coarse	Medium	Fine	Silt	Clay
0.0	33.8	33.4	7.0	11.3	8.1	6.4

SIEVE SIZE OR DIAMETER	PERCENT FINER	SPEC.* PERCENT	PASS? (X=NO)
1 1/2"	100.0		
1"	72.2		
3/4"	66.2		
1/2"	51.5		
3/8"	46.3		
#4	32.8		
#10	25.8		
#20	19.3		
#40	14.5		
#60	11.5		
#100	9.1		
#200	6.4

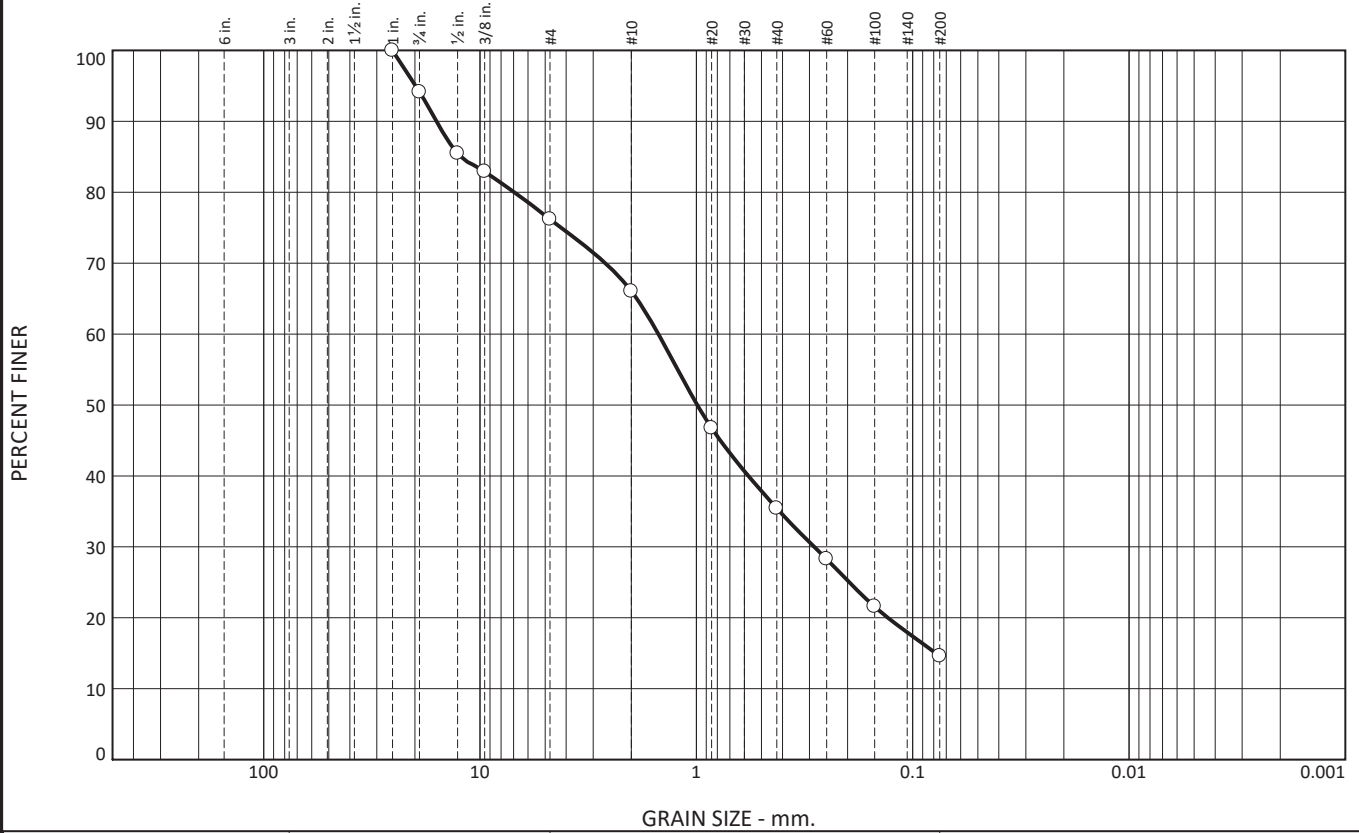
Particle Size Distribution Report

% +3"	% Gravel		% Sand			% Fines	
	Coarse	Fine	Coarse	Medium	Fine	Silt	Clay
0.0	5.9	17.9	10.2	30.6	20.8	14.6

SIEVE SIZE OR DIAMETER	PERCENT FINER	SPEC.* PERCENT	PASS? (X=NO)
1"	100.0		
3/4"	94.1		
1/2"	85.5		
3/8"	82.9		
#4	76.2		
#10	66.0		
#20	46.8		
#40	35.4		
#60	28.3		
#100	21.6		
#200	14.6

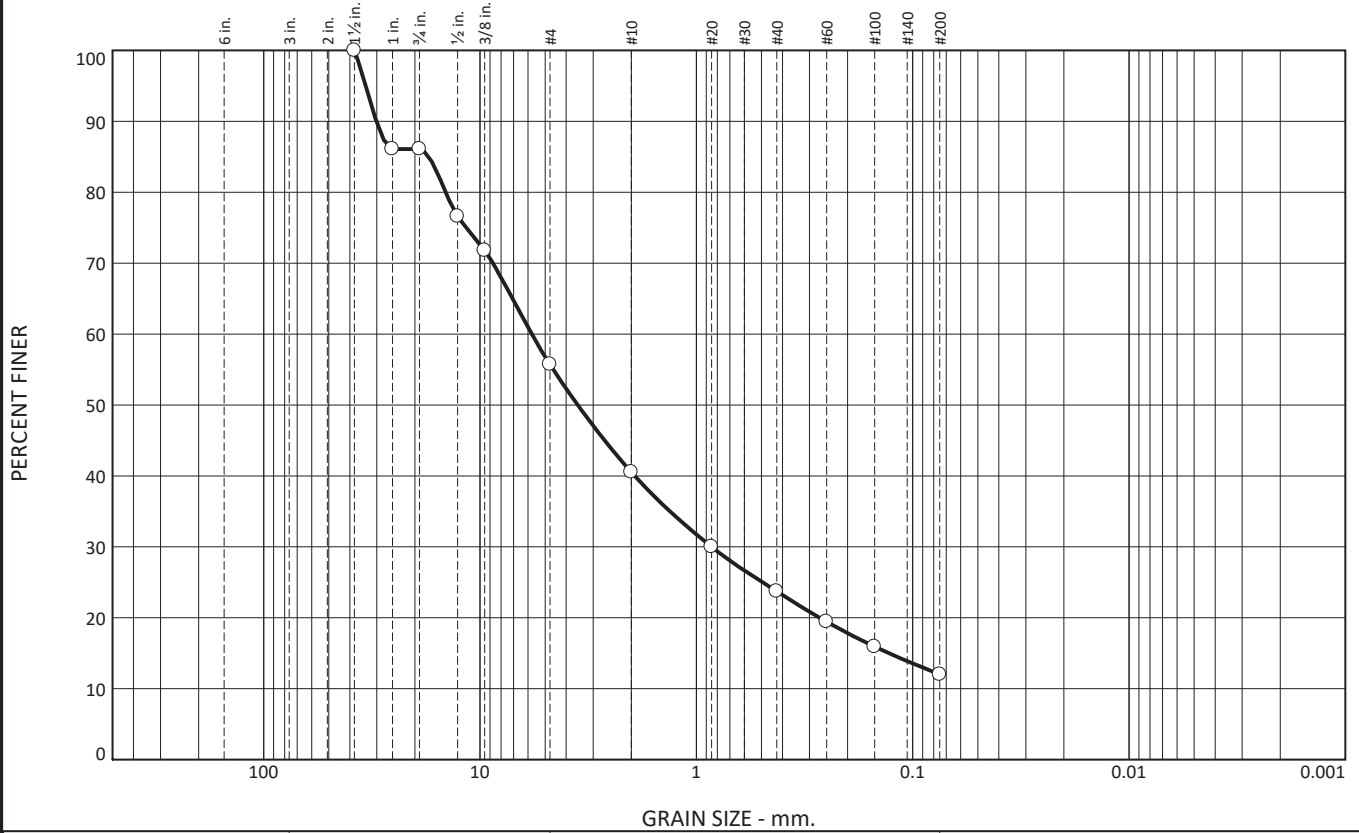
Particle Size Distribution Report

% +3"	% Gravel		% Sand			% Fines	
	Coarse	Fine	Coarse	Medium	Fine	Silt	Clay
0.0	13.9	30.4	15.2	16.8	11.7	12.0

SIEVE SIZE OR DIAMETER	PERCENT FINER	SPEC.* PERCENT	PASS? (X=NO)
1 1/2"	100.0		
1"	86.1		
3/4"	86.1		
1/2"	76.6		
3/8"	71.8		
#4	55.7		
#10	40.5		
#20	30.0		
#40	23.7		
#60	19.4		
#100	15.9		
#200	12.0

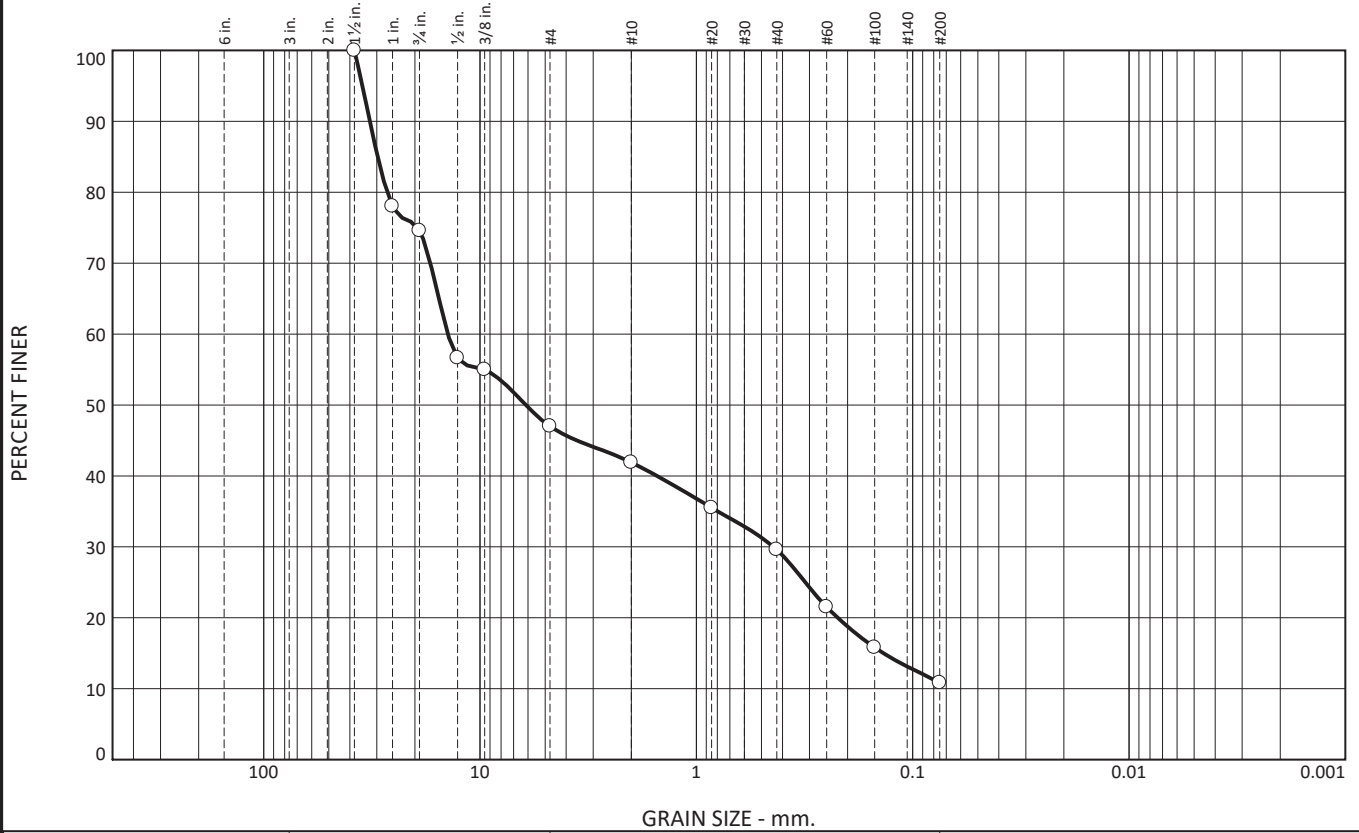
Particle Size Distribution Report

% +3"	% Gravel		% Sand			% Fines	
	Coarse	Fine	Coarse	Medium	Fine	Silt	Clay
0.0	25.4	27.6	5.1	12.3	18.8	10.8

SIEVE SIZE OR DIAMETER	PERCENT FINER	SPEC.* PERCENT	PASS? (X=NO)
1 1/2"	100.0		
1"	78.0		
3/4"	74.6		
1/2"	56.6		
3/8"	55.0		
#4	47.0		
#10	41.9		
#20	35.5		
#40	29.6		
#60	21.5		
#100	15.8		
#200	10.8
