CITY/TOWN
WAREHAMB.I.N.
45KBR. DEPT. NO.
W-06-0168.-STRUCTURE NO.
W06016-45K-DOT-NBIINSPECTION DATE
OCT 12, 2016

PHOTOS

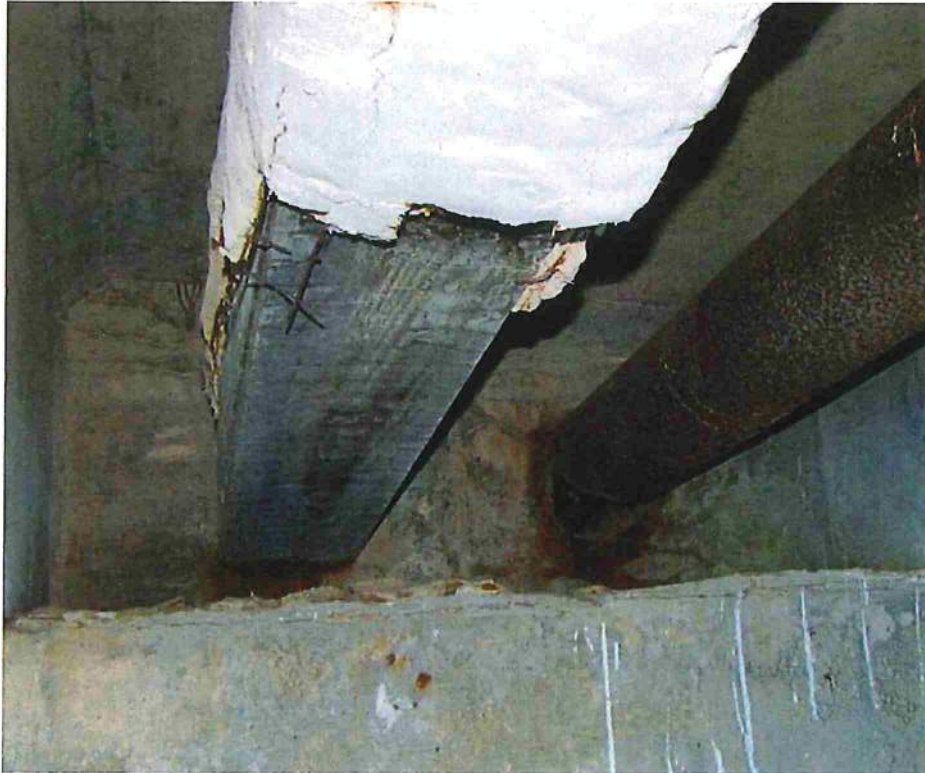
Photo 35: Same utilities as previous photo, span 3 at east abutment. Utility pipe on right with a hole, apparently abandoned

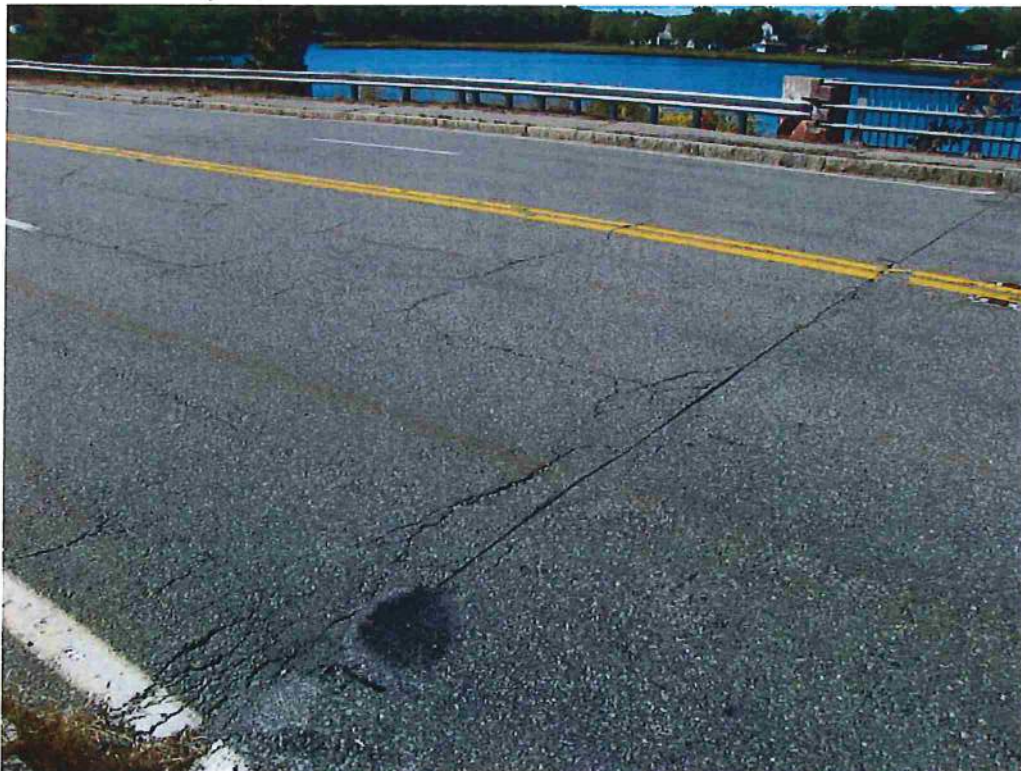
Photo 36: Overview of west approach pavement and sawcut joint. East approach pavement and sawcut joint is similar
