Subject: On-Call Asbestos, Lead, Air Quality & Demolition Compliance  
Agreement No. 10.04-02 (23)  
HazMat Inspection – Rehabilitation of Bridge No. 00870, Route 17 over New London  
Turnpike, Glastonbury, CT  
ConnDOT Assignment No. 524-8284  
ConnDOT Project No. 53-189  
TRC Project No. 501871.8284.0710

# SIH - WinSIH HBM Survey

## ConnDOT, Bridge No. 00870, Route 17 Over New London TPKE Glastonbury

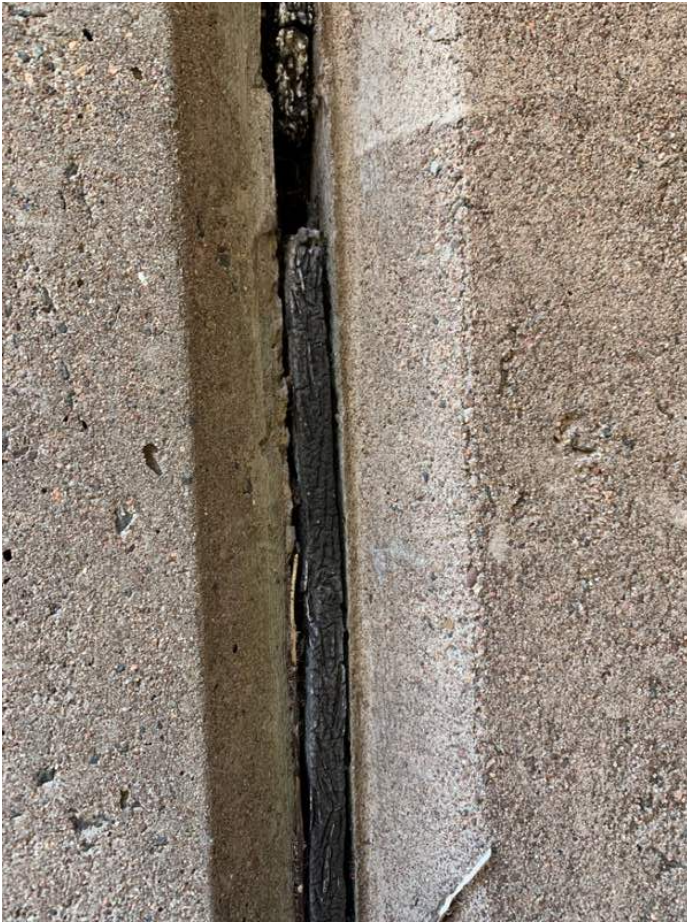
## Representative Photos

#### Materials & Samples - 1. (2) Samples #1-2: AJ 1-Black asphalt joint filler

Sampled or Assumed?	Sampled
Material Acronym	AJ 1
Material Description	Black asphalt joint filler
Material Color	Black

Analyze by layer?	No
Is material non-friable organically bound (NOB)?	Yes
Homogeneous Area	
Total Approximate Quantity	120 LF
Notes

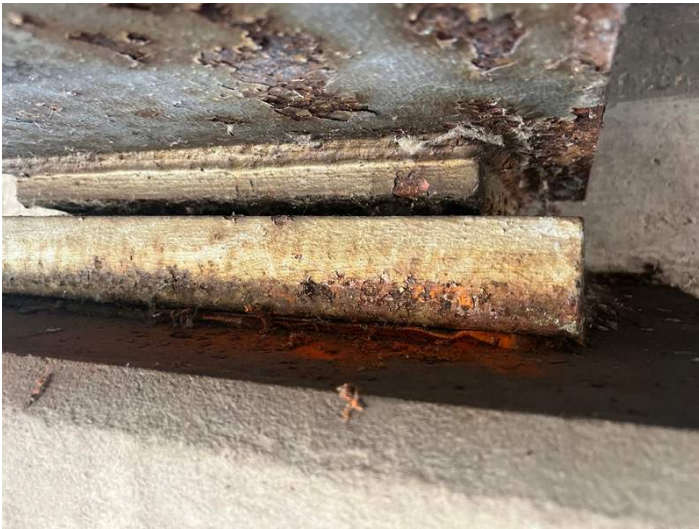
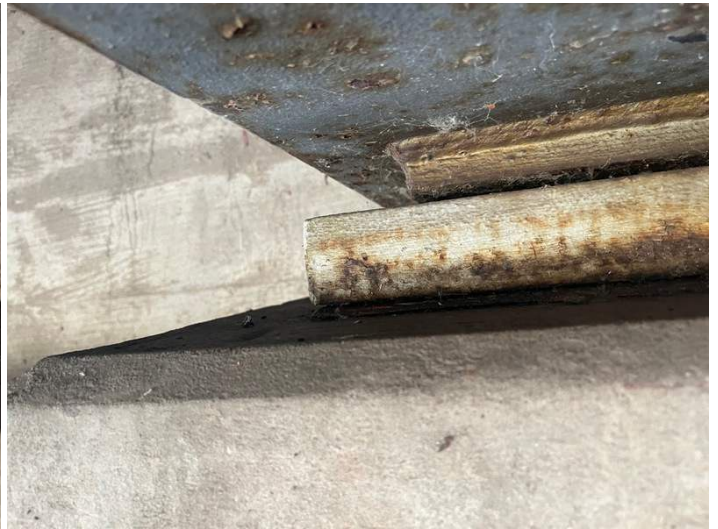
### Representative Photos

**Materials & Samples - 2. (2) Samples #3–4: BP 1–Orange base pad on ends of support beams**

Sampled or Assumed?	Sampled
Material Acronym	BP 1
Material Description	Orange base pad on ends of support beams
Material Color	Orange

Analyze by layer?	No
Is material non-friable organically bound (NOB)?	No
Homogeneous Area

Total Approximate Quantity	25SF
----------------------------	------

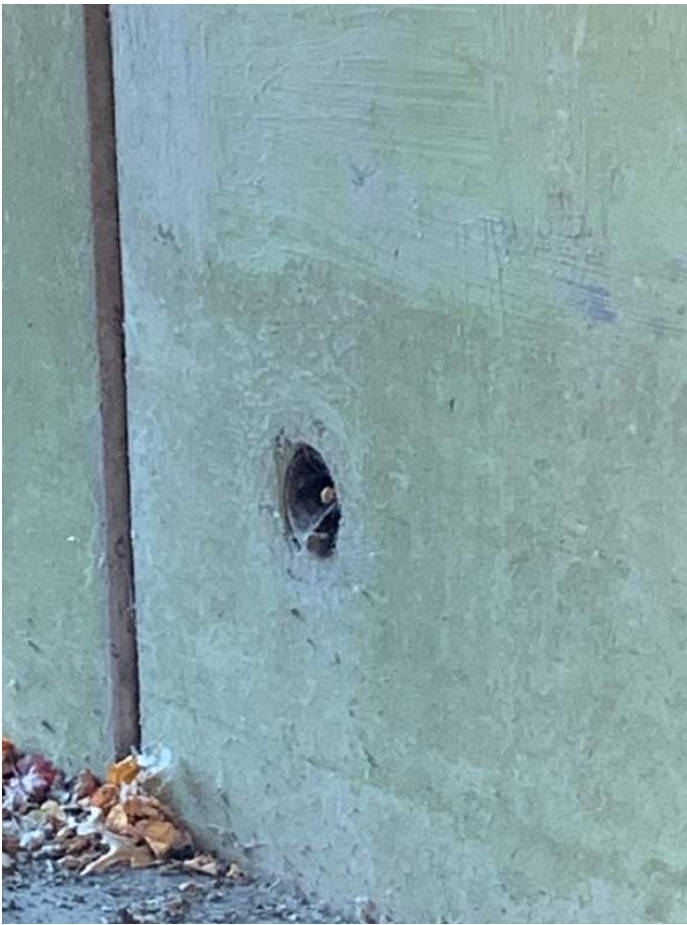
## Representative Photos

### Materials & Samples - 3. (2) Samples #5–6: DP 1–Black drain pipe

Sampled or Assumed?	Sampled
Material Acronym	DP 1
Material Description	Black drain pipe
Material Color	Black

Analyze by layer?	No
Is material non-friable organically bound (NOB)?	Yes
Homogeneous Area	
Total Approximate Quantity	8 total pipes
Notes

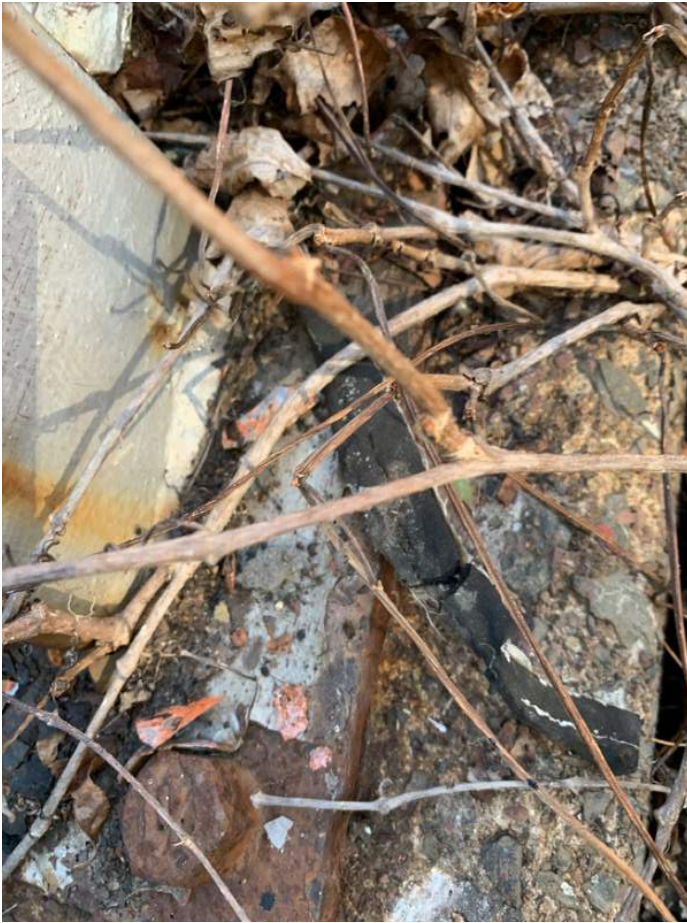
## Representative Photos

## Materials &amp; Samples - 4. (2) Samples #7-8: RC 1-Black Railing Caulk

Sampled or Assumed?	Sampled
Material Acronym	RC 1
Material Description	Black Railing Caulk
Material Color	Black

Analyze by layer?	No
Is material non-friable organically bound (NOB)?	Yes
Homogeneous Area	
Total Approximate Quantity	40SF
Notes
