Subject: On-Call Asbestos, Lead, Air Quality & Demolition Compliance
Agreement No. 8.07-01 (18)
HazMat Inspection – Rehabilitation of Bridge No. 06772, Route 63 (New Haven Rd) over Straitsville Brook, Naugatuck, CT
ConnDOT Assignment No. 519-7702
ConnDOT Project No. 87-148
TRC Project No. 289951.7702.0710

TRC performed a limited hazardous materials site investigation associated with the rehabilitation of Bridge No. 06772, Route 63 (New Haven Rd) over Straitsville Brook in Naugatuck, Connecticut. No painted surfaces were identified at Bridge No. 06772; therefore, no lead paint was identified. Suspect asbestos black asphalt tar coating on the ACCMP and a grey grout material were sampled and found to contain no detectable amounts of asbestos. No other hazmat/regulated items were identified at Bridge No. 06772.

Site: Culvert 06772, Route 63 over Straitsville Brook, Naugatuck, CT

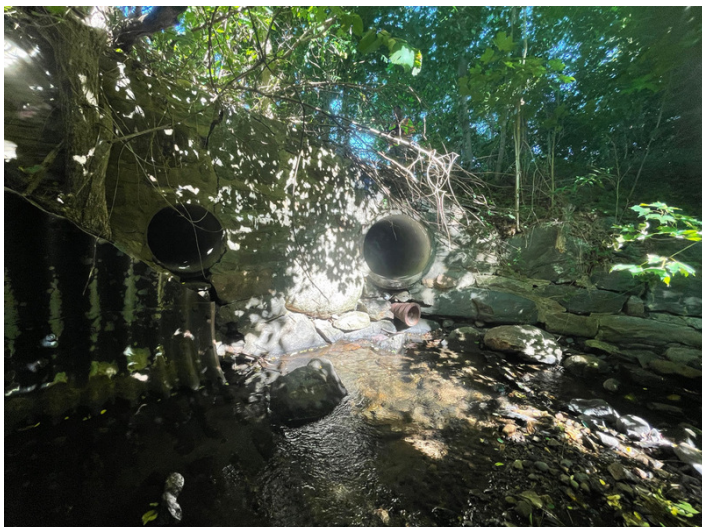
Representative Photos

Sampled or Assumed?	Sampled
Material Acronym	GR ► 1
Material Description	Grey grout associated with stone retaining wall
Material Color	Grey

Analyze by layer?	No
Is material non-friable organically bound (NOB)?	No
Homogeneous Area	Retaining wall north side of culvert
Total Approximate Quantity	
Notes

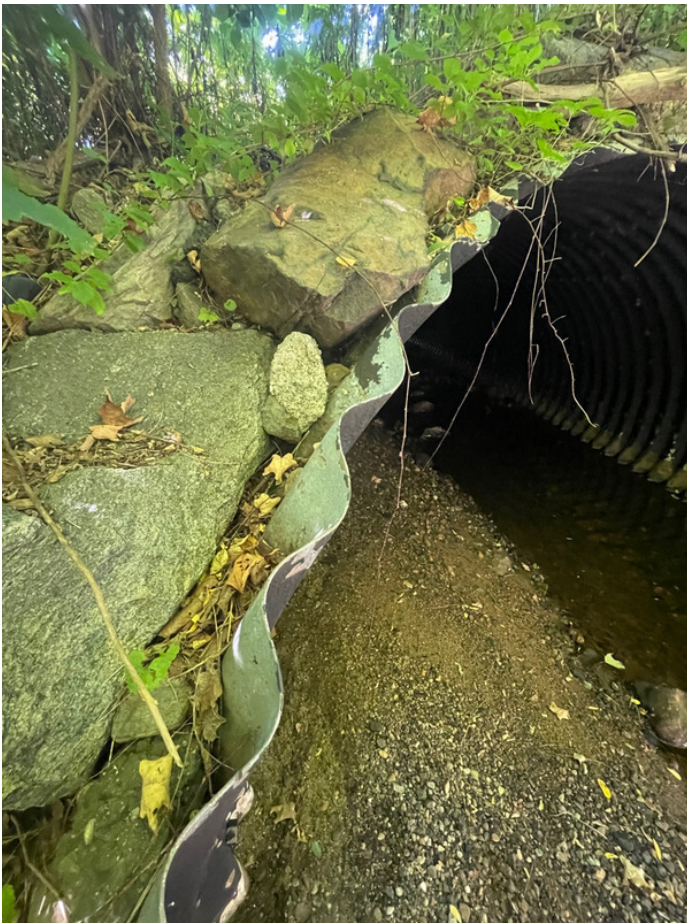
Representative Photos

LAB ID	Field ID	Description:	Color	Initial Weight	% Asbestos Types						% Other Non-asb.	% Organic	% Carb.	Total % Asbestos	Analyzed / Charged	Prepped / Charged
					CHR	AMO	ACT	CRO	ANT	TRE						
NT149292	03	Black Tar Coating		.1482	.00	.00	.00	.00	.00	.00	31.24	67.61	1.15	ND	Yes	No

Sampled or Assumed?	Sampled
Material Acronym	T1
Material Description	Black tar coating
Material Color	Black

Analyze by layer?	No
Is material non-friable organically bound (NOB)?	Yes
Homogeneous Area	Inner and outer sides of corrugated metal culvert tunnel
