Subject: On-Call Asbestos, Lead, Air Quality & Demolition Compliance
Agreement No.: 10.04-02 (23)
HazMat Inspection – Removal of I-84 EB Exit 21 Off-Ramp, Waterbury, CT
ConnDOT Assignment No. 524-8307
ConnDOT Project No. 151-340
TRC Project No. 501871.8307.0710

TRC performed a limited survey for hazardous building materials associated with the removal of the I-84 EB Exit 21 off-ramp in Waterbury, Connecticut. The scope of the inspection included Bridge 03191F, Bridge No. 03196 (lighting improvements only) and traffic signals and pedestrian control equipment at all the Traffic Signal Intersections detailed in the provided PP0151-014 Traffic Signal List. Results of the survey identified the following:

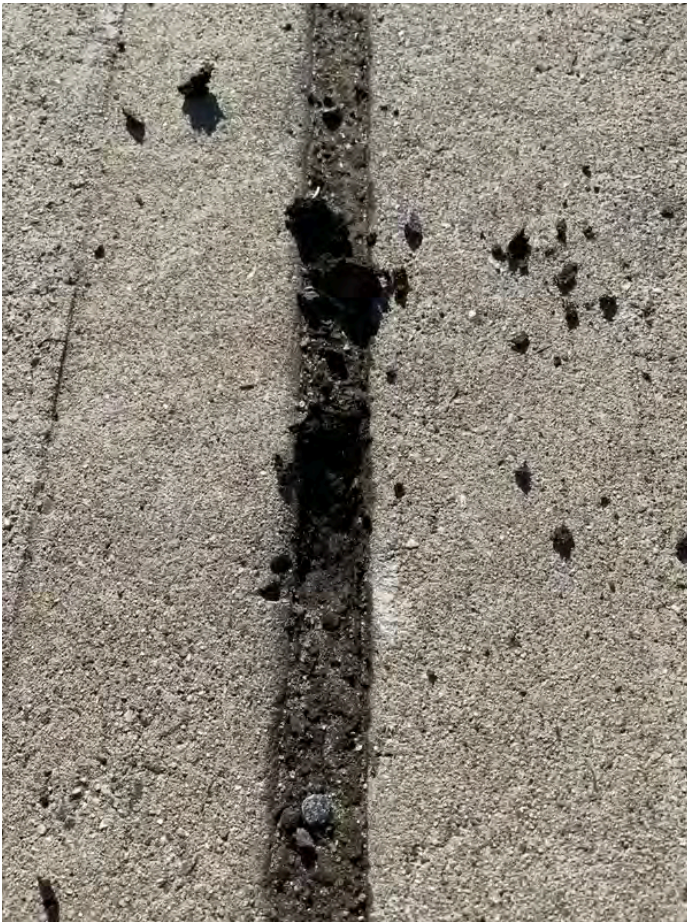
Representative Photos

Sampled or Assumed?	Sampled
Material Acronym	JF1
Material Description	Black joint filler between sidewalk segments
Material Color	Black

Analyze by layer?	No
Is material non-friable organically bound (NOB)?	Yes
Homogeneous Area	
Total Approximate Quantity	140 linear ft

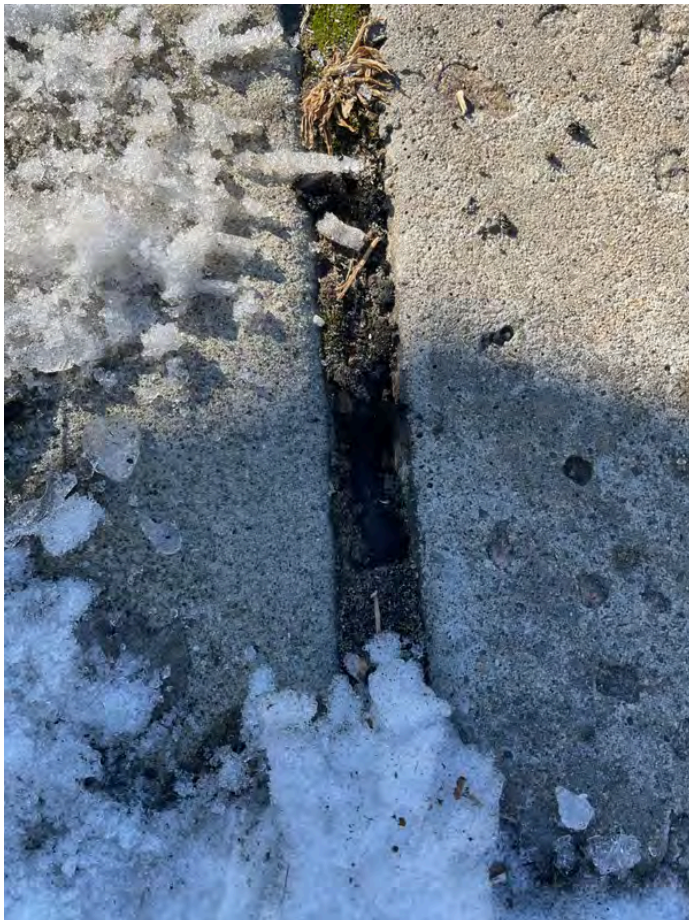
Representative Photos

Material Acronym	EJ1
Material Description	Expansion Joint tar around curb of storm drain
Material Color	Black

Analyze by layer?	No
Is material non-friable organically bound (NOB)?	Yes
Homogeneous Area	
Total Approximate Quantity	6 linear ft
Notes

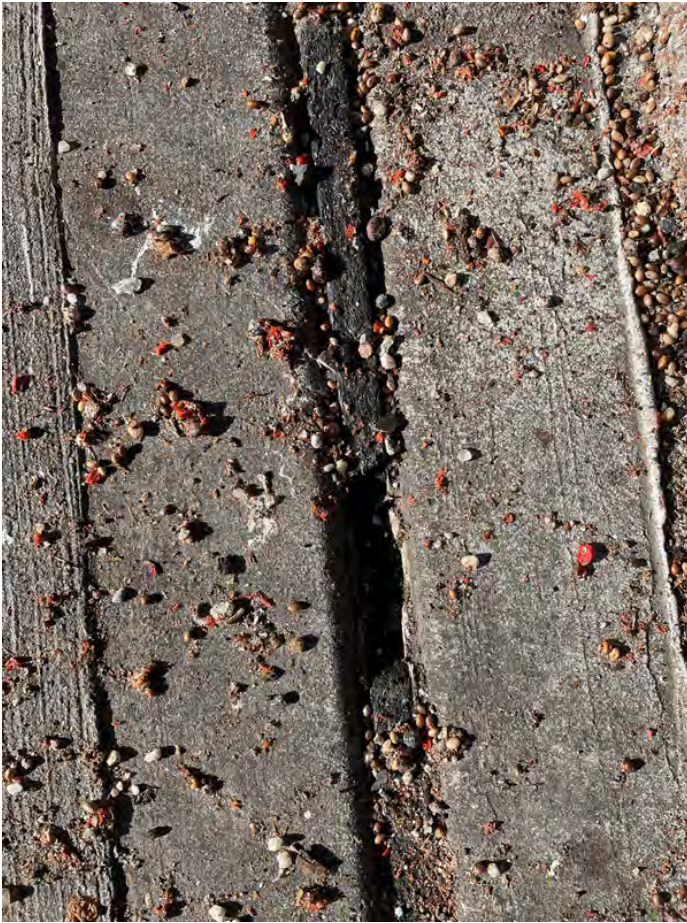
Representative Photos

Materials & Samples - 3. (2) Samples #07–08: JF2–Styrofoam with tar like coating on top**Sample Information****Asbestos Samples (2 Items)****Asbestos Samples - 1. Sample #07: JF2...Meadow St and Grand St Southwest Corner**

Analyze by layer?	Yes
Is material non-friable organically bound (NOB)?	Yes
Homogeneous Area	
Total Approximate Quantity	75 linear ft
Notes	Around span pole base and along back curb at southwest corner Around back curb, traffic box in ground and between sidewalk and asphalt at northwest corner North east corner between sidewalk segments

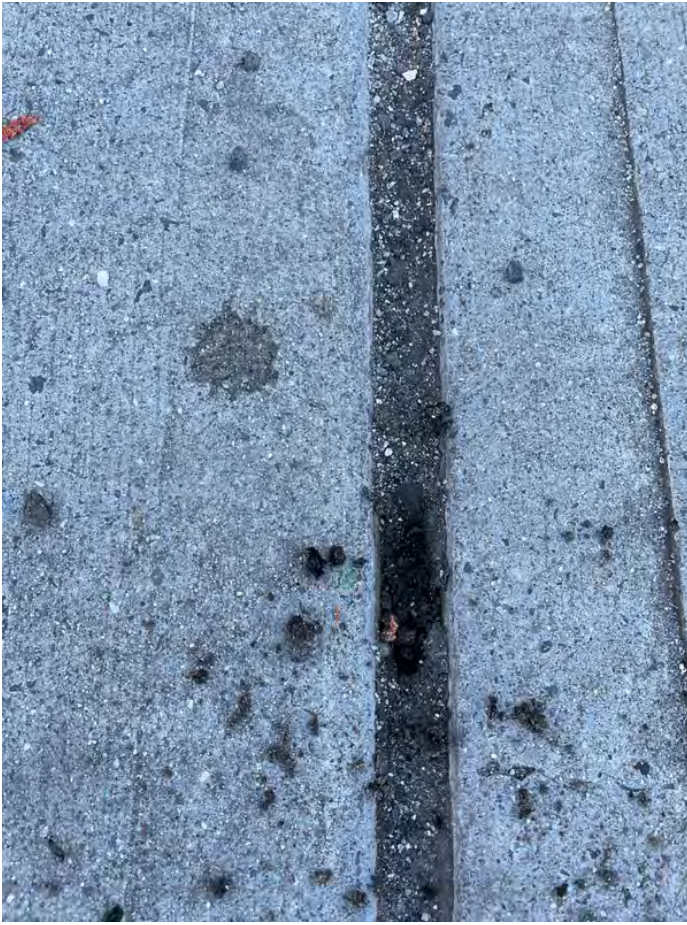
Representative Photos

Materials & Samples - 4. (2) Samples #09–10: EJ2–Black expansion joint tar between sidewalk segments

Analyze by layer?	No
Is material non-friable organically bound (NOB)?	Yes
Homogeneous Area	
Total Approximate Quantity	10 linear ft
Notes

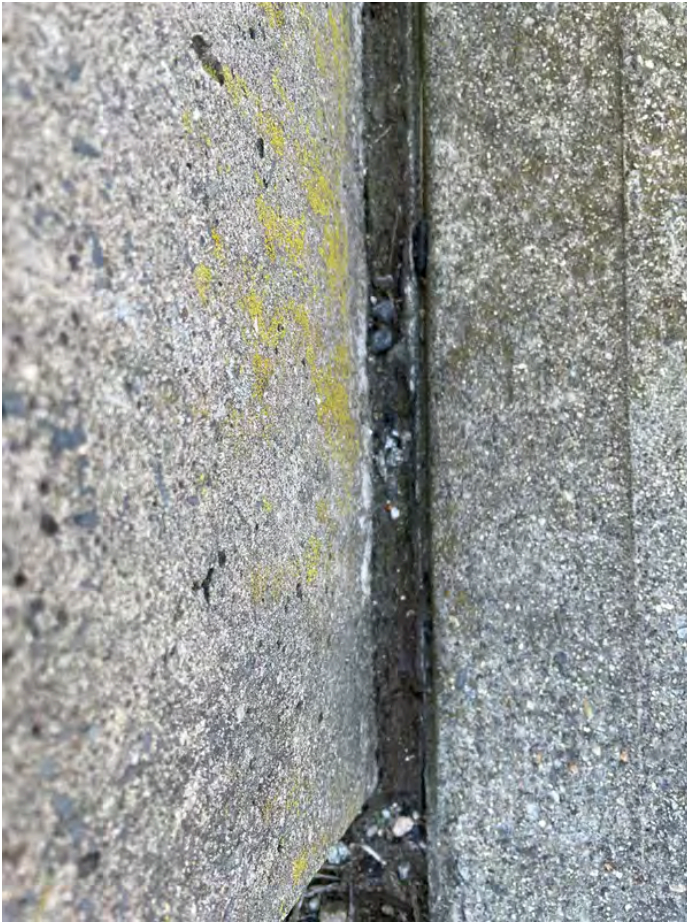
Representative Photos

Materials & Samples - 5. (2) Samples #11–12: JF3–Black and brown joint filler at base of controller box

Analyze by layer?	No
Is material non-friable organically bound (NOB)?	No
Homogeneous Area	
Total Approximate Quantity	20 linear ft
Notes

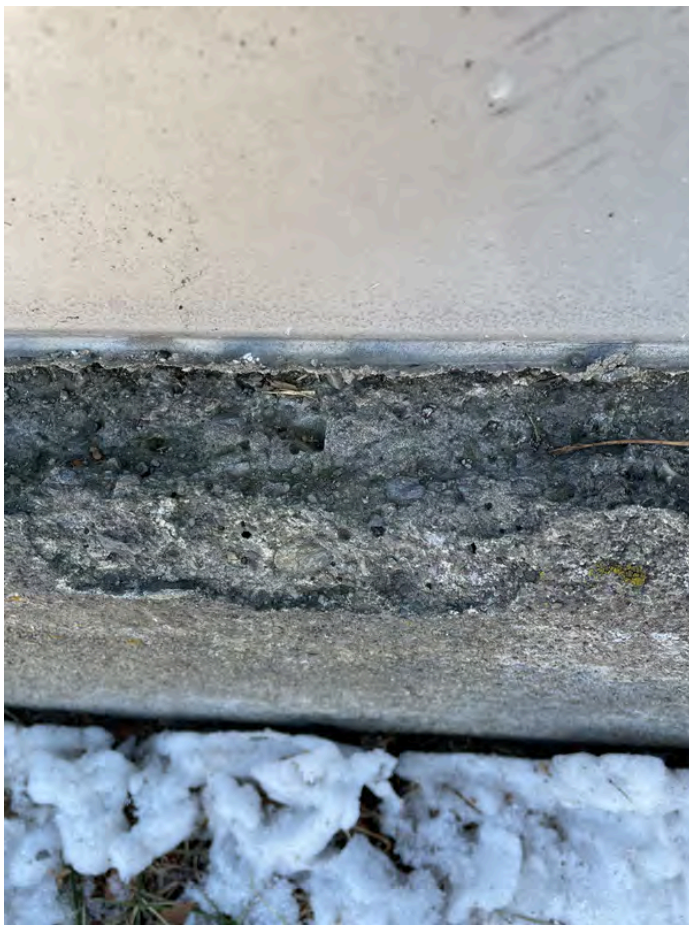
Representative Photos

Materials & Samples - 6. (2) Samples #13–14: C1–Grey caulk where metal component of controller box meets concrete base.

Analyze by layer?	No
Is material non-friable organically bound (NOB)?	Yes
Homogeneous Area	
Total Approximate Quantity	20 linear ft
Notes

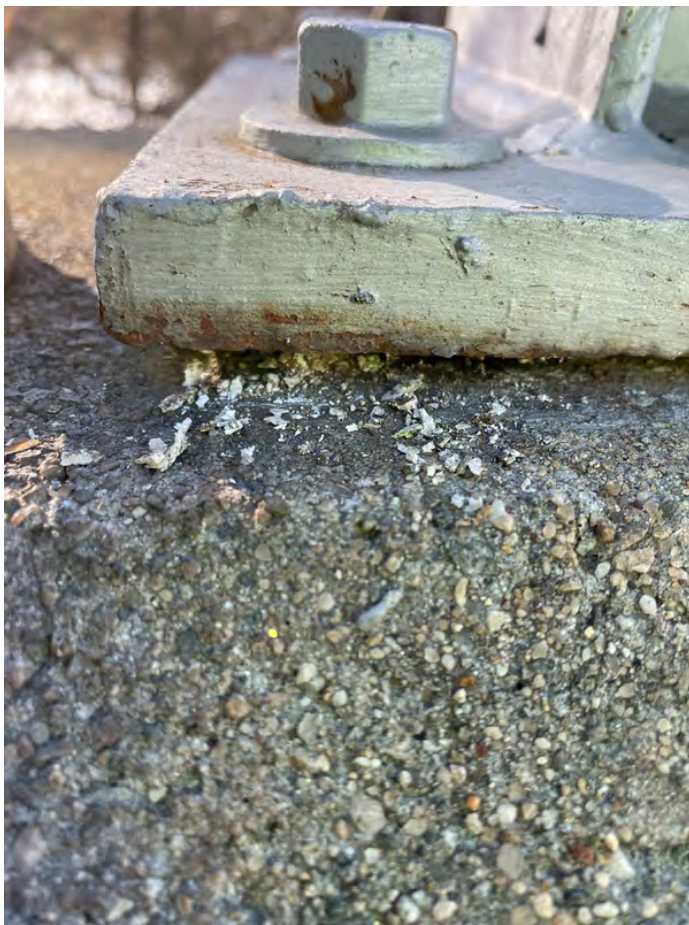
Representative Photos

Materials & Samples - 7. (2) Samples #15–16: C2–Caulking between railing base and concrete abutment wall

Analyze by layer?	No
Is material non-friable organically bound (NOB)?	Yes
Homogeneous Area	
Total Approximate Quantity	
Notes

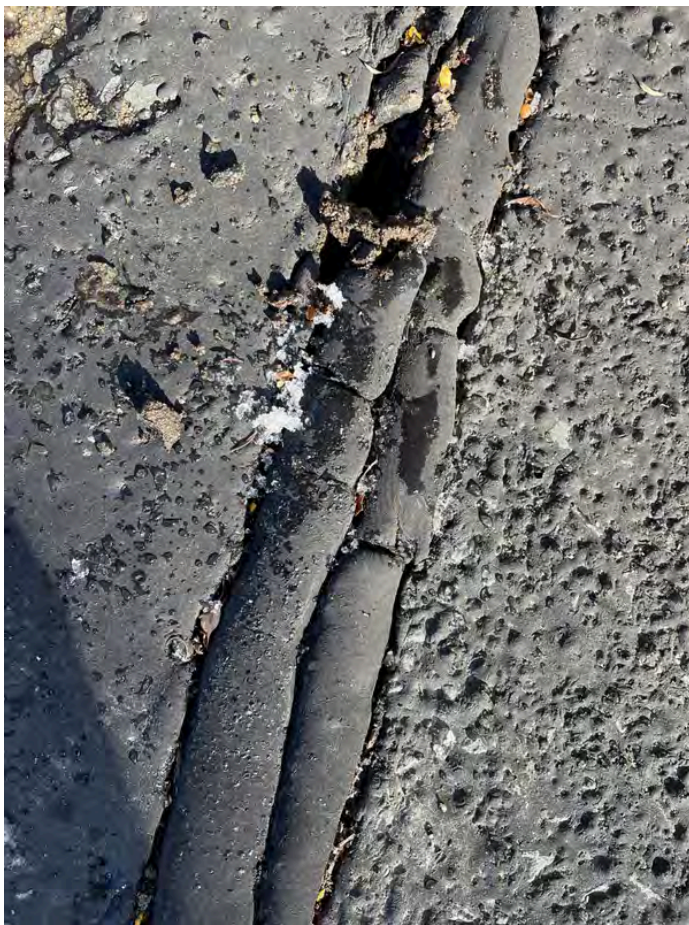
Representative Photos

Materials & Samples - 8. (2) Samples #17–18: EJ3–Black expansion joint tar

Analyze by layer?	No
Is material non-friable organically bound (NOB)?	Yes
Homogeneous Area	
Total Approximate Quantity	300 linear ft
Notes

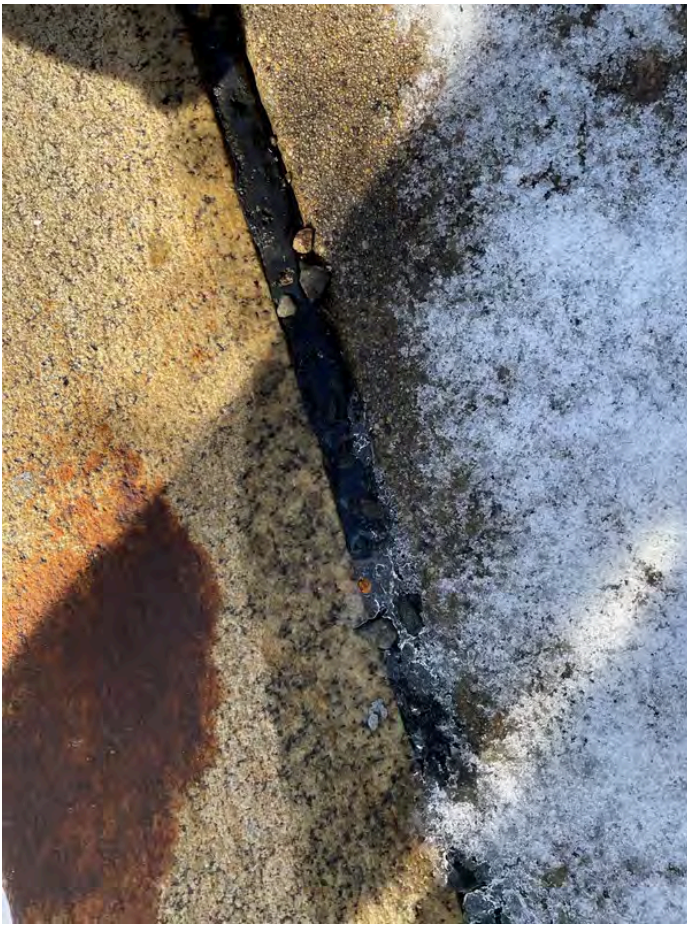
Representative Photos

Materials & Samples - 9. (2) Samples #19–20: EJ4–Expansion joint

Analyze by layer?	No
Is material non-friable organically bound (NOB)?	Yes
Homogeneous Area	
Total Approximate Quantity	
Notes	Entire length of bridge on both sides
