Subject: On-Call Asbestos, Lead, Air Quality & Demolition Compliance  
Agreement No. 10.04-02 (23)  
HazMat Inspection – Replacement of Bridge No. 05068, Wellers Bridge Road over  
Shepaug River, Roxbury, Connecticut  
ConnDOT Assignment No. 524-8482  
ConnDOT Project No. 119-121  
TRC Project No. 501871.8482.0710

TRC performed a limited hazardous materials site investigation associated with the replacement of Bridge No. 05068, Wellers Bridge Road over Shepaug River, Roxbury, CT. Lead paint is presumed present on the structural steel/metal bridge components scheduled for impact at Bridge No. 05068. Any paint waste stream generated from the structural steel/metal bridge components is presumed as CTDEEP/RCRA hazardous waste. The metal railing support and guardrail/guardrail support components were galvanized (unpainted) and the wooden railing components were also unpainted; therefore, no lead paint was identified. All suspect asbestos containing materials (light grey bridge caulk, black speckled expansion joint, tan expansion joint caulk) identified and sampled at Bridge No. 05068 were found to be non-ACM. No bird/pigeon guano accumulations, mice droppings/nests, bloodborne pathogen

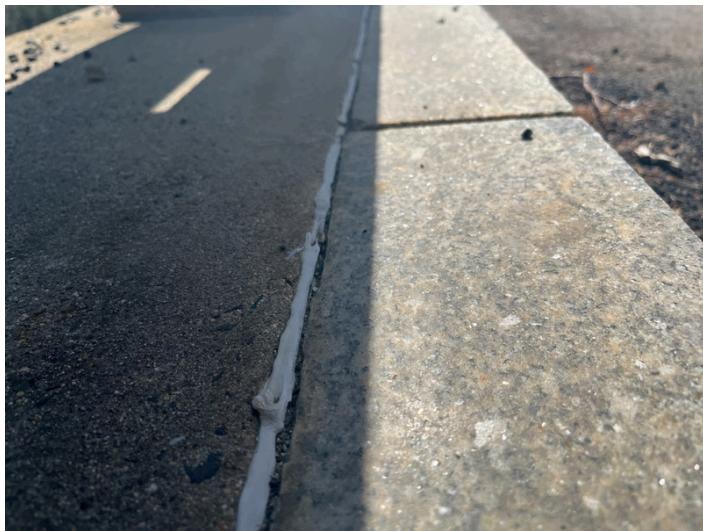
Sampled or Assumed?	Sampled
Material Acronym	C ▶ 1
Material Description	Light grey caulking along bridge
Material Color	Light Grey

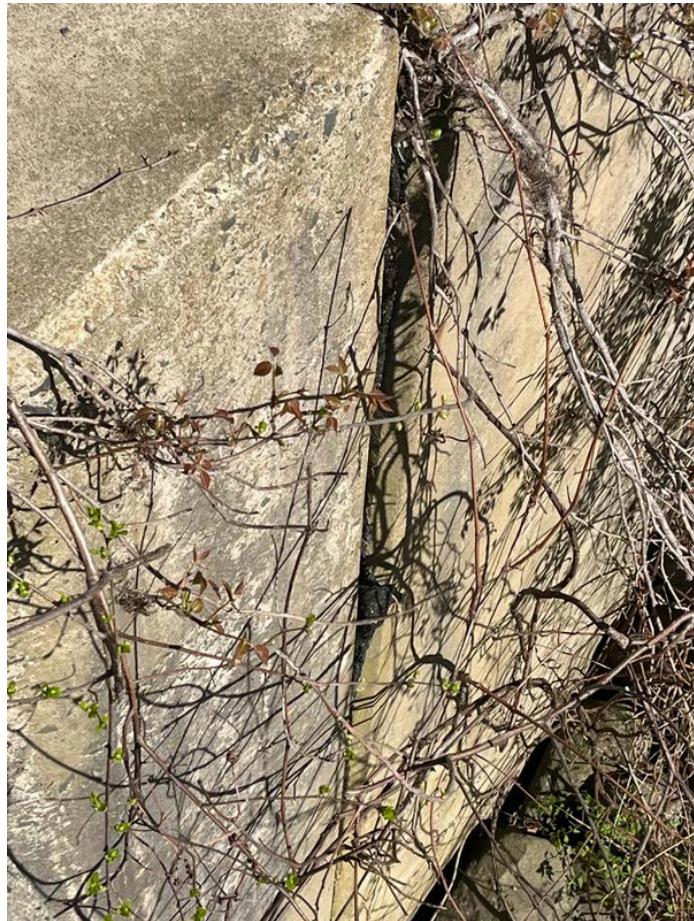
##### Asbestos Samples - 1. Sample #03: EJ1...North Wingwall

Sample Number	03
Sample Location	North Wingwall
Asbestos Bulk Analysis	PLM EPA 600/R93/116
Grab or Composite	Grab
Date	April 29, 2025
Time	09:59

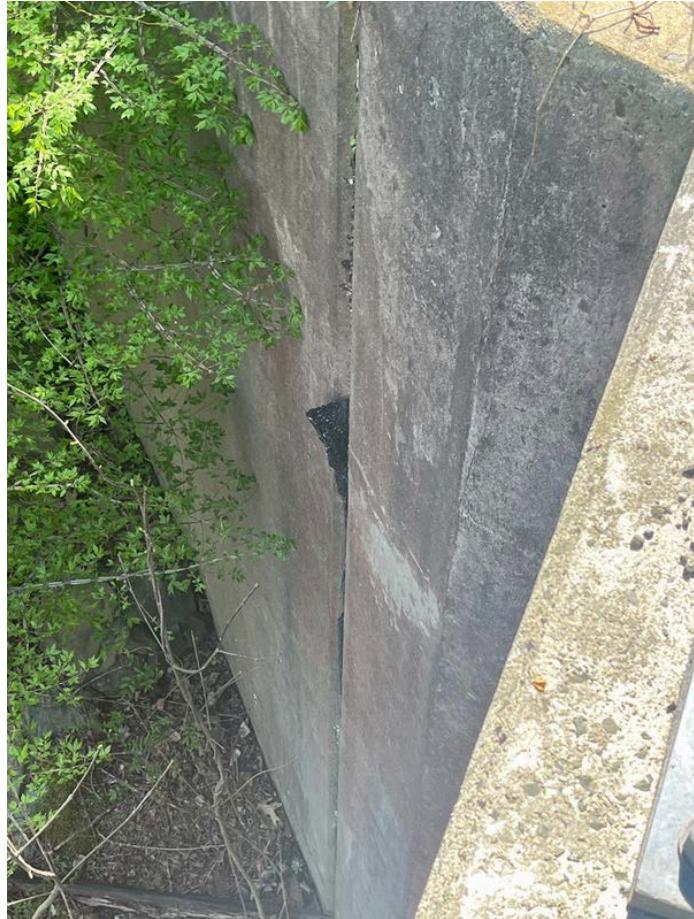
##### Asbestos Samples - 2. Sample #04: EJ1...East Wingwall

Sample Number	04
Sample Location	East Wingwall
Asbestos Bulk Analysis	PLM EPA 600/R93/116
Grab or Composite	Grab
Date	April 29, 2025
Time	09:59

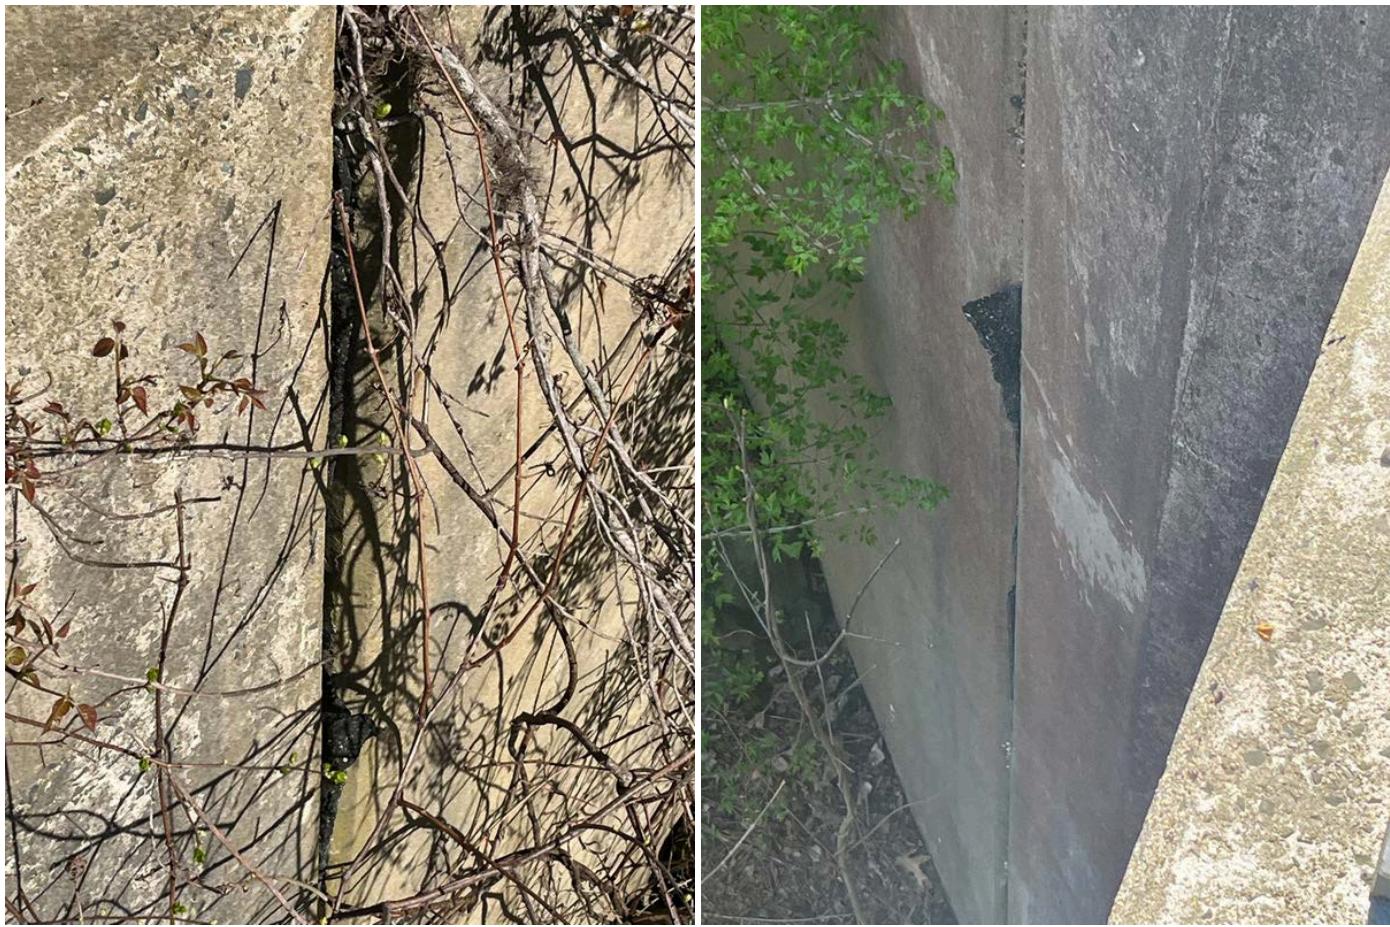
Sampled or Assumed?	Sampled
Material Acronym	EJ1
Material Description	Black speckled expansion joint
Material Color	Black

Total Approximate Quantity 150SF

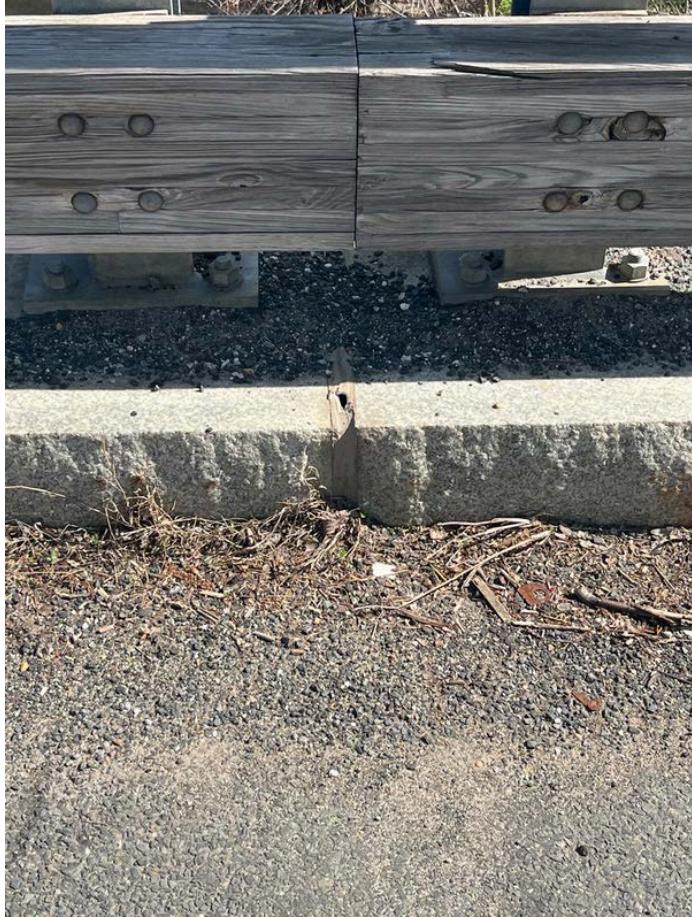
#### Asbestos Samples - 1. Sample #05: EJ2...North east bridge wall

Sample Location North east bridge wall

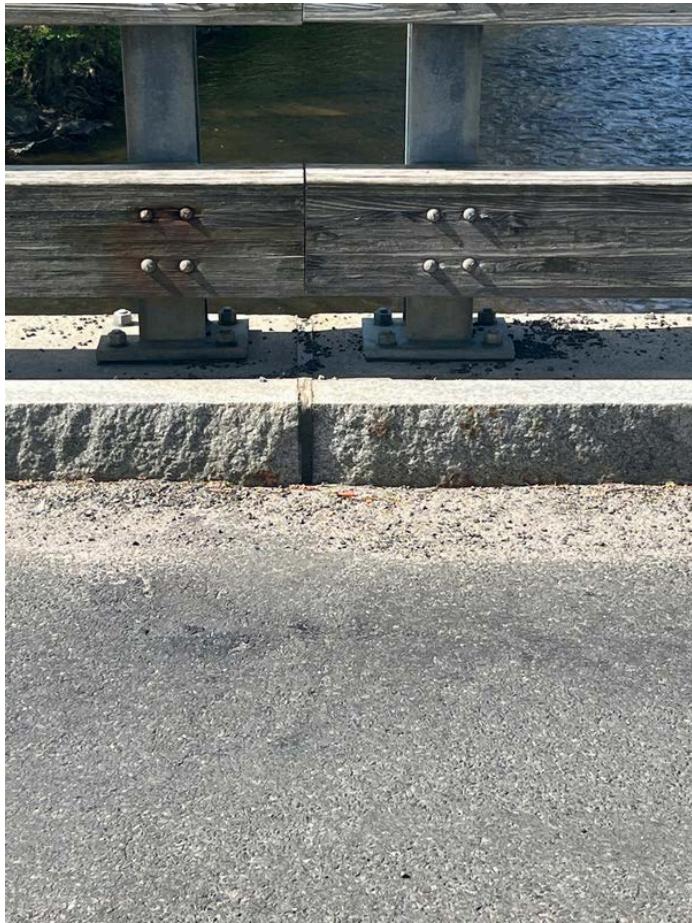
**Asbestos Samples - 2. Sample #06: EJ2...South west bridge wall**

Sample Number	06
Sample Location	South west bridge wall
Asbestos Bulk Analysis	PLM EPA 600/R93/116
Grab or Composite	Grab
Date	April 29, 2025
Time	10:11

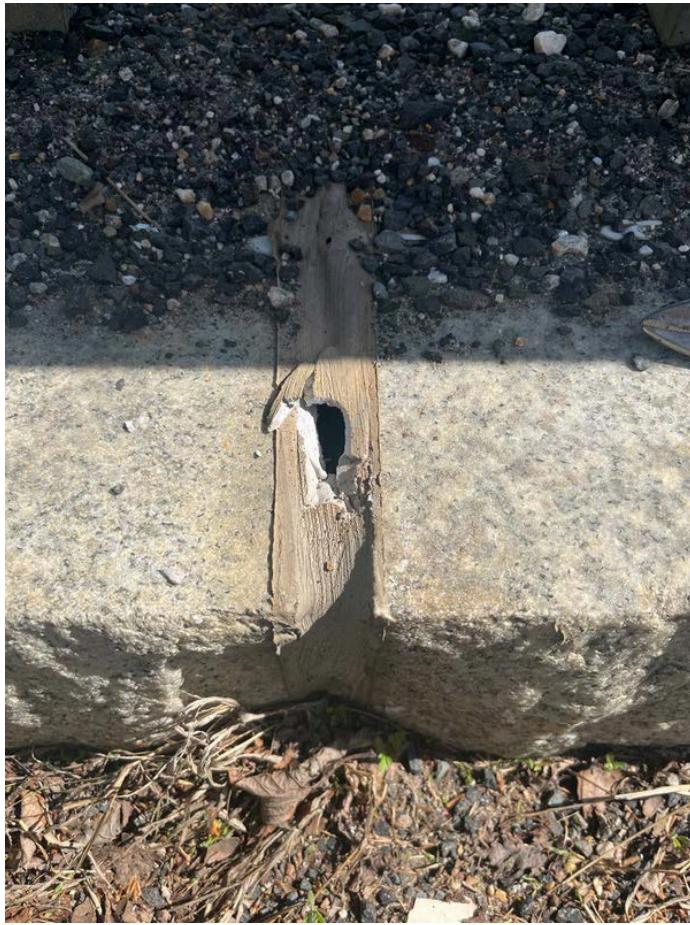
<b>Sampled or Assumed?</b>	Sampled
<b>Material Acronym</b>	EJ2
<b>Material Description</b>	Tan expansion joint
<b>Material Color</b>	Tan

Total Approximate Quantity	30SF
----------------------------	------

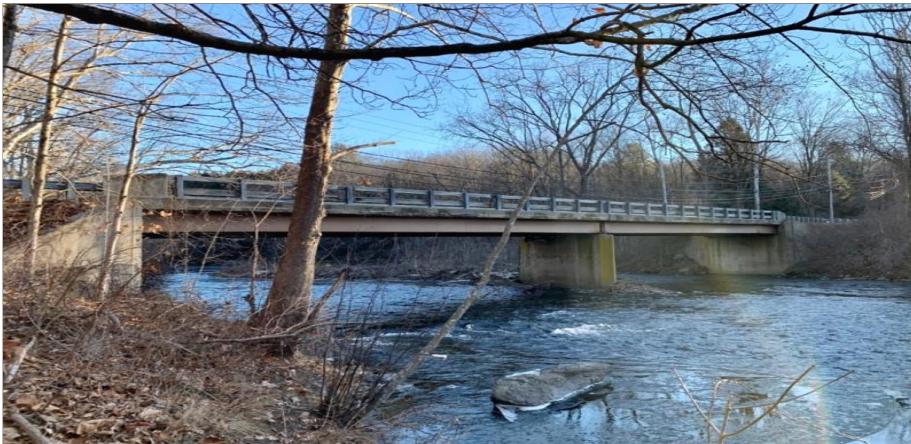
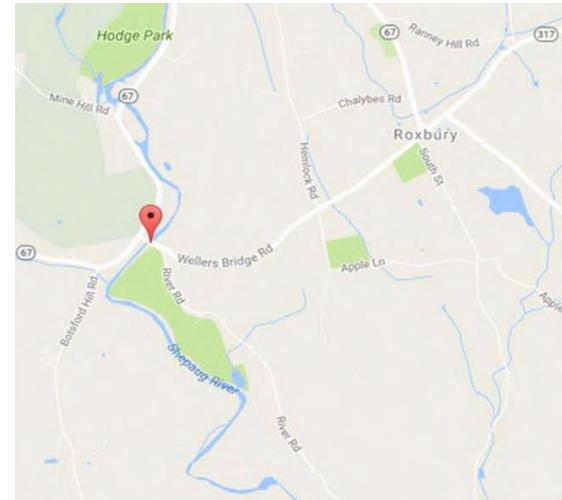
**Proposed Bridge:** Type: Hybrid Steel Metalized Multi-girder with concrete deck on pile supported integral abutments

**Length/Spans:** 177.8' / 1 span      **Width:** 37'
