Subject: On-Call Asbestos, Lead, Air Quality & Demolition Compliance
Agreement No. 10.04-02 (23)
HazMat Inspection – Replacement of Bridge No. 03474, Route 200 over Interstate 395,
Thompson, CT
ConnDOT Assignment No. 524-8423
ConnDOT Project No. 141-158
TRC Project No. 501871.8423.0710

TRC performed a limited hazardous materials site investigation associated with the replacement of Bridge No. 03474, Route 200 over Interstate 395, Thompson, CT. Results of the survey identified lead paint on the metal railings/railing support components (on both sides) and the structural steel/metal bridge components (on underside) at Bridge No. 03474. Results obtained from TCLP waste stream sampling and analysis for leachable lead from the paint on the railings/railing support components and structural steel/ metal bridge components characterized the paint waste streams at Bridge No. 03474 as **CTDEEP/RCRA hazardous waste**. All suspect asbestos-containing materials (various caulks, black asphaltic plug joint, black tar joint/curb filler, and tan bearing rope gasket) identified and sampled at Bridge No. 03474 were determined to be non-asbestos containing materials. No bird/pigeon guano, mice droppi

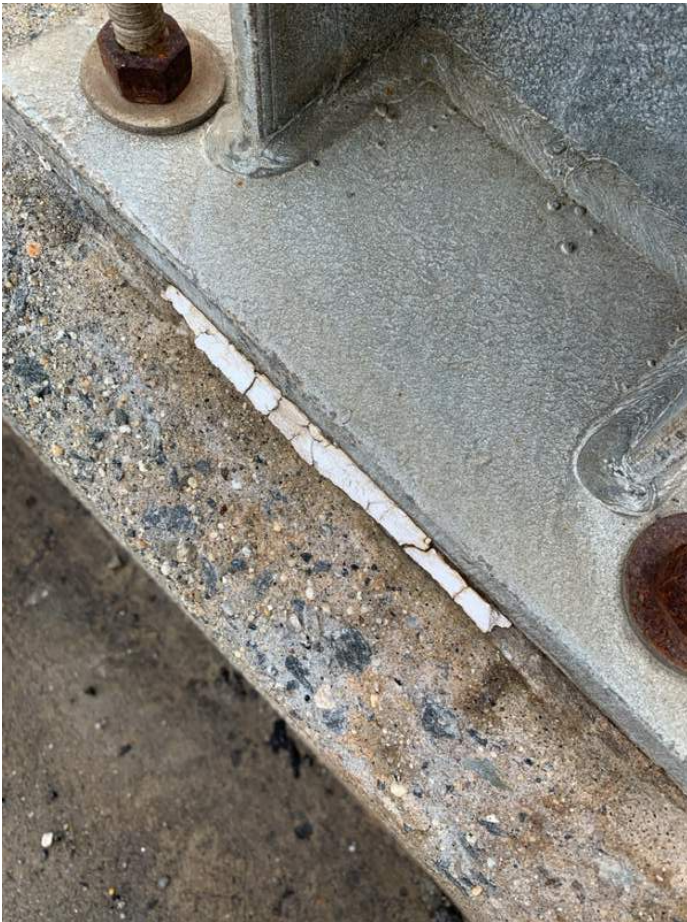
Materials & Samples - 1. (2) Samples #1-2: C1-White caulk on south side bridge railings

Sampled or Assumed?	Sampled
Material Acronym	C ▶ 1
Material Description	White caulk on south side bridge railings
Material Color	White

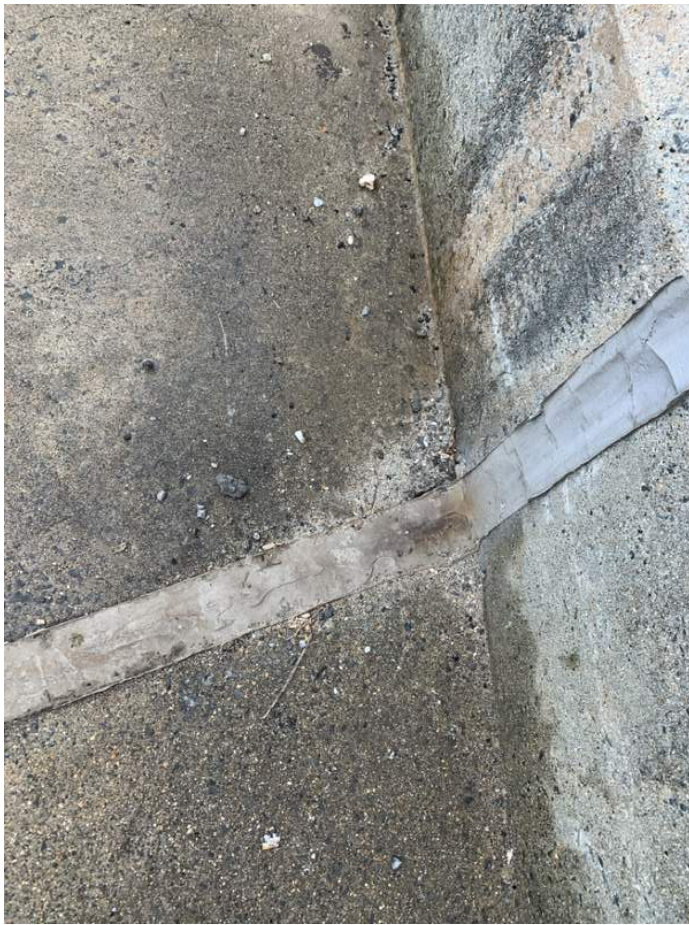
Materials & Samples - 2. (2) Samples #3-4: C2-Grey caulk in bridge joints

Sampled or Assumed?	Sampled
Material Acronym	C ▶ 2
Material Description	Grey caulk in bridge joints
Material Color	Grey

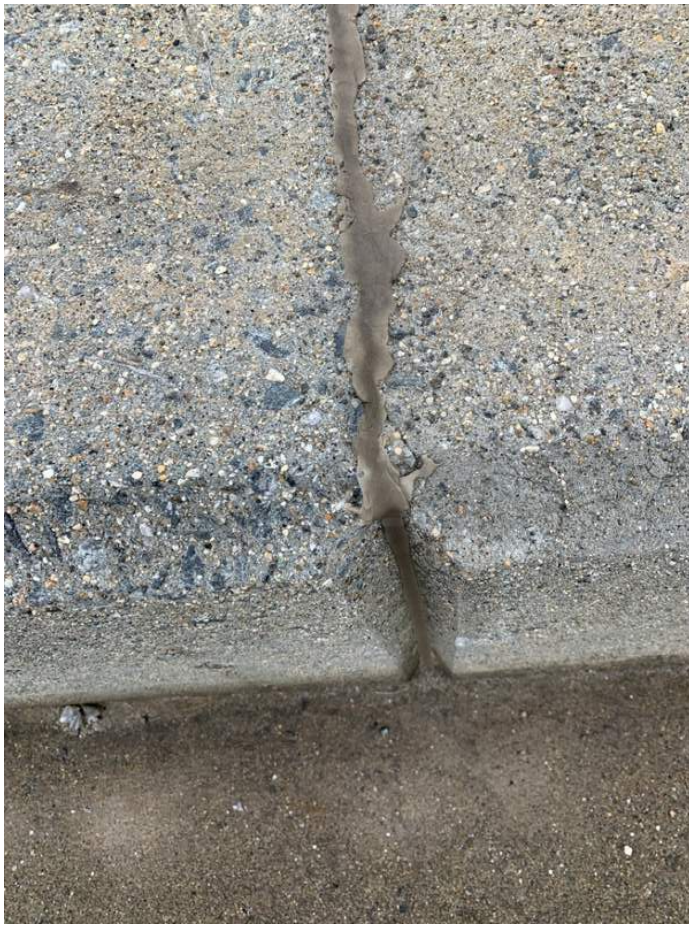
Materials & Samples - 3. (2) Samples #5-6: C3-Grey caulk in bridge seams

Analyze by layer?	No
Is material non-friable organically bound (NOB)?	Yes
Homogeneous Area	
Total Approximate Quantity	200 LF
Notes
