**AYER**

**Contract No. 27DPW01**

**Bridge No. A-19-011 (25M), Barnum Road Bridge Rehabilitation**

Addendum No. 1, July 29, 2026

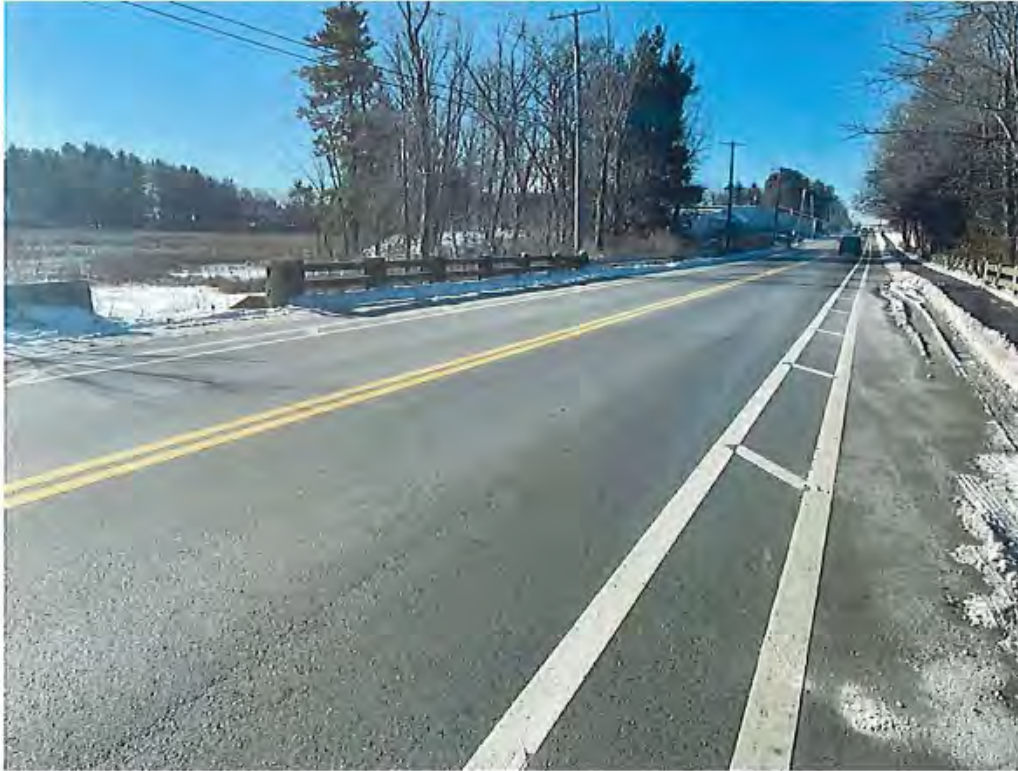
The wearing surface and approaches have been repaved since the previous inspection. Curb reveal could not be verified due to heavy build up of snow and ice. **See photo 1.** Item 58.4 comments were retained in Italics.

**Photo 1: View of the wearing surface and approach pavement.**

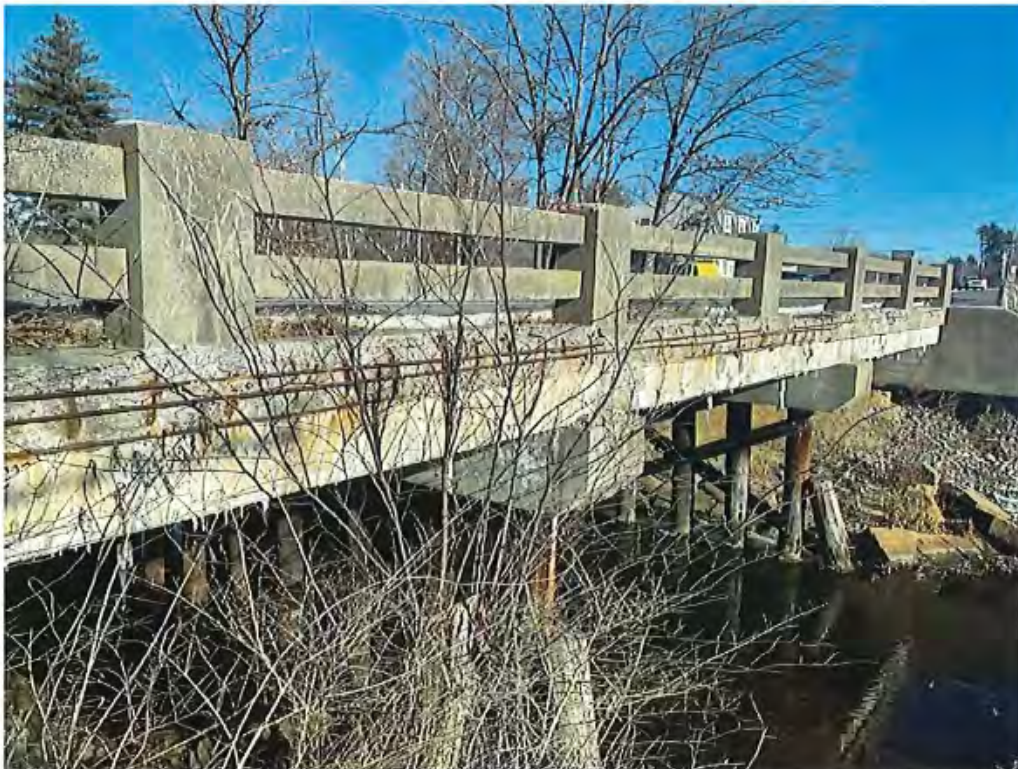
South fascia has minor hairline cracking with efflorescence, several minor delaminations, and efflorescence from the rail base interface. **See photo 2.**

South rail base south face has a full height (~12") x near full length (~60') x up to 4" deep spall/delamination with exposed rebar. **See photo 2.**

**Photo 2: South fascia and railing base deterioration.**

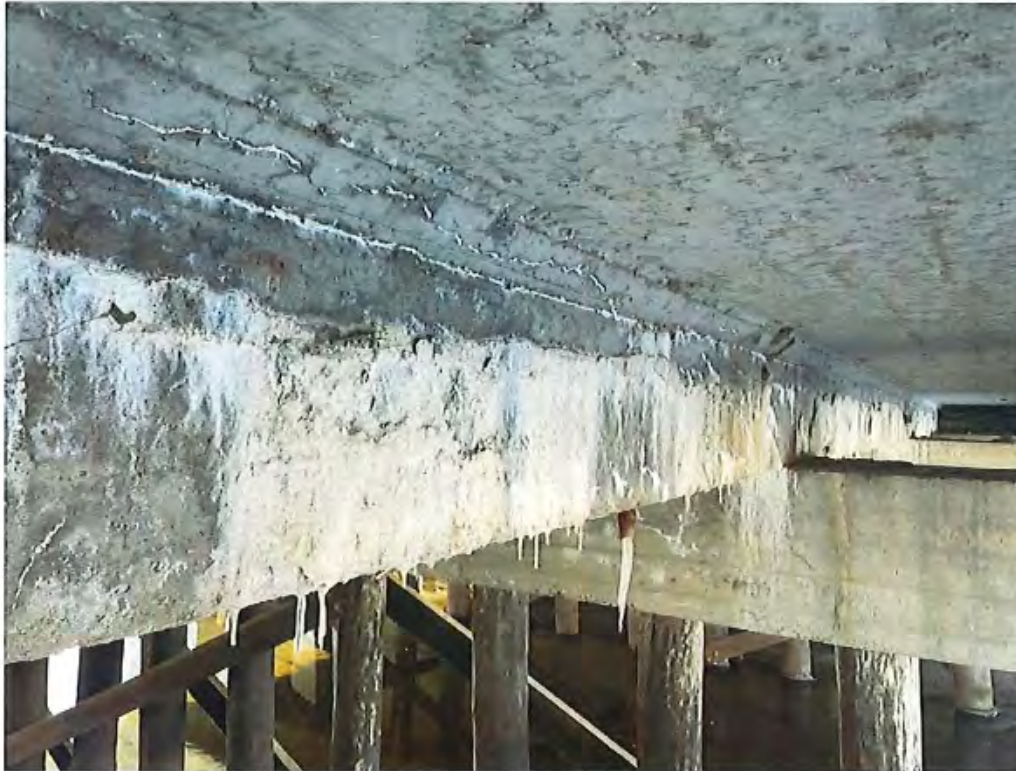
North fascia at sidewalk slab interface has intermittent minor horizontal cracking with heavy efflorescence. **See photo 3.**

**Photo 3: North deck fascia in span 3.**

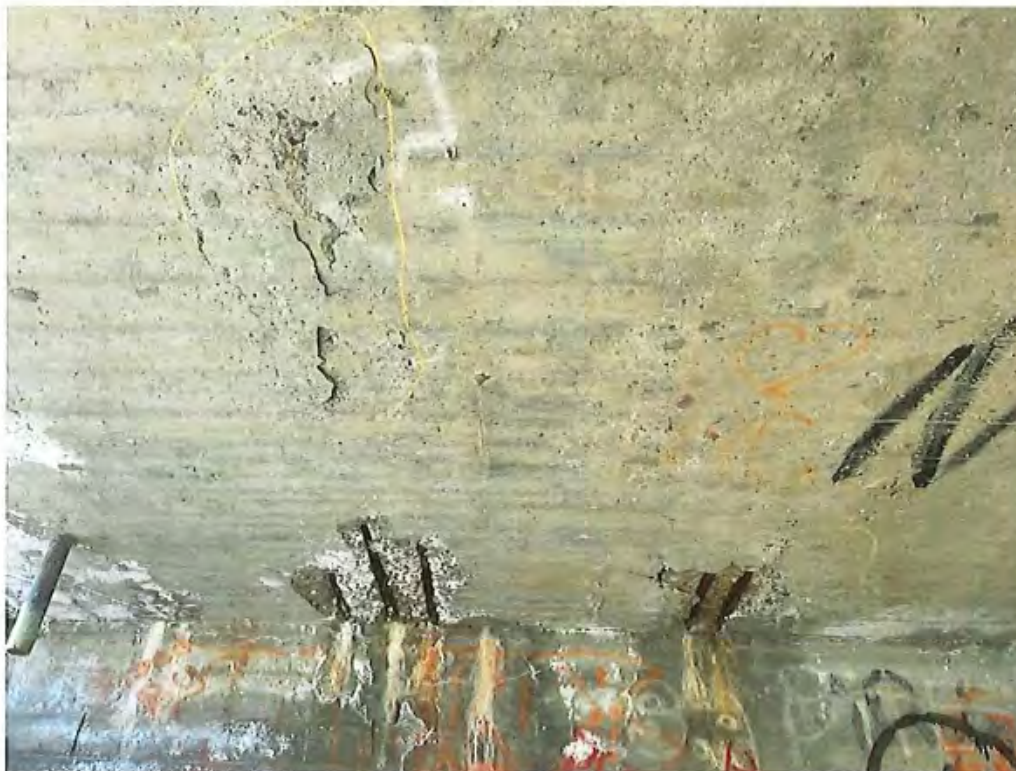
Southwest corner has two spalls with exposed rebar up to 2' Ø x 1.5" deep and an adjacent 2' Ø delamination. **See photo 4.**

**Photo 4: Span 1 spalls and delamination at the southwest corner.**

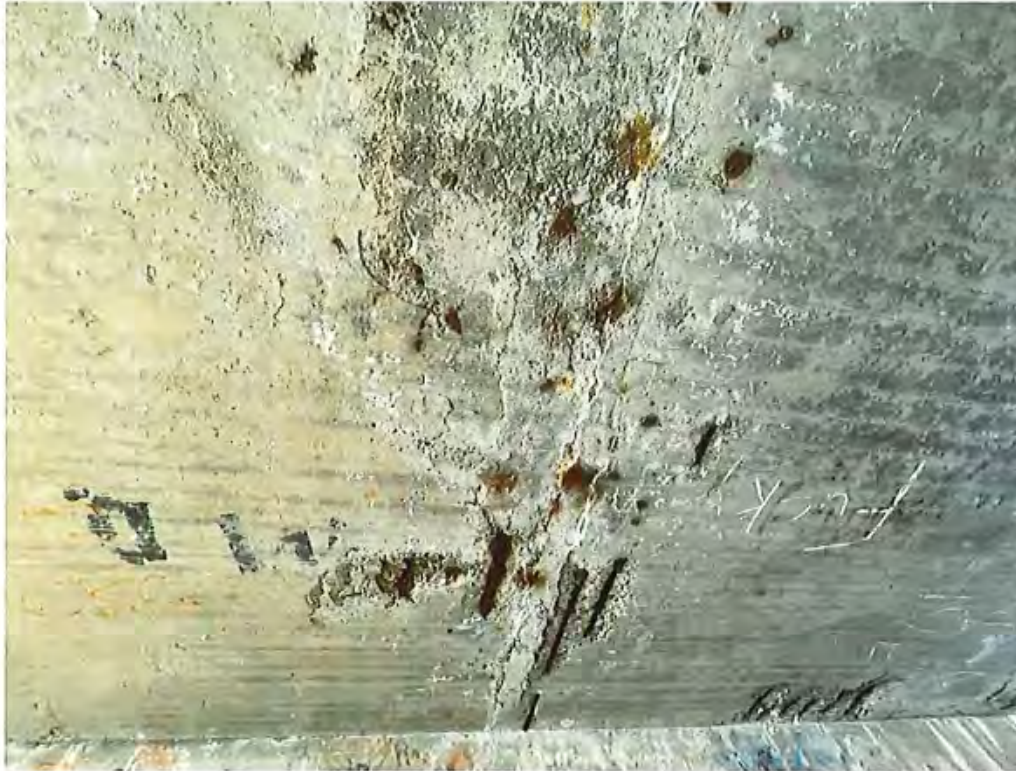
Center longitudinal construction joint has a 20' long (full span) x up to 4' wide x up to 1.5" deep delamination/spall with exposed rebar and rust/efflorescence. **See photo 5.**

**Photo 5: Span 1 deterioration at the center construction joint.**

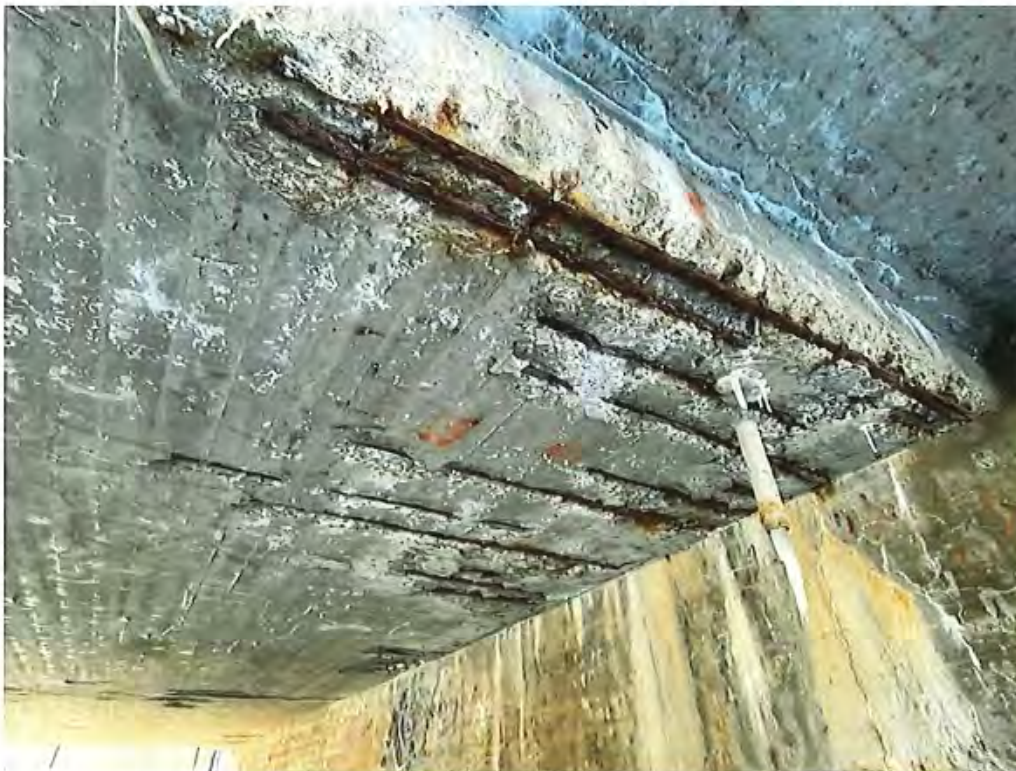
Northwest corner has an 8' long x 10' wide x up to 2.5" deep spall with exposed rebar. **See photo 6.**

**Photo 6: Span 1 deterioration at the northwest corner.**

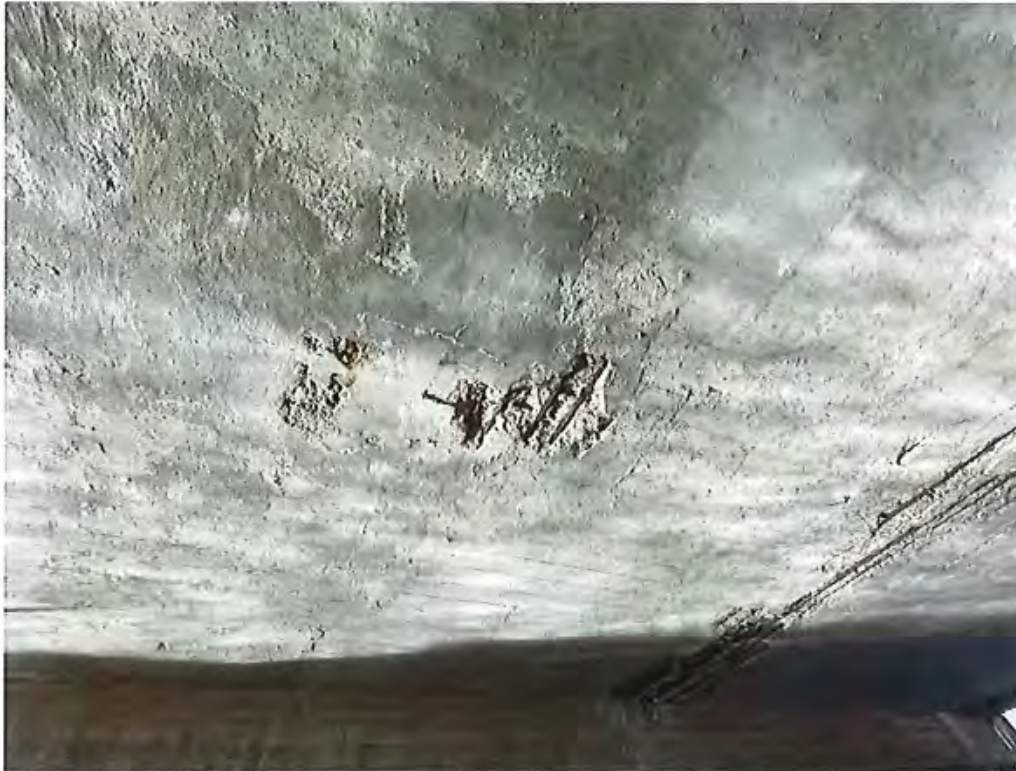
South half center has a 3' Ø x up to 4" deep spall with exposed rebar. **See photo 7.**

**Photo 7: Span 2 deterioration to the south half at center.**

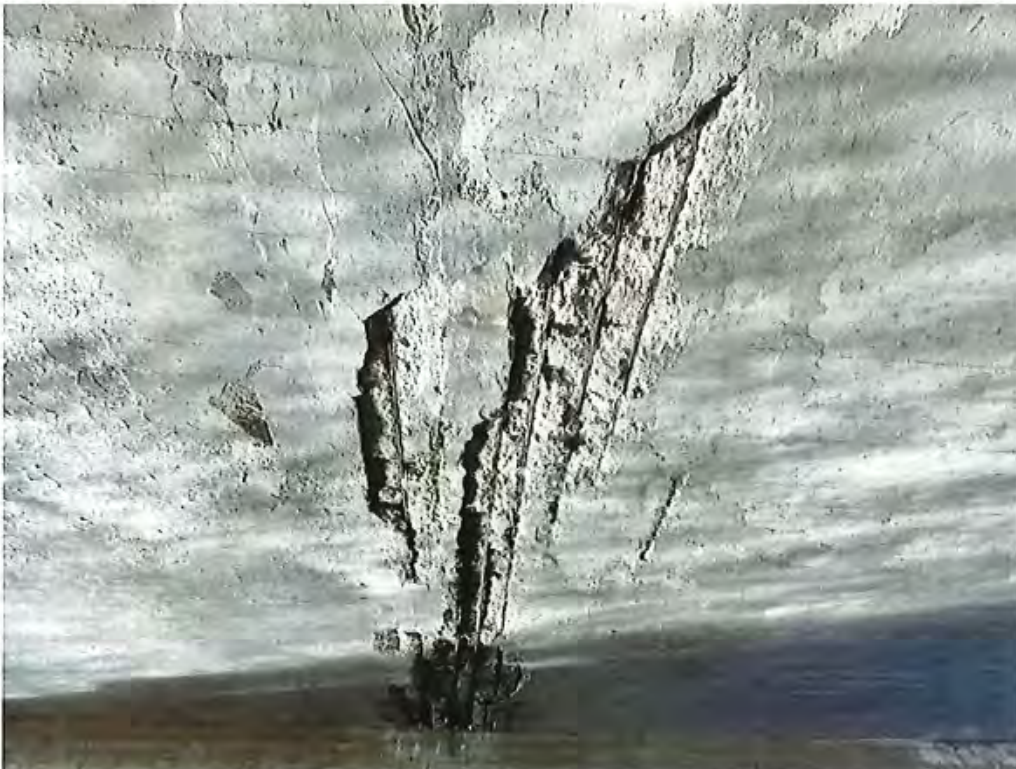
Center longitudinal construction joint has a 17' x up to 5' wide x up to 3" deep delamination/spall with exposed rebar. **See photo 8.**

**Photo 8: Span 2 deterioration at the center construction joint.**

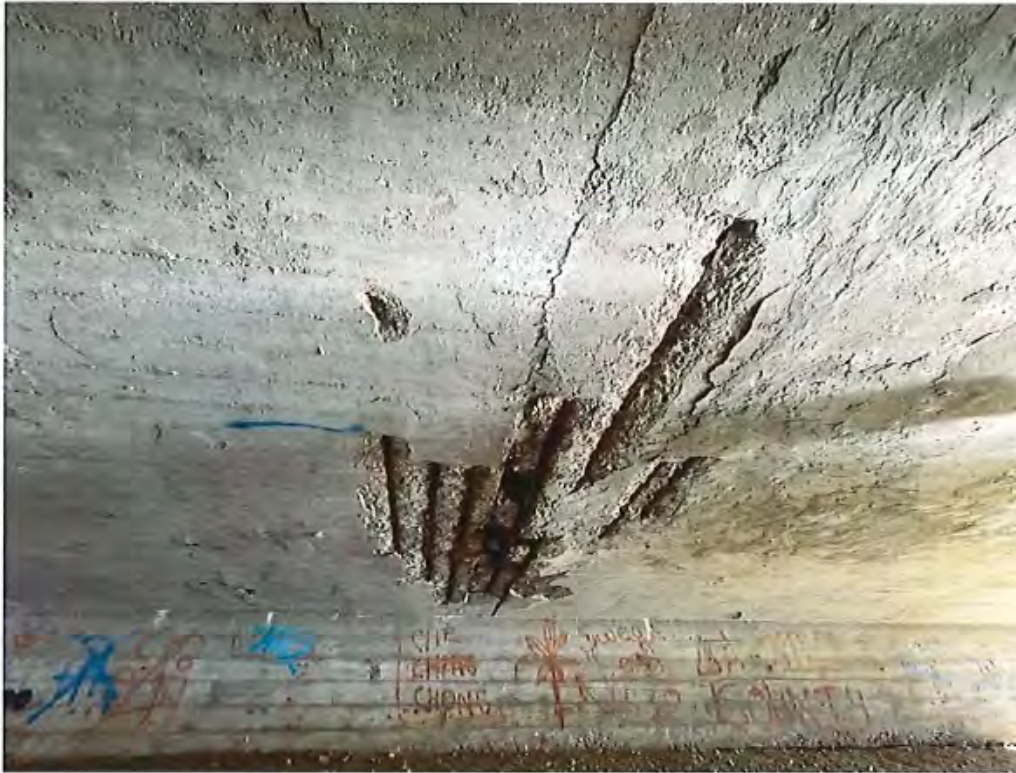
Center longitudinal construction joint has a 12' long x up to 5' wide x up to 4.5" deep delamination/spall with exposed rebar. **See photo 9.**

Photo 9: Span 3 deterioration at the center construction joint.

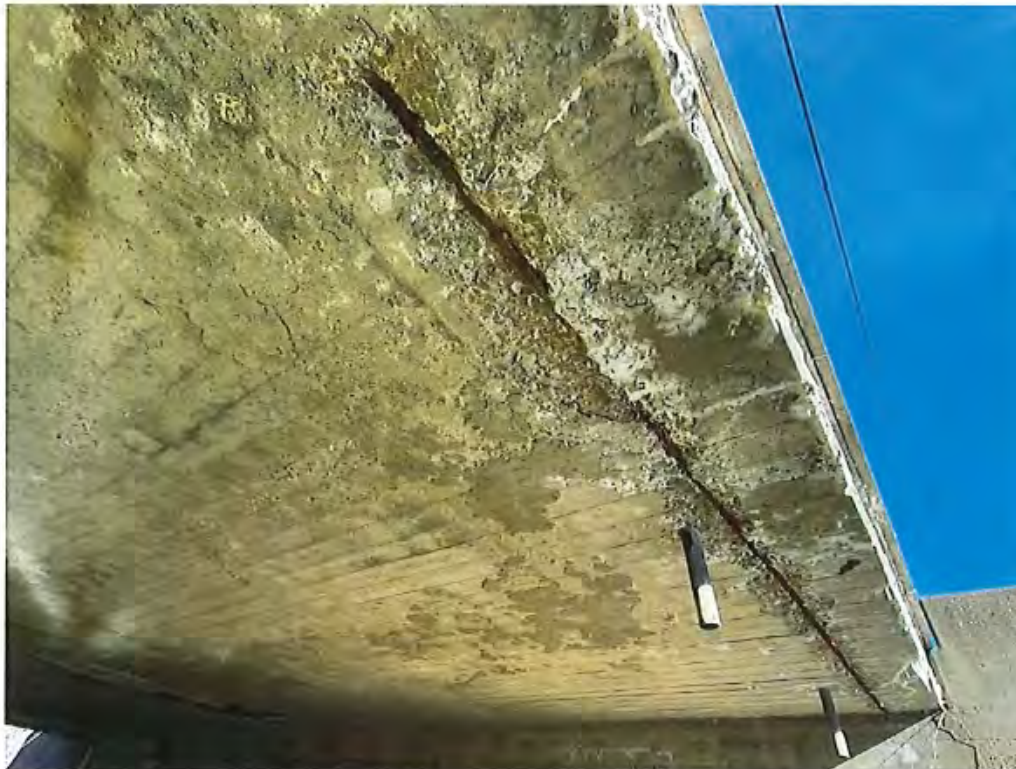
South end has a 13.5' long x up to 1' wide x 1" deep spall with exposed rebar. **See photo 10.**

Photo 10: Span 3 deterioration at the south end.

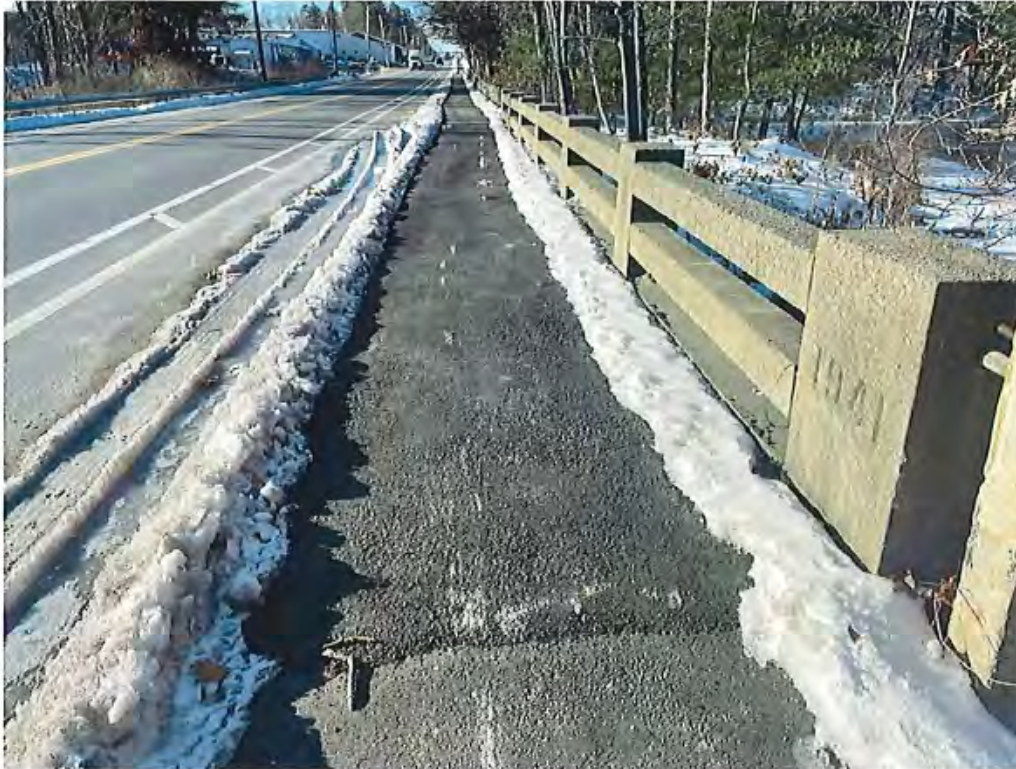
**Photo 11: New north sidewalk pavement.**

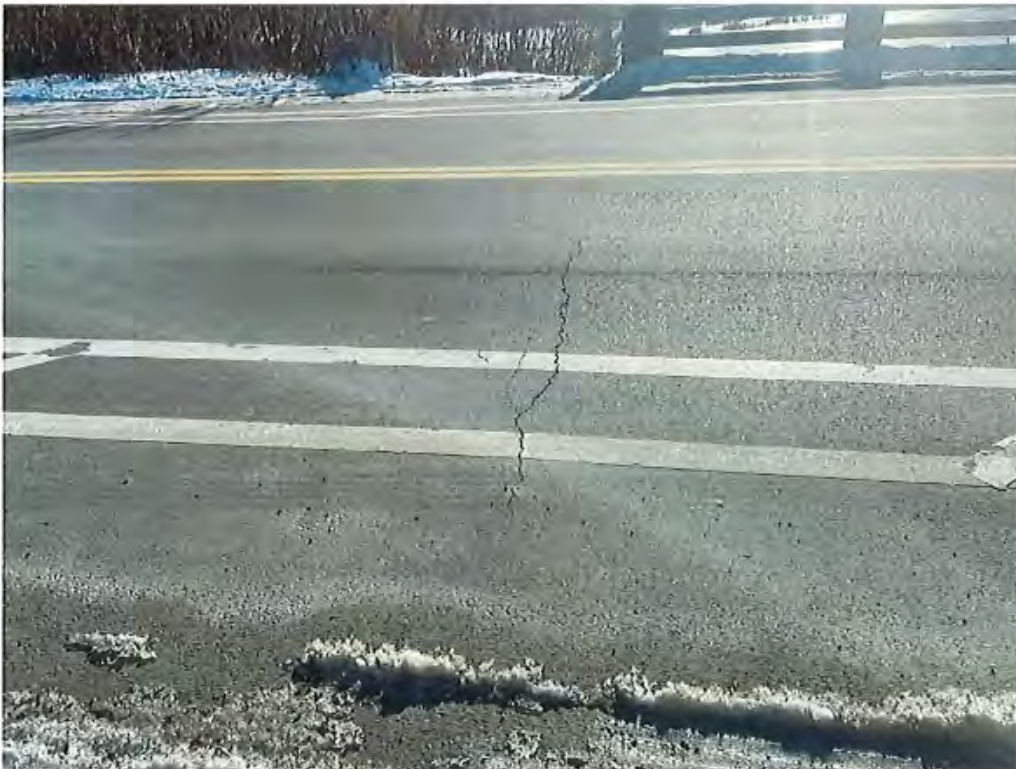
The east approach has minor transverse cracking at the transition area in the westbound lane. **See photo 12.**

**Photo 12: Transverse cracking in the westbound lane at the east deck transition.**

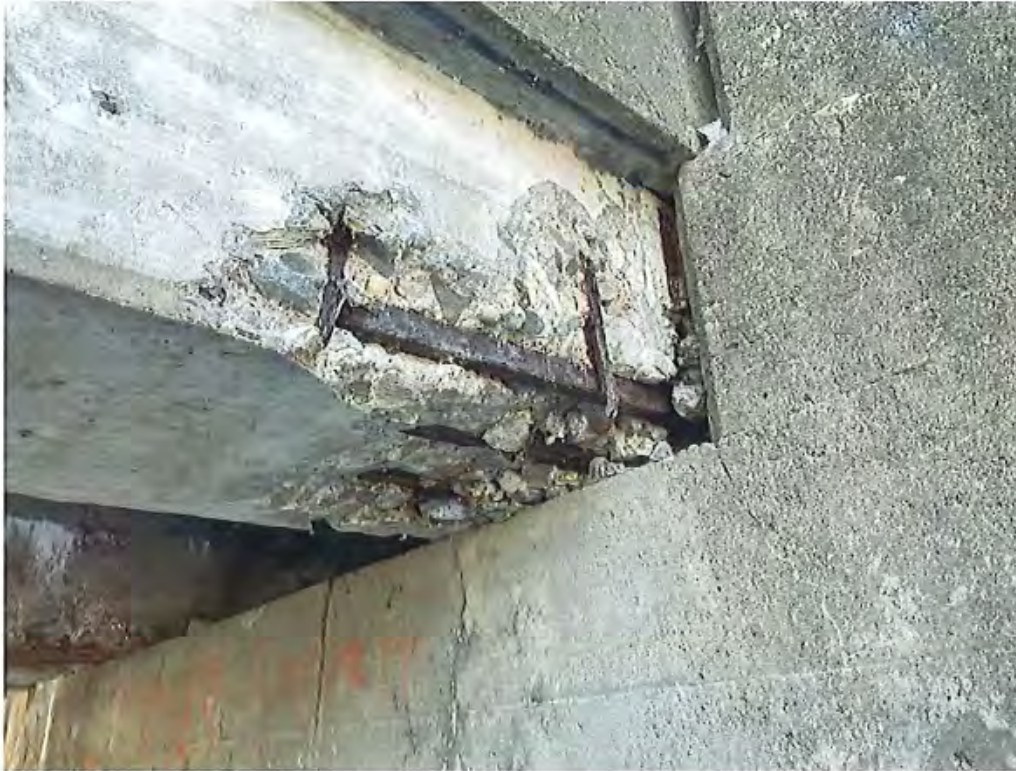
Span 1 west end bottom has a 2' long x 14" wide x 2" deep spall that extends 8" up the north face with exposed rebar and several stirrups with 100% section loss. **See photo 13.**

**Photo 13: North sidewalk beam deterioration at the west end in span 1.**

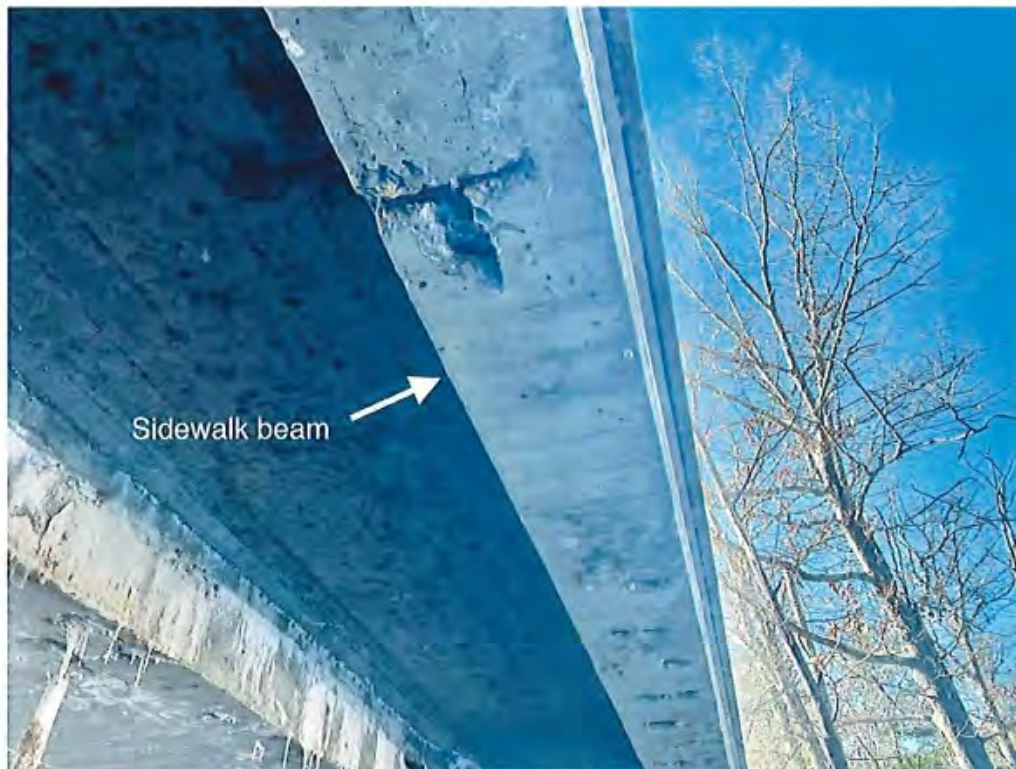
Span 2 & 3 bottoms have many near-full width shallow delaminations and spalls with exposed stirrups. **See photos 14 and 15.** Span 2 north face has one full height shallow spall.

**Photo 14: Span 2 sidewalk beam deterioration.**

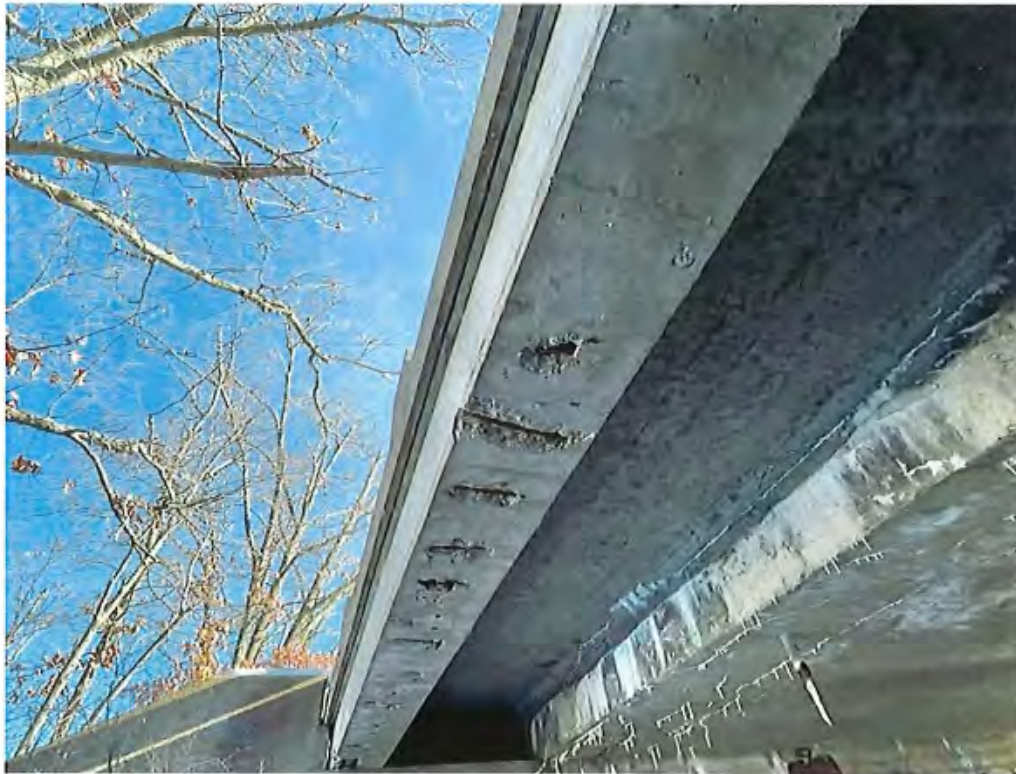
**Photo 15: Span 3 sidewalk beam deterioration.**

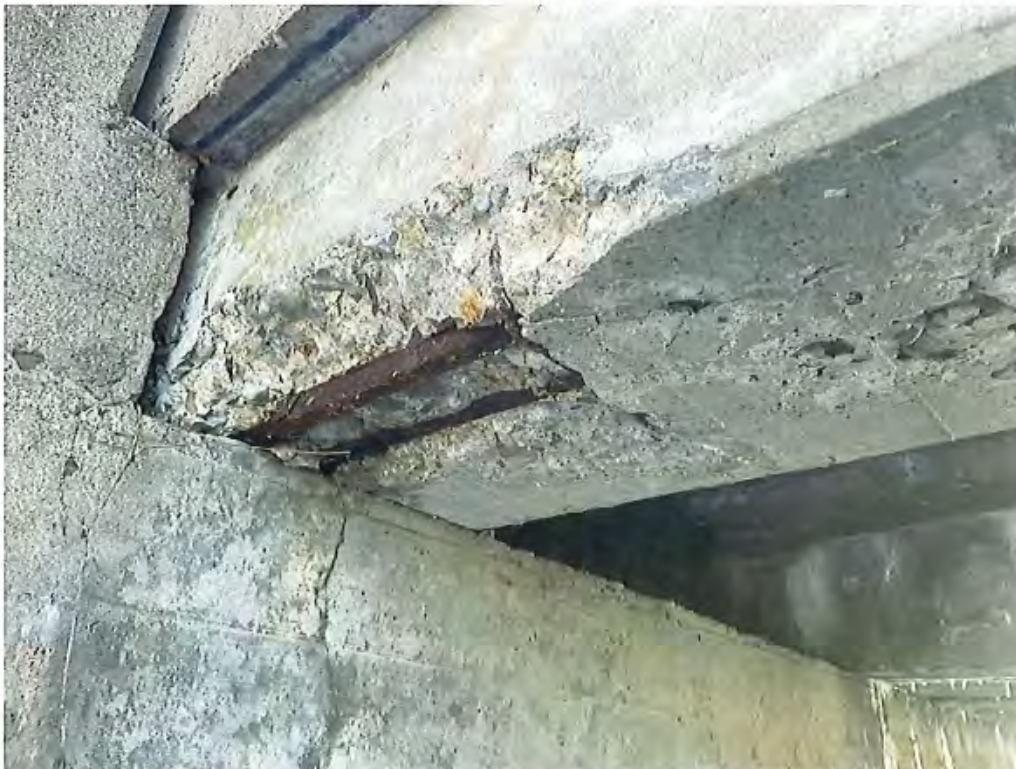
Span 3 east end bottom has a 15" long x 14" wide x up to 3" deep spall that extends 4" up the north face with exposed rebar. **See photo 16.**

**Photo 16: Span 3 sidewalk beam deterioration at the east end.**

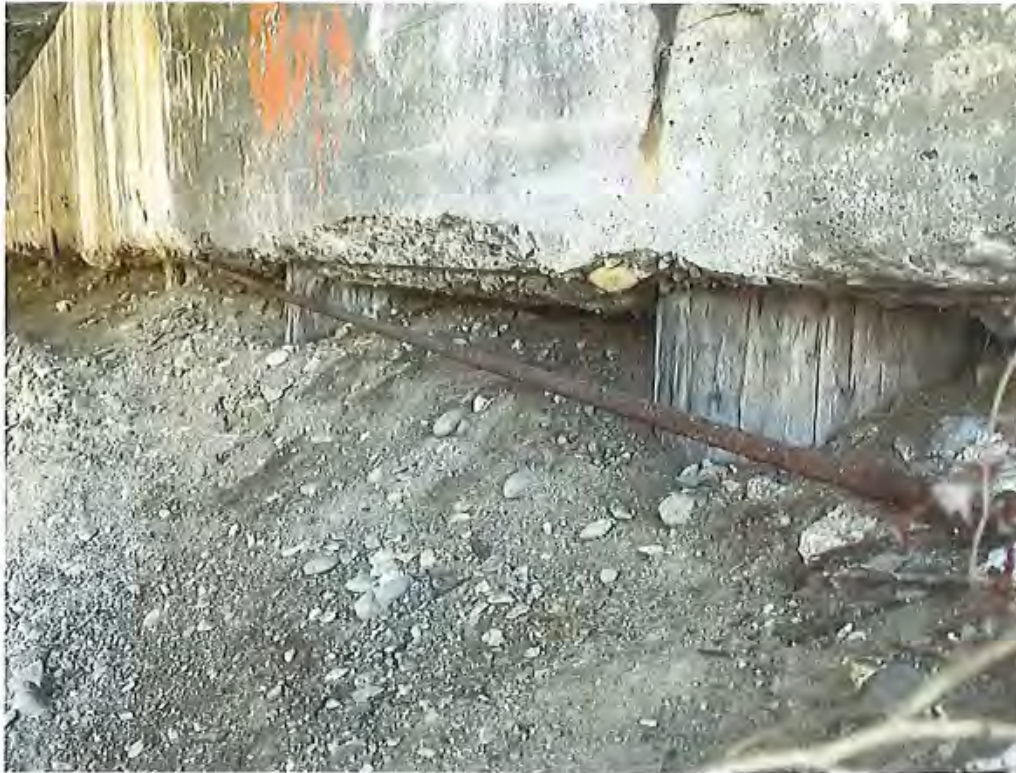
North half bottom corner has a 25' long x up to 6" high x 3" deep spall with exposed/debonded rebar. **See photo 17.**

**Photo 17:** West abutment bent deterioration. Note the embankment erosion exposing the piles.

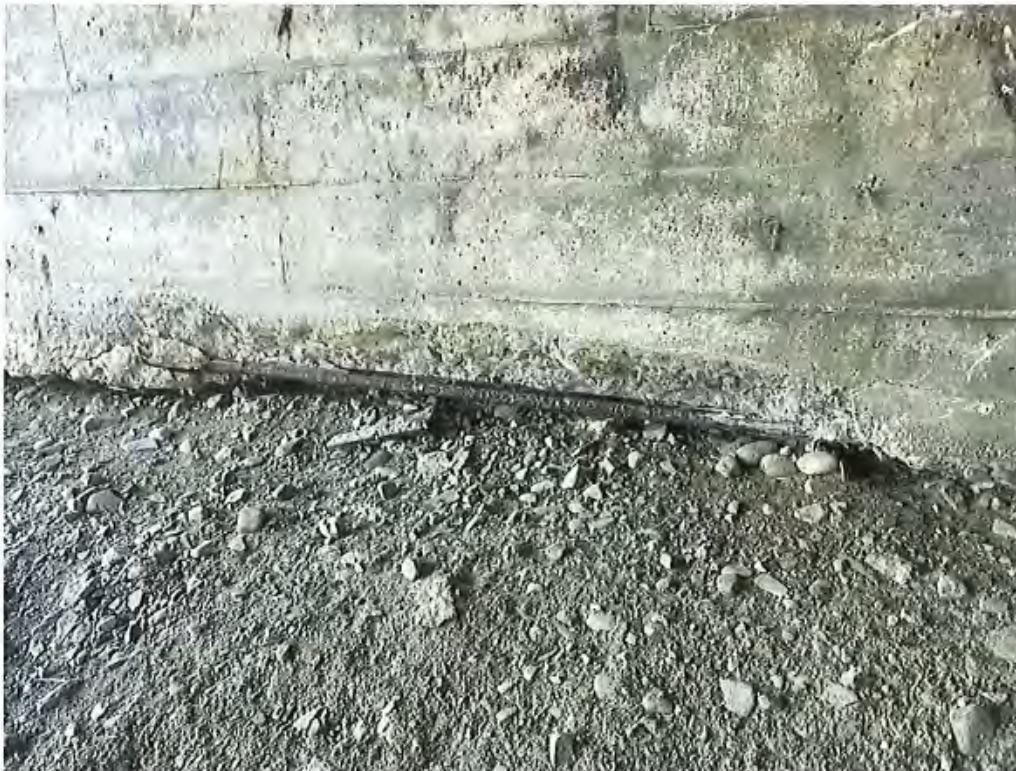
Bottom corner under sidewalk has a 5' long x 6" high x 3" deep spall with exposed rebar. **See photo 18.**

**Photo 18:** East abutment bent deterioration under the north sidewalk.

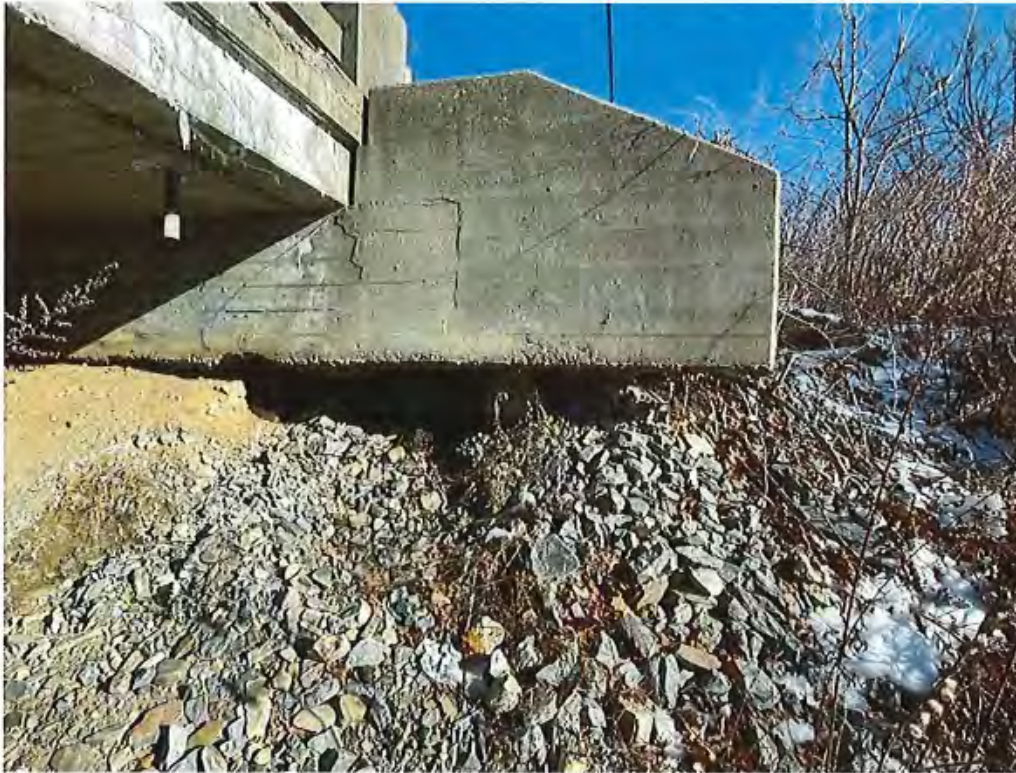
Response 2: The southeast corner has erosion. There is currently a minimum of 3' clearance from the underside of the slab to grade. Attached are also the existing plans and the latest inspection report.

**Photo 19: Embankment erosion at the southeast wingwall.**

Repair to existing bridge deck slab, sidewalk beam and sidewalk slab to an existing bridge along Barnum Road over Bowers Brook. The project will also stabilize to permanently improve observed erosion at the southeast corner of bridge. The proposed work is minor in nature and is therefore exempt from Riverfront Area requirements as stated in the WPA.

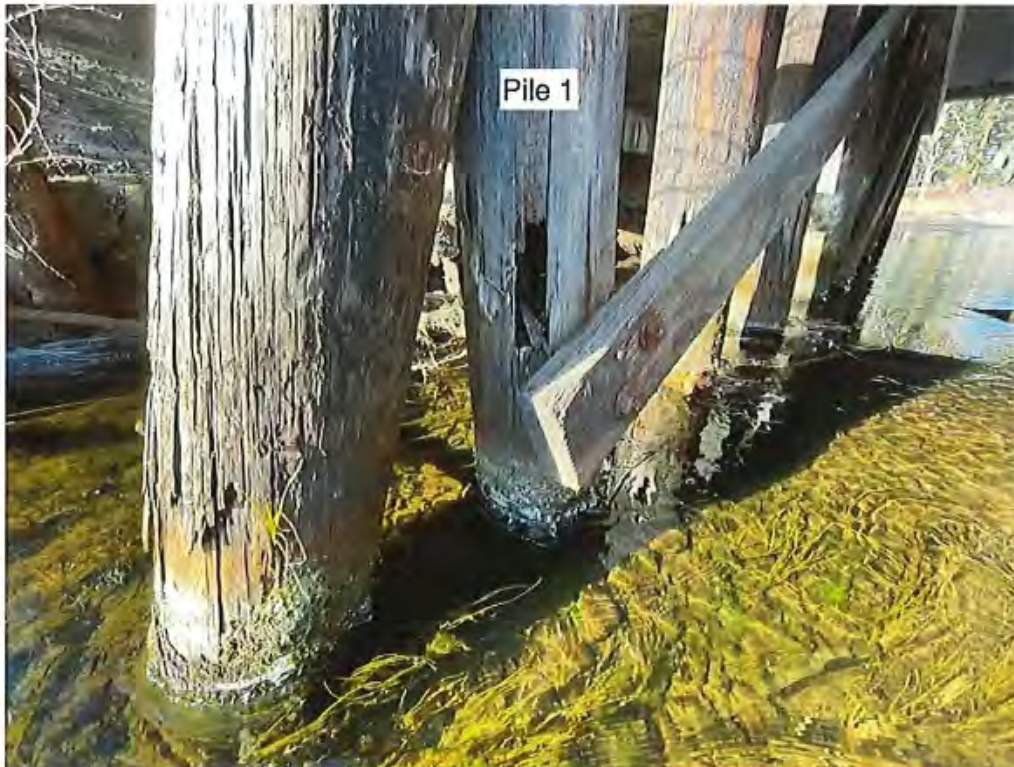
**Photo 20: Bent 2 pile 1 deterioration.**

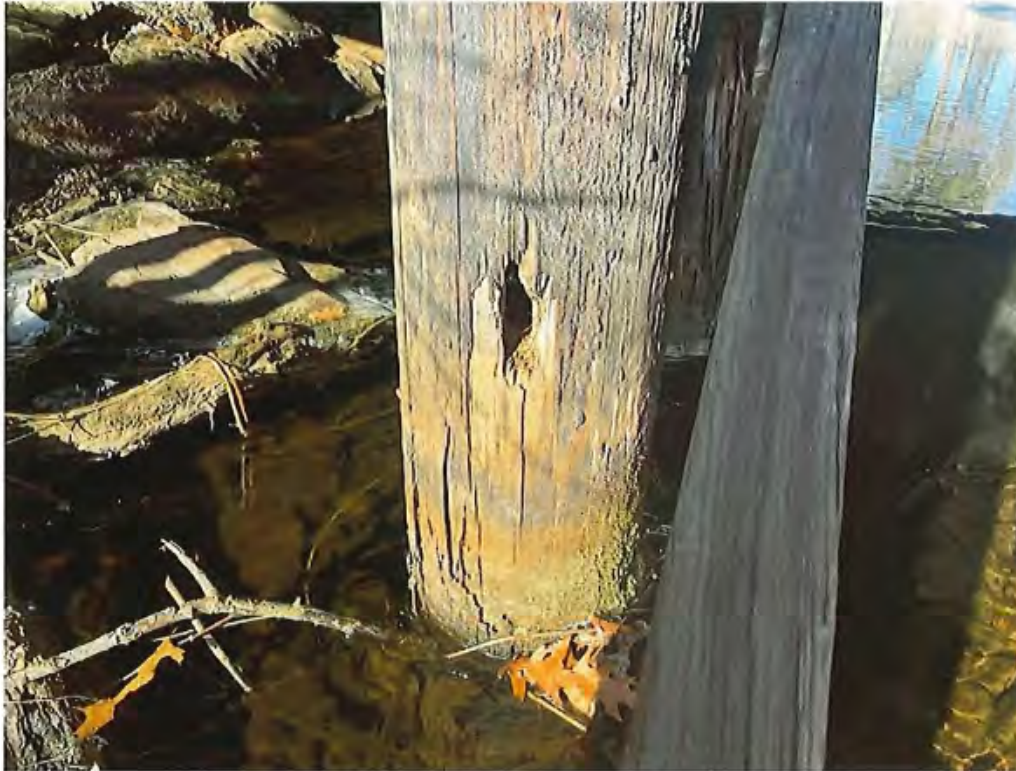
**Photo 21: Bent 2 pile 2 deterioration.**

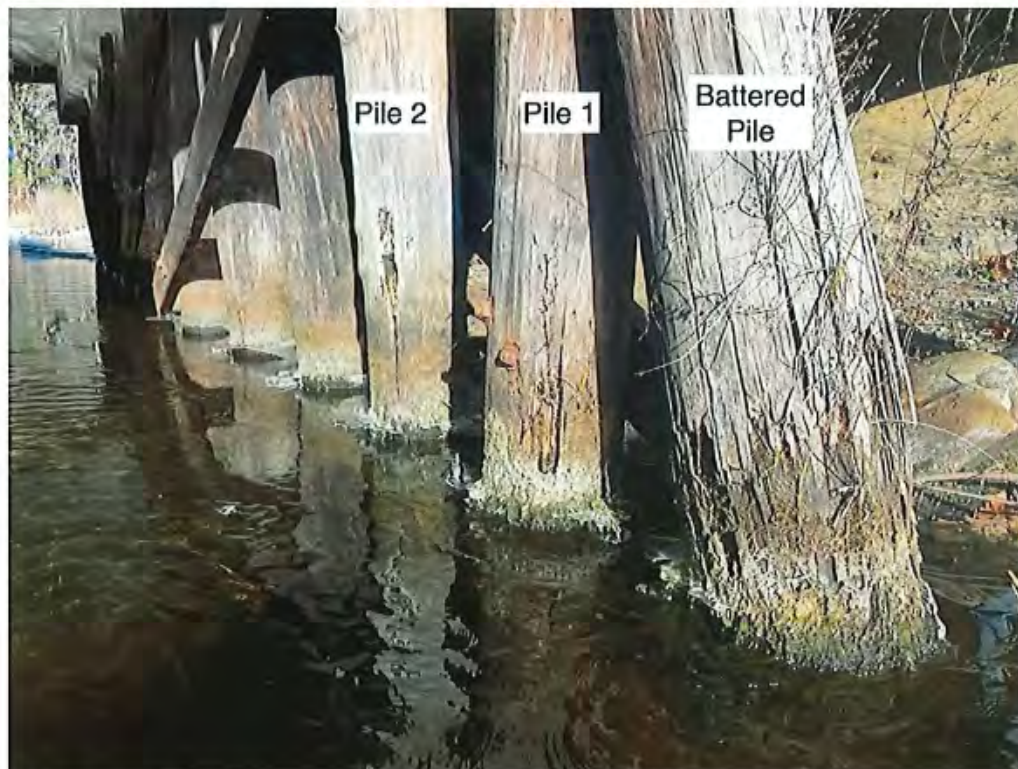
Piles 1, 2, 4, 7, 11 & 14 have minor decay 1' high with up to 1.5" penetration at waterline. **See photo 22.**

All batter piles have heavy decay at and above waterline. **See photo 22.**

**Photo 22: Bent 3 pile deterioration at the waterline.**

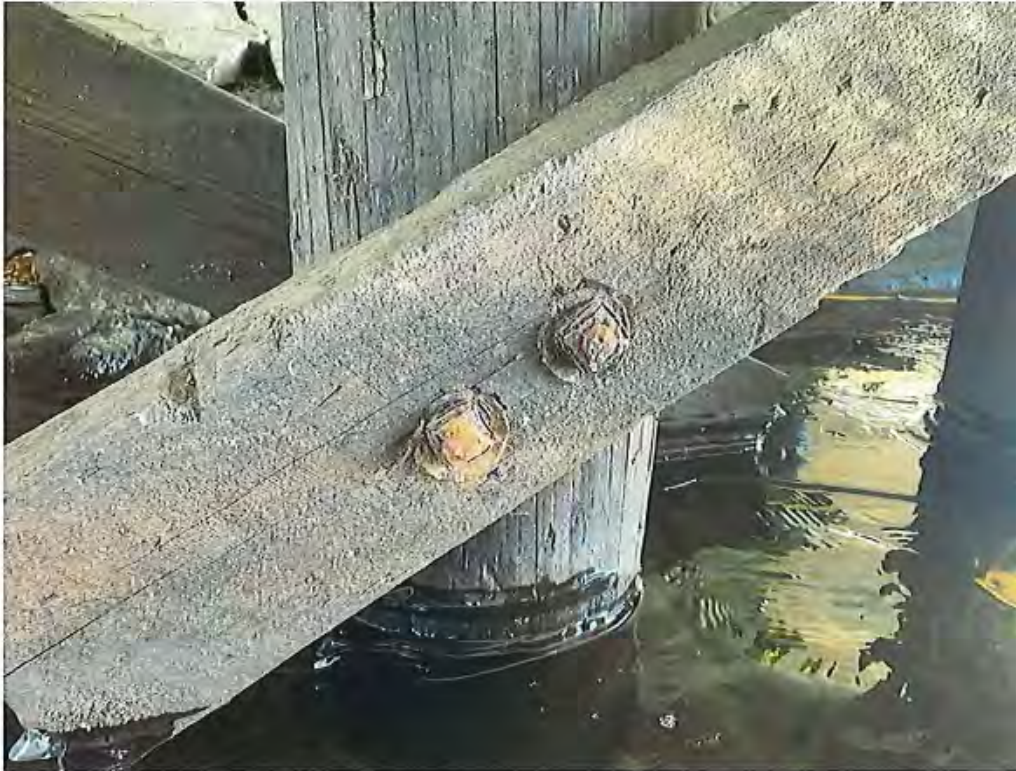
Lower diagonal bracing bolts (below waterline) have heavy surface rust with minor flaking. **See photo 23.**

**Photo 23:** Typical condition of the bents 2 and 3 fasteners at the waterline.

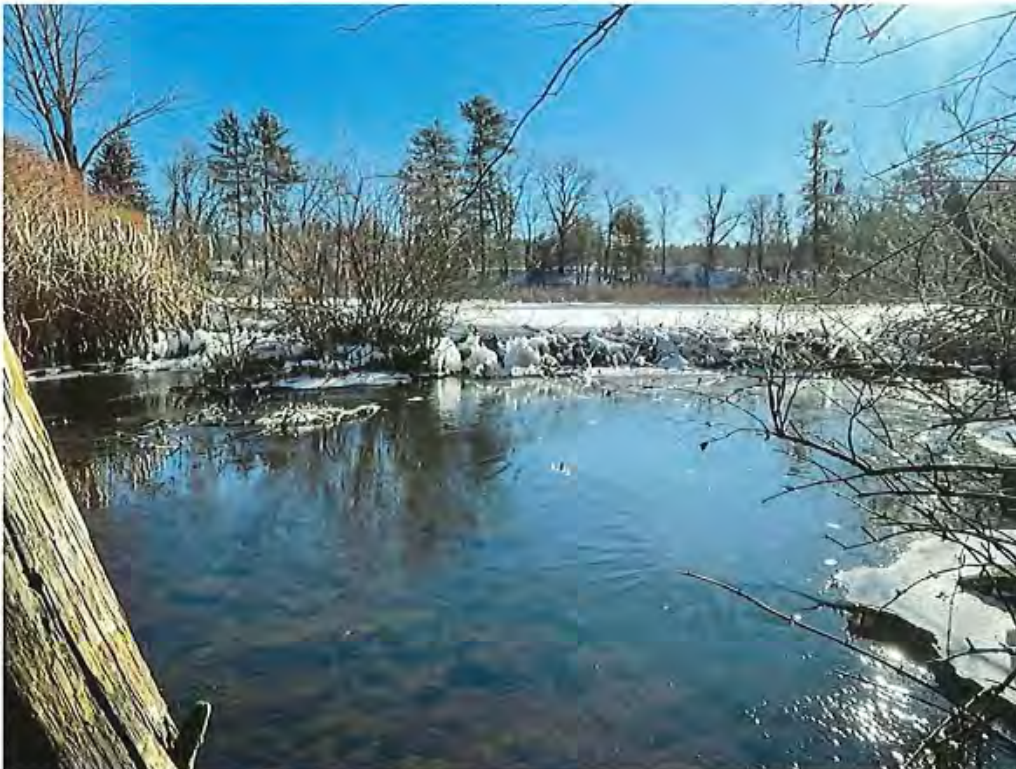
**Photo 24:** Beaver dam upstream.

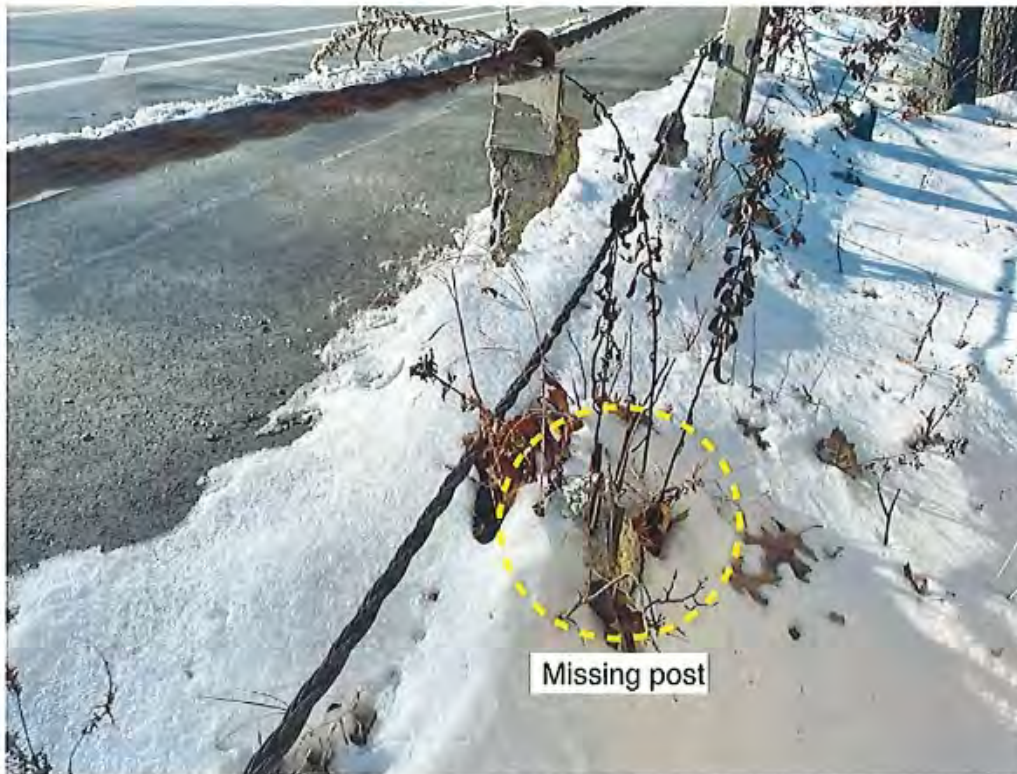
Both north approach traffic safety features consist of reinforced concrete posts with two steel cables. Many posts throughout have delaminations/shallow spalls with exposed rebar. Northeast feature has one concrete post with 100% deterioration. **See photo 25.**

**Photo 25: Southwest approach traffic safety feature missing post.**
