Appendix A: Existing Conditions Photos

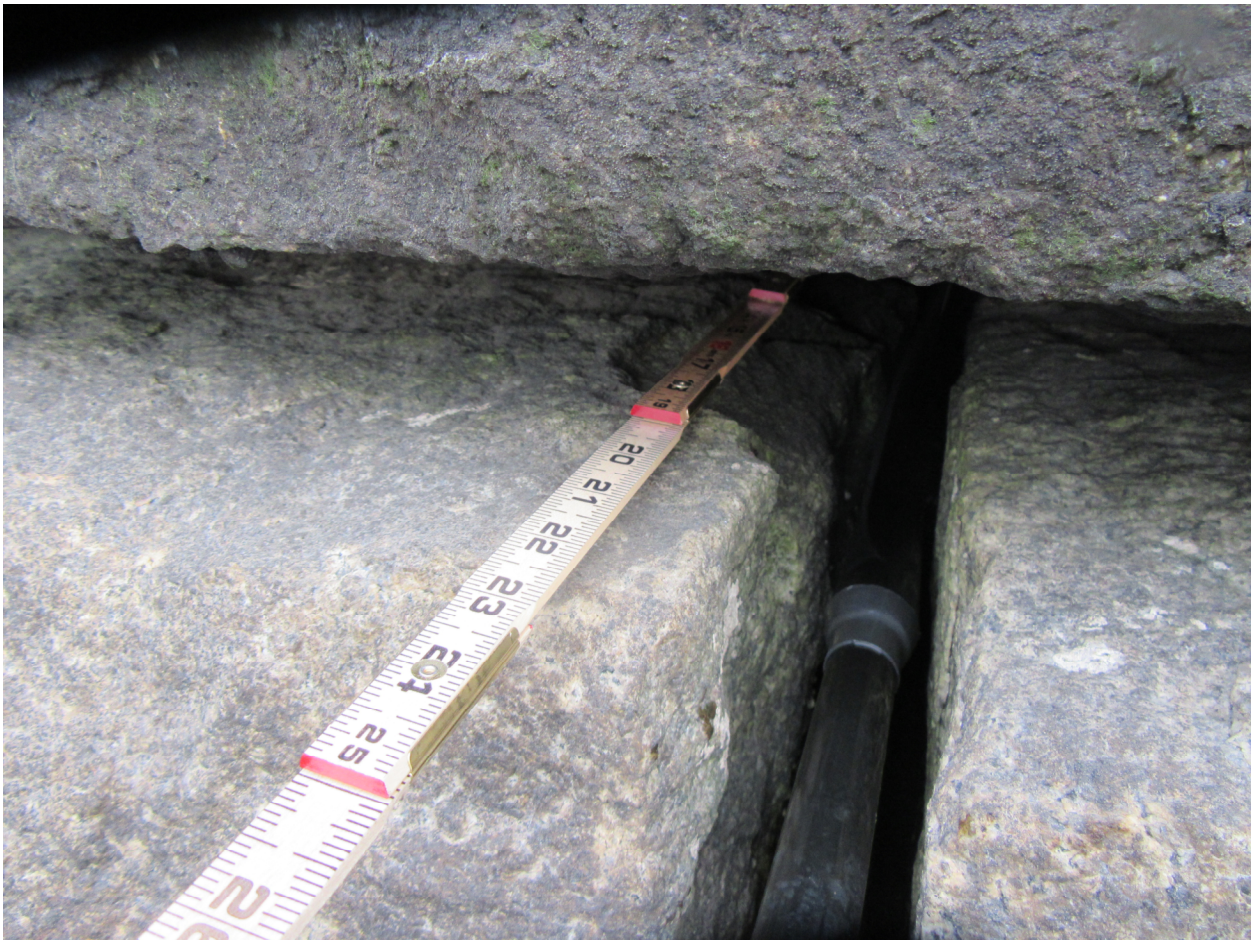
Figure 4 High Tide Corner of South and East Walls 12-in grout loss

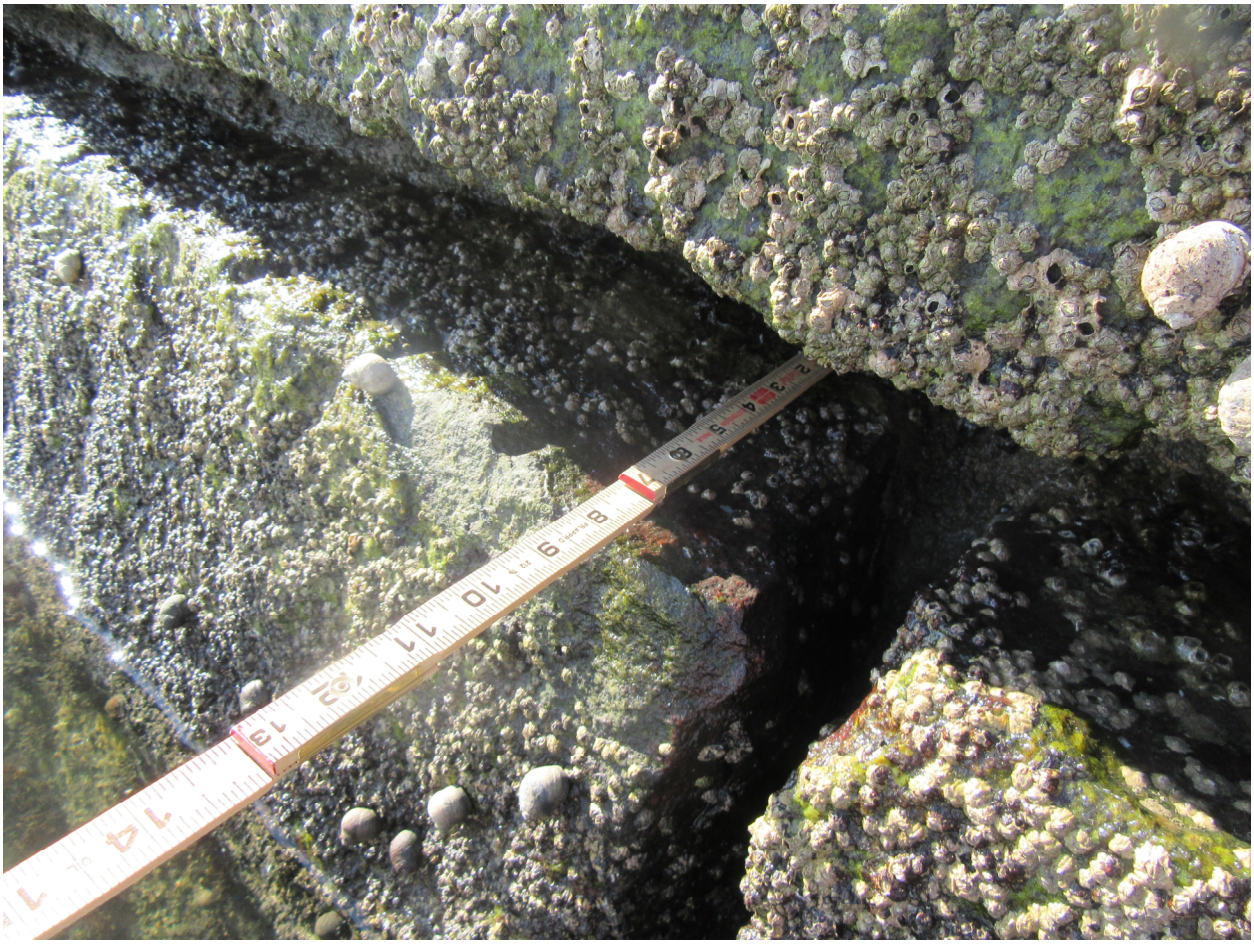
Figure 15 Low Tide South Wall near Corner of South and East Walls 30-in grout loss
