BRIDGE NO.00848

77830 - UNION
ROUTE 89
over
INTERSTATE 84

Routine Inspection

10/10/2023

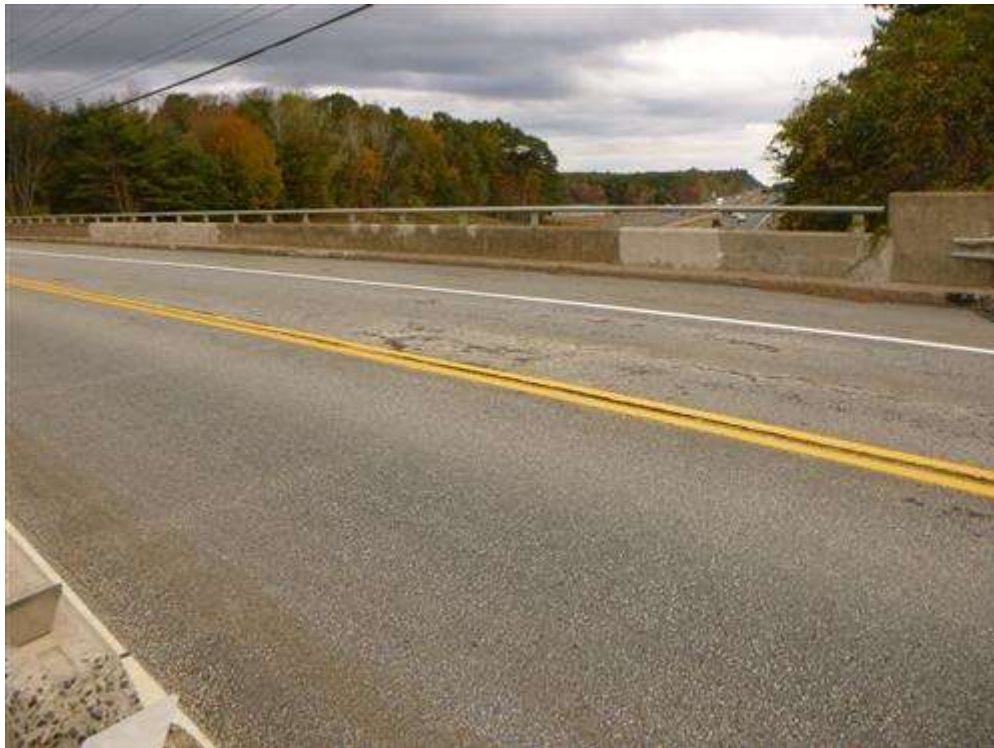
Photo Number: 8

Bituminous concrete overlay:
 - Transverse and longitudinal cracks up to 10' long x 1/8" wide.
 - Paving seam up to 1/4" wide.
 - Core sample holes have been drilled and patched.
 - Southwest shoulder has a 4' wide x 3' long area of heaving.
 - Rating decreased from '8' to '6'.
See Top of deck General Notes sketch, Top of Deck sketch and photo 8.
- Deck - Str. Condition: 5

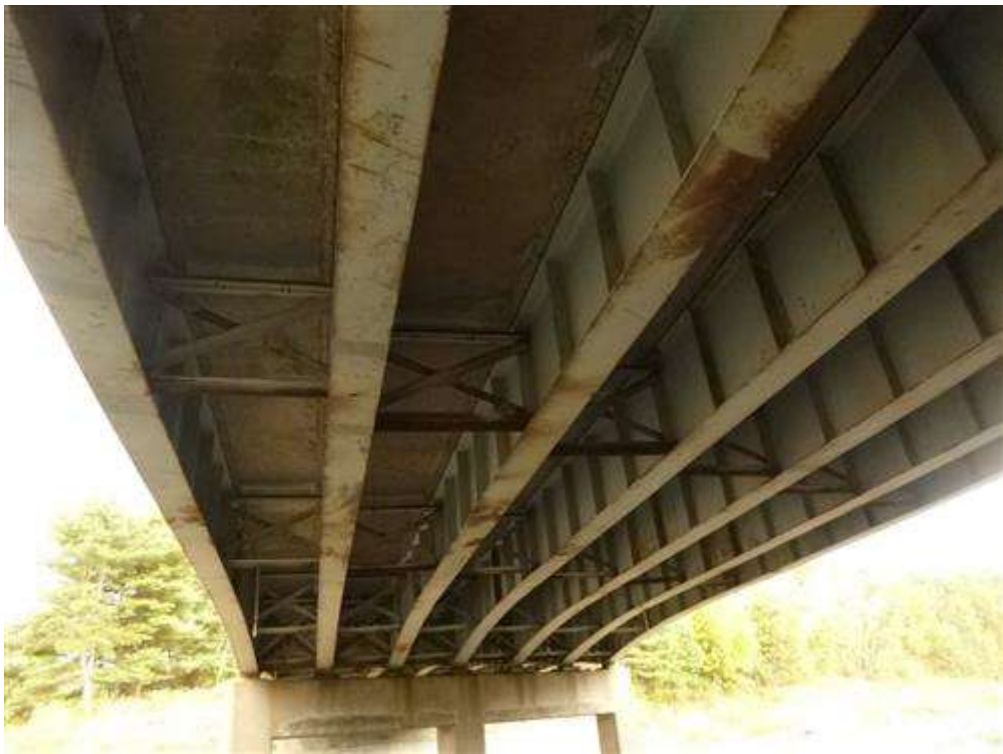
Photo Number: 9

- Approximate deck deterioration percentage: 12.5%.
See Underside of Deck & Framing - General Notes sketch, Underside of Deck & Framing sketches and photos 9-11 & 30.

Typical underside of deck and framing, span 1.

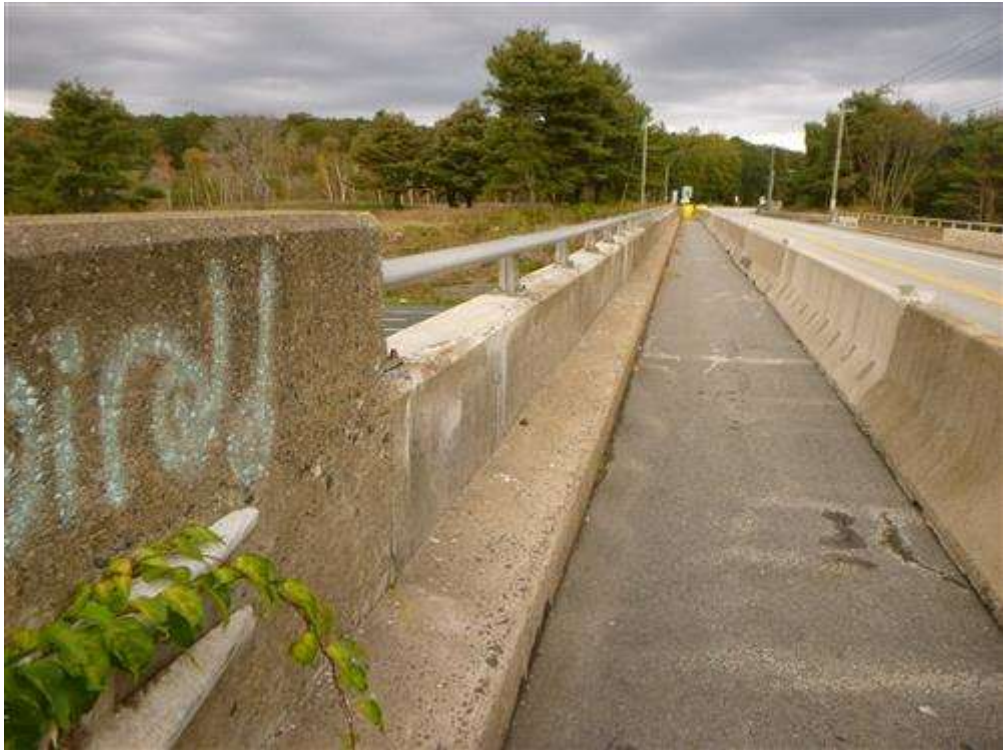
Photo Number: 12

- Northwest and southeast transition between concrete and approach curbs are missing up to 7" long. See Top of Deck General Notes sketch, Top of Deck sketch and photos 12-13.
Median: N	
Sidewalks: 6	See Item "Curbs" above.
Parapet: 5	Reinforced concrete parapets: - Random hairline cracking with and without efflorescence. - Isolated spalls up to 2' wide x 6" high x 2" deep (Photo 14). - Previous repairs have random cracks and minor spalling, with isolated intact hollow areas on top and outside faces (over roadways). - In spans 1 & 2, there are hollow areas on the outside face up to 6' long x 1' high over the dirt. The following (intact) hollow areas were found over the roadway: - Span 1, west fascia parapet with (2) hollow areas on the outside face up to 3' long x 1' high over the right lane/shoulder near abutment 1 (Photo 15). - Span 2, east fascia parapet with hollow area on the outside face 6" long x 1' high over the right shoulder near abutment 2. See Top of Deck General Notes sketch, Top of Deck sketch, Underside of Deck & Framing General Notes sketch, Underside of Deck & Framing sketches and photos 12-15.

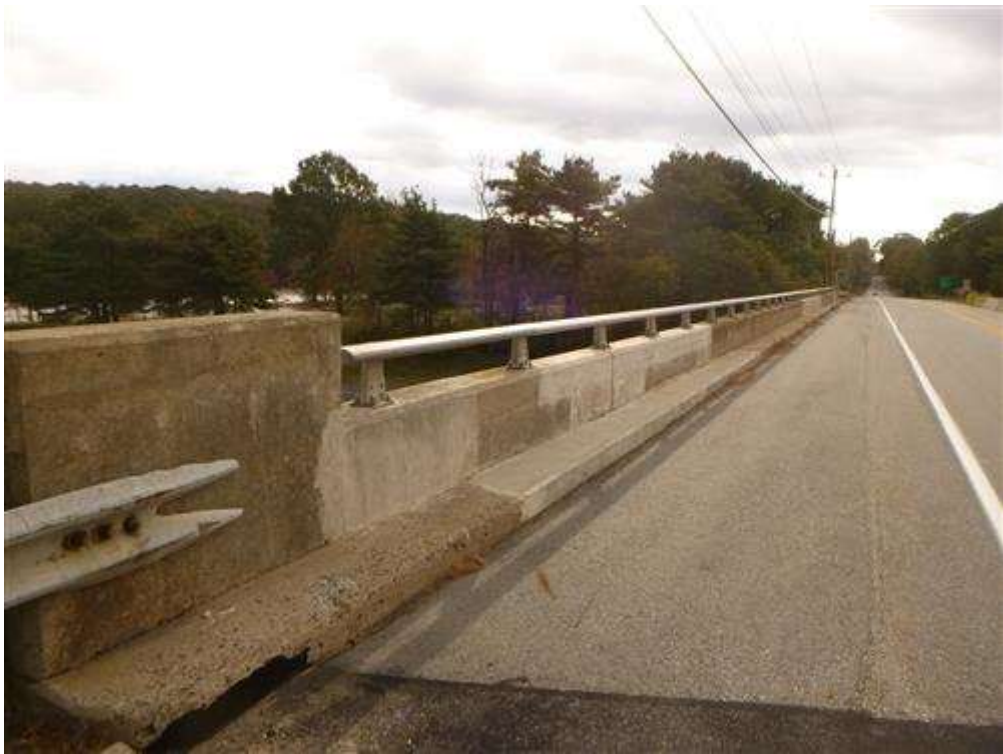
Photo Number: 13

East parapet, bridge railing, and safety walk.

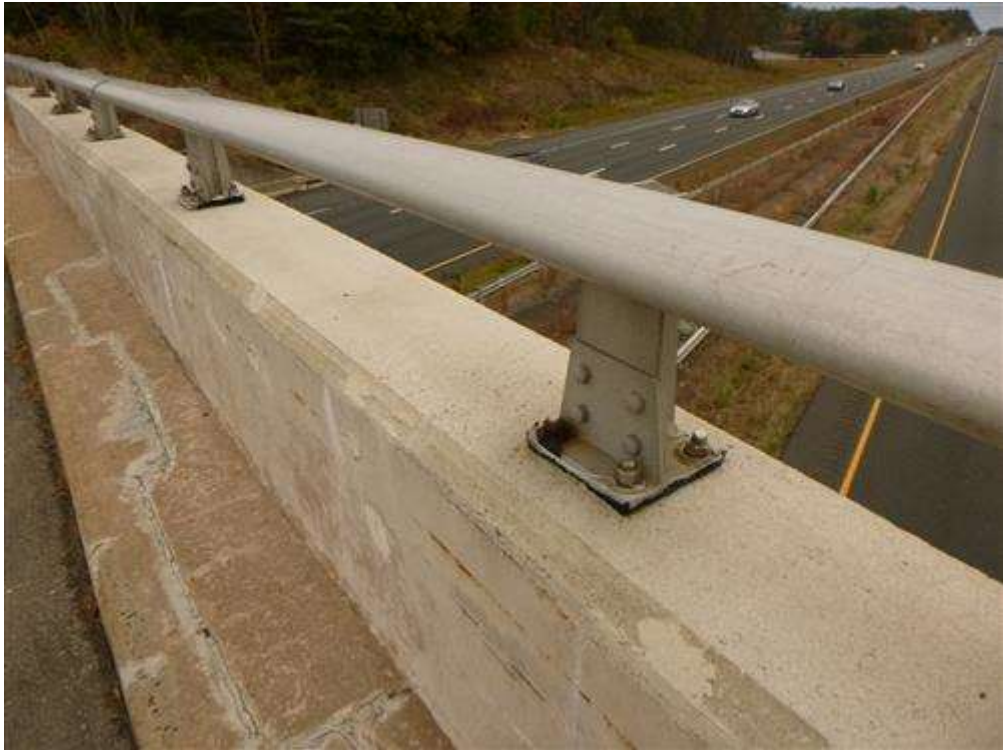
Photo Number: 16

Railing: 7	Throughout single pipe extruded aluminum rail: - Random railing posts have up to 4/4 anchor bolt nuts loose (Photo 16). See Top of deck General Notes sketch and photos 12, 13 and 16.
Paint: N	
Fence: N	
Drains: 6	- Between weeps and support steel, clips are typically rusted out throughout. See Underside of Deck & Framing General Notes sketch.
Lighting Standard: N	
Overall Utility Condition Rating	N - Not Applicable
Utility Type/Size	
N No Utilities present	
Construction Joints: N	
Expansion Joint: 7	- Adhesion cracks up to full length x 3/4" wide at both abutments (Photos 17 and 18). See Top of Deck General Notes sketch and Top of Deck sketch and photos 17 and 18.
Haunches Present over travelway?	NO

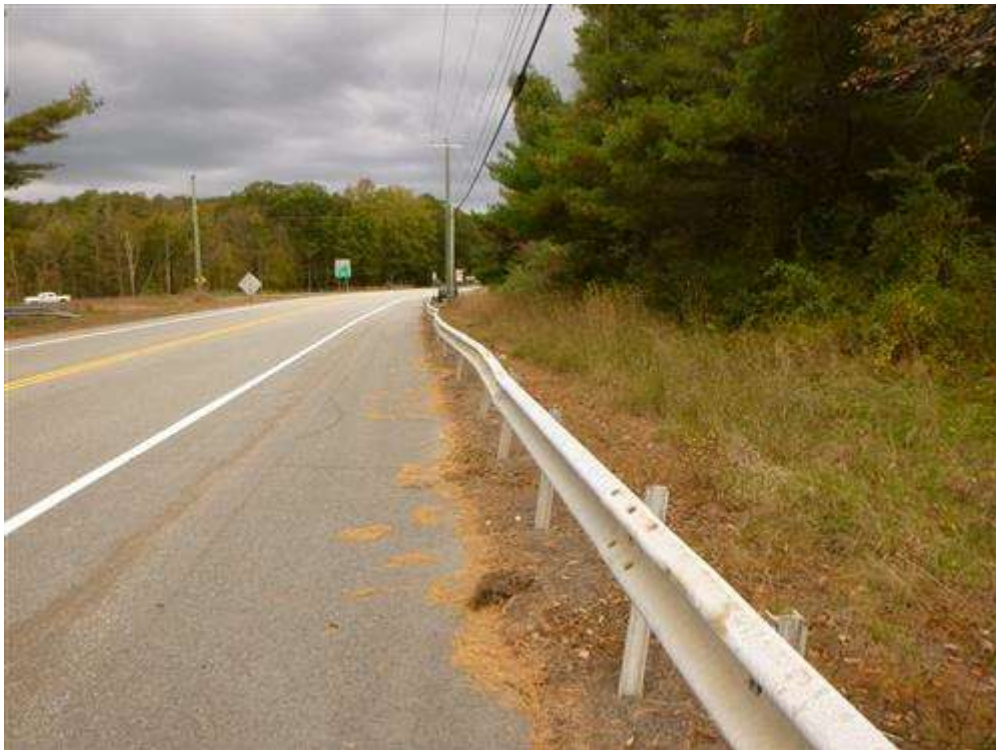
Photo Number: 20

Approach Slab: N	None per available plans.
Relief Joints: N	
Approach Guide Rail: 6	Steel W-beam guide rail with weak posts: - Random areas up to 20' long with collisions damage and up to four (4) bent/disconnected posts (Photos 20 & 21). - The northwest guide rail has a 3/4" long tear.

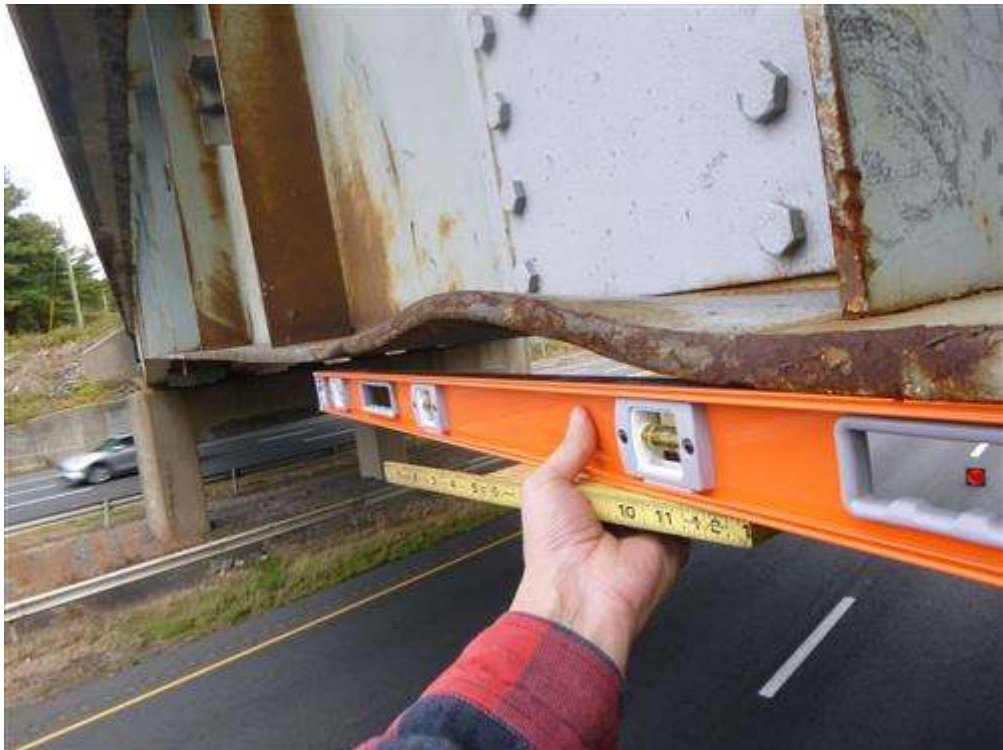
Photo Number: 32

Decreased from '7' to '5'.
	See Underside of Deck & Framing General Notes sketch, Underside of Deck & Framing sketches, Girder 1 Collision Damage Detail (Plan View) and Photos 31 & 32.
Member Alignment: 5	- Random girder bottom flanges are wavy - Also, see Items "Bearing Devices" and "Collision Damage" above
	Rating decreased from '7' to '5'.
	See Underside of Deck & Framing General Notes sketch, Underside of Deck & Framing sketches and Photos 31-33.
Deflection Under Load: N	(N) Normal; (E) Excessive
Vibration Under Load: N	(N) Normal; (E) Excessive
Stand Pipes: N	
Catwalks: N	
Movable Inspection System: N	
Barrel Ladders: N	
Are Barrel Ladders OSHA Compliant? NA

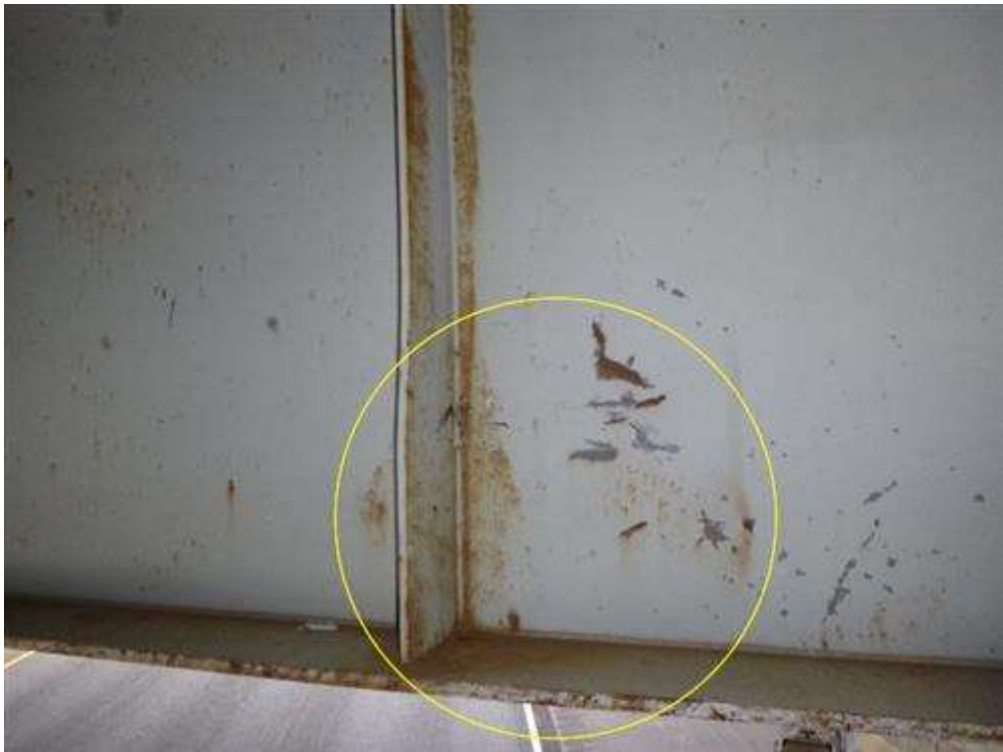
Photo Number: 34

Timber Decay:	N	
Concrete Cracking:	N	
Collision Damage:	5	<ul style="list-style-type: none"> - Random minor dents/gouges in bottom flanges up to 1/16" deep (ground smooth) - Girder 3, span 2, west bottom flange leg near midspan, bent upwards up to 1/4"; no change (construction). <p>Location of hit at Girder 1, 8th stiffener from Abutment 1 (14'-11" vertical clearance):</p> <ul style="list-style-type: none"> - Bottom Flange, West side, bent up 1-5/16" for 20" L w/ numerous gouges up to 1/4" deep (Photos 32-33). - Bottom Flange, East side, bent down 3/8" over 4' for 12" long. - Girder out of plane to the North up to 3-1/2" over approximately 22'. - Top flange separated from the deck for approximately 22' long x up to 13/16" high (no shear studs) (Photo 30). - Hole through web has been repaired with a bolted repair plate. <p>A laser aligned against the outside of the bottom flange above the bearing was used to determine how out of plane the girder is.</p> <p>Girder 2, West face:</p> <ul style="list-style-type: none"> - 9th stiffener from Abutment 1 bent out of plane up to 5/8" over 2'. Stiffener twisted from original position on bottom flange. - Web with 10" diameter area with 1/8" to 3/16" deep dent. Adjacent to this area there is a 3" diameter x up to 5/16" deep dent/gouge (Photo 34).

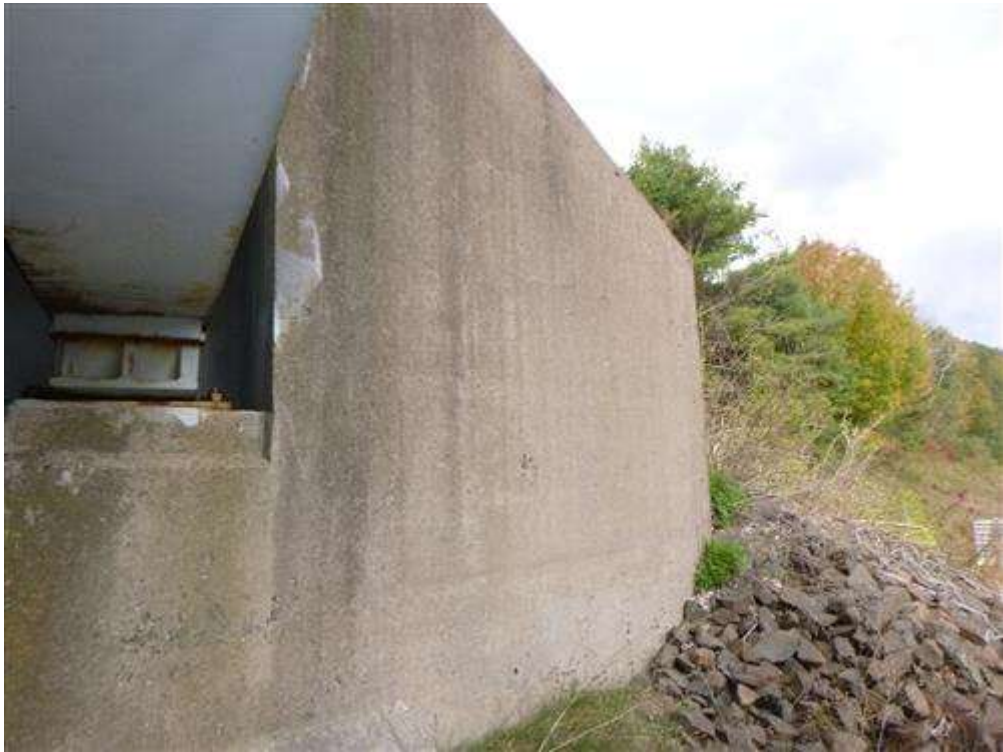
Photo Number: 37

Abutments - Stem: 7	Reinforced concrete abutment stems: - Random hairline cracking with isolated efflorescence (some cracks extend across seats). - Random concrete patches with isolated hairline cracks. - Pedestals have random hairline cracks. - Abutment 2 has a spall 7" wide x 5" high x 1/4" deep. - Both abutments have areas of light scale, light honeycombing, and isolated popouts. See Abutment sketch and photos 35-36.
Abutments - Backwall: 7	Reinforced concrete abutment backwalls: - Random vertical hairline cracking and areas of hairline mapcracking with isolated efflorescence. - Random chipping along top. - Construction joints are open up to 1/4" wide; (no change). See Abutment sketch and photos 35-36.
Abutments - Footings: N	Not visible.
Abutments - Settlement: 8	None noted.
Abutments - Wingwalls: 7	Reinforced concrete wingwalls - Isolated popouts/shallow rebar - The joint fill material is deteriorated/missing - Light to heavy vegetation growth along wingwalls - Wingwall 2B has a 4" diameter x 3/4" deep spall - Both abutments have areas of light scale, light honeycombing, and isolated popouts with random shallow rebar. See Abutment sketch and photos 37-38.

Wingwall 2B.

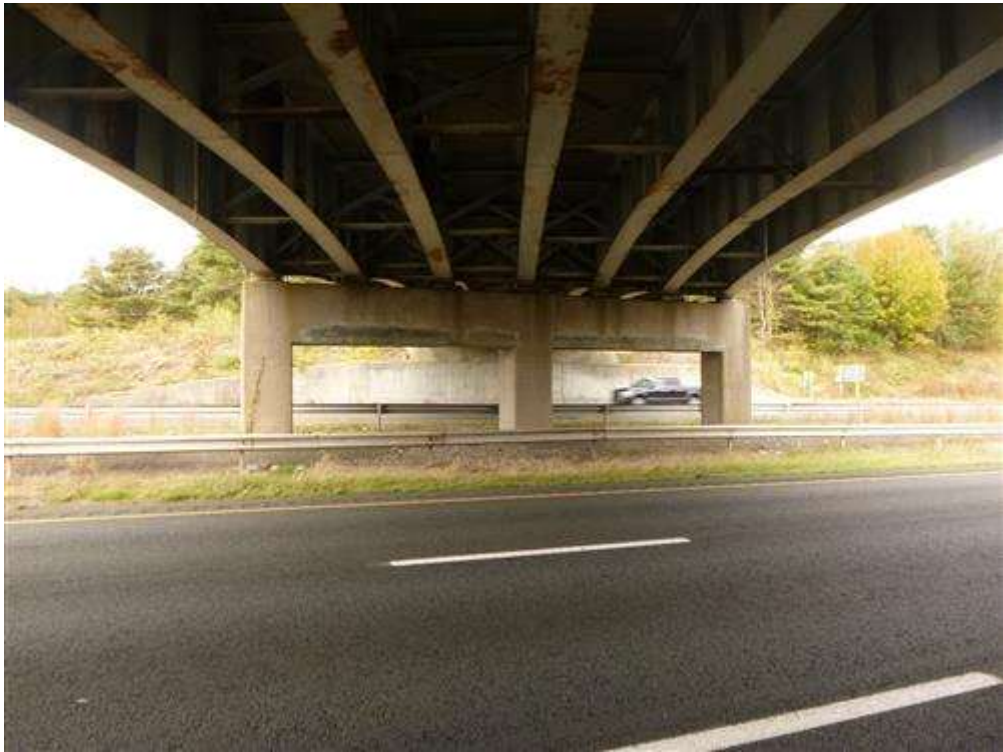
Photo Number: 39

Piers/Bents - Caps: 6	Reinforced concrete pier cap: - Random hairline cracks with and without efflorescence. - Random spalls up to 4" long x 8" wide x 1-1/2" deep with exposed rebar. - Isolated hollow areas up to 16" x 18".

- Concrete patches along 75% of cap length, some with shrinkage/hairline cracking.
		See Pier sketch and photo 39.
Piers/Bents - Pile Bent:	N	
Piers/Bents - Columns:	7	Reinforced concrete pier columns: - Column 1, south elevation has a 6'-0" high x 2'-0" wide area of hairline mapcracks . See Pier sketch and photo 39.
Piers/Bents - Footings:	N	Not visible.
Piers/Bents - Settlement:	8	None noted.
Erosion - Scour:	7	Concrete block abutment slope protection has cracks in the mortar joints and blocks up to 1" wide Scour = 'N'. See Abutment sketch and photo 35.
Concrete Crack - Spall:	6	See Item 'Piers/Bents - Caps' above.
Steel Corrosion:	N	
Paint:	N	
Timber Decay:	N	
Collision Damage:	8	
Debris:	7	- Light sand debris on the abutment seats See Abutment sketch.

Pier, looking south.
