Subject: On-Call Asbestos, Lead, Air Quality & Demolition Compliance  
Agreement No. 10.04-02 (23)  
HazMat Inspection – Replacement of Bridge No. 02698, Route 149 over Dykas Brook  
East Haddam, CT  
ConnDOT Assignment No. 524-8221  
ConnDOT Project No. 40-148  
TRC Project No. 501871.8221.0710

TRC performed a limited hazardous materials site investigation associated with the replacement of Bridge No. 02698, Route 149 over Dykas Brook in East Haddam, CT.

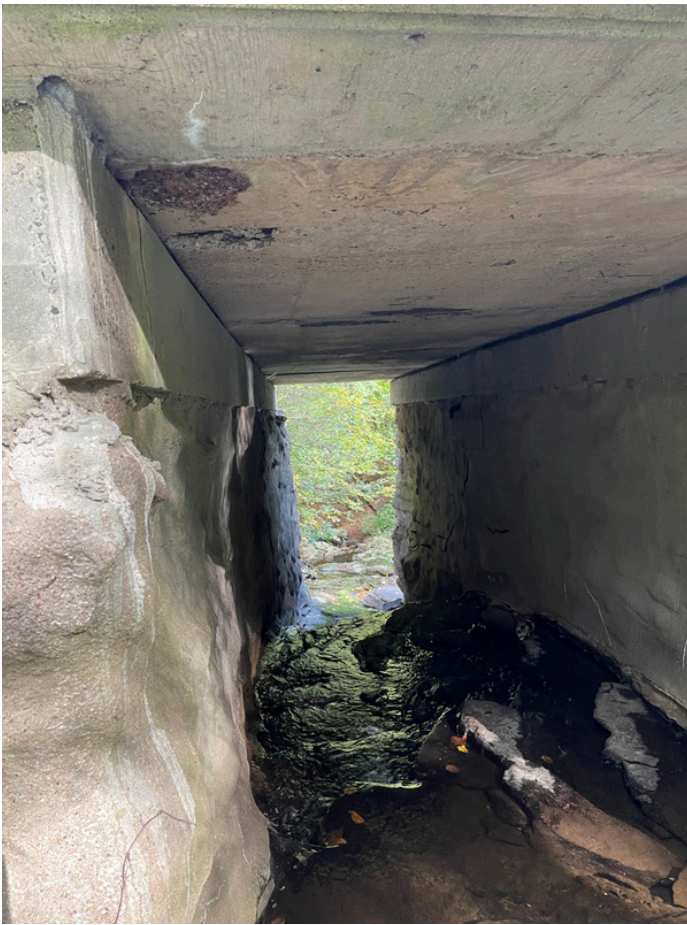
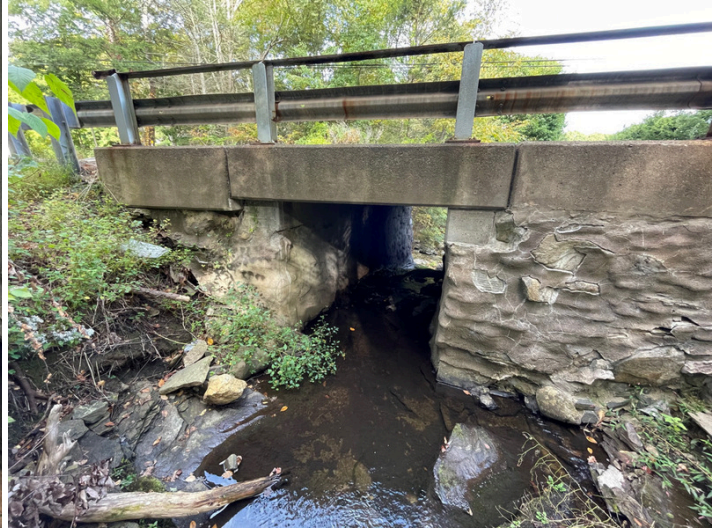
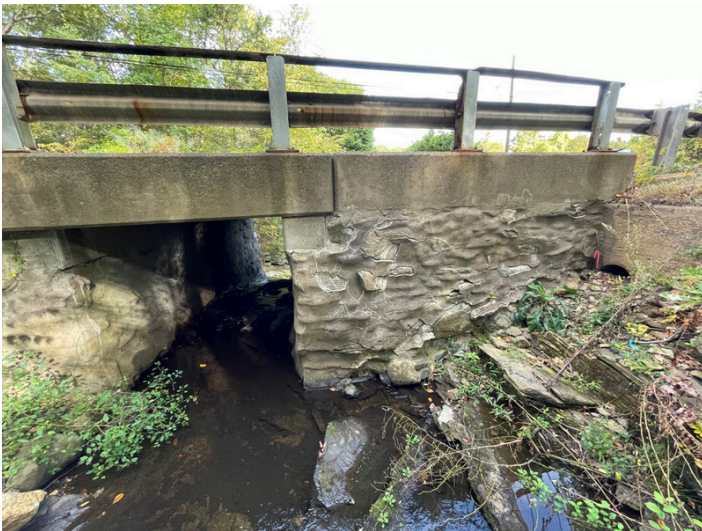
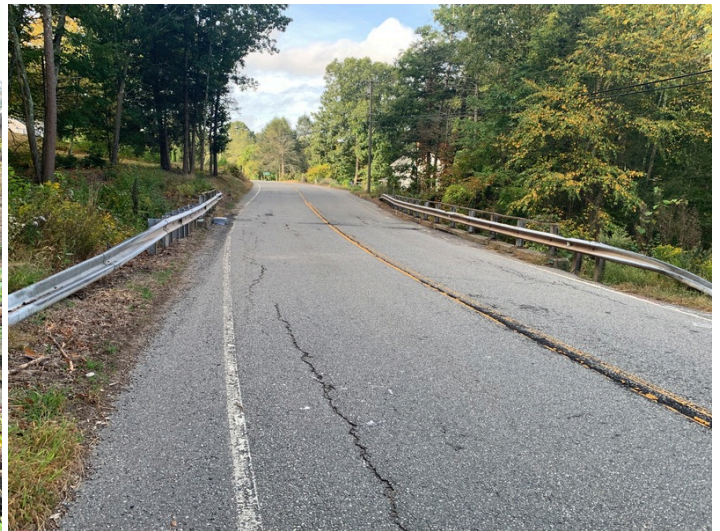
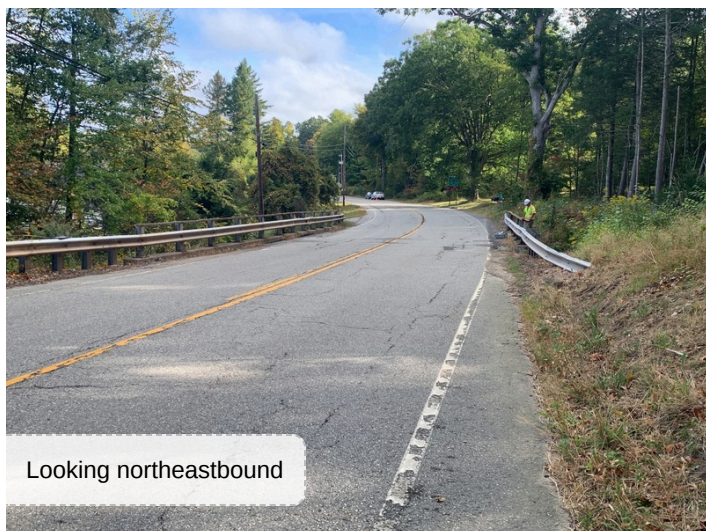
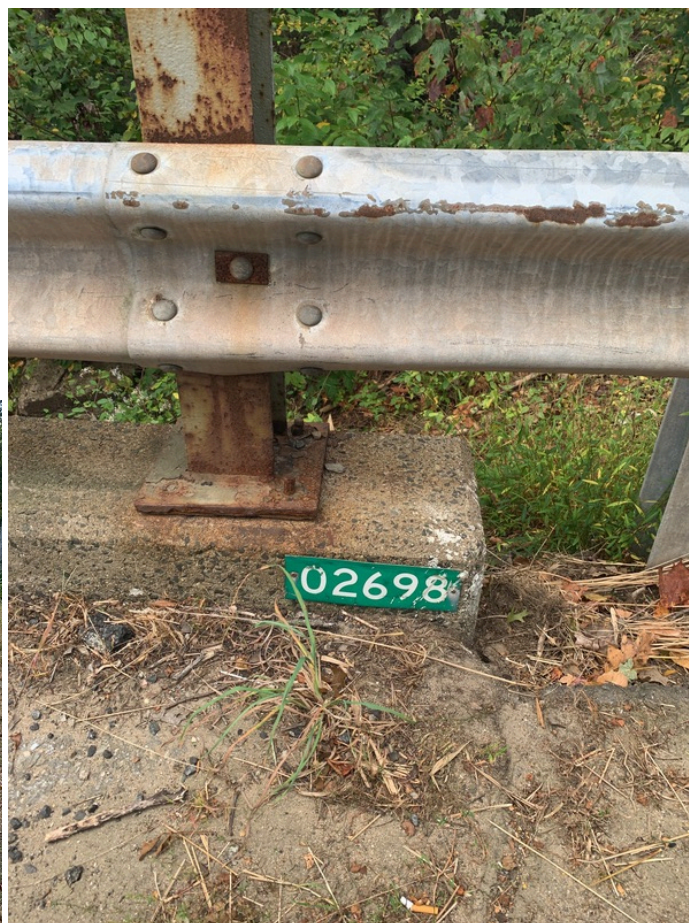
Overview Photo

Site Name	Bridge 02698; East Haddam, CT
Address	Route 149 over Dykas Brook East Haddam CT US
TRC Project Number	501871.8221.0710
Project Manager	Erik Plimpton, Stephen Arienti
Inspector(s)	David Heelon, Cole Bova
Client	ConnDOT
Type of Asbestos Survey	Reno/Demo
Site Sketch Diagrams	
Additional Analysis for NOB Materials (Calc)	TEM NY NOB 198.4
PLM Turnaround Time (TAT)	3-day
TEM Turnaround Time (TAT)	5-day
Date	September 24, 2024
General Notes	No Regulated Items/hazardous materials found at site. No guano found at site. Railings and railing supports at top of bridge had deteriorated gray paint that was sampled for TCLP. Gray paint is >1.0 mg/ cm <sup>2</sup> on the Niton. Items sampled for asbestos: black asphalt filler between concrete walls (AF1) and black tar coating on concrete wall (TC1). Guardrails at top of bridge are galvanized and not painted.
