ADDENDUM No. 1

LEE, LENOX AND PITTSFIELD

MassDOT Berkshire Line Civil Improvements

RESPONSE TO BIDDERS' QUESTIONS	4 Pages
DOCUMENT A00801	Pages 17, 21, 107 and 108; Edits are in red.
2018 CULVERT INSPECTION REPORTS	30 Pages

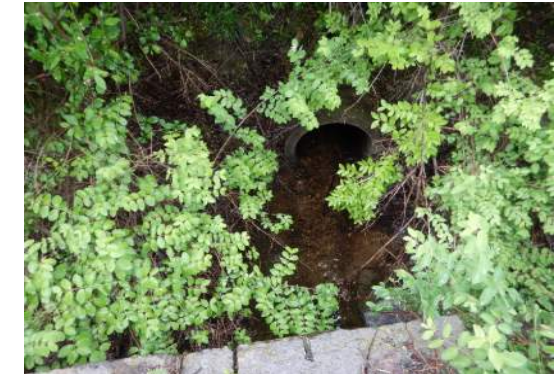
Photo 2

Comment: Culvert pipe for siding, just upstream.

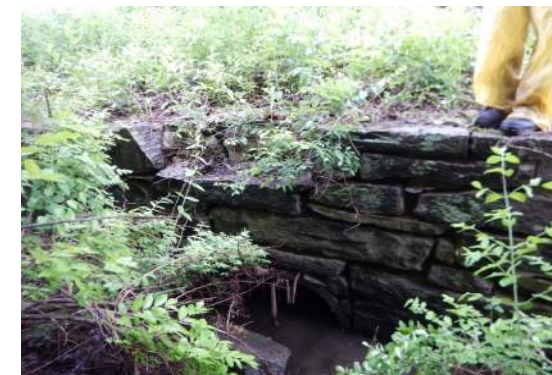
Photo 3

ITEM	CULVERT STRUCTURE	RATING: 6	REMARKS	PHOTO #
12	Abutment (N or E)	N		
13	Abutment (S or W)	N		
14	Head Walls - West	5	Loose and missing mortar. See Note 3.	3 & 8
15	Head Walls - East	5	See Note 4.	4
16	Wingwalls	N		
17	Ceiling Slab	N		
18	Invert Slab	N		
19	Walls	N		
20	Arch Ring	N		
21	Pointing	N		
22	Pipes/Circular Culverts	7	Slight surface rusting.	6
23	Apron	N

MAINTENANCE: Reset displaced stone in West Headwall.

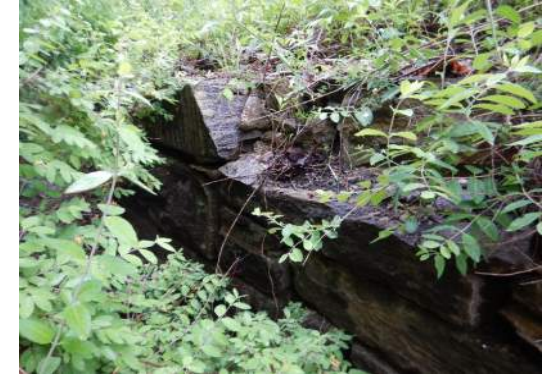
Photo 8

- 1) Culvert Cover: 7' from Top of Culvert to Top of Rail.
- 2) Minor stream bank erosion on both banks on the East side.
- 3) Stone from N.W. corner has fallen into stream slightly restricting flow. See Photo 8.
- 4) Cracked block at south half of east headwall one course down from cap. Stone displaced at mud line 6" from East headwall. See Photo 4.

Description: West Headwall
 Comment: Dislodged masonry block.

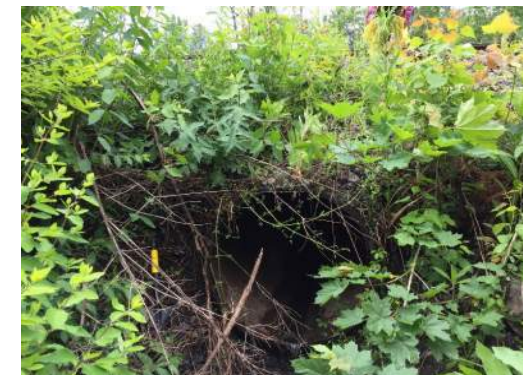
Photo 3

ITEM	STREAM CONDITIONS	RATING: 5	REMARKS	PHOTO #
4	Alignment - West	7	Stream aligned perpendicular to track.	
5	Alignment - East	7	Stream aligned perpendicular to track.	
6	Channel - East	5	Degradation/local scour hole 6' east of downstream end, 24" deeper than stream bank.	8
7	Channel - West	5	Slight restriction of flow due to downed tree inside culvert.	4
8	Stream Bed	5	See Items 6,7 and 11.	7,8
9	Channel Protection	N	None present.	
10	Drift/Debris	6	6" diameter tree at west end of the pipe.	4
11	Scour	5	Scour is present beneath the east end of the pipe.	7

Comment: Scour present underneath pipe.

FOR IMMEDIATE ATTENTION: Repair open joints before. Protect east end of culvert from scour, consider installing headwall.

MAINTENANCE: Fill scour hole and undermining with stone and rip rap. Clear pipe. Repair rail profile dip. Perform track maintenance.

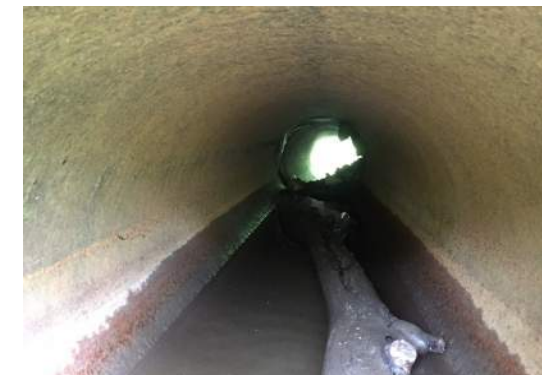
Photo 4

Comment: 6" dia. log within culvert.

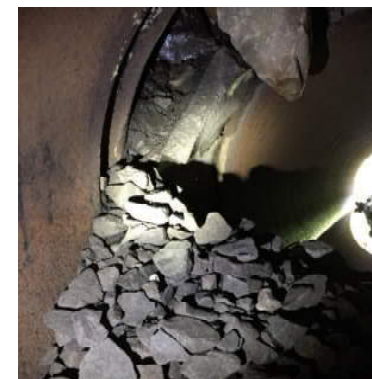
Photo 5

ITEM	CULVERT STRUCTURE	RATING: 4	REMARKS	PHOTO #
12	Abutment (N or E)	N		
13	Abutment (S or W)	N		
14	Head Walls - West	5	Masonry block at upper, south corner is displaced by 7". See Note 3.	2 & 6
15	Head Walls - East	N	No east headwall present.	
16	Wingwalls	N		
17	Ceiling Slab	N		
18	Invert Slab	N		
19	Walls	N		
20	Arch Ring	N		
21	Pointing	5	Loose/missing mortar present on west headwall.	
22	Pipes/Circular Culverts	4	See Notes 2 & 6. Pipe joint open, 16" L, ballast spilling into culvert.	4, 5 & 7
23	Apron	N

Comment: Open Pipe Joint. Ballast lost into culvert.

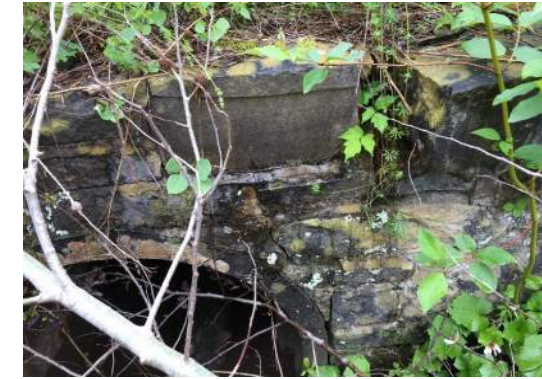
Photo 6

Comment: Vertical crack. Masonry block displaced by 7".

3) West headwall has a vertical crack starting at the 2 o'clock position on pipe. See Photo 6.

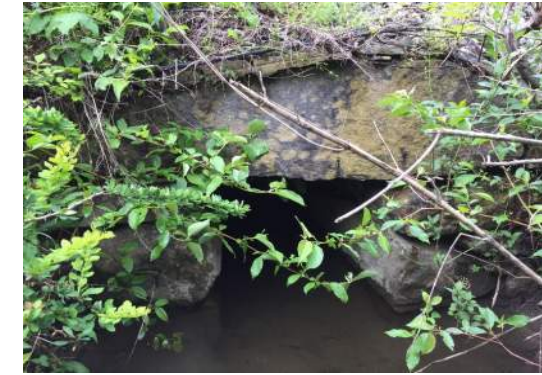
Photo 2

Comment: Minor settlement and displacement.

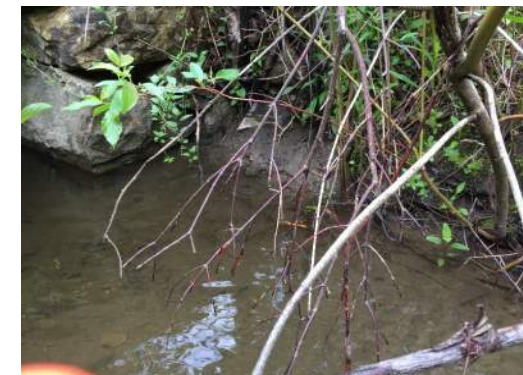
Photo 3

Comment: Minor scour, without undermining at corner.

MAINTENANCE: Protect embankment and track from erosion and culvert from scour. Clear debris. Track Maintenance.

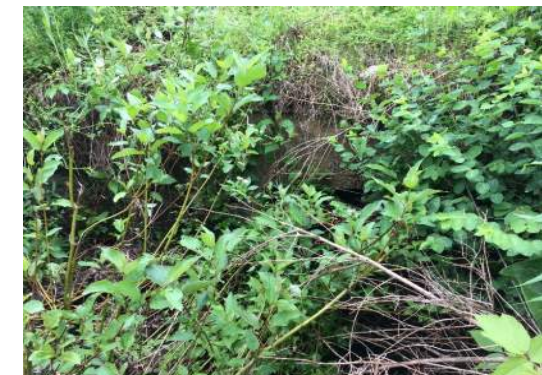
Photo 4

Comment: Vegetation restricting stream.

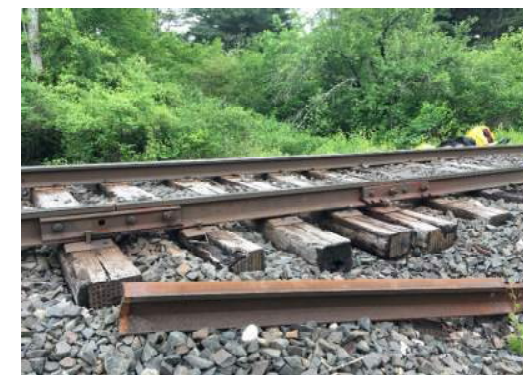
Photo 5

ITEM	GENERAL	RATING: 4	REMARKS	PHOTO #
1	Action Under Trains	H	Not observed. Trains not present during inspection.	
2	Embankment	5	Low ballast around ties over culvert. Possible due to settlement, loss of fill.	1 & 5
3	Track Over Culvert	4	Track dips over culvert and joint. Low ballast beneath joint.	5

Comment: Track dips over culvert. Low ballast under joint.

FOR IMMEDIATE ATTENTION: Consider replacement or culvert lining. Correct track defects.

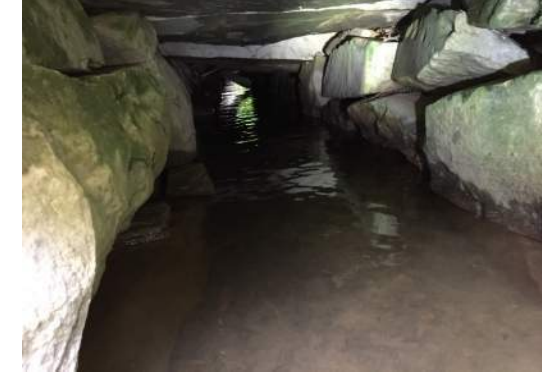
Photo 8

- 1) Culvert Cover: 36" from Top of Culvert to Top of Rail.
- 2) Ceiling slab has several stones displaced downward approximately 4-6". One stone beneath the tracks has been dislodged.
- 3) Walls have displaced and missing stones, typical along the length of both sides. Most blocks show displacement/rotation or are missing.
- 4) Culvert profile sags under track approximately 4" to 6".
- 5) 27" of erosion along west banks.
- 6) Top stone is 12" thick.

Description: Typical Culvert Interior (from east end)
Comment: Displaced walls and ceiling masonry.

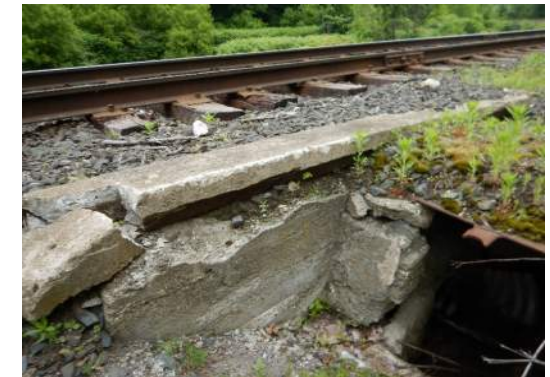
Photo 6

2) East headwall: spall concrete at embedded steel 3-6" from top F. full length. See Photo 6.

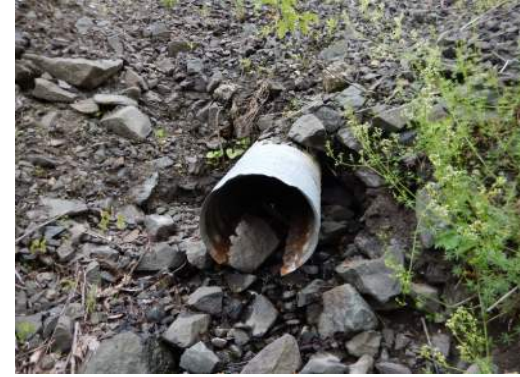
Photo 7

Comment: Severe erosion around outtake of pipe

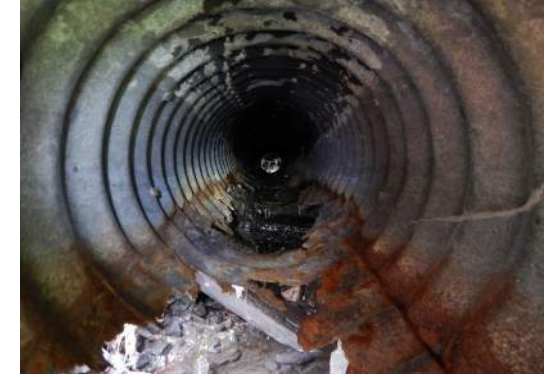
Photo 8

5) From 7 o'clock to 5 o'clock position, pipe has corrosion holes along full length. See photo 8.

Comment: Corrosion holes

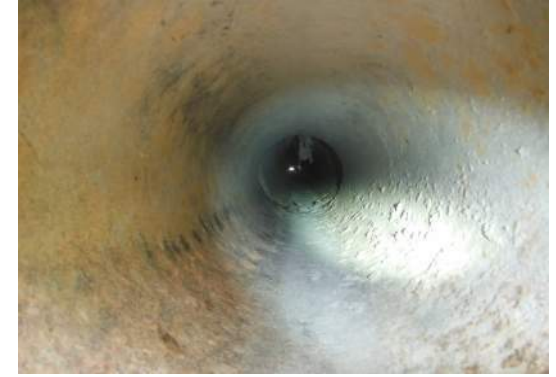
Photo 2

Comment: Note open joints in pipe

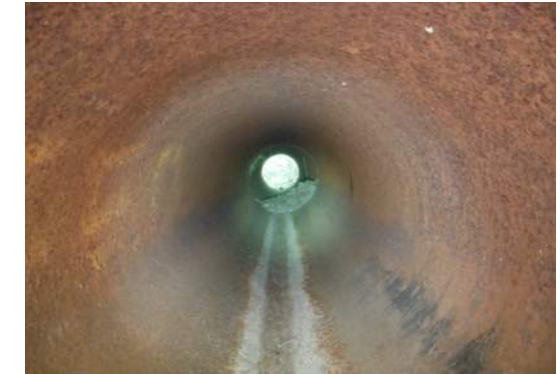
Photo 2

Comment: Subballast pile at open joint

MAINTENANCE: Adress settlement and subballast infiltration into pipe

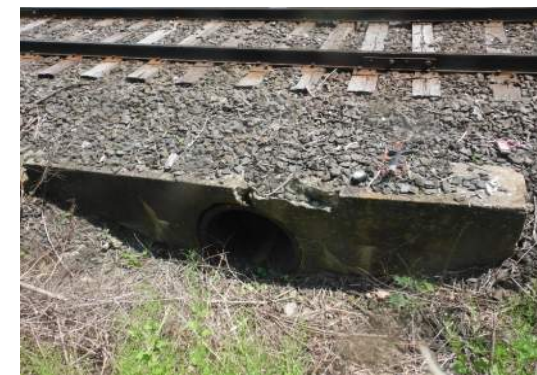
Photo 5

Comment: Concrete has cracks, edge spall, and delam.

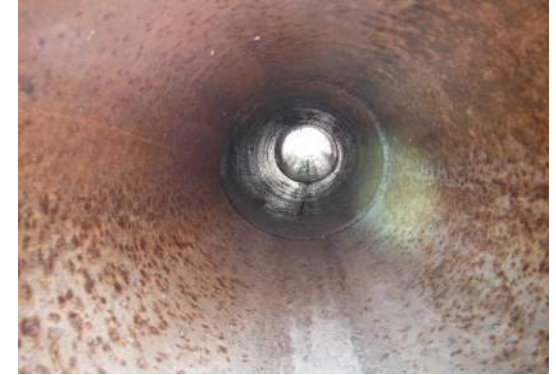
Photo 2

Comment: Note misaligned joints

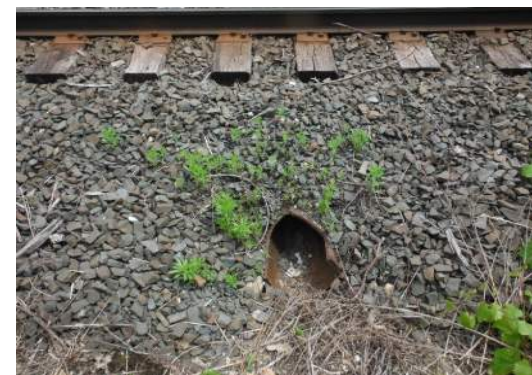
Photo 5

Comment: Pipe broken at top

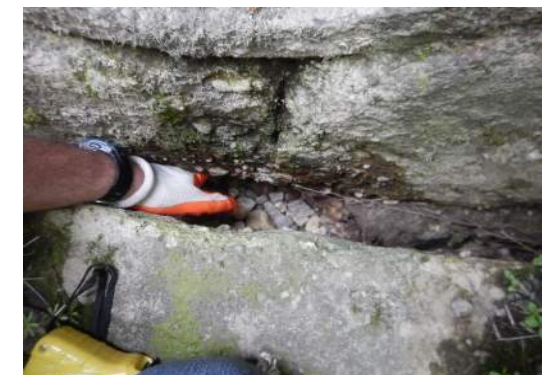
Photo 6

ITEM	CULVERT STRUCTURE	RATING: 4	REMARKS	PHOTO #
12	Abutment (N or E)			
13	Abutment (S or W)			
14	Head Walls - West	6	Full height vertical crack 1/32" thick	7
15	Head Walls - East	3	Concrete has no defects, 24" W undermining at 6"	6
16	Wingwalls			
17	Ceiling Slab			
18	Invert Slab			
19	Walls			
20	Arch Ring			
21	Pointing			
22	Pipes/Circular Culverts	6	Clear with light rust	5
23	Apron		Slab broken and undermined

FOR IMMEDIATE ATTENTION: Repair scour under east headwall and repair riprap on stream bank

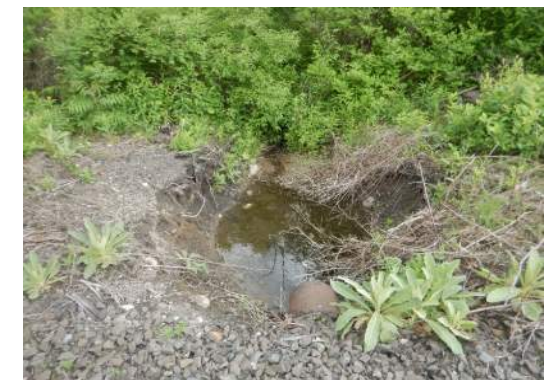
Photo 6

ITEM	GENERAL	RATING: X	REMARKS	PHOTO #
1	Action Under Trains			
2	Embankment	3	Severe erosion around outfall	6
3	Track Over Culvert		No dips, similar to adjacent track	7
ITEM	STREAM CONDITIONS	RATING: X	REMARKS	PHOTO #
4	Alignment - West		Drainage ditch parallel to track	3
5	Alignment - East			
6	Channel - East			
7	Channel - West			
8	Stream Bed		Silt and sand present	
9	Channel Protection			
10	Drift/Debris		None	
11	Scour	3	Scour at outfall, 12" below natural stream bed and 24" before outfall invert.	3
ITEM	CULVERT STRUCTURE	RATING: 7	REMARKS	PHOTO #
12	Abutment (N or E)			
13	Abutment (S or W)			
14	Head Walls - West			
15	Head Walls - East			
16	Wingwalls			
17	Ceiling Slab			
18	Invert Slab			
19	Walls			
20	Arch Ring			
21	Pointing			
22	Pipes/Circular Culverts	7	Clear, minor scour, joints tight	3
23	Apron

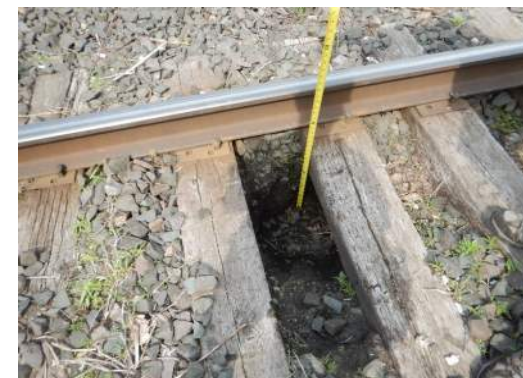
Photo 5

ITEM	GENERAL	RATING: X	REMARKS	PHOTO #
1	Action Under Trains			
2	Embankment		Hole has opened beneath ties 18" D x 18" L x 36" W	5
3	Track Over Culvert			
ITEM	STREAM CONDITIONS	RATING: X	REMARKS	PHOTO #
4	Alignment - West		Parallel to RR	
5	Alignment - East		Flow at 15 degrees S.E. skew to centerline of culvert	
6	Channel - East		Heavy veg.	
7	Channel - West			
8	Stream Bed		Agr. 15-20' downstream restricts flow	
9	Channel Protection			
10	Drift/Debris			
11	Scour			
ITEM	CULVERT STRUCTURE	RATING: 5	REMARKS	PHOTO #
12	Abutment (N or E)			
13	Abutment (S or W)			
14	Head Walls - West			
15	Head Walls - East			
16	Wingwalls			
17	Ceiling Slab			
18	Invert Slab			
19	Walls			
20	Arch Ring			
21	Pointing			
22	Pipes/Circular Culverts			
23	Apron

Description: Track Elevation

Comment: Hole beneath ties

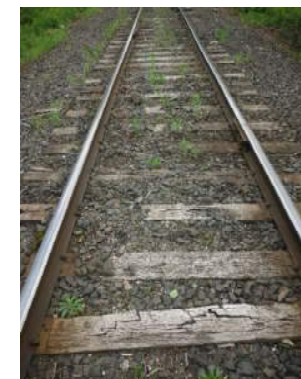
Photo 5

ITEM	GENERAL	RATING: X	REMARKS	PHOTO #
1	Action Under Trains			
2	Embankment			
3	Track Over Culvert	5		5
ITEM	STREAM CONDITIONS	RATING: X	REMARKS	PHOTO #
4	Alignment - West			
5	Alignment - East			
6	Channel - East			
7	Channel - West			
8	Stream Bed			
9	Channel Protection			
10	Drift/Debris			
11	Scour			
ITEM	CULVERT STRUCTURE	RATING: H	REMARKS	PHOTO #
12	Abutment (N or E)			
13	Abutment (S or W)			
14	Head Walls - West	H		
15	Head Walls - East	H		
16	Wingwalls			
17	Ceiling Slab			
18	Invert Slab			
19	Walls			
20	Arch Ring			
21	Pointing			
22	Pipes/Circular Culverts	H		
23	Apron

Description: Typ. Track/Top Side
