Soil Corrosivity Results and Corrosion Evaluation Report

**Corrosion Evaluation Report
Weston Aqueduct Supply Main 3 (CP2)
Massachusetts Water Resource Authority**

**CorrTech Inc.
25 South Street
Hopkinton, MA 01748
Report No. 9301-FOR-03-3**

April 2023

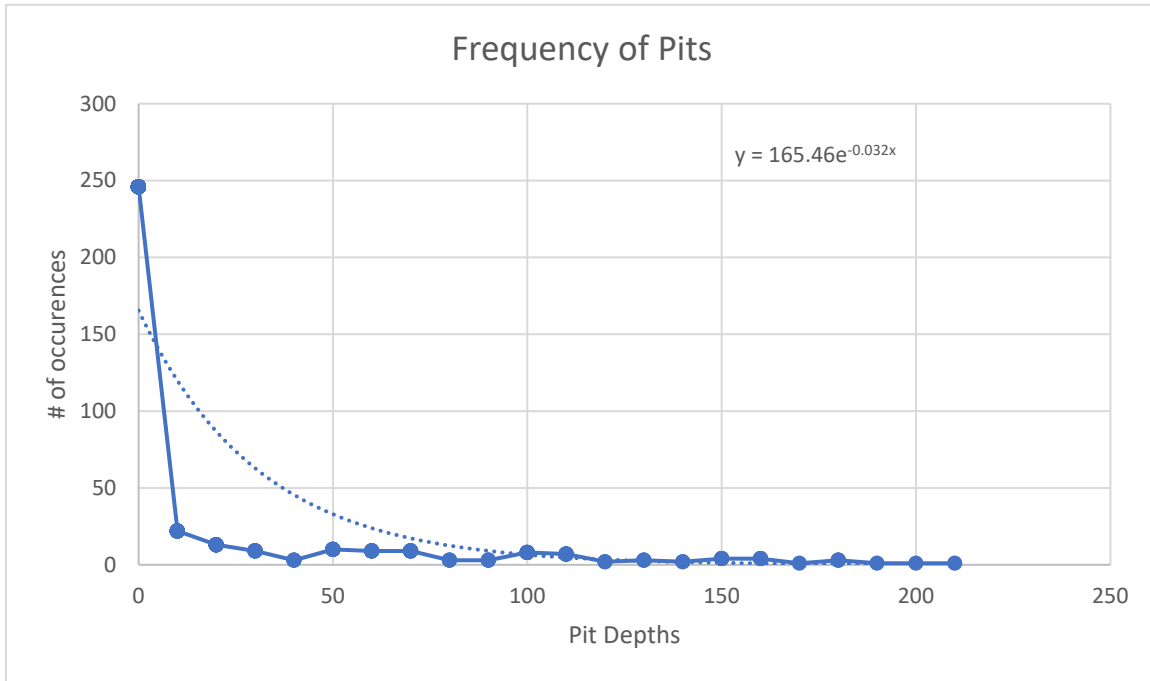
It is considered that an additional seven 26 external leaks will manifest within the next approximately 25-year time frame.

Frequency of Through Hole	0.001016621
Area of Pipe (ft.^2) statistical units	46,660
Number of leaks	47

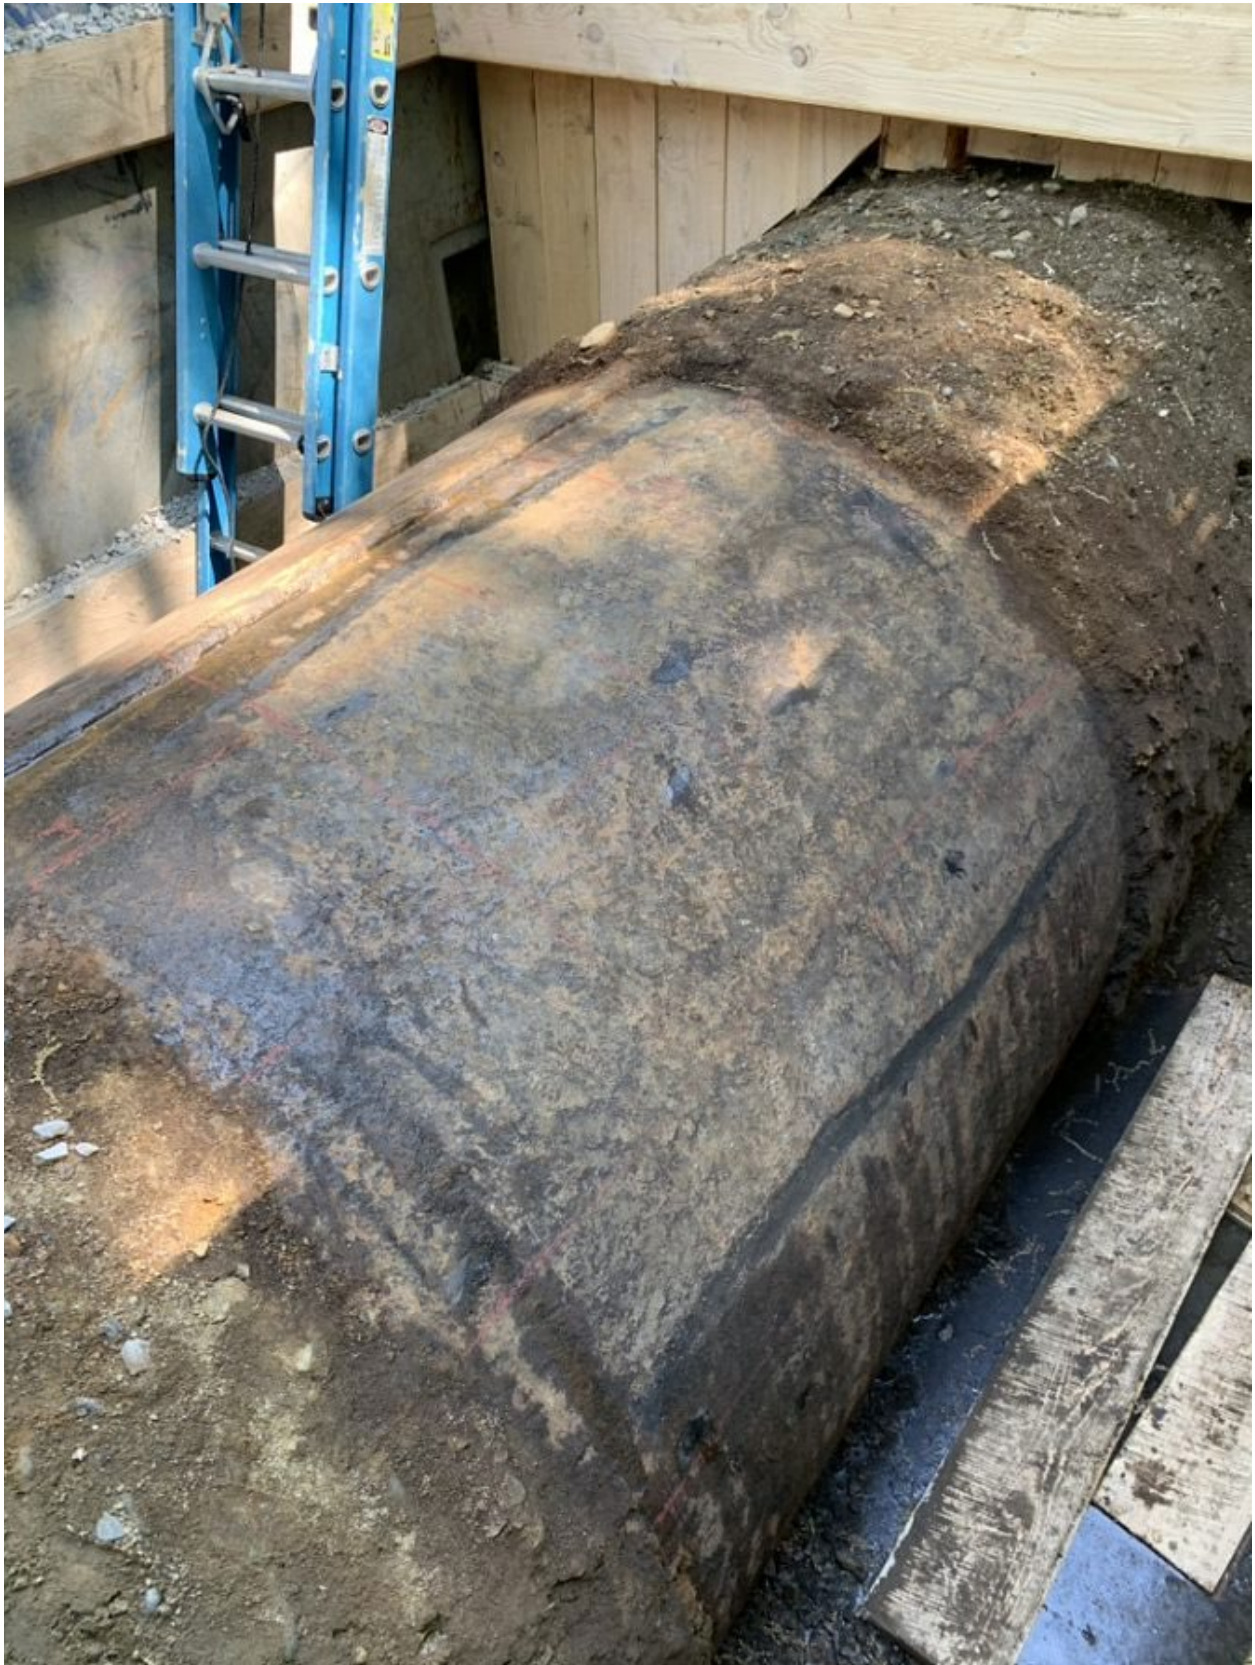
Site #3: Waverly Oaks Road: General Overview
