Proposal No. 613219-132950

ADDENDUM NO. 2

CHICOPEE-HOLYOKE-NORTHAMPTON-SPRINGFIELD-WEST SPRINGFIELD
Bridge Preservation of 26 Bridges along I-91

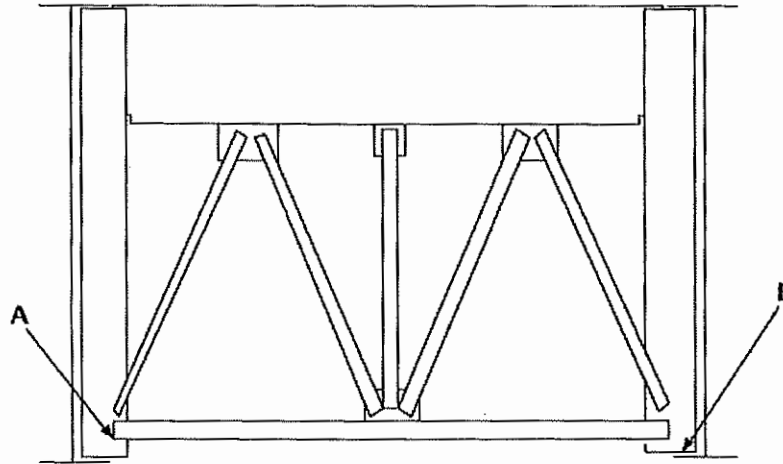
Chart 1: Cracked Weld and Base Metal on Steel End Diaphragms

Crack Location A = Crack along weld of end diaphragm connection plate to web stiffener plate.
Crack Location B = Crack along weld of end diaphragm connection plate to top of bottom flange.

NB Bridge - Summary of Crack Locations					
Span	Type	Adjacent Beam	Location	Location Relative to Beam	Length
1	A	25	Pier 1	South	1.5"
1	B	29	Pier 1	North	0.88"
1	B	28	E Abutment	North	0.75"
1	B	30	E Abutment	North	0.25"
1	B	30	Pier 1	North	0.75"
2	A	31	Pier 1	South	0.63"
2	A	31	Pier 2	South	1.25"
2	B	34	Pier 2	South	0.25"
2	A	36	Pier 1	North	0.13"
2	B	36	Pier 2	North	0.25"
3	B	37	Pier 2	South	0.75"
3	A	37	Pier 3	South	0.75"
3	B	42	Pier 2	North	0.5"
3	B	40	Pier 2	South	0.75"
3	B	41	Pier 2	South	0.5"
3	A	42	Pier 2	South	0.5"
3	B	42	Pier 3	South	0.5"
4	B	43	Pier 3	South	0.5"
4	B	43	W Abutment	South	1.75"
4	B	44	Pier 3	South	0.5"
4	B	47	W Abutment	South	0.63"
4	A	48	Pier 3	North	0.75"

There are specific welded repairs to the end diaphragms shown on pages A00808-16, bridge structure 10A and on A00808-43, bridge structure 10B (both pages attached for reference). Does the Department intend to perform any 961 activities to the welded end diaphragms?

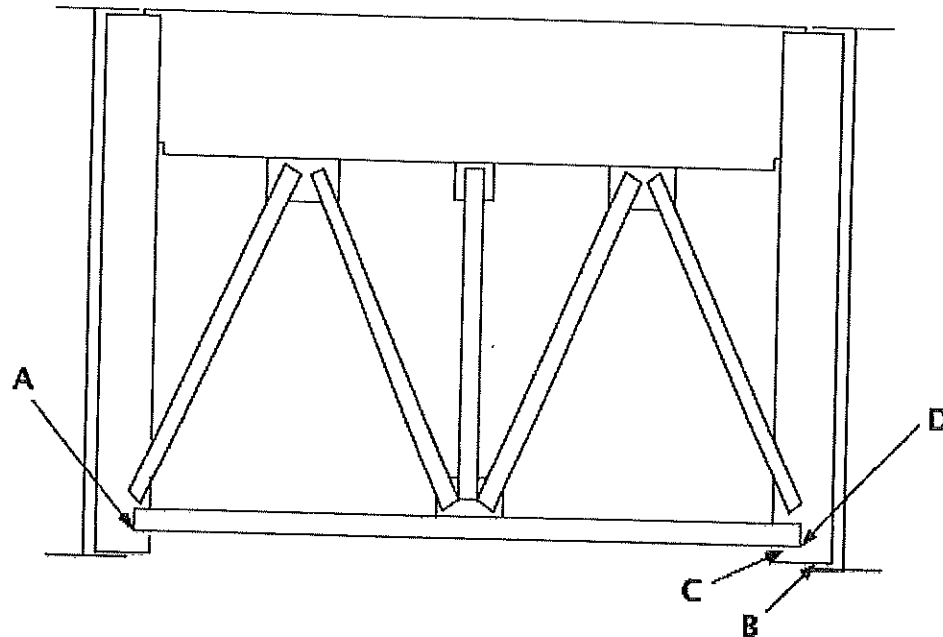
Chart 1: Cracked Weld Locations on Steel Diaphragms

Crack Location A = Crack along weld of end diaphragm connection plate to web stiffener plate.
Crack Location B = Crack along weld of end diaphragm connection plate to top of bottom flange.
Crack Location C = Crack along weld of end diaphragm connection plate to bottom of angle.
Crack Location D = Crack along weld of end diaphragm connection plate to side of angle.

SB Bridge - Summary of Crack Locations					
Span	Type	Adjacent Beam	Location	Location Relative to Beam	Length
1	A	1	Pier 1	North	0.5"
1	D	1	Pier 1	North	2.0"
1	B	4	Pier 1	South	0.38"
1	B	5	Pier 1	South	0.5"
1	B	6	Pier 1	South	1.0"
1	A	7	Pier 1	North	0.5"
2	C	9	Pier 2	North	1.75"
2	B	11	Pier 2	North	0.25"
2	B	12	Pier 1	South	1.25"
3	B	13	Pier 2	North	1.0"
3	B	17	Pier 2	North	0.5"
4	B	19	Pier 3	North	0.56"
4	B	20	W Abutment	North	0.5"

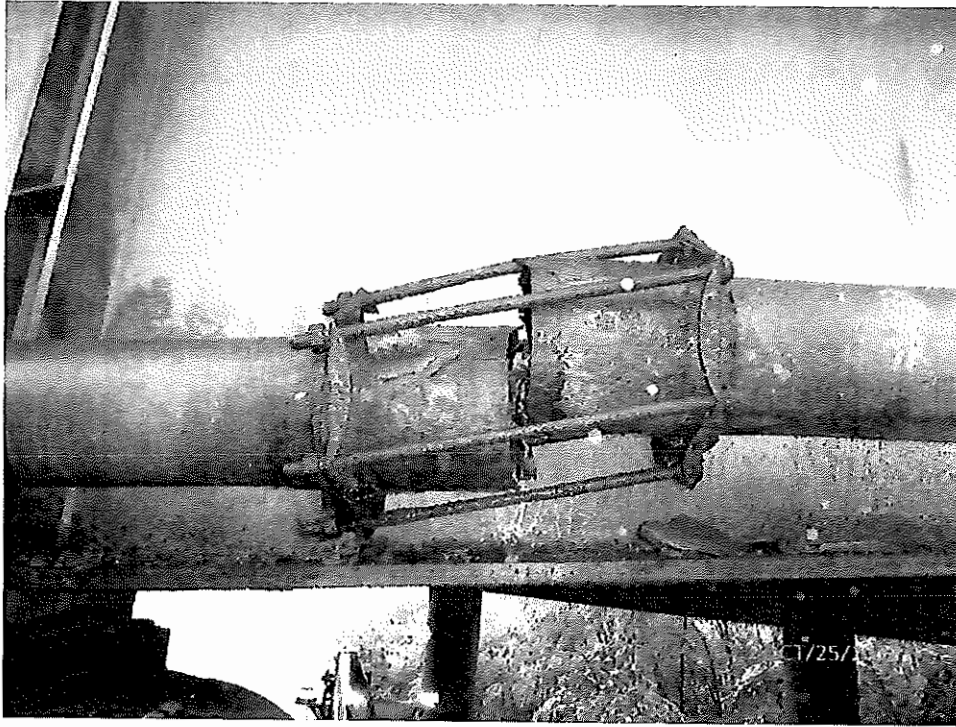
Photo 5: At Pier 2, the drainpipe is disconnected, and is leaking onto the roadway below.

On page A00808-46, photo # 5 (page attached for reference) identifies a broken steel drain pipe. Would there be any 961 activities (painting) required to be performed at these locations?

Repairs to the broken steel drainpipe identified in the attached bridge inspection report is not covered in this contract. See Document A00804 for anticipated locations to be cleaned and painted as part of this project.

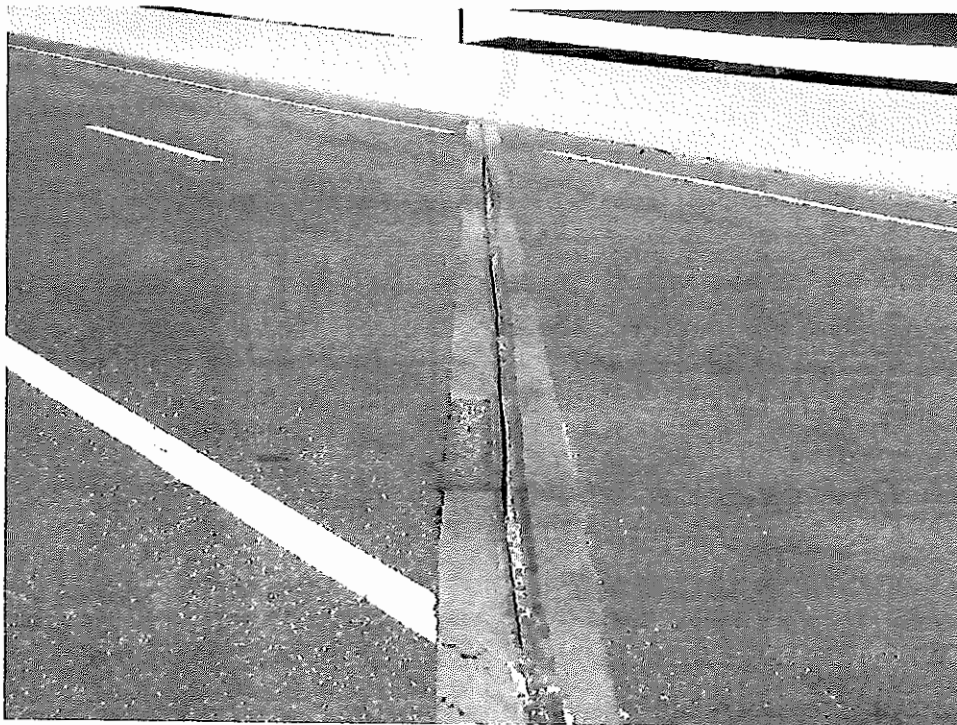
Photo 6: Pier 1 Deck Joint has debris impaction, a patched header, moderate misalignment, and a 3" gap in the north lane.
