PROJECT:
42 Inch PCCP Raw Water
Conveyance Pipeline and EDV
Facility
1515 Granville Road
Westfield, MA 01085
Project No. 24-01

ADDENDUM NO. 1 03/14/2024

**IFB# 24-01 WEST PARISH FILTERS WATER TREATMENT PLANT 42 INCH
RAW WATER CONVEYANCE REHABILITATION AND ENERGY
DISSIPATION VALVE CHAMBER
WESTFIELD, MASSACHUSETTS 01201**

Internal Inspection Findings – Summary

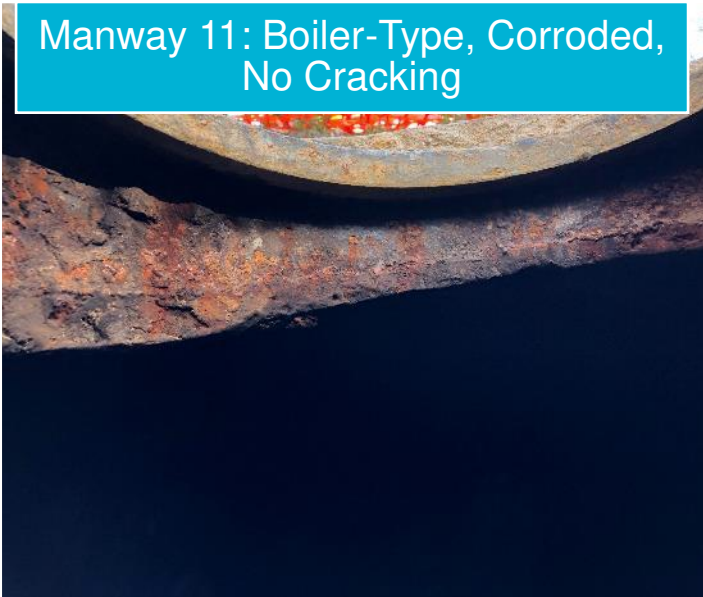
Manway 11: Boiler-Type, Corroded, No Cracking

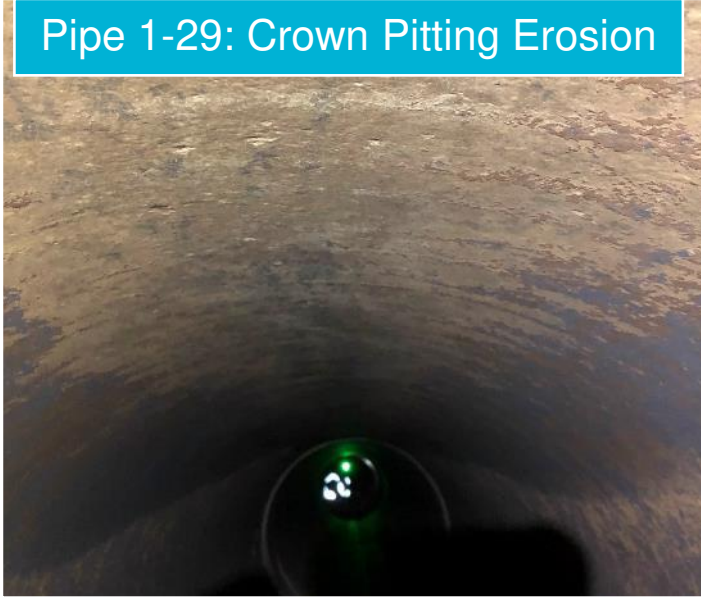
Pipe 1-29: Crown Pitting Erosion

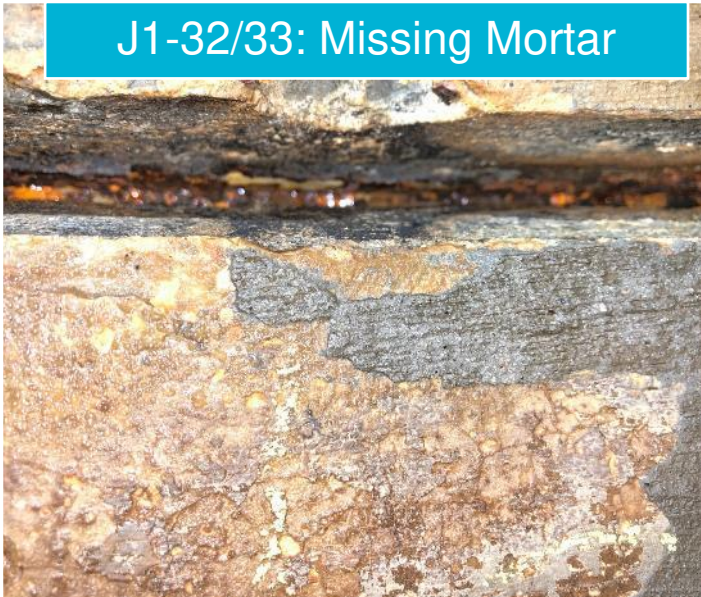
J1-32/33: Missing Mortar

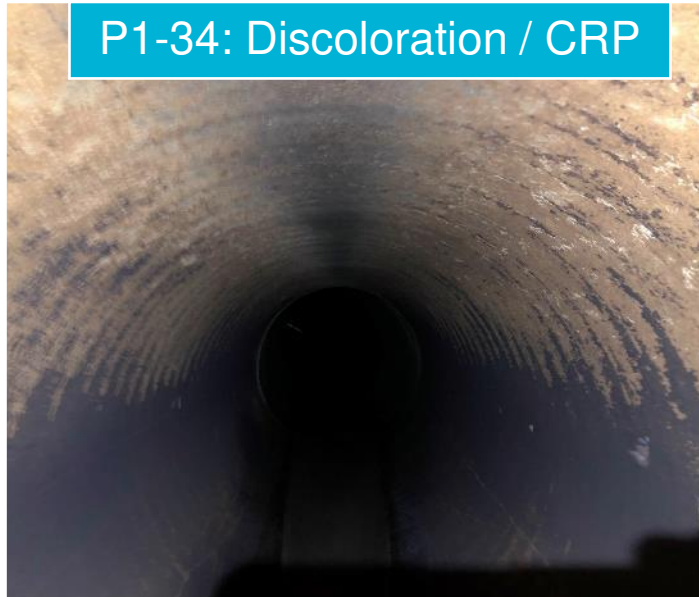
P1-34: Discoloration / CRP

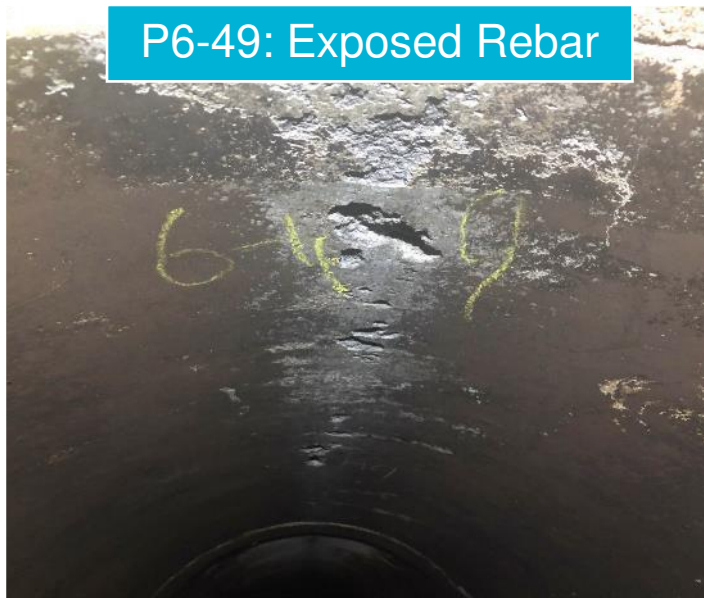
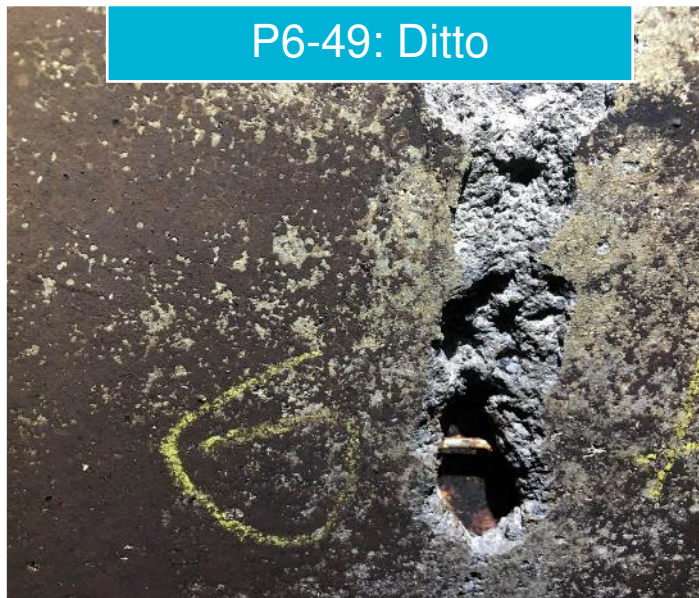
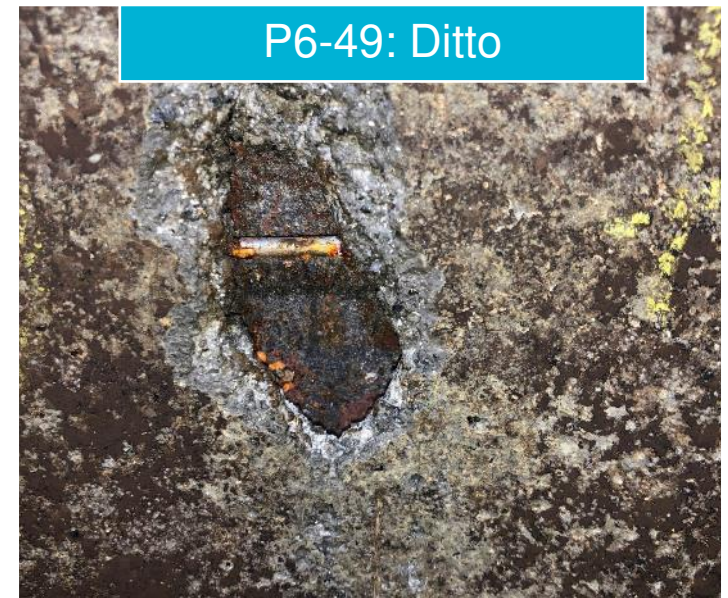
P6-49: Exposed Rebar

P6-49: Ditto

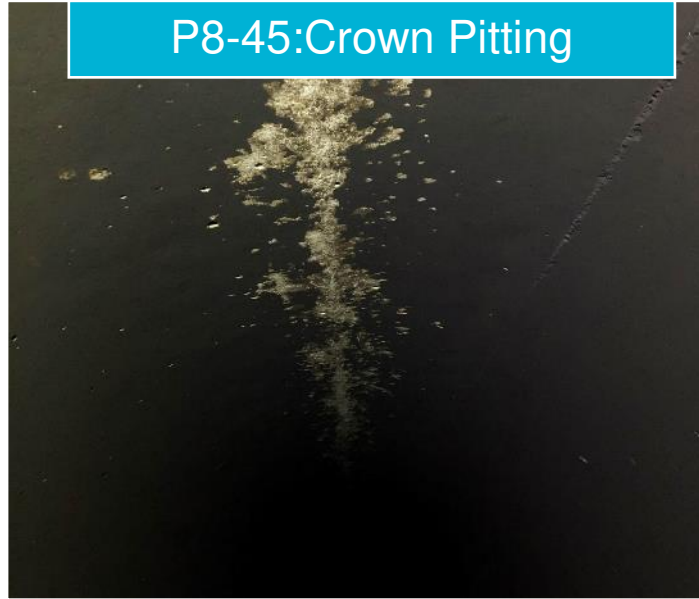
P8-45: Crown Pitting

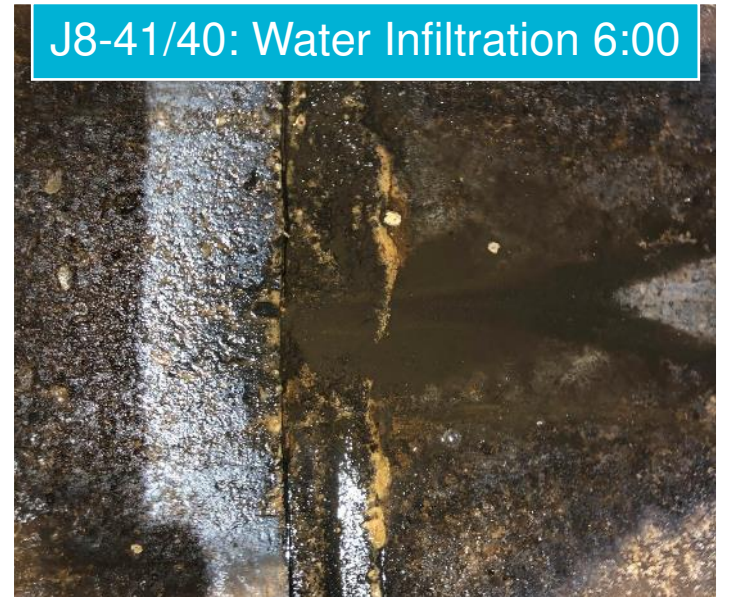
J8-41/40: Water Infiltration 6:00

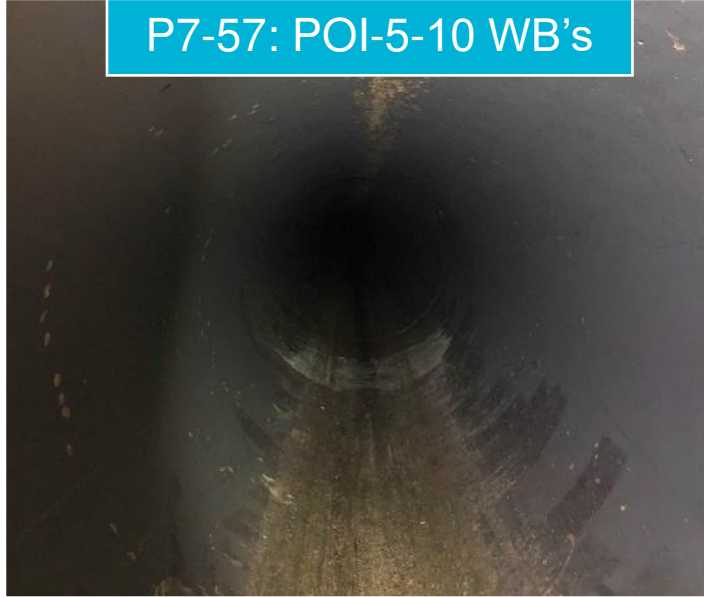
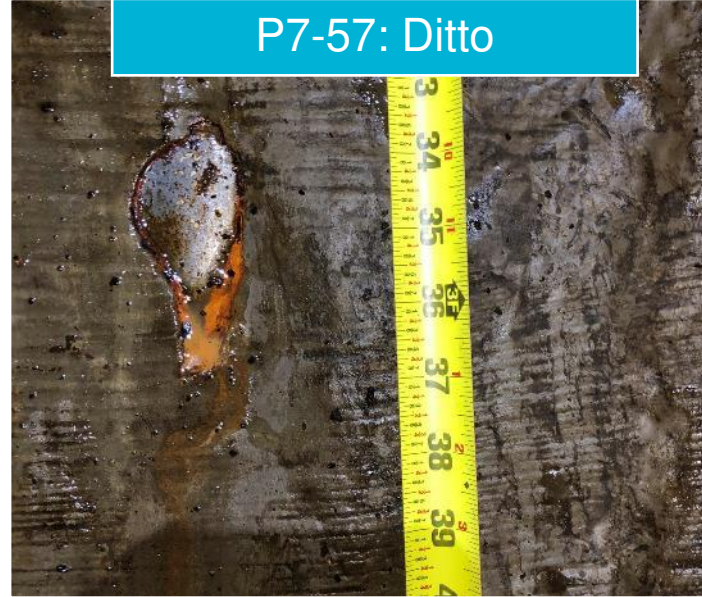
P7-57: POI-5-10 WB's

P7-57: Ditto

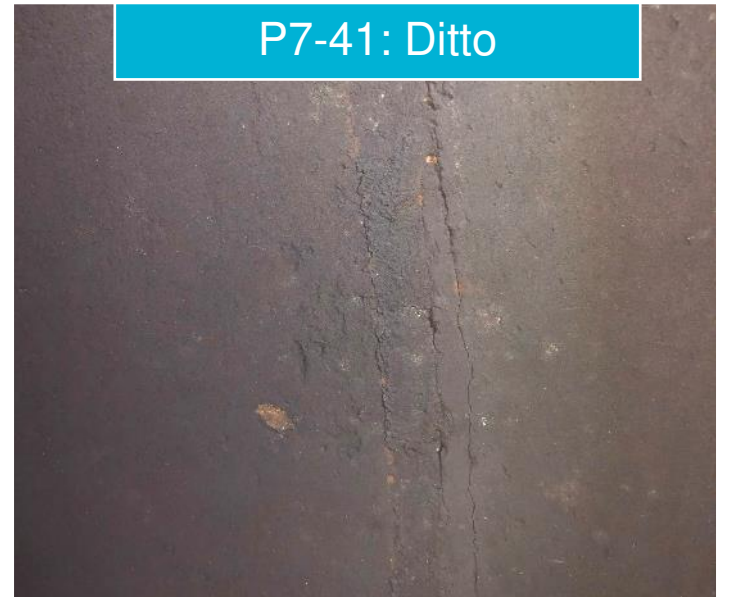
P7-41: Circumferential Cracks
10:30-12:00; 4:30-5:30; 2:00-3:00

P7-41: Ditto

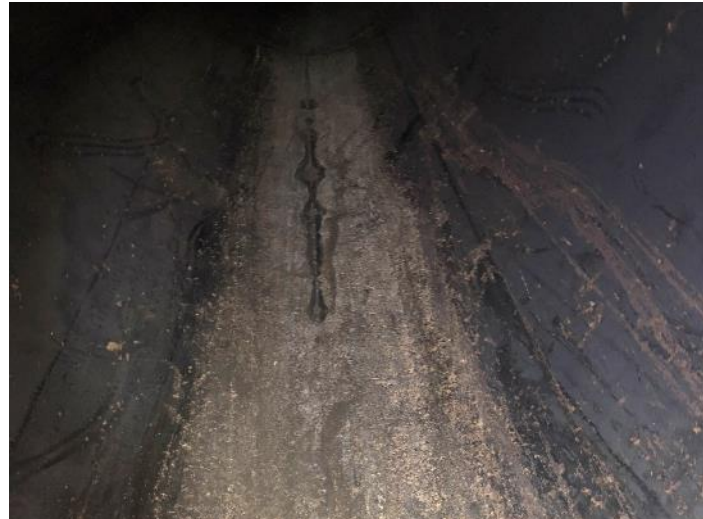
Black Streak Along 6:00
at Steep Section

Ditto

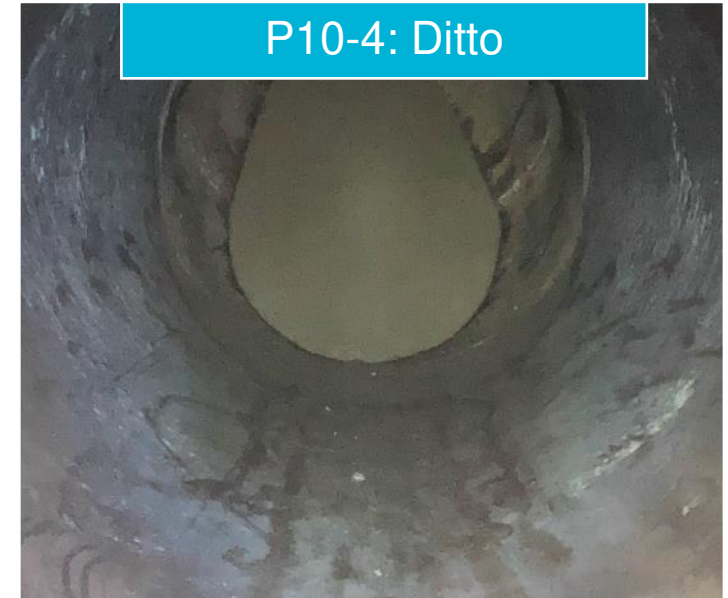
P10-4: ECP250 Water in Background

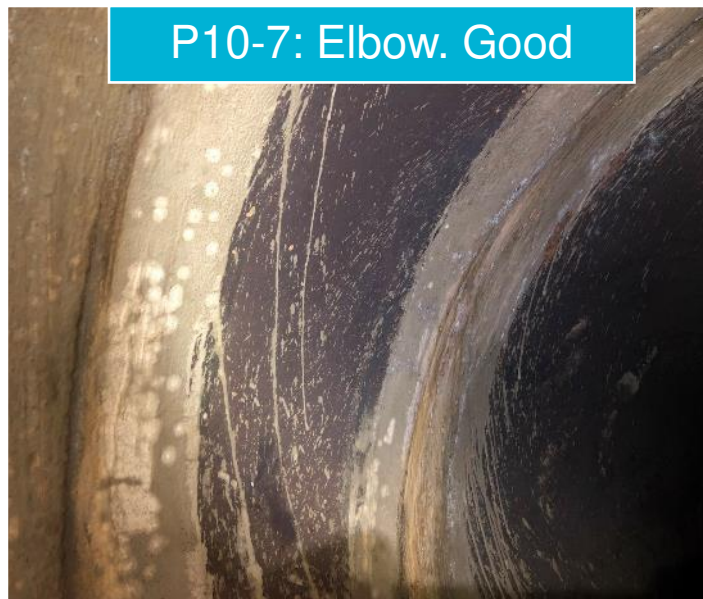
P10-7: Elbow. Good

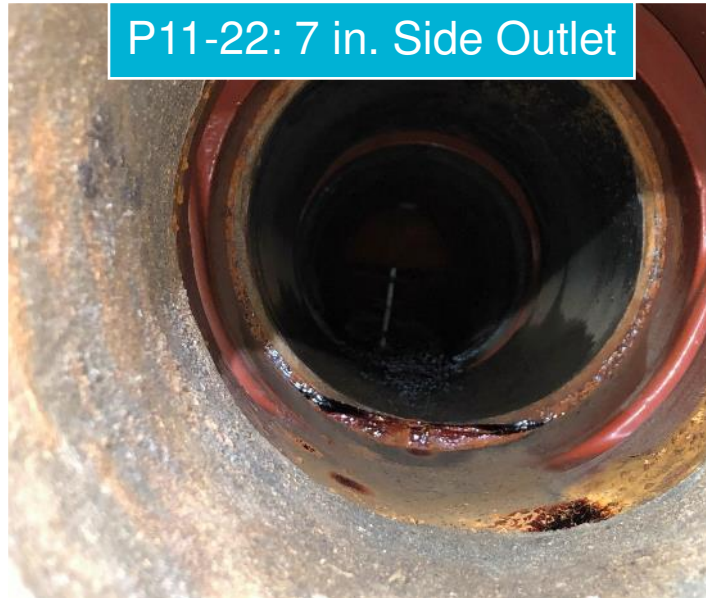
P11-22: 7 in. Side Outlet

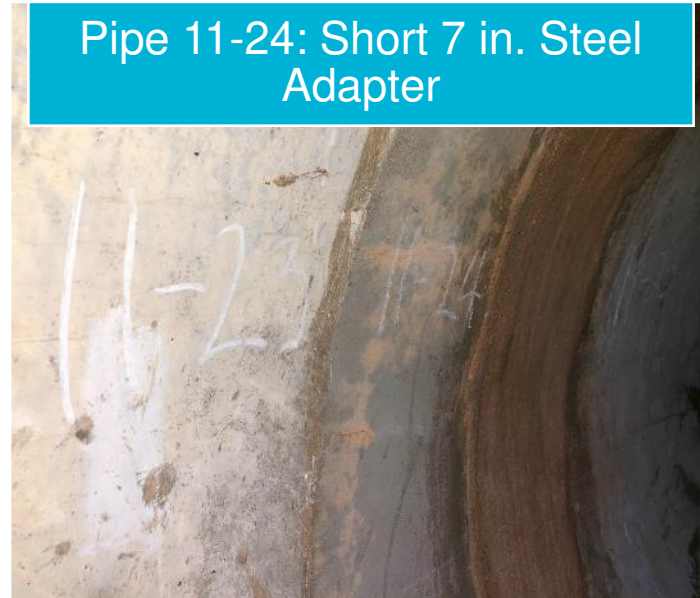
Pipe 11-24: Short 7 in. Steel Adapter

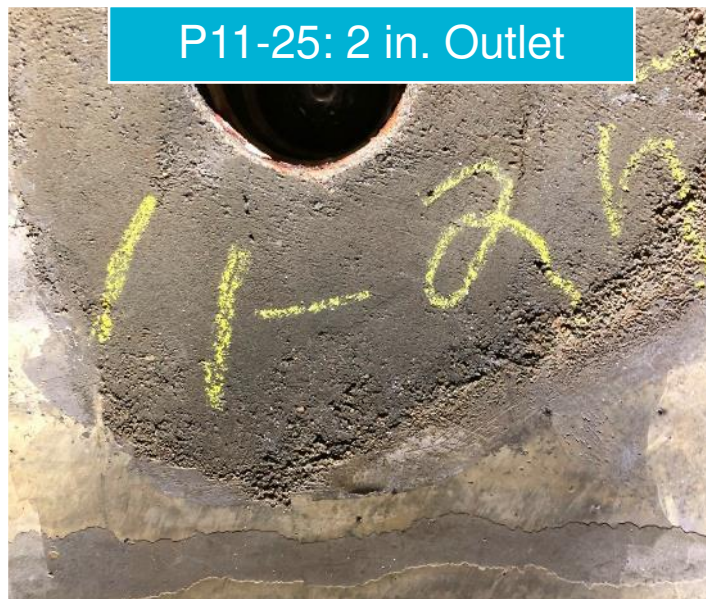
P11-25: 2 in. Outlet

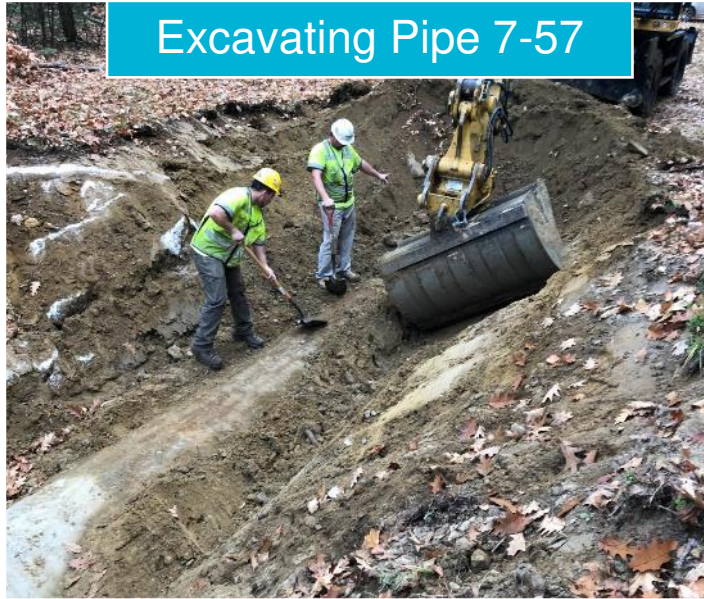
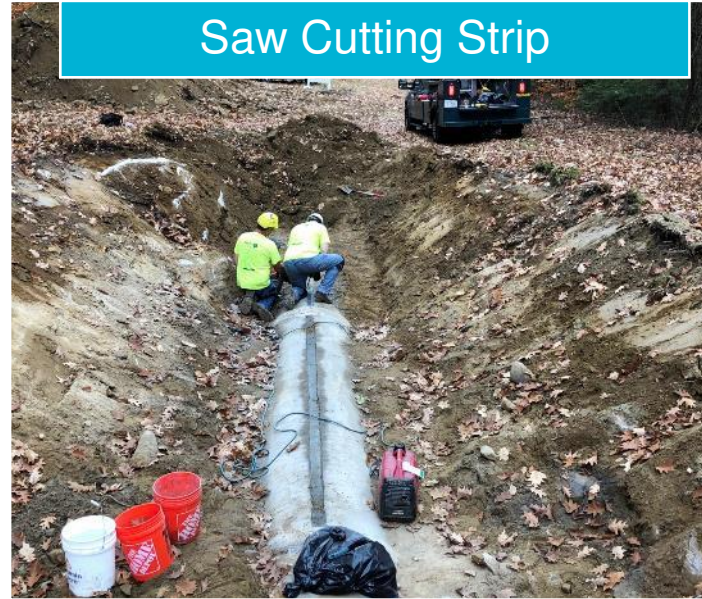
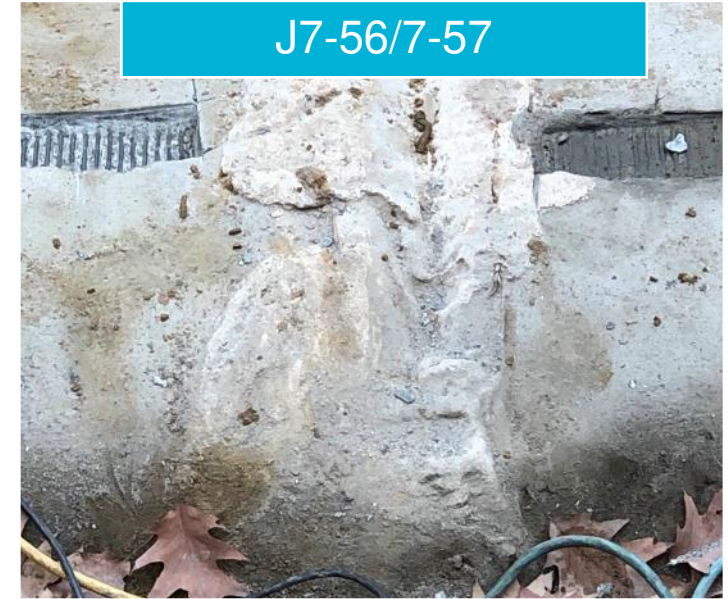
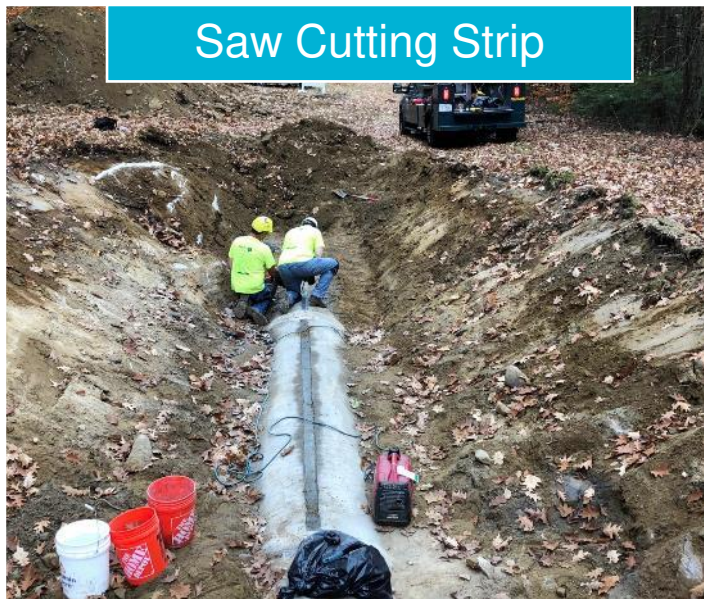
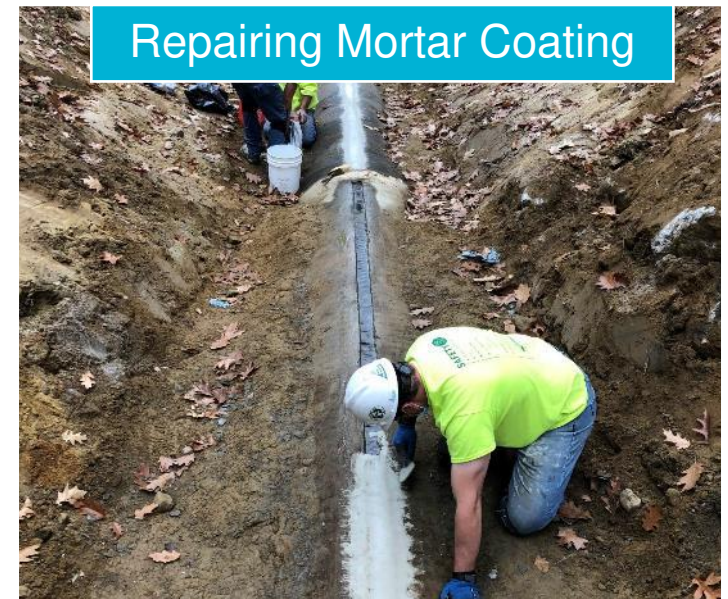
Inspection Day 8 – 11 November 2020: Continuity Testing on Pipe 7-57

| Internal Pipe No | Low STA., ft | Dia. In. | Pipe Class | Pipe Length, ft | Distance to BWZ ¹ , ft (2012) | Total NBW ² (2012) | Distance to BWZ ¹ , ft (2019) | Total NBW ² (2019) | Change |
|---|---|---|---|---|--|---|--|---|---|
| 7-57 | 68+51 | 42 | ECP175 | 16 | 2.0 | 5 | 2.5 | 10 | 5 |
