NOTICE TO PROSPECTIVE BIDDERS
RI CONTRACT NO. 2024-CB-018 – ADDENDUM NO. 1

Add New Appendix to this Addendum No. 1. “Bridge Inspection Report” has been added.

SPECIAL INSPECTION SCOPE: The scope of the special inspection shall include the advanced deterioration of the beam ends including the web area beyond the end diaphragms, end diaphragms, fixed bearings and moveable bearings. The special inspection shall also include the AASHTO Fatigue Category E' welds at the transverse ends of the cover plates and the bottom flanges of the beams. If any cracks are observed at these weld details, the RIDOT Bridge Ratings Section shall be notified.

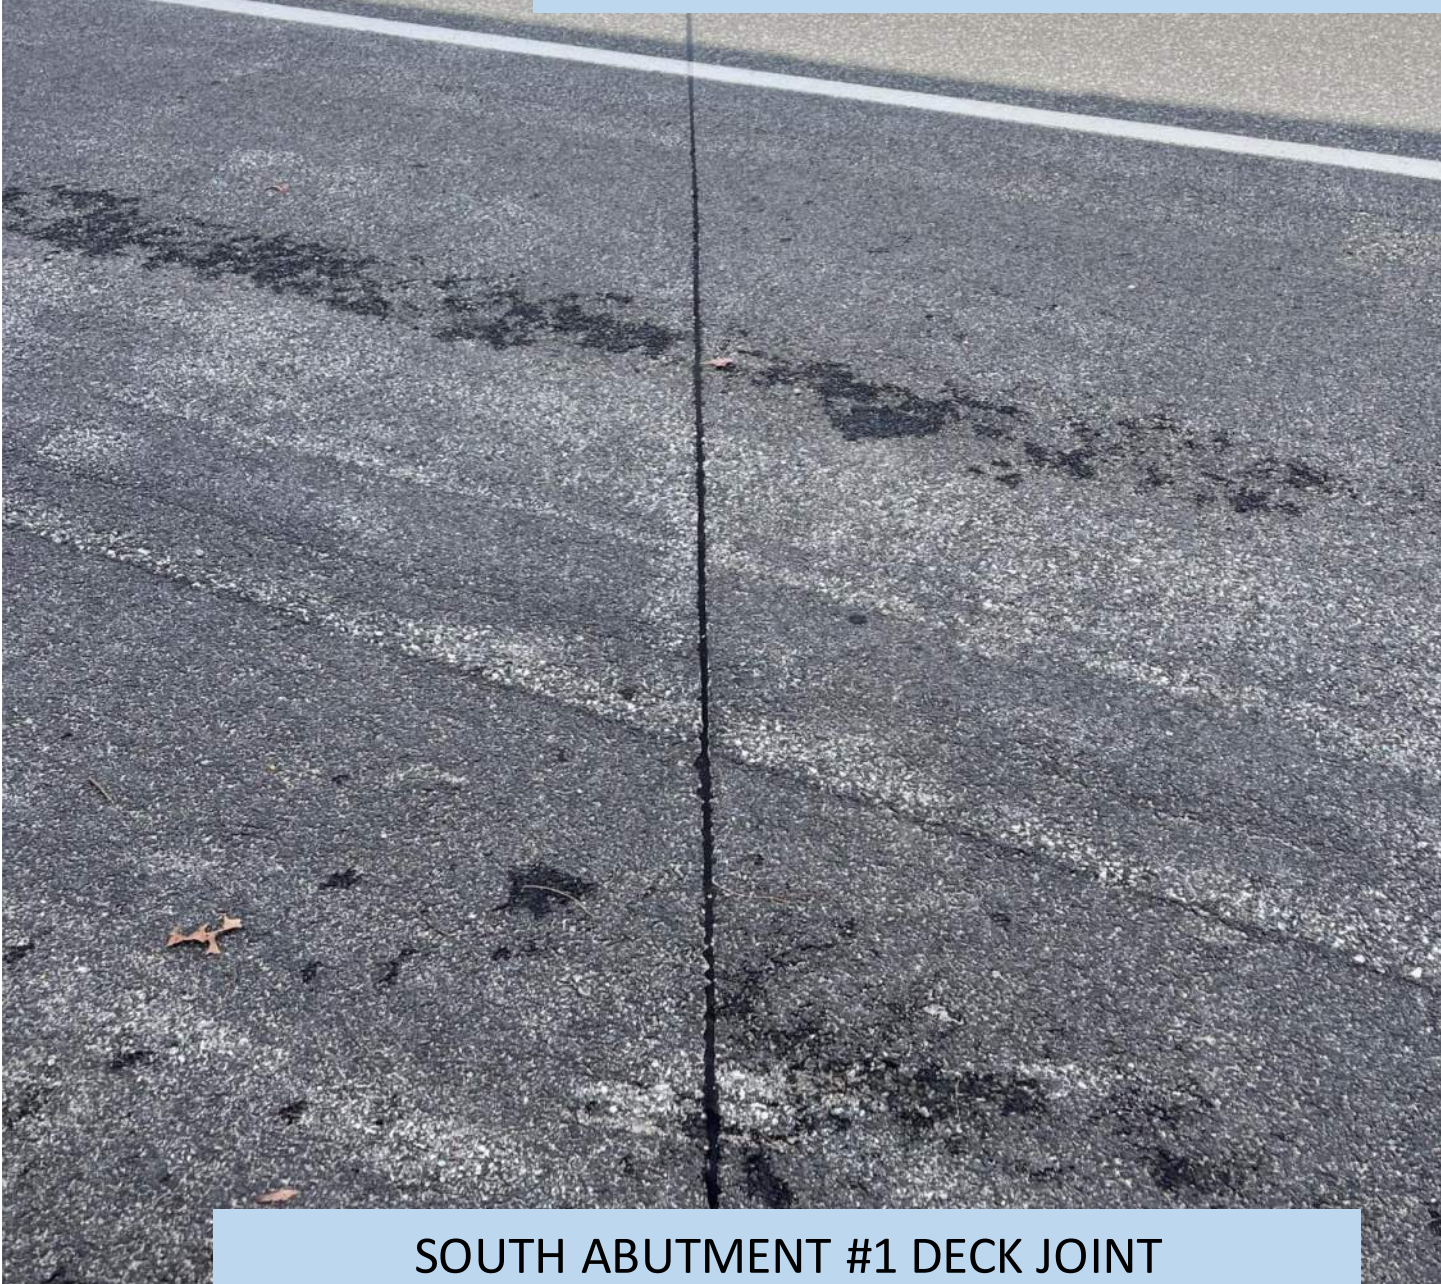
PHOTO #10

There are pourable joint seals in both lanes at South Abutment #1 (see photos 10 & 11).

**SOUTH ABUTMENT #1 DECK JOINT
(RI-4 SOUTHBOUND)(LOOKING EAST)**

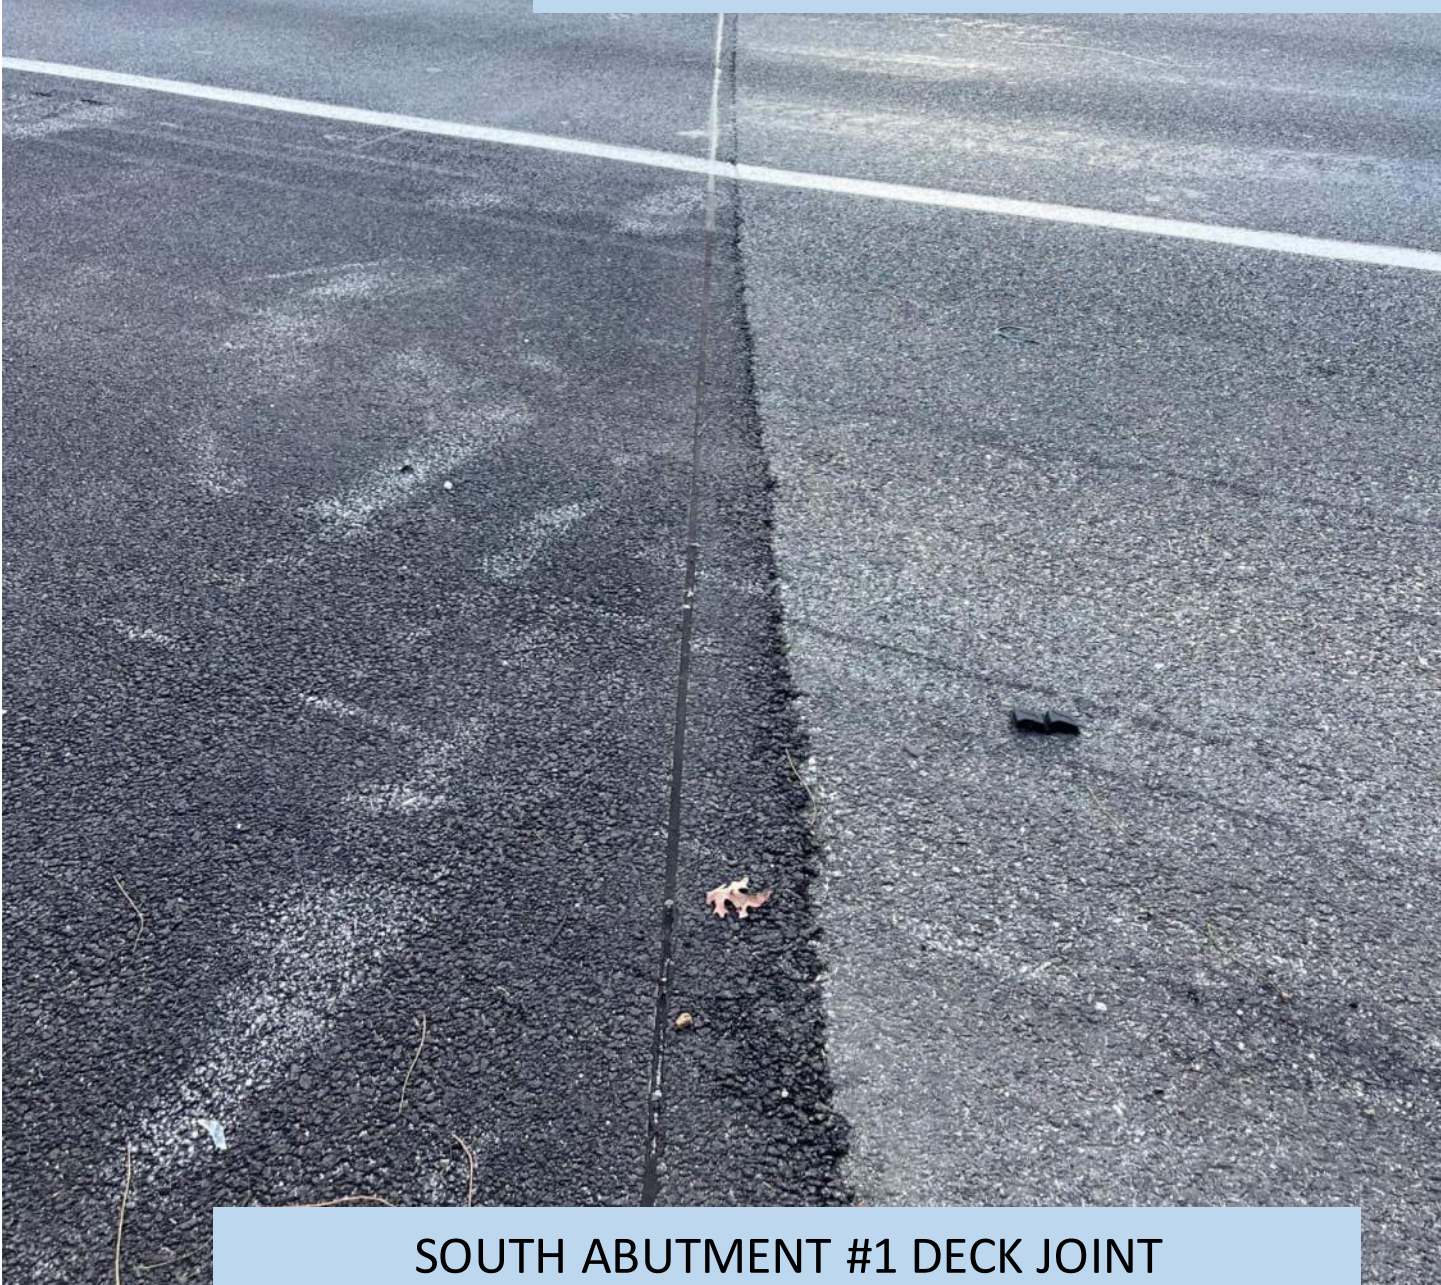
PHOTO #11

**SOUTH ABUTMENT #1 DECK JOINT
(RI-4 NORTHBOUND) (LOOKING WEST)**

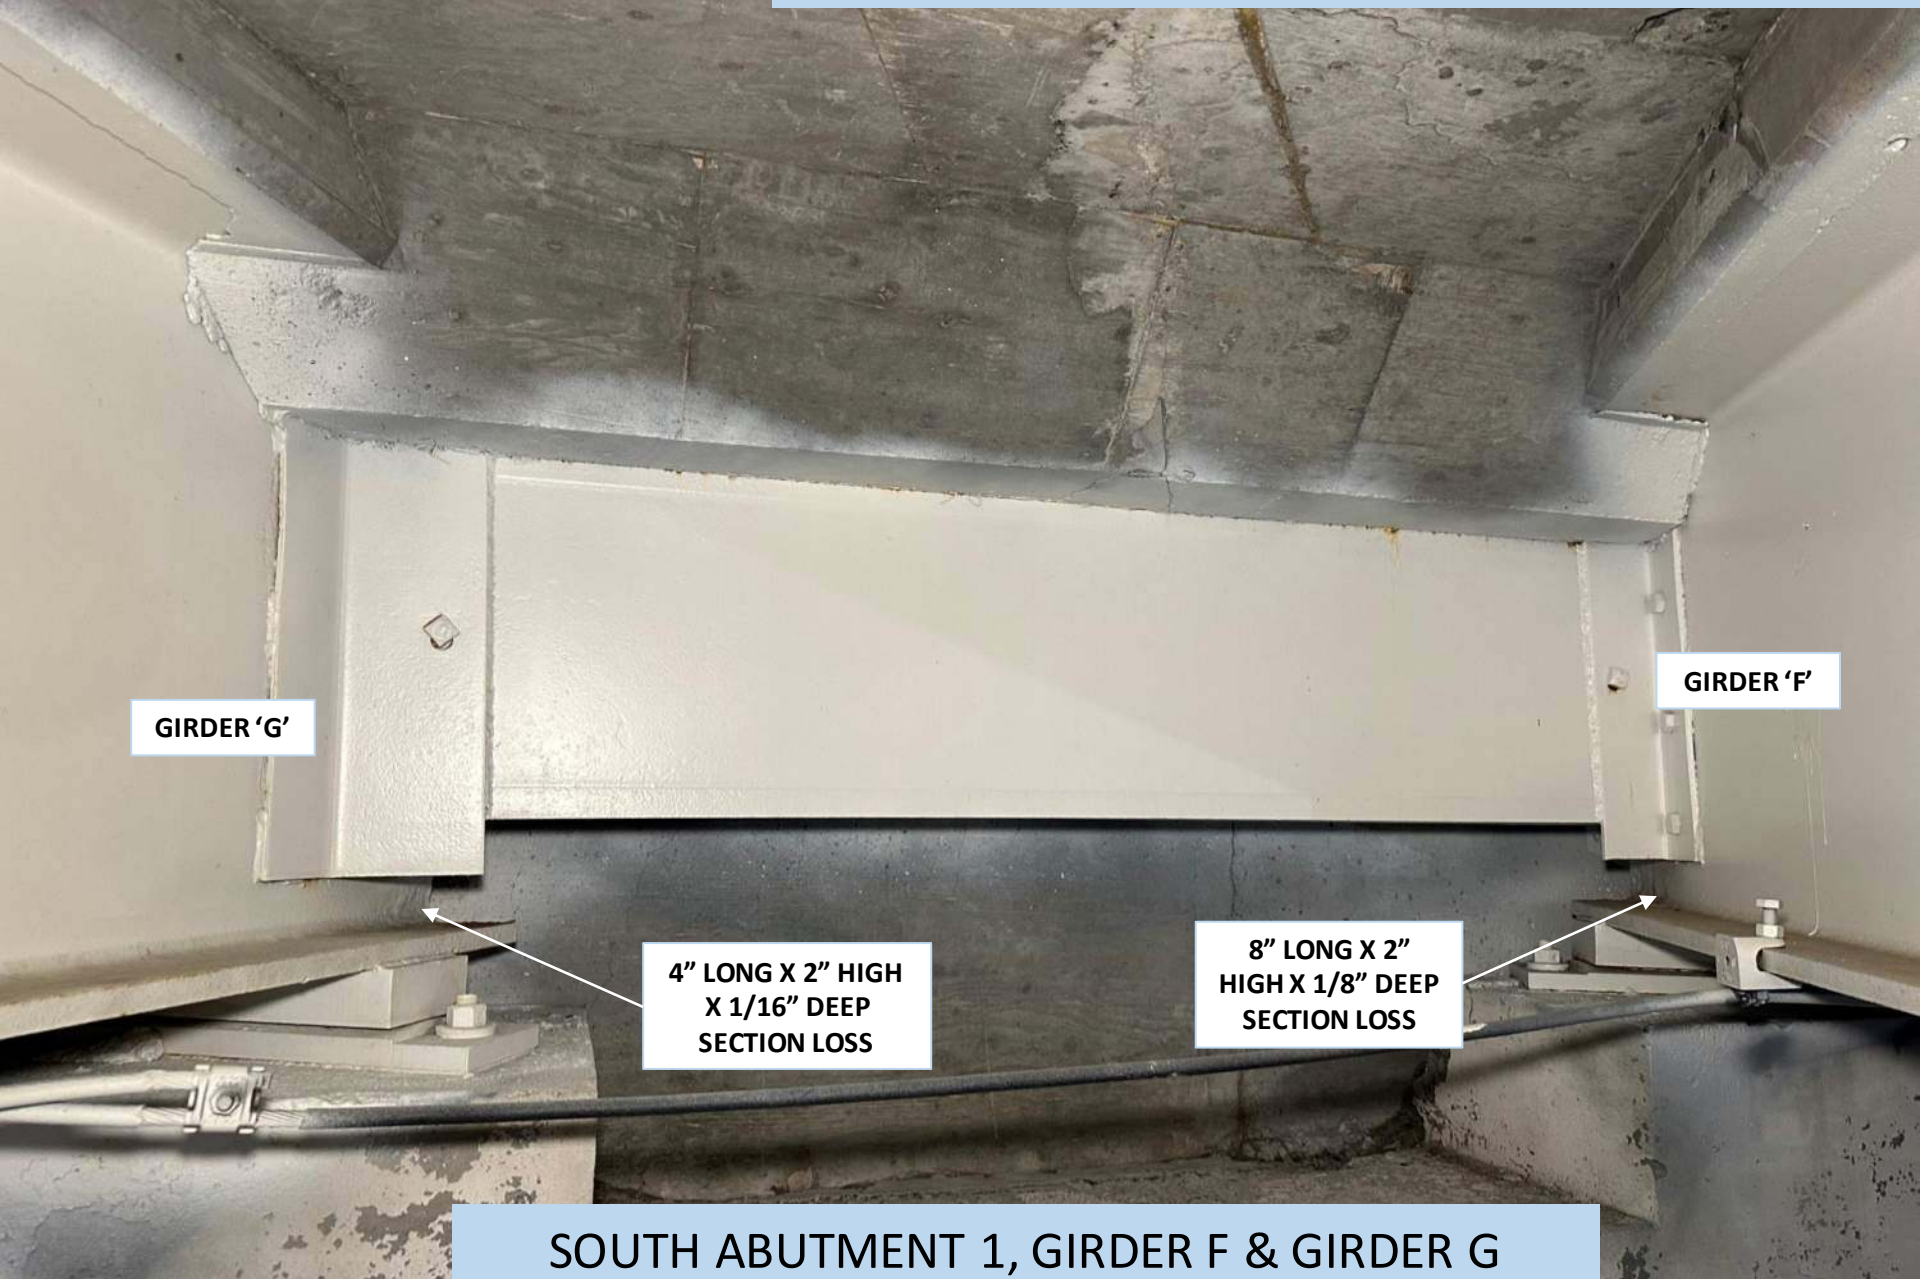
**8" LONG X 2"
HIGH X 1/8" DEEP
SECTION LOSS**

**SOUTH ABUTMENT 1, GIRDER F & GIRDER G
(LOOKING SOUTH)**
