ADDENDUM No. 1

LEE, LENOX AND PITTSFIELD

MassDOT Berkshire Line Civil Improvements

2018 CULVERT INSPECTION REPORTS 30 Pages

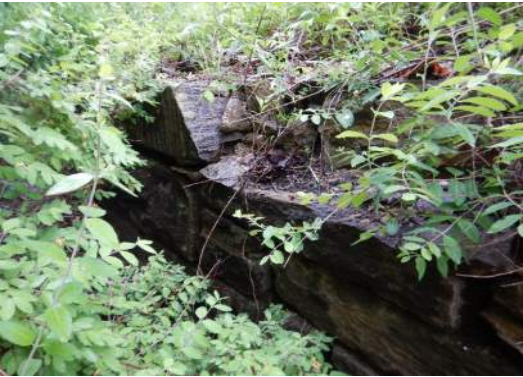
Description: West Headwall

Comment: Dislodged masonry block.

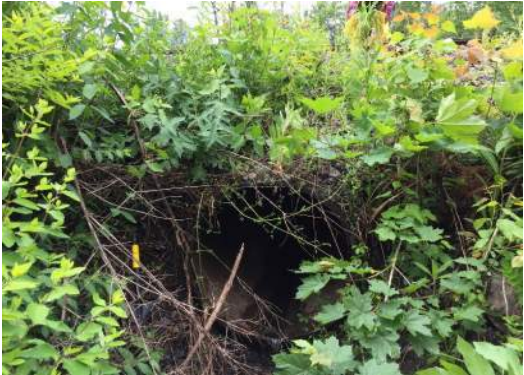
Photo 3

Description: East Elevation

Comment: Scour present underneath pipe.

OVERAL CONDITION RATING: 4
CRITICAL FINDINGS: None
FOR IMMEDIATE ATTENTION: Repair open joints before. Protect east end of culvert from scour, consider installing headwall.
MAINTENANCE: Fill scour hole and undermining with stone and rip rap. Clear pipe. Repair rail profile dip. Perform track maintenance.

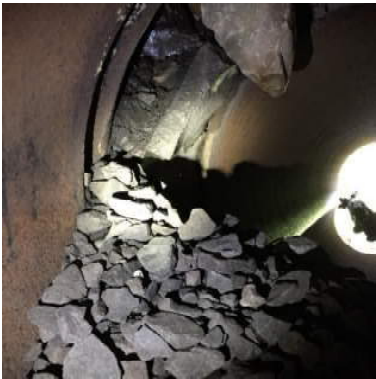
Photo 5

Description: Pipe Interior

Comment: Open Pipe Joint. Ballast lost into culvert.

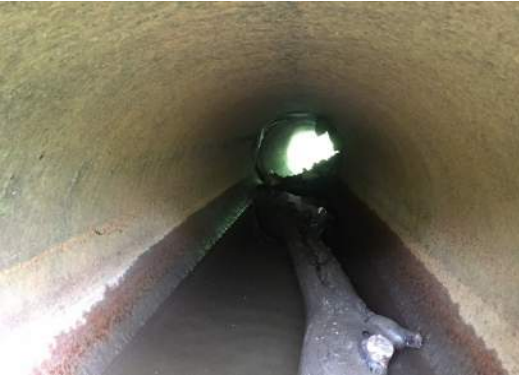
Photo 4

Description: Typical Culvert Interior

Comment: 6" dia. log within culvert.

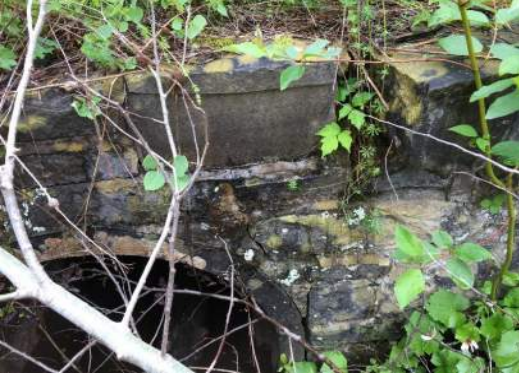
Photo 6

Description: West Headwall

Comment: Vertical crack. Masonry block displaced by 7".

3) West headwall has a vertical crack starting at the 2 o'clock position on pipe. See Photo 6.

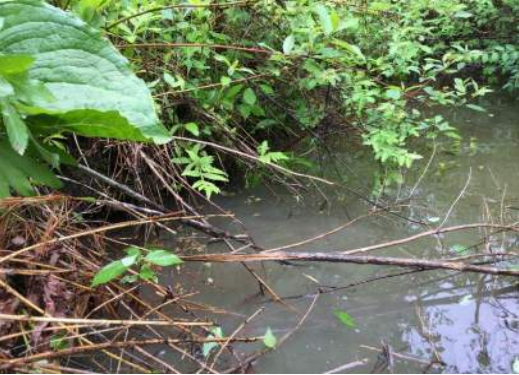
Photo 8

Description: East Channel

Comment: Degradation and local scour present.

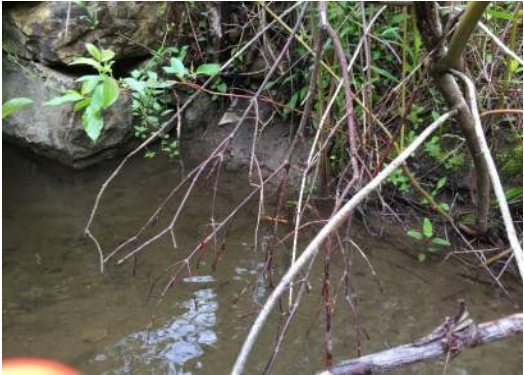
Photo 3

Description: East Stream Bed

Comment: Minor scour, without undermining at corner.

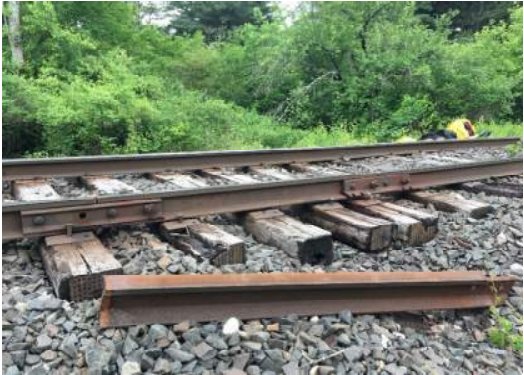
Photo 5

Description: Track over Culvert

Comment: Track dips over culvert. Low ballast under joint.

OVERAL CONDITION RATING: 4
CRITICAL FINDINGS: None
FOR IMMEDIATE ATTENTION: Consider replacement or culvert lining. Correct track defects.
MAINTENANCE: Protect embankment and track from erosion and culvert from scour. Clear debris. Track Maintenance.

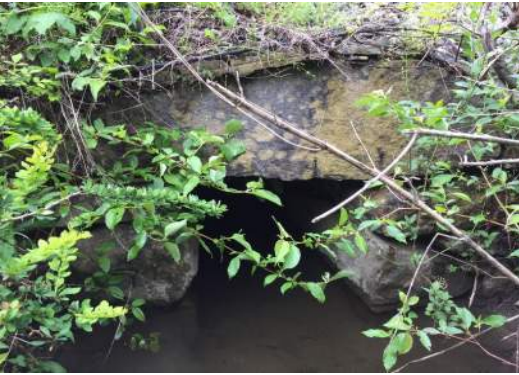
Photo 2

Description: East Elevation

Comment: Minor settlement and displacement.

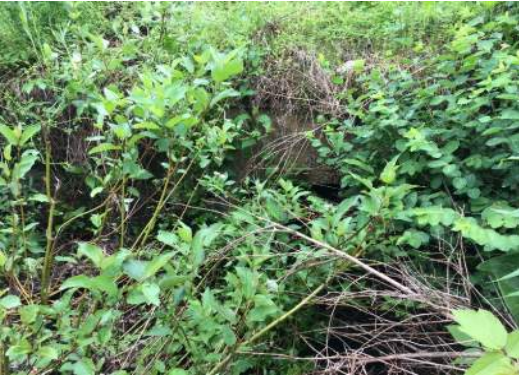
Photo 4

Description: West Elevation

Comment: Vegetation restricting stream.

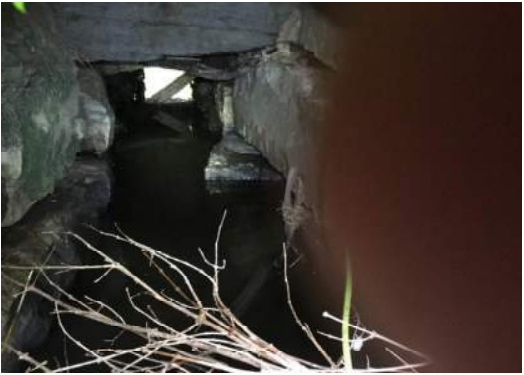
Photo 7

3) Walls have displaced and missing stones, typical along the length of both sides. Most blocks show displacement/rotation or are missing.

Description: Typical Culvert Interior (from west end)

Comment: Displaced walls and ceiling masonry.

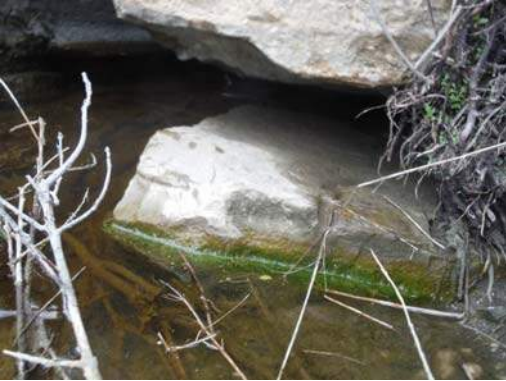
Photo 7

Description: West Inflow

Comment: Missing Stone at South Aabutment

OVERAL CONDITION RATING: 6 - Satisfactory
CRITICAL FINDINGS:
FOR IMMEDIATE ATTENTION:
MAINTENANCE: Monitor culvert abutment movement, replace missing stone and shore culvert.

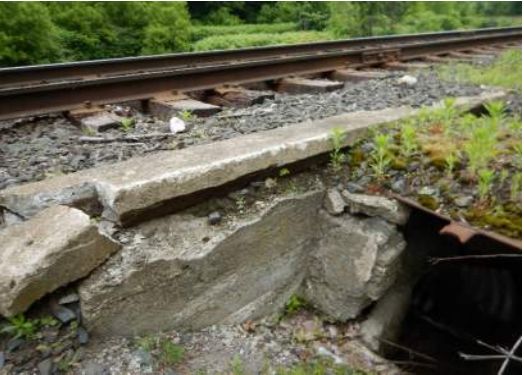
Photo 6

Description: East Headwall

2) East headwall: spall concrete at embedded steel 3-6" from top F. full length. See Photo 6.

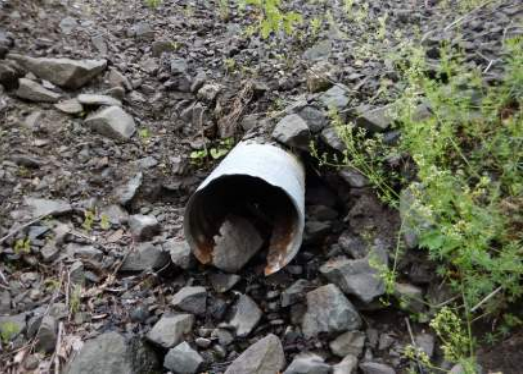
Photo 7

Description: West Elevation
Comment: Severe erosion around outtake of pipe

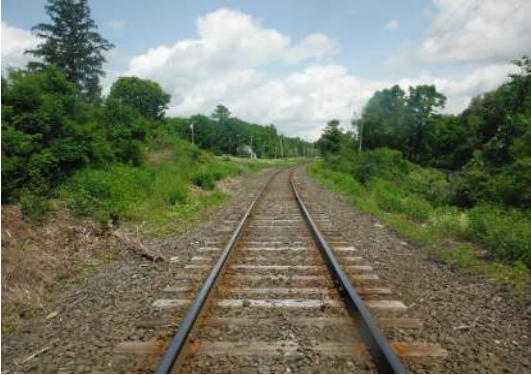
Photo 1

Description: From Bridge Look. N.

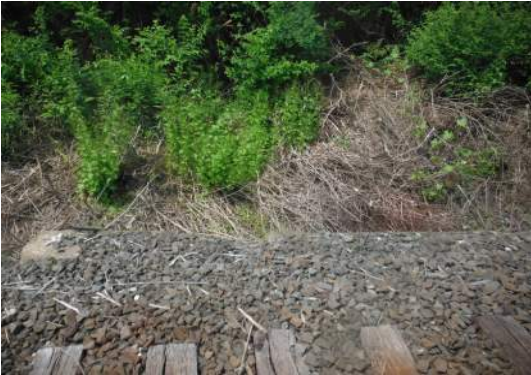
Photo 3

Description: Looking Upstream

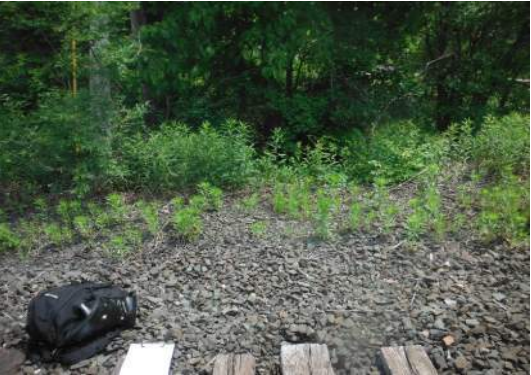
Photo 4

Description: Looking Downstream

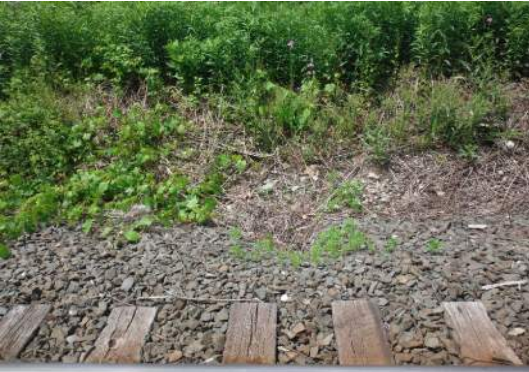
Photo 3

Description: Looking Upstream

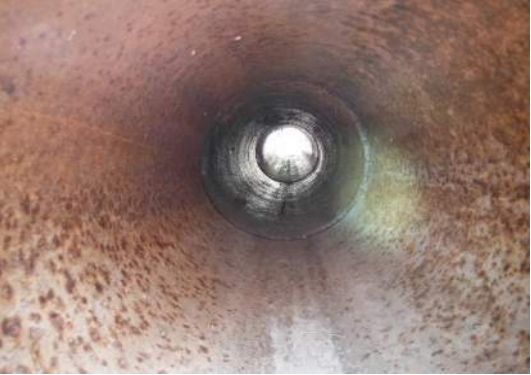
Photo 2

Comment: Note misaligned joints

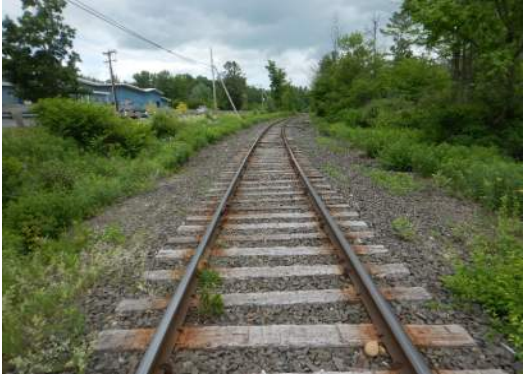
Photo 1

Description: From Culvert Look. N.

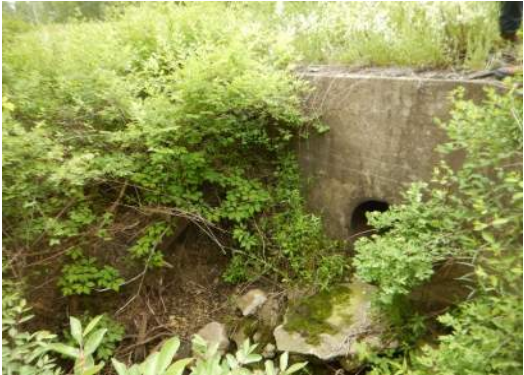
Photo 3

Description: East Elevation

FOR IMMEDIATE ATTENTION: Repair scour under east headwall and repair riprap on stream bank

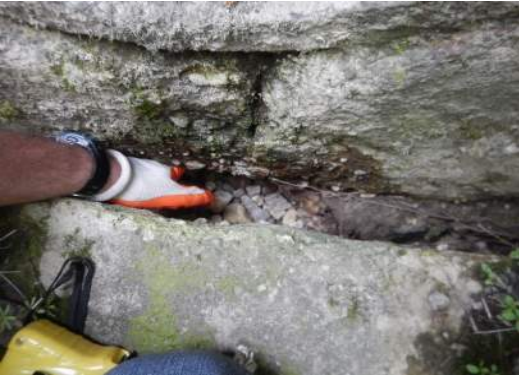
Photo 6

Description: East Headwall

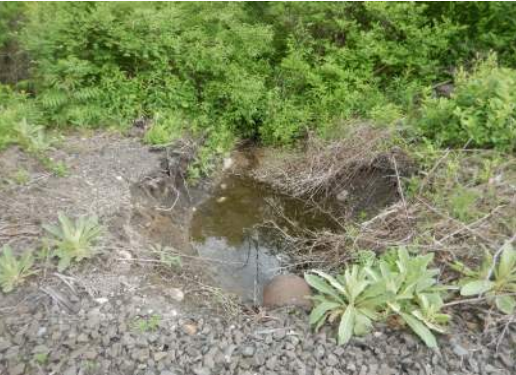
Photo 6

ITEM	GERNERAL	RATING: X	REMARKS	PHOTO #
1	Action Under Trains			
2	Embankment	3	Severe erosion around outfall	6
3	Track Over Culvert		No dips, similar to adjacent track	7
ITEM	STREAM CONDITIONS	RATING: X	REMARKS	PHOTO #
4	Alignment - West		Drainage ditch parallel to track	3
5	Alignment - East			
6	Channel - East			
7	Channel - West			
8	Stream Bed		Silt and sand present	
9	Channel Protection			
10	Drift/Debris		None	
11	Scour	3	Scour at outfall, 12" below natural stream bed and 24" before outfall invert.	3
ITEM	CULVERT STRUCTURE	RATING: 7	REMARKS	PHOTO #
12	Abutment (N or E)			
13	Abutment (S or W)			
14	Head Walls - West			
15	Head Walls - East			
16	Wingwalls			
17	Ceiling Slab			
18	Invert Slab			
19	Walls			
20	Arch Ring			
21	Pointing			
22	Pipes/Circular Culverts	7	Clear, minor scour, joints tight	3
23	Apron

Description: East Outfall

OVERAL CONDITION RATING:
CRITICAL FINDINGS:
FOR IMMEDIATE ATTENTION: Armor embankment and stream bed at outfall
MAINTENANCE:

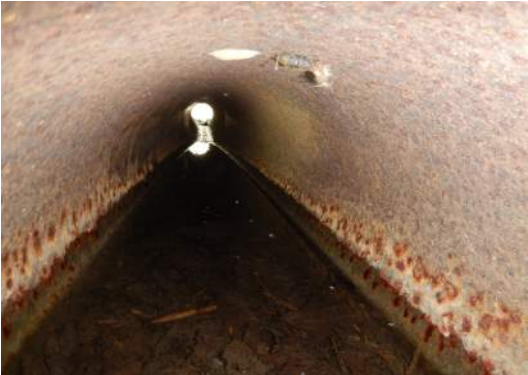
Photo 6

Comment: Minor surface rusting

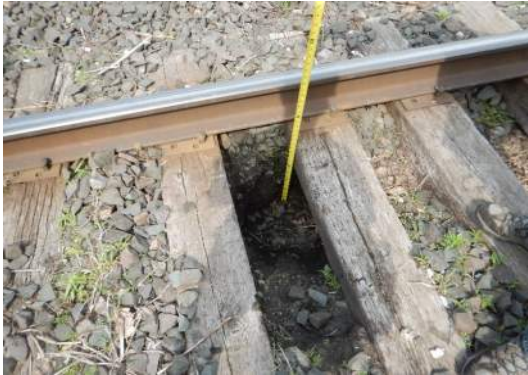
Photo 5

ITEM	GERNERAL	RATING: X	REMARKS	PHOTO #
1	Action Under Trains			
2	Embankment		Hole has opened beneath ties 18" D x 18" L x 36" W	5
3	Track Over Culvert			
ITEM	STREAM CONDITIONS	RATING: X	REMARKS	PHOTO #
4	Alignment - West		Parallel to RR	
5	Alignment - East		Flow at 15 degrees S.E. skew to centerline of culvert	
6	Channel - East		Heavy veg.	
7	Channel - West			
8	Stream Bed		Agr. 15-20' downstream restricts flow	
9	Channel Protection			
10	Drift/Debris			
11	Scour			
ITEM	CULVERT STRUCTURE	RATING: 5	REMARKS	PHOTO #
12	Abutment (N or E)			
13	Abutment (S or W)			
14	Head Walls - West			
15	Head Walls - East			
16	Wingwalls			
17	Ceiling Slab			
18	Invert Slab			
19	Walls			
20	Arch Ring			
21	Pointing			
22	Pipes/Circular Culverts			
23	Apron

Description: Track Elevation

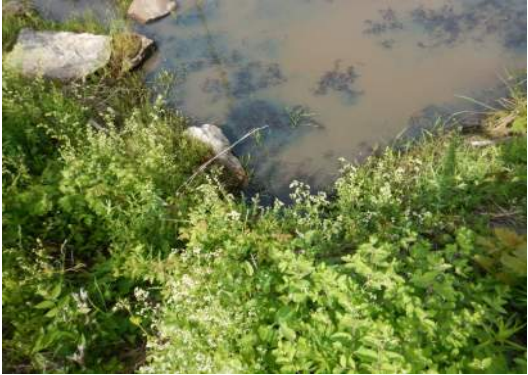
Photo 2

Description: Looking Upstream

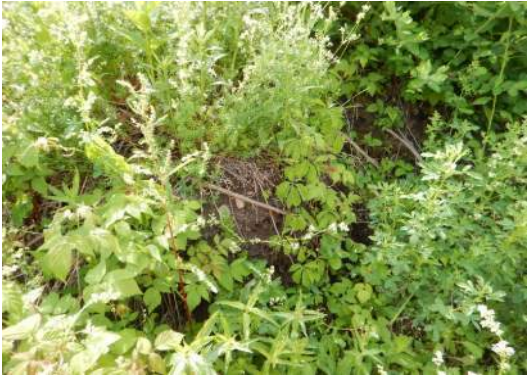
Photo 6

Description: West Embankment

- 1) Culvert Cover: 49" from Top of Culvert to Top of Rail.
- 2) Upstream there is light corrosion at south, tree and debris, and 2" misc. of joint under track.
- 3) Signs of sluffing on embankment, erosion present. See photo 6.
- 4) Downstream has soil build-up and aggregation.
- 5) East headwall has stone displaced and rotated outward 9" and is partially collapsed at both North and South end. Scour is undermined by 6" deep 12" long underneath pipe. No sign of undermining headwall.

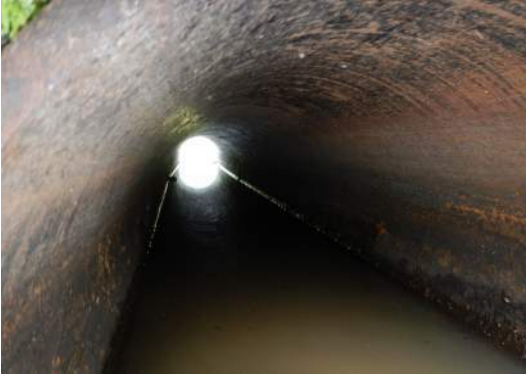
Photo 8

Description: Typ. Culvert Interior
Comment:
